### **South Wellington School Renovation Design Consulting Services**

**Addendum 1 (191 pages)**

## FEASIBILITY STUDY REPORT

## **BUILDING CONDITION ASSESSMENT REPORT**

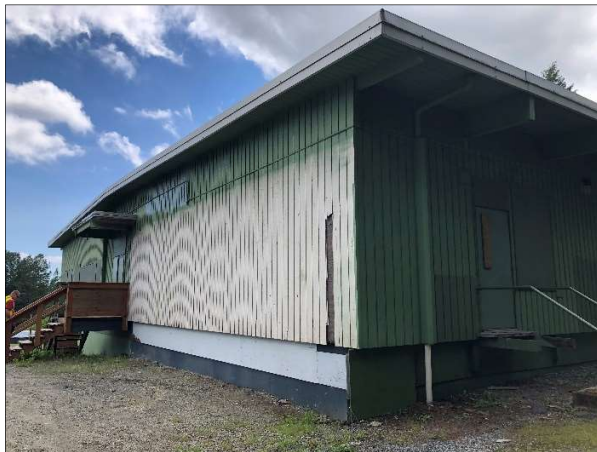
Photo 1 - North-West corner of building shows where the building was painted around a portable.

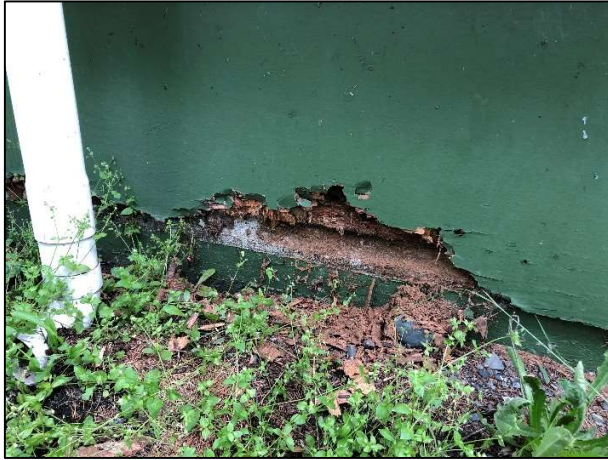
Photo 5 - Deterioration of painted plywood at base of wall due to close proximity to ground surfaces

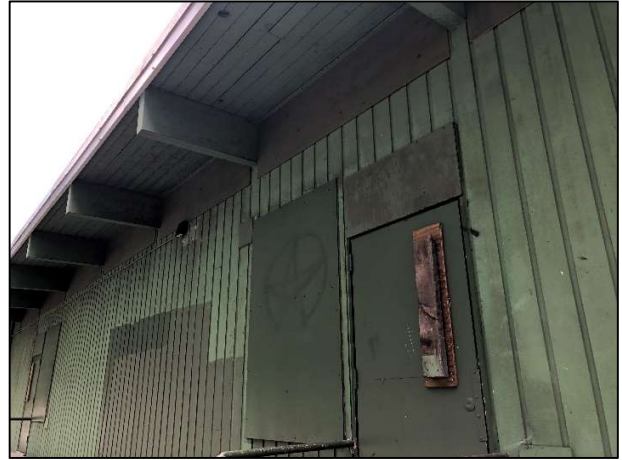
Photo 6 - Overall, the cedar cladding appears to be in good condition.

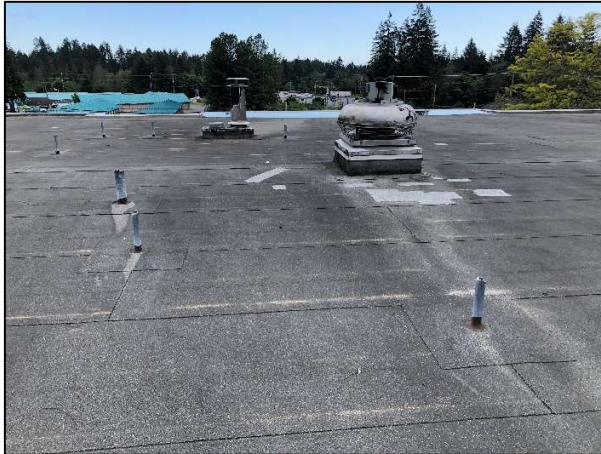
- 0-2 years for 2-ply SBS Roofing
- Asset Condition: Poor

Photo 1 - View of primary roof shows degradation and patch repairs

The SBS roof membrane appears to be in poor condition, with degranulation of the membrane, blistering, and significant ponding at low points of the roof. It is our understanding that the roof was last replaced in 1992 and it is recommended that the roofing membrane is replaced. This recommendation is supported by roofing reports in 2019 suggesting that reroofing is required.

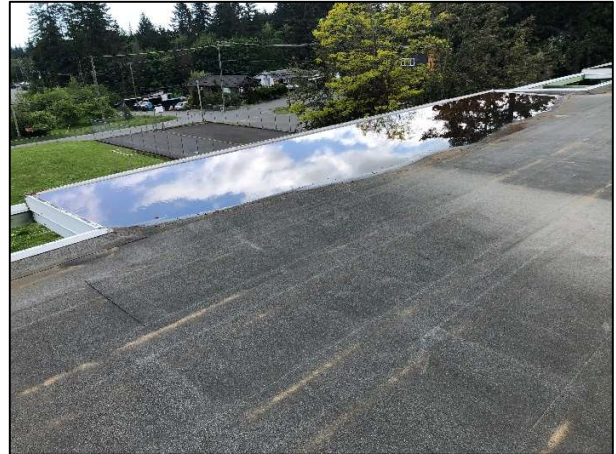
Photo 2 - Significant ponding

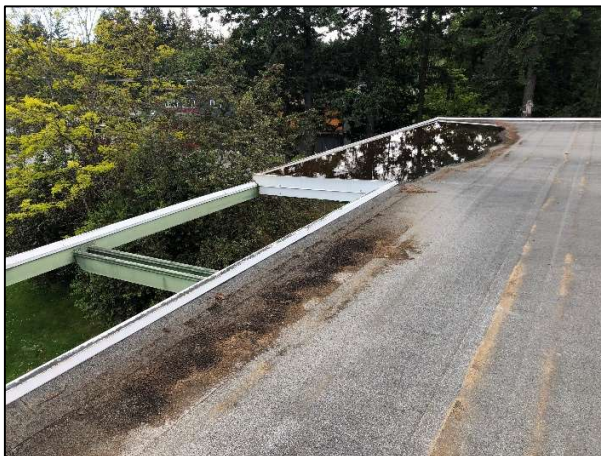
Photo 3 - Ponding and staining

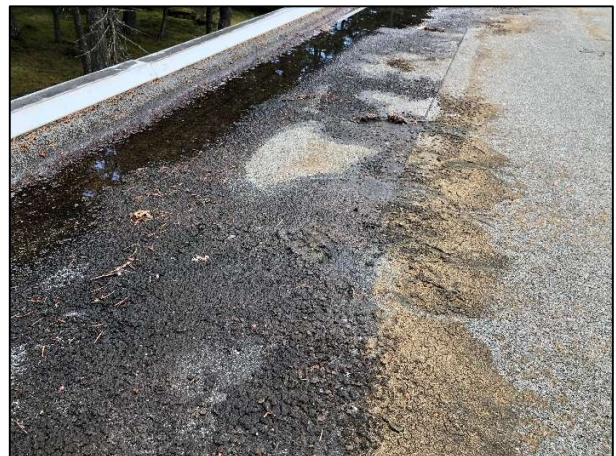
Photo 4 - Significant staining and debris collection

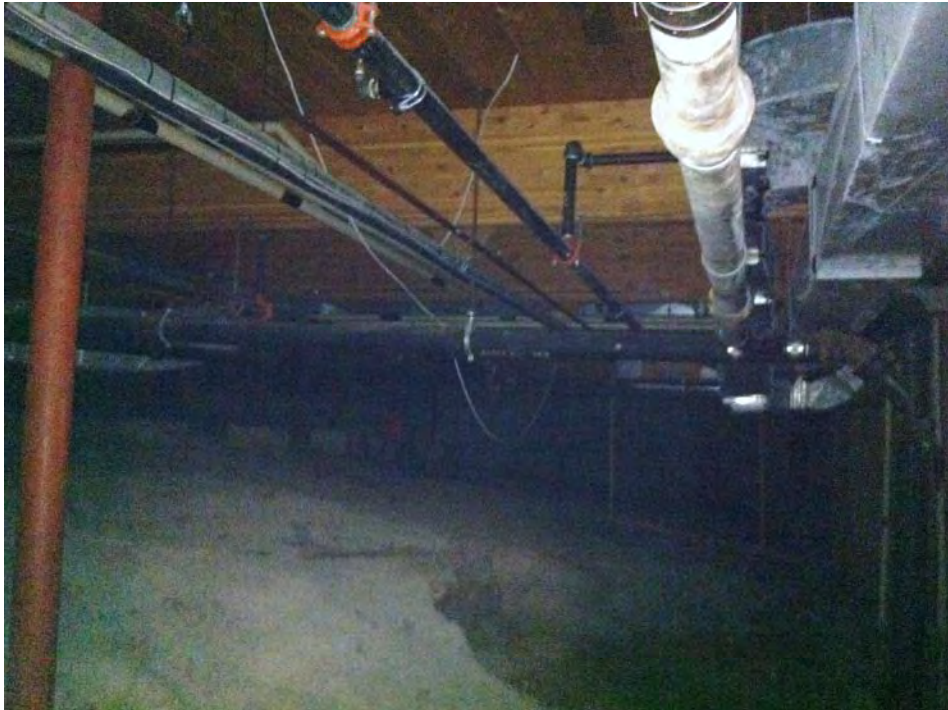
View of crawlspace behind basement storage areas. Note rock slope and lack of interior bearing walls.

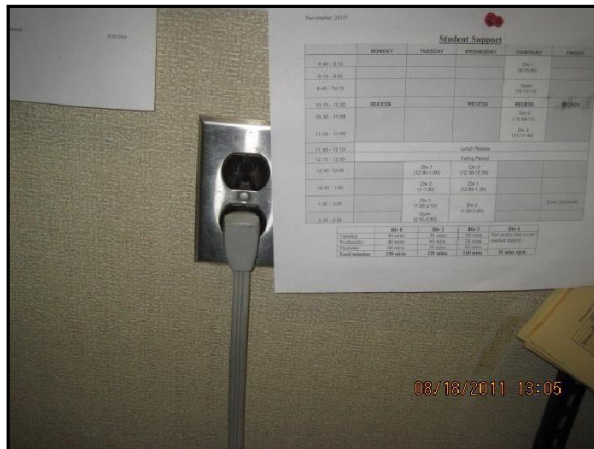
Auto generated renewal for Branch Wiring - Equipment & Devices. System Description: Branch wiring for this building includes interior and exterior branch wiring, devices, and utilization equipment. The system is aged beyond the BOMA life expectancy of 30 years and replacement should be planned.

Branch Wiring - Equipment Devices Renewal

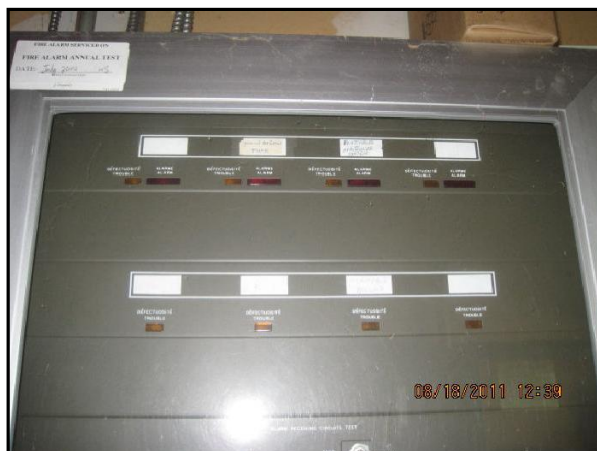
Auto generated renewal for Fire Alarm System. System Description: The building is provided a fire alarm system that includes Edwards 6500 master control panel, annunciator, manual pull stations, smoke detectors, heat detectors, and audible bell and visual alarms. The system is aged beyond the BOMA life expectancy of 20 years and replacement should be planned.

Fire Alarm System Renewal

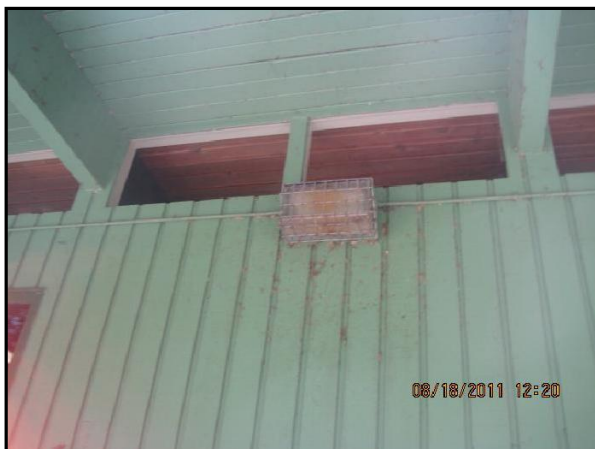
Auto generated renewal for Lighting - Exterior. System Description: Exterior lighting consists of wall mounted and under canopy HID fixtures. The system is aged beyond the BOMA life expectancy of 20 years and replacement should be planned.

Lighting - Exterior Renewal

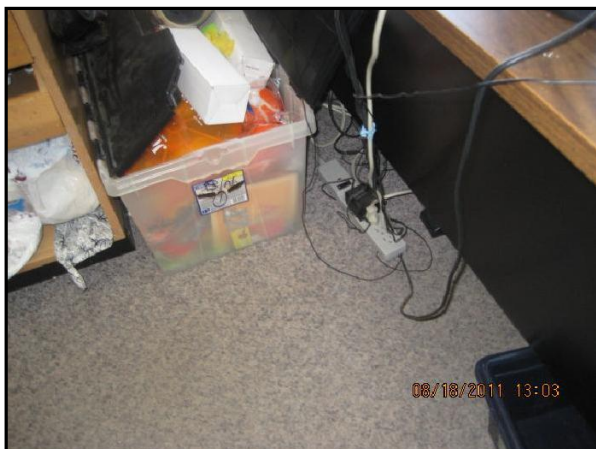
Branch Wiring Devices - Insufficient Quantity of Receptacles

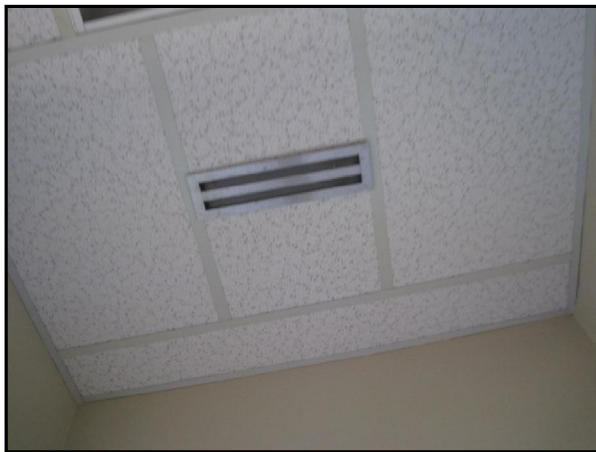
Distribution Systems - HVAC Ductwork Dirty

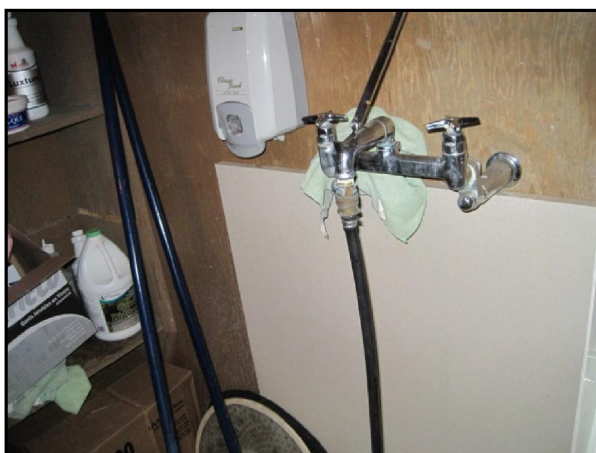
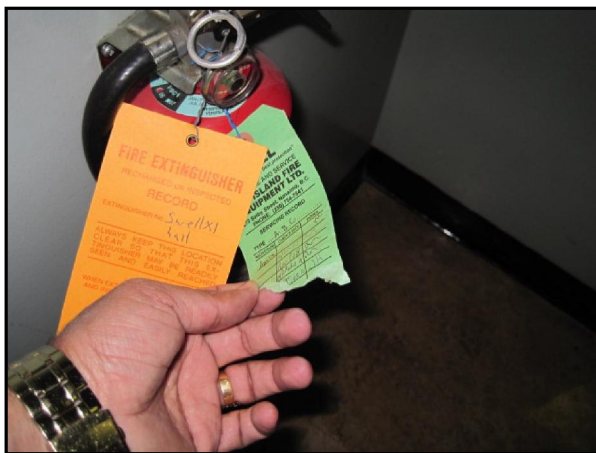
Various Mechanical Deficiencies
