## Exterior Reference Photos

## General Interior/Mechanism Reference Photos

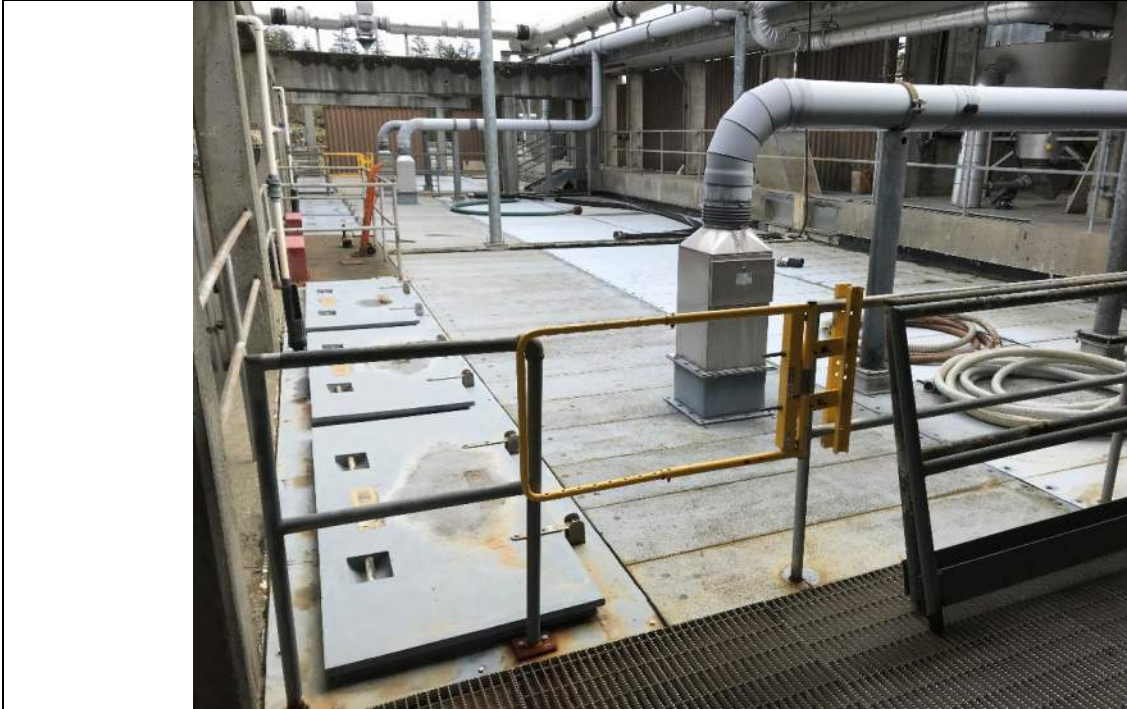
1. GNPCC No. 1 Grit Tank top (foreground), looking east.

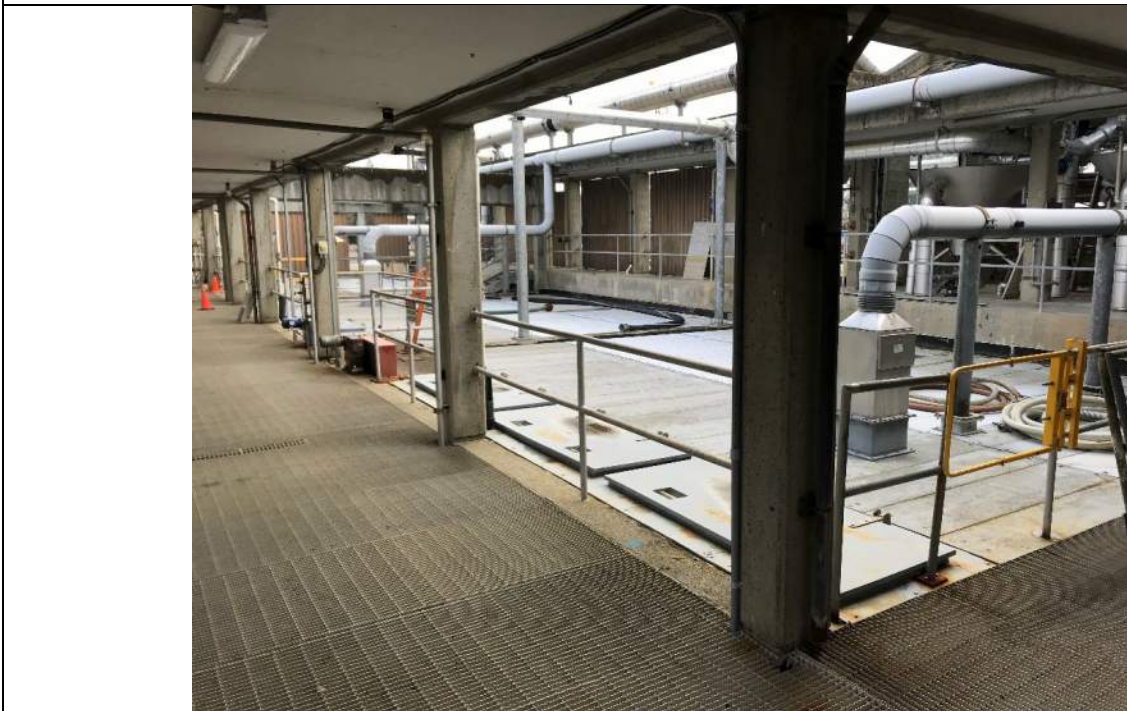
2. GNPCC grit tank tops, looking southeast – No. 1 Grit Tank in foreground.

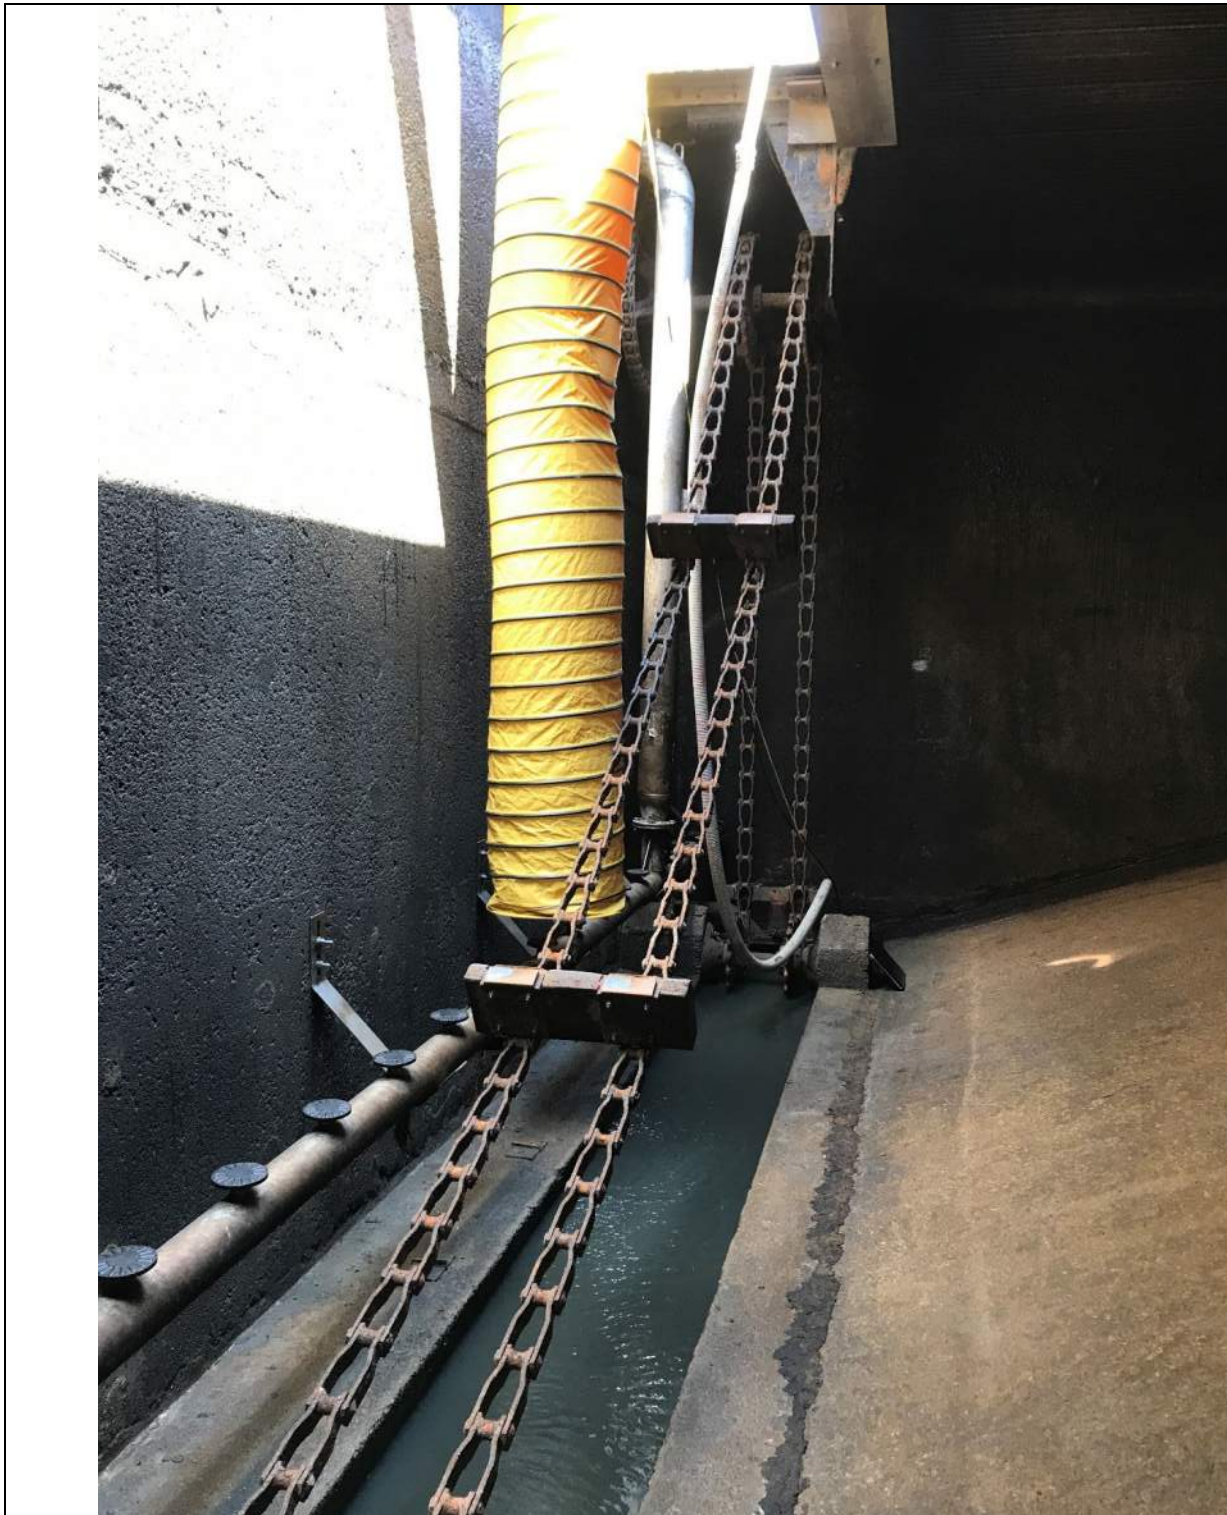
3. Collector chain (drive end) and air header piping, looking east (trough filled with water – pump unplugged)

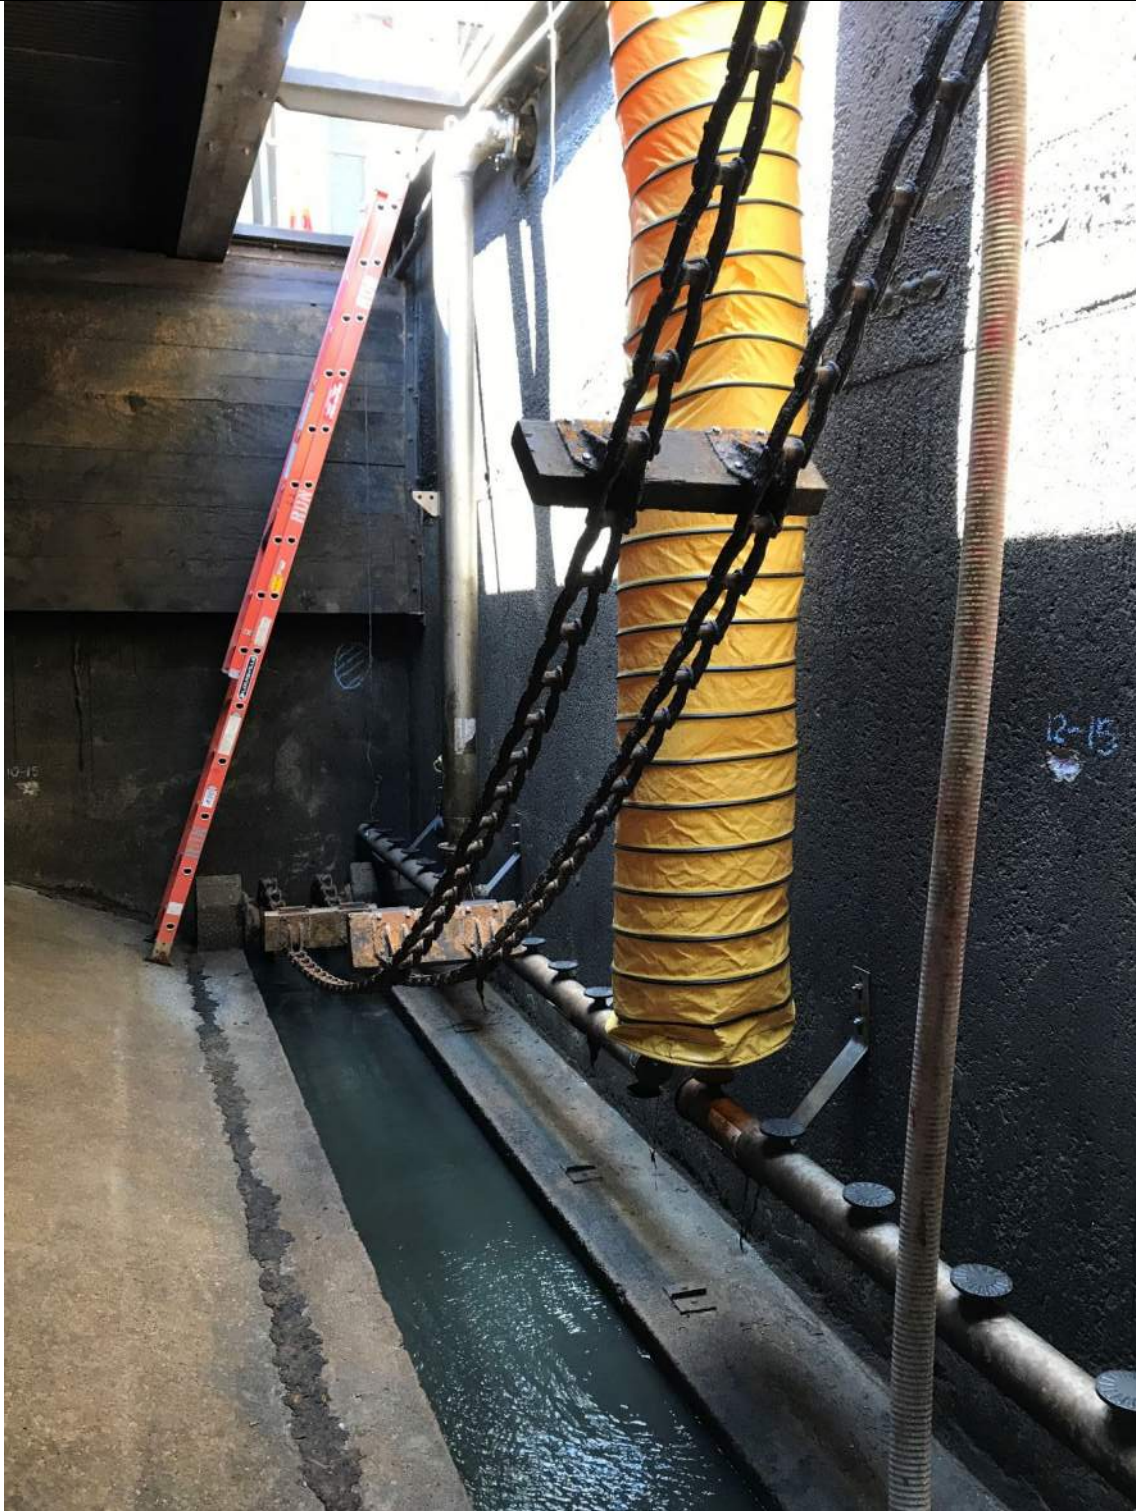
4. Collector chain and air header piping, looking west (trough filled with water – pump unplugged)

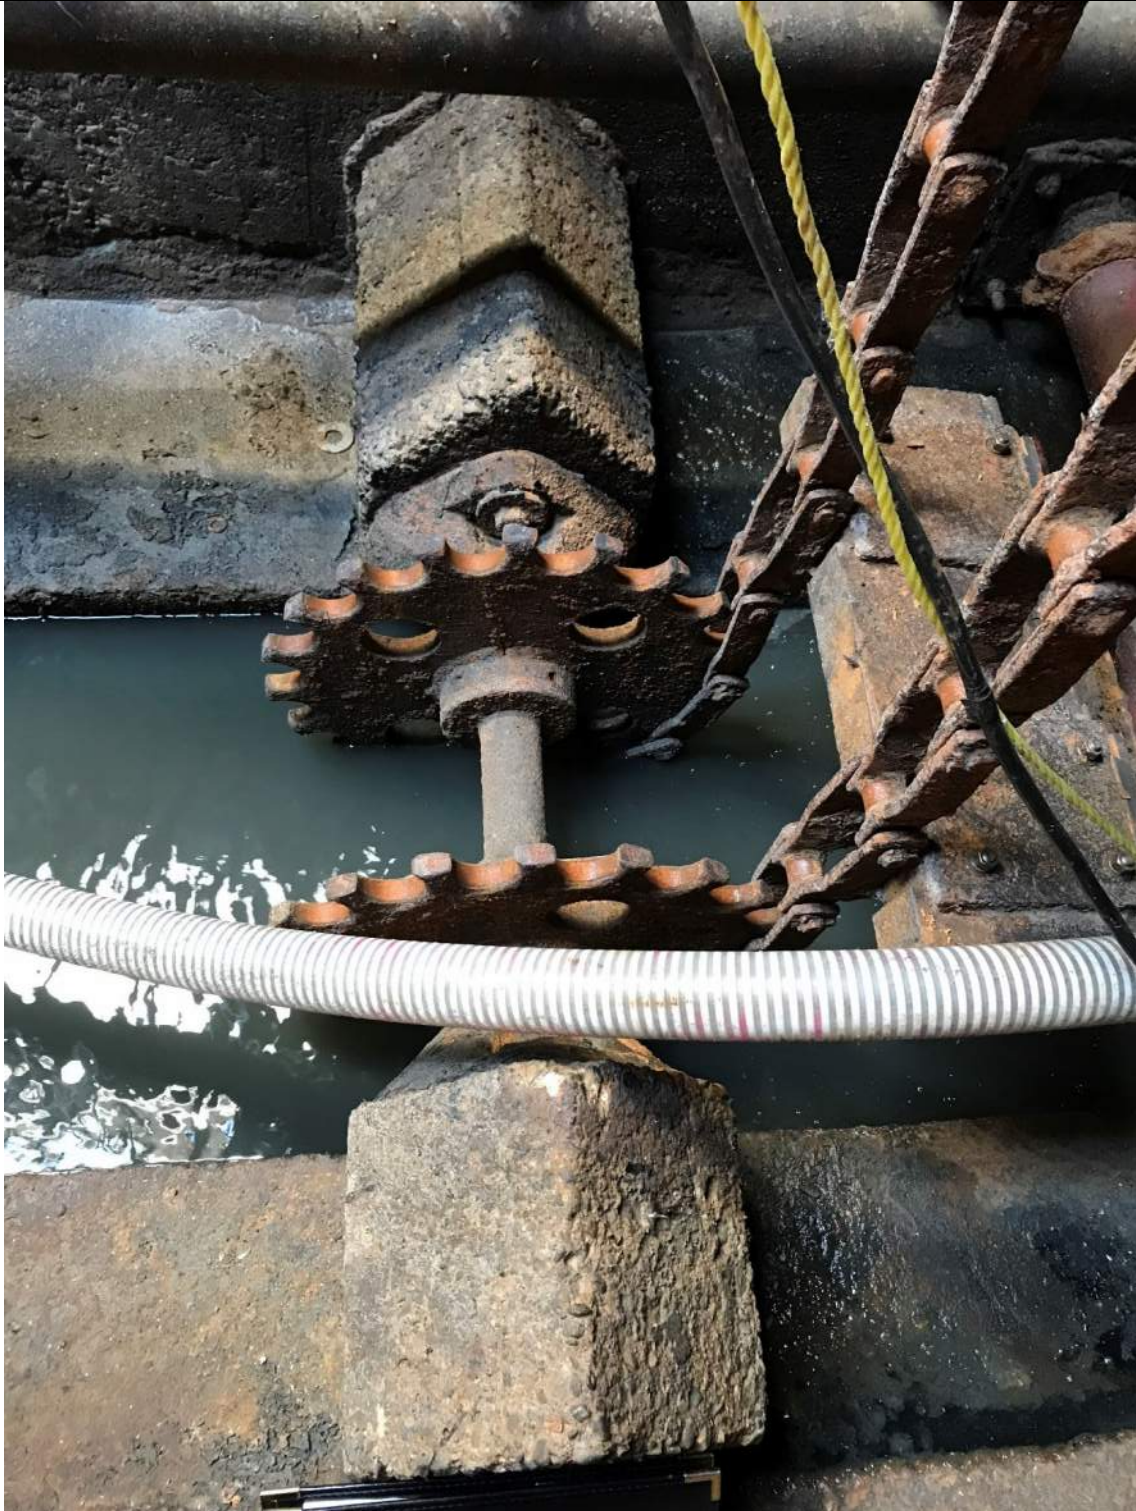
5. Close-up of idler sprockets and collector chain at east end of trough. Note sprockets are heavily worn.

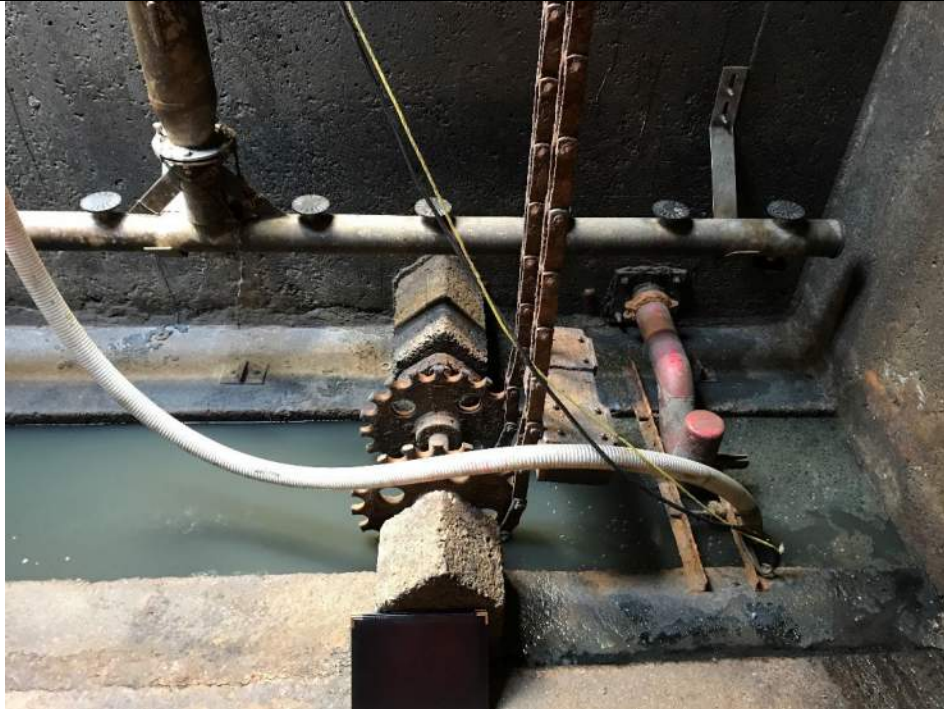
6. Close-up of drive end idler sprockets at east end of collector trough (white hose from sump pump installed for tank entry only).

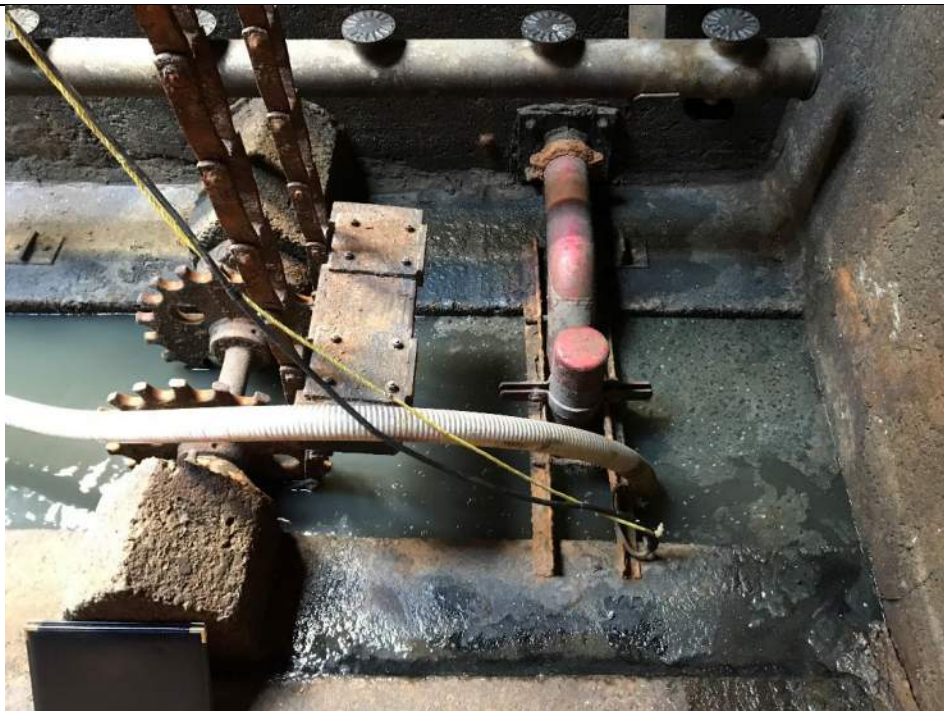
7. Close-up of collector trough sump permanent suction piping (red colored).

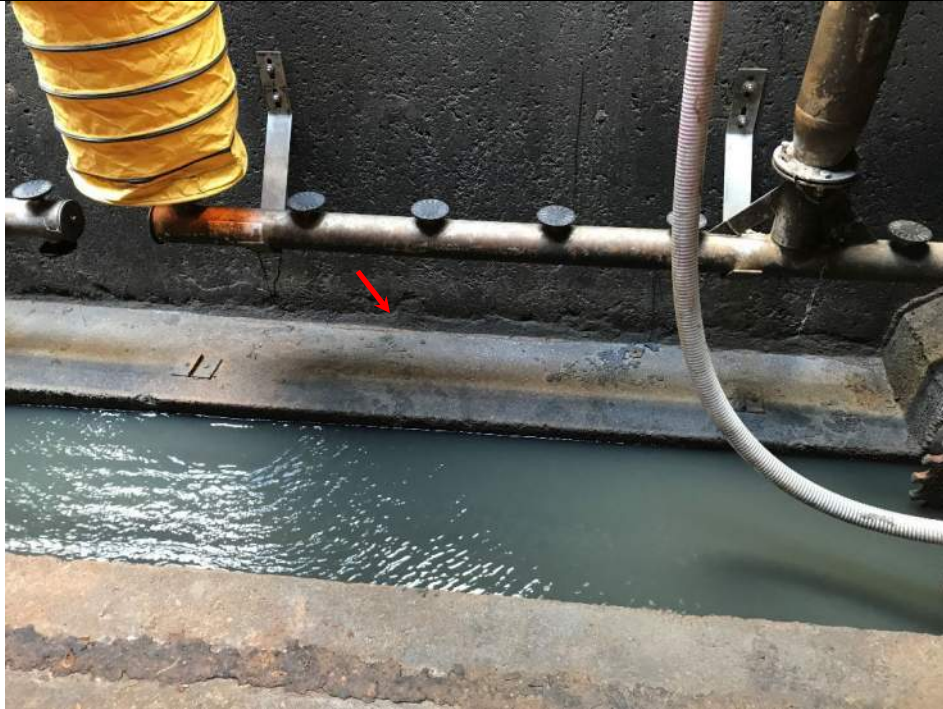
8. Moving west along collector trough from photo 7 – previous patch repair along wall to floor joint (red arrow).

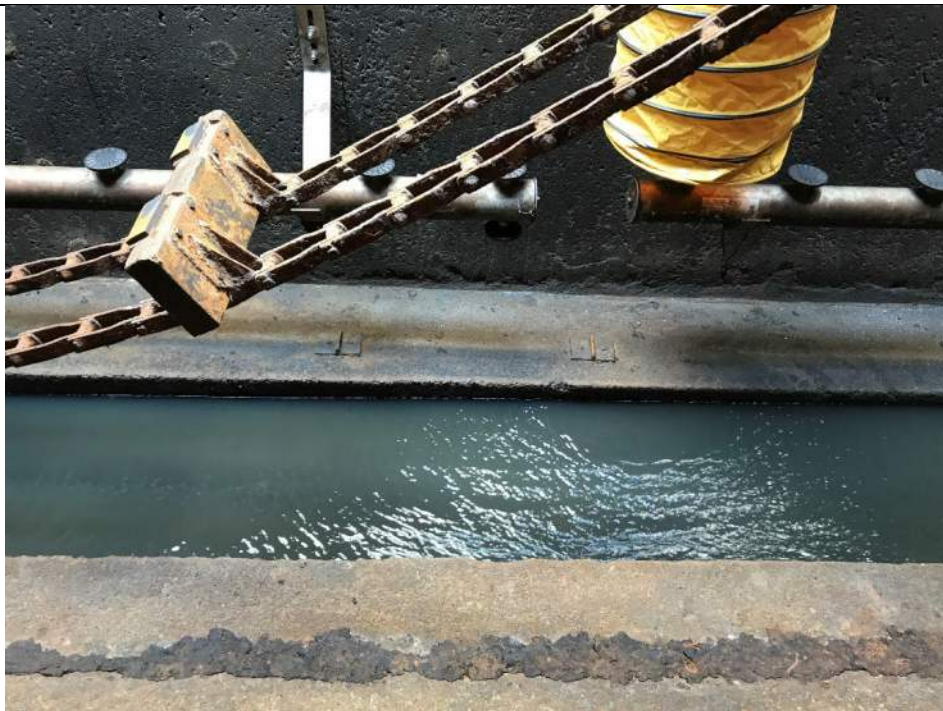
9. Moving west along collector trough from photo 8 – previous patch repair still visible at bottom of wall.

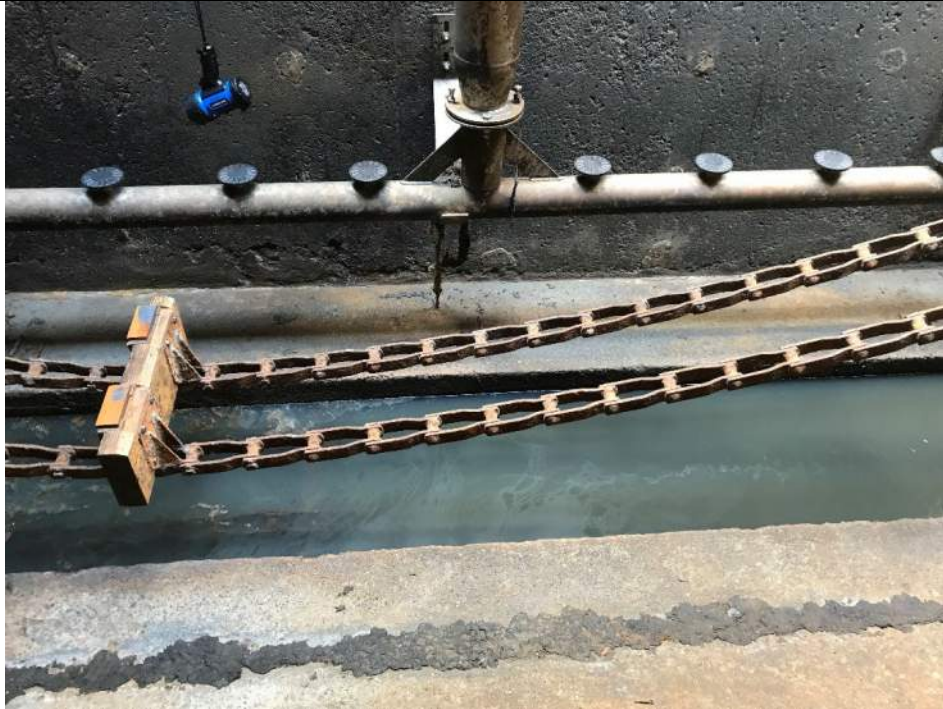
10. Moving west along collector trough from photo 9 – previous patch repair still visible at bottom of wall.

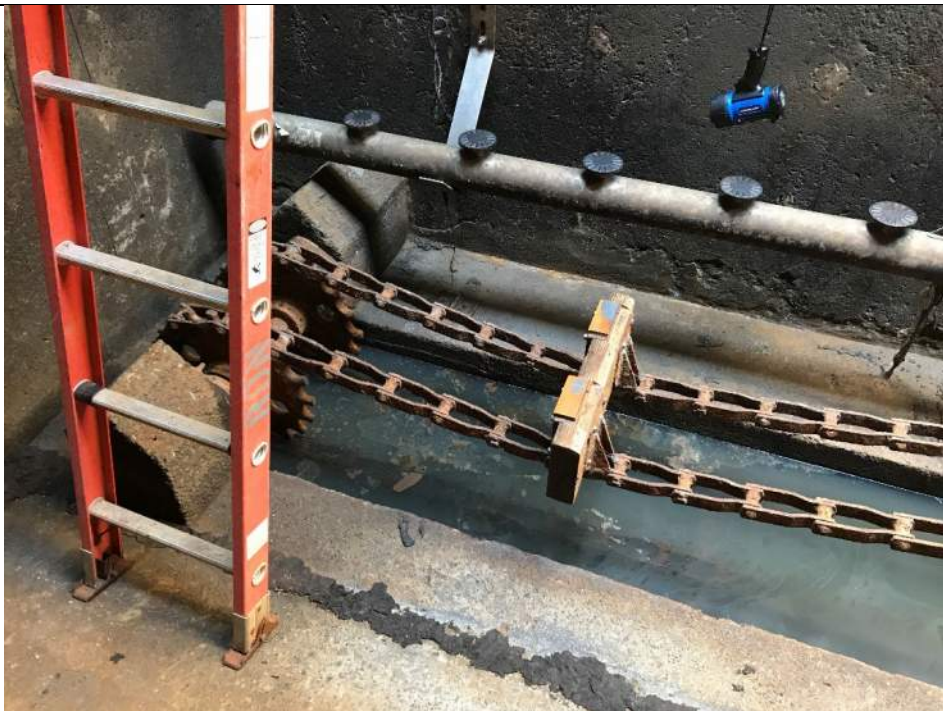
11. Moving west along collector trough from photo 10 – tail shaft sprocket and previous grout repair visible.

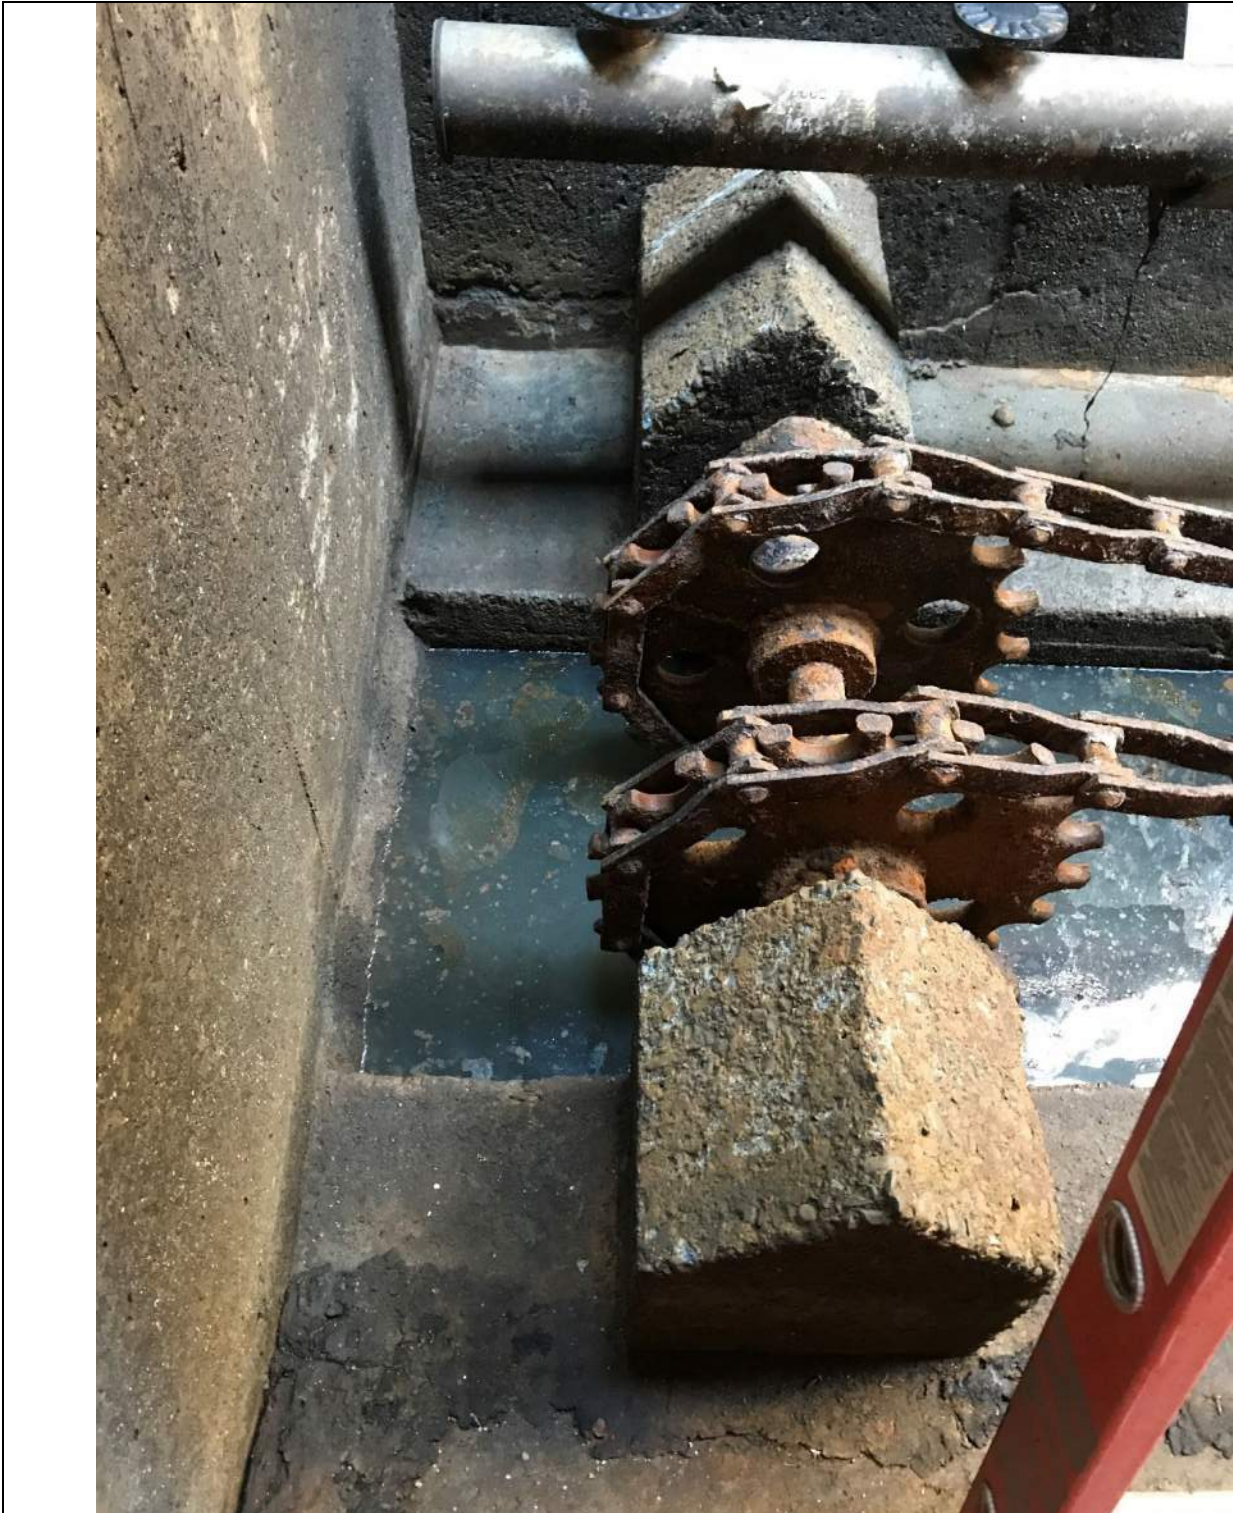
12. Close-up of heavily worn collector tail shaft sprockets – note shaft is not centered on concrete mounting blocks.

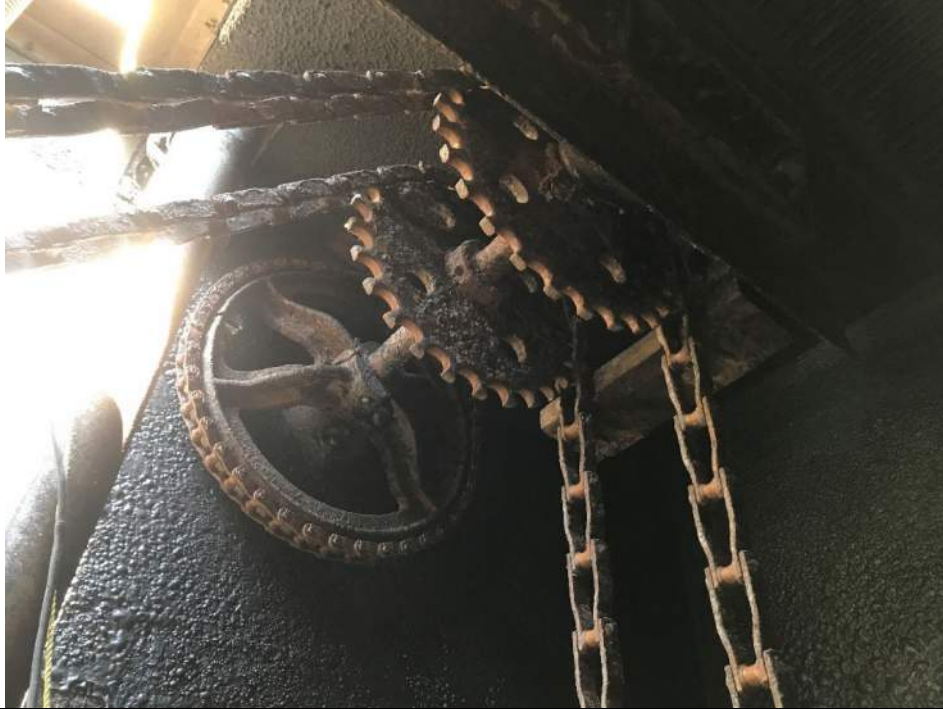
13. Close-up of head shaft and drive end sprockets at east end of tank.

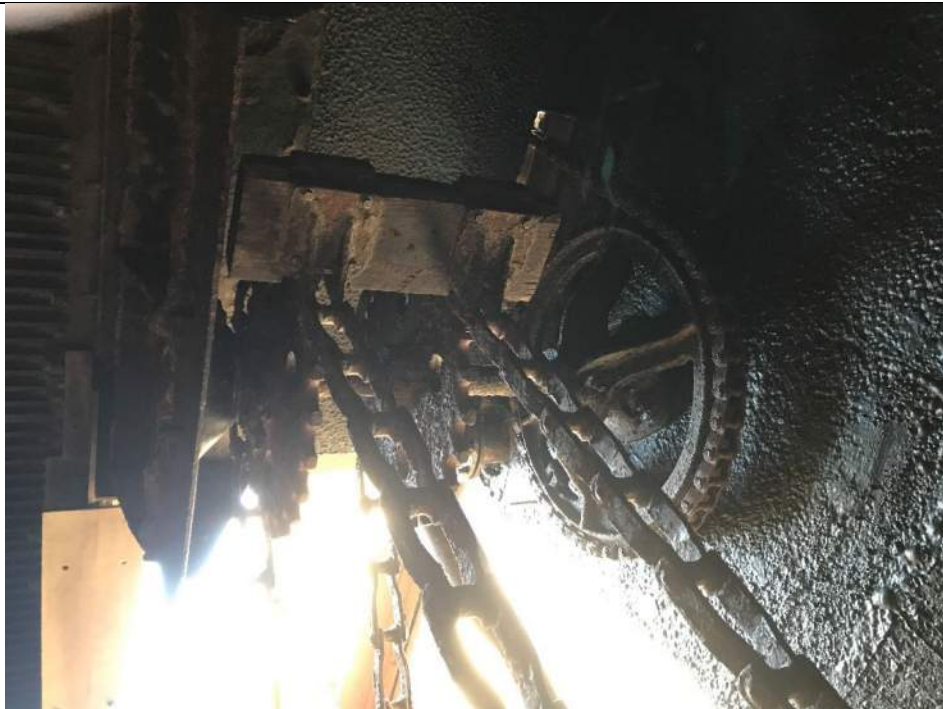
14. Another bottom view of head shaft and drive end sprockets at east end of tank.

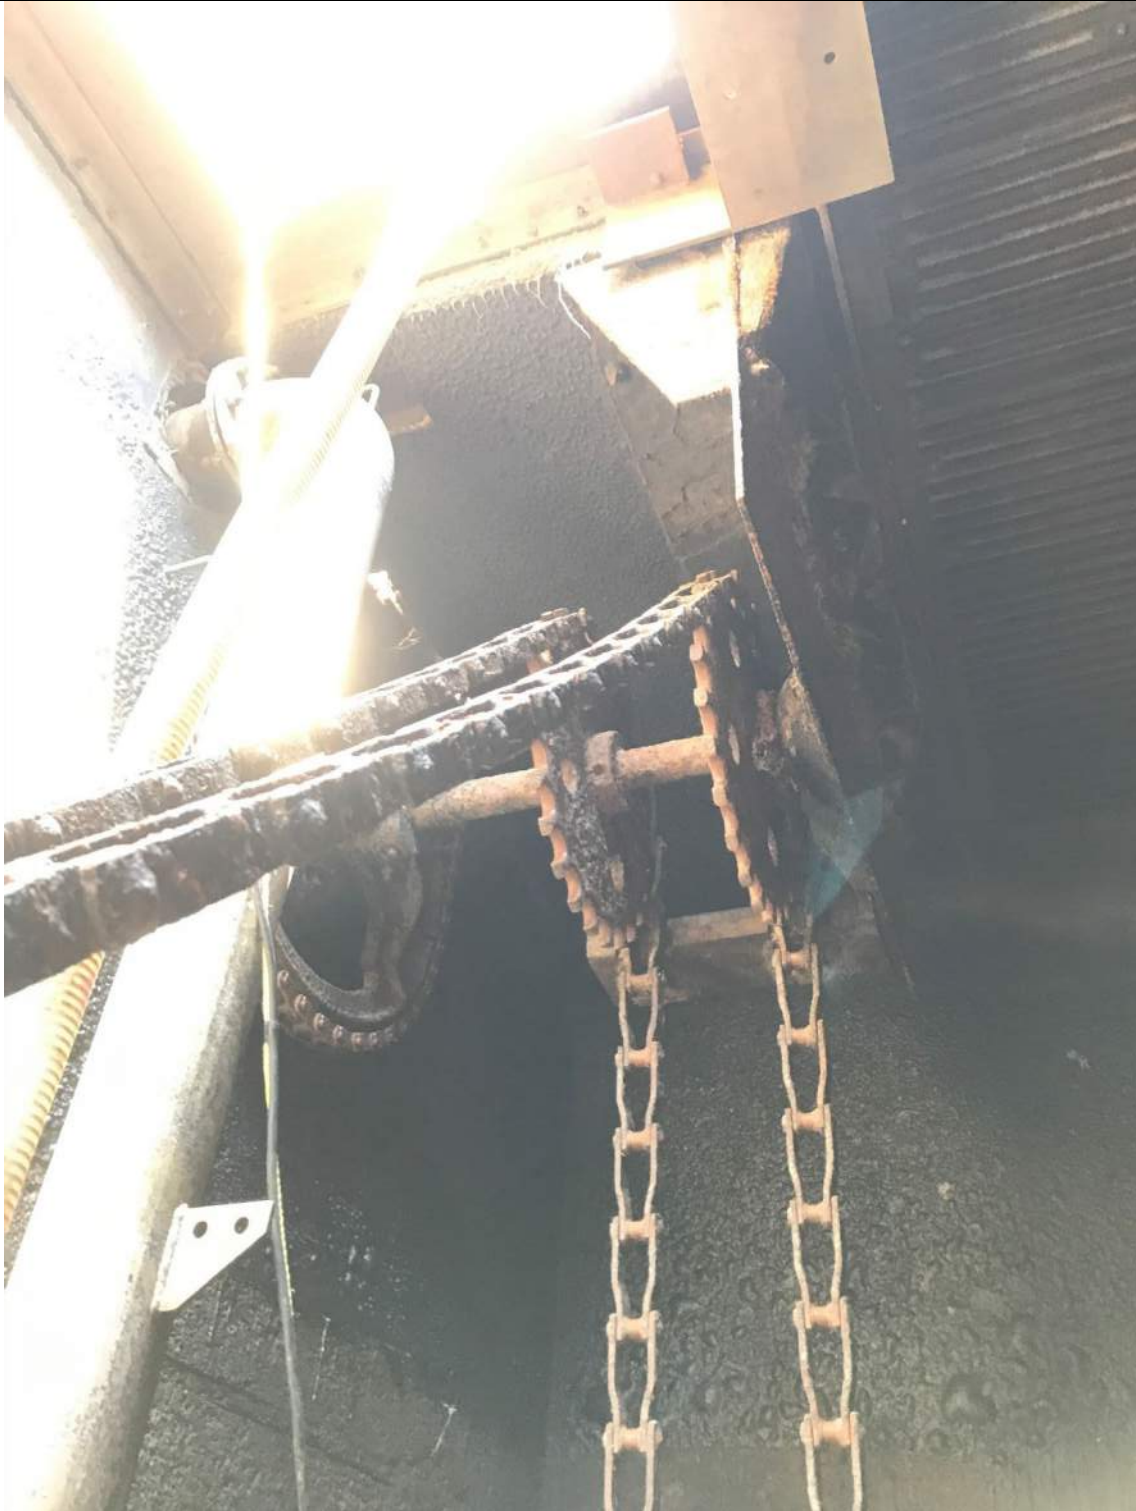
15. Another view of drive end sprockets at east end of tank. Black wall coating drip lines/blisters/delaminations visible.

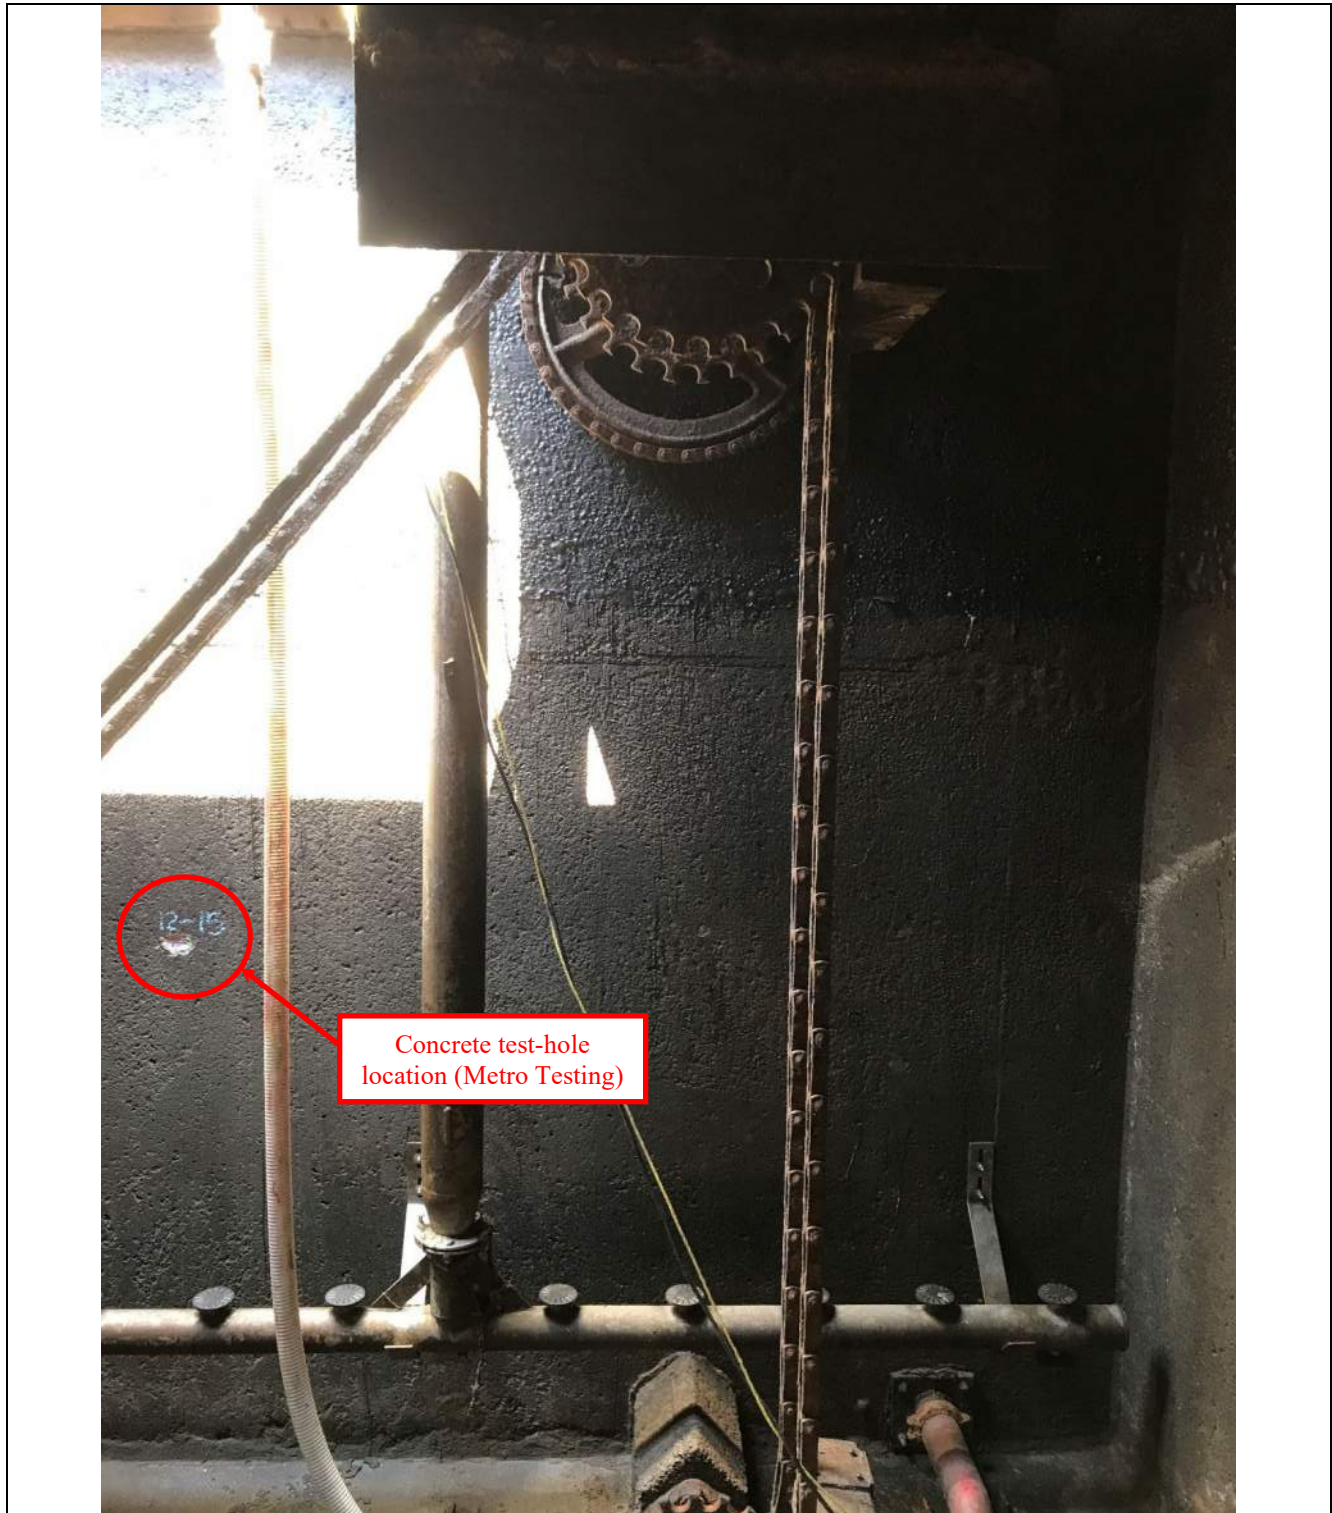
16. North wall of tank at east (drive) end (white sump pump hose only installed for tank entry). Note black coating on upper wall.

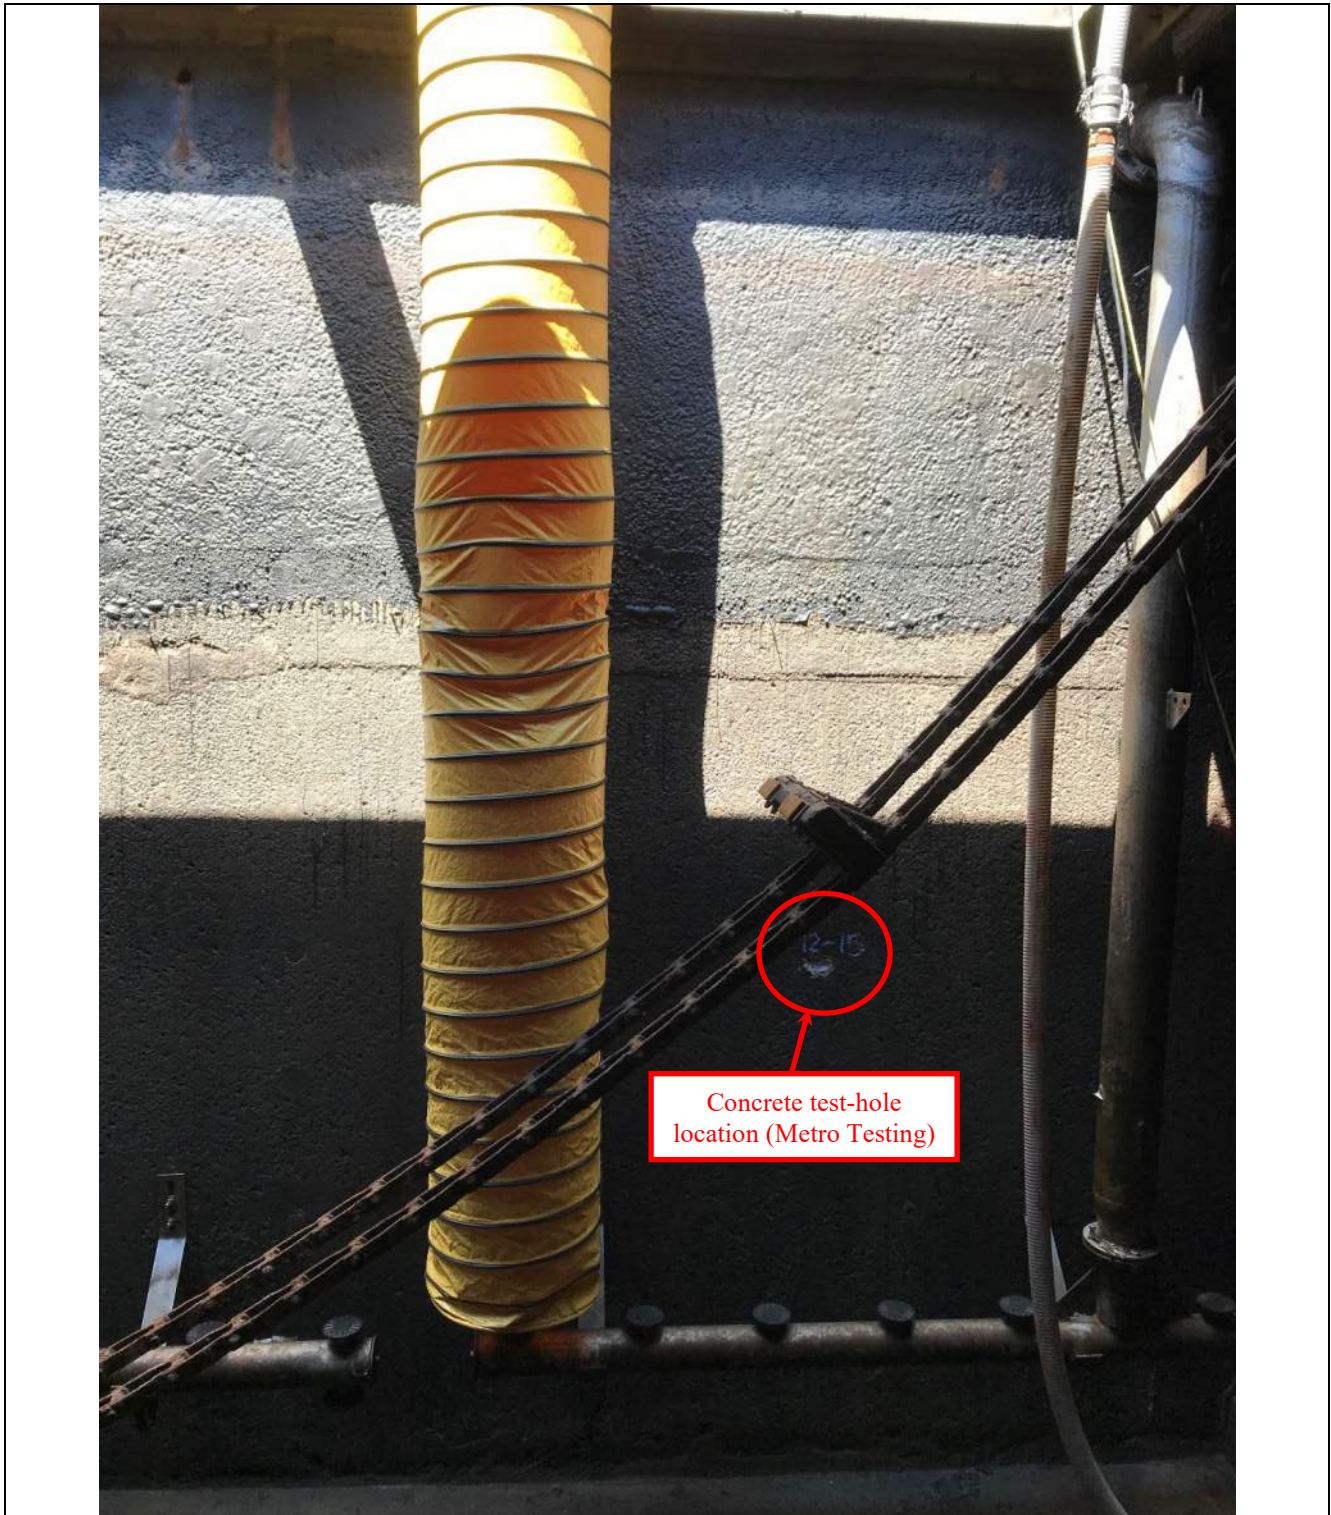
17. Center of north wall of tank. Note some blisters in black coating on upper wall (lower concrete is uncoated)

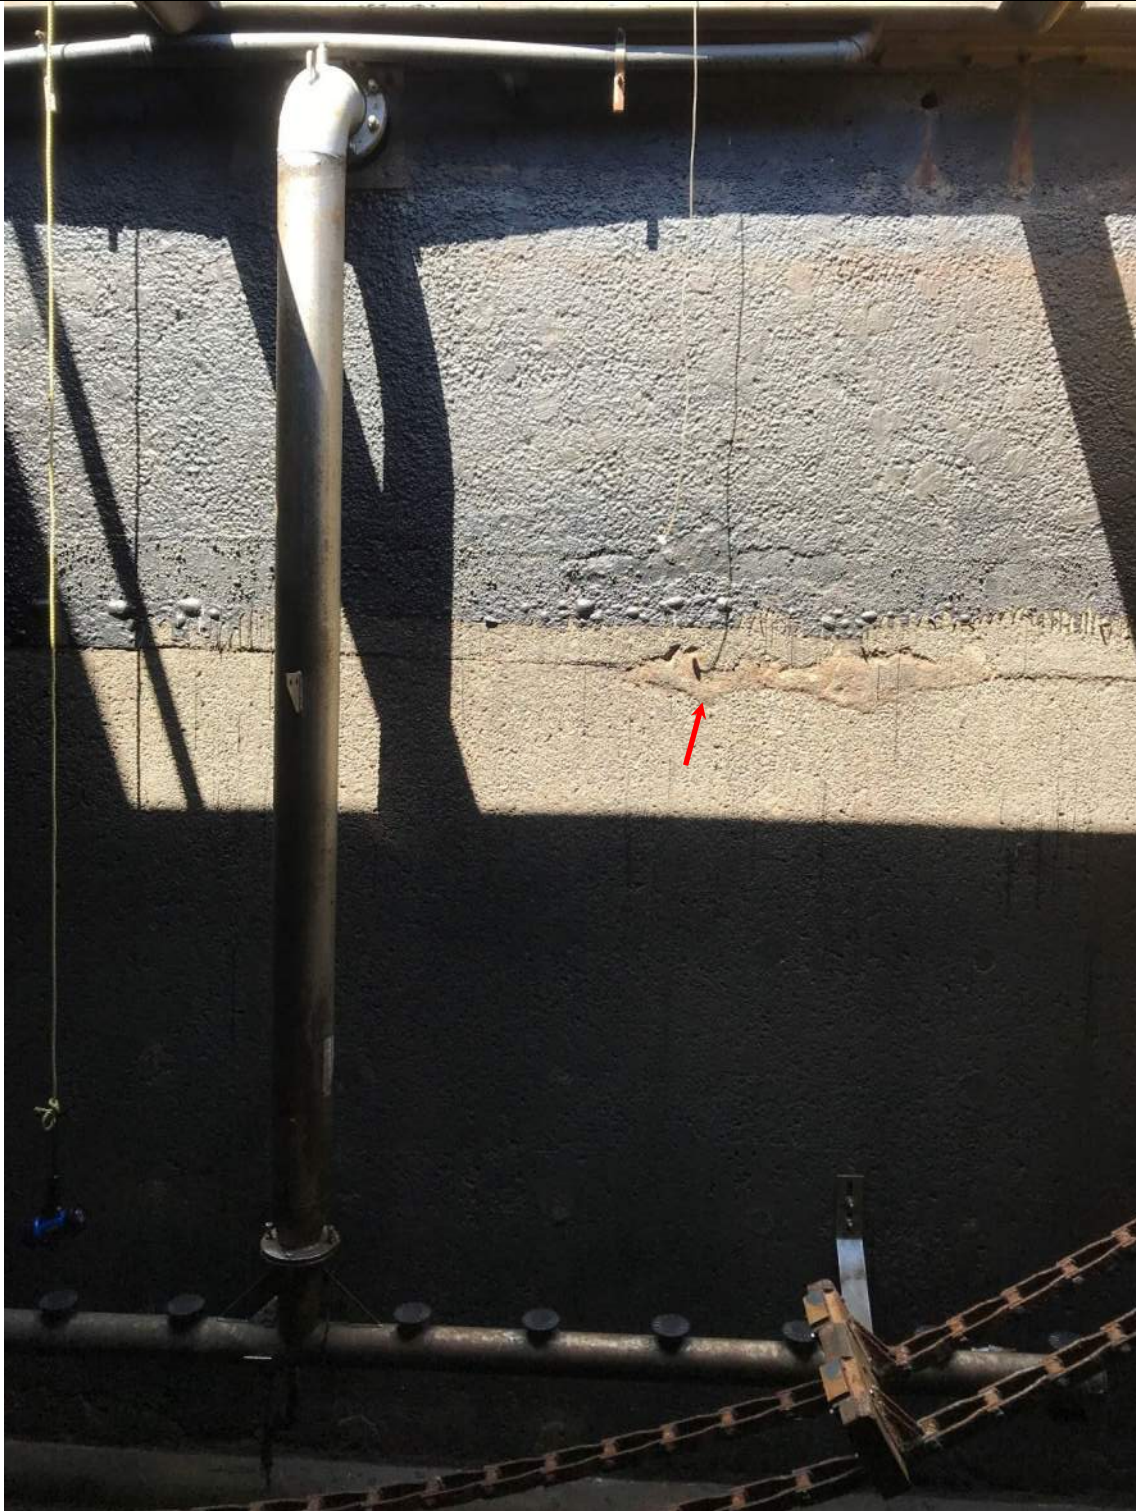
18. North wall of tank near west end. Note some blisters in black coating on upper wall and previous patch repair (red arrow)
