## Exterior Reference Photos

## General Interior/Mechanism Reference Photos

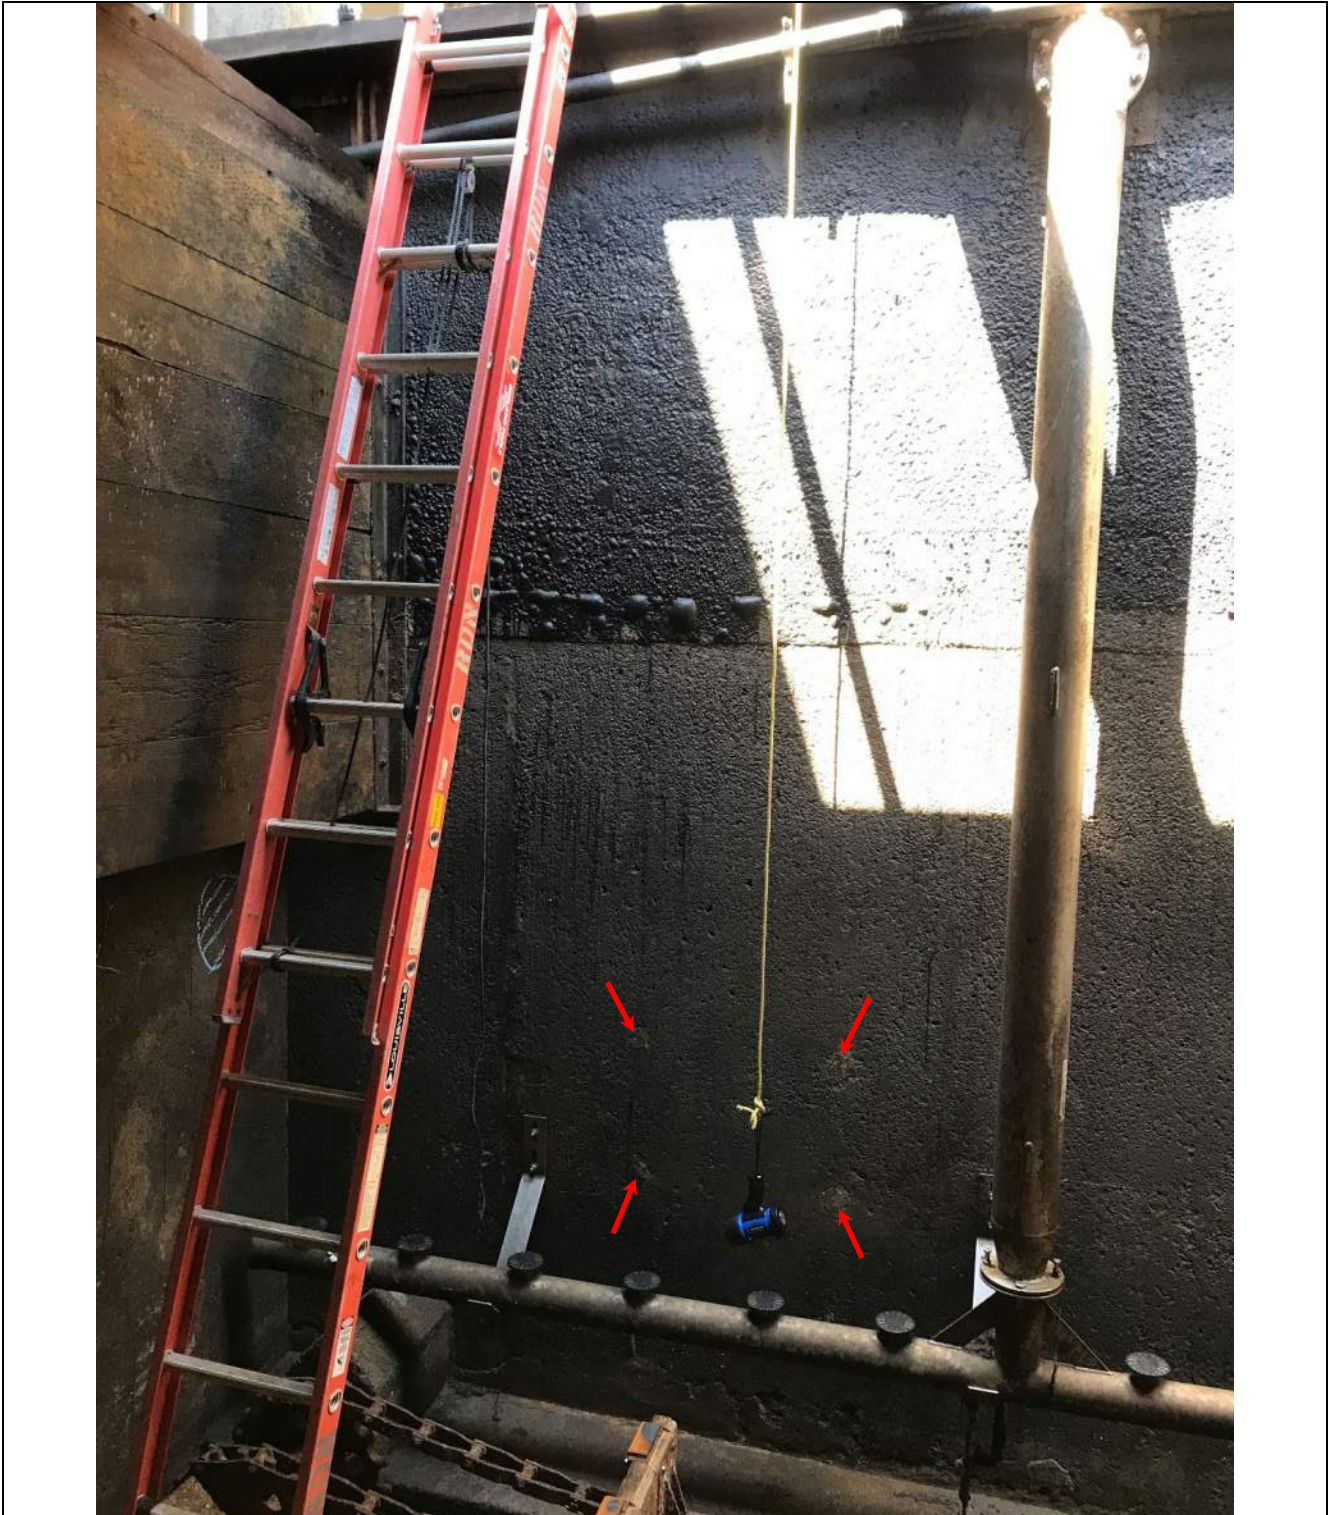
19. North wall of tank at west end. Note some blisters in black coating on upper wall and previous patch repairs in wall (red arrows)

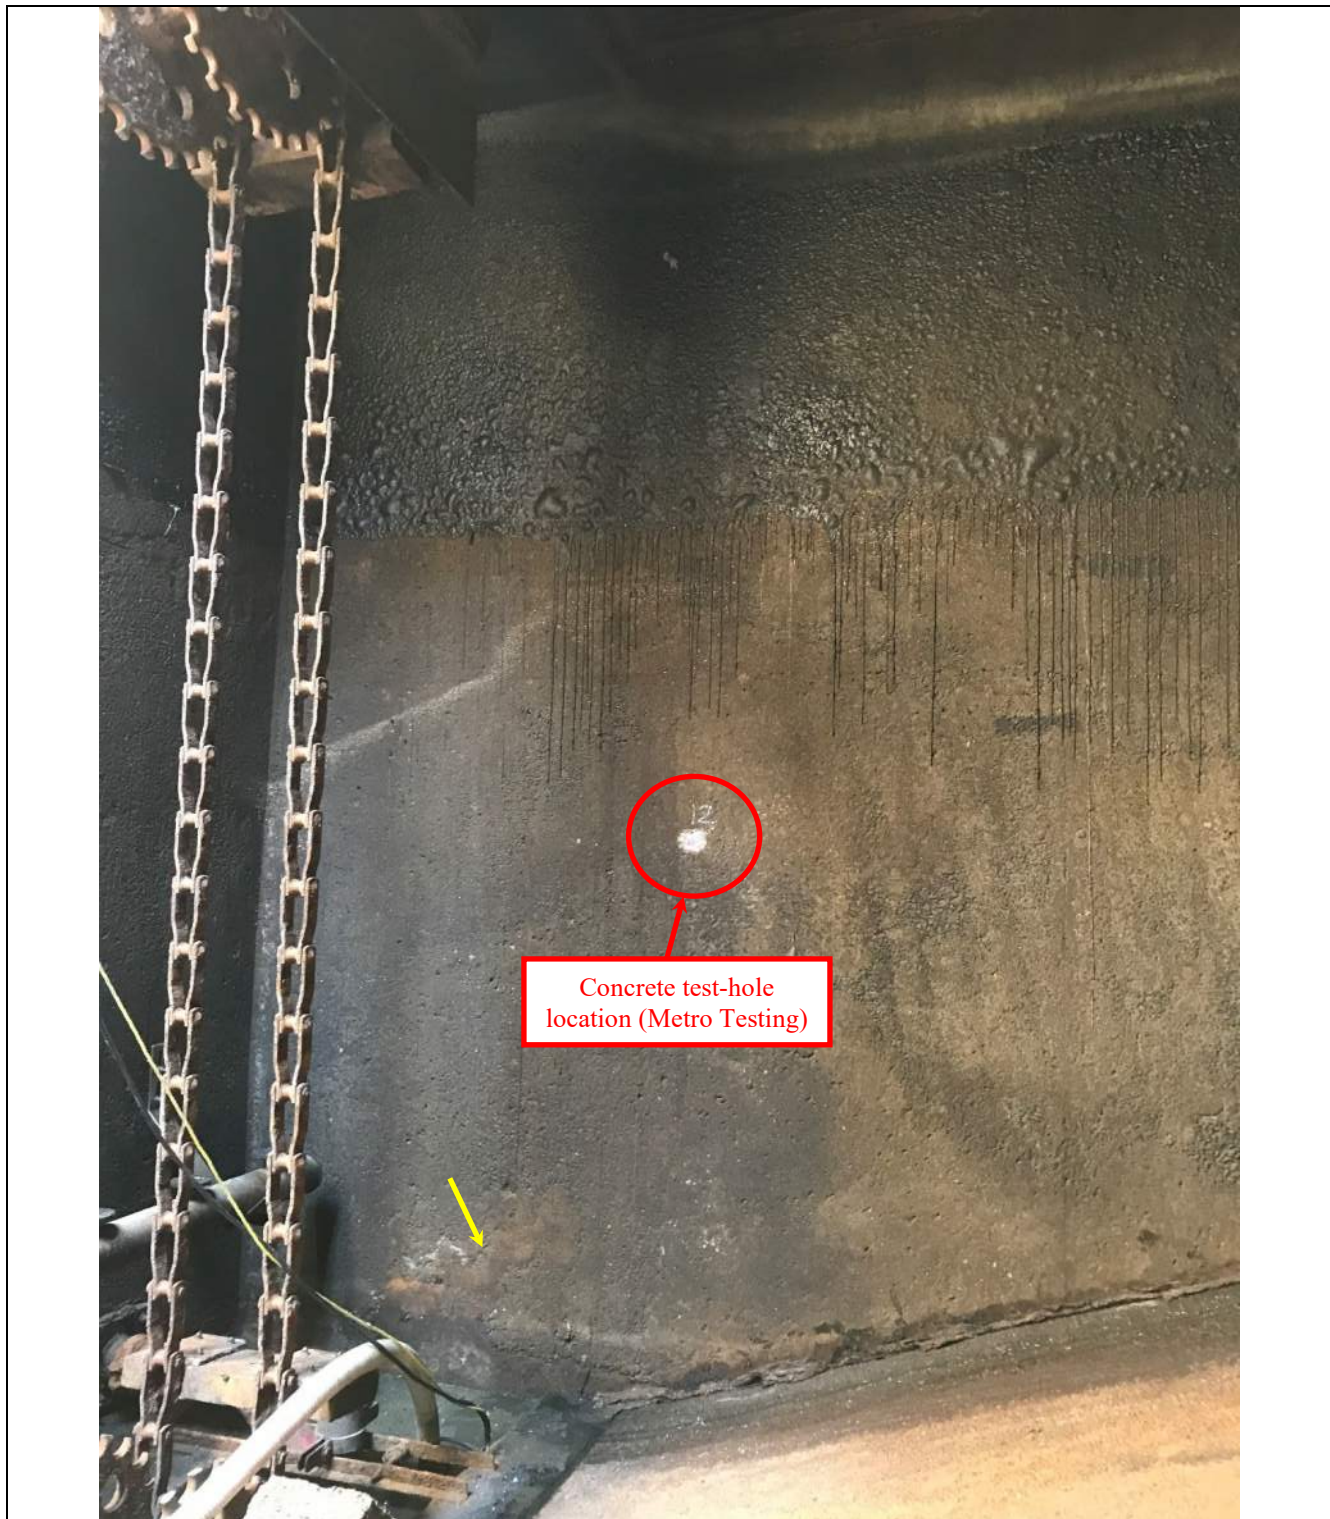
20. East wall of tank at north end. Note blisters and runs in black coating on upper wall and previous patch repair (yellow arrow)

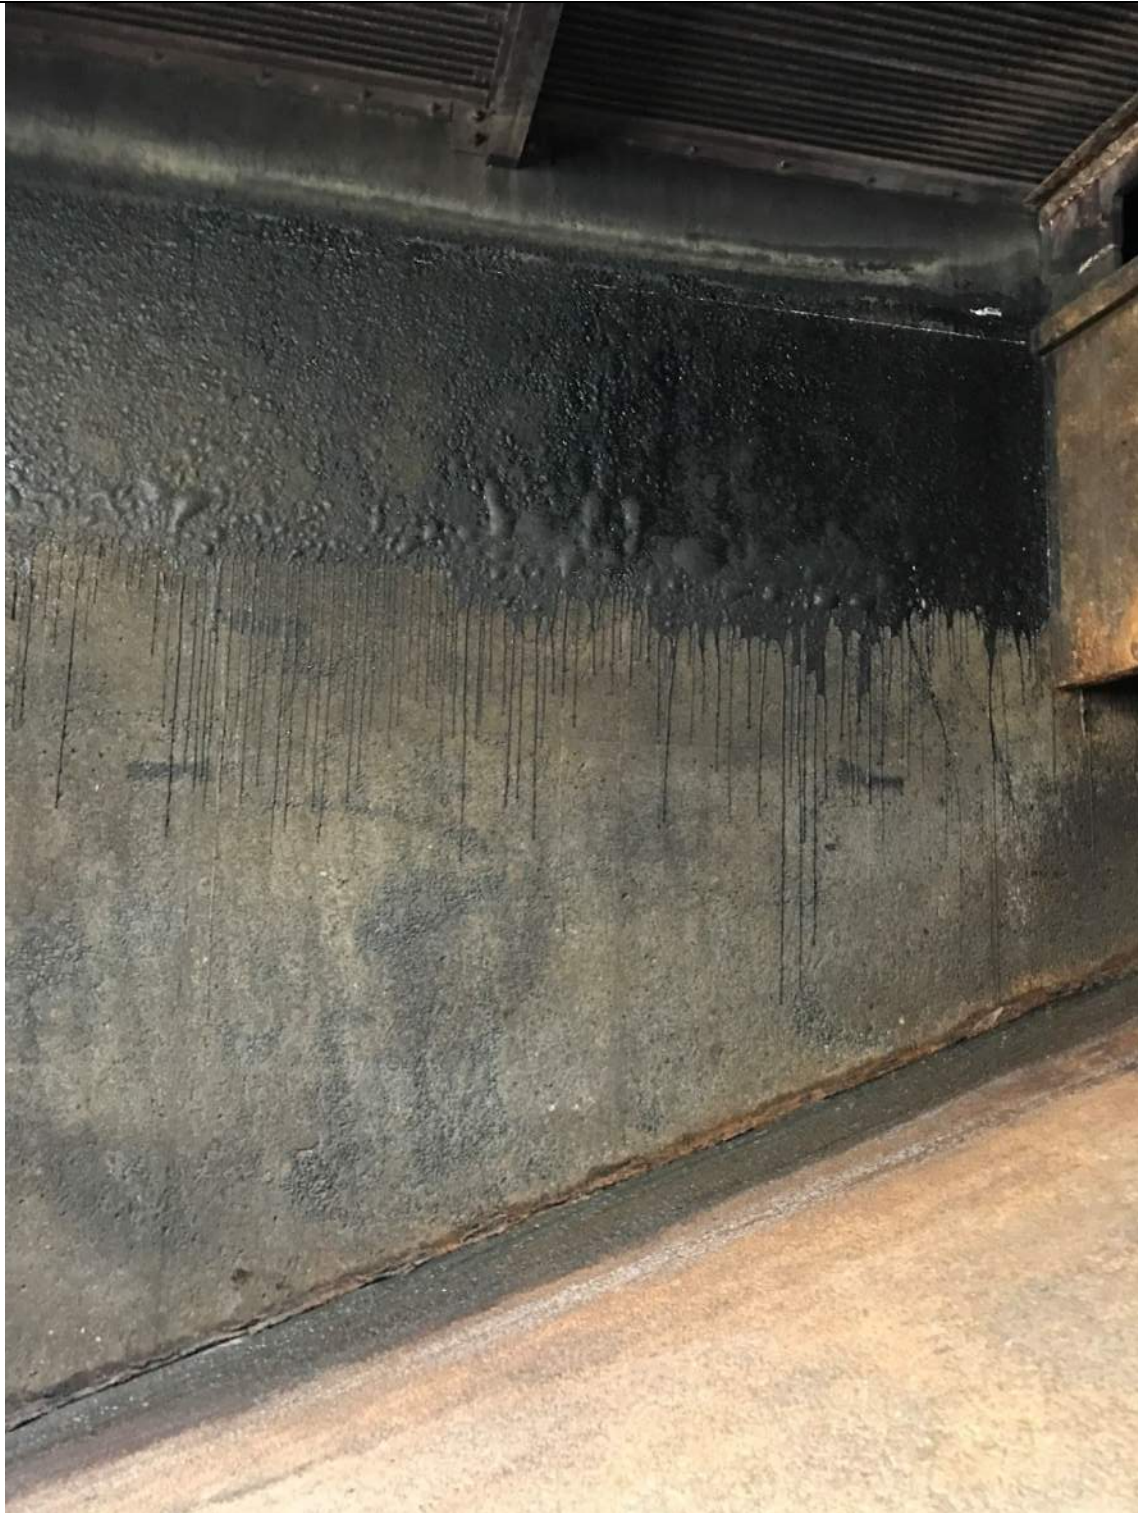
21. East wall of tank at middle. Note blisters and runs in black coating on upper wall (lower concrete is uncoated)

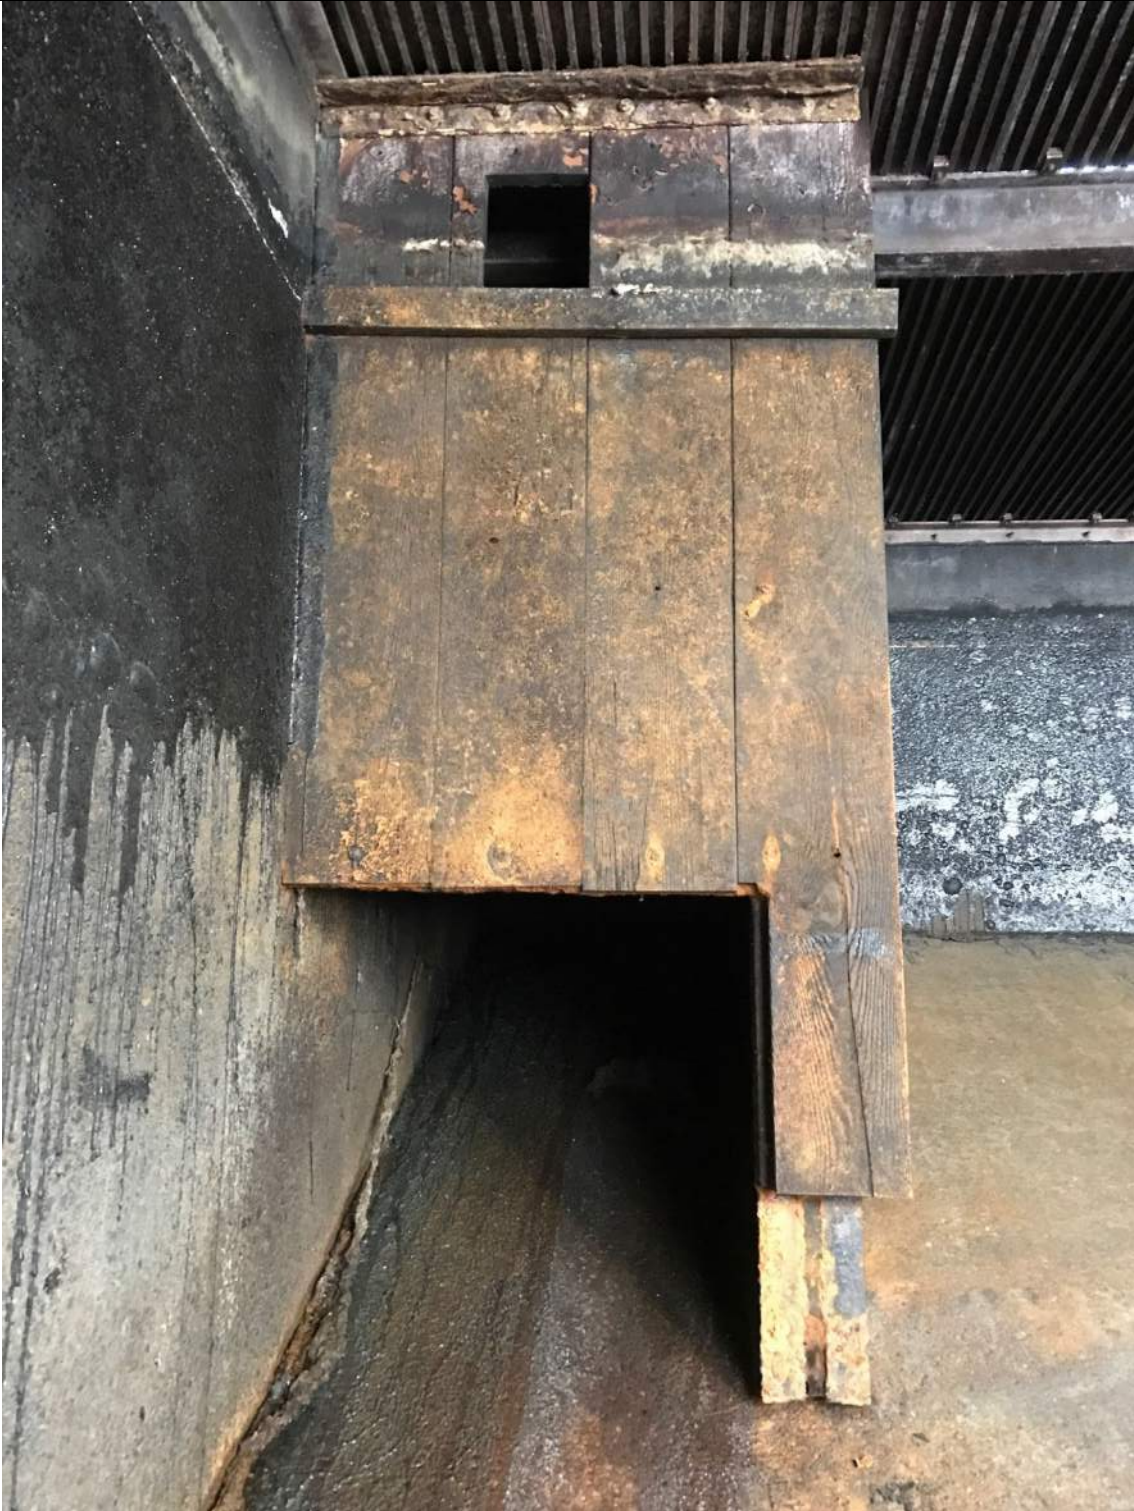
22. No. 1 grit tank inlet box looking south.

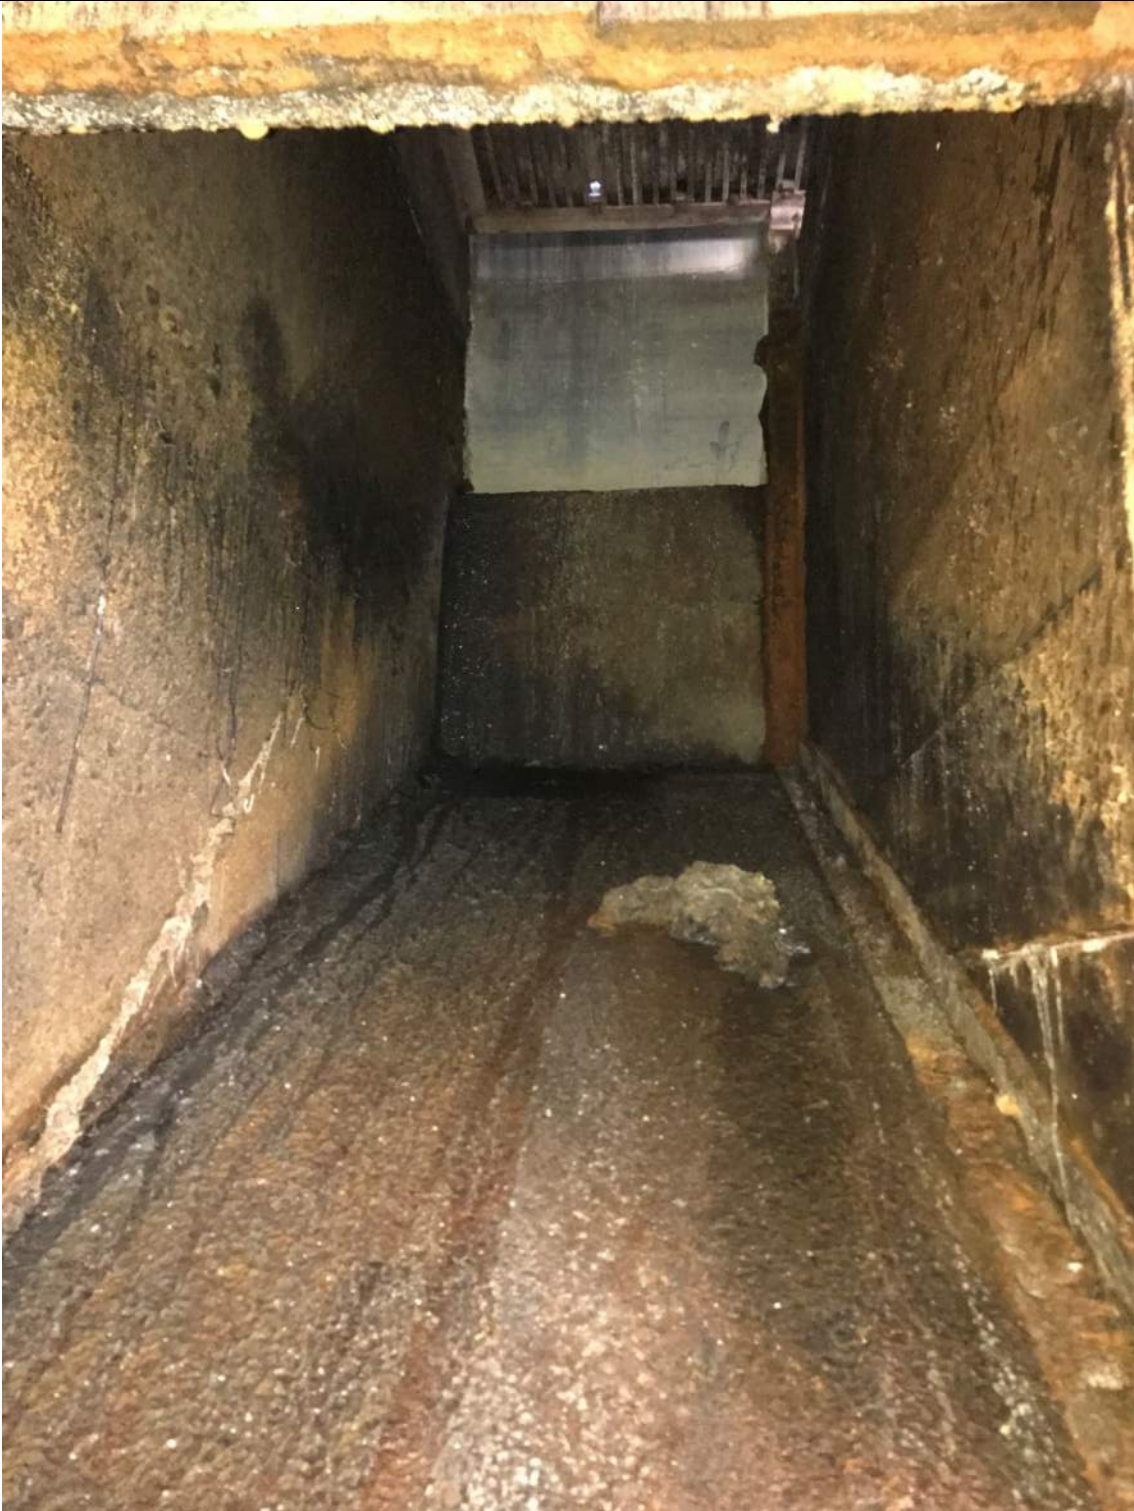
23. View inside inlet box – light colored vertical rectangle at top is the inlet slide gate.

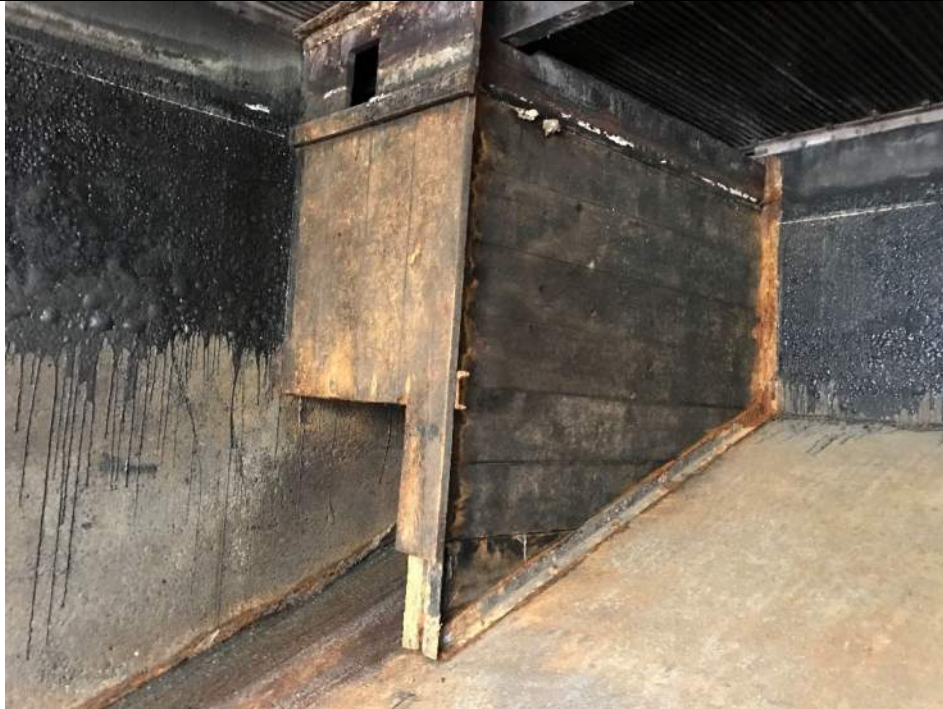
24. No. 1 grit tank inlet box looking southeast.

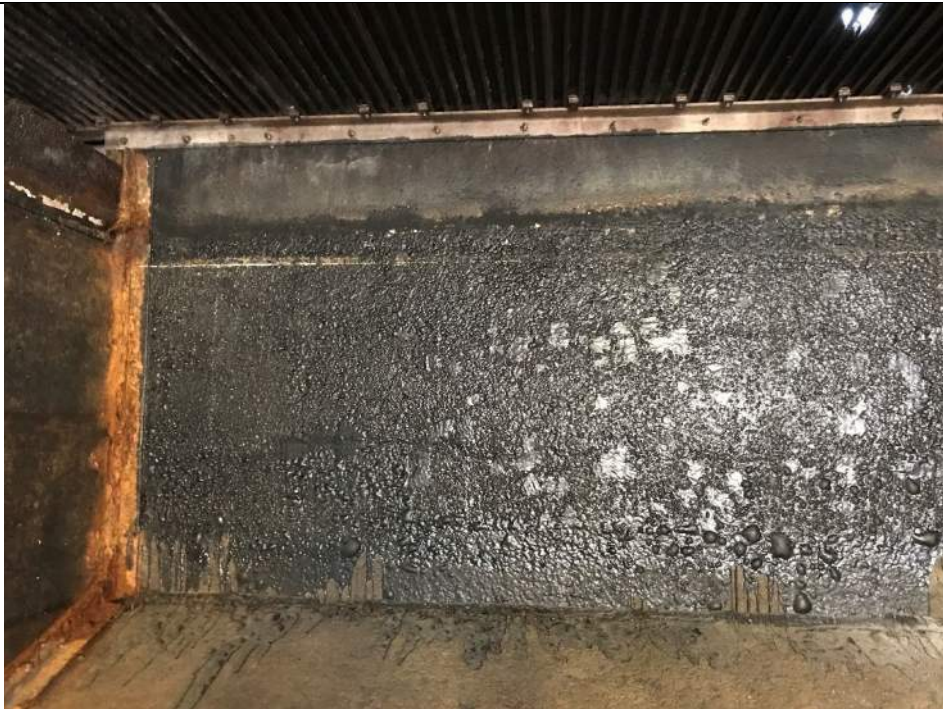
25. East end of grit tank south wall. Blistered black coating visible.

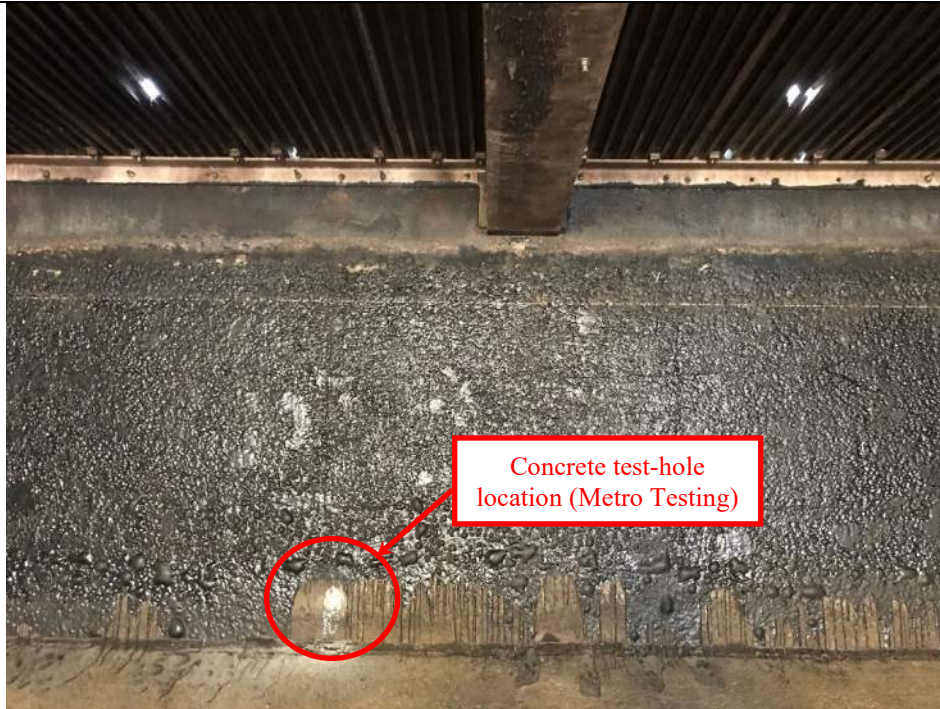
26. Middle of grit tank south wall. Blistered black coating visible.

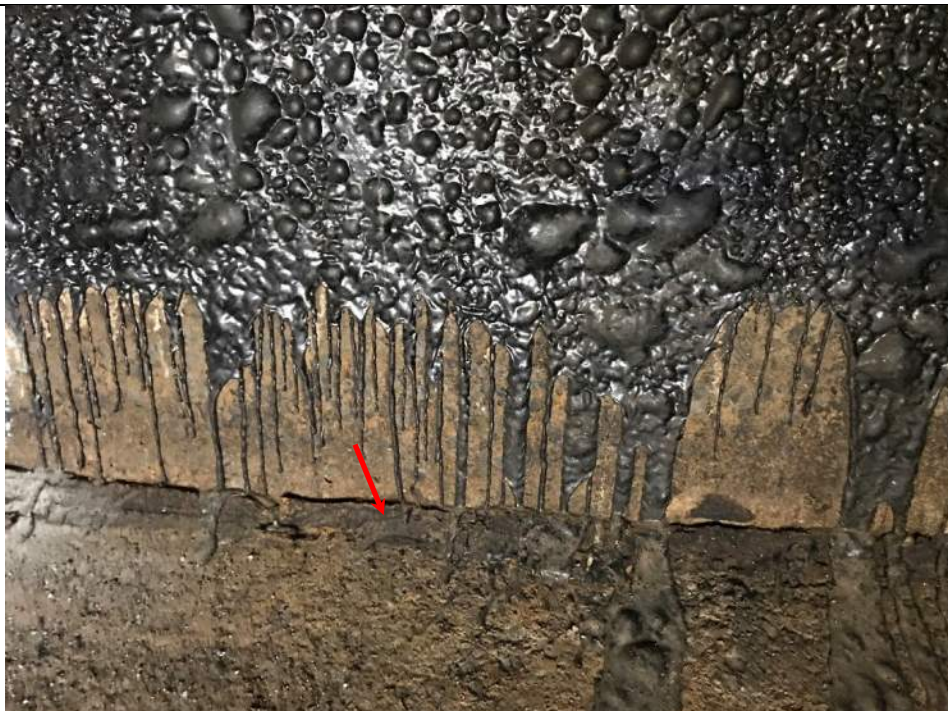
27. Closeup of photo 26 showing asbestos containing joint sealant at tank wall to bottom joint (red arrow).

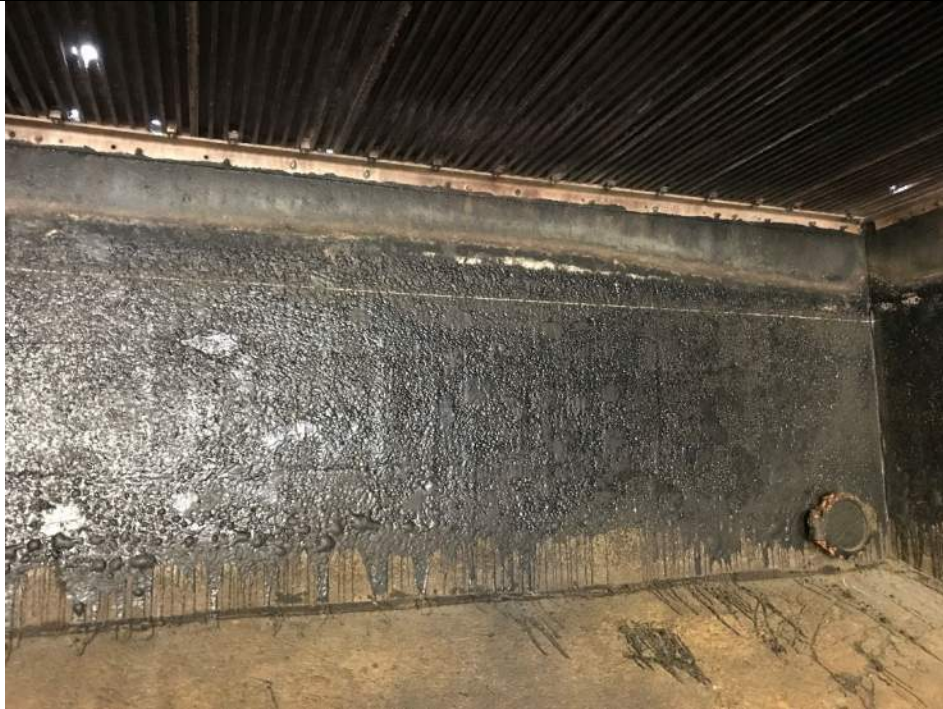
28. West end of grit tank south wall. Blistered black coating and capped, obsolete 200 mm (8") skimmer pipe visible

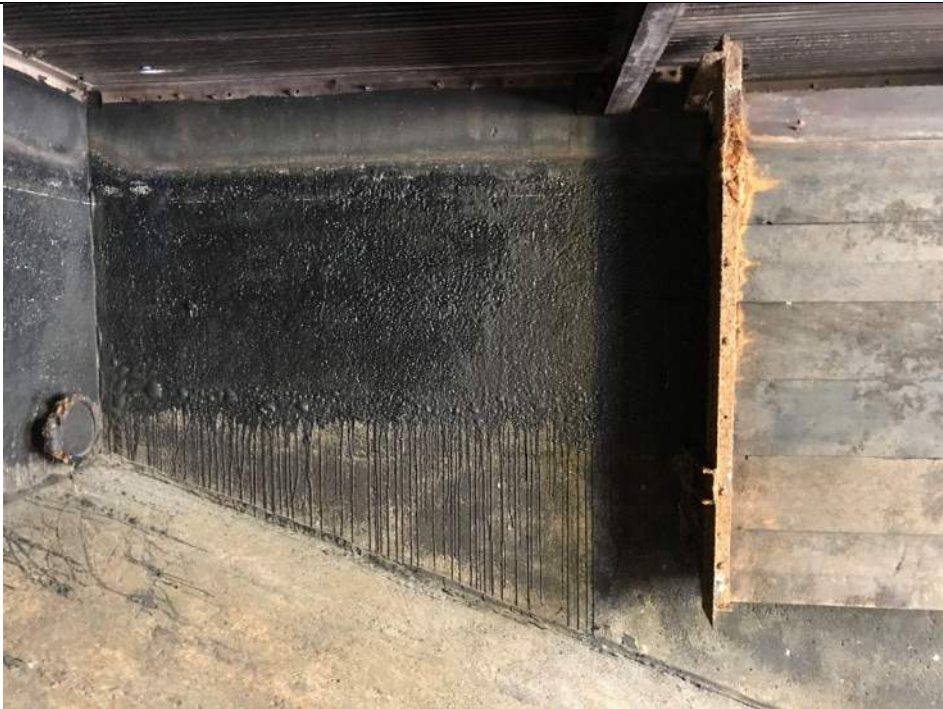
29. West wall of tank at south end. Note coating (drip lines) on upper wall and start of wooden outlet baffle at right.

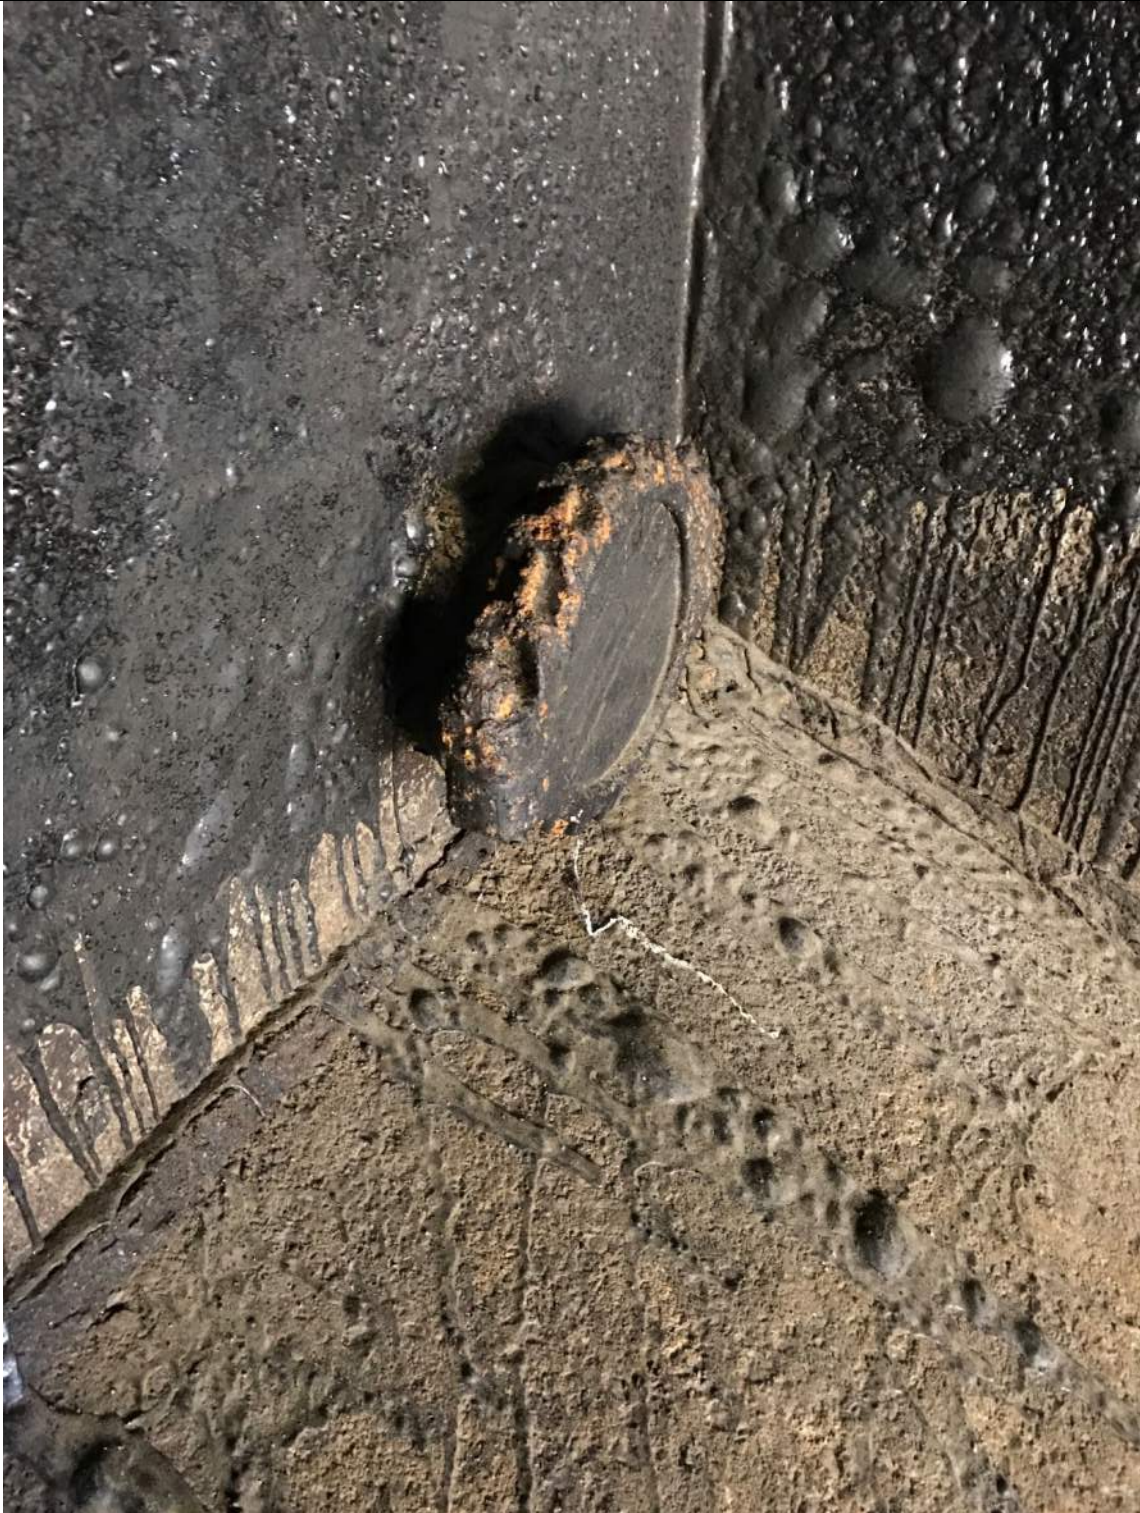
30. Closeup of capped, obsolete 200 mm (8") skimmer pipe.

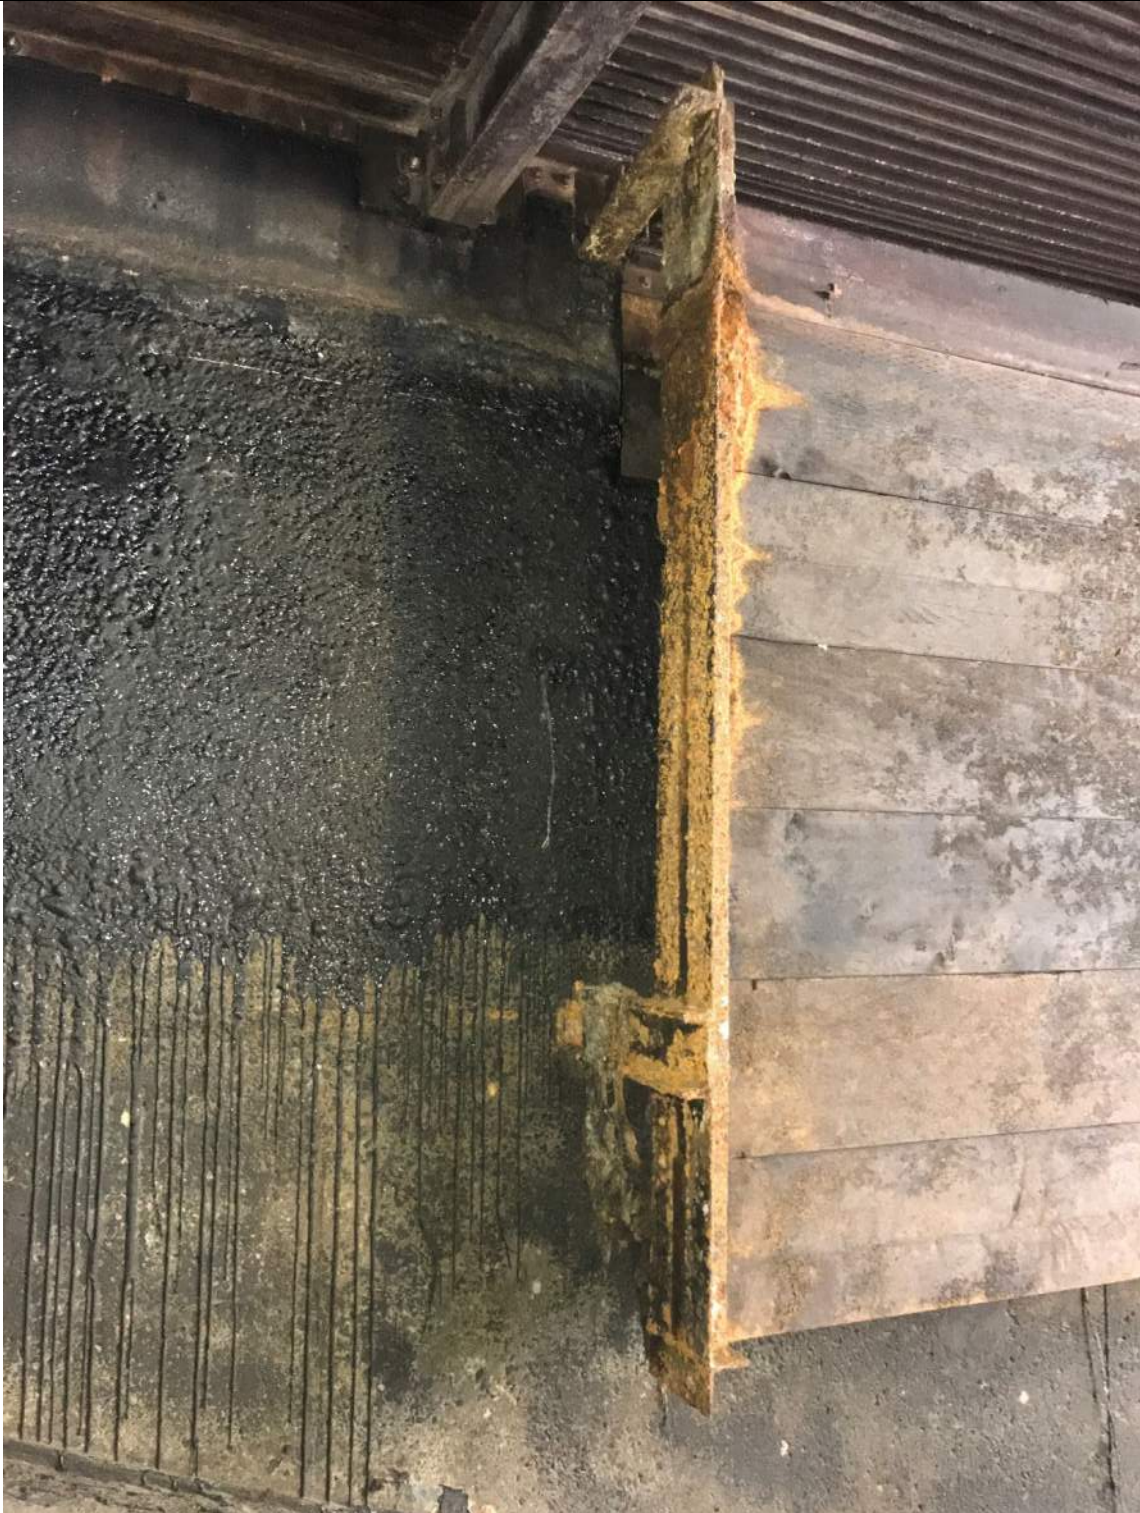
31. South support steel of wooden outlet baffle.

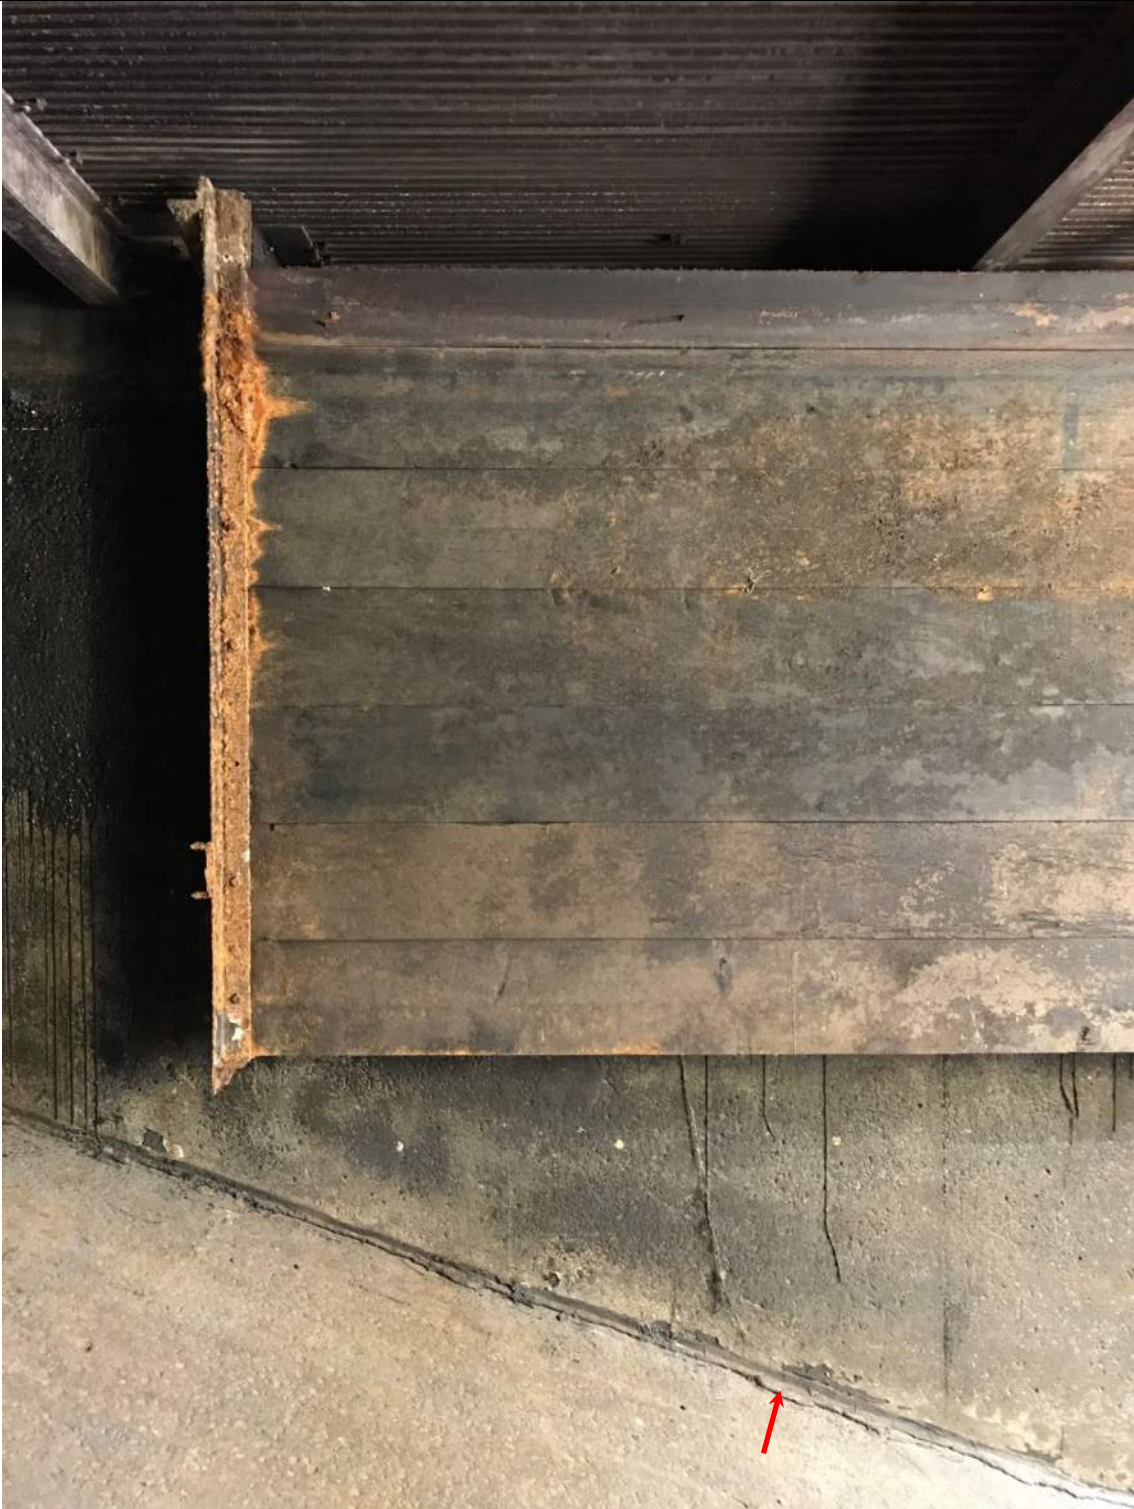
32. Middle view of west tank wall and wooden outlet baffle. Note heavy buildup of asbestos containing joint sealant (red arrow).

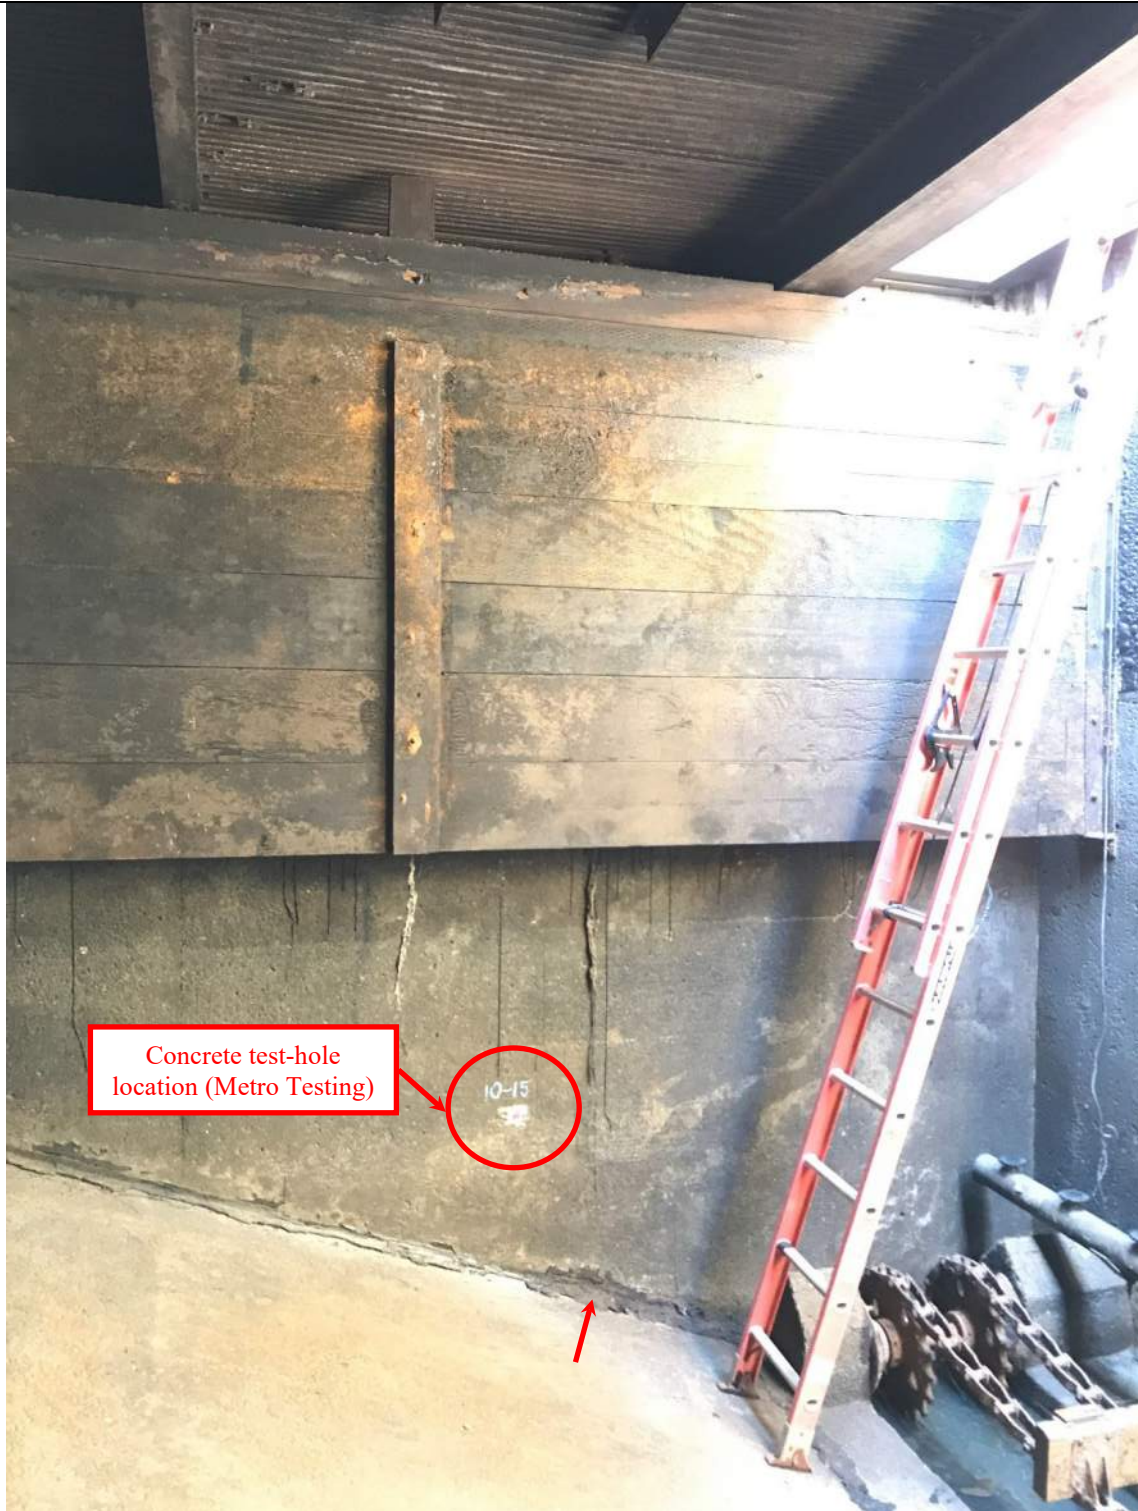
33. North end of west tank wall and wooden outlet baffle. Note heavy buildup of asbestos containing joint sealant (red arrow).

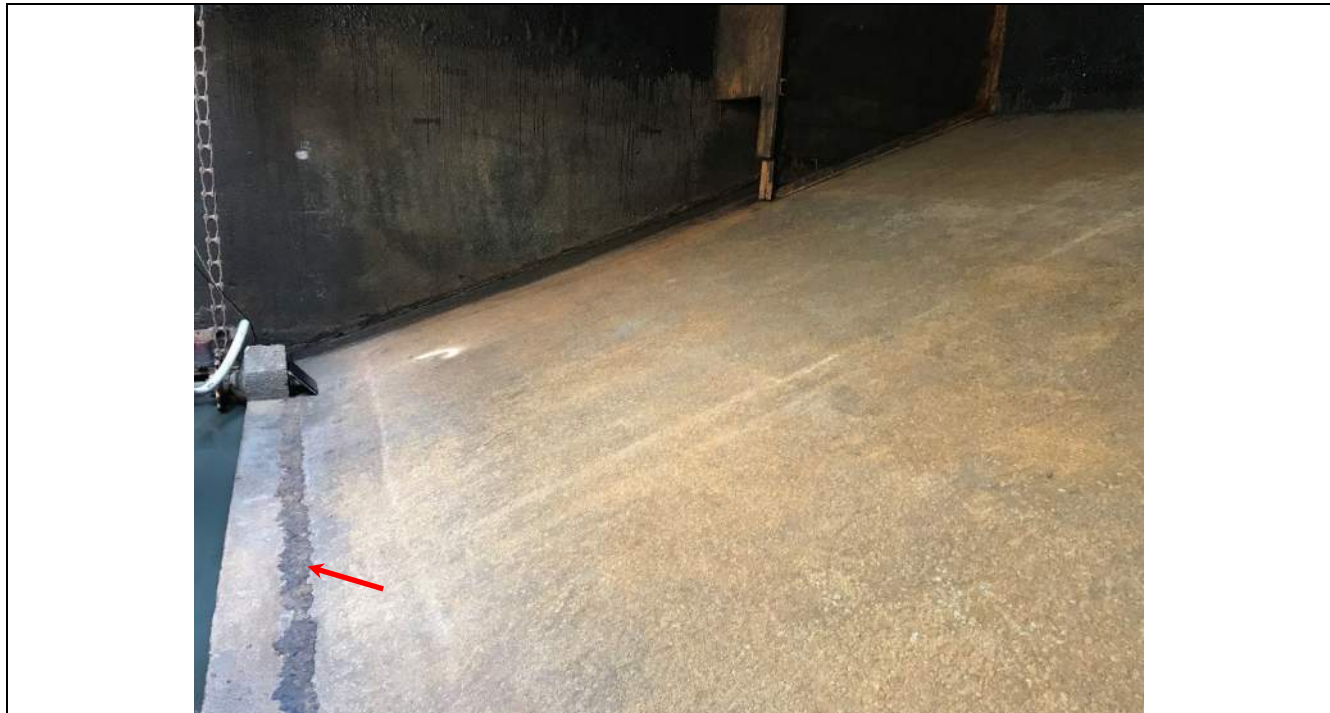
34. East view of tank bottom. Note heavy buildup of asbestos containing joint sealant (red arrow).

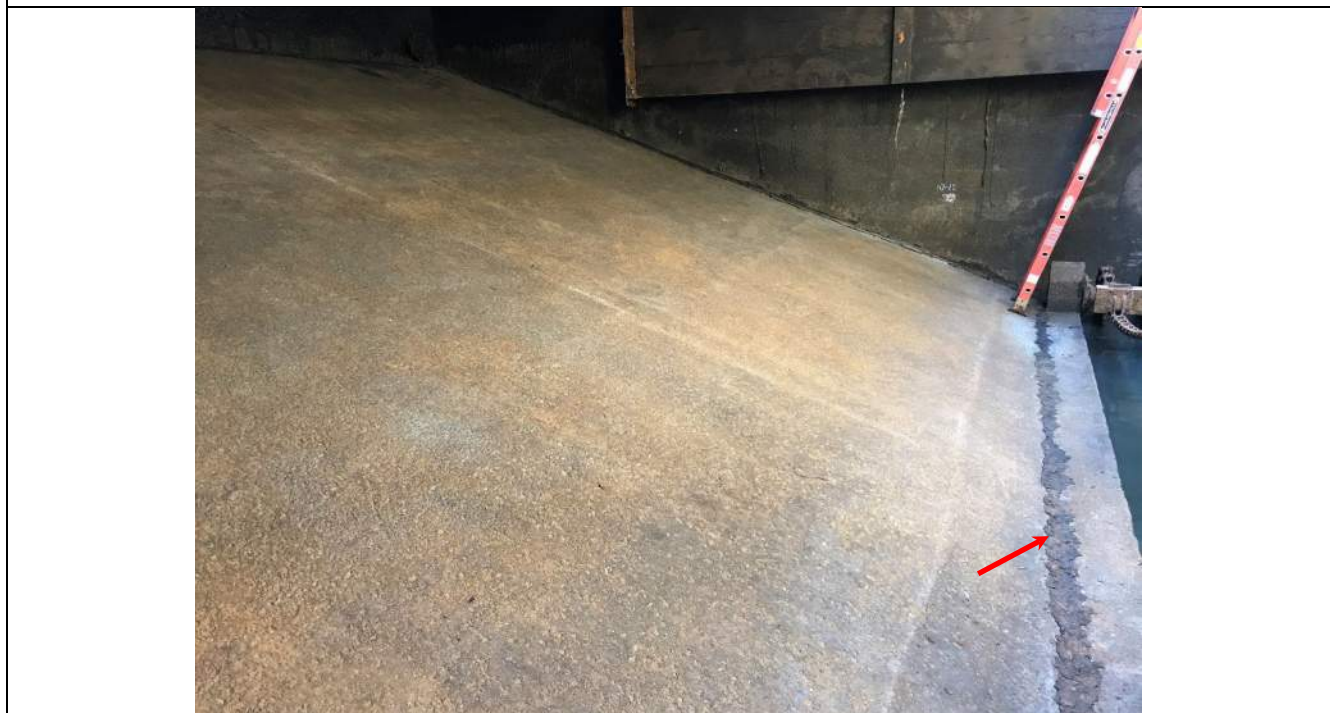
35. West view of tank bottom. Note heavy buildup of asbestos containing joint sealant (red arrow).
