## Exterior Reference Photos

## General Interior/Mechanism Reference Photos

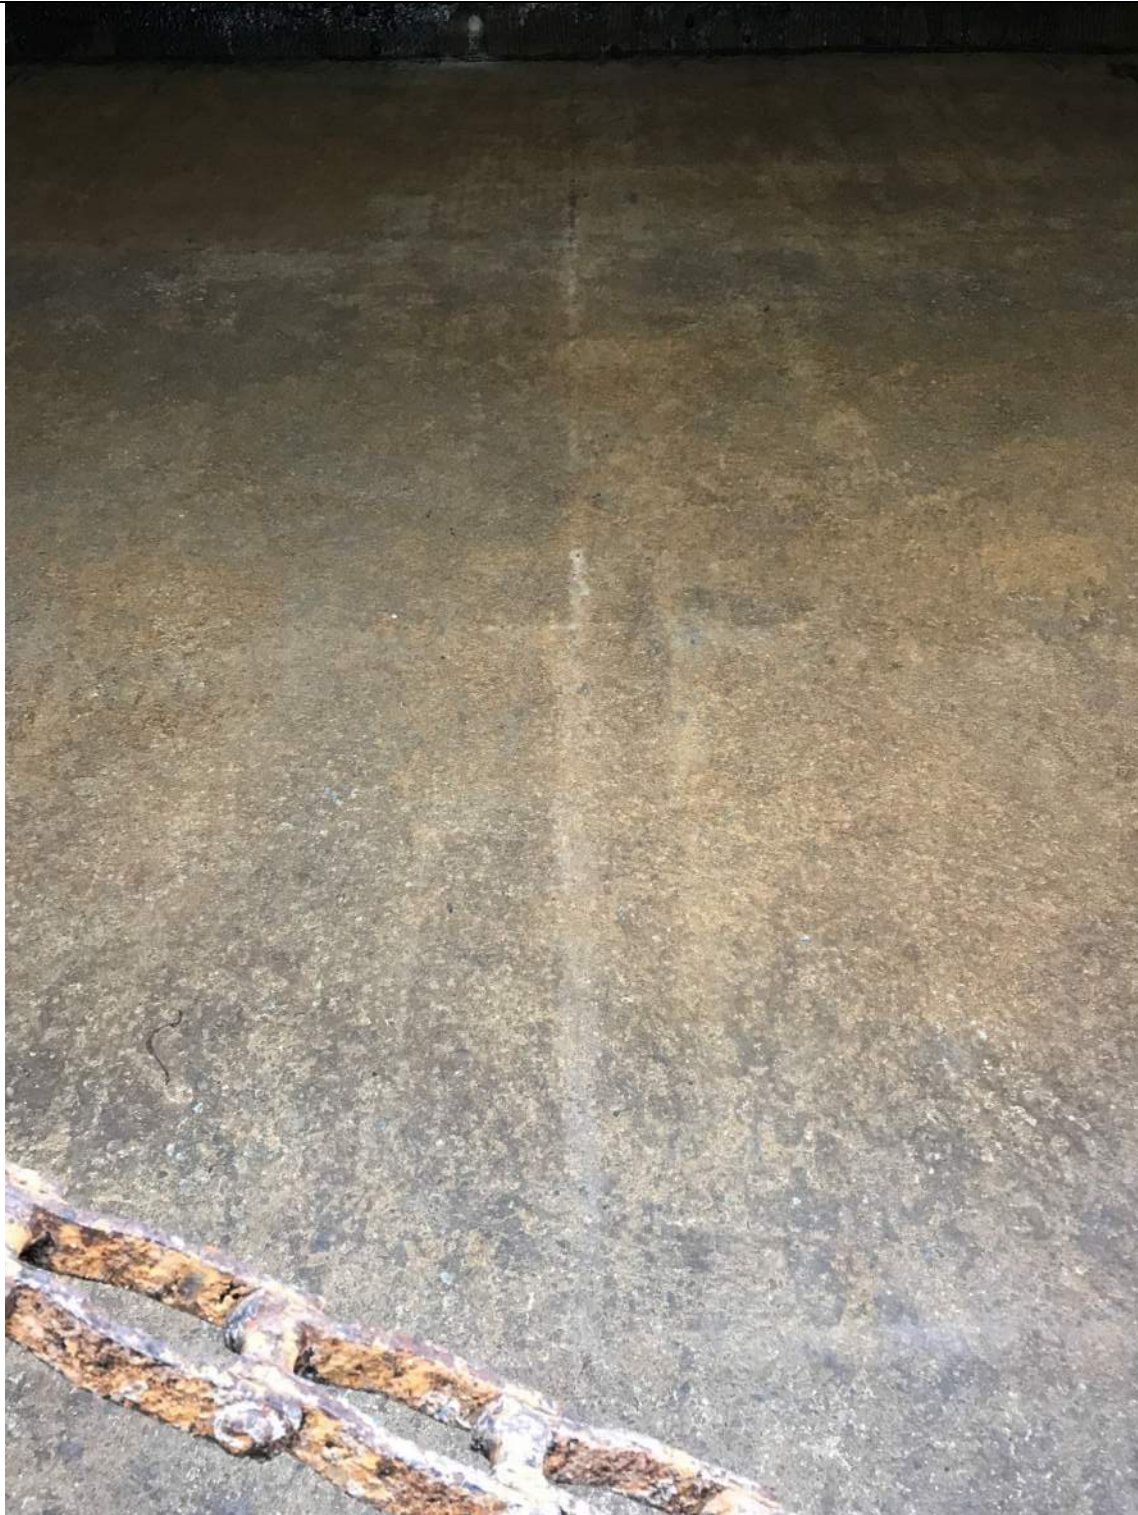
36. Middle view of tank floor.

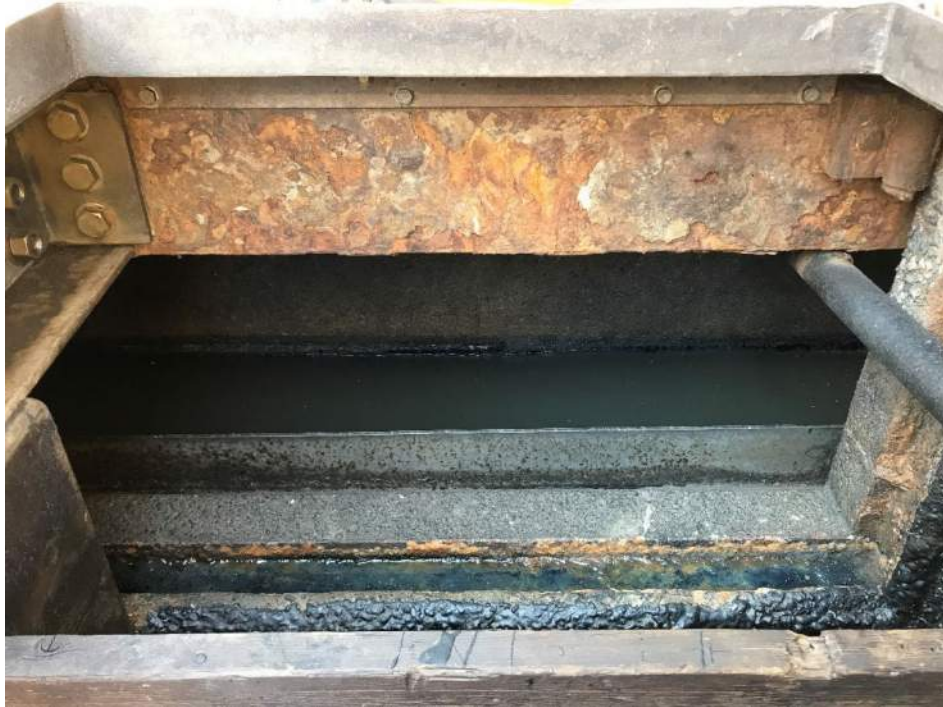
37. Stainless steel tank outlet weir behind wooden outlet baffle (outlet channel in background).

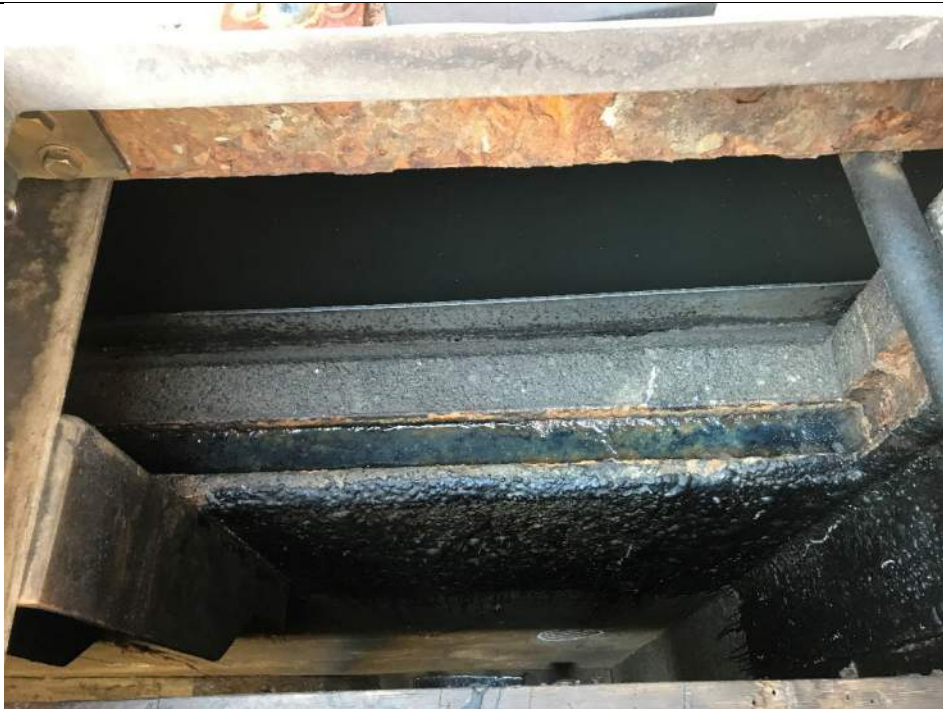
38. Top view of tank outlet weir (west tank wall visible below).

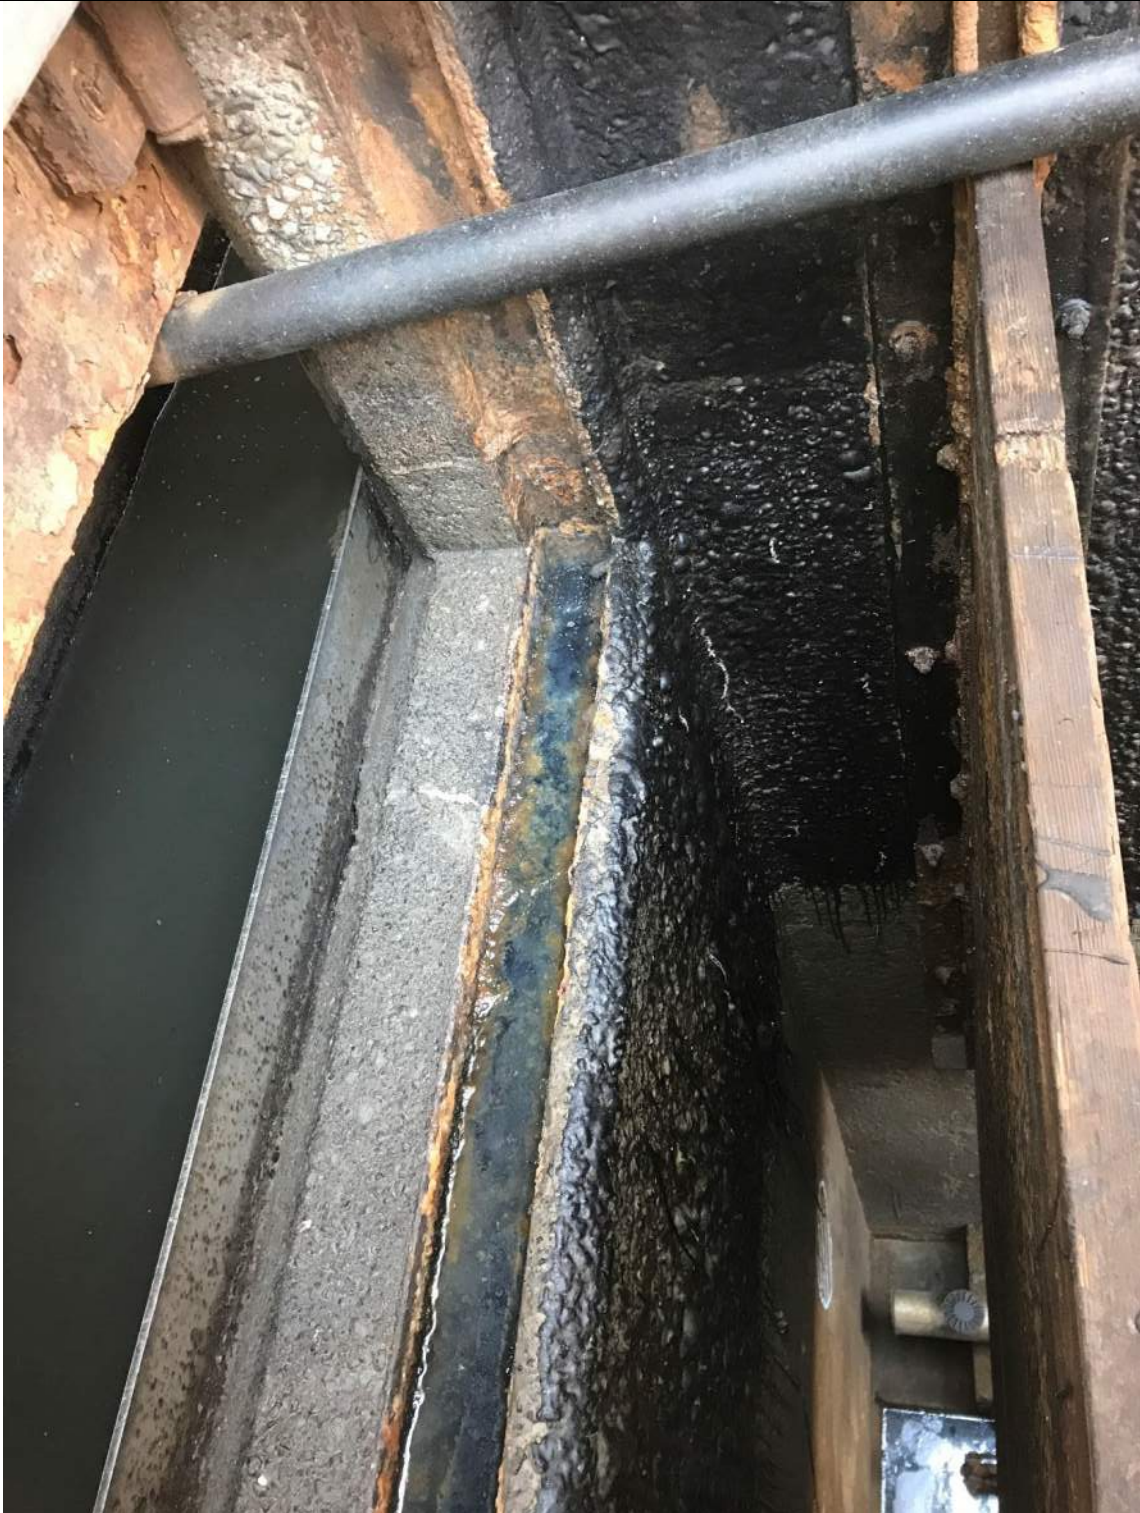
39. North end of outlet weir and wooden outlet baffle.

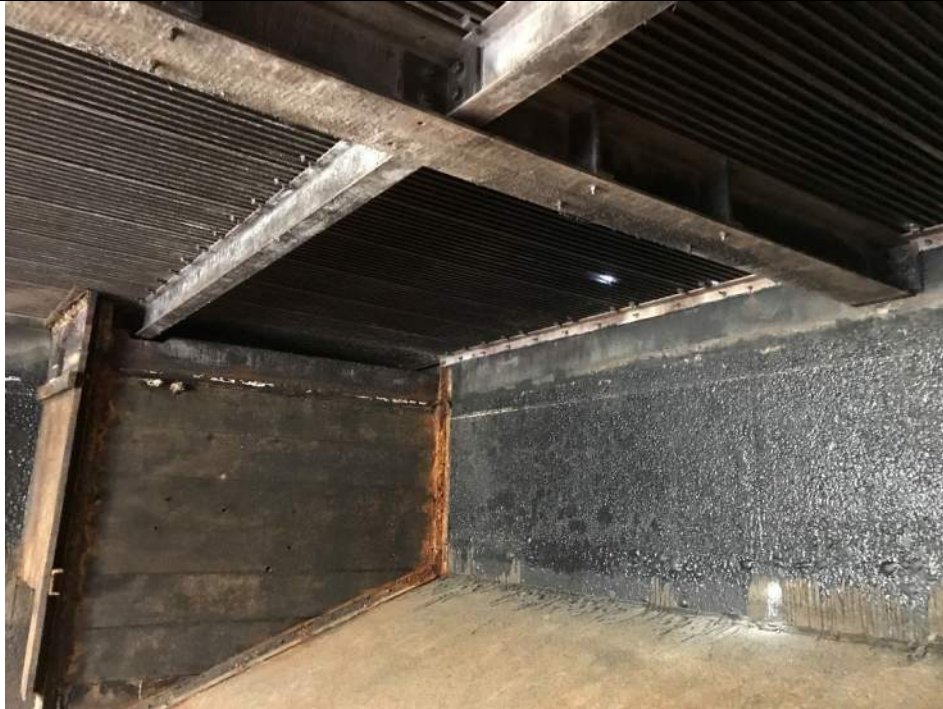
40. Tank top and support steel looking southeast.

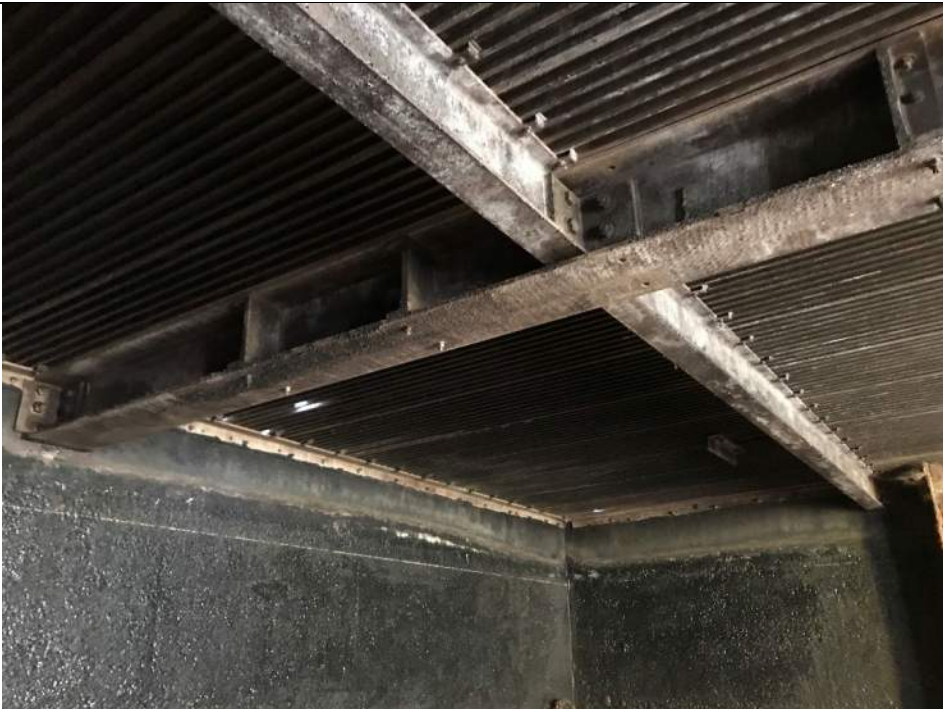
41. Tank top and support steel looking southwest.
