## General Exterior Reference Photos

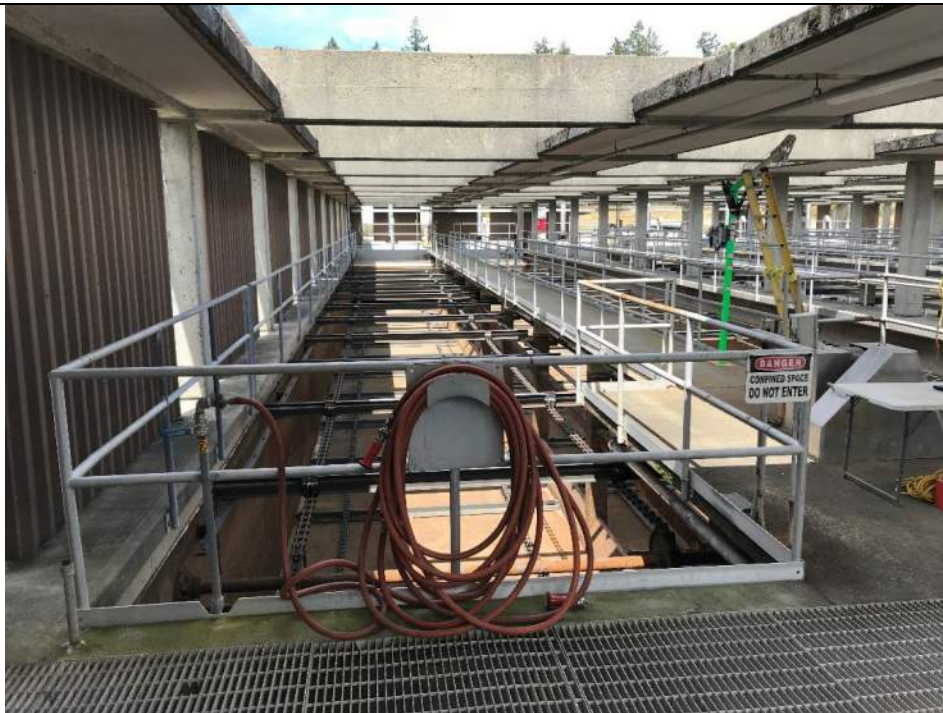
1. GNPCC No. 1 primary sedimentation tank west bay, looking north from influent inlet end.

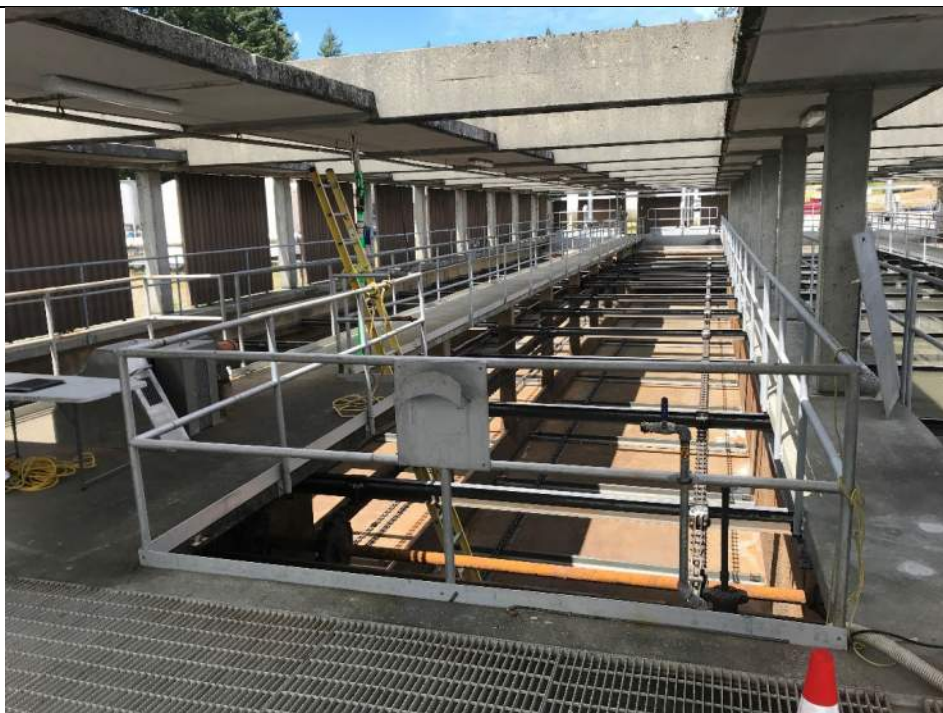
2. GNPCC No. 1 primary sedimentation tank east bay, looking north from influent inlet end.

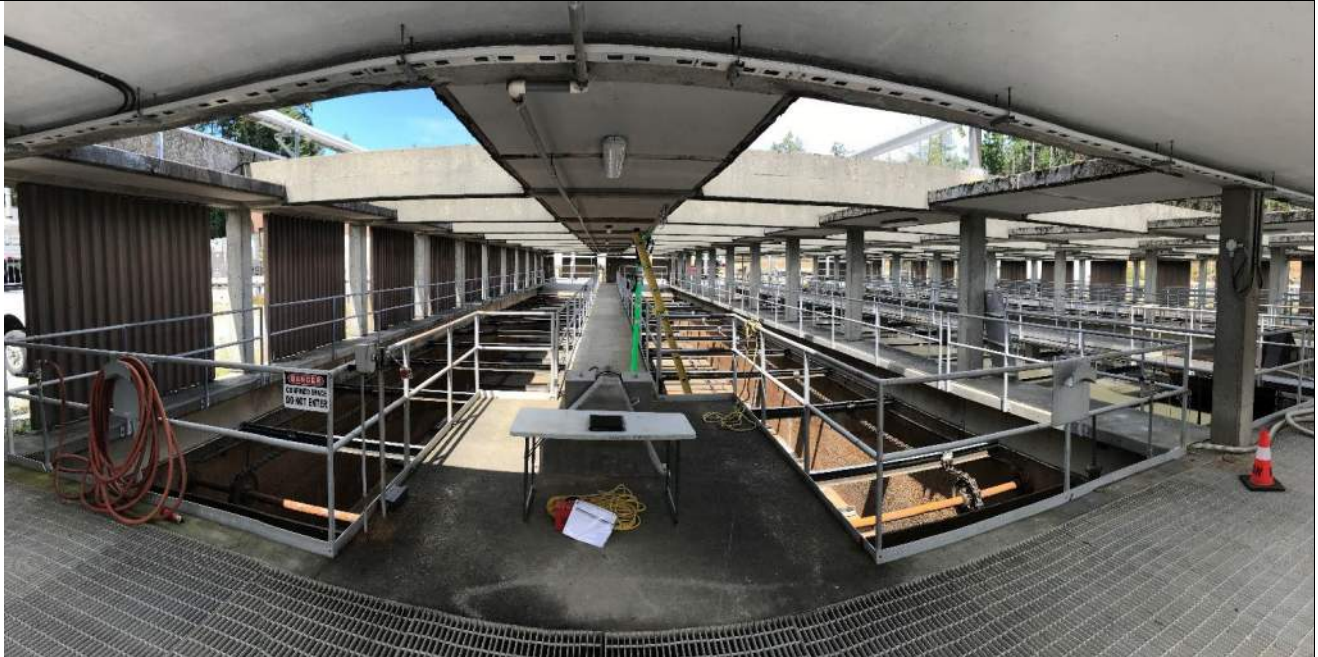
3. Panoramic view of GNPCC No. 1 primary sedimentation tank, looking north.

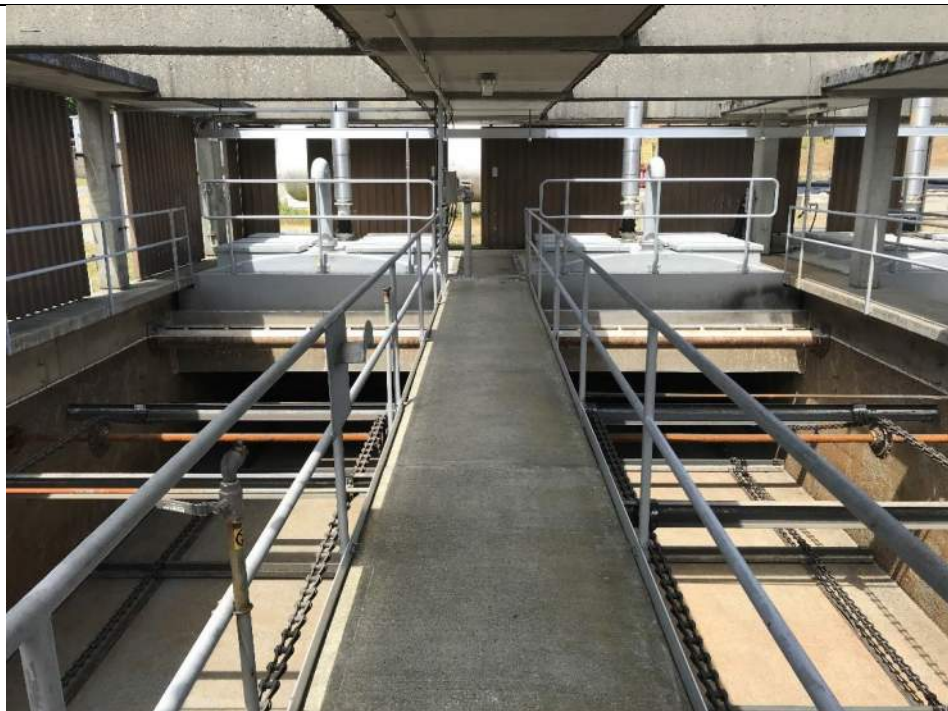
4. Effluent discharge end of GNPCC No. 1 primary sedimentation tank, looking north.

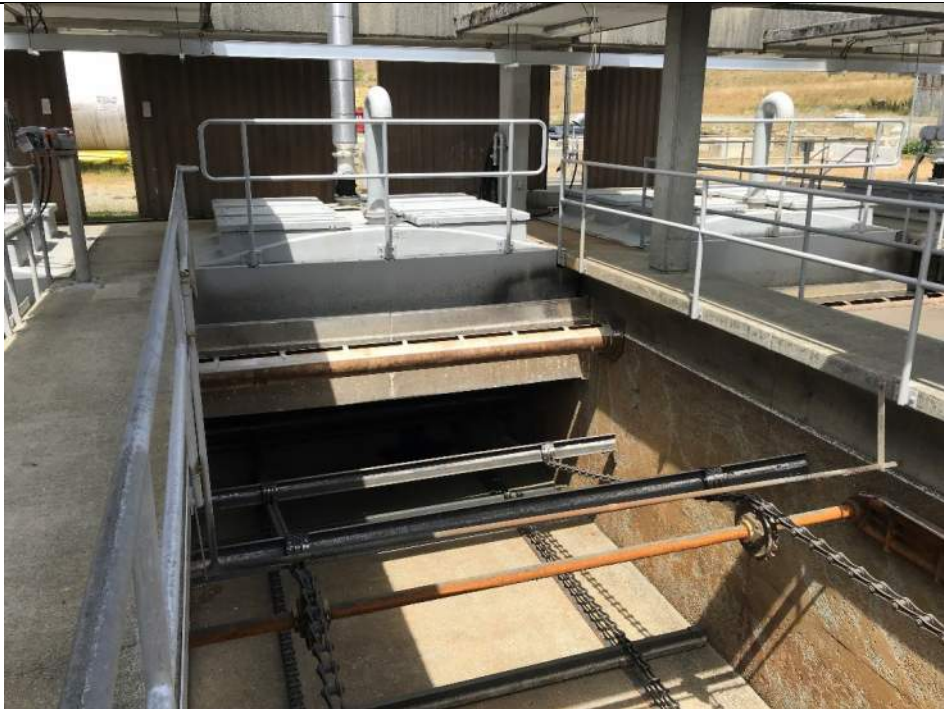
6. East bay scum skimmer and effluent discharge odour collection hood, looking north.

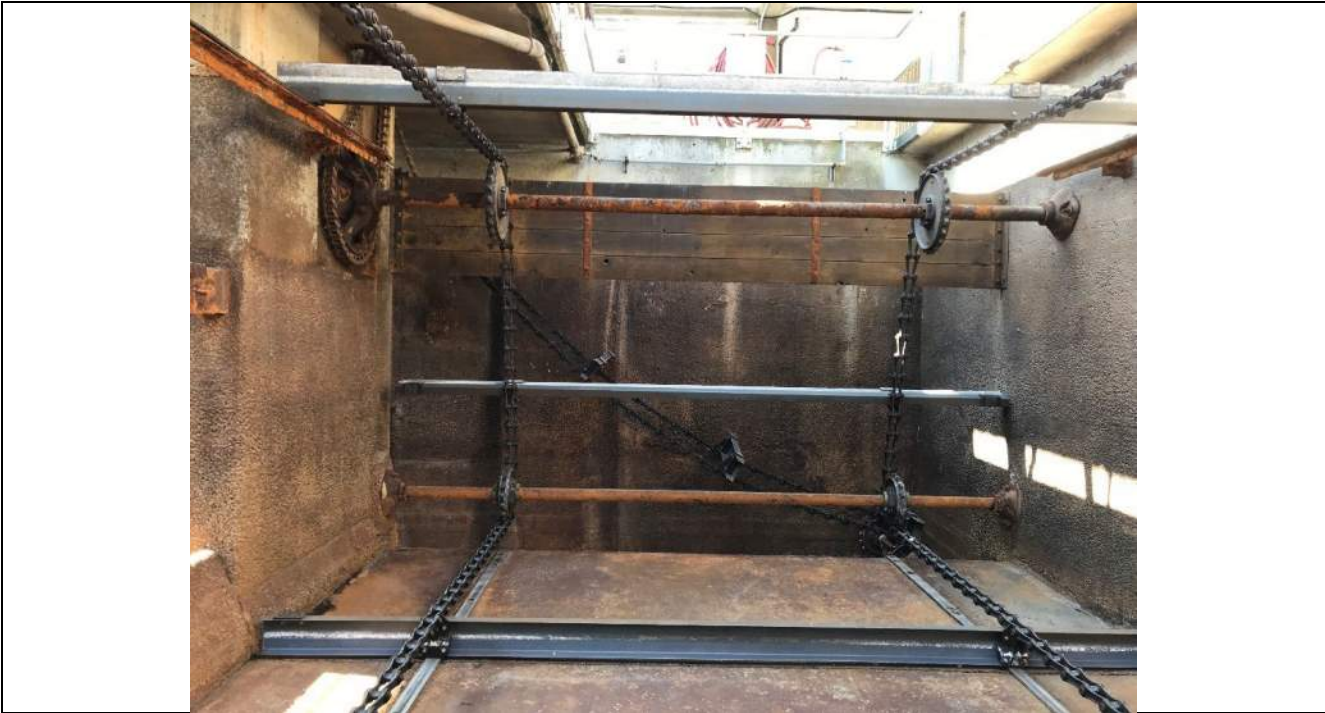
9. West bay longitudinal collector headshaft mechanism in foreground, wooden inlet baffle and cross collector mechanism in background.

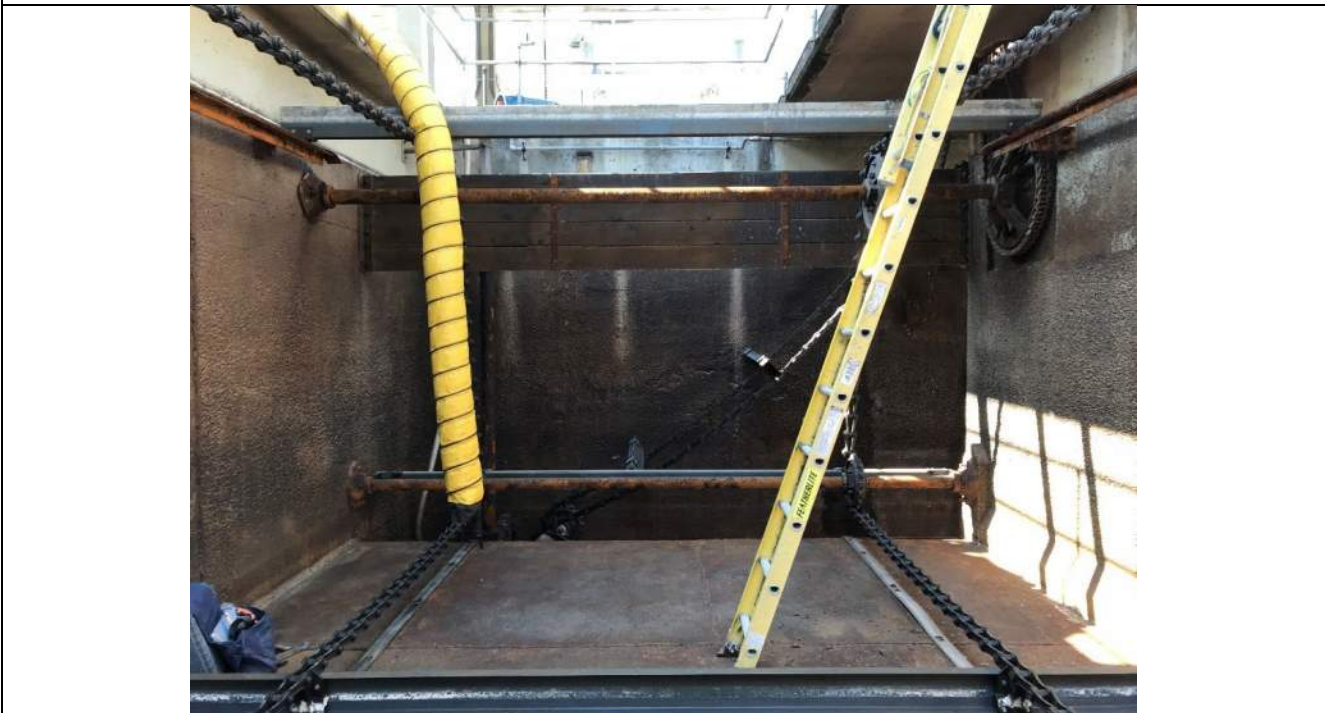
10. East bay longitudinal collector headshaft mechanism in foreground, wooden inlet baffle and cross collector mechanism in background

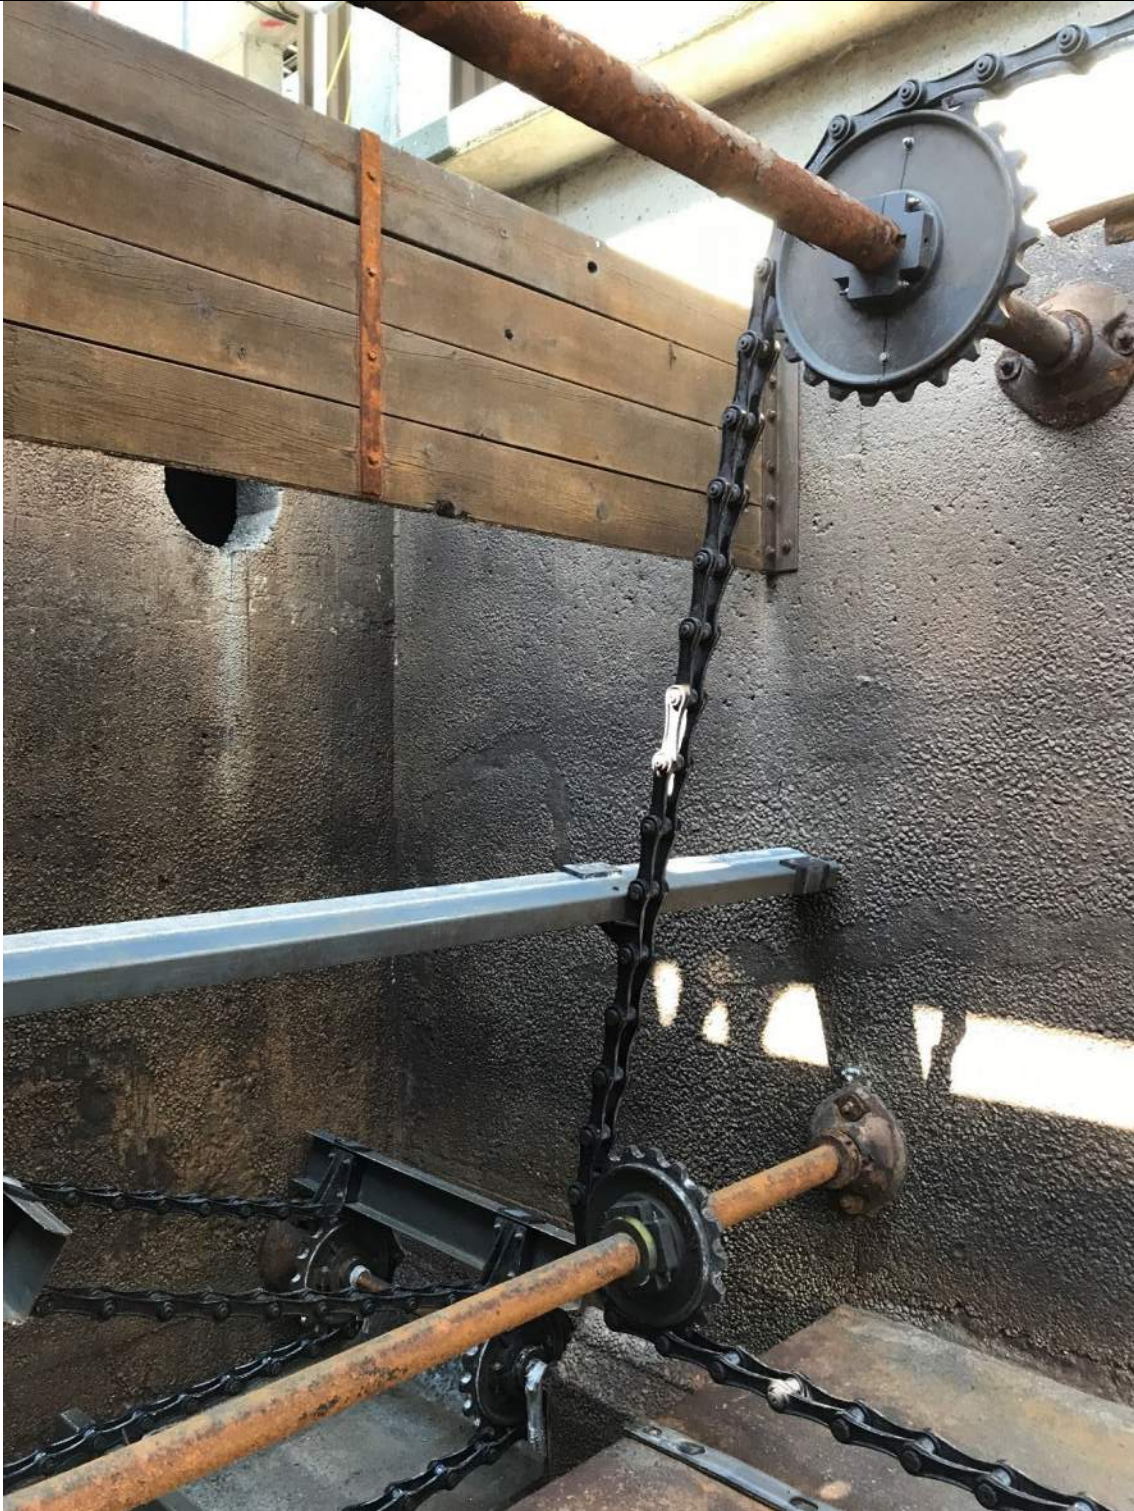
11. From right: West wall, SW corner and south wall of tank. Headshaft and west drive sprocket at upper right.

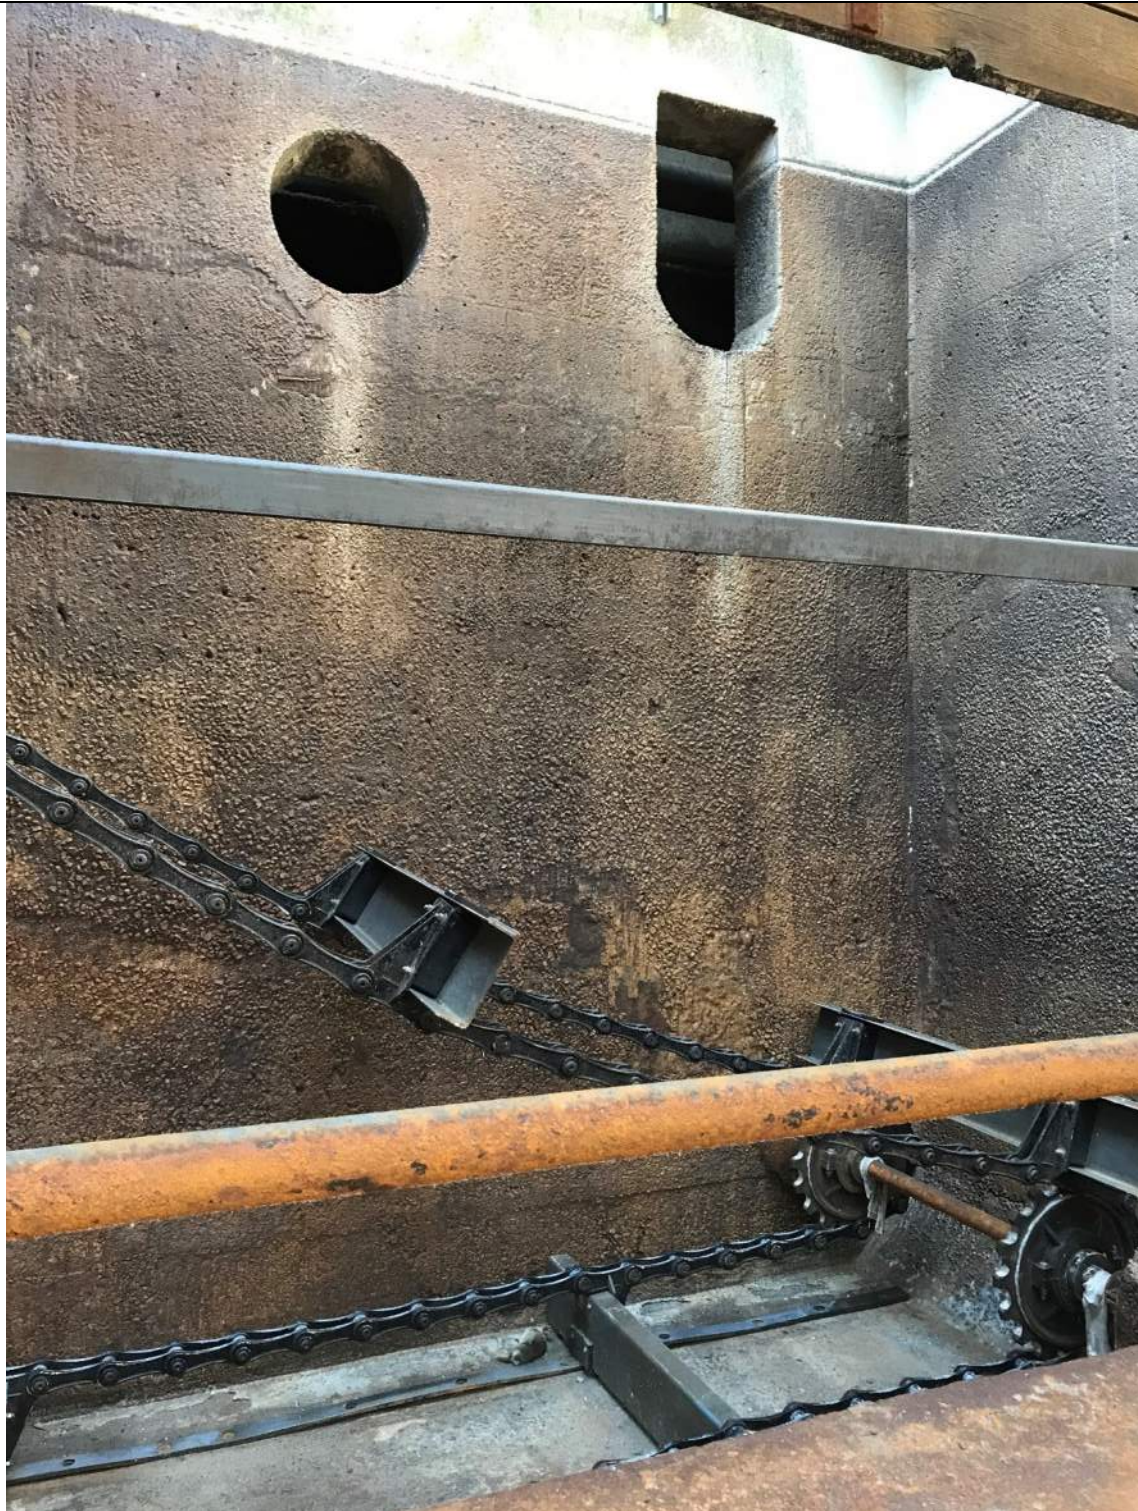
12. From right: West wall, SW corner and south wall of tank, cont'd from photo 11 moving east. Note smooth previous patch repair areas.

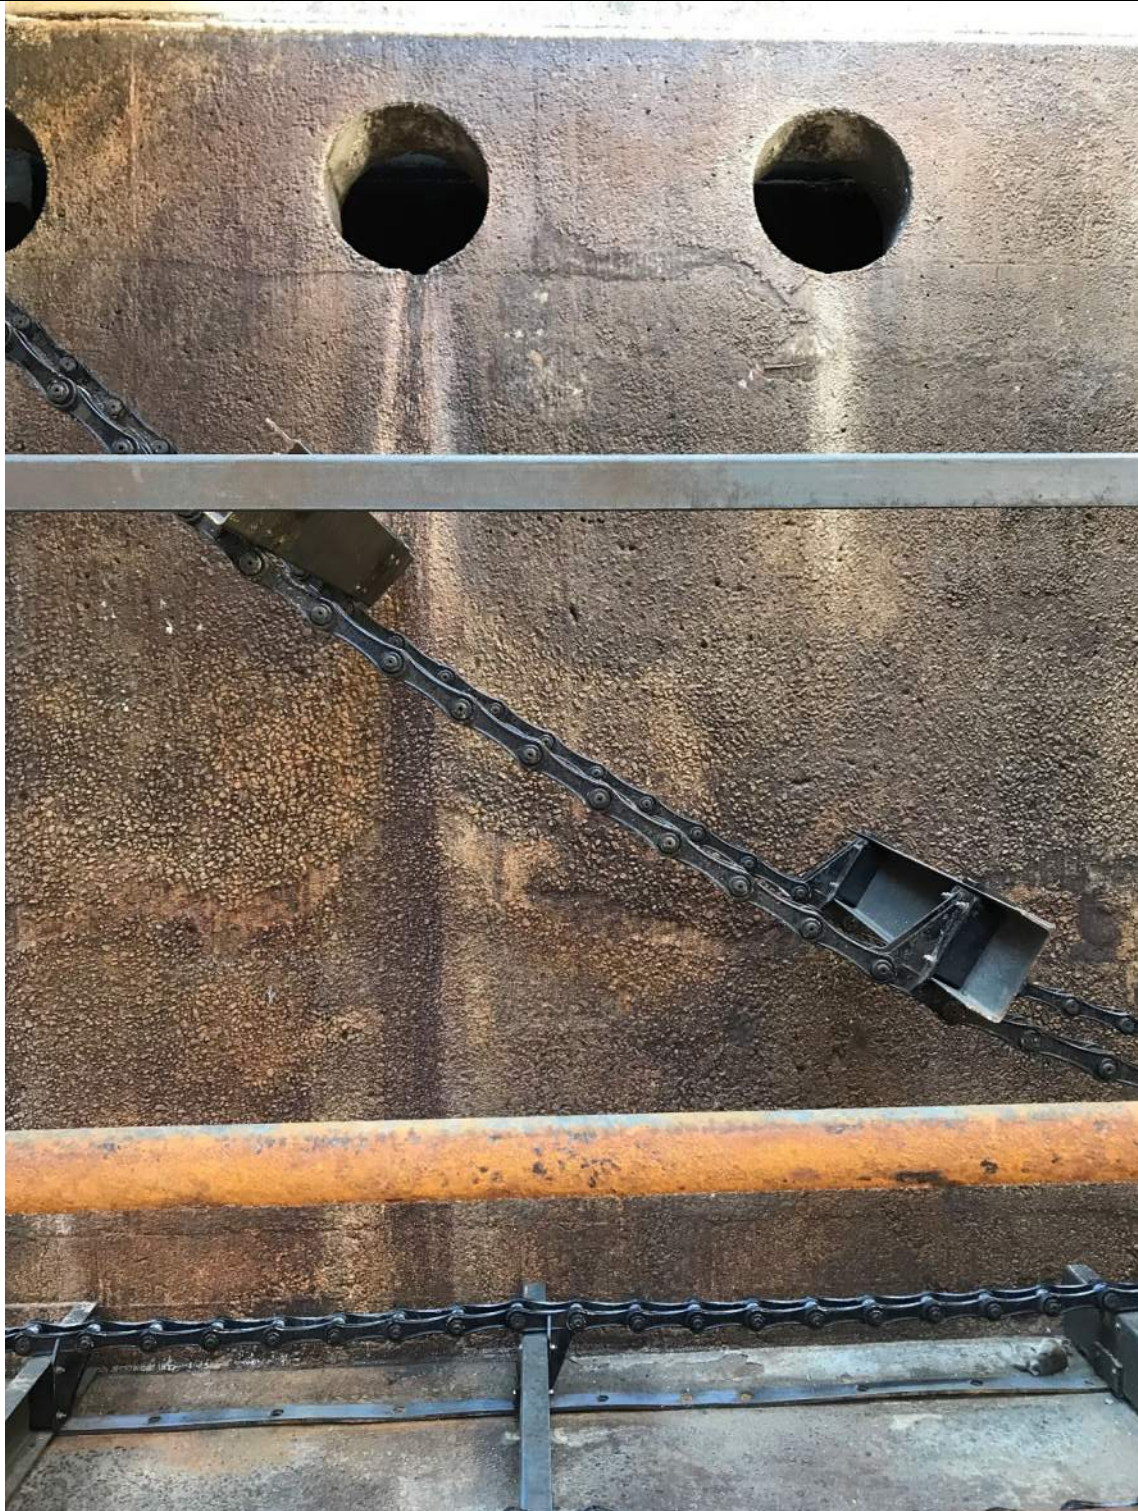
13. South wall of tank, continued from photo 12 moving east. Note: Previous coating applied to exposed aggregate without filling.

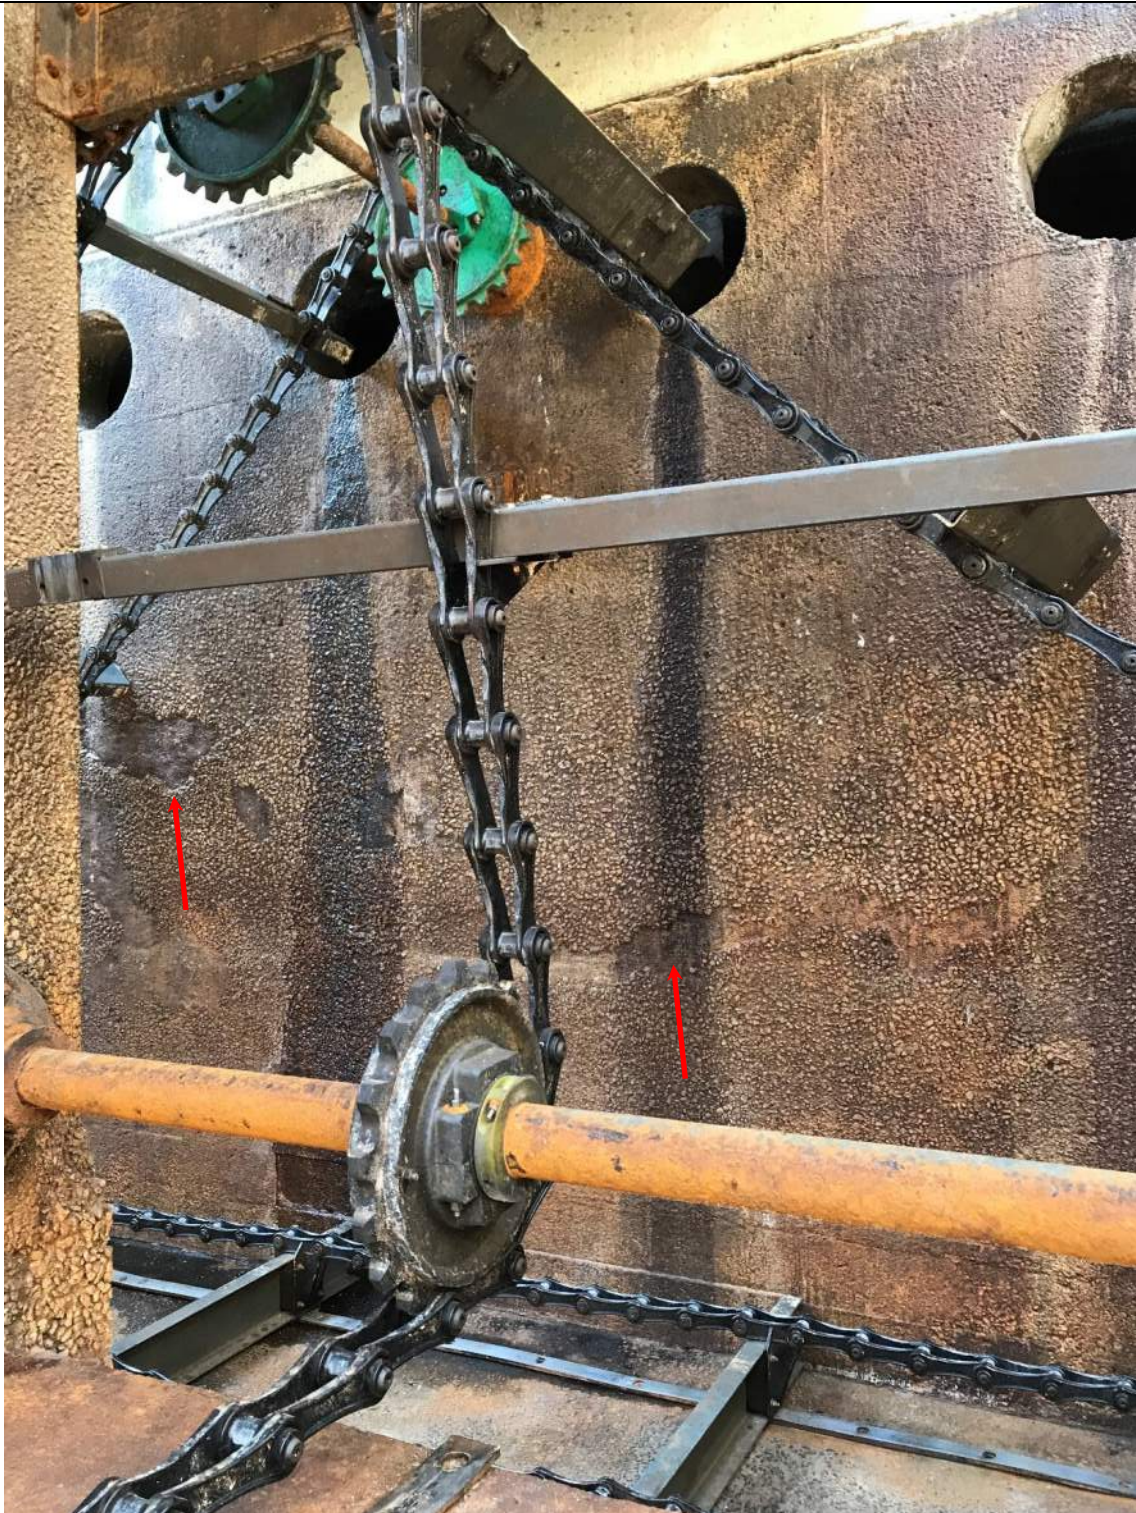
14. South wall of tank, continued from photo 13 moving east. Note smooth previous patch repair areas on wall (red arrows).

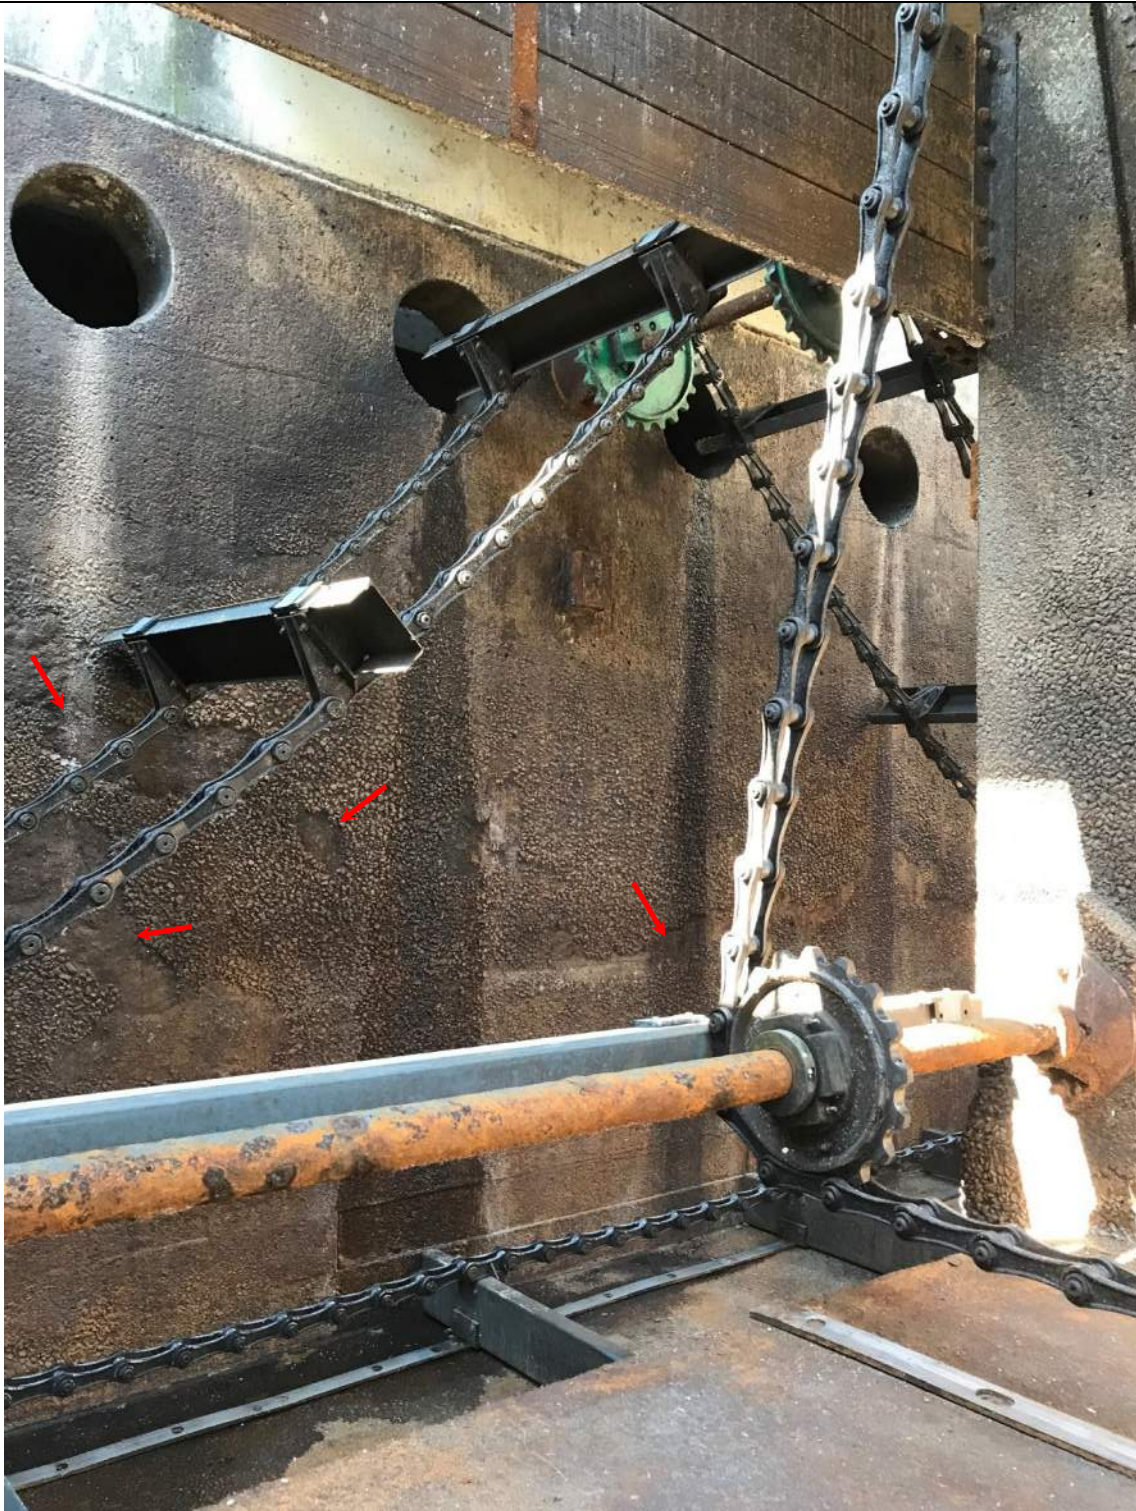
16. South wall of tank, continued from photo 14 moving east. Note smooth previous patch repair areas on wall (red arrows).

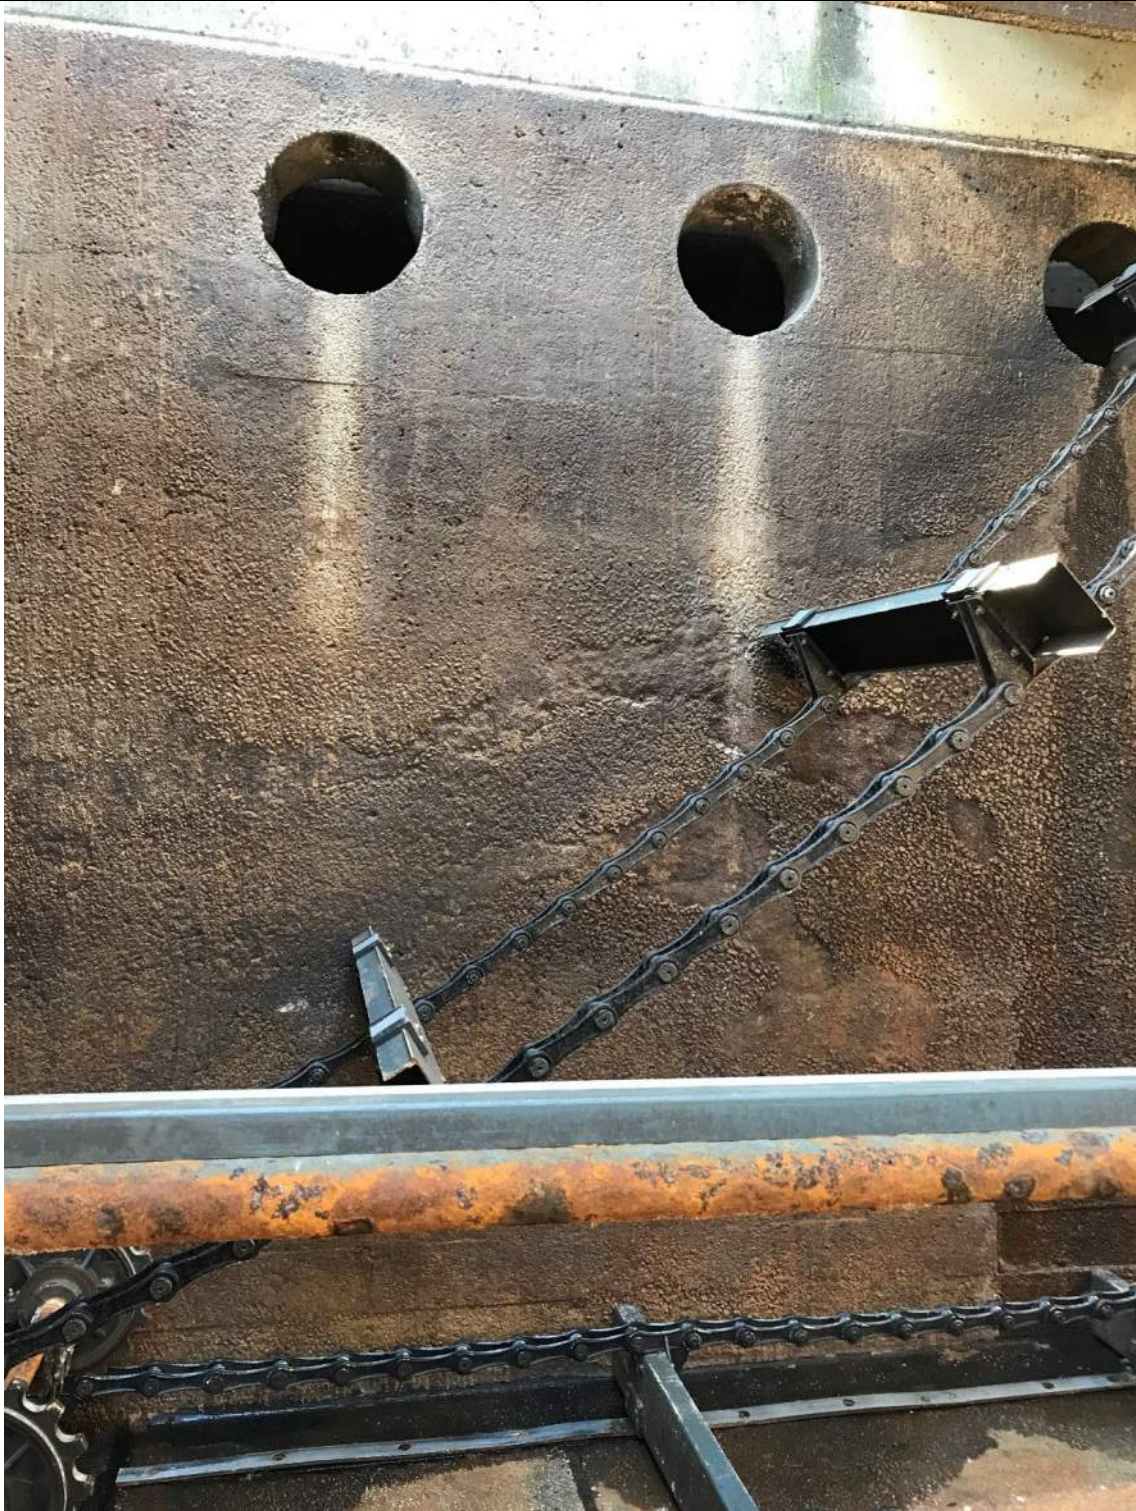
18. South wall of tank, continued from photo 16 moving east. Note smooth previous patch repair areas on wall.

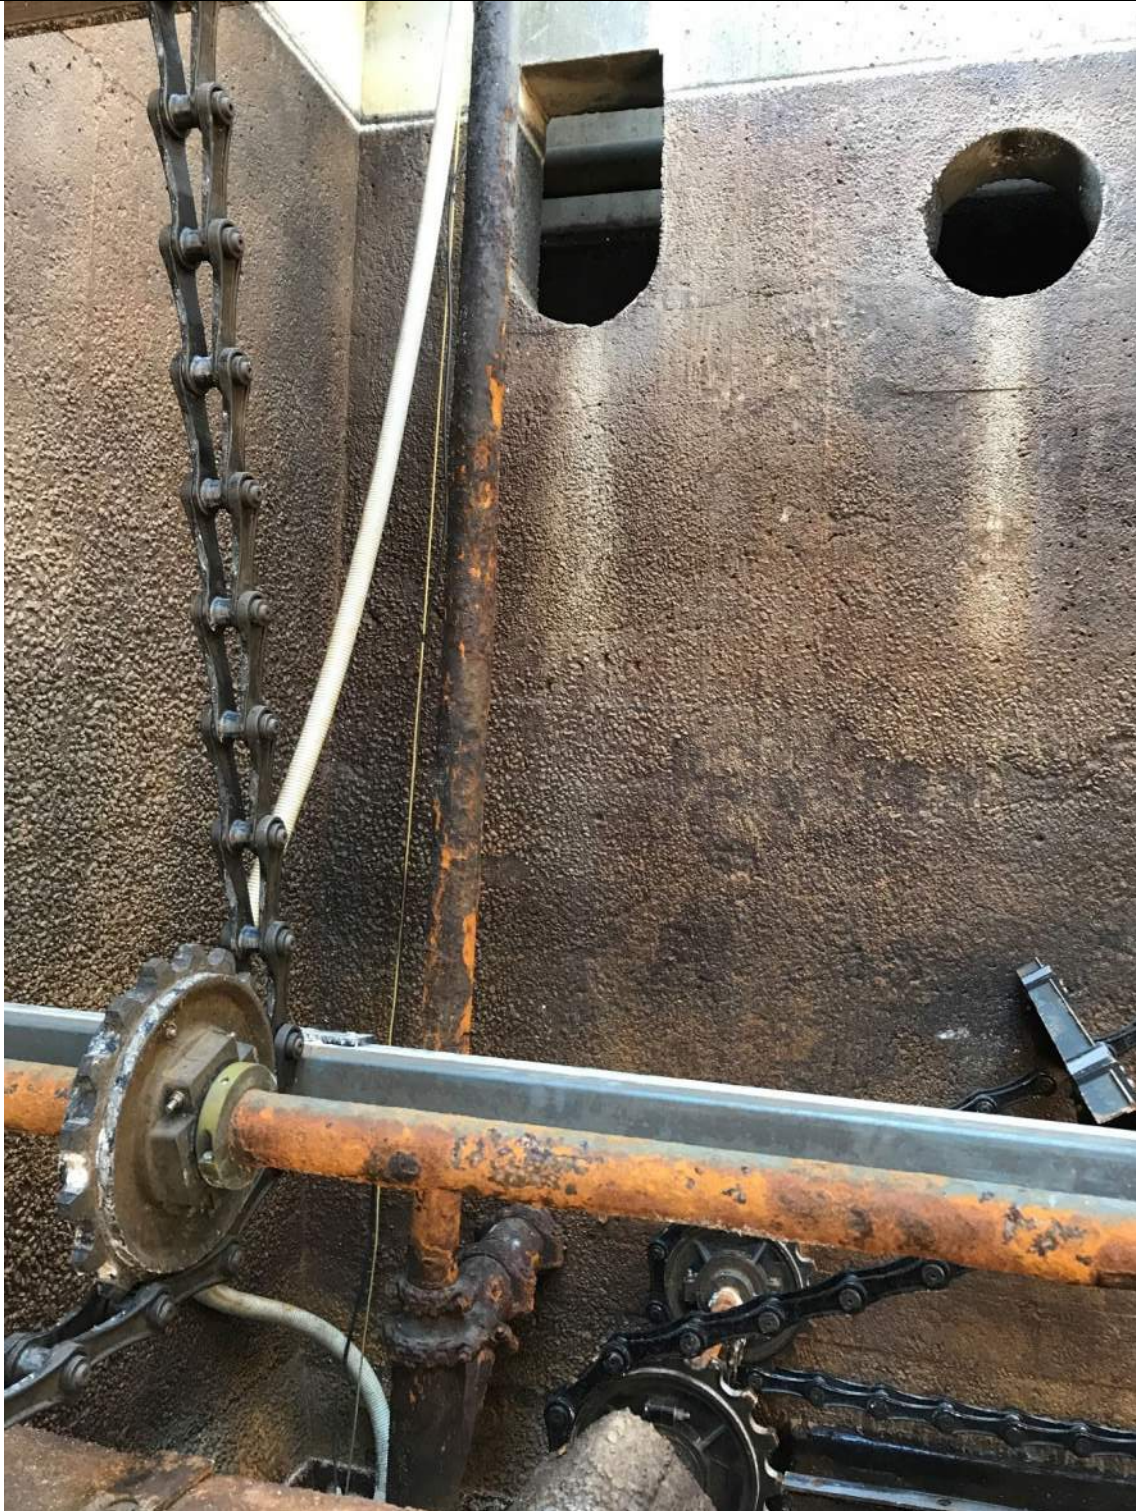
19. South wall of tank, continued from photo 18 moving east. Note: Previous coating applied to exposed aggregate without filling.

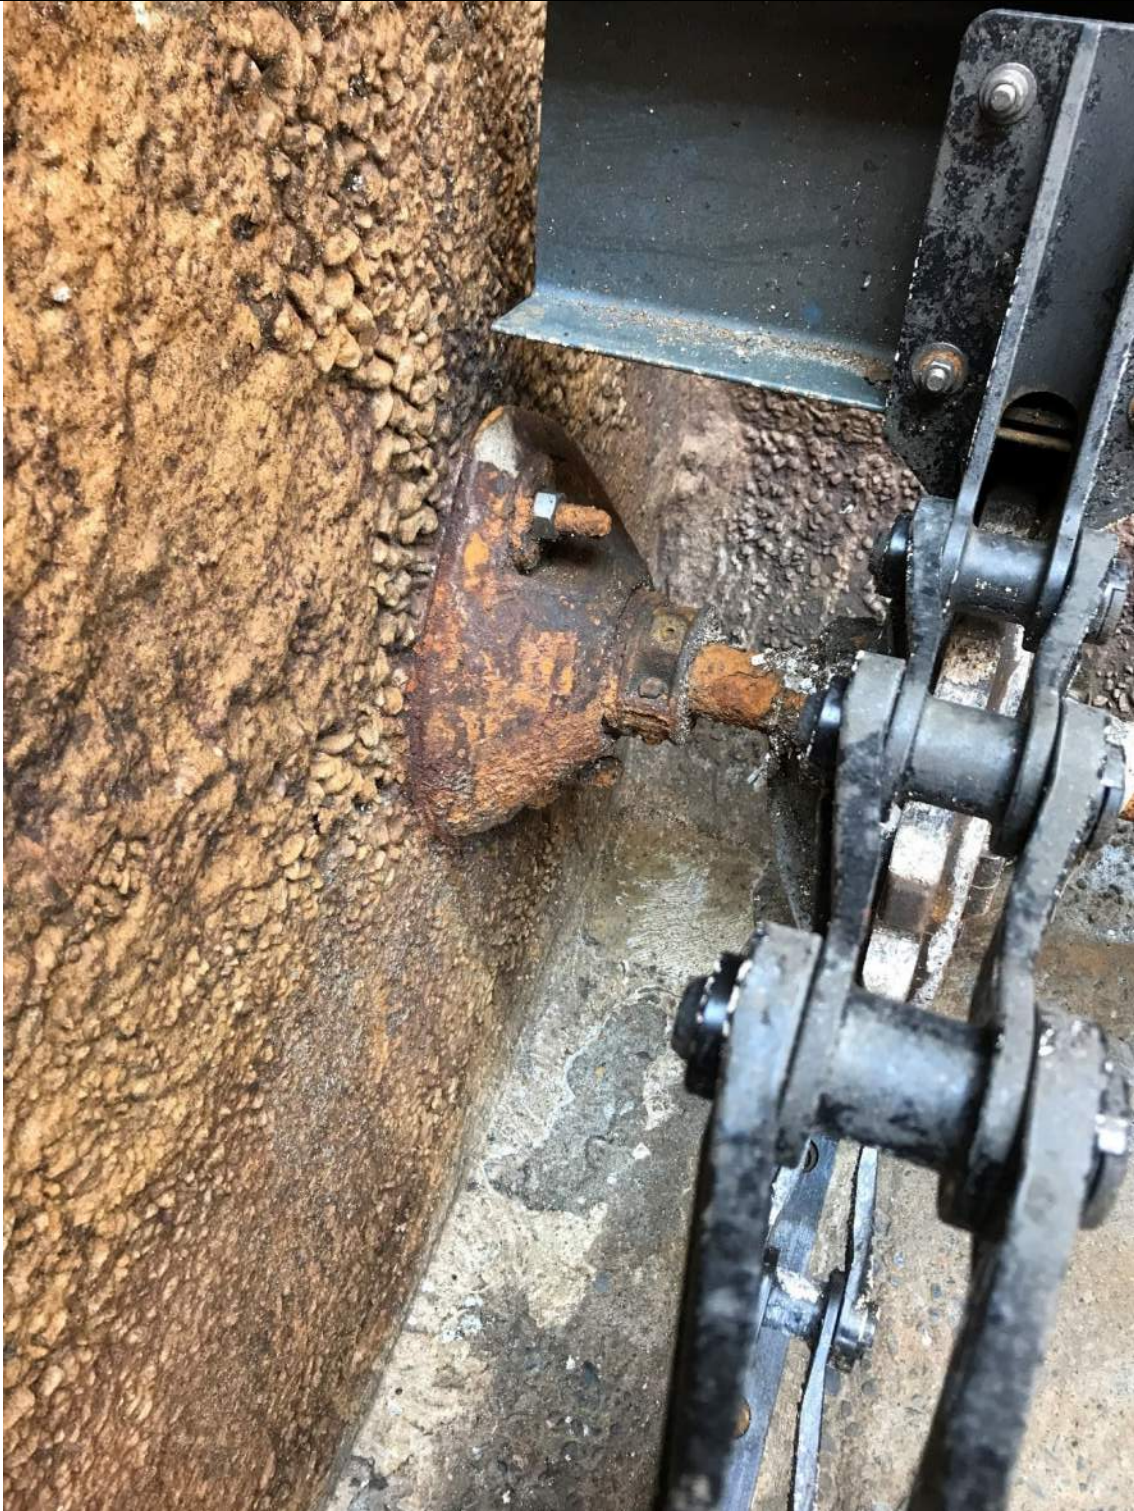
22. Close-up of cross collector tail (east) end idler south shaft bearing.

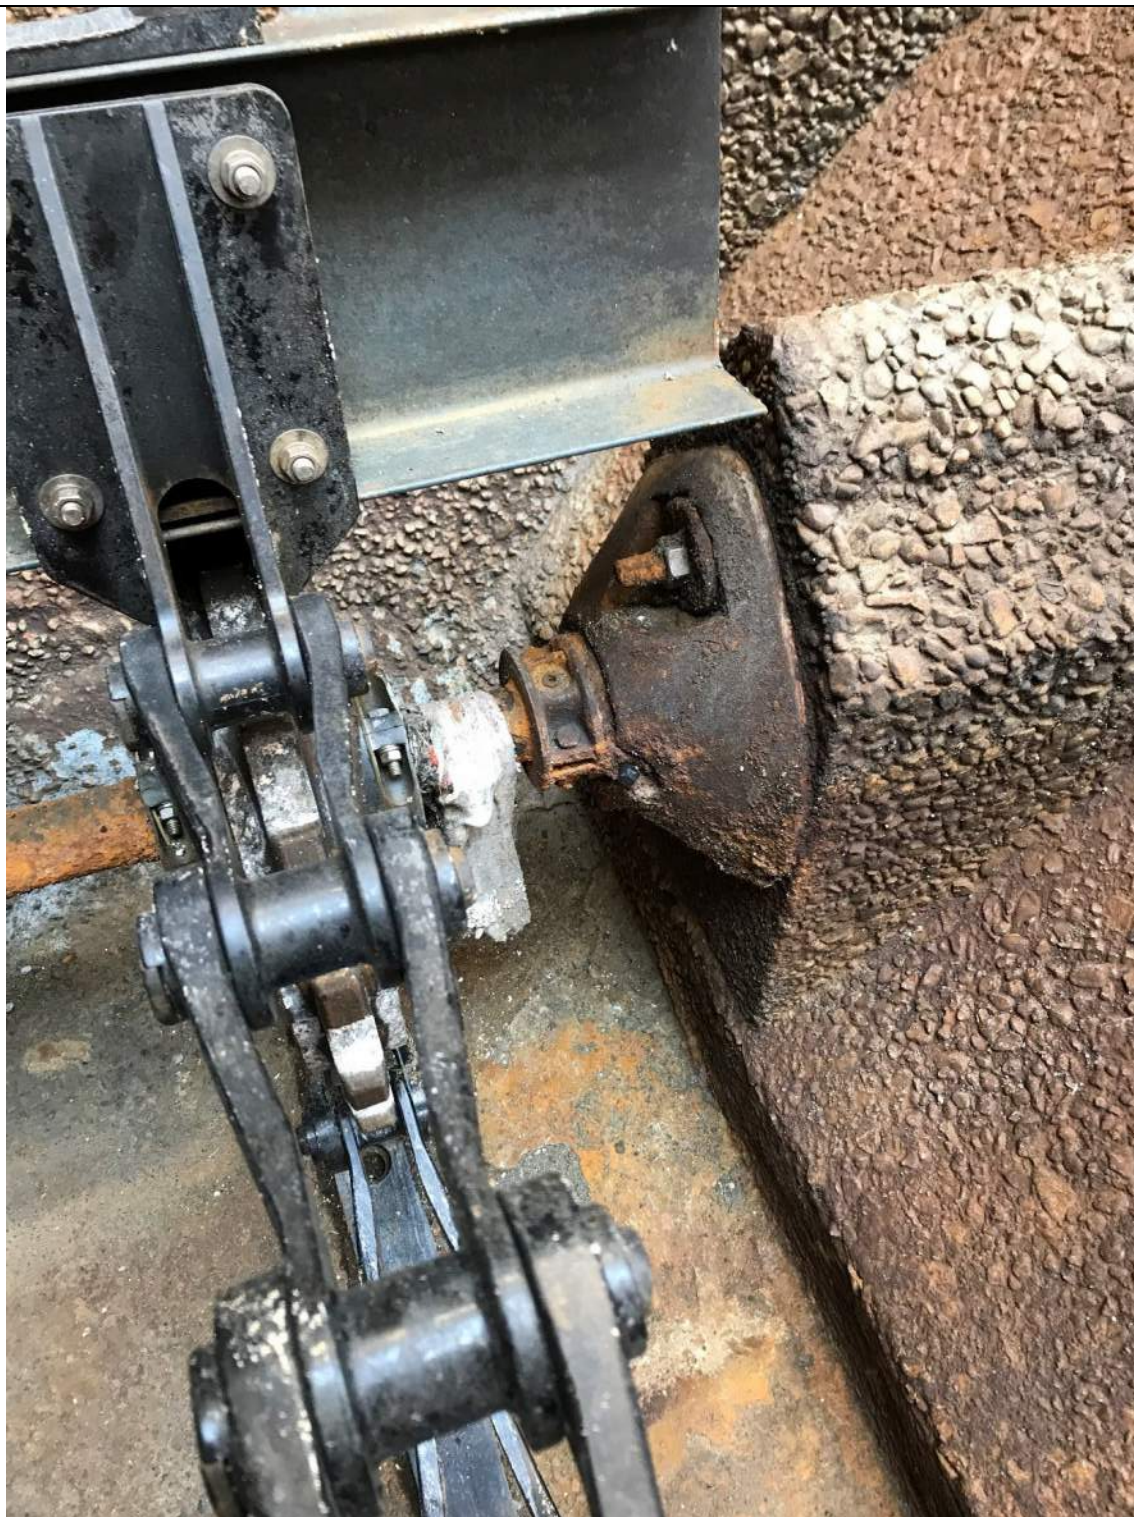
23. Close-up of cross collector tail (east) end idler north shaft bearing.

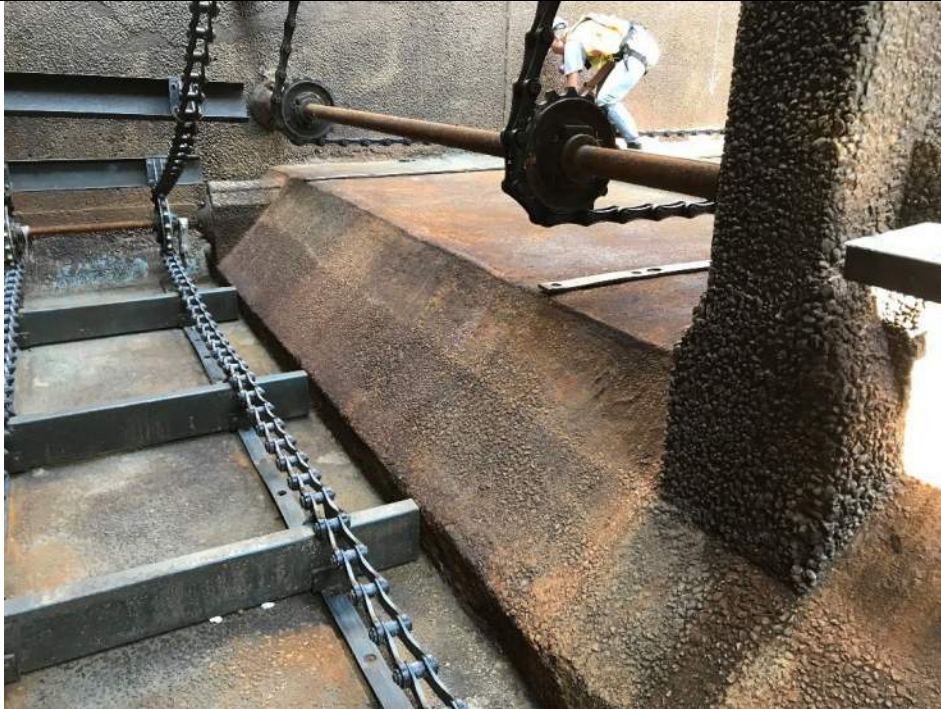
34. Confluence of west longitudinal collector bay with cross collector trough. Note exposed concrete aggregate (coated from past repair).

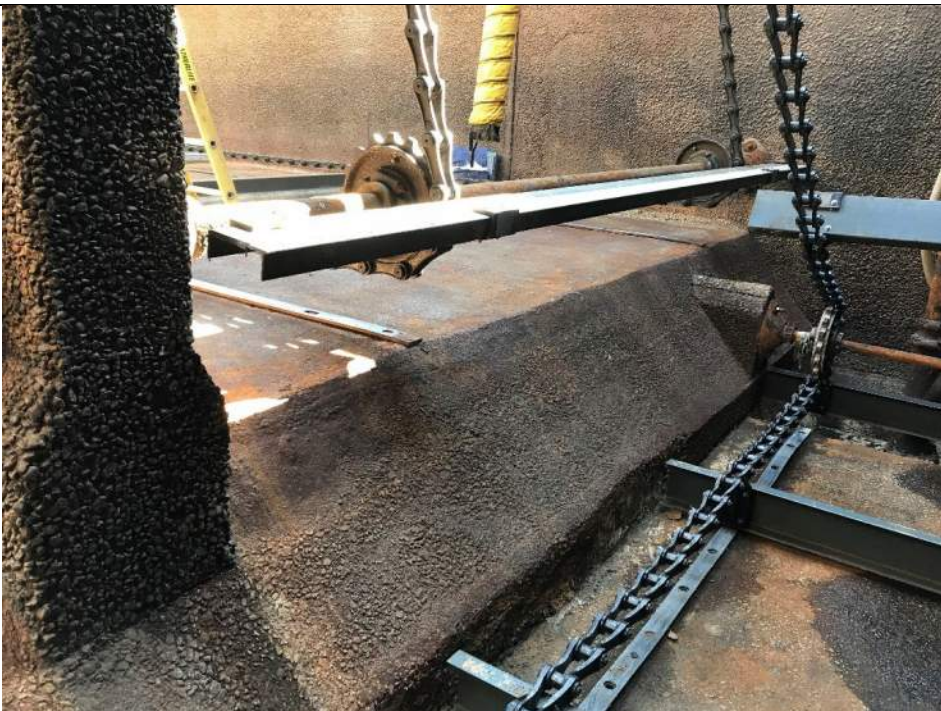
35. Confluence of east longitudinal collector bay with cross collector trough. Note exposed concrete aggregate (coated from past repair).
