## General Exterior Reference Photos

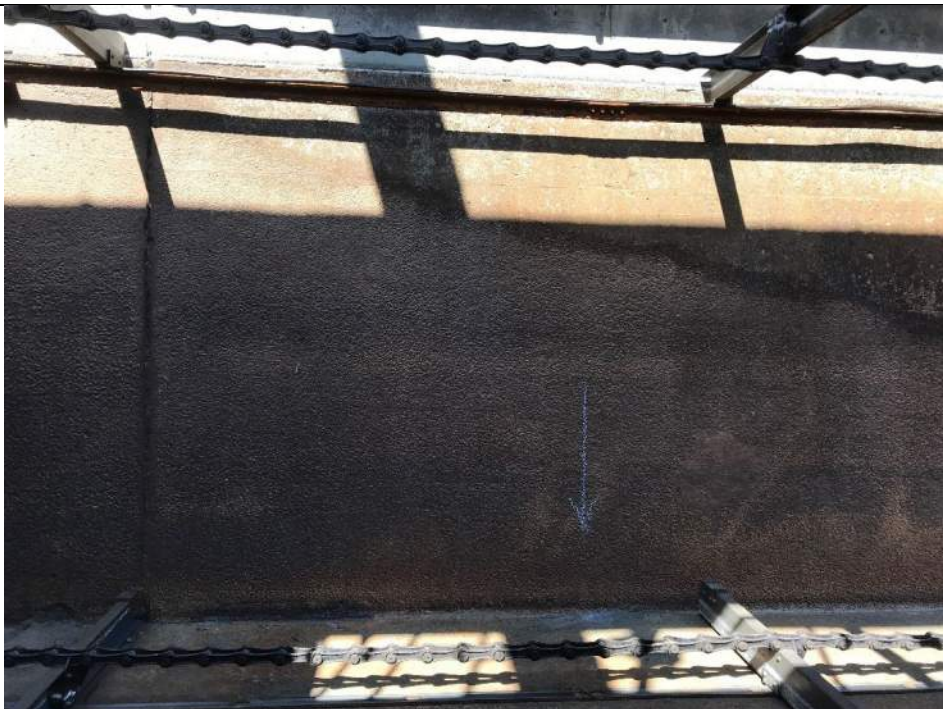
37. West wall of tank, north of photo 36 (diagonal line is where previous coating ends).

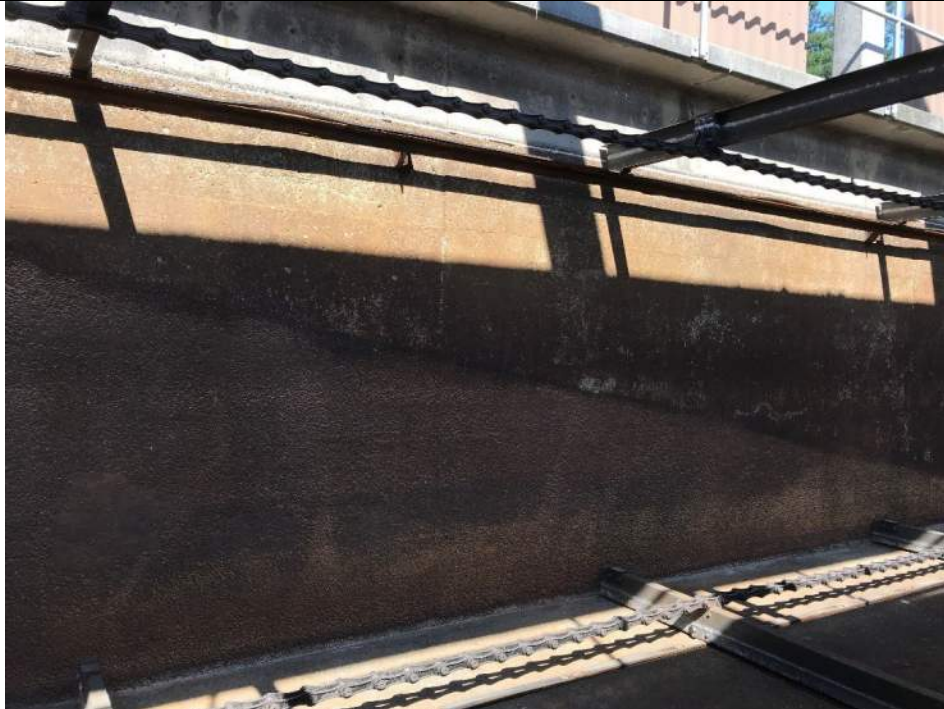
38. West wall of tank, north of photo 37 (diagonal line is where previous coating ends).

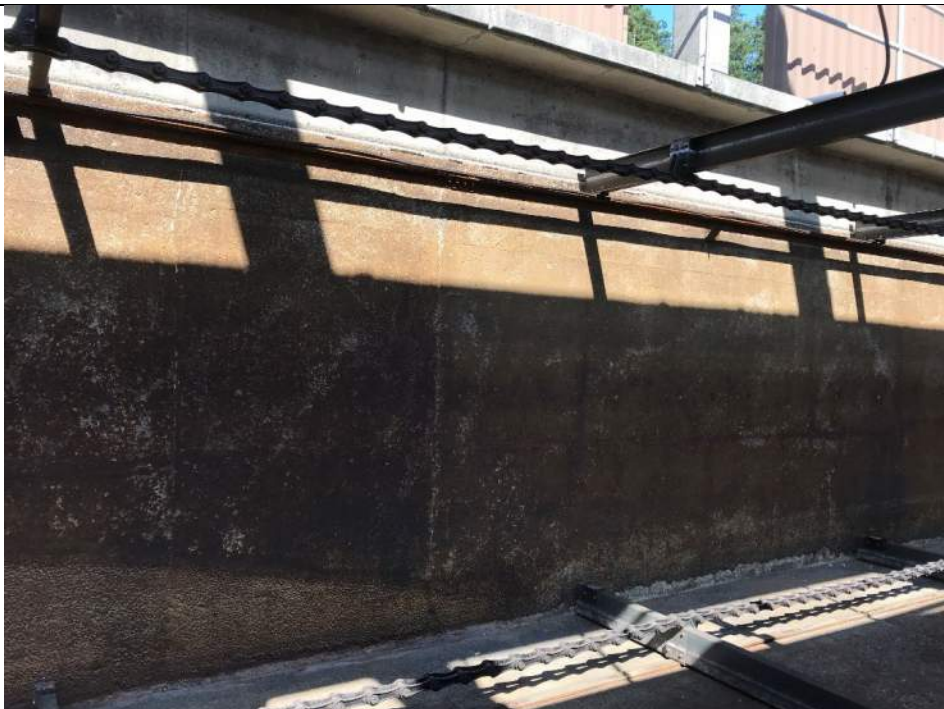
39. West wall of tank, north of photo 38 (diagonal line is where previous coating ends).

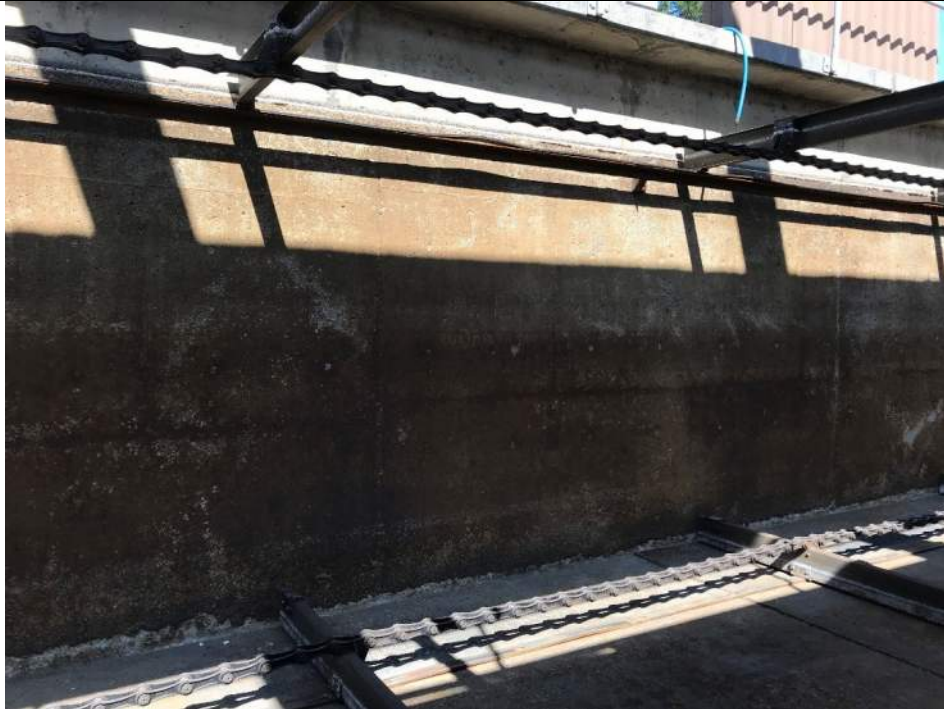
40. West wall of tank, north of photo 39 (Note black asbestos containing sealant in floor expansion joint).

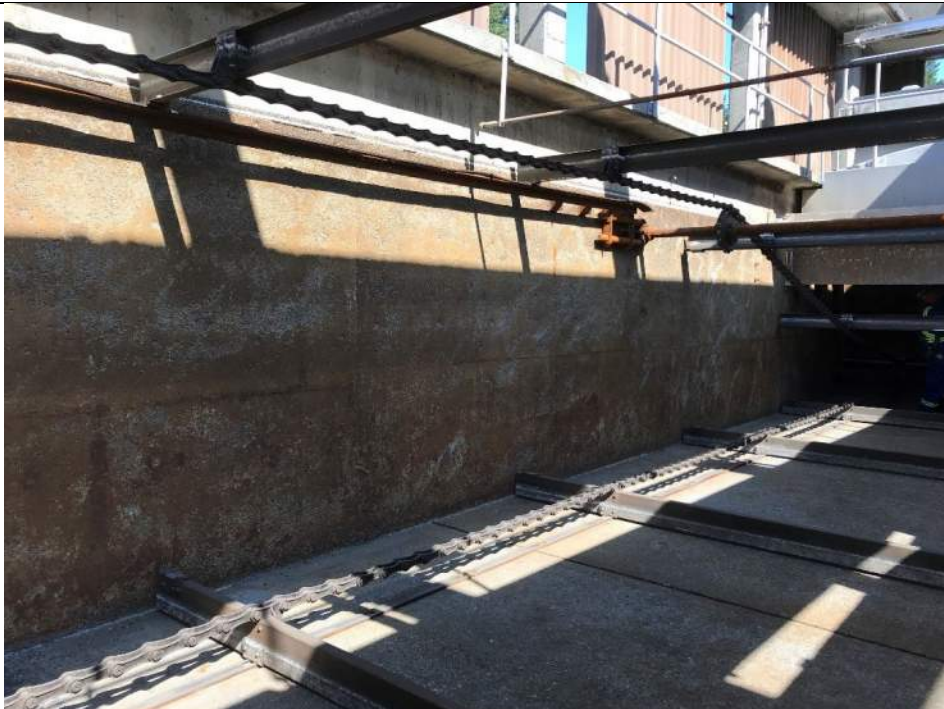
43. West wall of tank, north of photo 42; near effluent discharge end (Note black asbestos containing sealant in floor expansion joint).

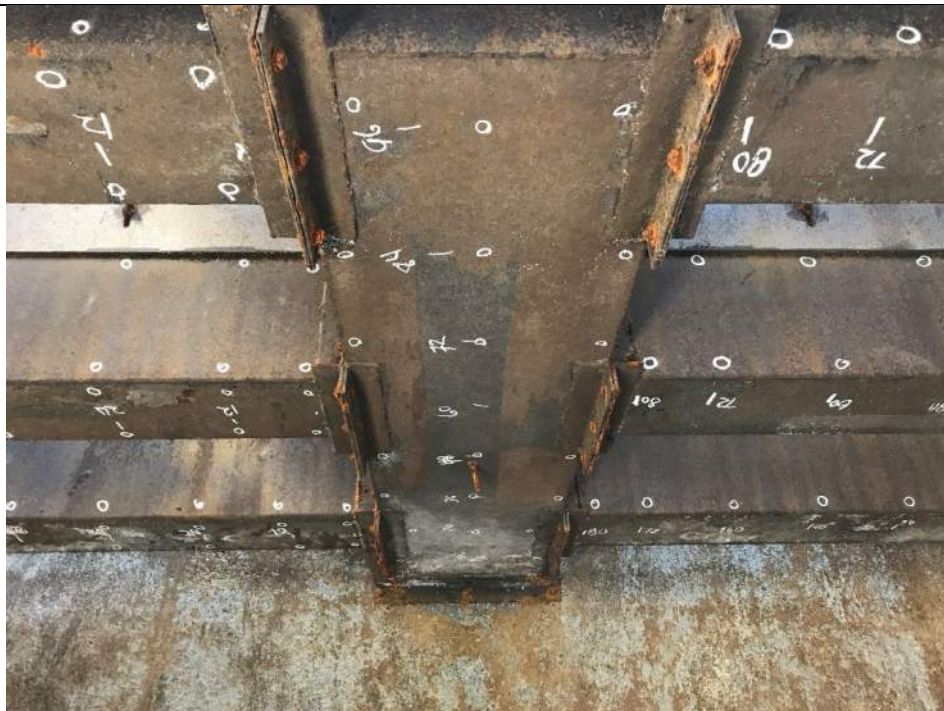
51. Bottom middle of west bay effluent discharge channel weir boxes (marked for thickness testing). Note – black coating contains lead.

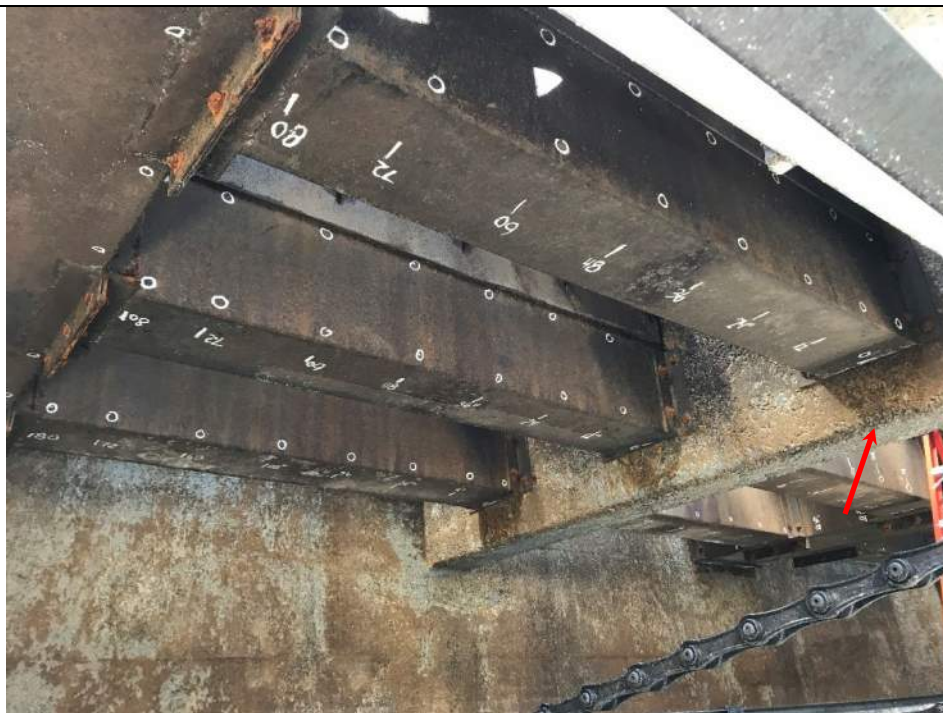
52. Bottom east side of west bay effluent discharge channel weir boxes. Note exposed concrete aggregate (red arrow)

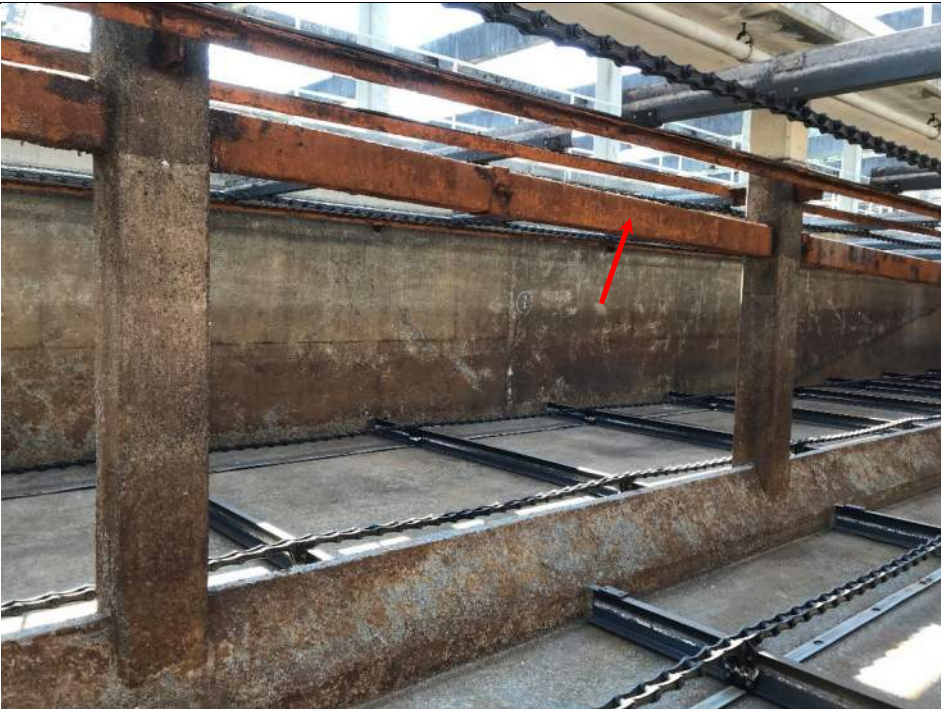
57. Tank center columns cont'd from photo 56, viewed from west bay. Rusty 150 mm (6") X 200 mm (8") scum pipe visible (red arrow).

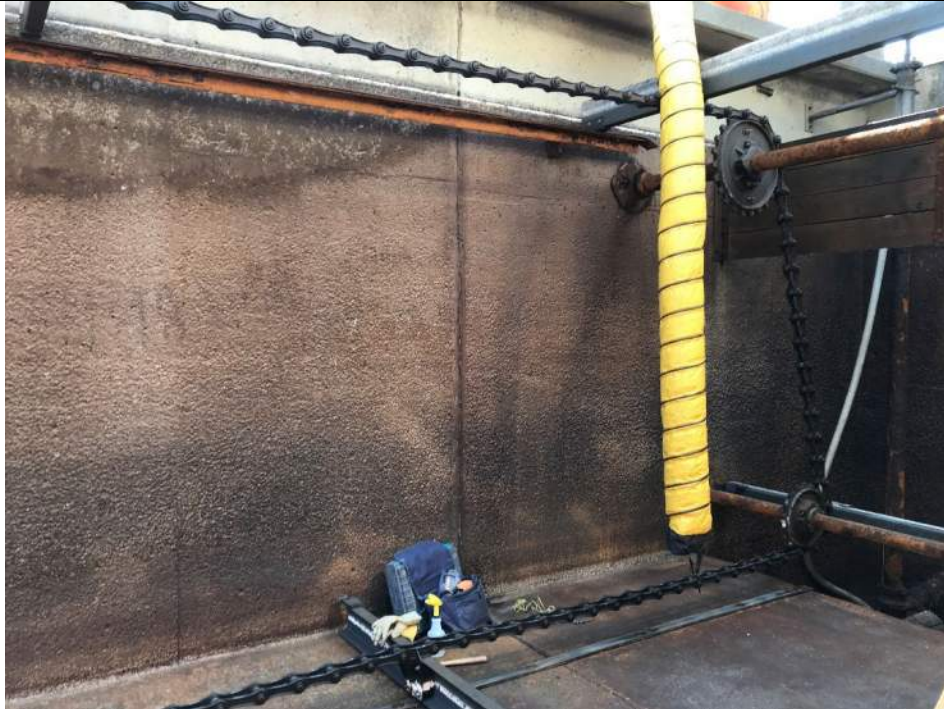
60. East tank wall at south end (longitudinal collector head shaft & drive sprocket visible upper right). Note floor/wall expansion joint).

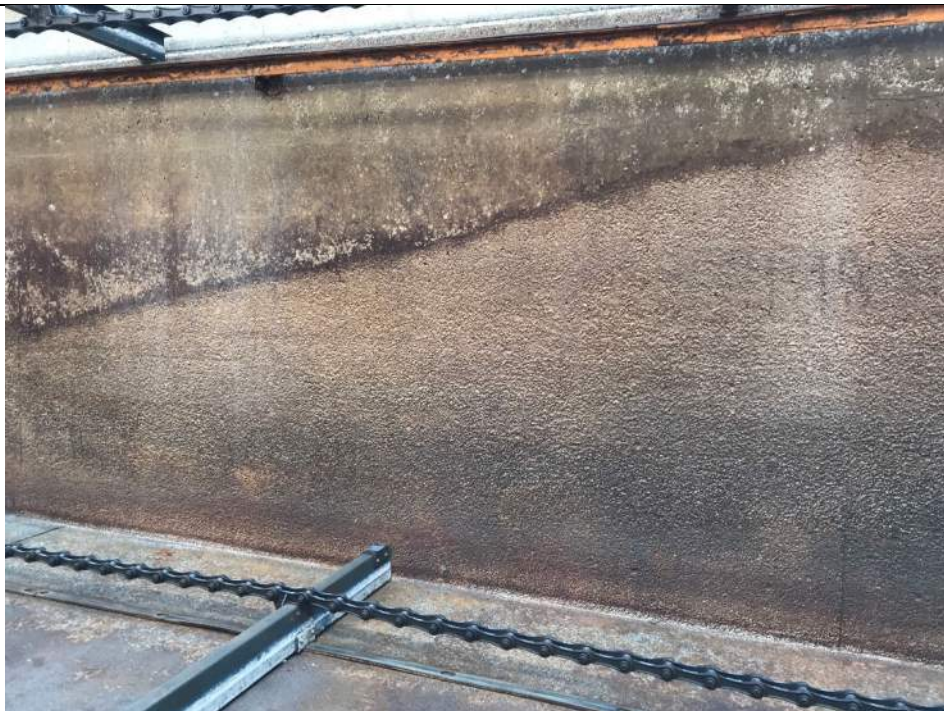
61. East wall of tank, north of photo 60 (diagonal line is where previous coating ends).

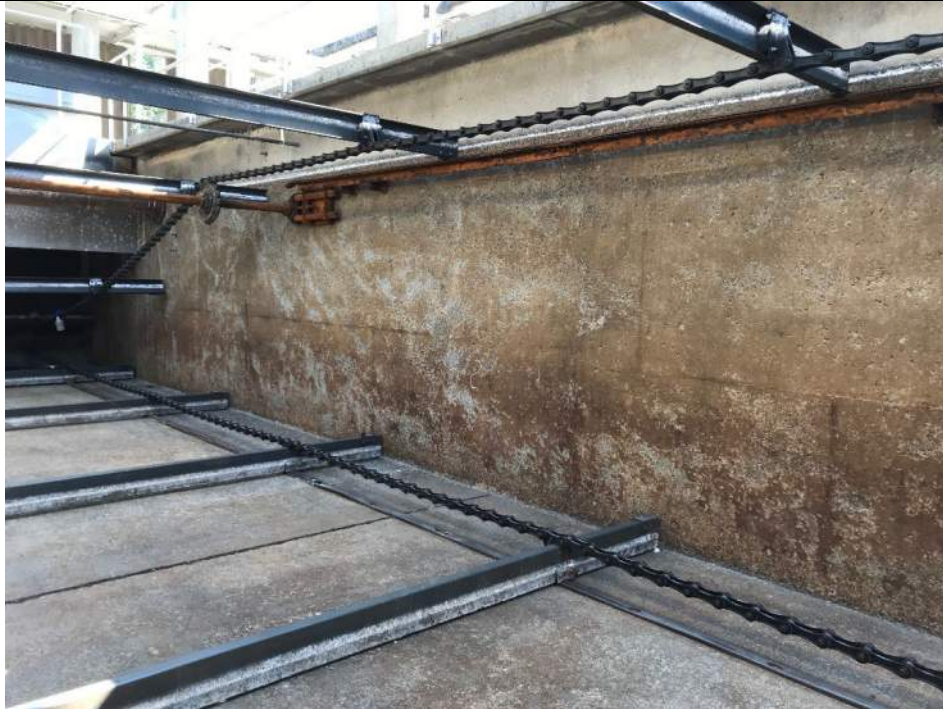
66. East wall of tank, north of photo 65. Tail end idler shaft and sprocket visible upper left. Note black asbestos containing sealant in floor expansion joint.

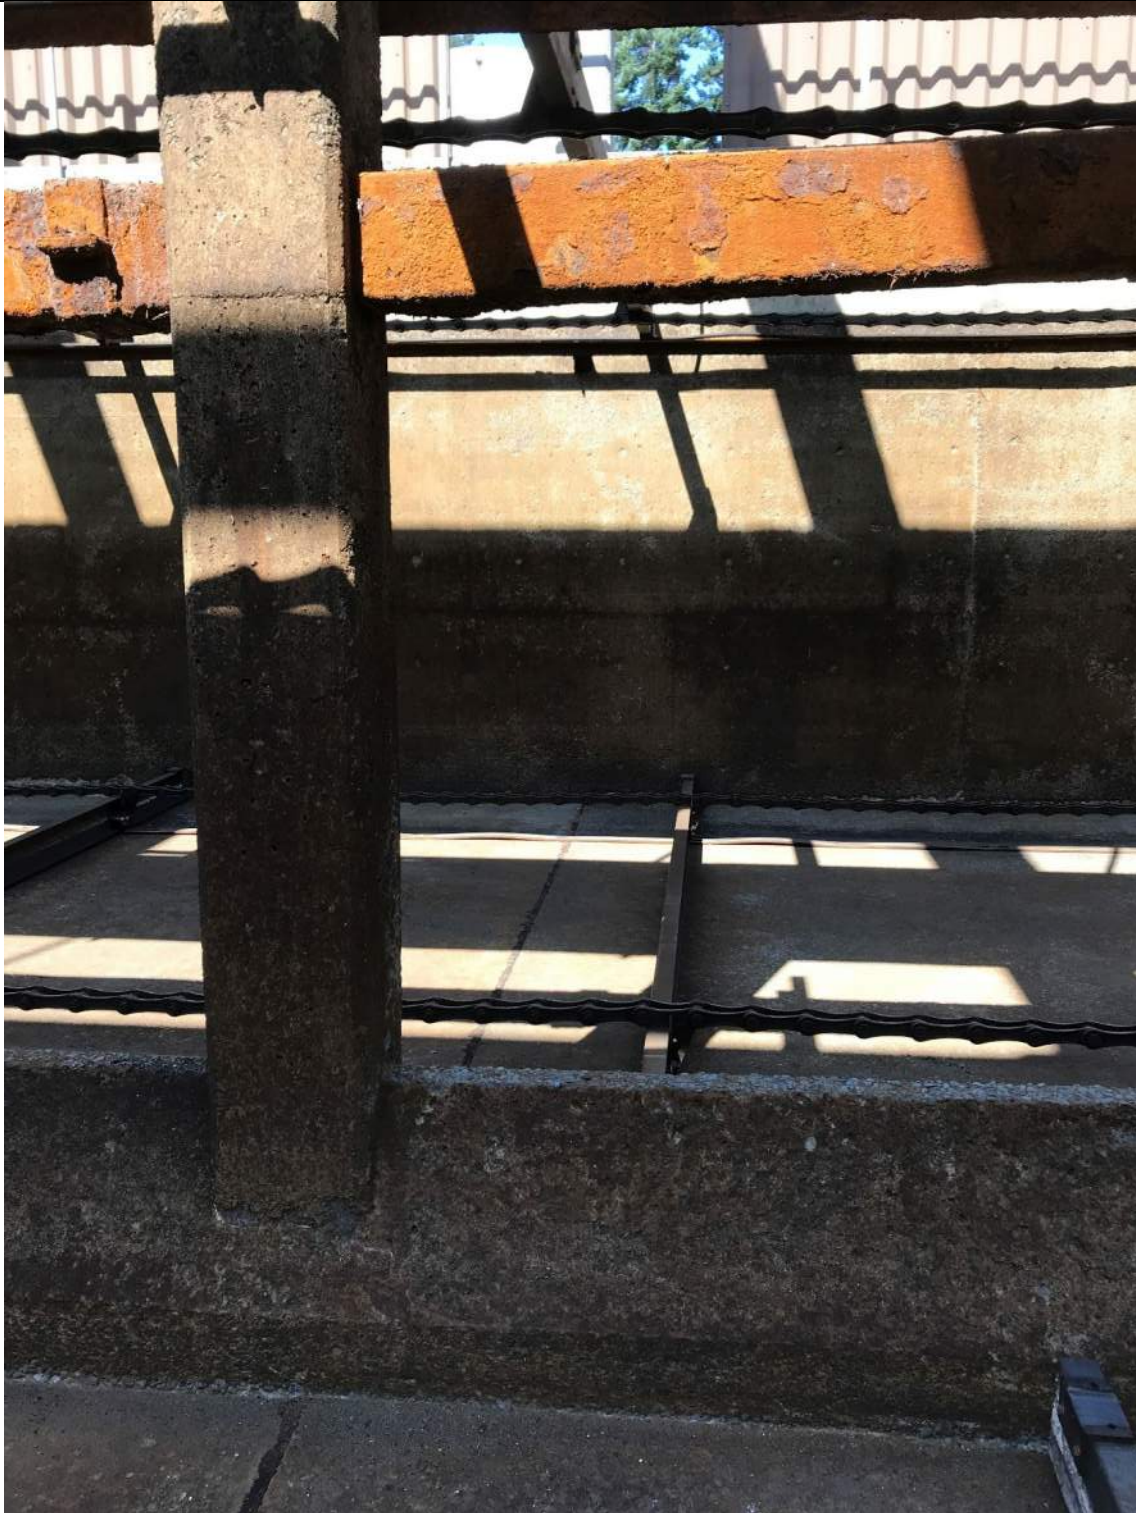
78. Close-up of center column and rusty obsolete 6" X 8" scum piping, viewed from east bay. Note exposed concrete aggregate and black asbestos containing sealant in floor expansion joint.

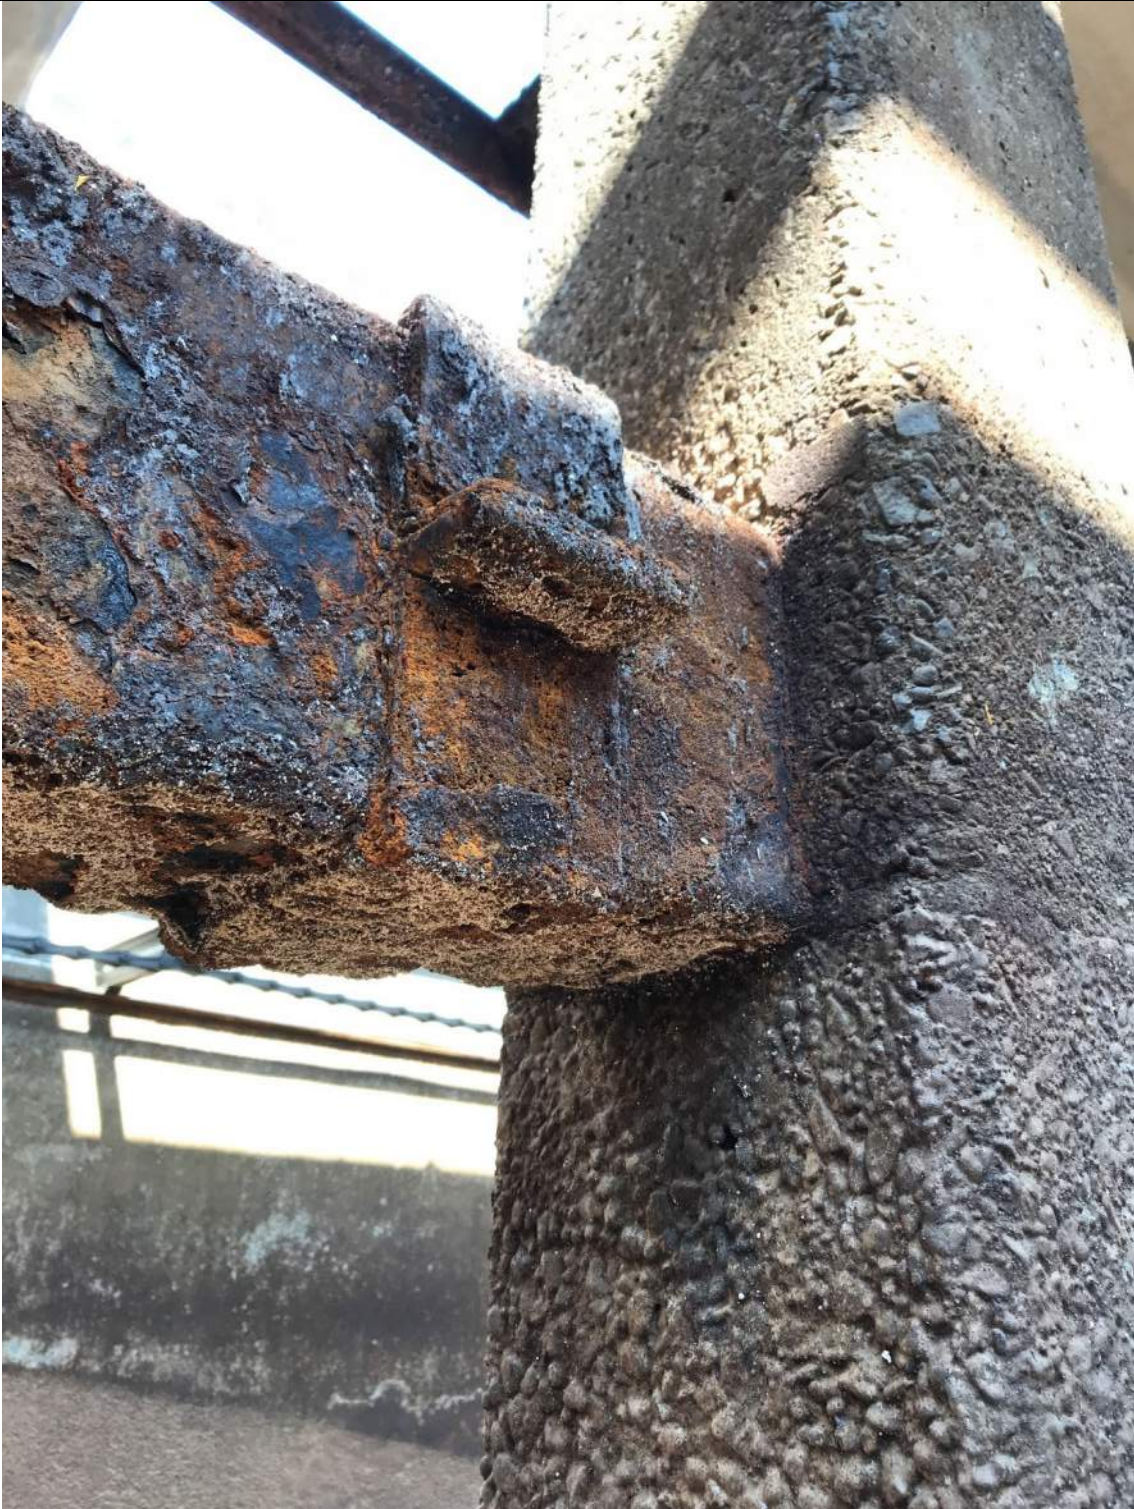
79. Close-up of intersection of center column and rusty obsolete 6" X 8" scum piping, viewed from east bay.

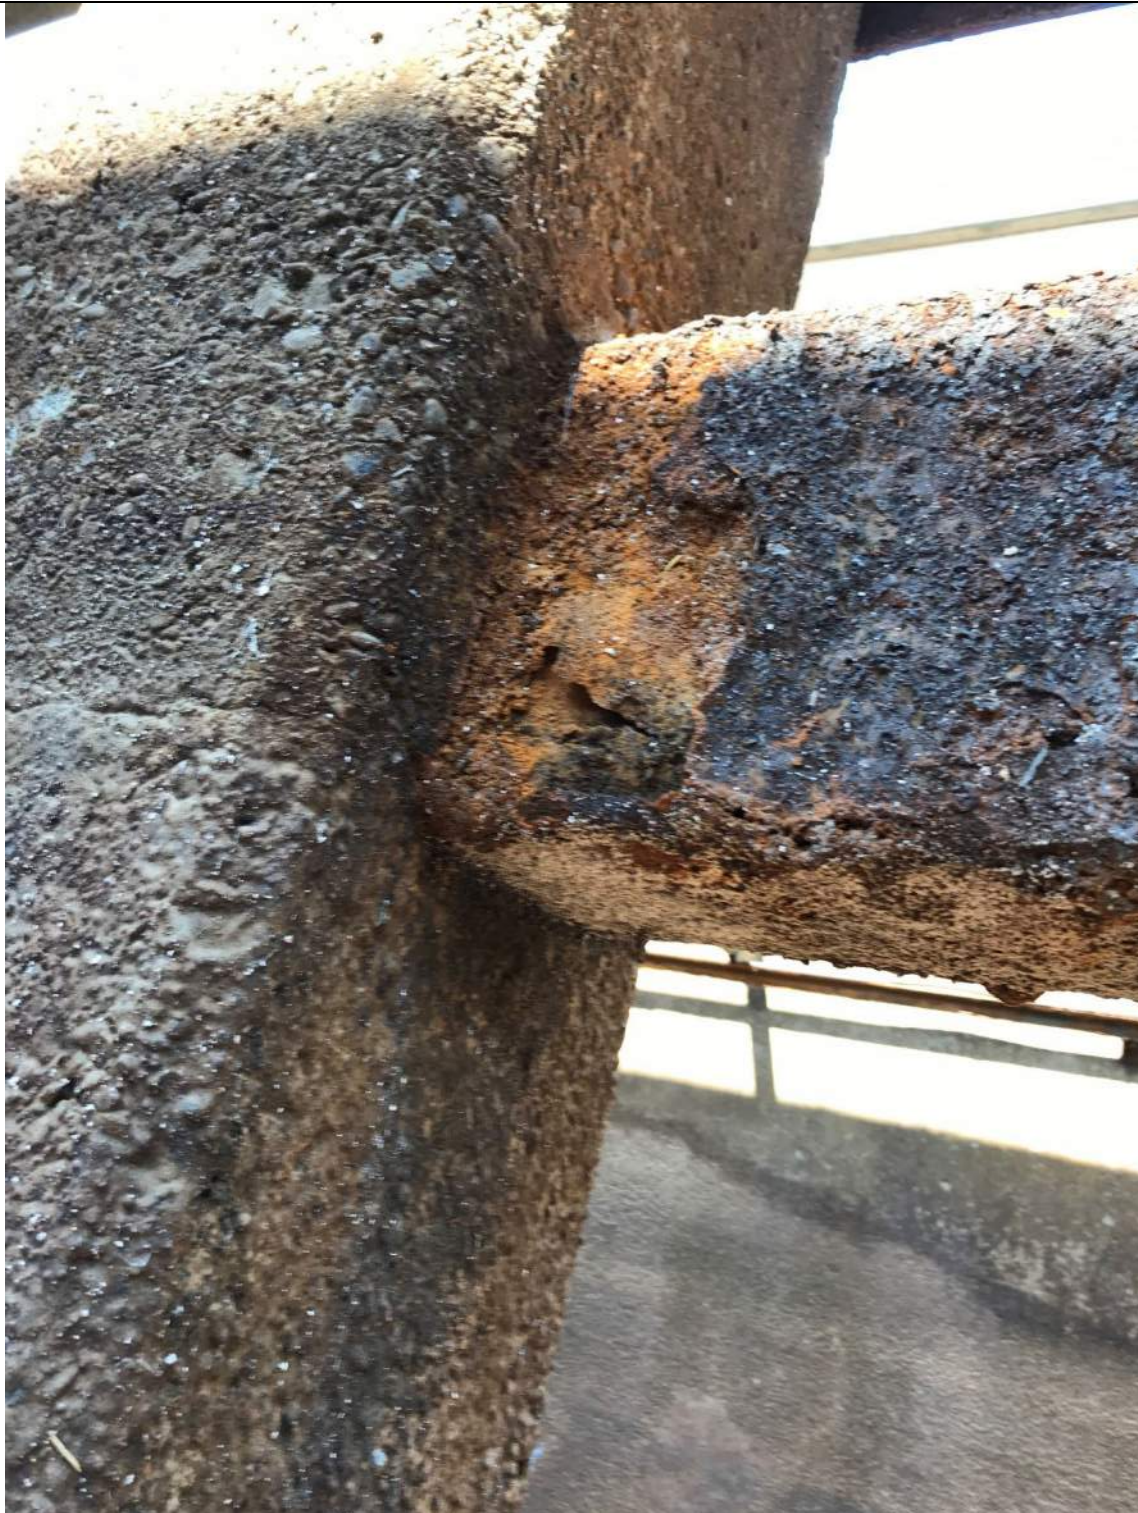
80. Close-up of intersection of center column and rusty obsolete 6" X 8" scum piping, viewed from east bay.

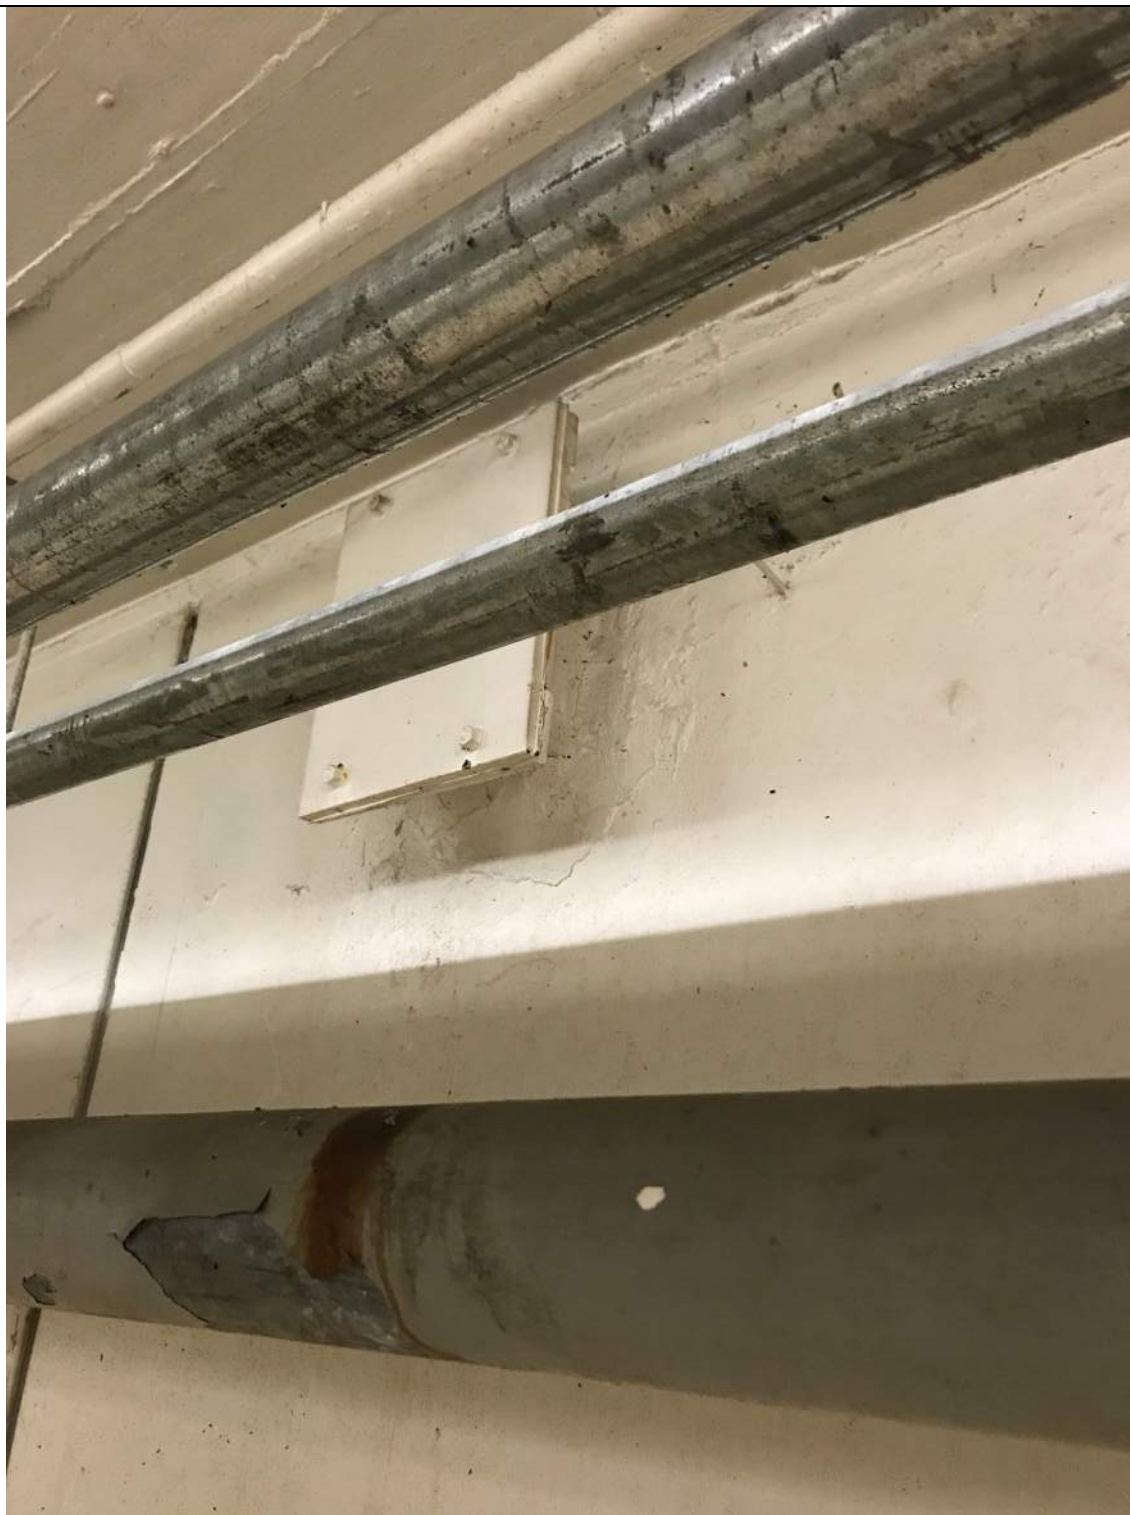
81. Blanked, obsolete 6" x 8" HSS scum piping connection in UG gallery at inlet end of sedimentation tank.
