Project Number: MB44022

Date: 16 October 2023

**Project:** GNPCC – Grit and Primary Sedimentation Tanks Refit  
**RE:** Evaluation of Concrete in Grit and Sed Tanks 1 to 3, Revision 01

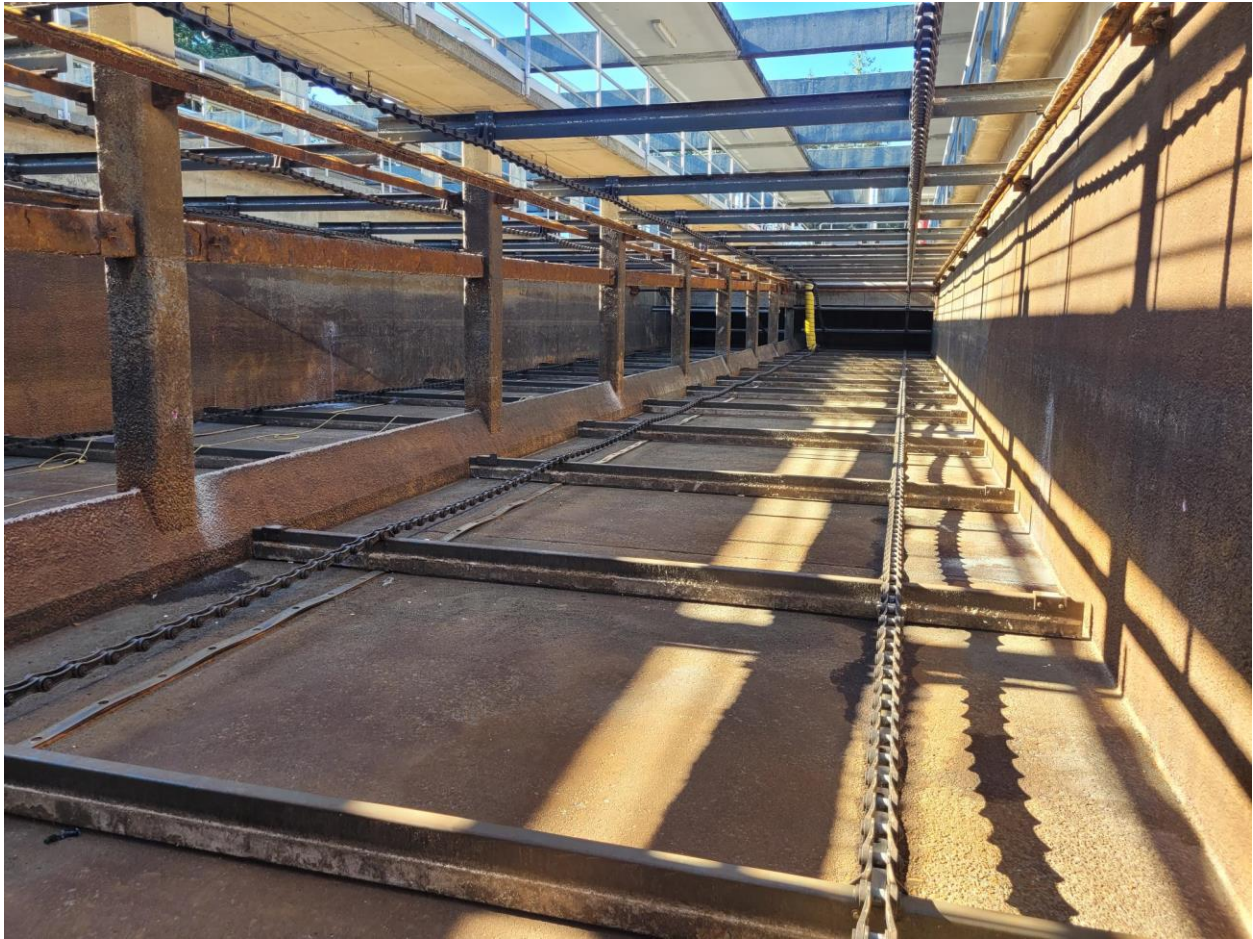
**Photograph 1** illustrates the interior of Sed Tank 2 looking north. Note the demarkation between the coated areas and non coated areas.

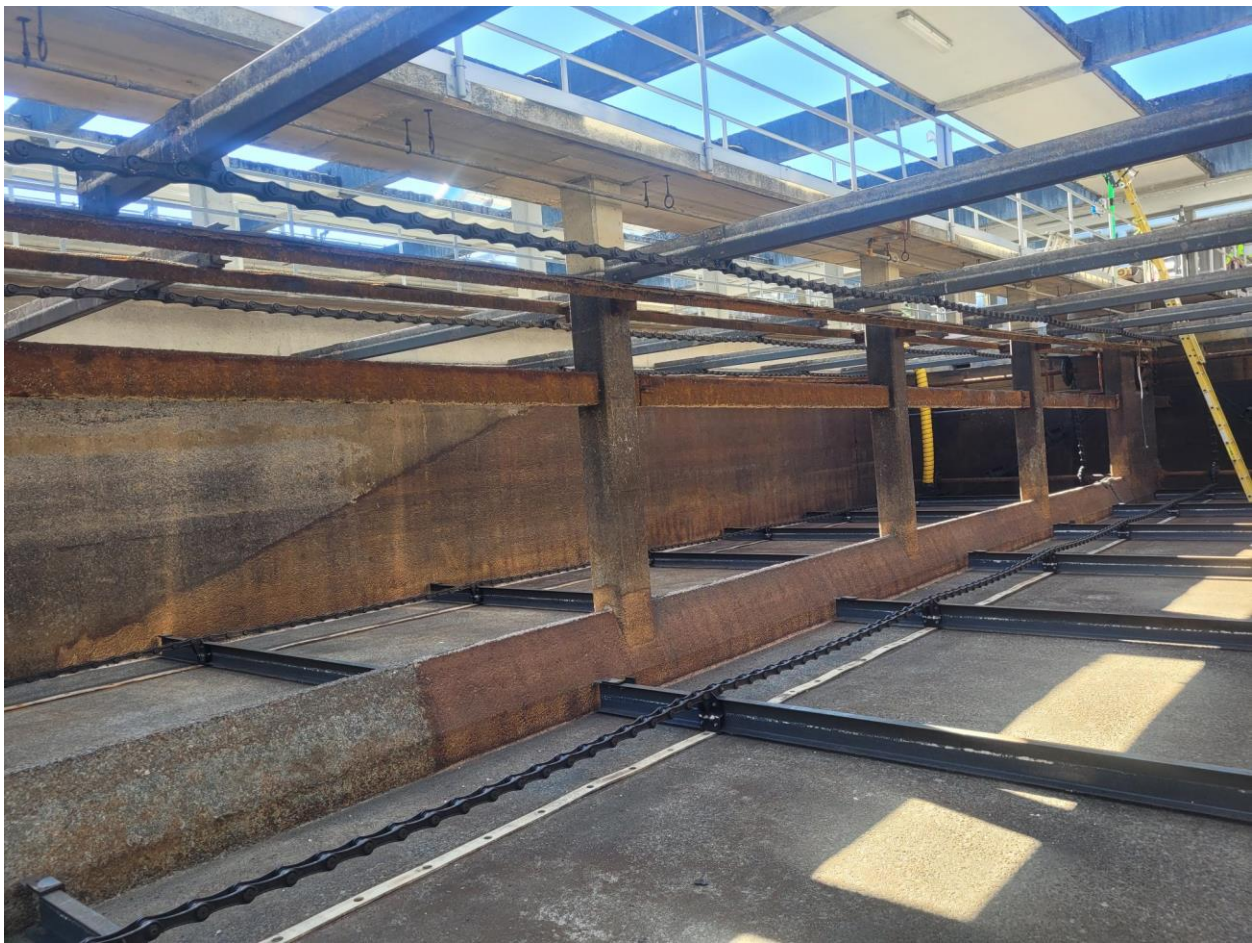
**Photograph 2** illustrates Sed Tank 2 looking south toward the grit tank. Again, note the coated and uncoated concrete.

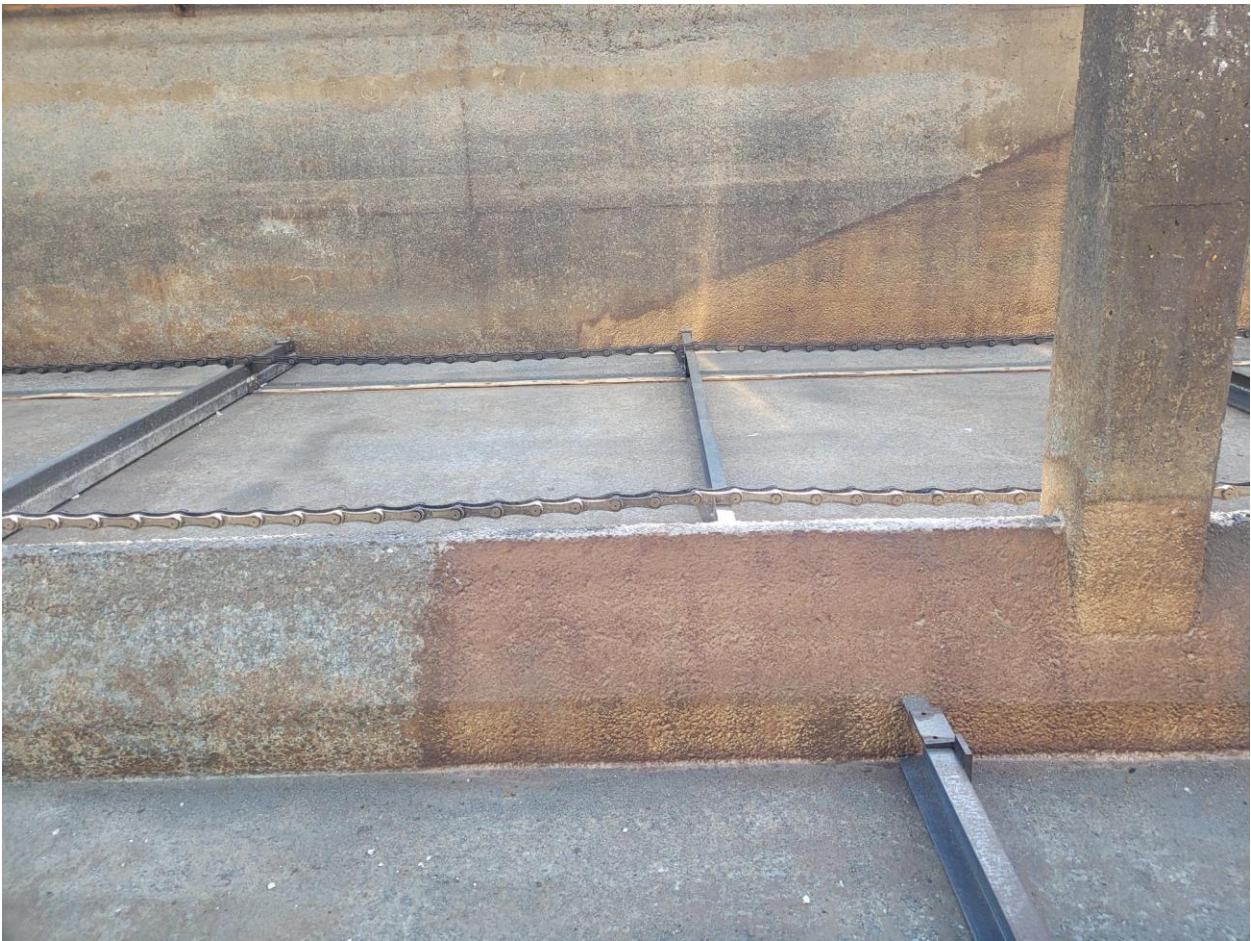
**Photograph 3** illustrates a clear demarcation between the coated and non coated areas in Sed Tank 2. The coating has clearly preserved the surface and appears to bond well.

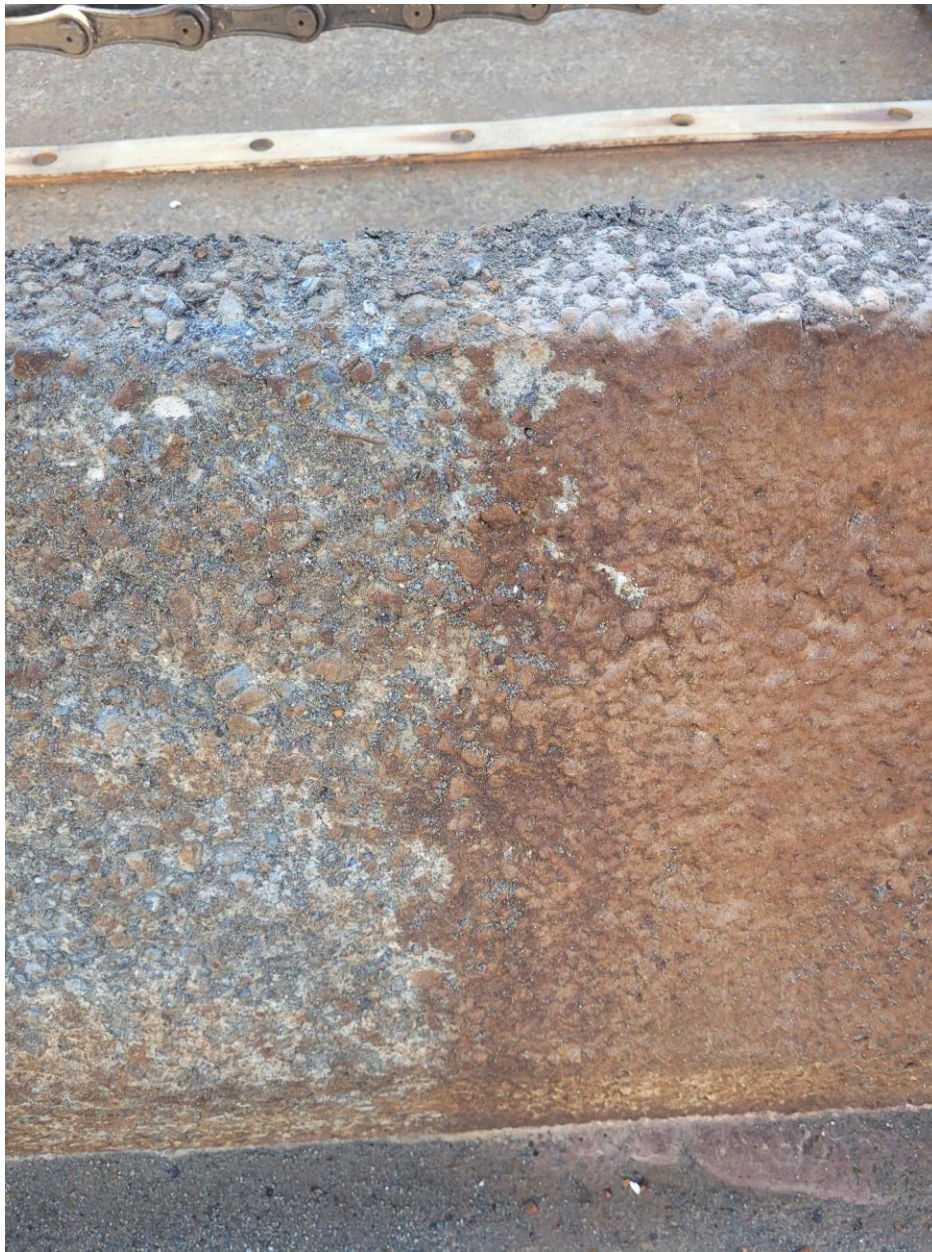
**Photograph 4** illustrates the coated and uncoated portion of the centre curb of Sed Tank 2. The area on top of the curb does not appear to be coated and is heavily eroded.

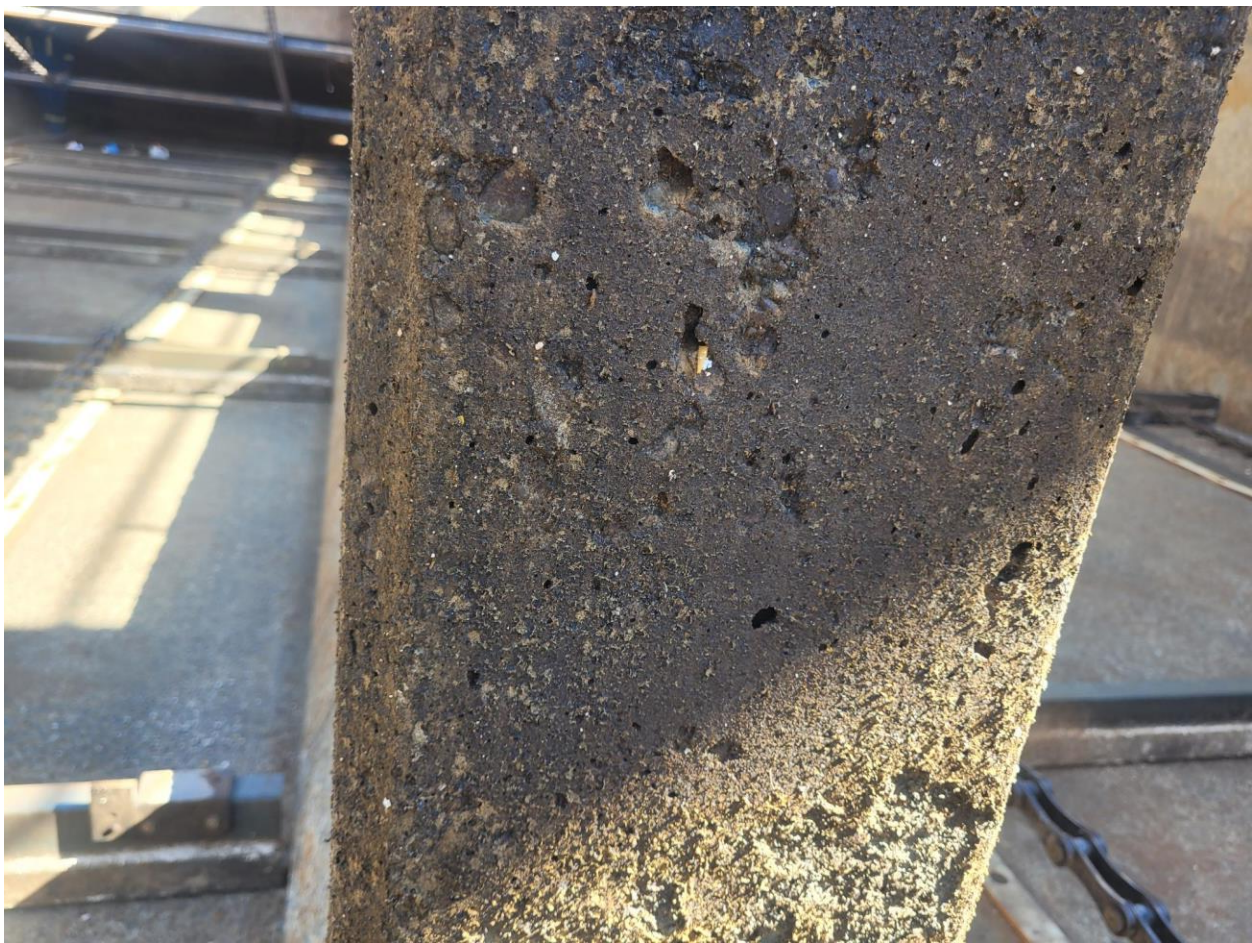
**Photograph 5** illustrates the existing surface on a typical column in Sed Tank 2. Refer to Photograph 6 where the soft surface has been scratched off.

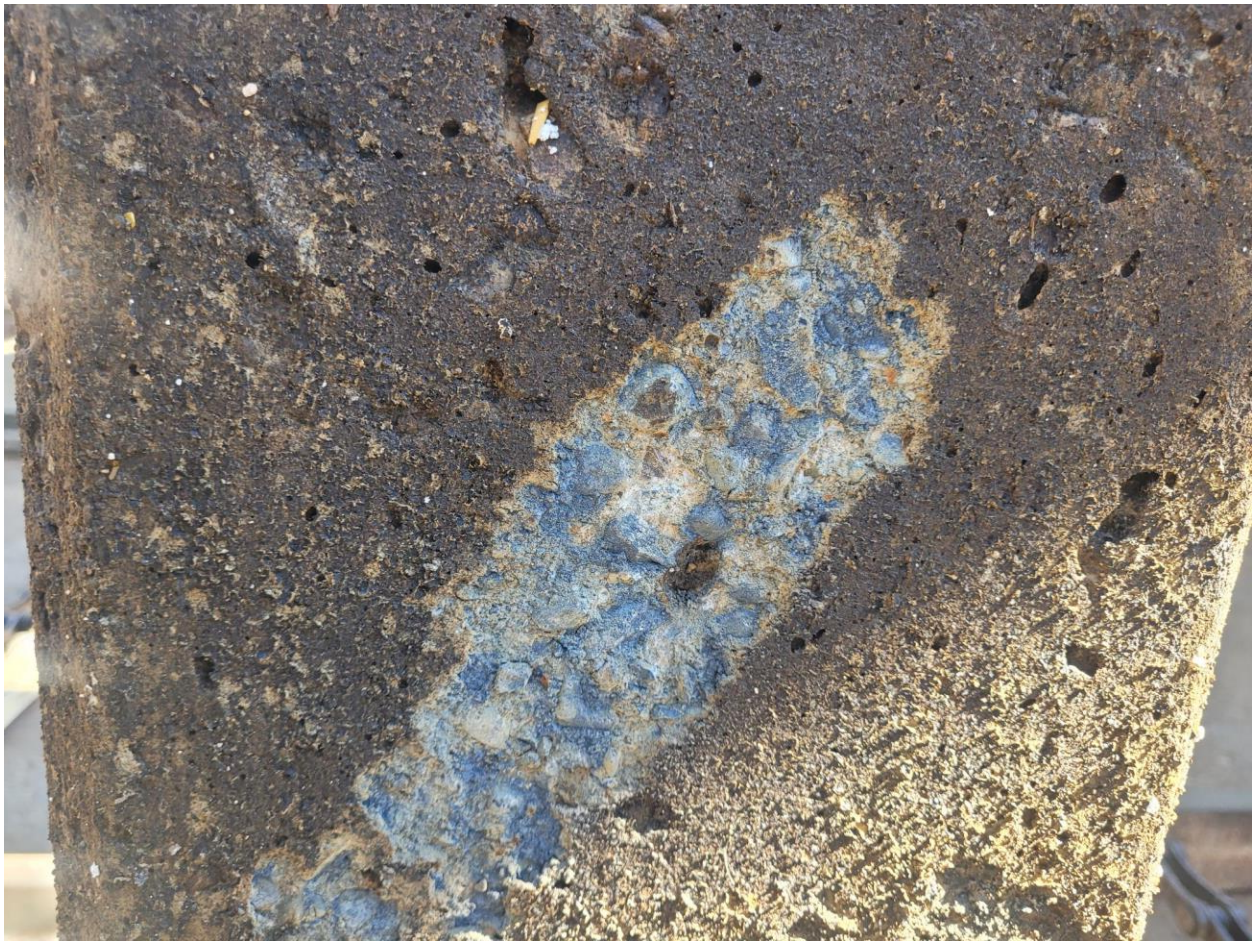
The columns were not coated. Their surfaces were visibly eroded, although no exposed reinforcing steel was noted. The approximate depth of neutralization of the column concrete was approximately 10 to 12 mm below the inner margin of the rough surface.

**Photograph 6** illustrates the column in Photograph 5 where the weakened neutralized surface was easily scratched off revealing a hard dense and alkaline surface 10 to 12 mm below the existing surface.

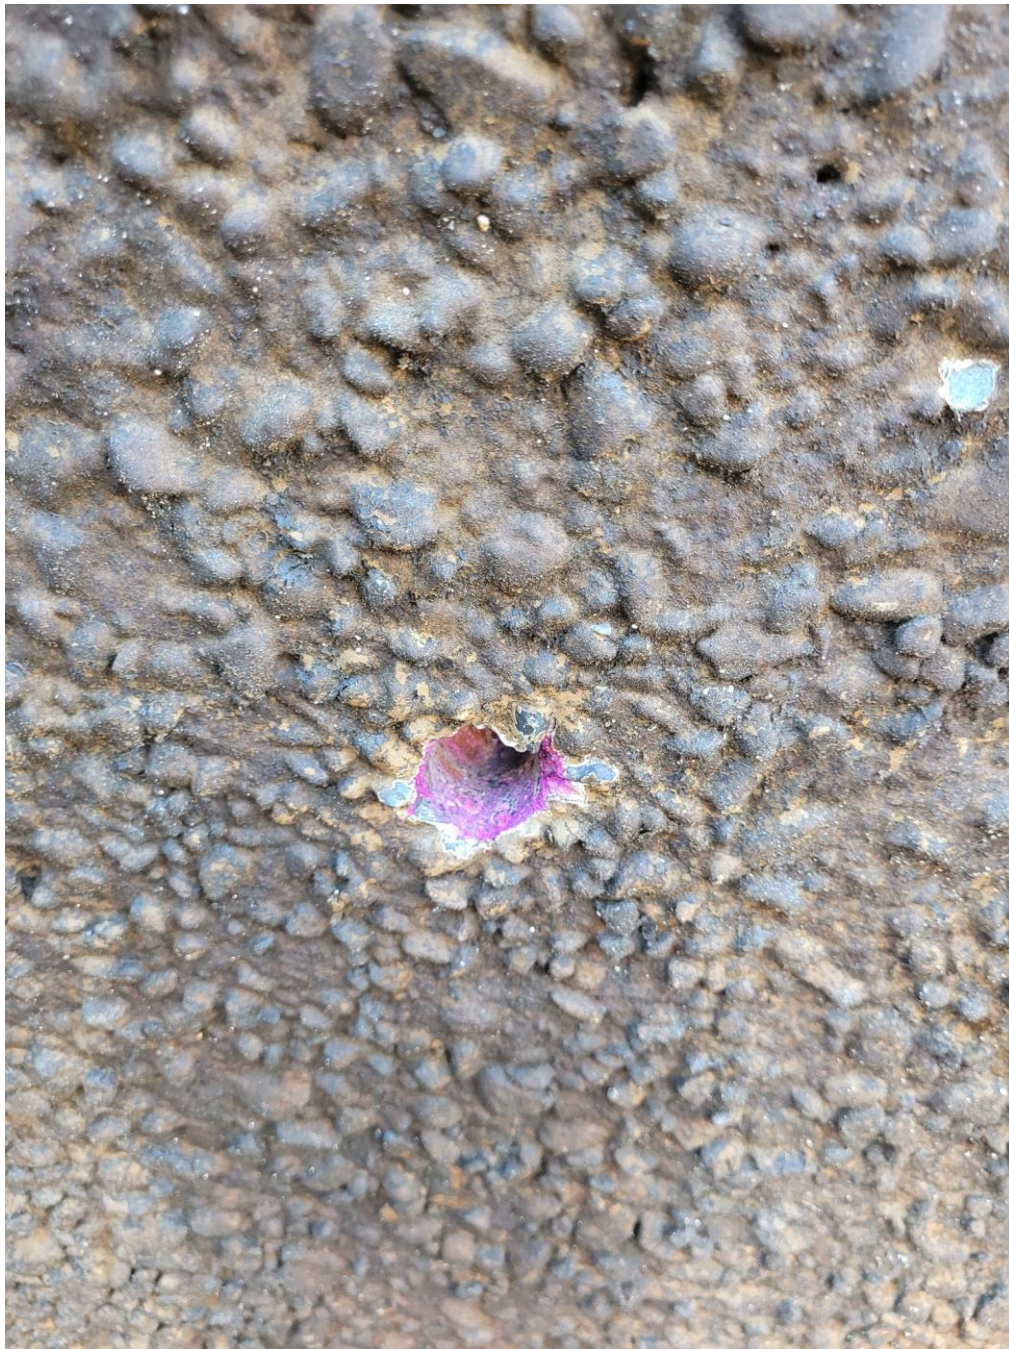
**Photograph 7** illustrates a coated area in Sed Tank 2. Note the roughness of the surface and the minimal depth of neutralization in drill hole. Also, no areas were noted where the existing coating is peeling off.

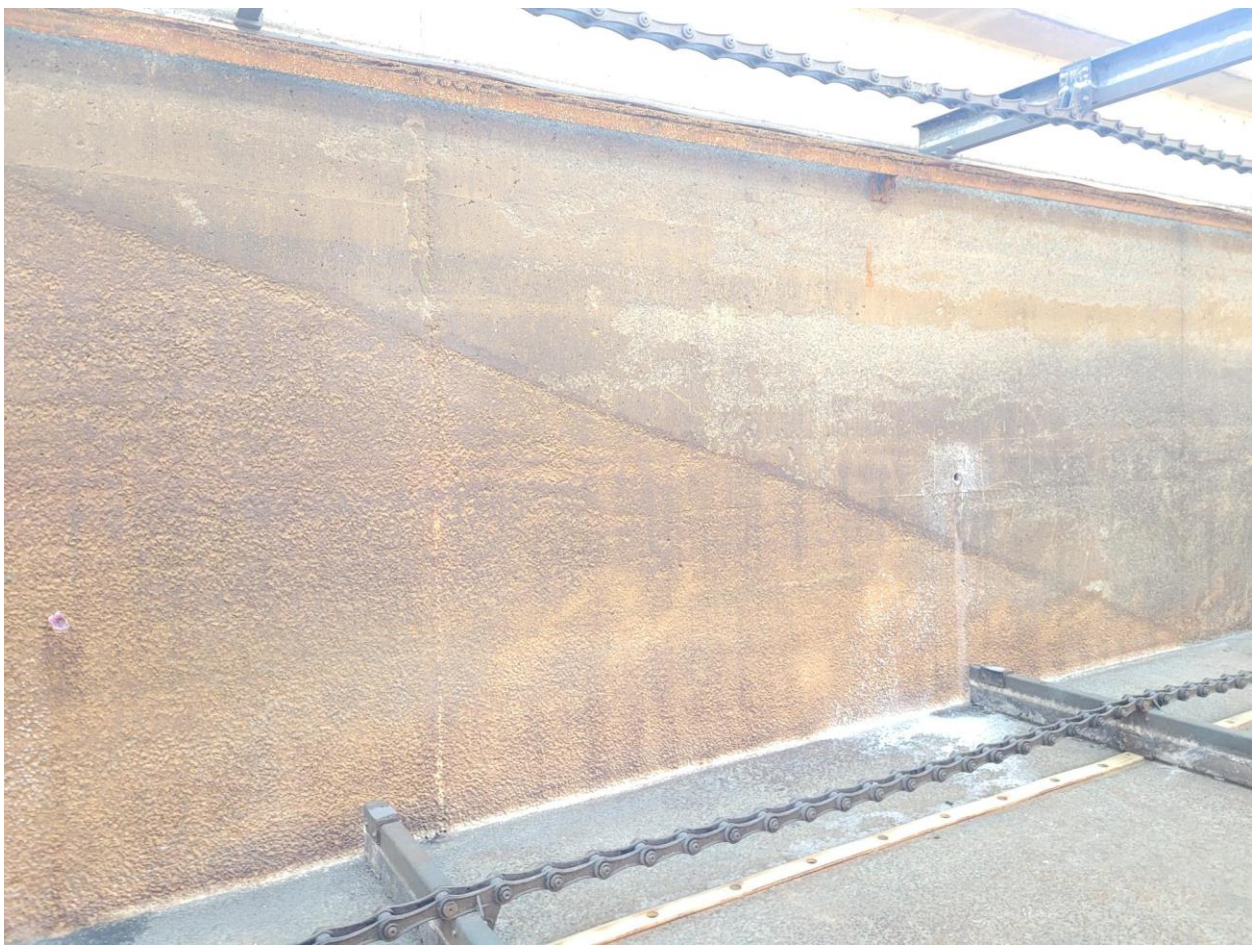
**Photograph 8** illustrates the transition of coated area to non coated area on the west side of Sed Tank 2.

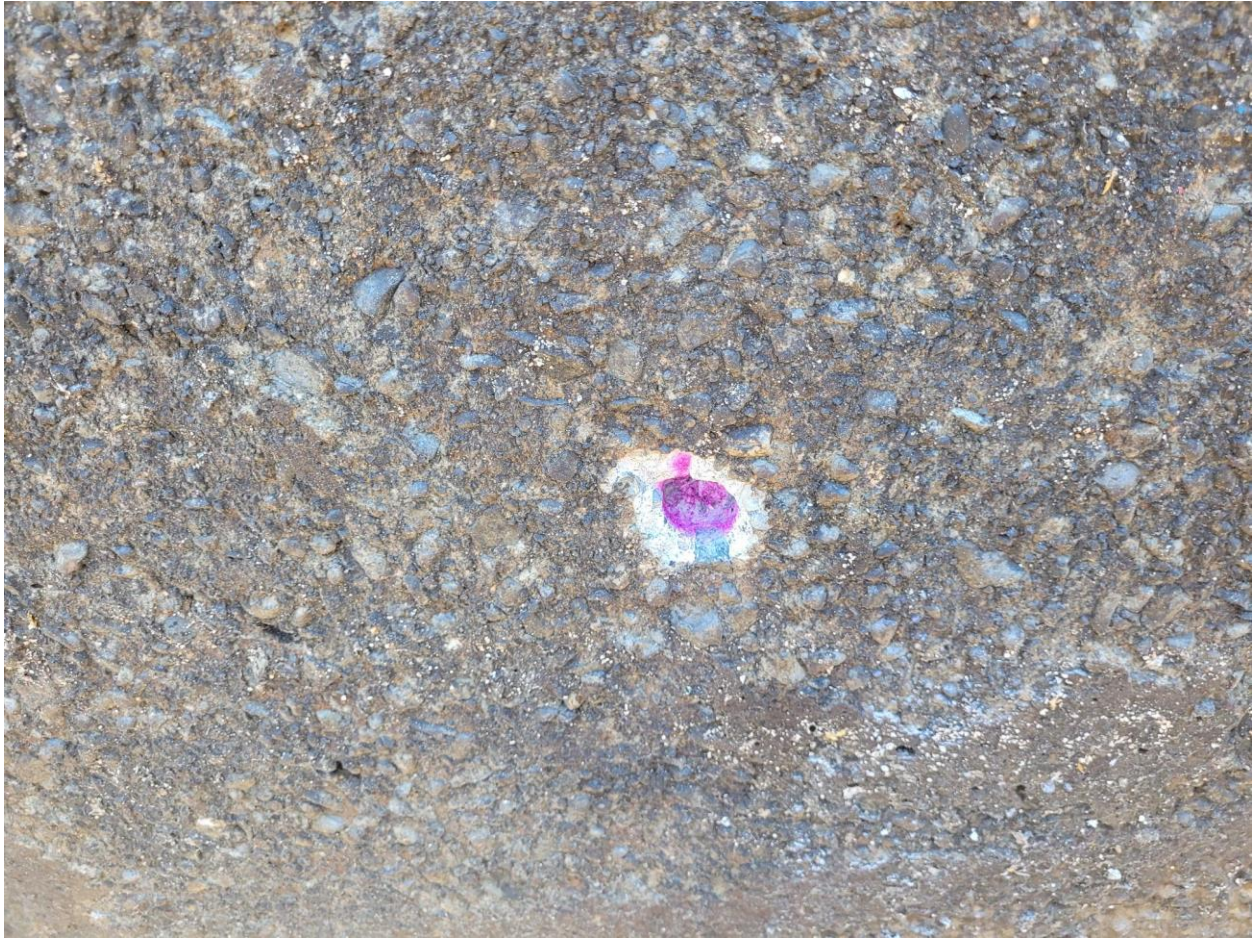
**Photograph 9** illustrates a drill sample into an uncoated area with typical depth of neutralization of 10 to 12 mm in Sed Tank 2.

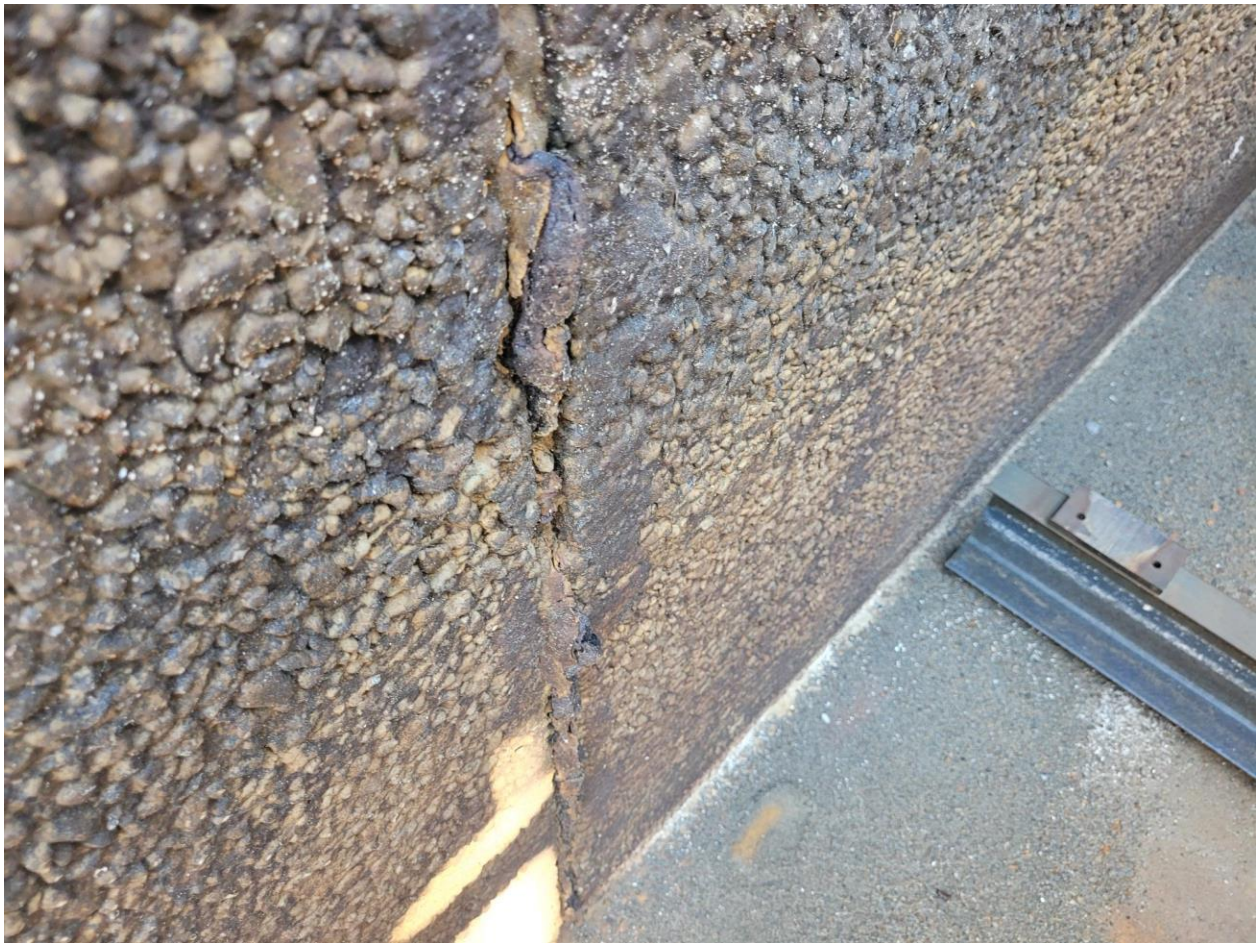
**Photograph 10** illustrates a wall joint between Sed Tank 2 and 3. Note the lack of leakage even though the adjacent tank is full of liquid.

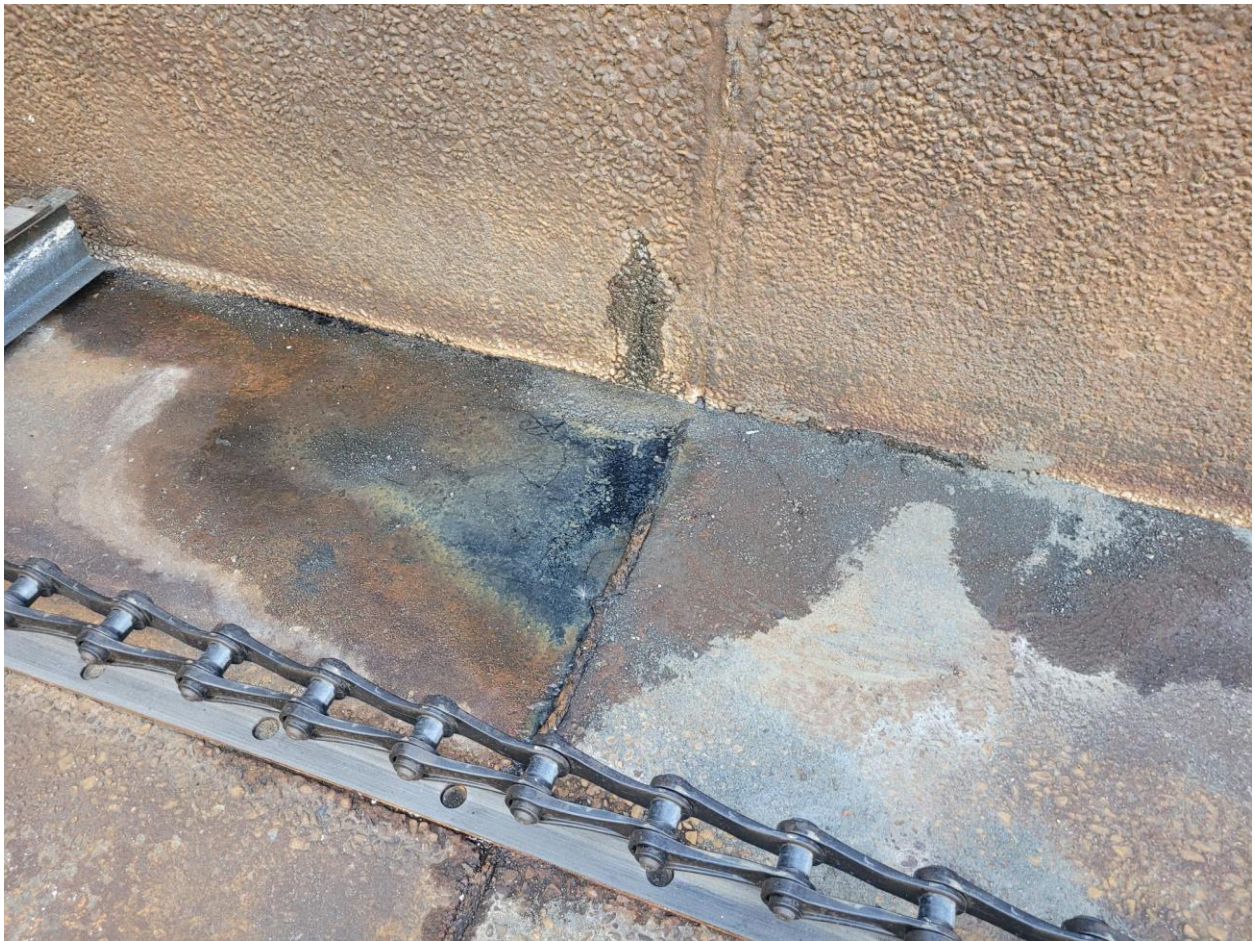
**Photograph 11** illustrates slight seepage in Sed Tank 2, coming from an adjacent, liquid-filled Sed tank.

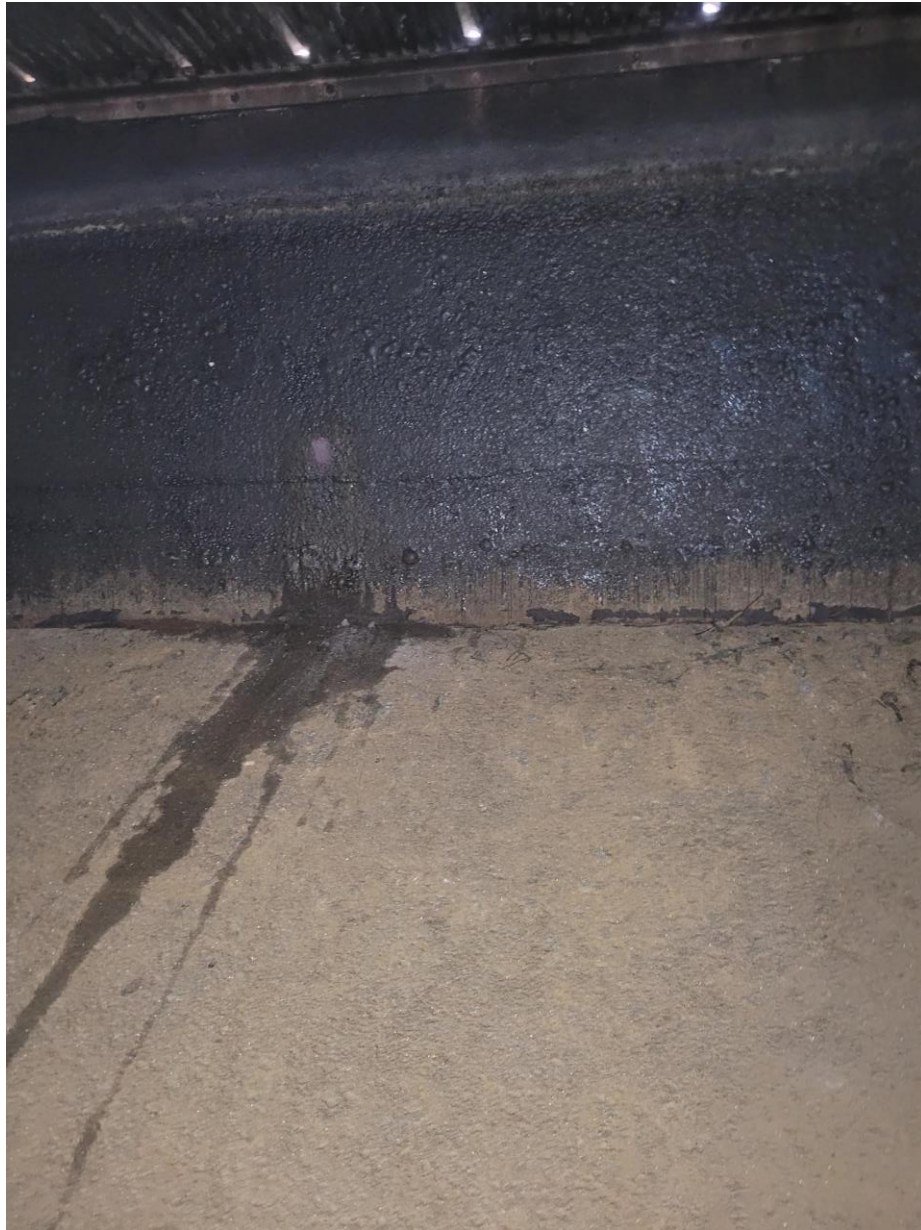
**Photograph 12** illustrates the South wall of Grit Tank 2 where it intersects the sloping floor. Note the blistering of the coating on the back wall. The floor of the grit tank is uncoated and has typical depth of neutralization of 10 to 12 mm. Refer to Photograph 13 for details of the wall coating.

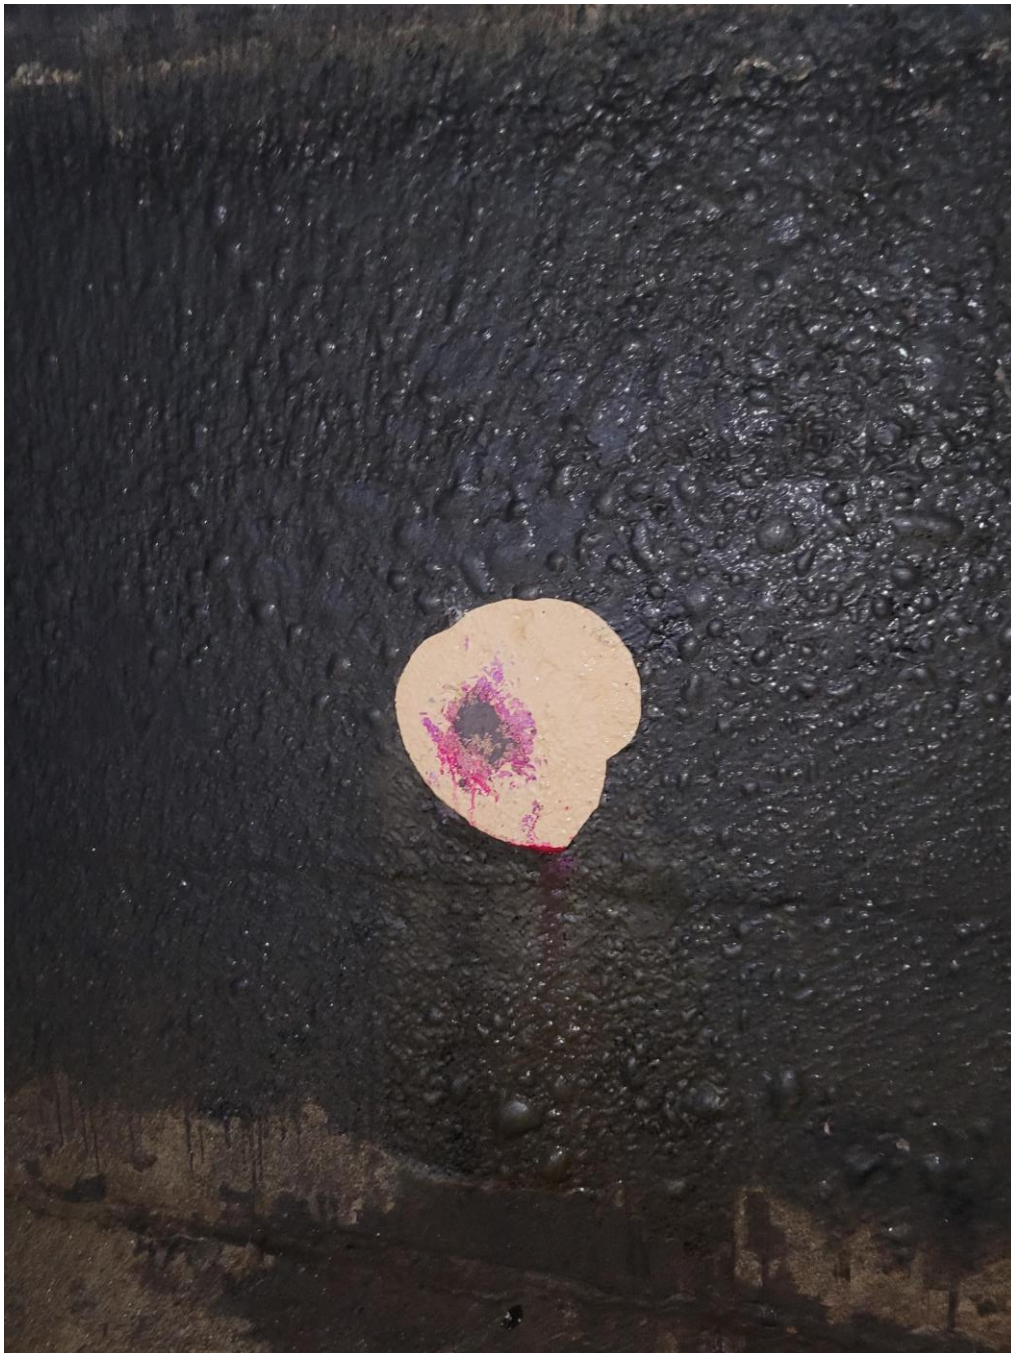
**Photograph 13** is an area of the south wall of the Grit Tank 2 shown in Photograph 12. The soft rubbery blistered coating was easily removed revealing harder better adhered coating underneath. Only slight neutralization of the concrete was noted under the two coatings.

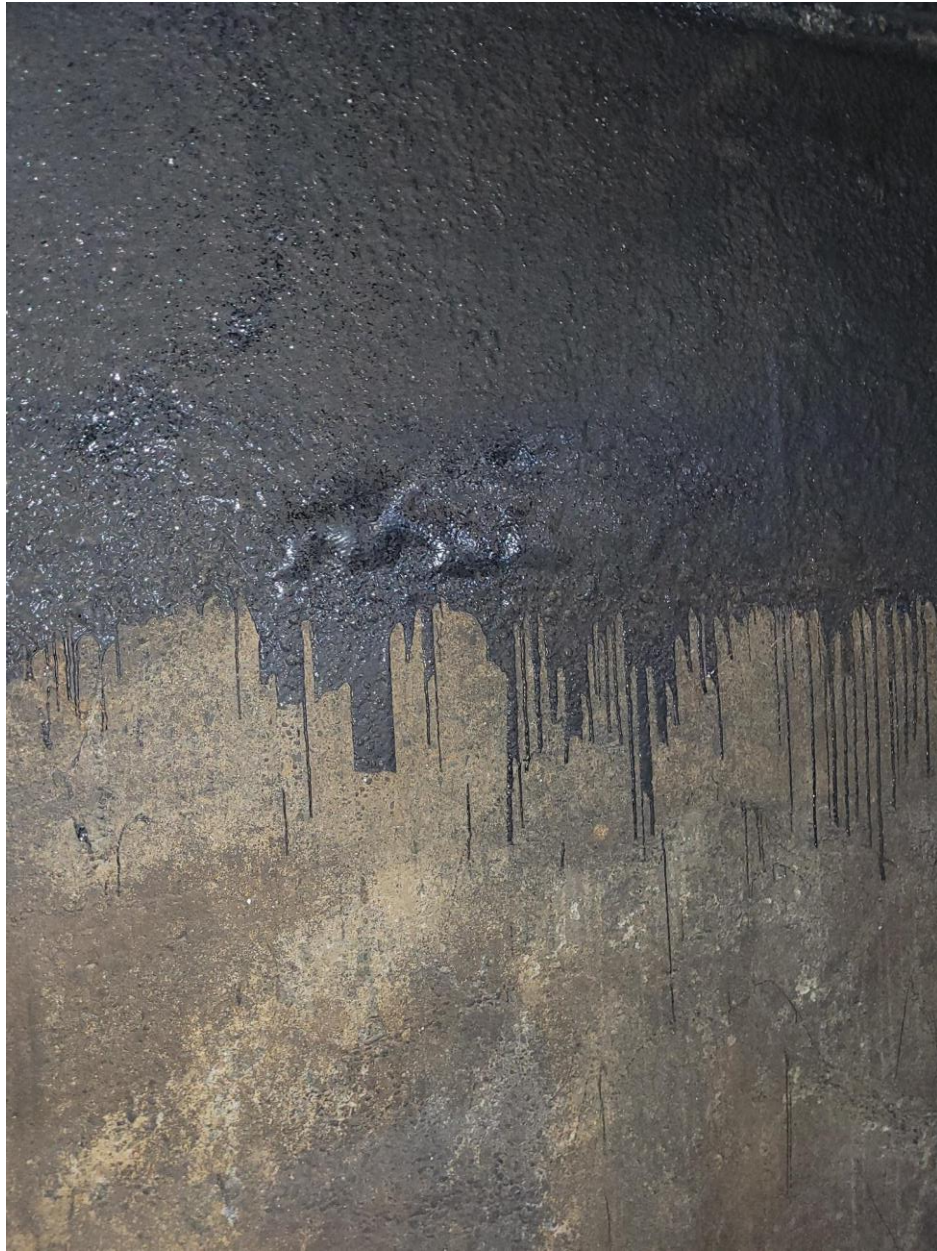
**Photograph 14** illustrates the west wall of Sed Tank 2. Note the extensive blistering of the coating and the uncoated concrete below.

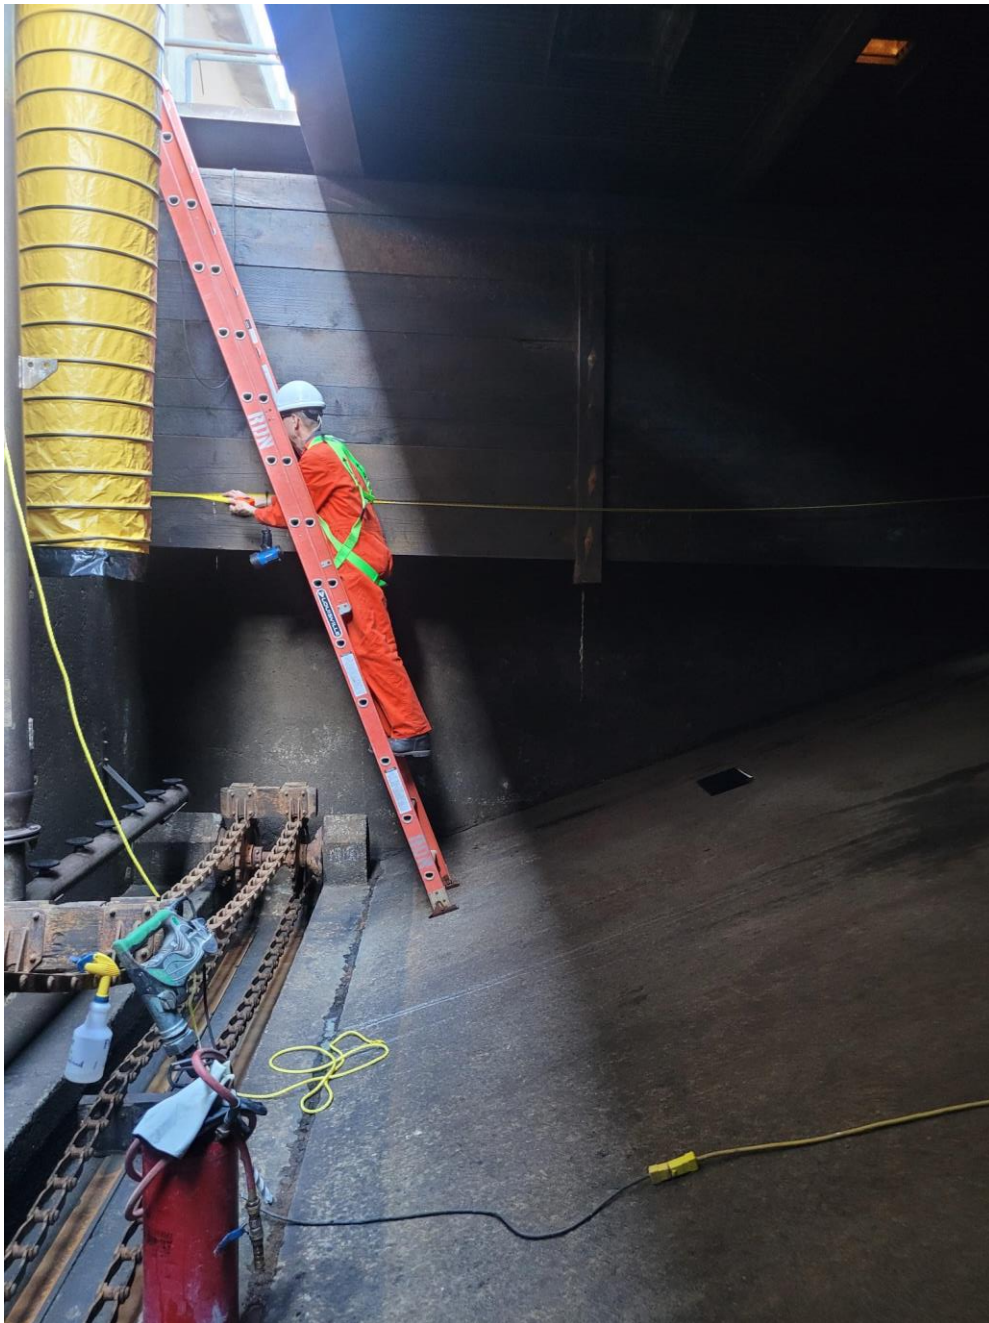
**Photograph 15** illustrates the sloping floor and East Wall of Grit Tank 2.

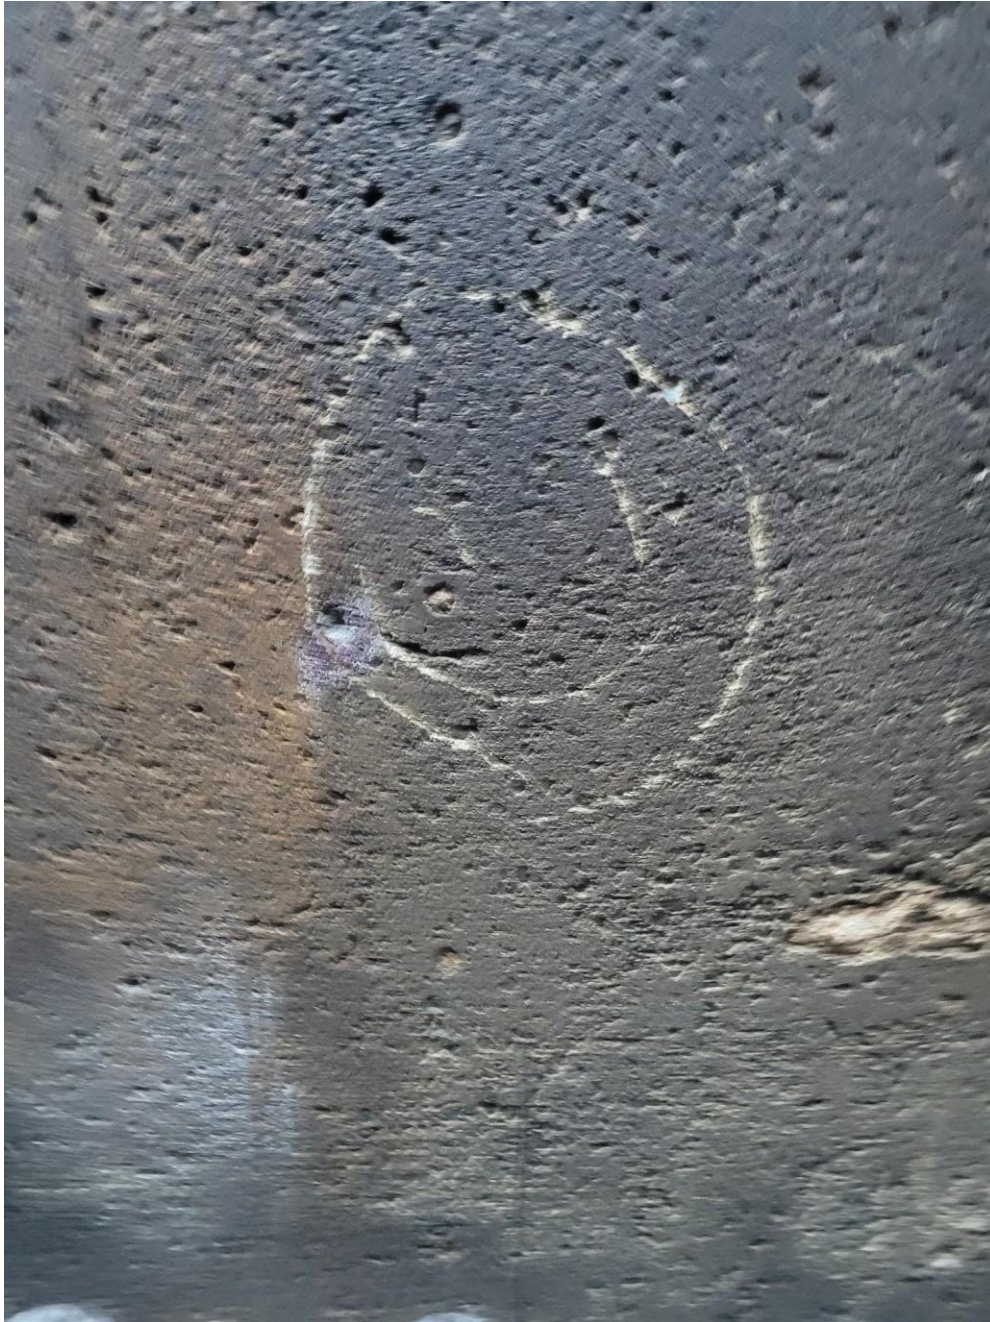
**Photograph 16** shows the uncoated north wall of Grit Tank 2. The surface is soft and easily scratched typical to other areas in Sed Tank 2. The underlying surface is sound and hard when hammer sounded.

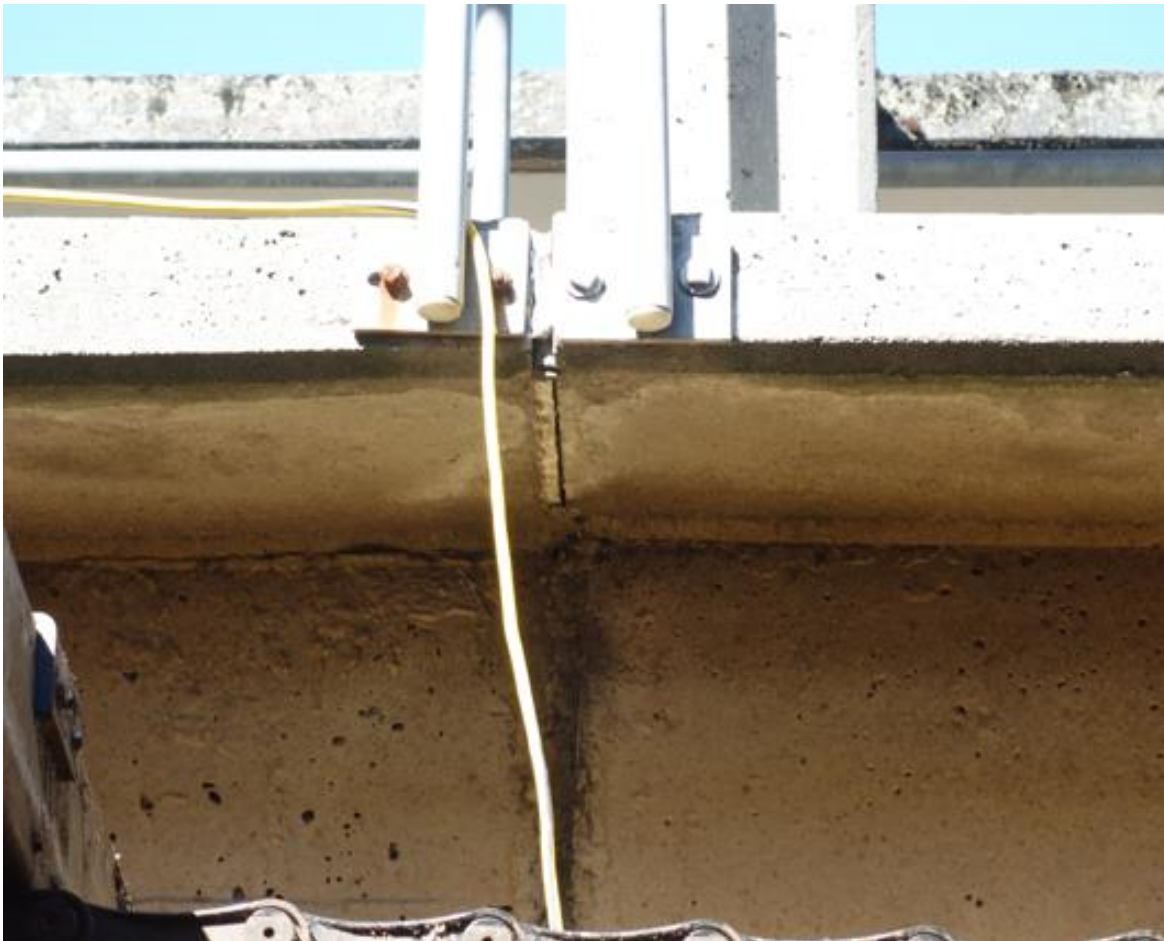
**Photograph 17** Sed Tank 3, open construction joint in walkway on top of tank.

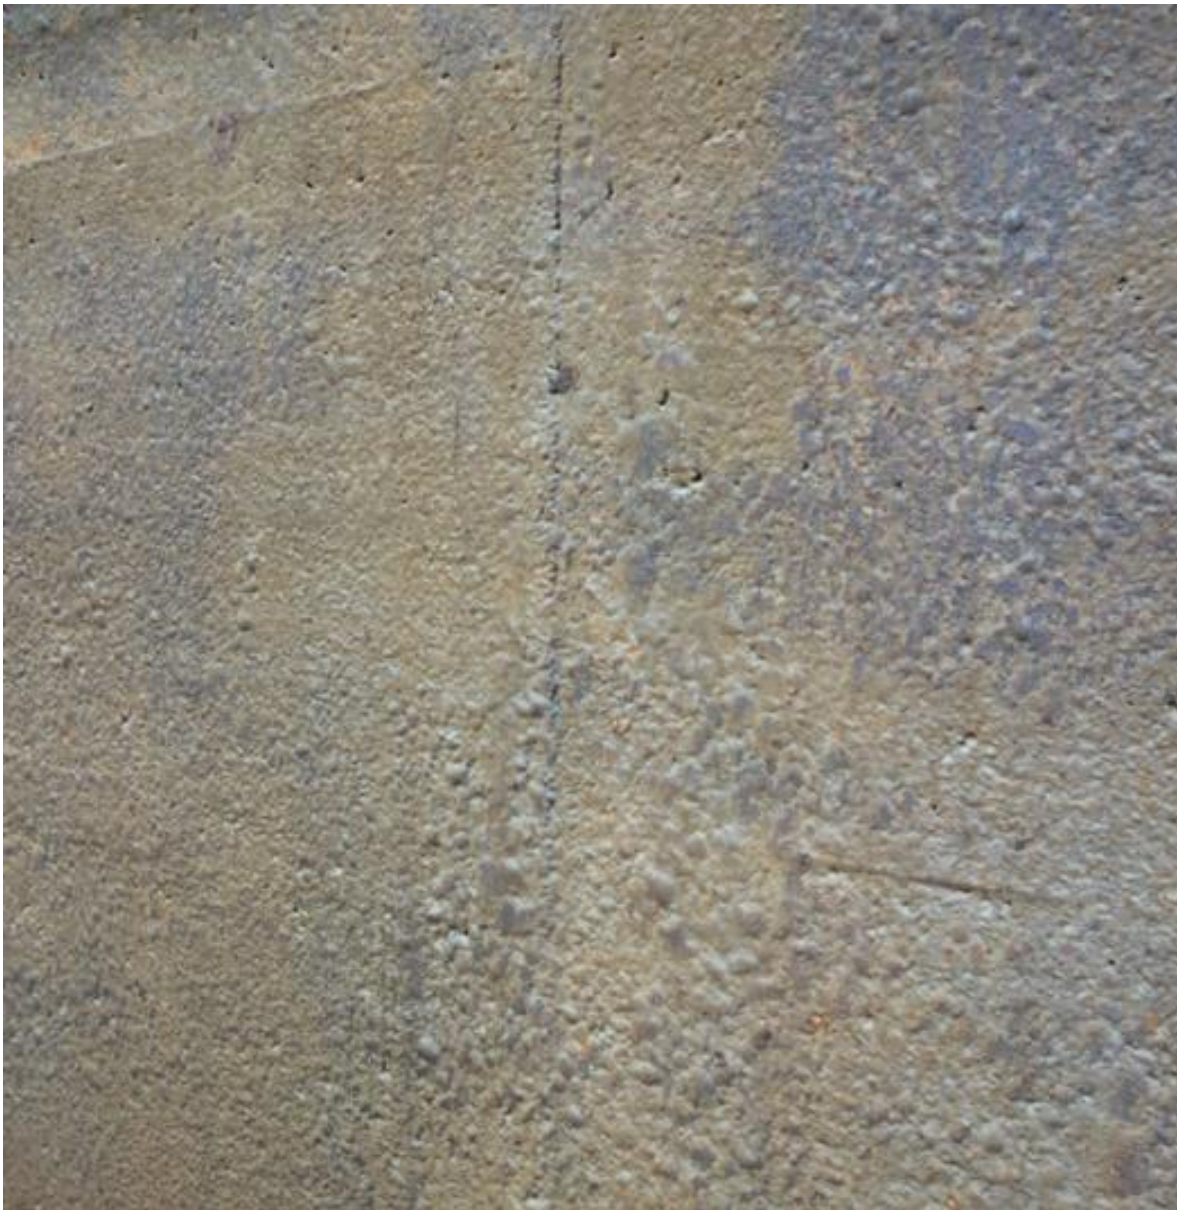
**Photograph 18** Sed Tank 3, blistered coating.
