Project Number: MB44022

Date: 16 October 2023

**Project:** GNPCC – Grit and Primary Sedimentation Tanks Refit  
**RE:** Evaluation of Concrete in Grit and Sed Tanks 1 to 3, Revision 01

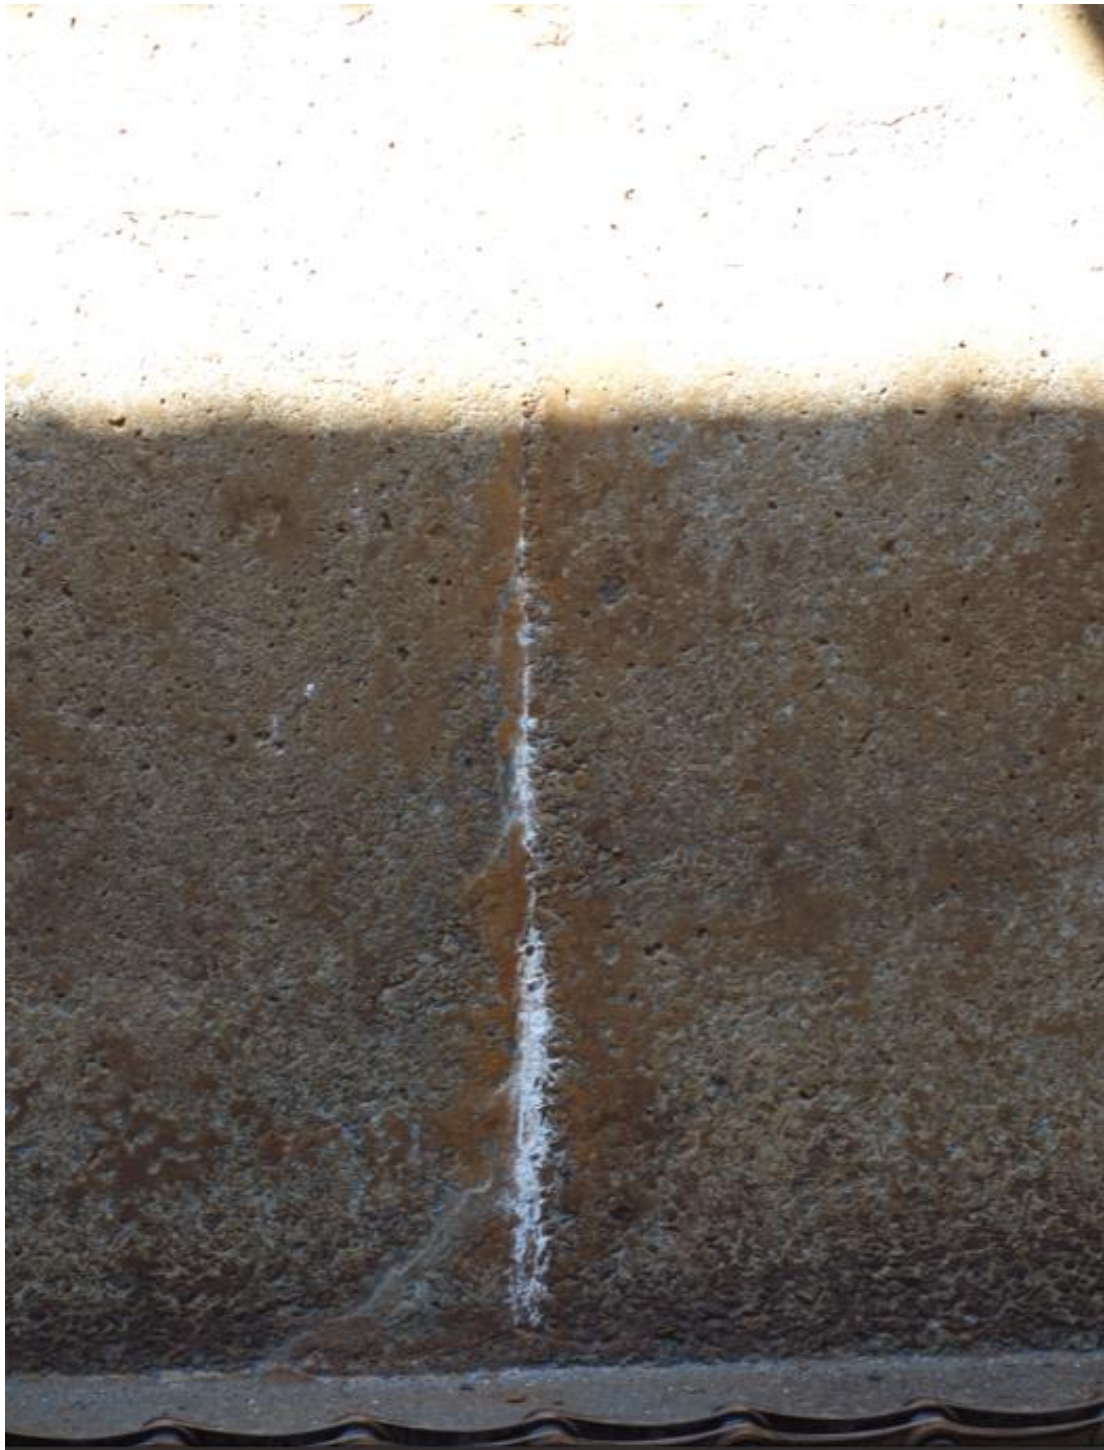
**Photograph 19** Sed Tank 3, West wall, efflorescence around crack, indicating minor leakage.

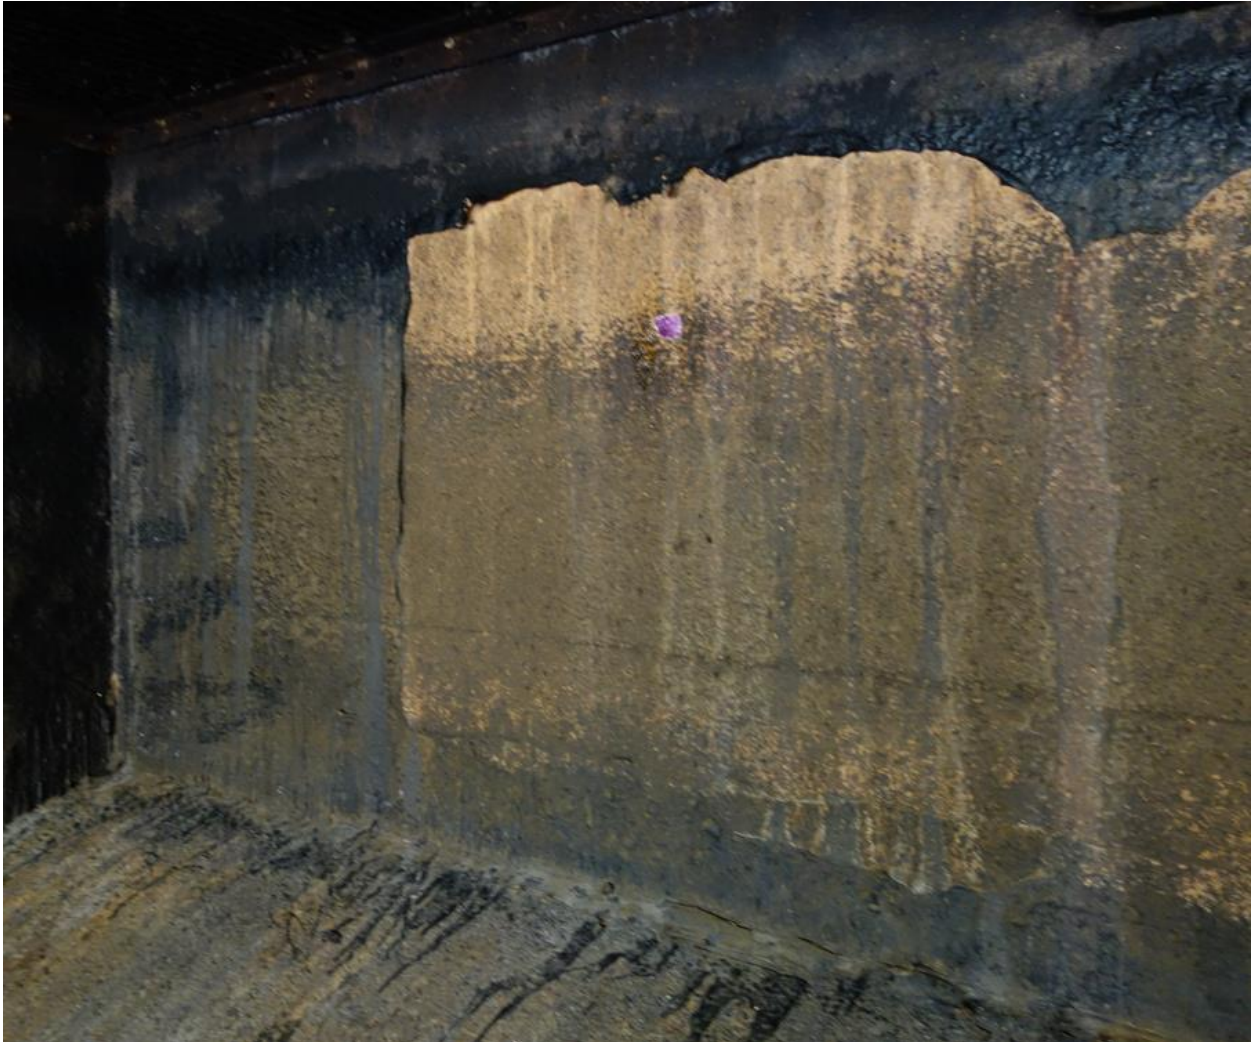
**Photograph 20** Grit Tank 3, South wall, delaminated top coating, exposing base layer.

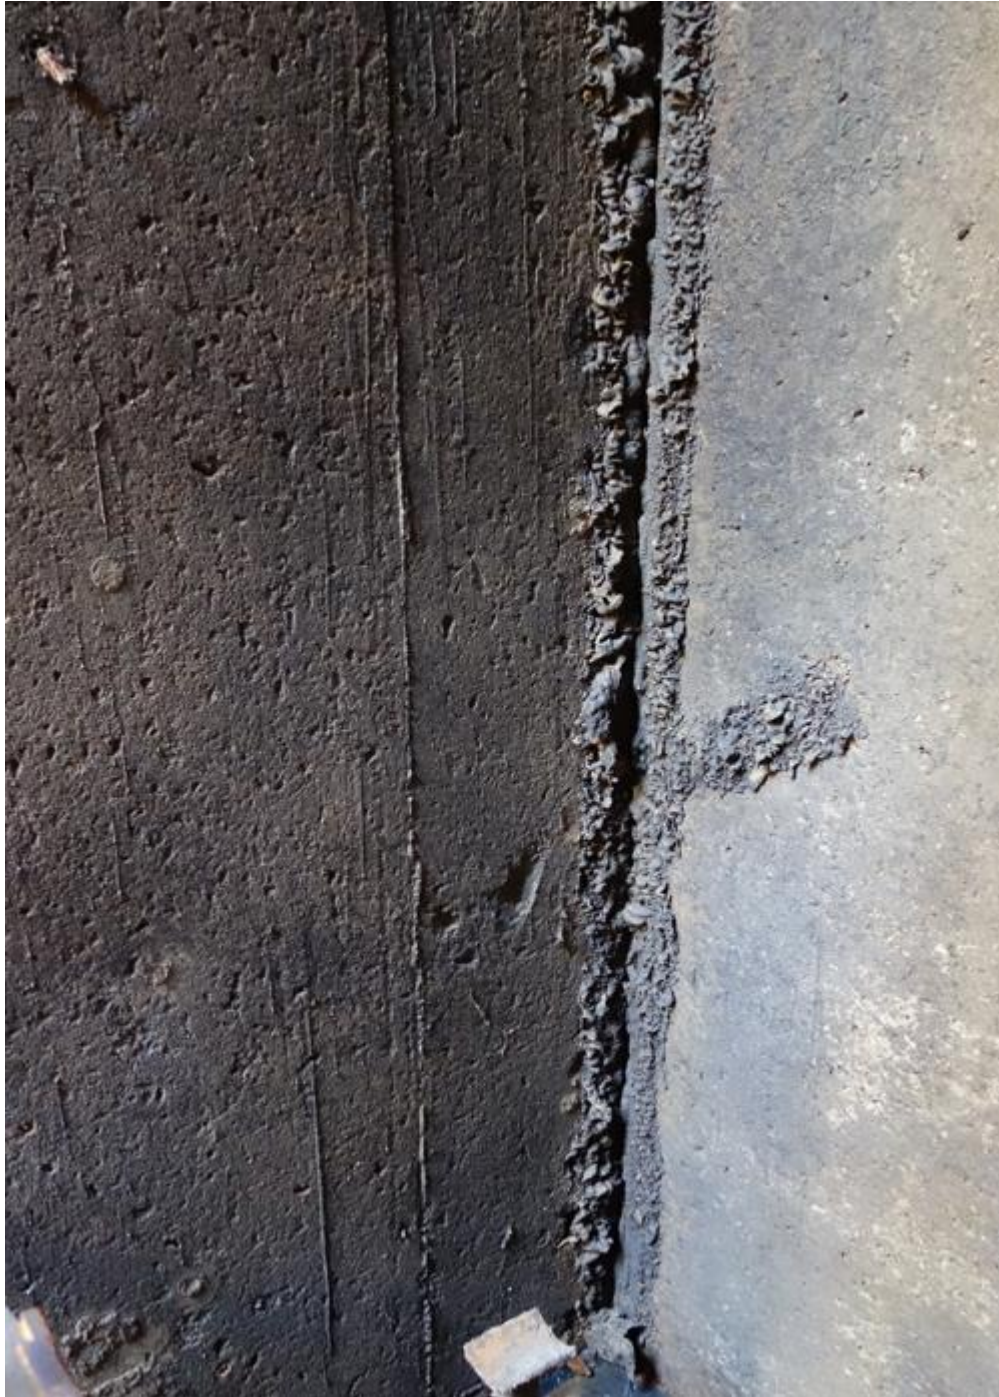
The coating in the NE corner appeared to have partially flaked off. It could not be removed with reasonable effort, and obscured the concrete. The condition of the concrete, and of any joint which may be present, is uncertain at that location.

**Photograph 21** Grit Tank 3, North-East corner, rough joint, condition could not be evaluated non-destructively.

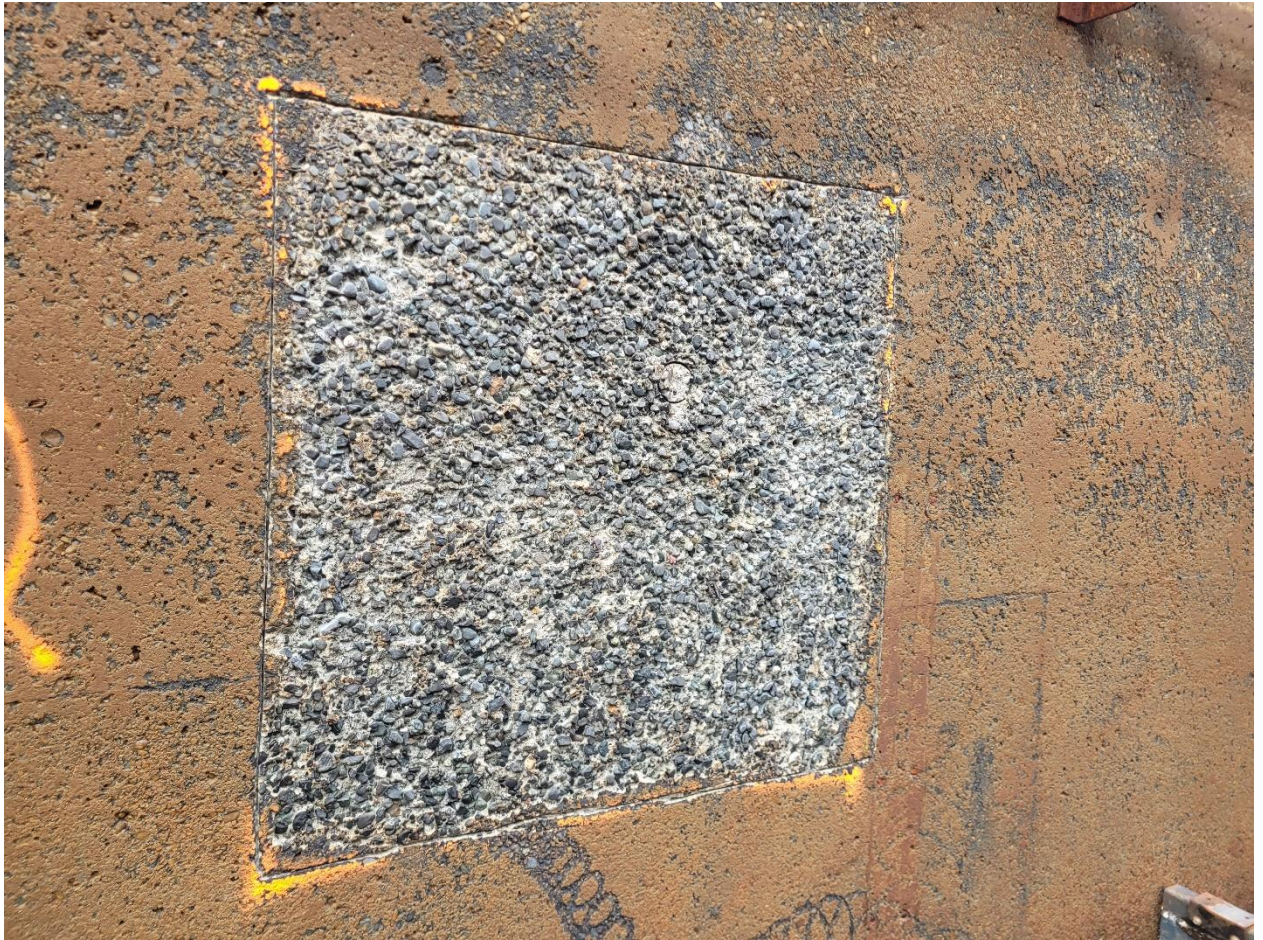
A high-pressure water jetted test patch observed by Metro on 30 August 2023 showed that after removing approximately 10 – 12 mm weakened concrete, the next layer of relatively firm concrete still showed whitish deposits around large aggregate to an additional depth of approximately 10 to 12 mm. Thus, the total affected depth is approximately 20 to 25 mm. We did not have the opportunity to determine the nature of these deposits. However, they may be related to sulphate attack. Photographs 22 and 23 illustrate the test patch surface profile.

**Photograph 22** illustrates the test area in Sedimentation Tank 3. Refer to Photograph 23 for a close-up view.

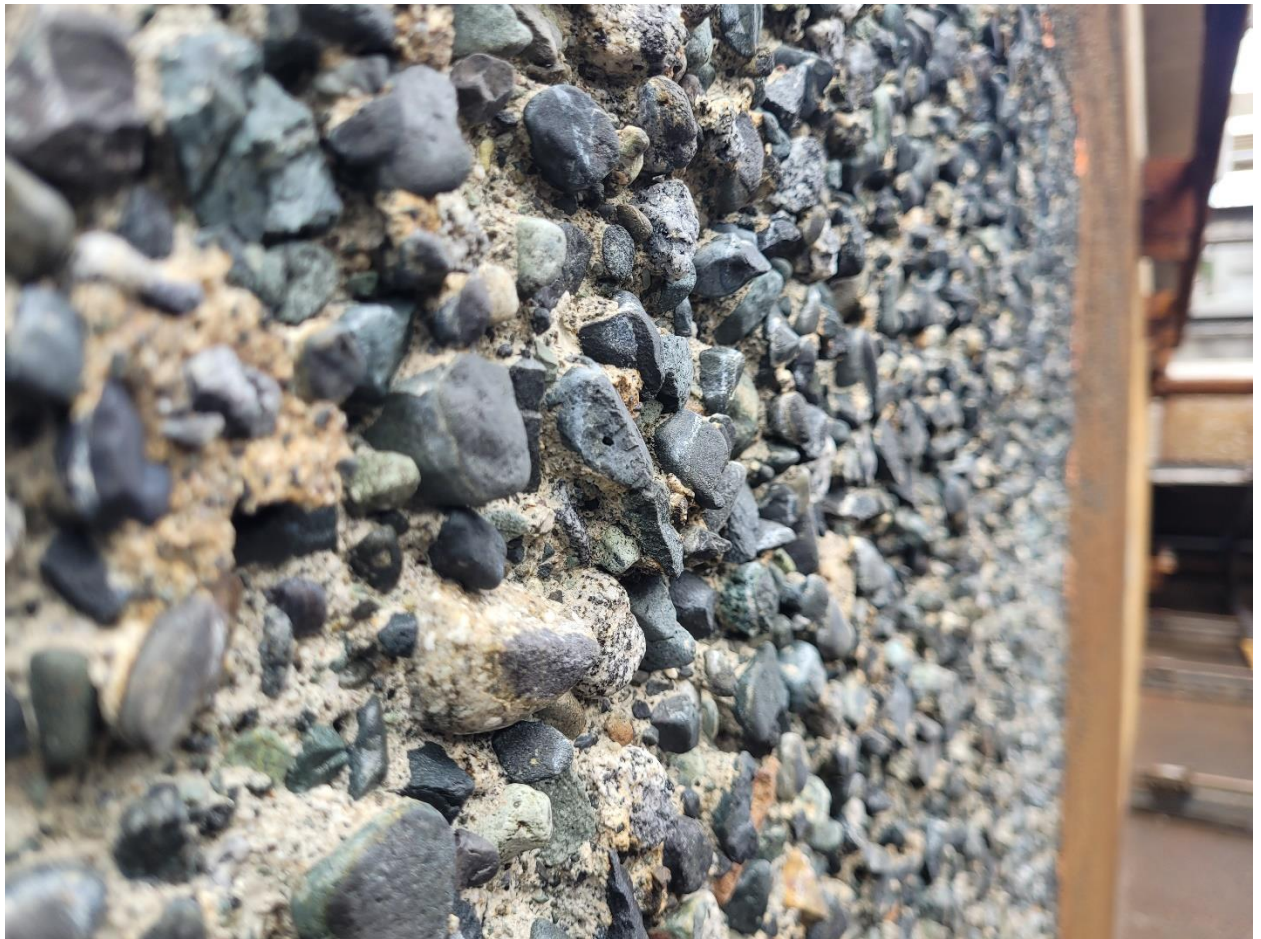
**Photograph 23** illustrates a close-up view of the surface preparation in the Sedimentation Tank 3.

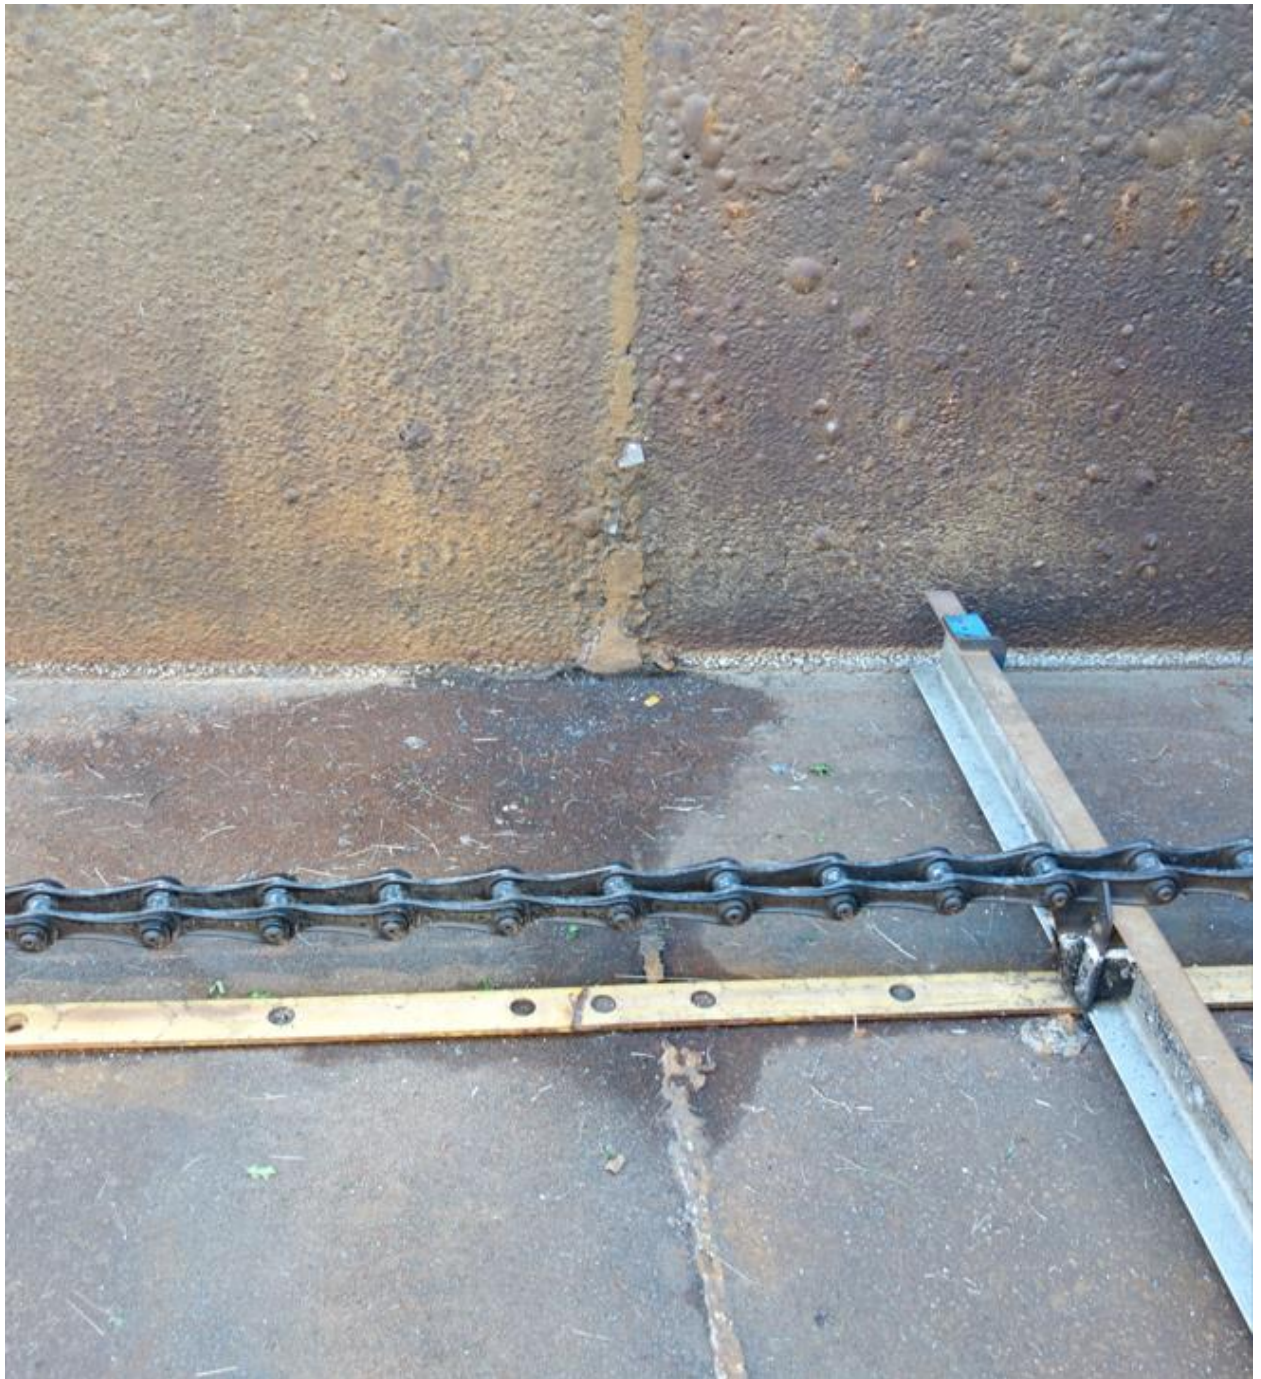
**Photograph 24** Sedimentation Tank 3, dampness around joint in floor.

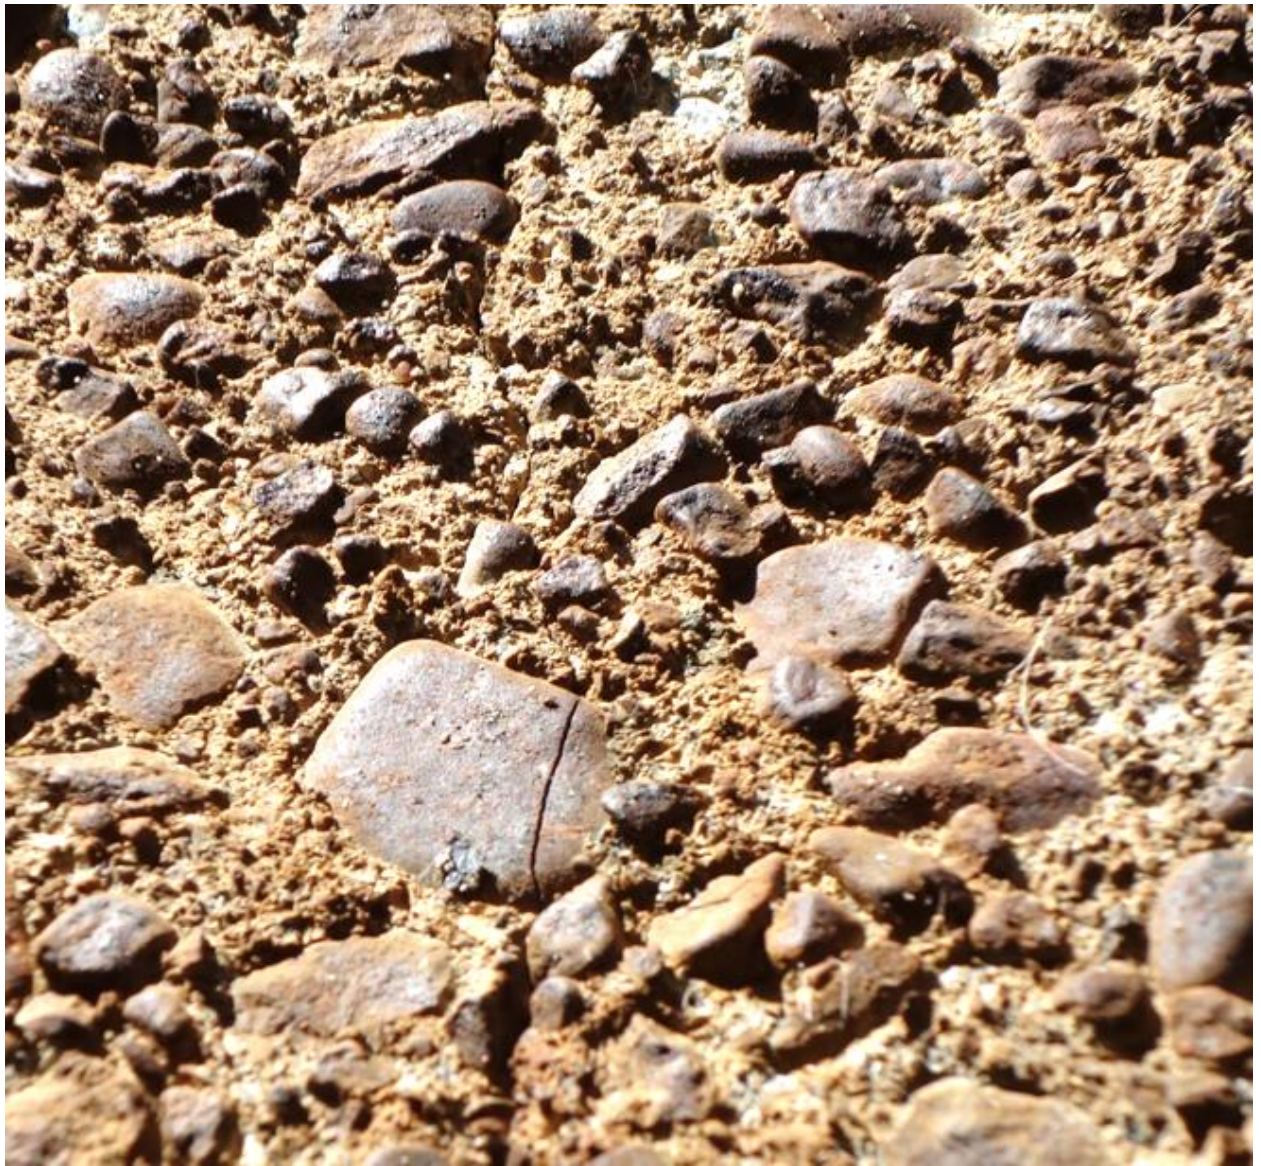
The West wall was almost completely dry, even though the adjacent tank was filled with sewer water. One obvious leak observed was from a pipe penetration, and is not related to cracked concrete or deficient joints. None of the joints and cracks were wet or actively leaking, although some dampness was observed around a joint in the floor in the South-East portion of the tank (Photograph 24). A vertical pour joint in the West wall showed efflorescence (see Photo 19), indicating that moisture had percolated at some time. No significant concrete deterioration was visible at the scum line (approximately 2.9 m above main floor level, as measured at the East wall at about mid-tank). Several pour joints, narrow cracks, and missing caulking material in control joints were observed. An irregular crack in the East wall has passed through aggregate, indicating that it is a stress crack through concrete with a generally competent and strong cement matrix (Photograph 25).

**Photograph 25** Sedimentation Tank 3, East wall, detail of a narrow stress crack through cement paste and aggregate, indicating strong cement matrix.
