French Creek Stream Survey – 2015

The Regional District of Nanaimo

August 2015

Written By D.R. Clough Consulting

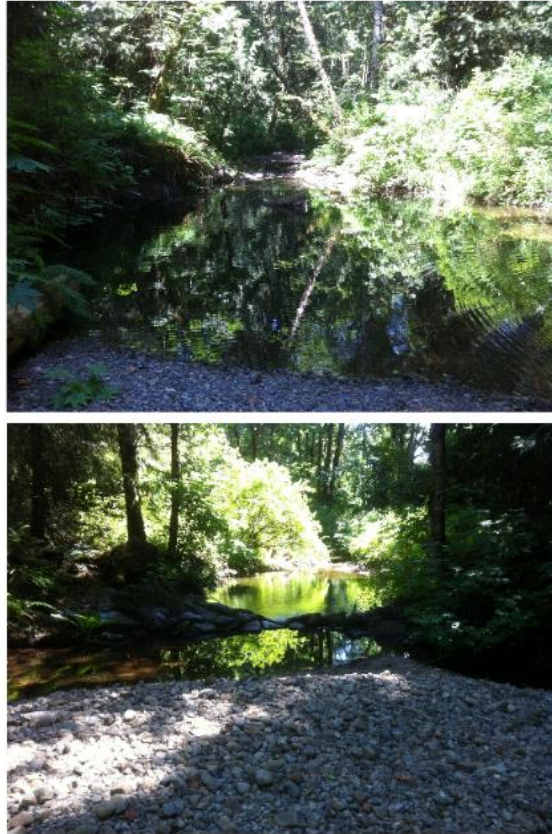
Figure 1: Reach 1 Photo Page

Photo 1 & 2- Pool 1

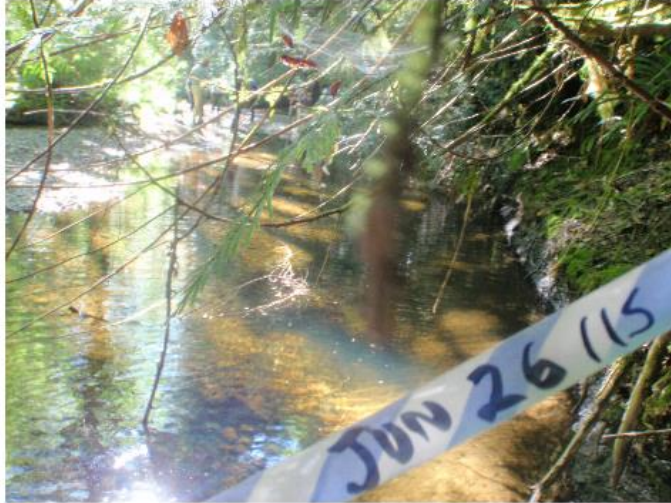
1.) Pool 1 start

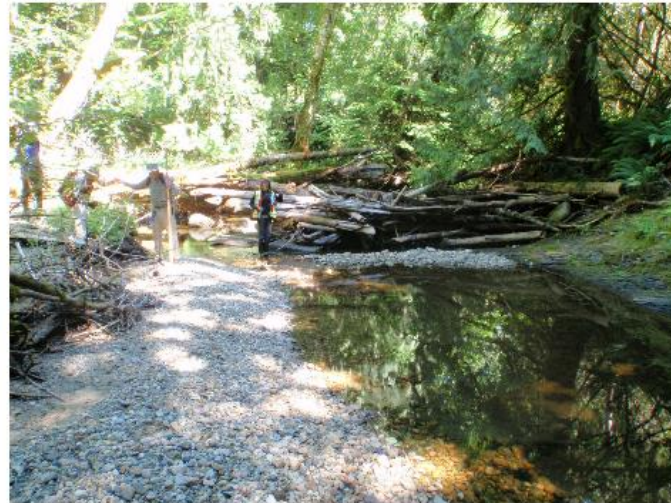
3.) Blow down LWD

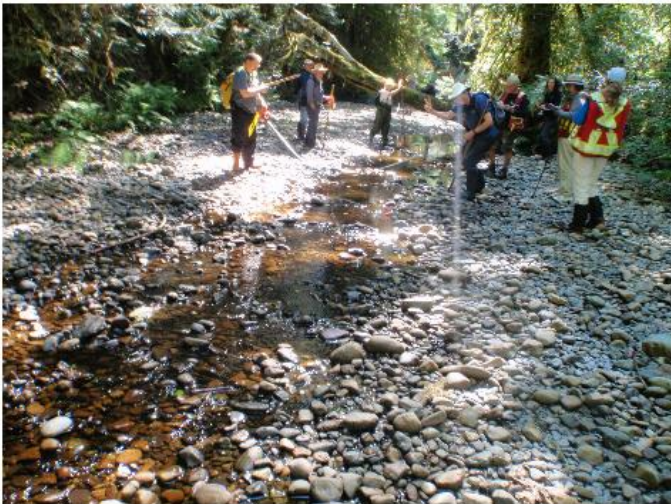
2.) Riffle 4 gang.

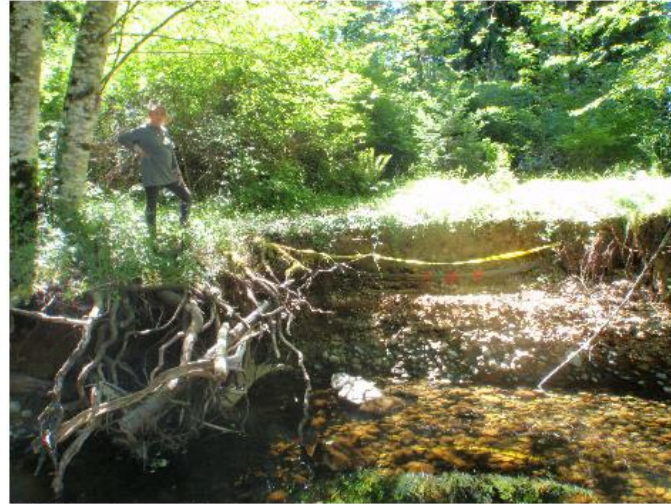
4.) Terry Property bank erosion

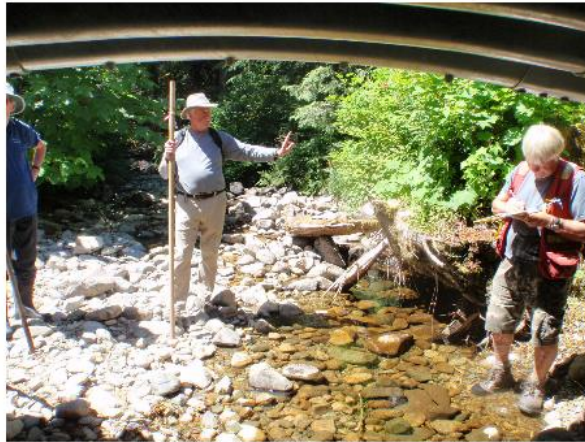
1.) Start pool at Pratt Bridge

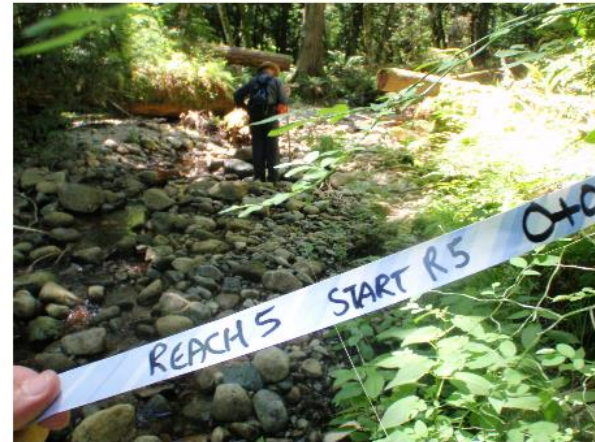
3) Last Riffle in R5 survey.

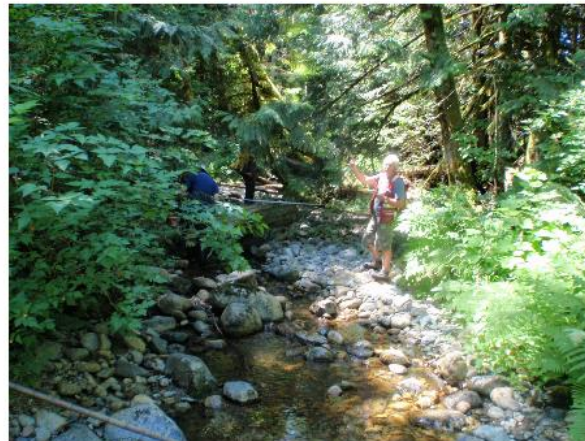
2.) Riffle in R5 clean gravel for spawning.

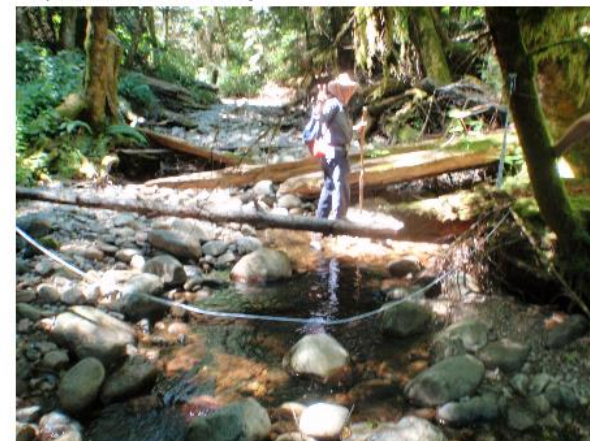
4.) Shallow pools and LWD
