# **Departure Creek Habitat Assessment Report**

**Departure Bay Neighbourhood Association, Nanaimo B.C.**

**D.R. Clough Consulting  
6966 Leland Road  
Lantzville B.C. V0R 2H0  
Ph/fax: 250-390-2901  
Email: drclough@shaw.ca**

**October 2016**

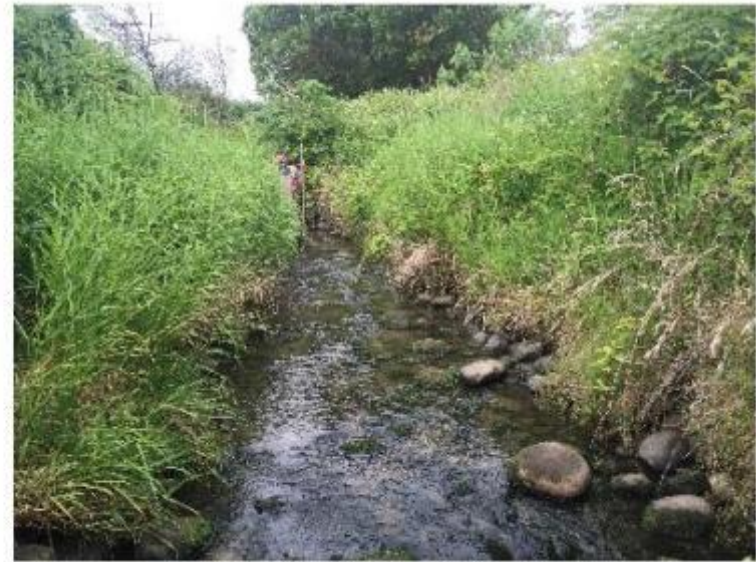
3.) R1 above culvert needs trees and gravel

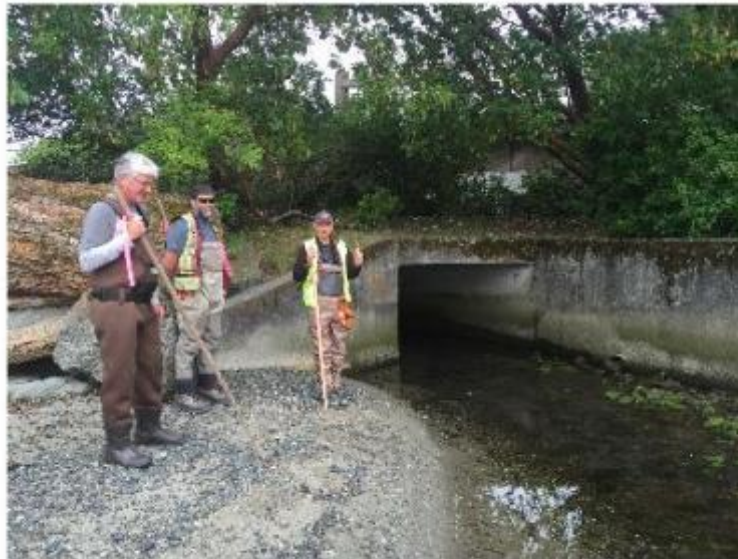
2.) Departure Road culvert is fish friendly

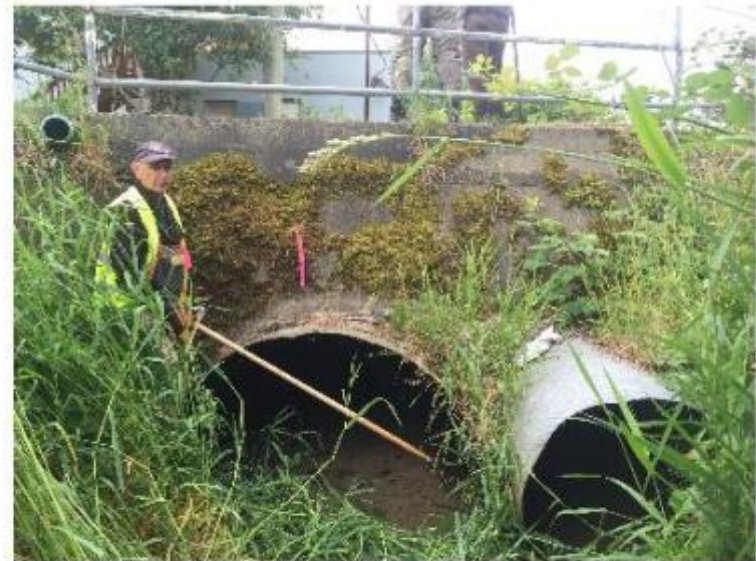
4.) Bay St twin culverts are smaller but passable..

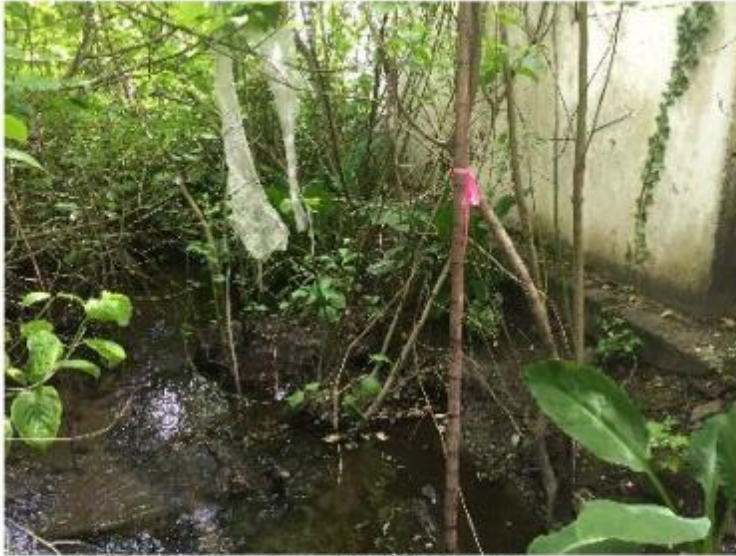
1.) R2 - ditch line along side of 7-11 is poor.

The Centennial Park/7-11 parking lot off Bay Street is a 75m long ditch that offers an opportunity to naturalize the segment if the parking lot is deactivated. As noted, the proper function of any new design would have to consider the effect of the restricted flow upstream and the sediment inputs that could bury pools and riffles.

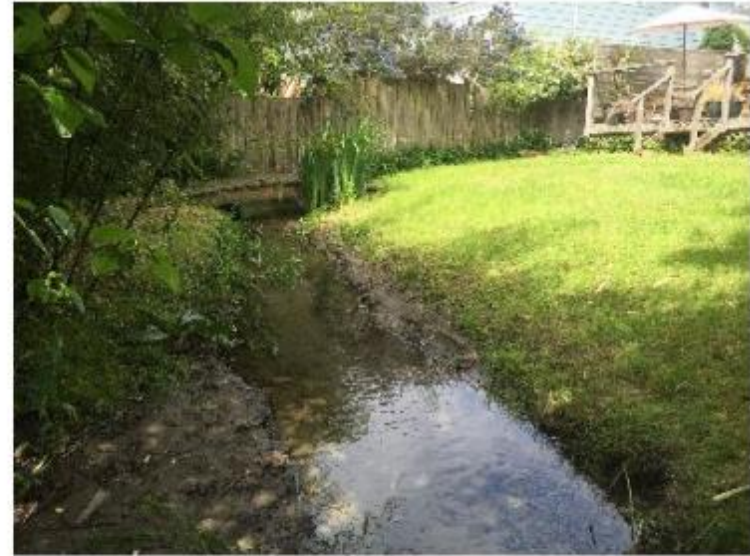
3.) R2 - Cleared to grass along several homes

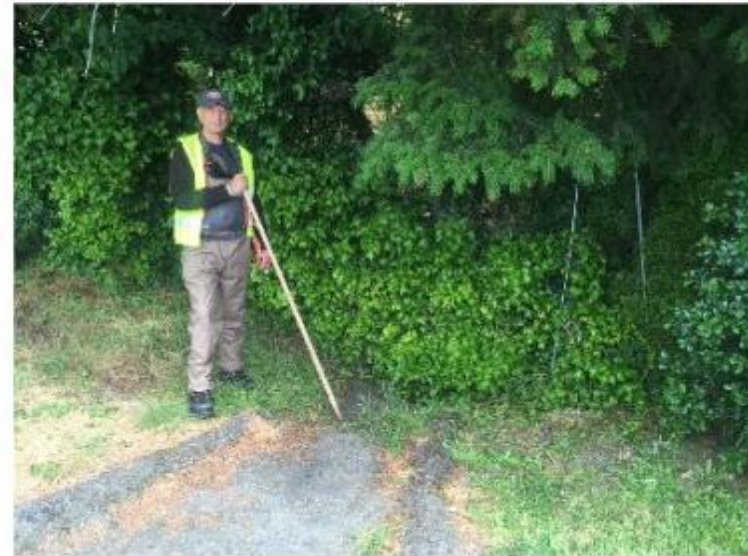
4.) R2 - Elk St. runoff directed to Creek

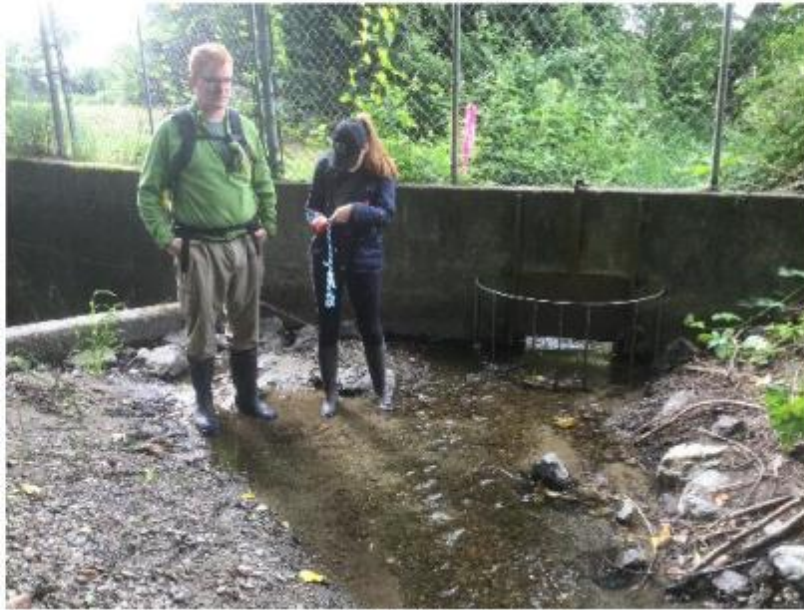
1.) Reach 3: Looking downstream at the diversion structure

designed and the City of Nanaimo conducts regular maintenance of the sump but stewards routinely maintain the orifice plate for sedimentation and wood debris to ensure fish/flow makes it through the channel. It is suspected this structure does not meet fish flow/passage requirements and we recommend an engineering review to determine if improvements can be made to the flow regulation. The sediment sump at the bottom of reach three should be cleaned out annually to protect lower areas from further infilling. There is little LWD cover in this reach, and could be added with relatively good machine access and existing prescriptions from NHC.

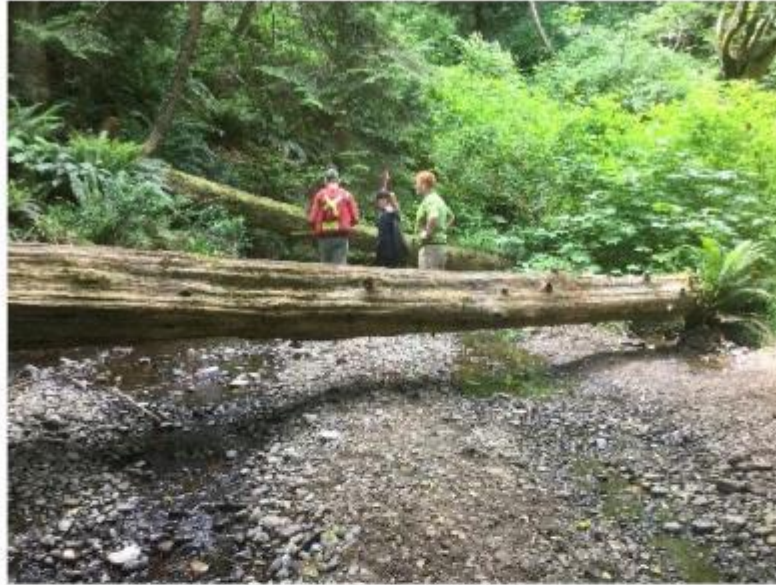
1.) Reach 4; erroded riffle 5. Typical habitat of Reach 4

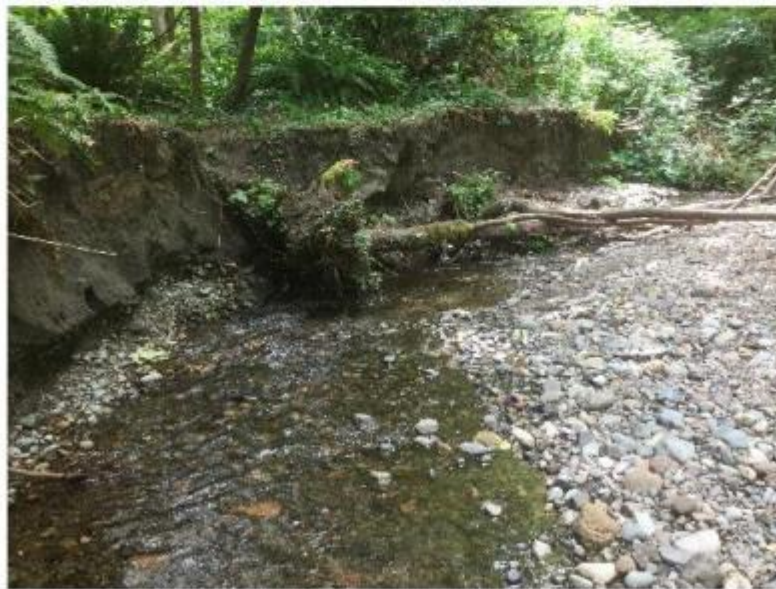
2.) Reach 4: Bank Erosion site at riffle 6

Potential restoration activities in this reach should include removal and stabilization of the debris jam, repairs to the outfall of the stormwater culvert, bio stabilization of 15m long erosion site on the left bank. Addition of LWD and riparian planting would be beneficial.

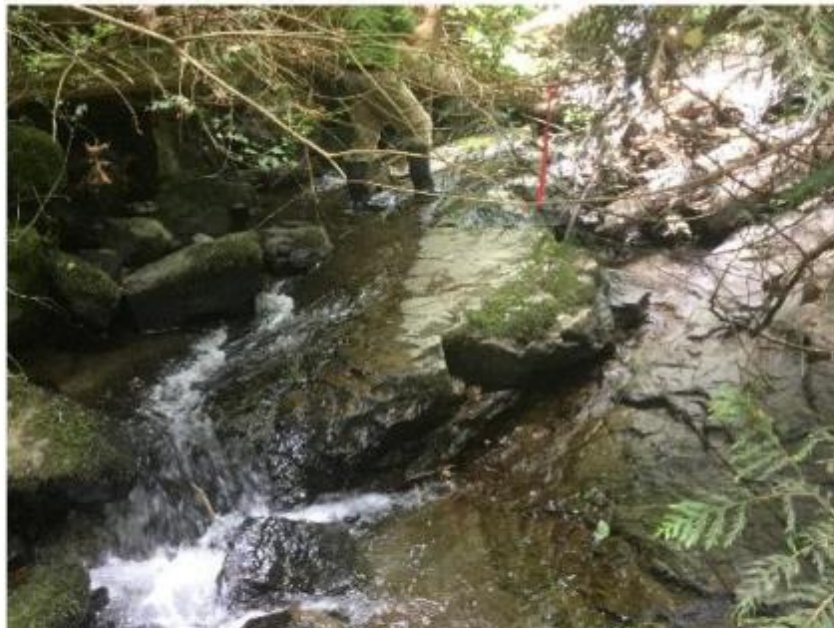
2.) Reach 5: Looking upstream at first of two bedrock chutes which limit upstream salmon migration

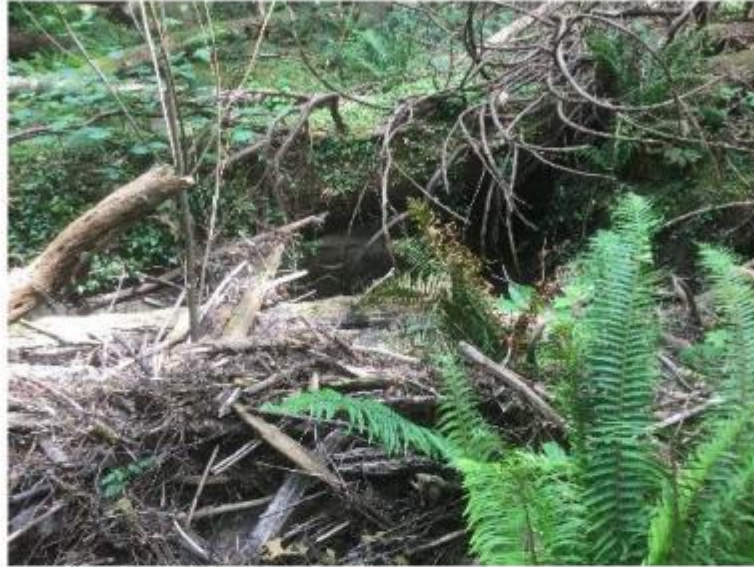
Reach 6: Pool 7 typical debris jam

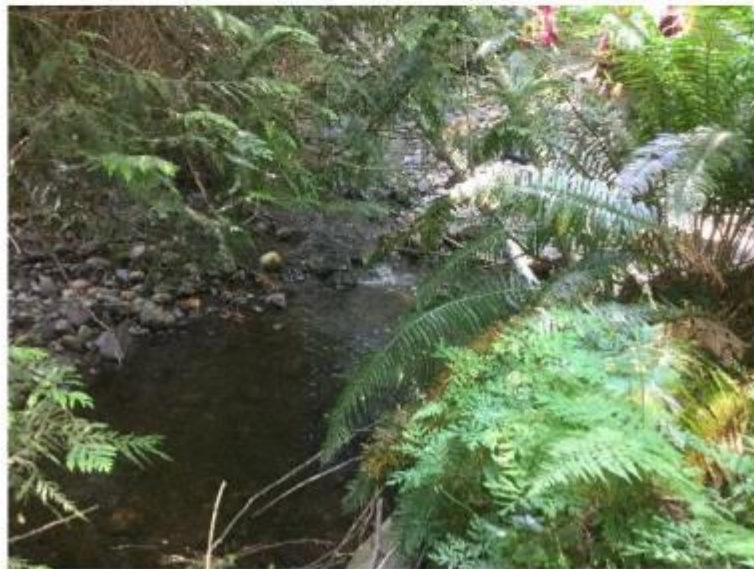
2.) Reach 6: Pool 23 near confluence with Joseph Creek, (Note Lack of pool cover)

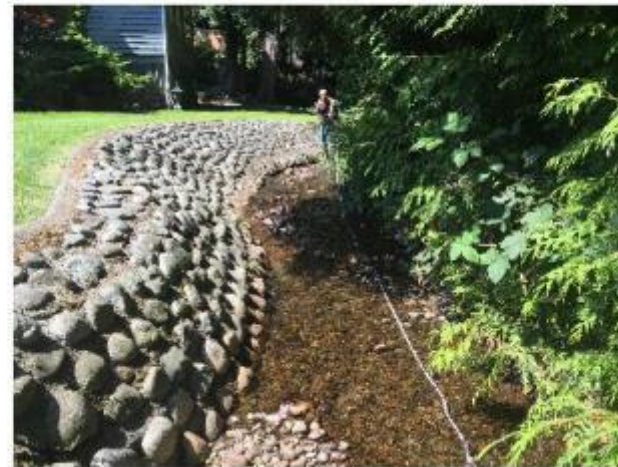
3.) R7 - alterations above Newton St.

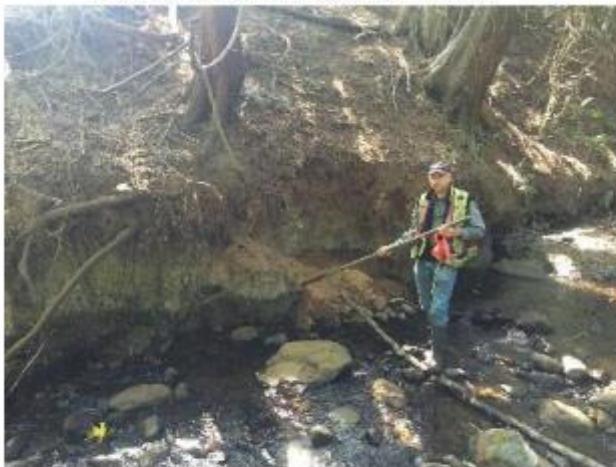
2.) Bank erosion below Newton st.

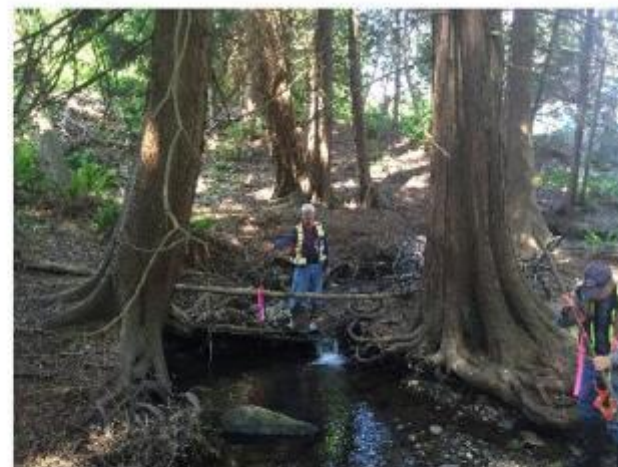
4.) R7 erosion below Keighly Ck

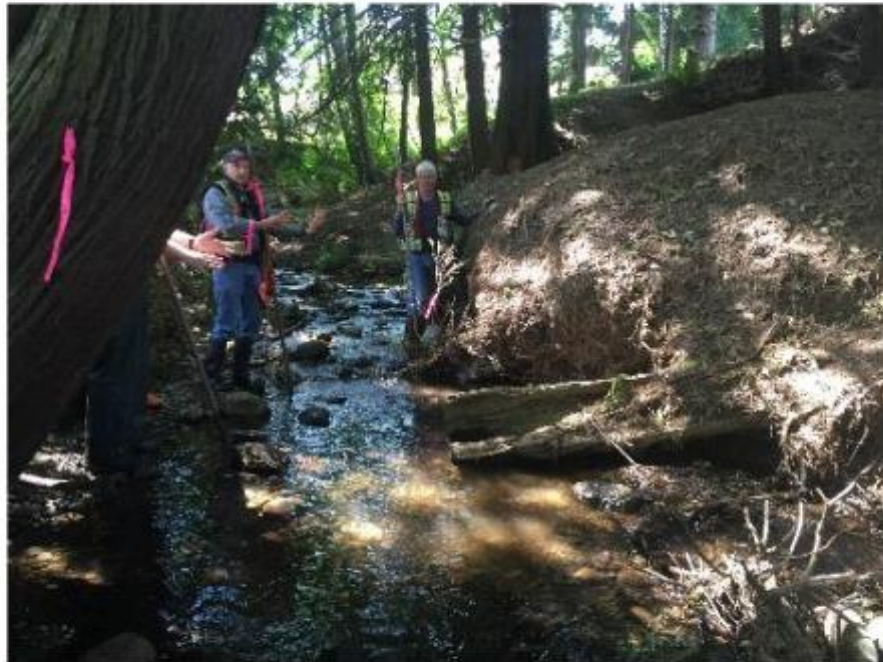
**2.) R8 - Storm Water erodes historic stable banks**

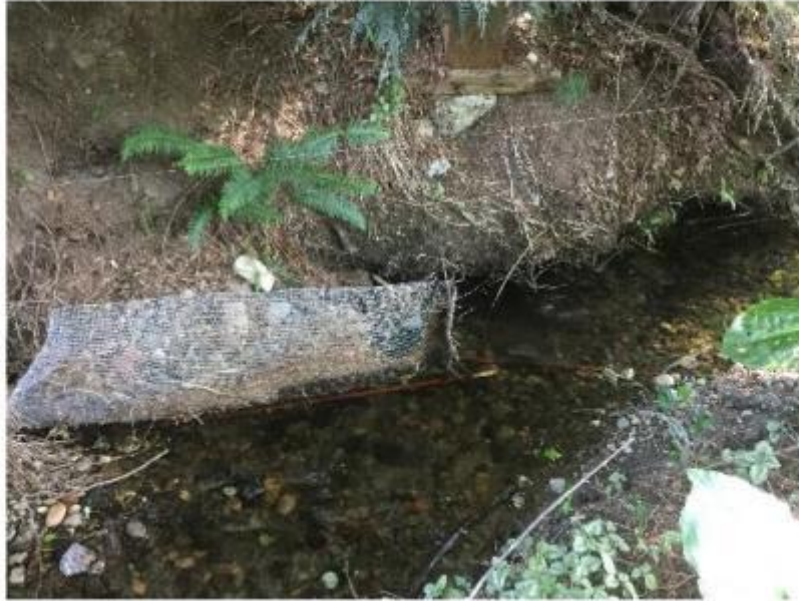
1.) Reach 9: Looking downstream at riffle 2 eroding bank

This reach was highly eroded given the amount of alterations to the riparian zone which ranged from vegetation removal to placement of fill. As noted similar needs in reach 8 of backyard watershed stewardship to address encroachment and promote riparian areas is needed.

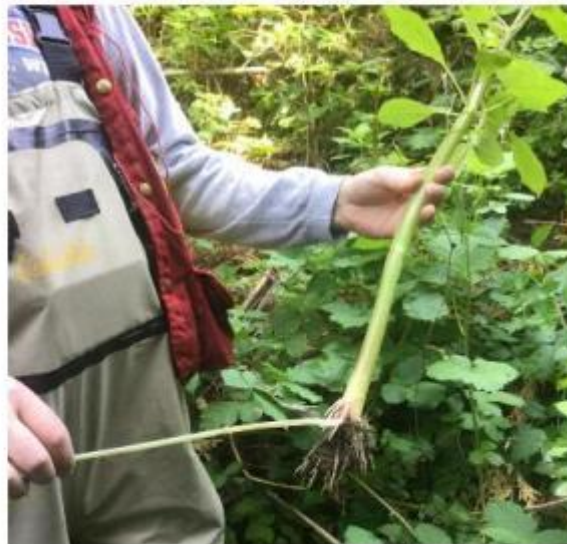
Joseph Creek with Himalayan Balsam
