Cottle Creek Urban Salmonid Habitat Assessment

January 17, 2026

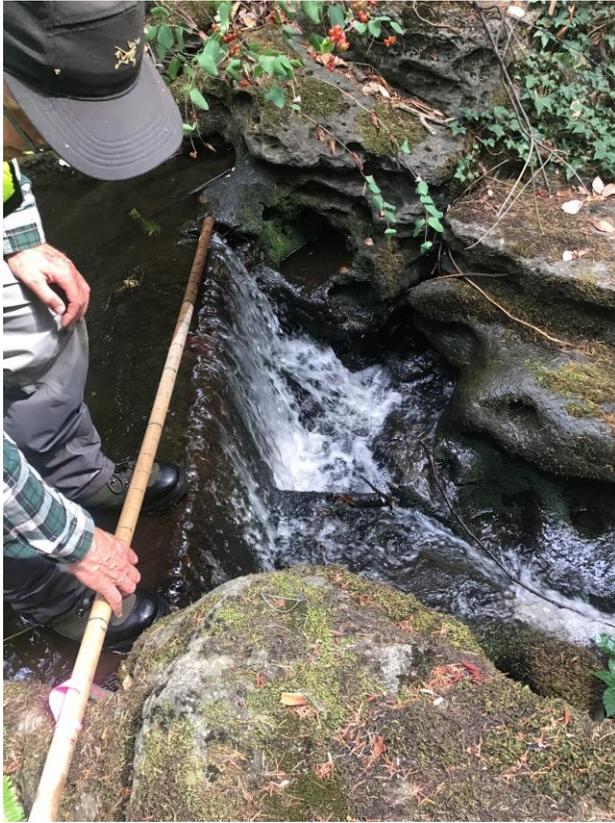
a) Concrete weir at survey terminus

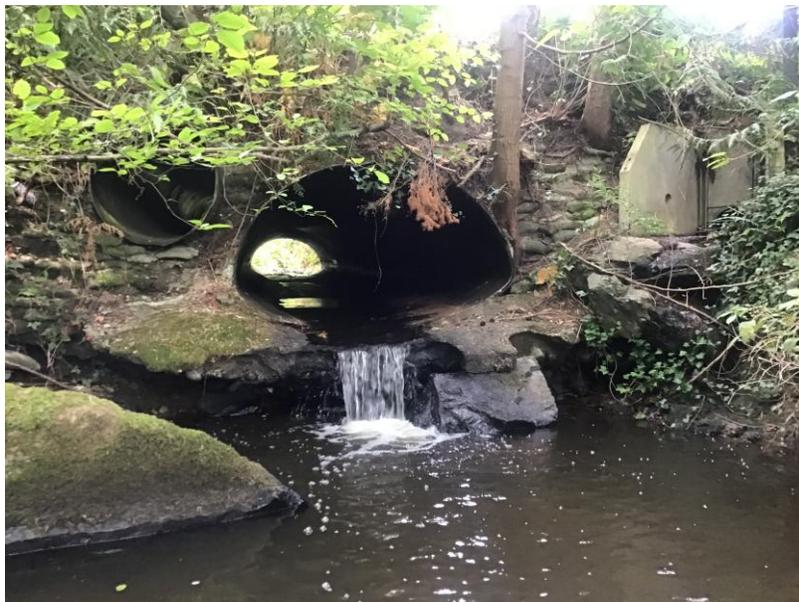
c) Stephenson Point Road culvert and pool

Reach & Placemark #	Habitat Limiting Factor	Description
R1 – PM 179	Human-made migration barriers	The Stephenson Point Road culvert is a fish barrier at all flows; replacement with open-bottom culvert/bridge would restore connectivity to Reach 2.

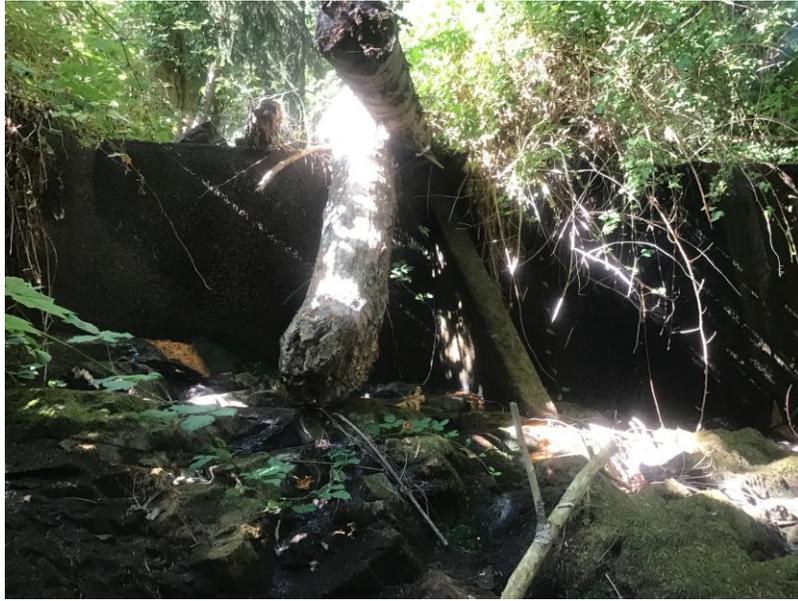
a) Concrete irrigation dam

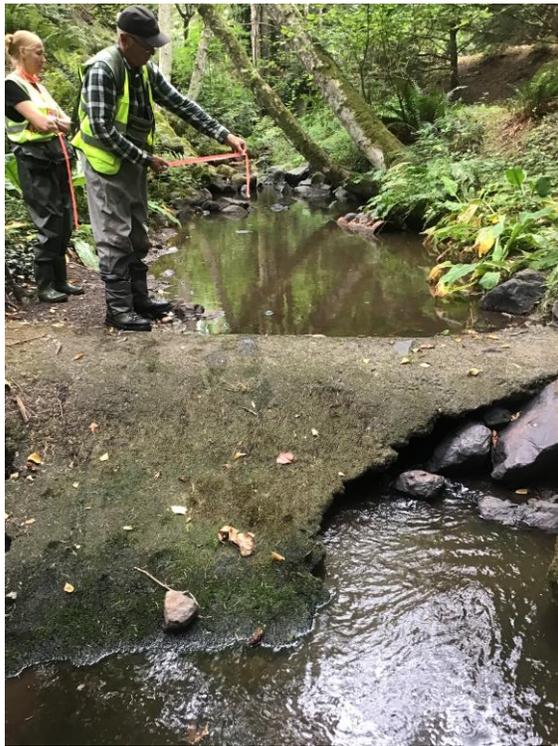
b) Channel spanning concrete sill

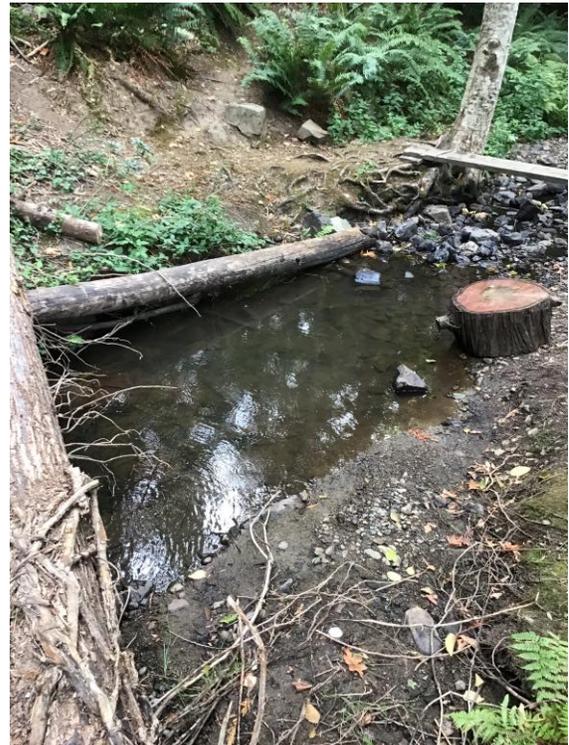
- **Erosion:** Nearly 40% of the stream channel showed signs of erosion. Debris from recent flood events were noted in the riparian zone as high as 3 m above the current wetted edge, an indication of possible high storm flows in the stream.

c) Erosion area near daycare access

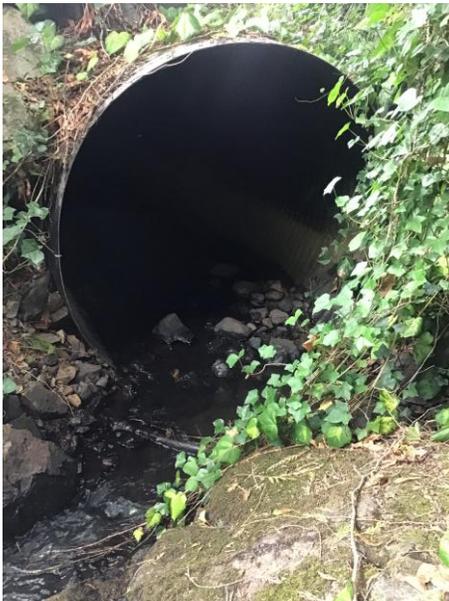
e) Outlet of Hammond Bay Road culvert

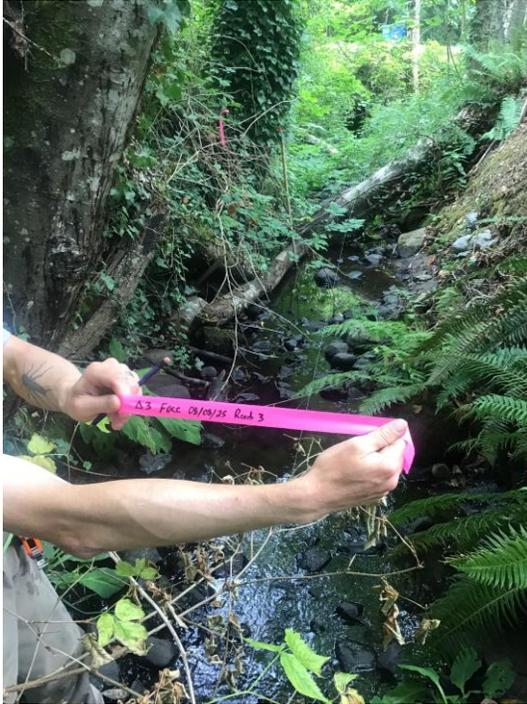
Directly upstream of Hammond Bay Road the stream runs in a steep, riprap-confined ravine between private properties (Fig. 10a) until opening into a wider floodplain as it flows through Cottle Creek Park. The channel has been ditched for the entire length of the park, leaving a mostly straight channel dominated by low gradient glide habitat (Fig. 10b). This may be remnants of the small farm that was subdivided for housing in 2000 (Aquaterra, 2002). Iron oxidizing bacteria was observed blanketing the stream bed throughout this area. This survey encountered a City of Nanaimo public works project underway to remove sediments from a multiplate culvert at Nottingham Road. Riparian vegetation had been removed in this area to facilitate machinery access for culvert maintenance.

a) Ravine u/s of Hammond Bay Road culvert

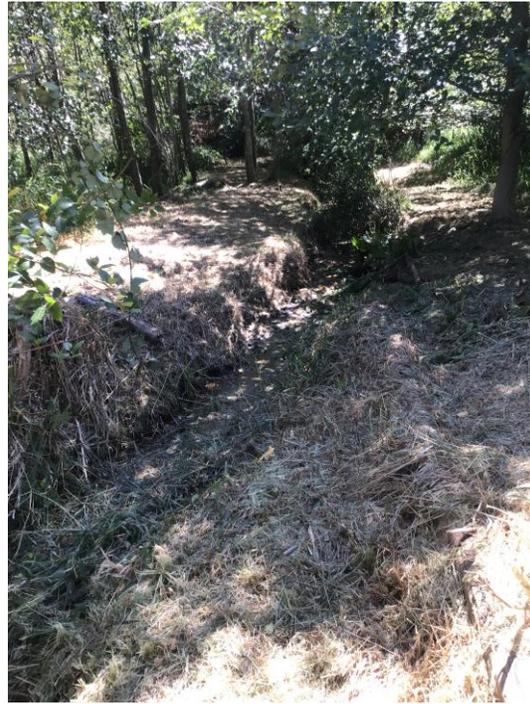
b) Ditched channel in Cottle Creek Park

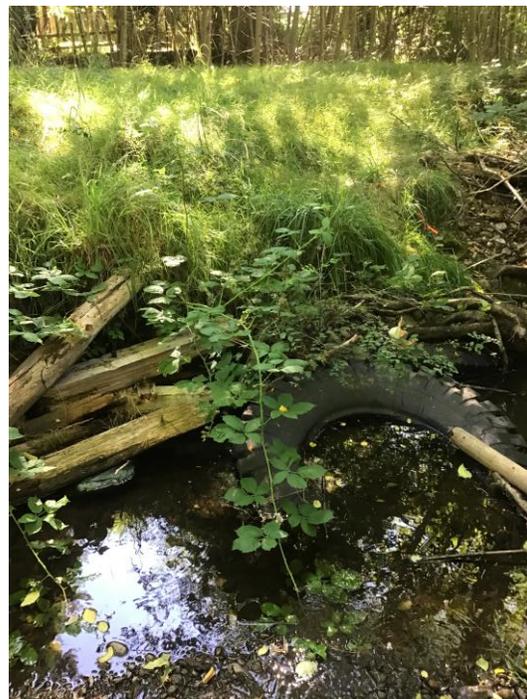
d) One of multiple cement filled tires in bank

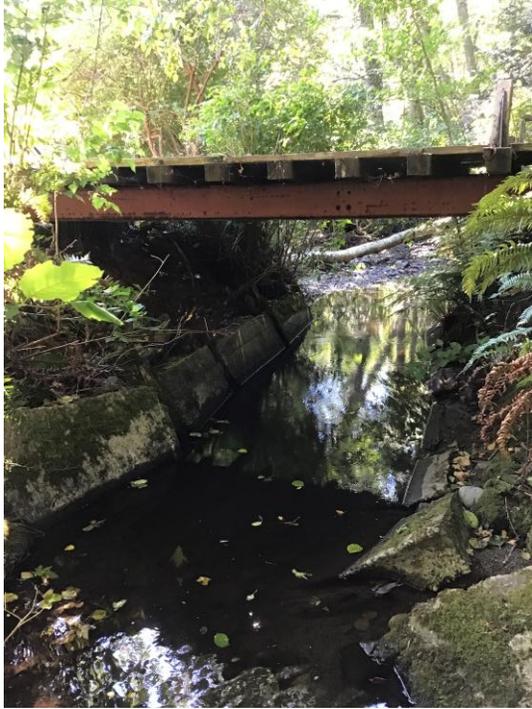
f) Bridge and bank armoring on old Miller Farm property

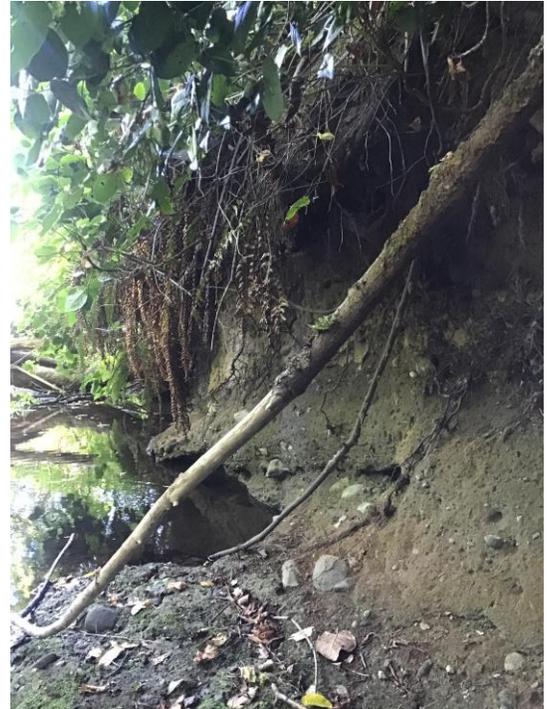
- **Erosion:** Erosion was noted on both stream banks, often present on the outside of a meander. In many places, bare eroded banks extended 1 to 2 m vertically from the wetted edge, an indication of the intensity of storm flows the creek experiences.

g) Typical bank erosion observed in Reach 3

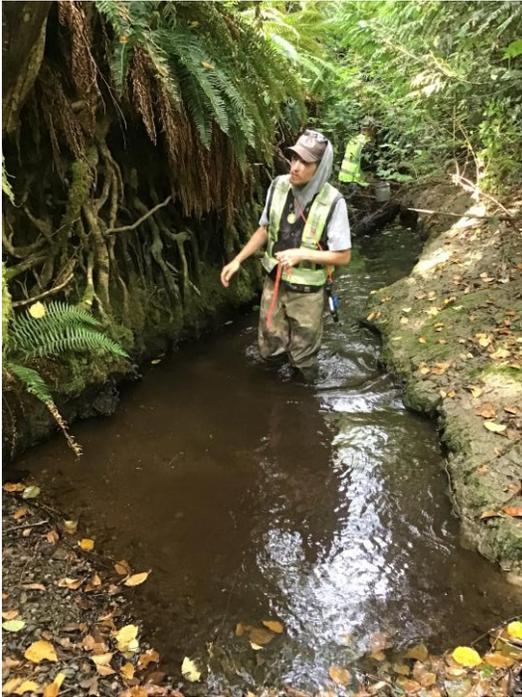
a) Down-cut channel & eroded banks typical of Reach 4 b) Pool with overhanging Vegetation & LWD

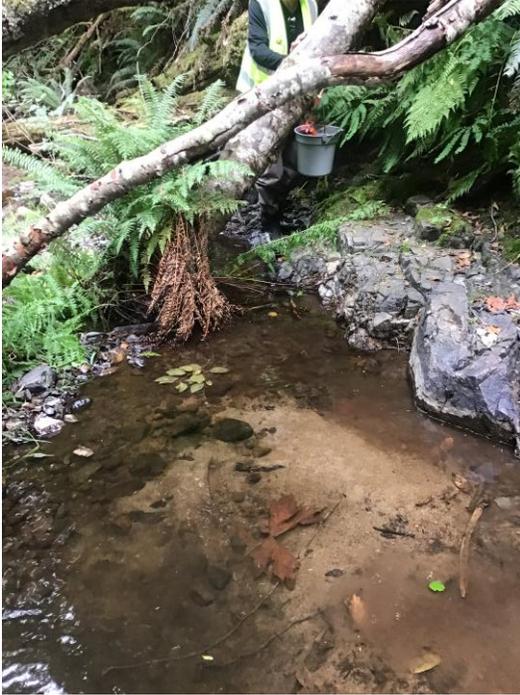
a) Fine sediment deposit at riffle tail-out

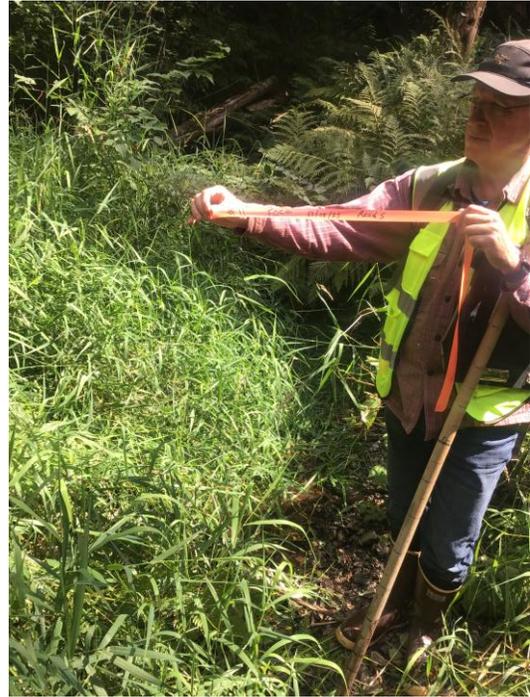
b) Reed canary grass (*Phalaris arundinacea*) on banks

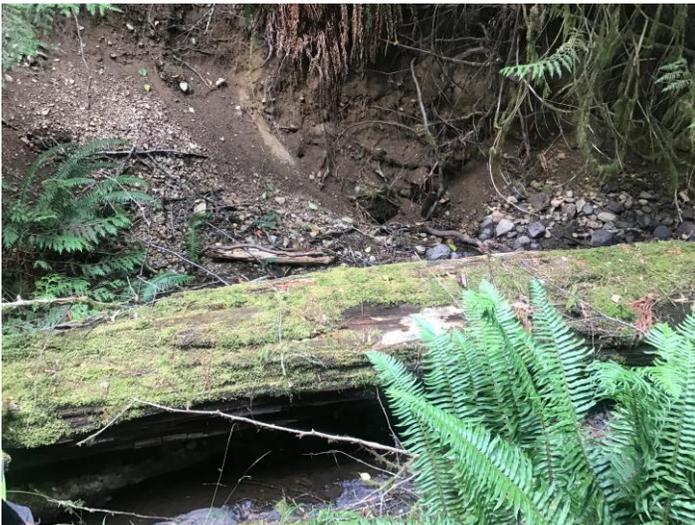
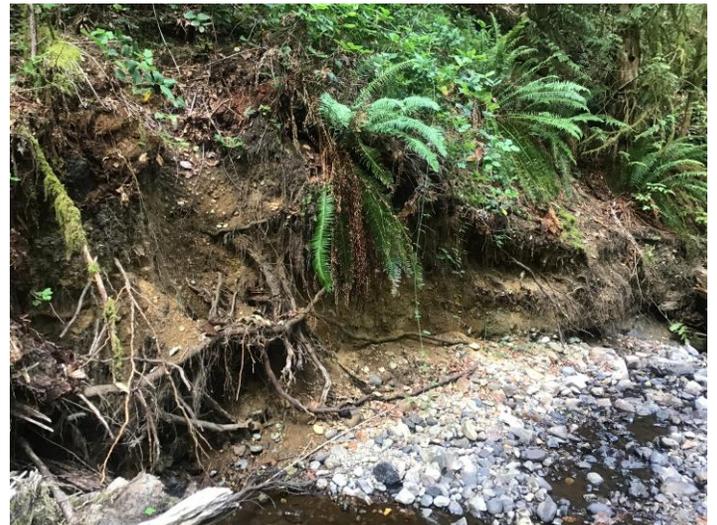
c & d) Areas of significant bank erosion and wasting observed in Reach 5

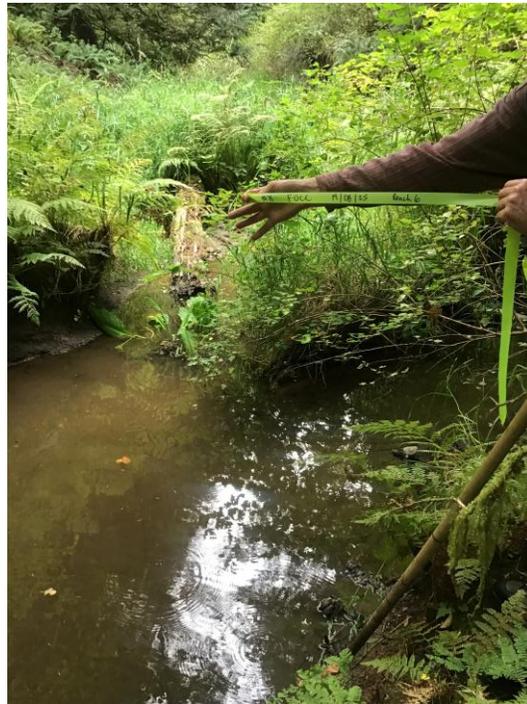
Backwatering by a small beaver dam near USHP placemark 134 (Fig. 16c) has caused the upper half of Reach 6 to be dominated by pool and glide habitat. LWD was the only cover type observed in pools.

c) Backwatered pool above abandoned beaver dam

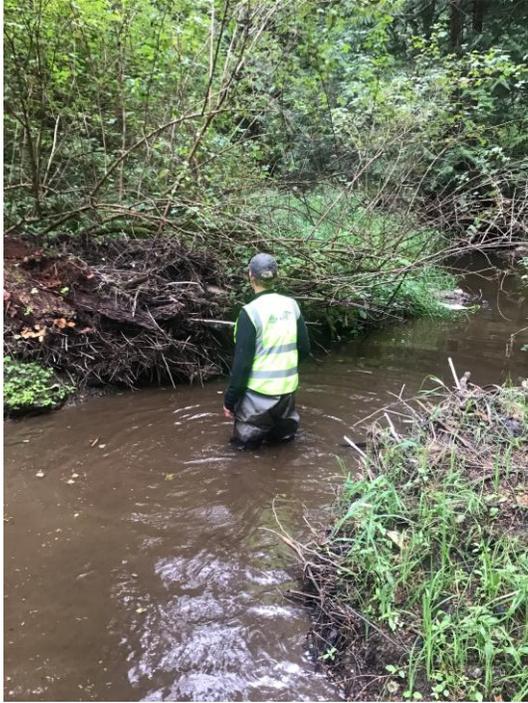
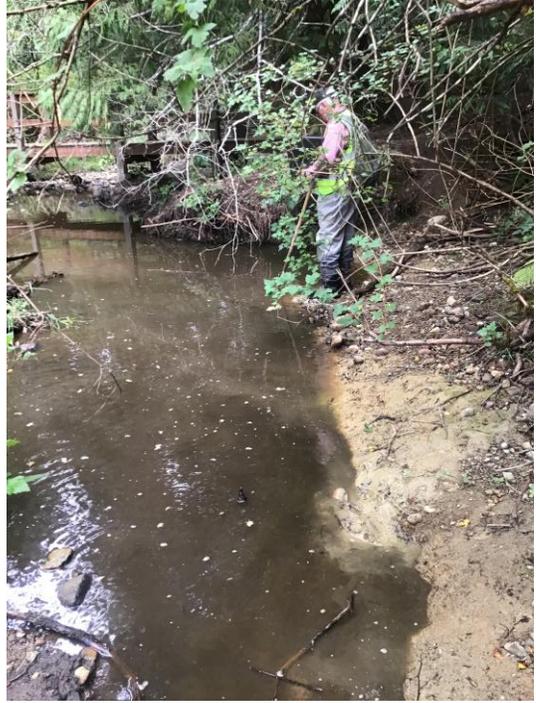
Erosion of the streambanks in this area is significant and flood impacts from the beaver dam breach is still evident. In total, 62 % of the reach's banks were accessible to the public. Reach 6 was the most eroded (40%) reach in the entire survey. Erosion in Reach 6 is tied to both bank access and flood/debris flows. Trail users and their pets have caused significant impacts to riparian conditions near the lake outlet (Figure 16e).

d) Failed beaver dam downstream of lake outlet e) Bank erosion just downstream of lake outlet

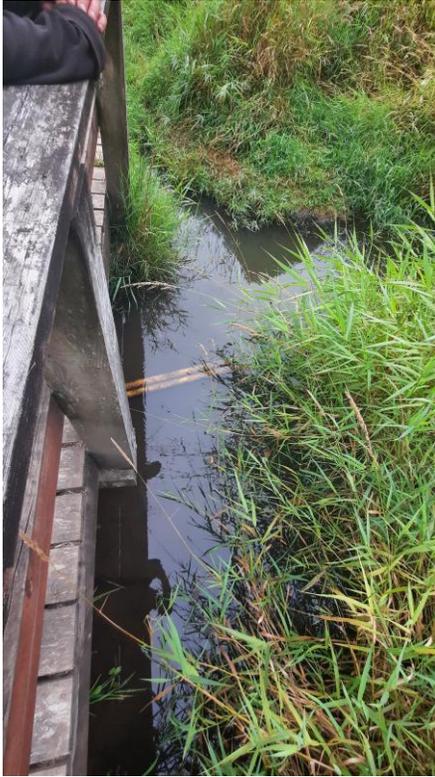
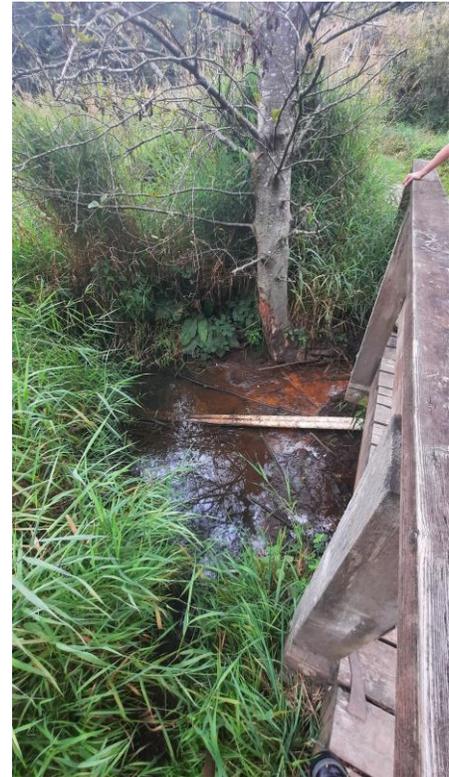
a & b) Upstream and downstream sides of walking trail bridge with beaver dam bypass pipes

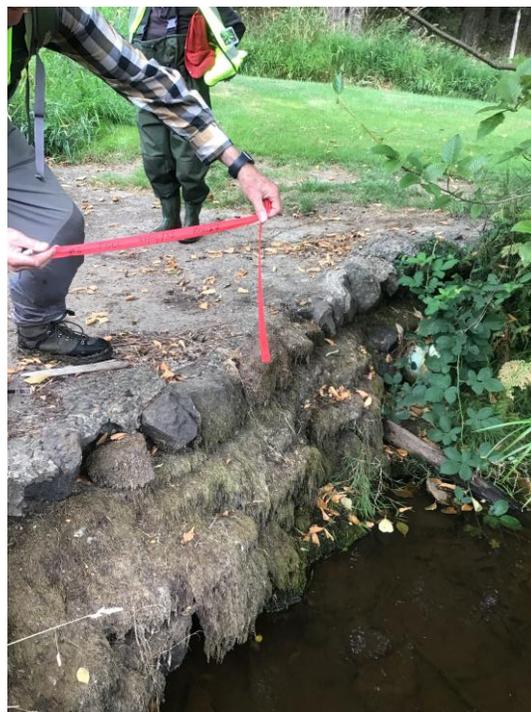
c) Collapsed roadbed on private property

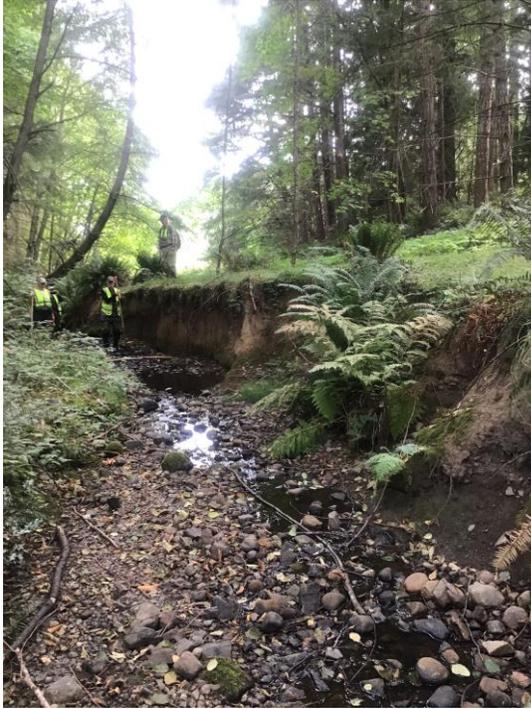
- **Bank Stability:** Bank stability was poor for the majority of the reach. Multiple locations of bank collapse were observed.

d) Down-cutting and erosion that dominates Reach 8

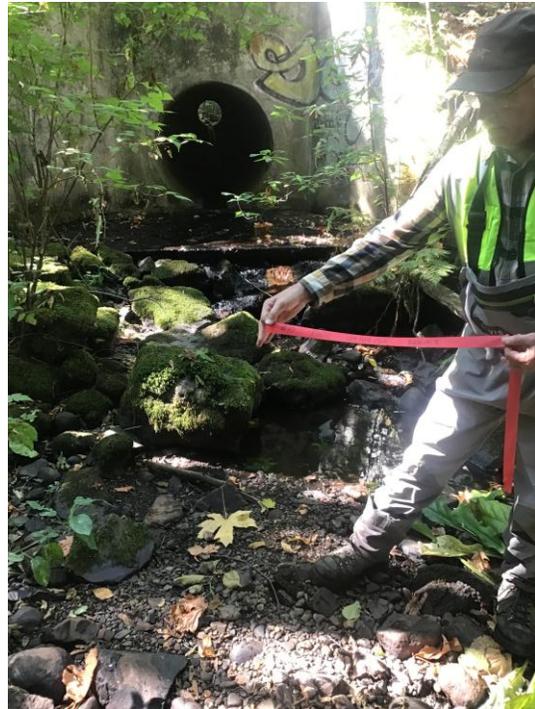
through several large properties running south adjacent to Arrowsmith Road. At Landalt Road, the creek flows into a 20m long x 4m wide culvert that appears impassable to salmonids at this time (P. Law pers. comm., August, 2025).

e) Downstream side of Landalt Road culvert
