**Conservation Evaluation of a Wetland,  
within DL 42, Nanoose Land District,  
South of Qualicum Beach, B.C.**

by Ron Buechert, BSc., ecologist  
for Qualicum Beach Streamkeepers Society

8 October 2002

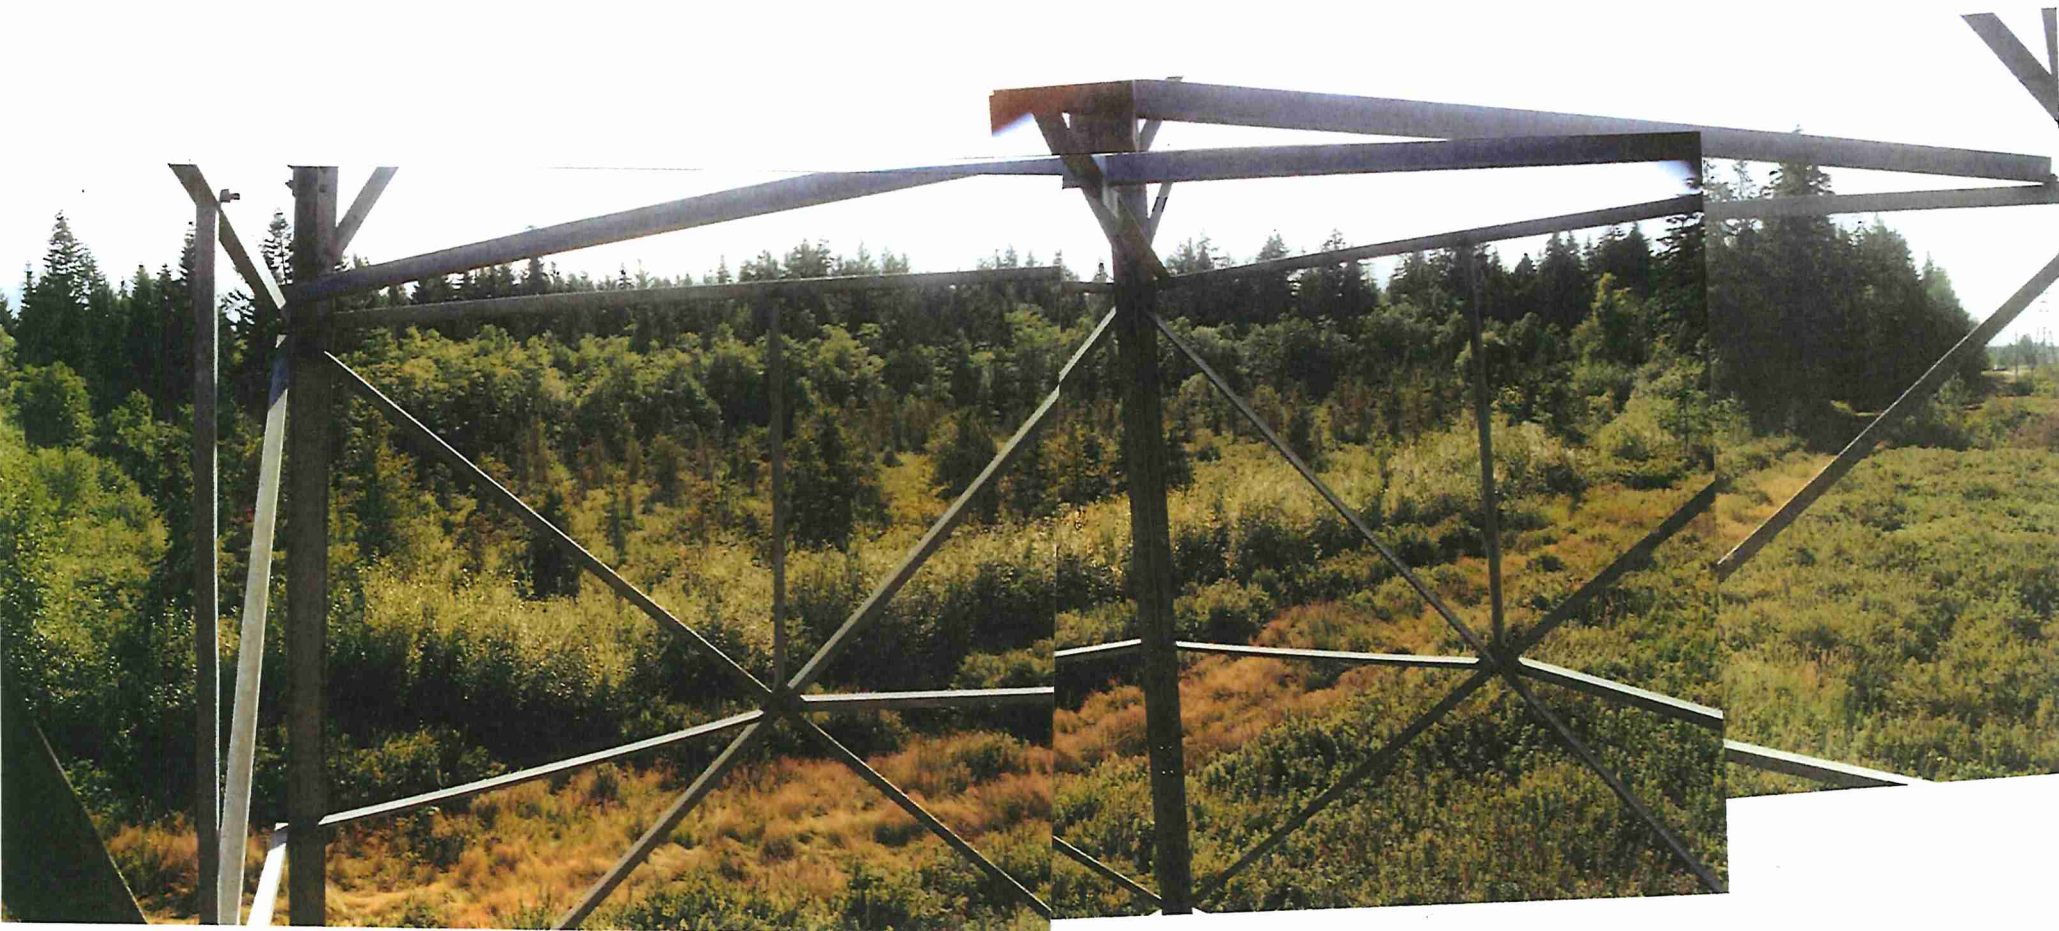
**Figure 1.**  
**Composite photograph of wetland, SEI Polygon N1189, looking southwest. Note shrubs in foreground and riparian forest in background.**
