Community Watershed Monitoring Network 2020 Results by Water Region

Water Region 1
sampled by:
**Fanny Bay Salmonid
Enhancement Society (FBSES)
&
Nile Creek Enhancement Society
(NCES)**

CMMN Water Quality Trend Analysis 2011-2020

WR1: Big Qualicum

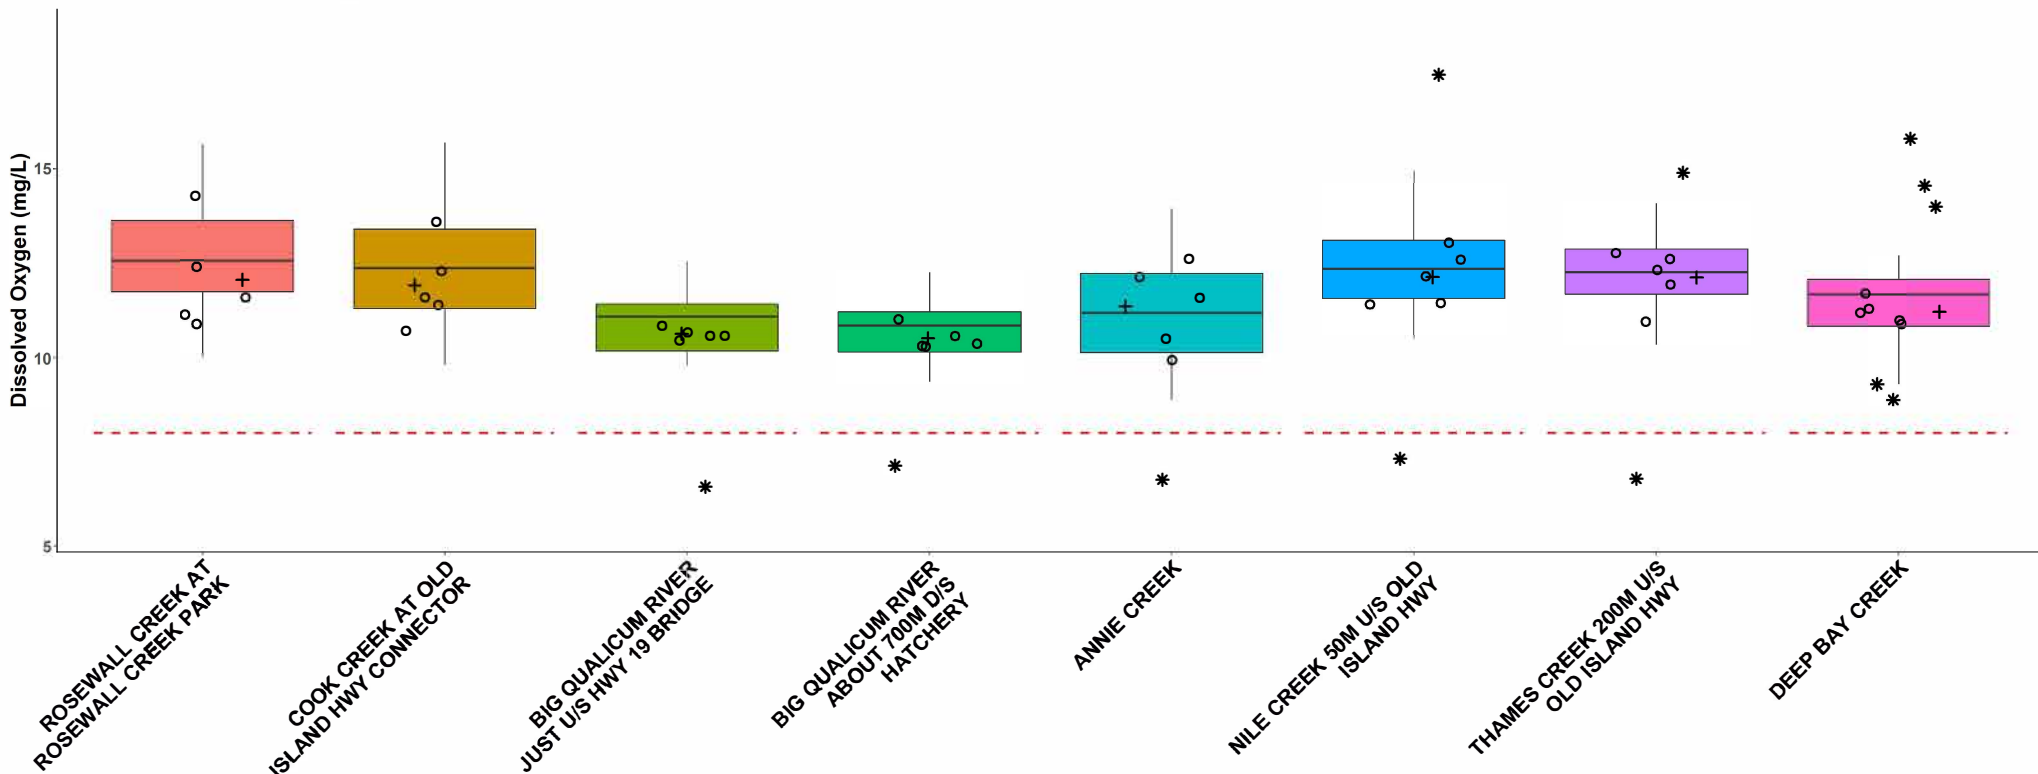
WR1 Fall Dissolved Oxygen

○ 2020 Samples Guideline
 * Outlier 2011-2019 -- 30 Day Average (<8 mg/L)
 + 2020 30 Day Avg - - Instantaneous Minimum (<5 mg/L)

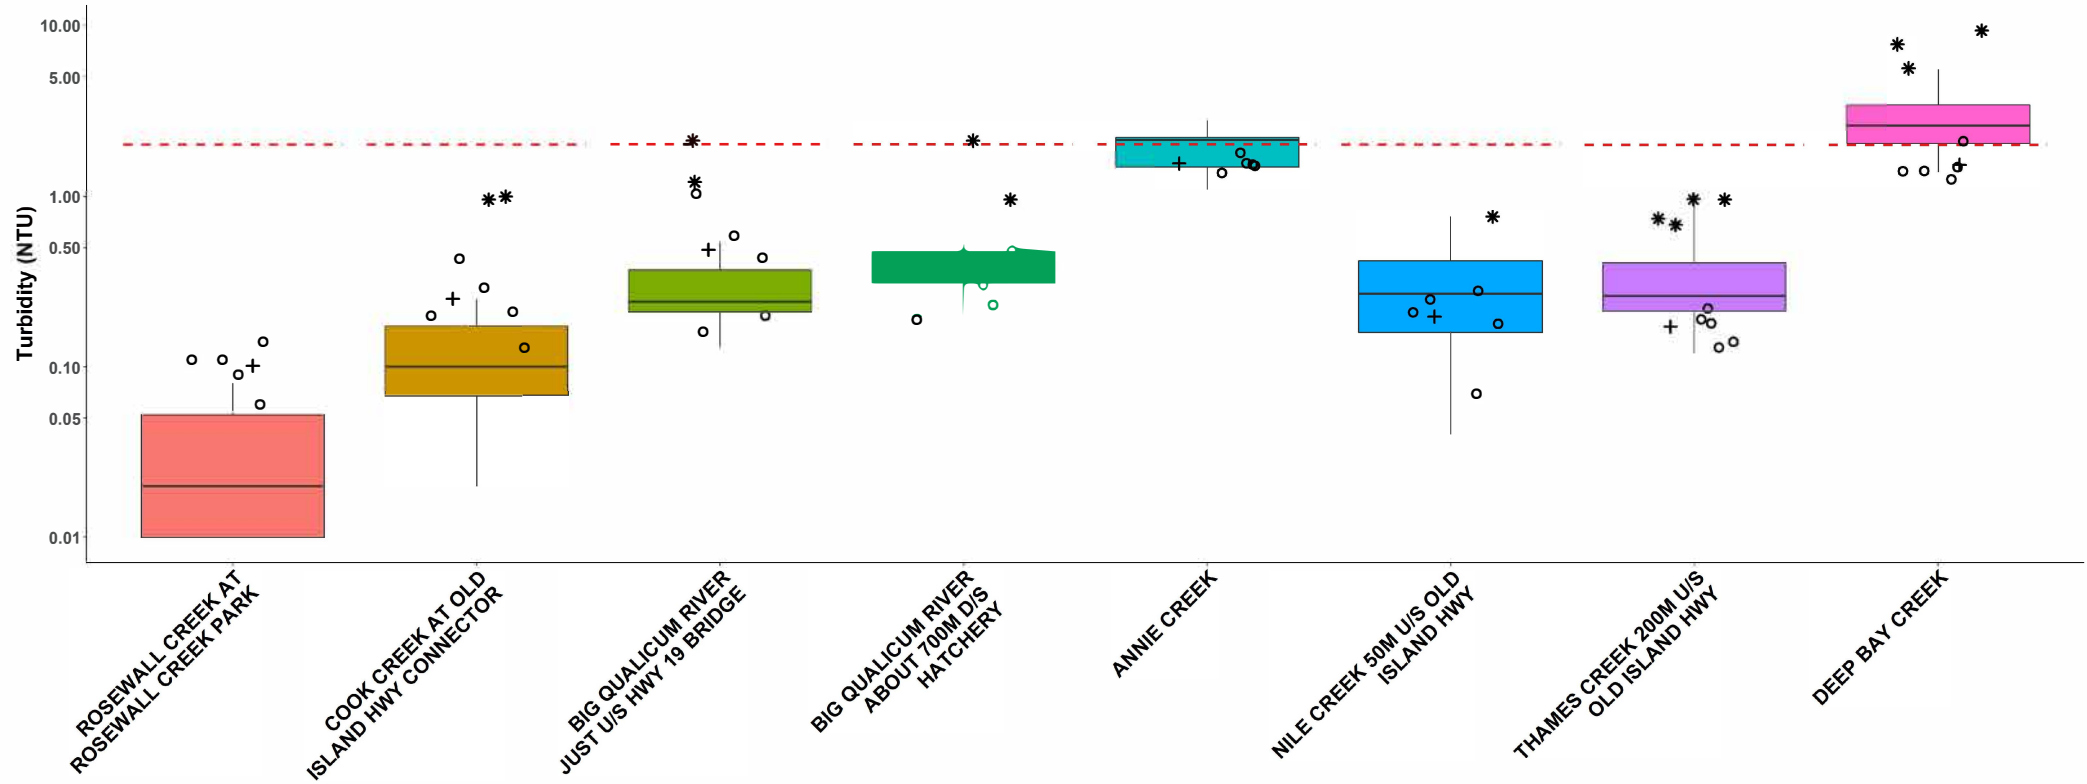
WR1 Summer Turbidity

○ 2020 Samples
 * Outlier 2011-2019
 + 2020 30 Day Avg
 --- Guideline
 --- Jan-Sept Max (2 NTU)

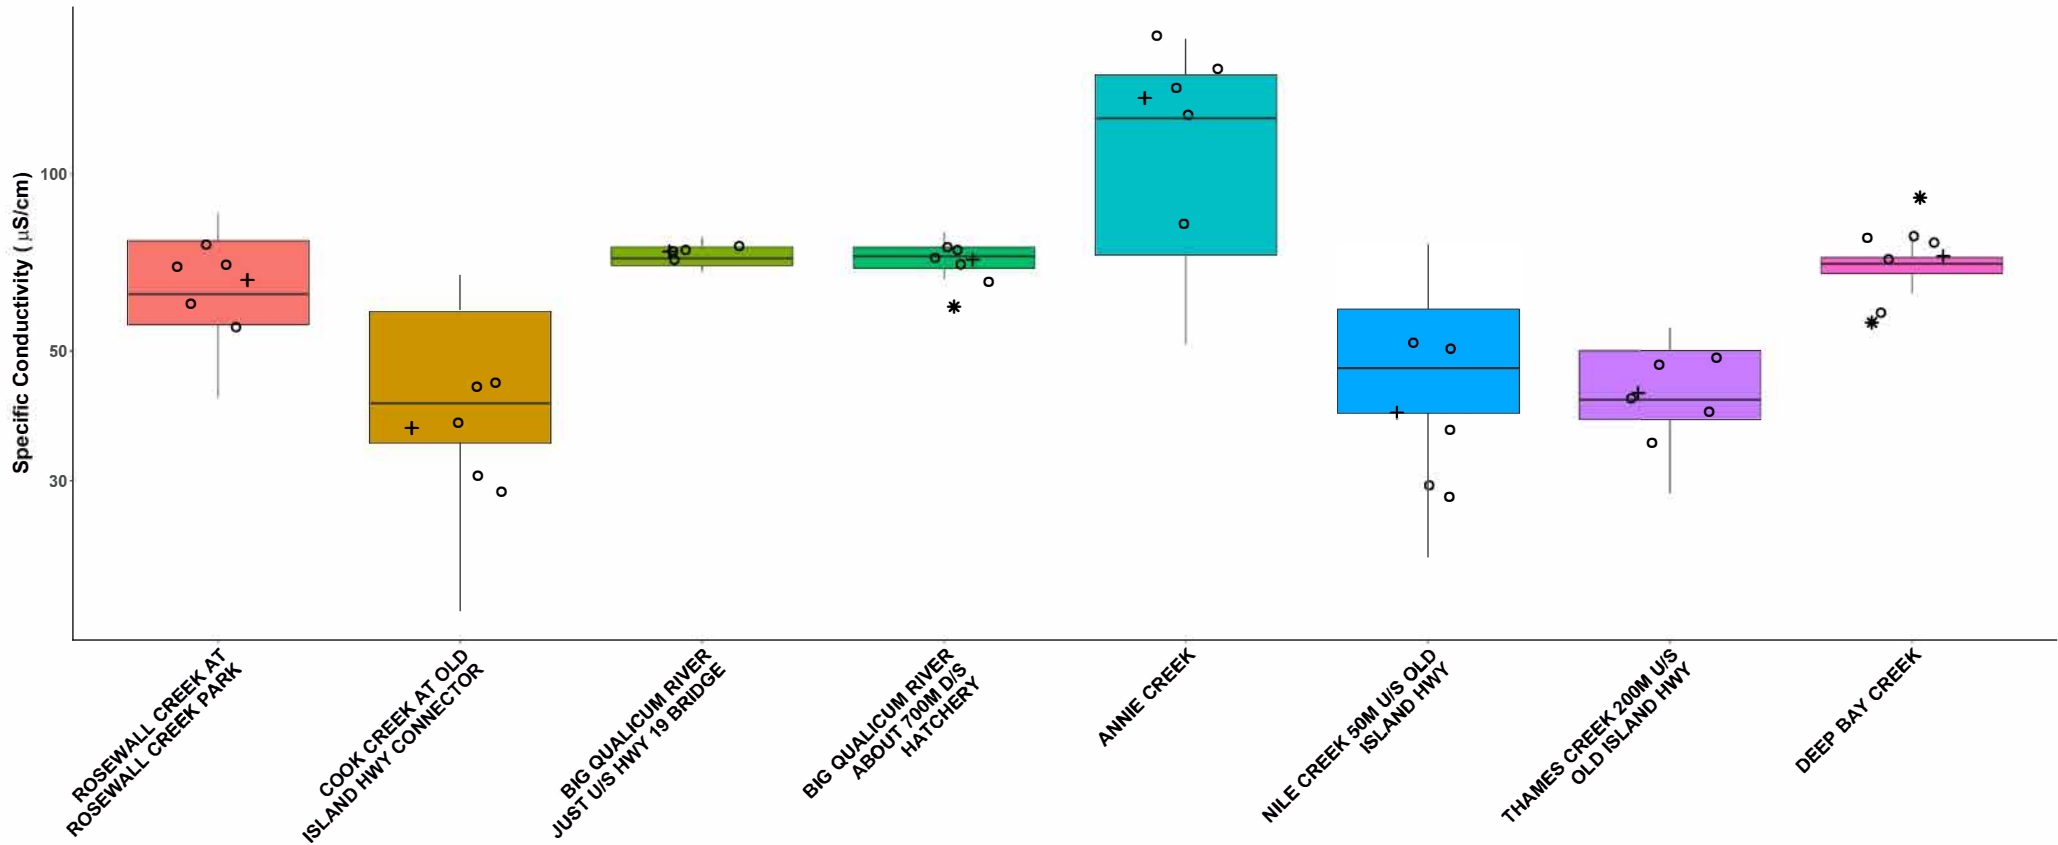
WR1 Fall Conductivity

○ 2020 Samples * Outlier 2011-2019 + 2020 30 Day Avg

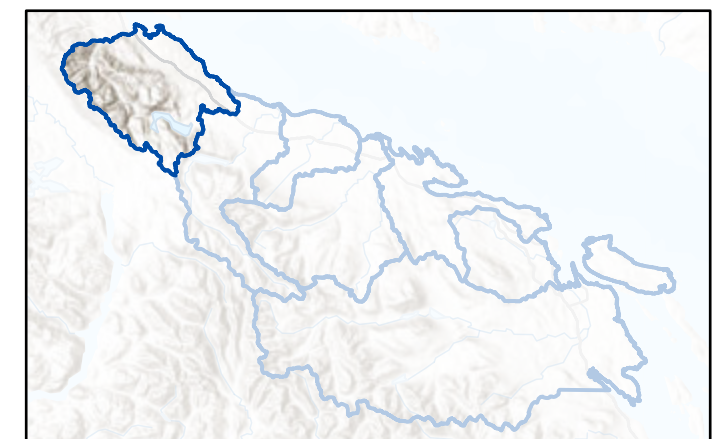
Conductivity can be influenced by factors such as groundwater and ocean spray that are not necessarily indicative of a degrading condition. For simplicity, an increase in conductivity is categorized here as degrading.

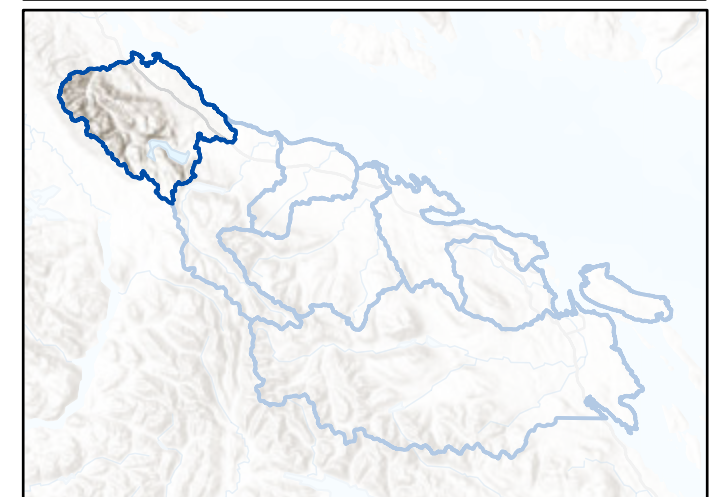
CMMN 2011-2020 Fall Exceedance Assessment

WR1: Big Qualicum

Lake
- Note the exceedance frequency categories are reflective of the number of sample periods with exceedances, not the number or values of the exceedances.*

The summer and fall exceedance frequency maps included in this package express the number of sample periods (summer low-flow / fall flush) with exceedances for each site. There are four frequency categories for the number of sample periods with exceedances: no exceedance recorded (0), low (1 – 2), moderate (3 – 4), and high (5 or more). The exceedance categories are for the three parameters with aquatic water quality guidelines and objectives based on the following thresholds: temperature $\geq 17^{\circ}\text{C}$, dissolved oxygen $\leq 5\text{mg/L}$, summer turbidity $\geq 2\text{NTU}$, and fall turbidity $\geq 5\text{NTU}$.
