# Community Watershed Monitoring Network 2019

## Results by Water Region

## **CWMN Sample Sites in WR 1:**

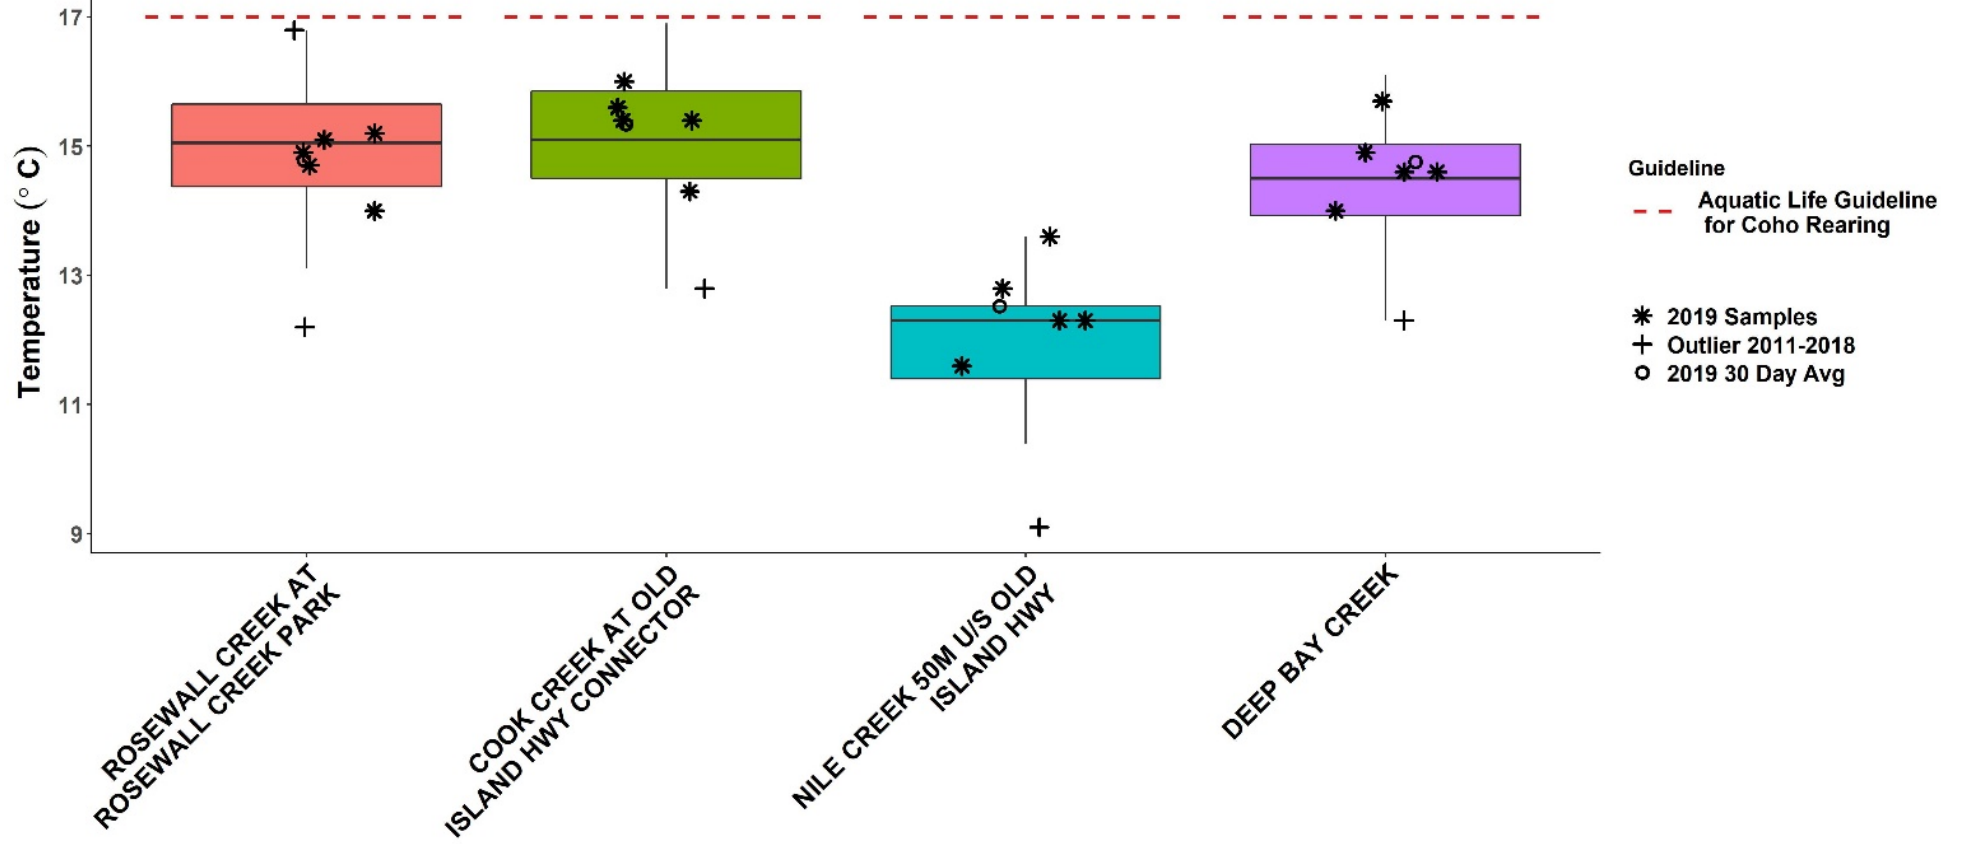
# WR1 Summer Temperature

*Graphs displayed per parameter (Temperature, Dissolved Oxygen, Turbidity, Conductivity) per sample period (summer and fall)*
