# NANAIMO RIVER WATERSHED WILD SALMON POLICY FISH HABITAT STATUS REPORT

November 24, 2021

MC Wright and Associates Ltd.  
2231 Neil Drive  
Nanaimo, BC  
V9R 6T5  
Tel. 250-753-1055  
[www.mcwrightonline.com](http://www.mcwrightonline.com)

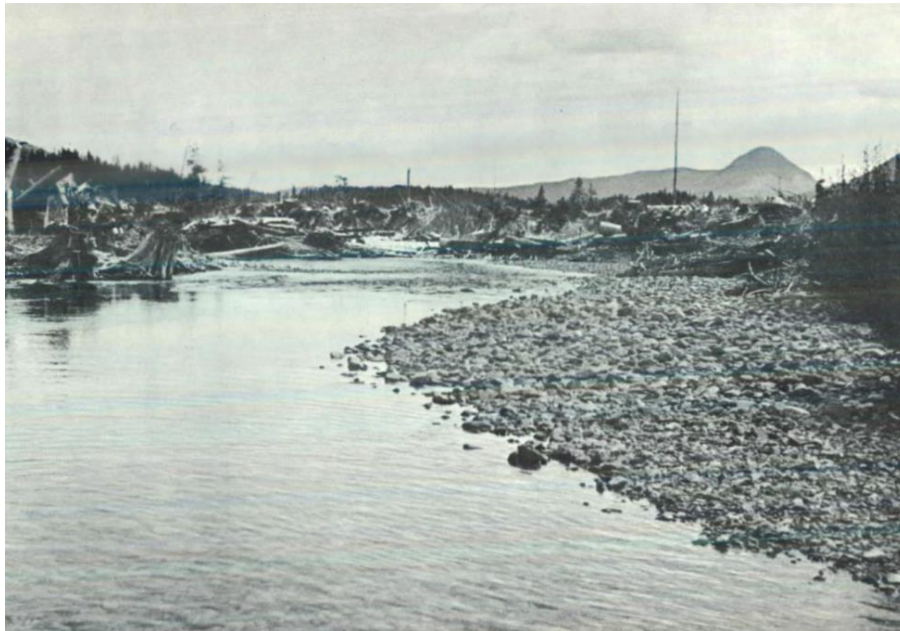
**Figure 2. Looking downstream Jump Creek, a tributary to the South Nanaimo River, in May 1970 (photo taken from Narver 1972).**

MacMillan Bloedel Ltd. opened the pulp mill at Harmac in 1950 and as coal was depleted in the 1950s, the economy became dependent on the forestry industry (Bell and Kallman 1976). The Nanaimo River watershed has been logged since the late 1800s and by the 1970s was largely comprised of second growth forest (Bell and Kallman 1976). First Lake was historically used for log booming (Figure 1). Historical clear-cut logging and burning eliminated riparian forest, increased erosion and sedimentation in the river and its tributaries, altered stream flow and channel morphology, and increased stream temperatures, all of which adversely impacted fish habitat and decreased fish production (as reviewed by Bell and Kallman 1976). For instance, in one of the first studies of the impacts of logging on BC streams, Narver (1972) found the number of trout in Jump Creek, a tributary to the South Nanaimo River, was twice as high in a forested section as in a recently clearcut and burned section. The logged section had a highly unstable channel with eroded banks, fewer pools, and very few remaining undercut banks with overhanging vegetation due to removal of all riparian vegetation (Figure 2). The impacted stream section was also ~2°C warmer than the forested section.

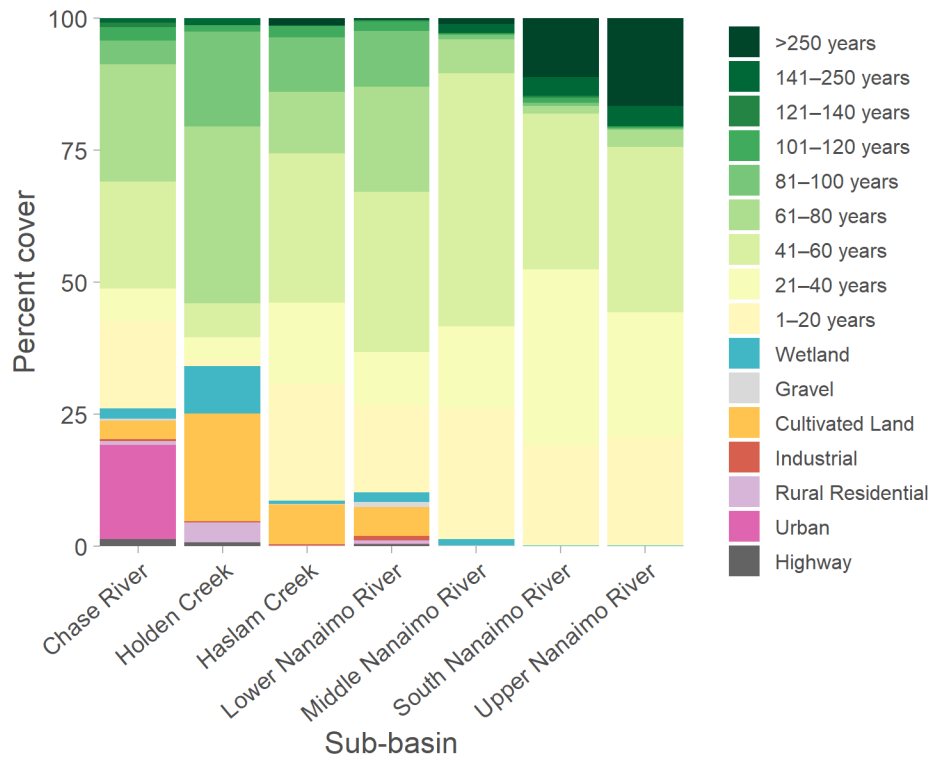
**Figure 10. Percent cover of land cover types in the Nanaimo River watershed sub-basins and the Chase and Holden Creek sub-basins, excluding lakes and typically unvegetated land (i.e., bedrock, alpine areas, and avalanche chutes).**

The sub-basins of the Nanaimo River watershed, as well as the Chase River and Holden Creek watersheds, which drain into the Nanaimo River estuary, have experienced near complete land cover alteration (Map 4). Only 0.55%, 2.8%, and 1.4% of what would have historically been vegetated land or wetland (i.e., excluding alpine areas and avalanche chutes) in the Lower Nanaimo River, Middle Nanaimo River, and Haslam Creek sub-basins, respectively, is unaltered (Figure 10). The mountain zones of the South and Upper Nanaimo River still contain old growth forest, covering 15% and 20% of what would have historically been vegetated land or wetland. The remaining forested land is covered by early regenerating forest: 41%, 30%, 41%, 53%, and 44% of forest in the Haslam Creek, and Lower, Middle, South, Upper Nanaimo River sub-basins is under 40 years old, respectively.

comprise a low of 7.4% of the Lower Nanaimo River, up to 23.8% of the Chase River sub-basin and 25% of the Holden Creek sub-basin (Figure 10).

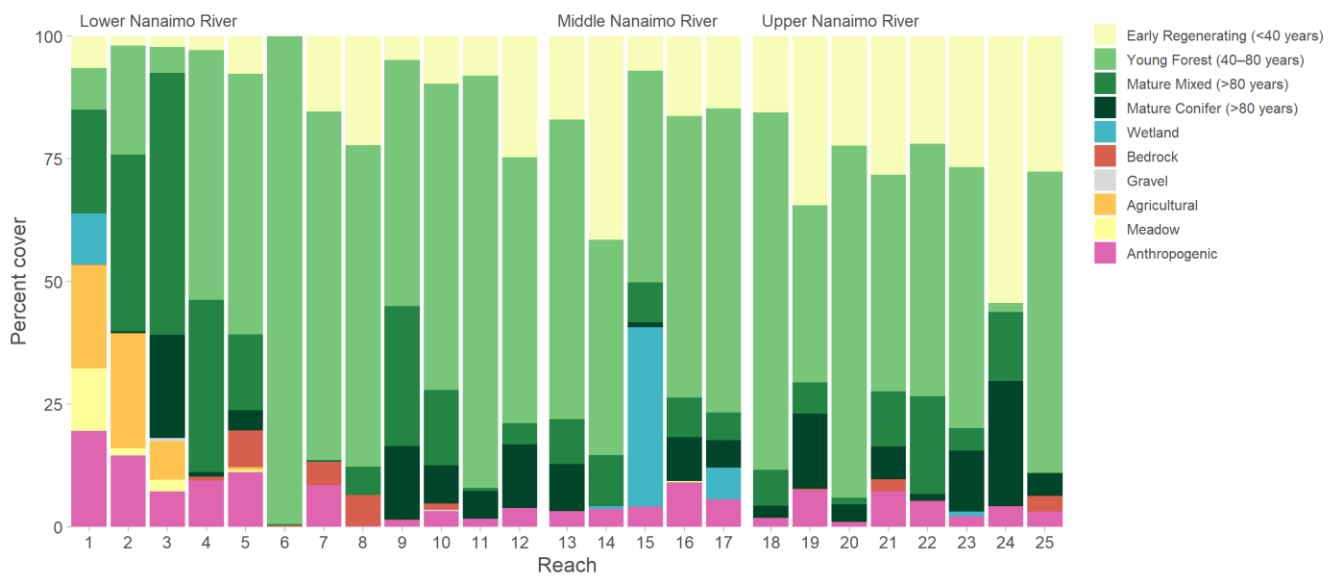
**Figure 13. Riparian vegetation types along the Lower, Middle, and Upper Nanaimo River, within 30 m and 100 m of the stream banks.**

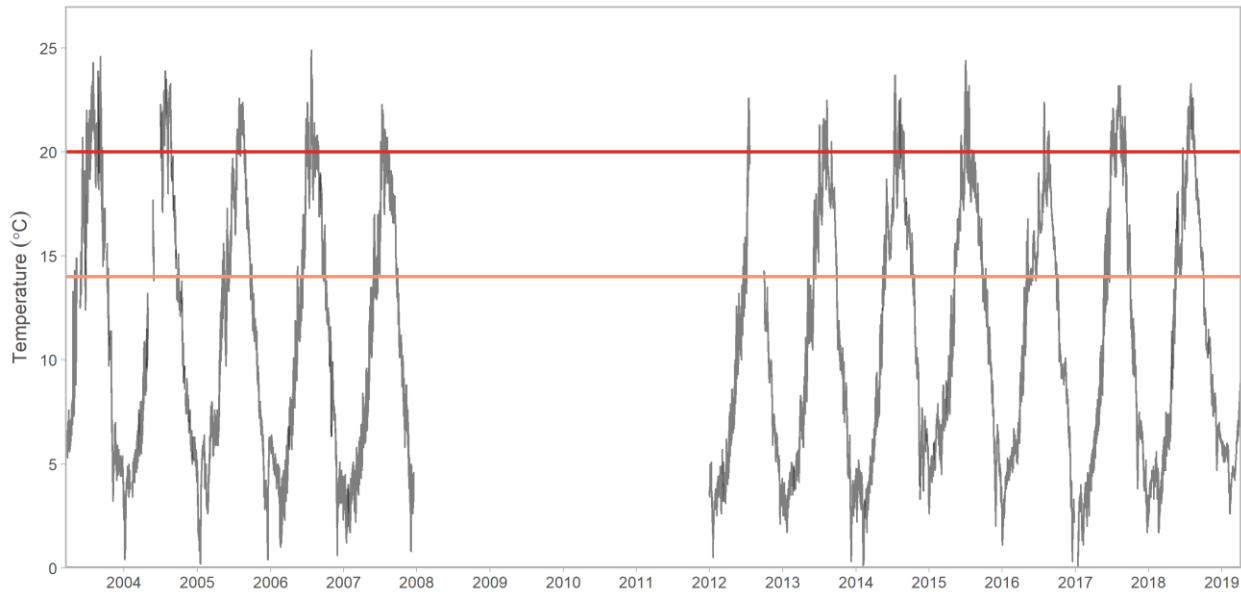
**Figure 18. Nanaimo River hourly water temperatures from Water Survey of Canada station 08HB034. The orange and red lines indicate the 14°C maximum daily Upper Optimum Temperature and 20°C Impairment Temperatures, respectively, for in-migrating Chinook and Coho Salmon (Stalberg et al. 2009).**

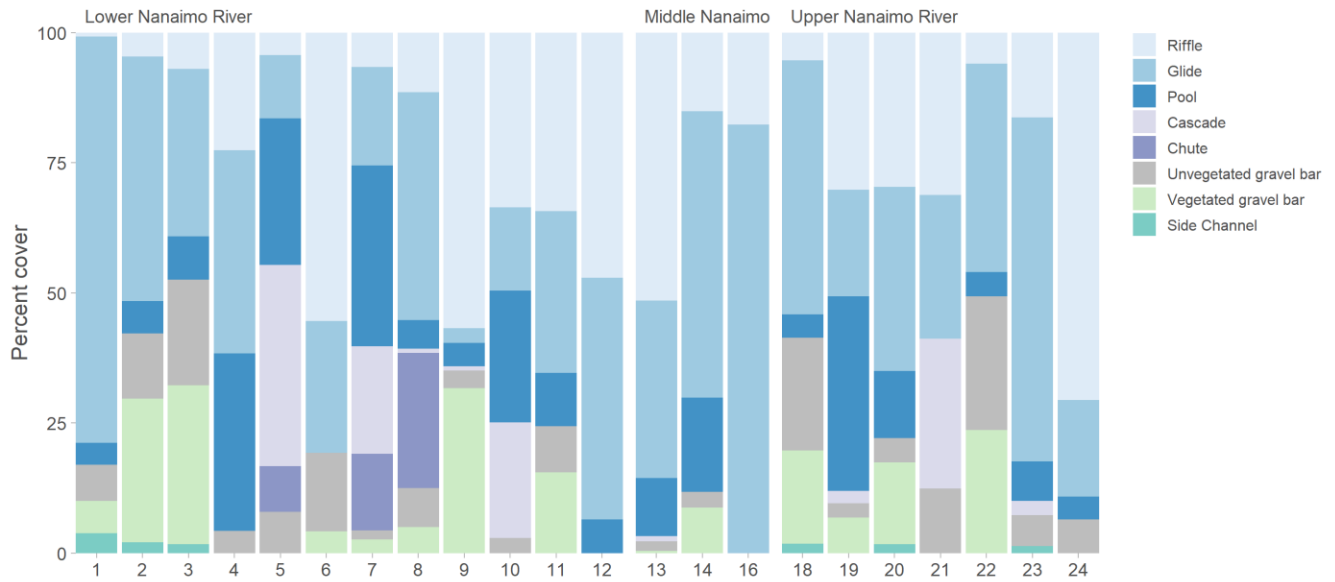
**Figure 23. Mesohabitat types in the Lower, Middle, and Upper Nanaimo River.**
