# Regional District of Nanaimo Biosolids Management Program

## TimberWest Properties Surface Water Quality Report 2017-2018

February 2019

SYLVIS DOCUMENT #1211-19

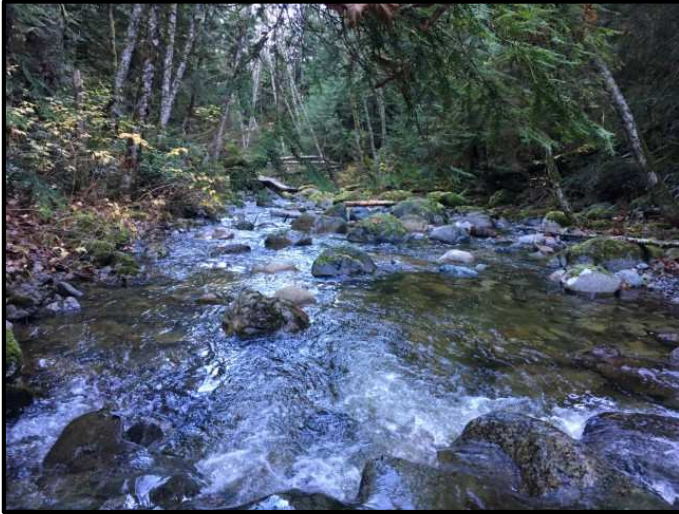
Benson Creek, the control sample location, flows north along the eastern edge of the TimberWest Properties. Biosolids fertilization does not occur upstream from the sampling location, although some logging activity does. Benson Creek and its sampling point are depicted in Figure 1, Appendix Two, and Photograph 1, Appendix Three.

**Photograph 1:** Benson  
Creek sampling location.  
(November 2018)

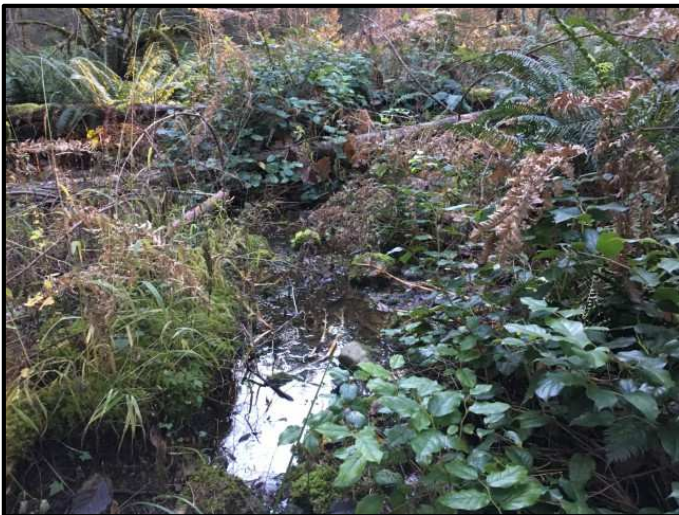
flows into Benson Creek before draining into Brannen Lake. No surface water diversion permits are in effect along Flynfall or Benson Creeks. Flynfall Creek and its sampling points are depicted in Figure 1, Appendix Two, and Photograph 2 and Photograph 3, Appendix Three.

**Photograph 2:** Upper Flynfall  
Creek sampling location.  
(November 2018)

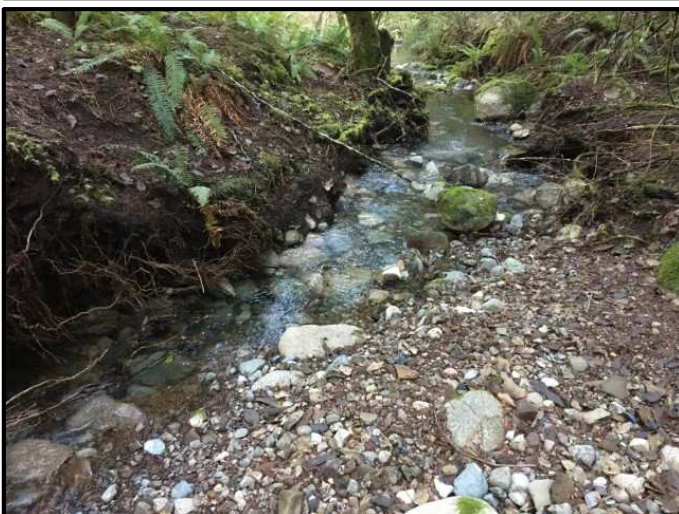
**Photograph 3:** Lower Flynfall  
Creek sampling location.  
(November 2018)

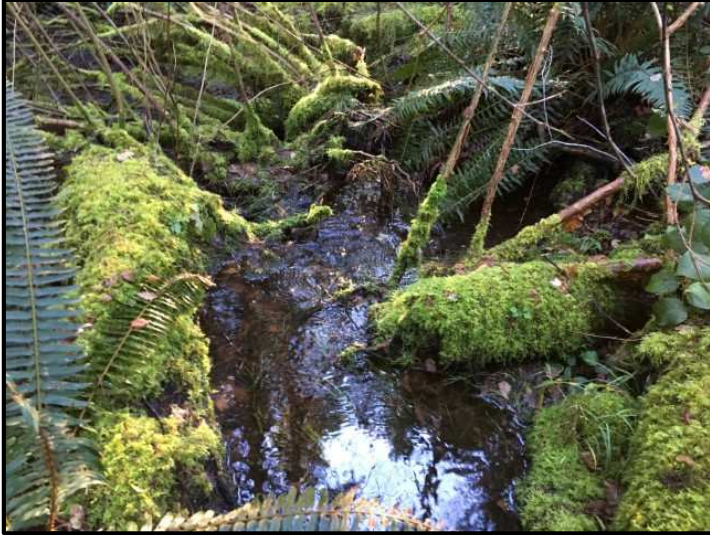
Caillet Creek drains the northern portion of the TimberWest Properties. The creek originates from roughly the center of the northern third of the TimberWest Properties and generally flows eastward parallel to Weigles Road. Upstream samples were taken at the location of suitable flow nearest to the headwaters and downstream samples were taken downstream of the entire biosolids application area. Caillet Creek flows into Brannen Lake. No surface water diversion permits are in effect along the length of the creek. Caillet Creek and its sampling points are depicted in Figure 1, Appendix Two, and Photograph 4 and Photograph 5, Appendix Three.

**Photograph 4:** Upper Caillet Creek sampling location. (November 2018)

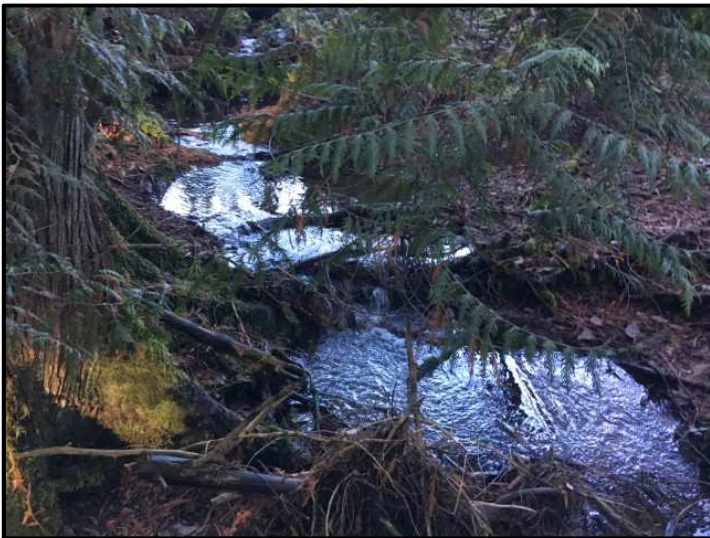
**Photograph 5:** Lower Caillet Creek sampling location. (November 2018)

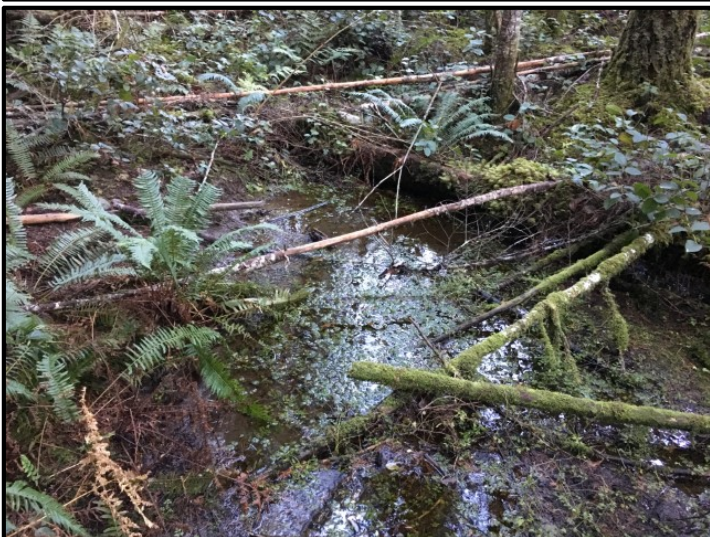
Bonnell Creek drains a small portion of the TimberWest Properties to the west. The creek originates from an area of high elevation which serves as the headwaters to Bonnell and Flynfall Creeks and generally flows westward out of the TimberWest Properties. Upstream samples were taken at the outflow of the headwaters and downstream samples were taken before the next tributary flows into the creek. Bonnell Creek flows off the TimberWest Properties and then turns north, eventually draining into Nanoose Bay; no known surface water diversion permits are in effect along the creek. Bonnell Creek and its sampling points are depicted in Figure 1, Appendix Two, and Photograph 6 and Photograph 7, Appendix Three.

**Photograph 6:** Upper Bonnell Creek sampling location. (November 2018)

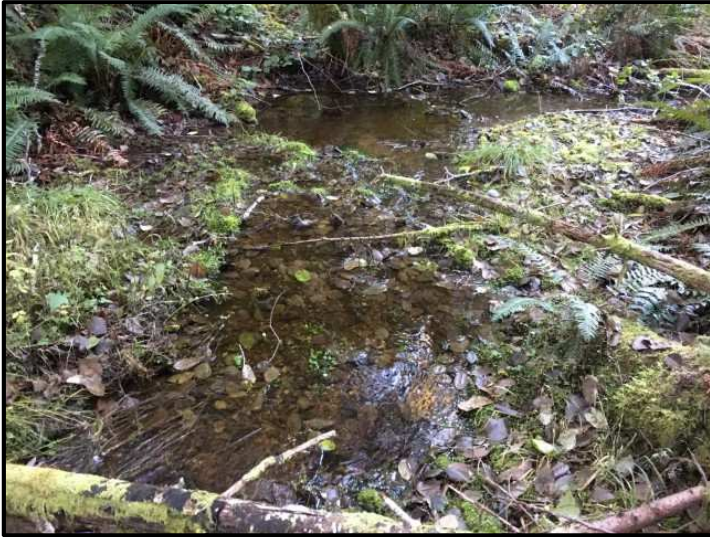
**Photograph 7:** Lower Bonnell Creek sampling location. (November 2018)

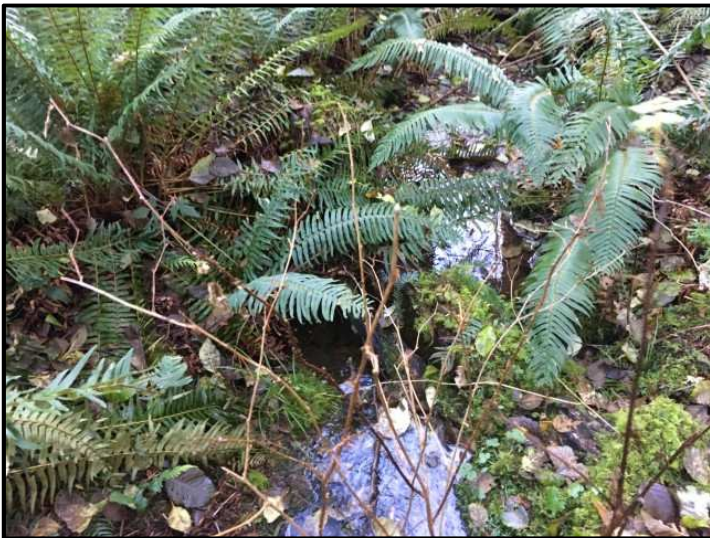
points are depicted in Figure 1, Appendix Two, and Photograph 8 and Photograph 9, Appendix Three.

**Photograph 8:** Upper W1500 Creek sampling location. (November 2018)

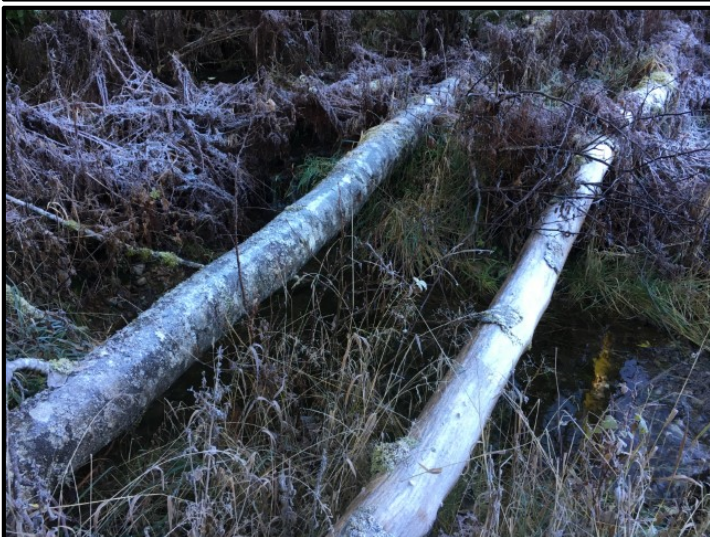
**Photograph 9:** Lower W1500 Creek sampling location. (November 2018)
