Community Watershed Monitoring Network 2020

Results by Water Region

CWMN Sample Sites in WR 5-2:

WR5-2: South Wellington to Nanoose

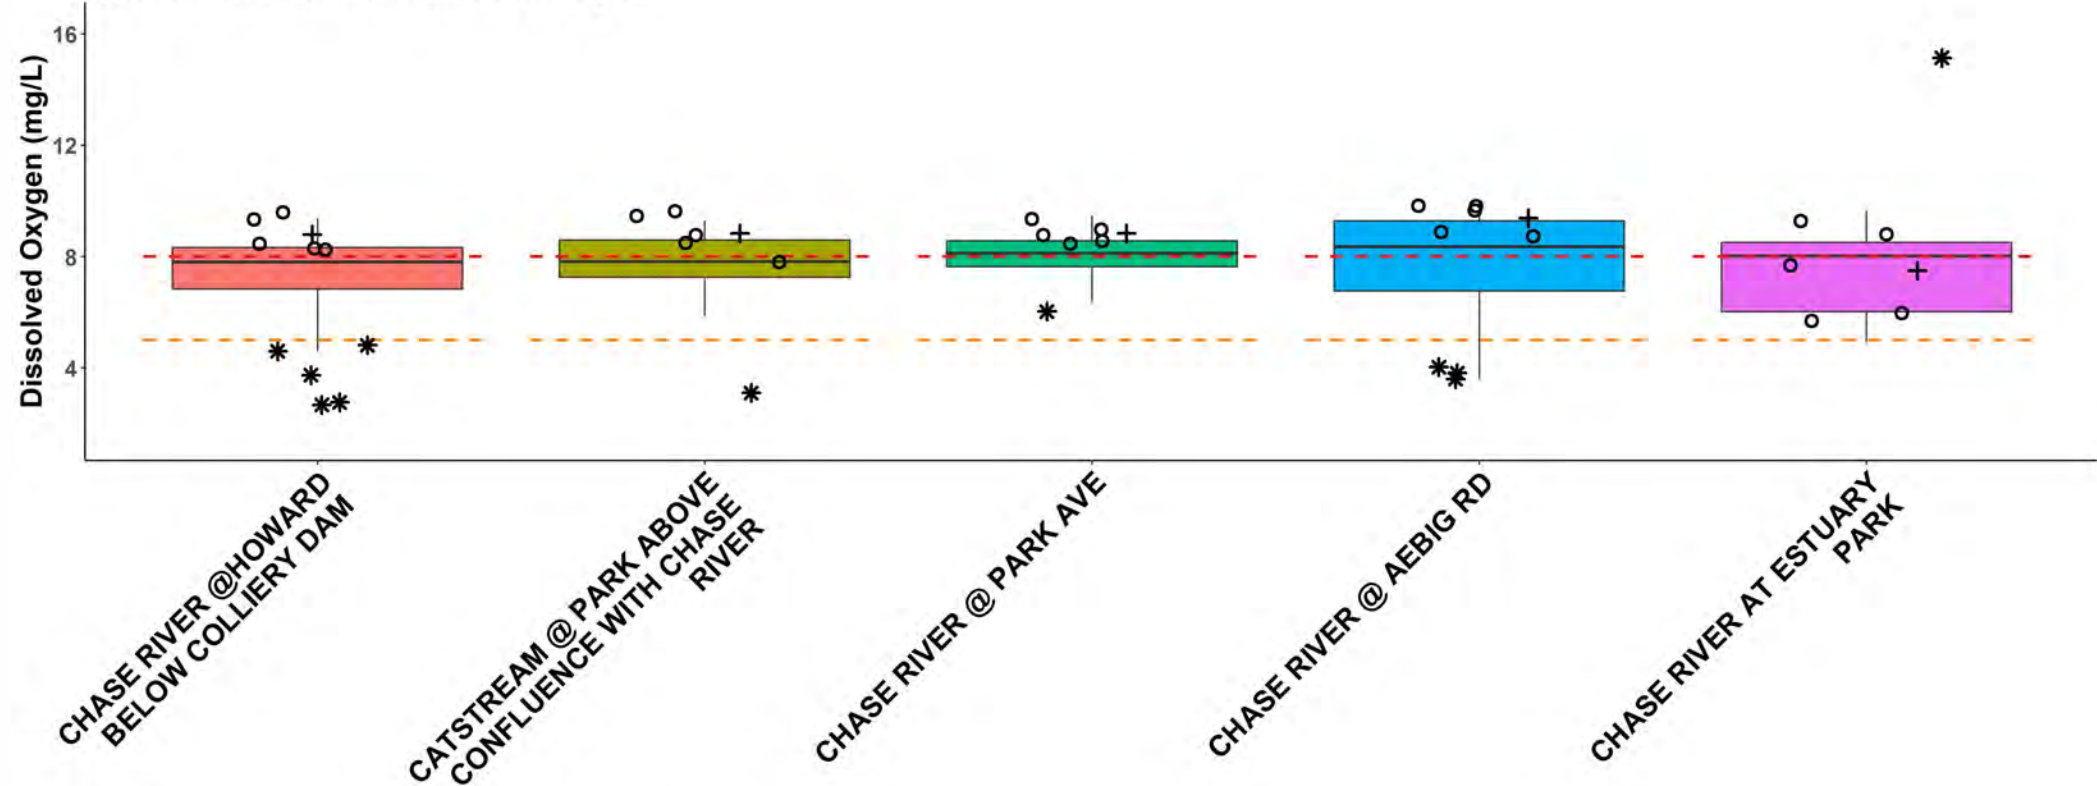
WR5-2b Summer Dissolved Oxygen

- 2020 Samples
 - * Outlier 2012-2019
 - + 2020 30 Day Avg
- Guideline**
- 30 Day Average (<8 mg/L)
 - Instantaneous Minimum (<5 mg/L)

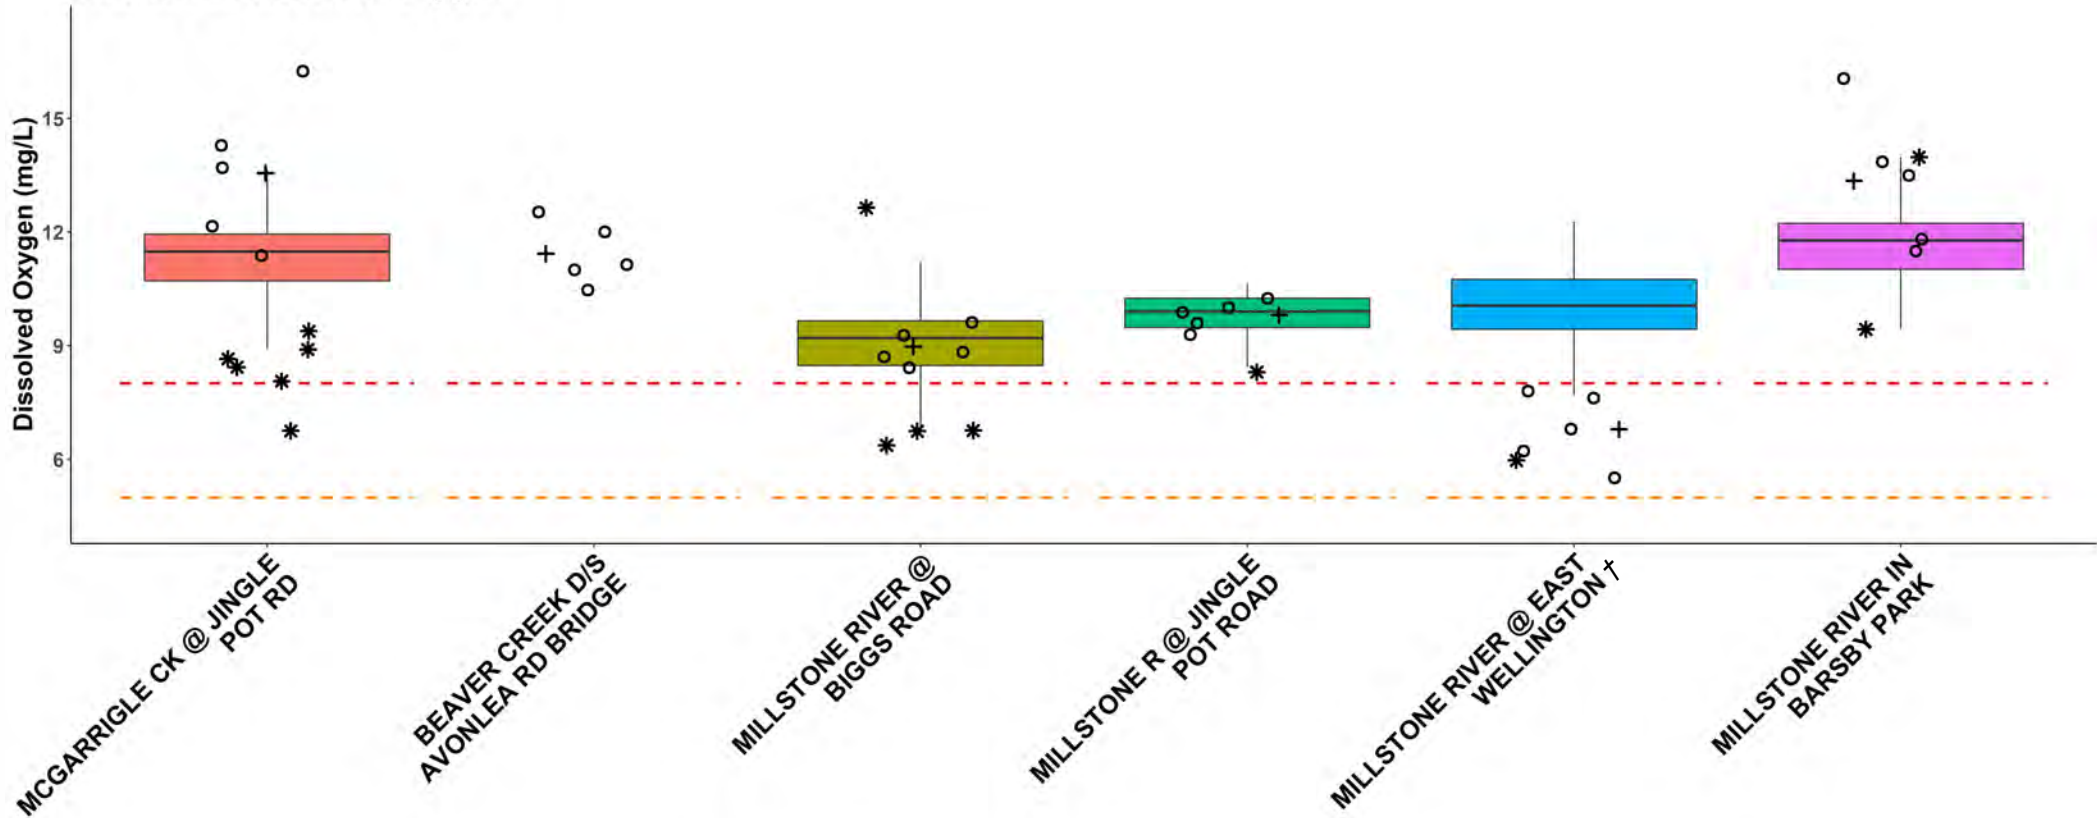
WR5-2a Fall Dissolved Oxygen

- 2020 Samples
- * Outlier 2012-2019
- + 2020 30 Day Avg
- Guideline
- - 30 Day Average (<8 mg/L)
- - Instantaneous Minimum (<5 mg/L)

†Fall 2020 data for Millstone River at East Wellington was entered into the Environmental Monitoring System (EMS) database incorrectly prior to graph production, it has been corrected in the EMS database and the 2021 CWMN Data Analysis (2011 - 2020) Report.

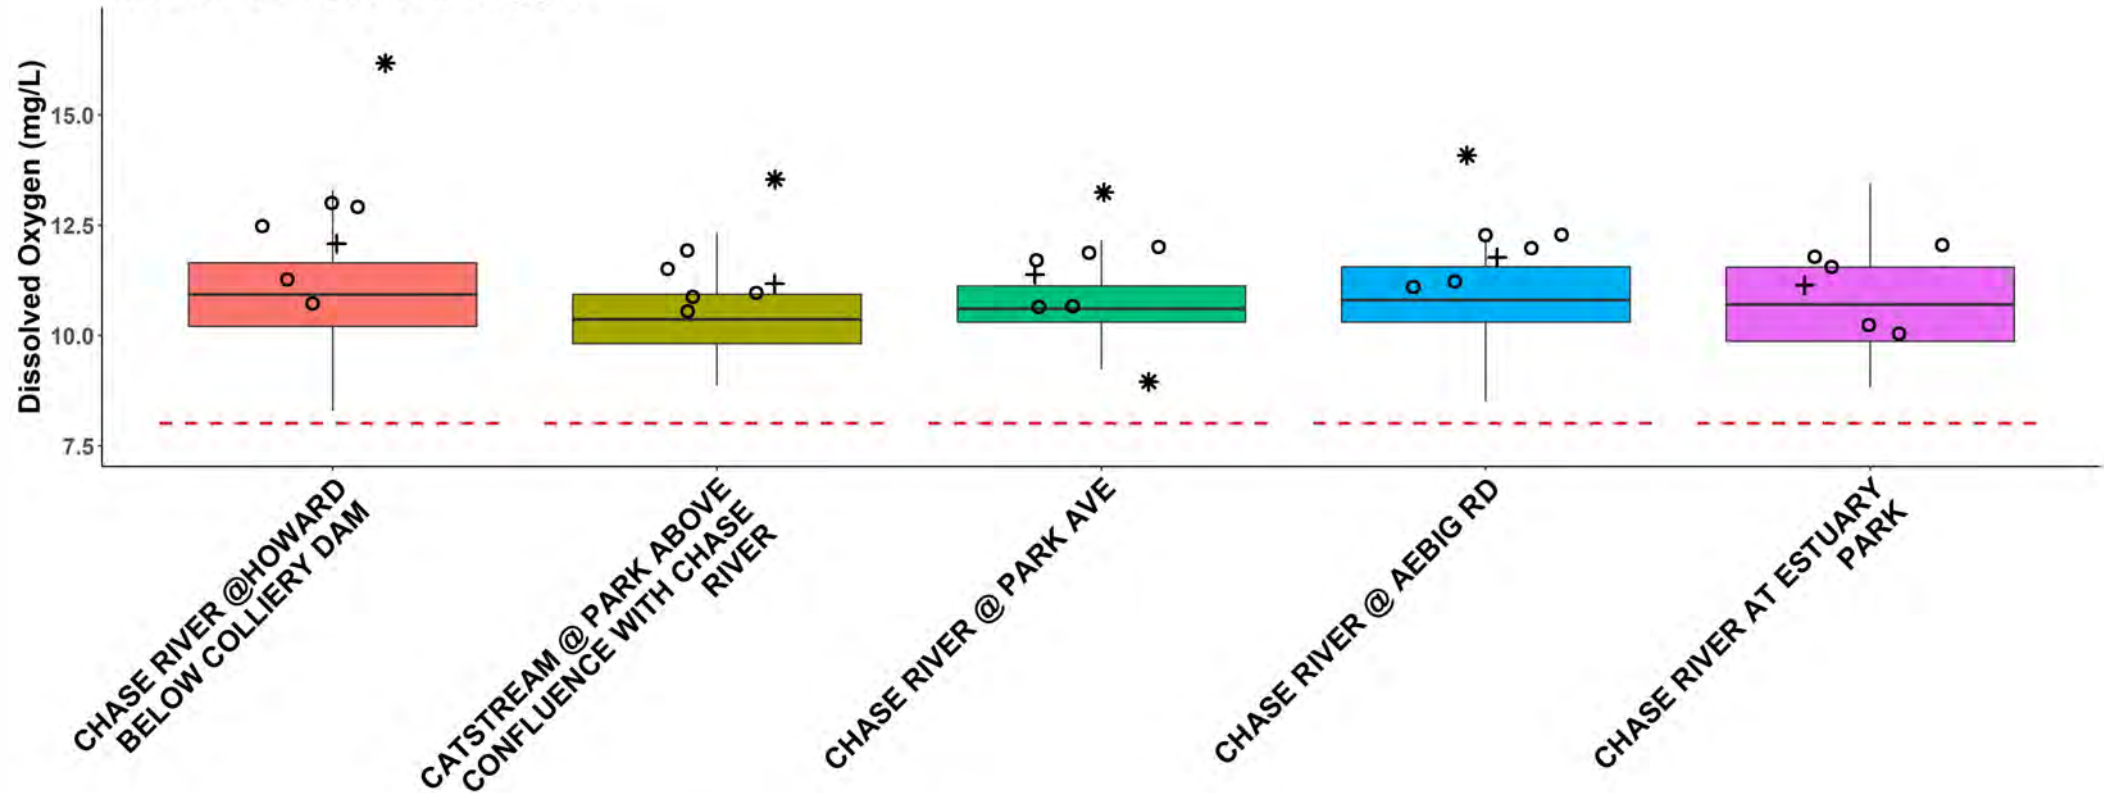
WR5-2b Fall Dissolved Oxygen

○ 2020 Samples
 * Outlier 2012-2019
 + 2020 30 Day Avg
 --- Guideline
 - - - 30 Day Average (<8 mg/L)
 - - - Instantaneous Minimum (<5 mg/L)

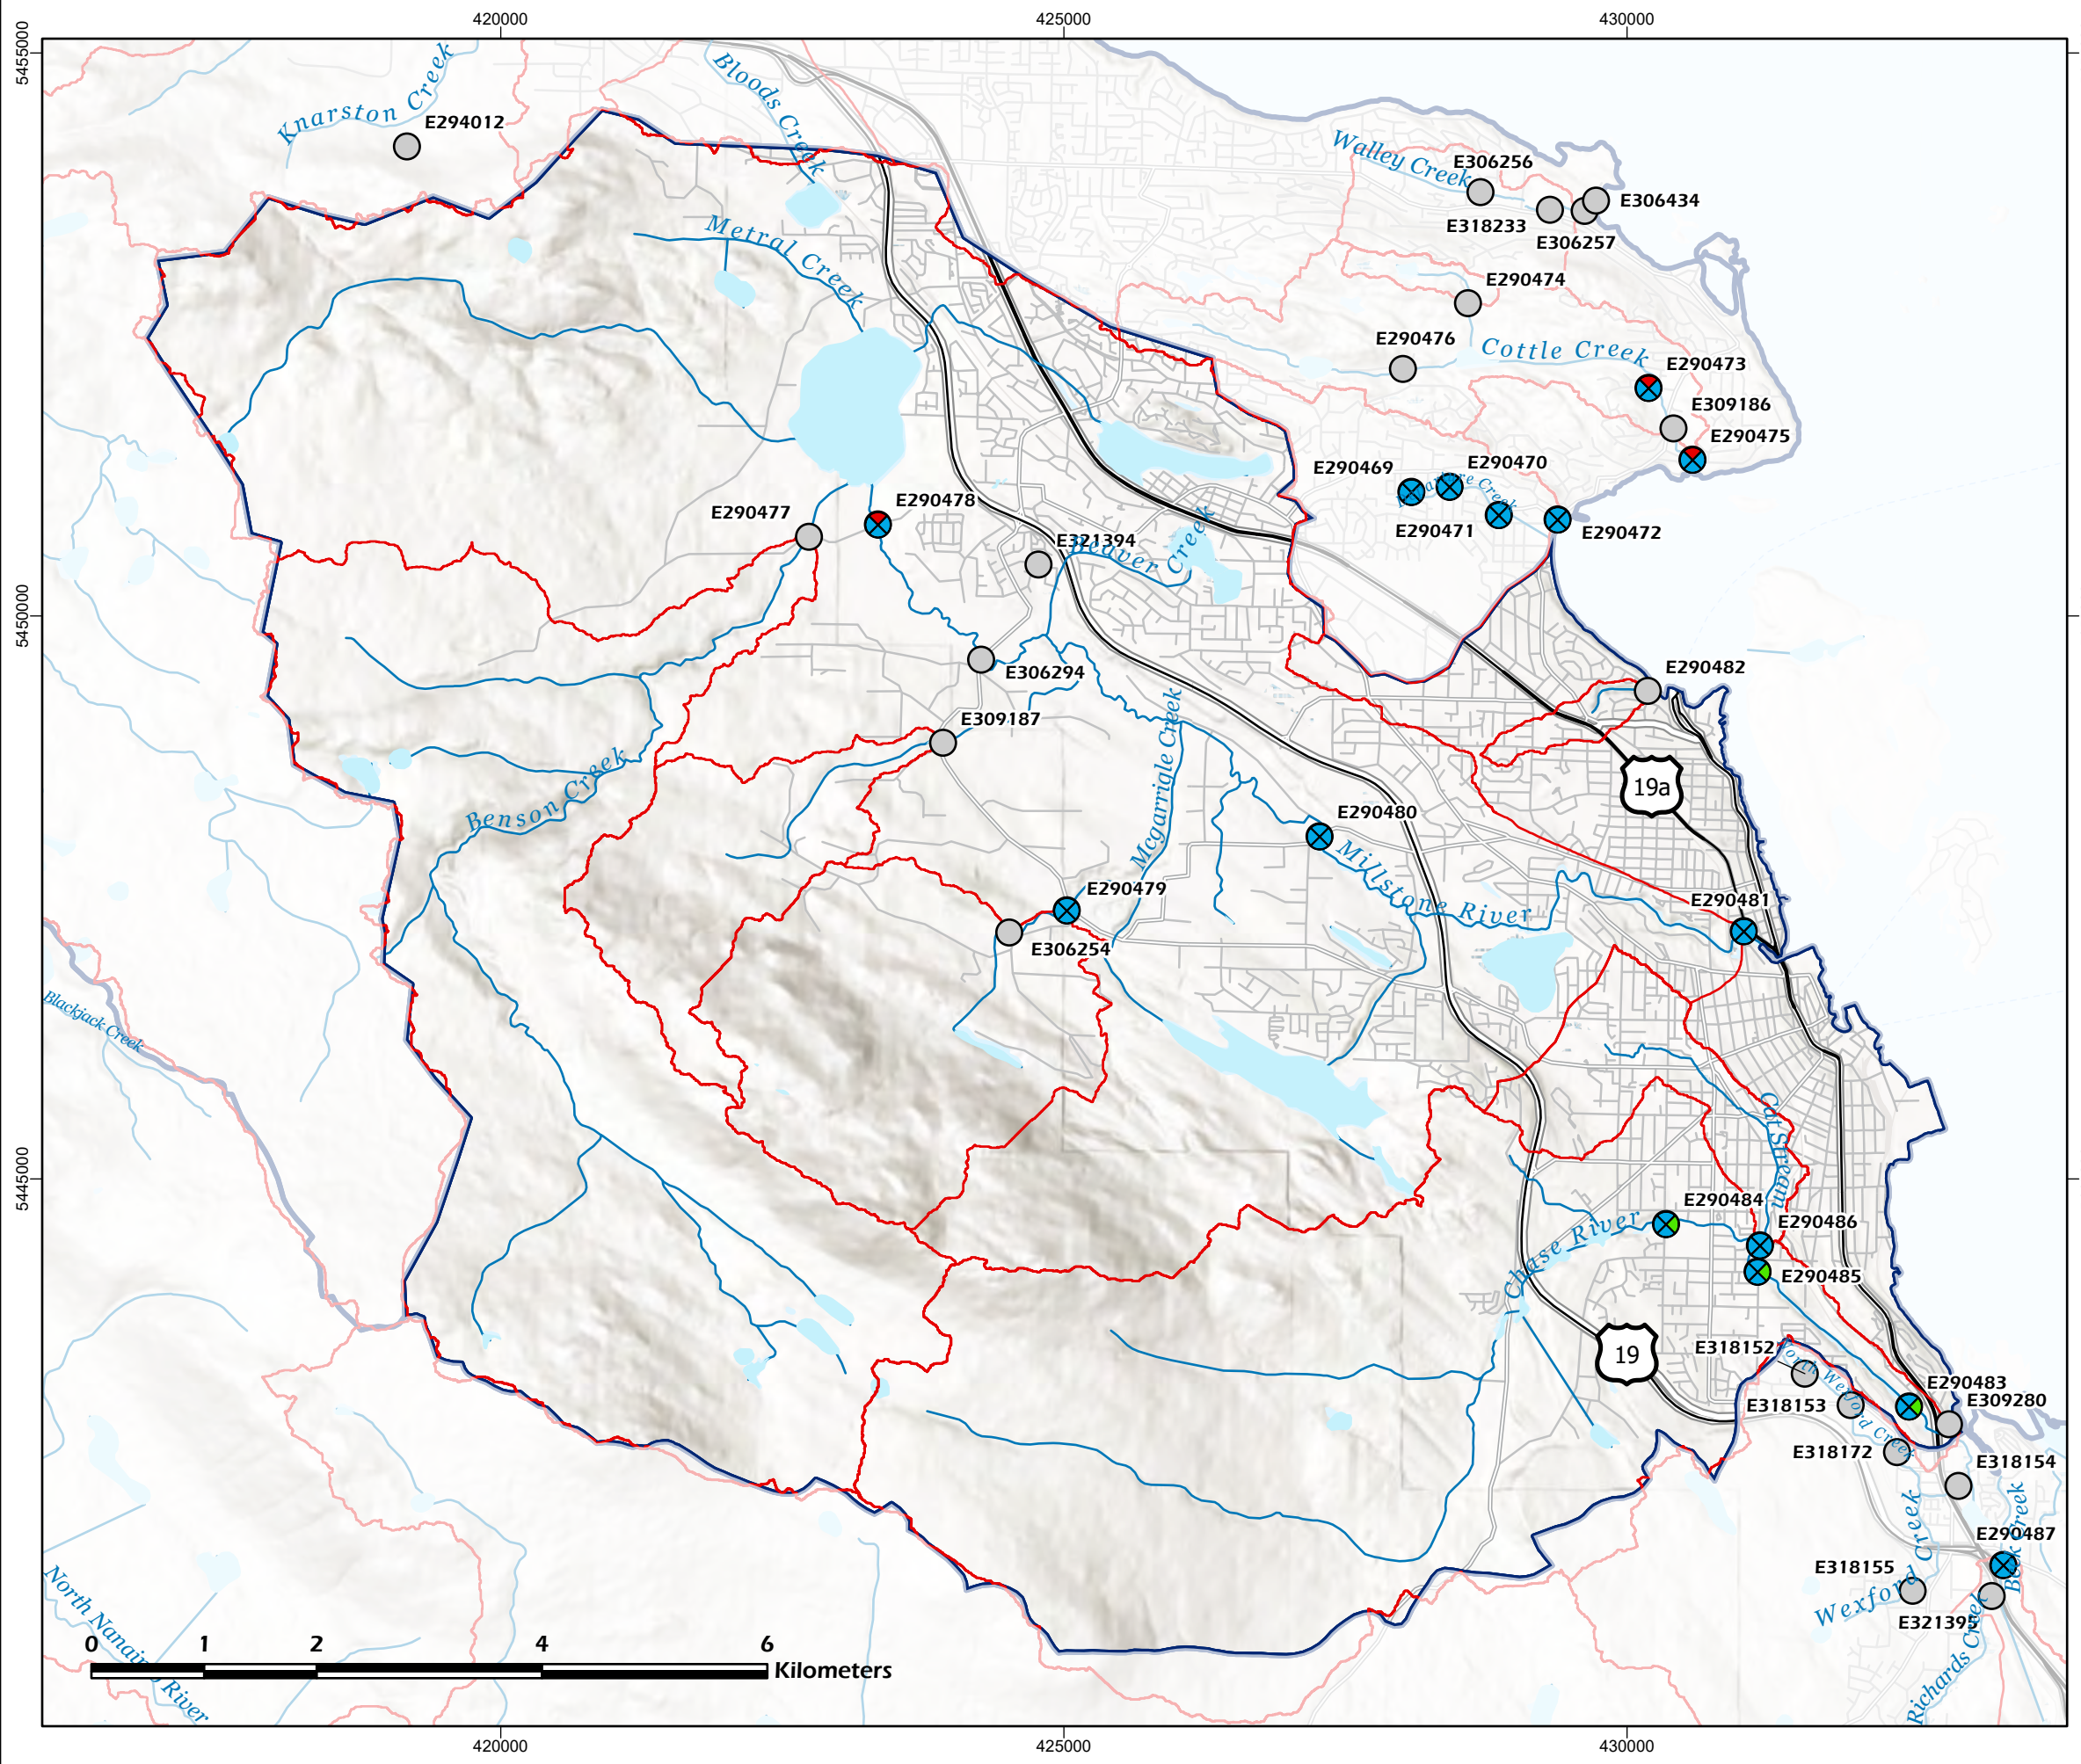
CMMN Water Quality Trend Analysis 2011-2020

Conductivity can be influenced by factors such as groundwater and ocean spray that are not necessarily indicative of a degrading condition. For simplicity, an increase in conductivity is categorized here as degrading.
