Community Watershed Monitoring Network 2020

Results by Water Region

Water Region 7
sampled by:

**Gabriola
Streamkeepers (GSK)**

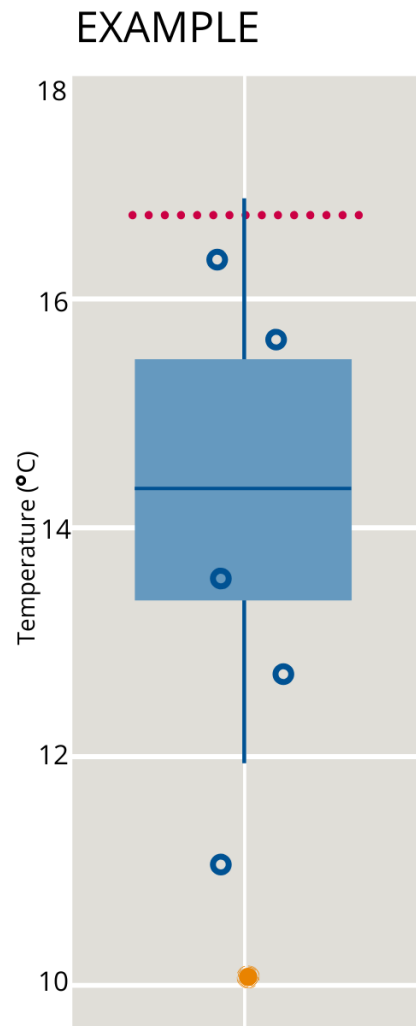
How to Interpret a Box Plot:

The summer and fall exceedance frequency maps included in this package express the number of sample periods (summer low-flow / fall flush) with exceedances for each site. There are four frequency categories for the number of sample periods with exceedances: no exceedance recorded (0), low (1 – 2), moderate (3 – 4), and high (5 or more). The exceedance categories are for the three parameters with aquatic water quality guidelines and objectives based on the following thresholds: temperature $\geq 17^{\circ}\text{C}$, dissolved oxygen $\leq 5\text{mg/L}$, summer turbidity $\geq 2\text{NTU}$, and fall turbidity $\geq 5\text{NTU}$.

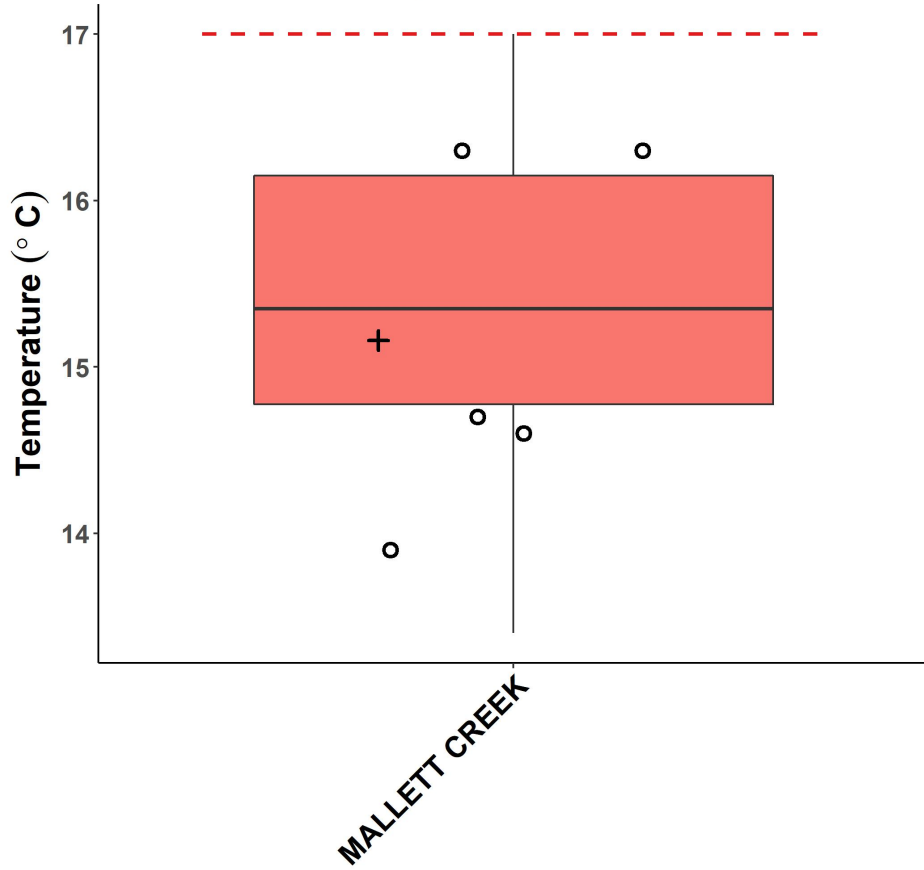
WR7 Summer Temperature

○ 2020 Samples Guideline
+ 2020 30 Day Avg - - - Aquatic Life Guideline for Coho Rearing (17°C)

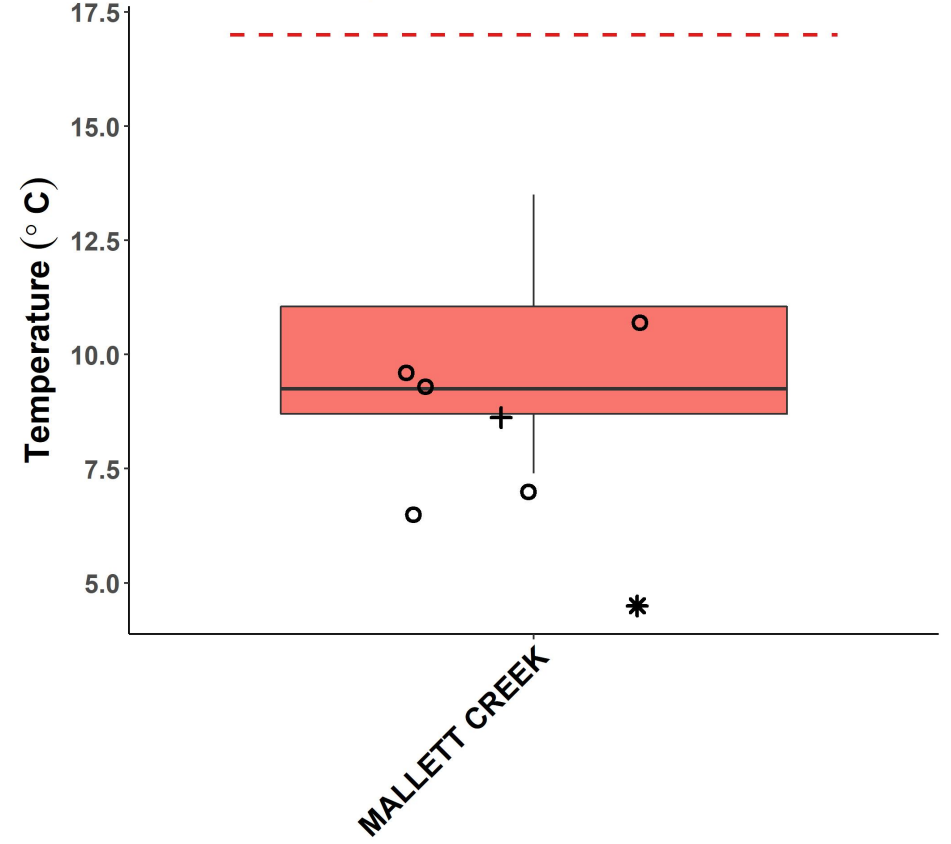
WR7 Fall Temperature

○ 2020 Samples Guideline
* Outlier 2015-2019 - - - Aquatic Life Guideline for Coho Rearing (17°C)
+ 2020 30 Day Avg

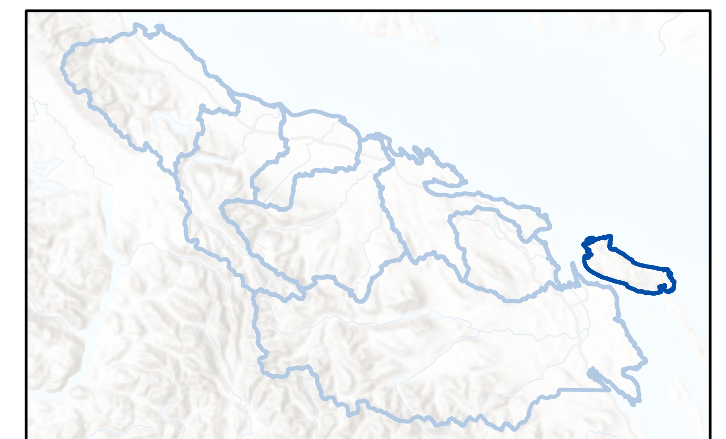
CMMN Water Quality Trend Analysis 2011-2020

Conductivity can be influenced by factors such as groundwater and ocean spray that are not necessarily indicative of a degrading condition. For simplicity, an increase in conductivity is categorized here as degrading.

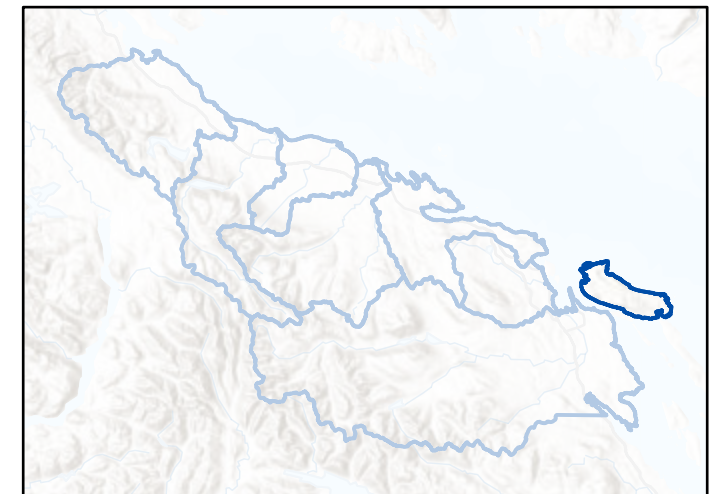
CMMN 2011-2020 Summer Exceedance Assessment

- ⊗ Sample Site
 - Highway
 - Stream
 - ▭ Watershed
 - ▭ Water Region
 - ▭ Lake
- Note the exceedance frequency categories are reflective of the number of sample periods with exceedances, not the number or values of the exceedances.*

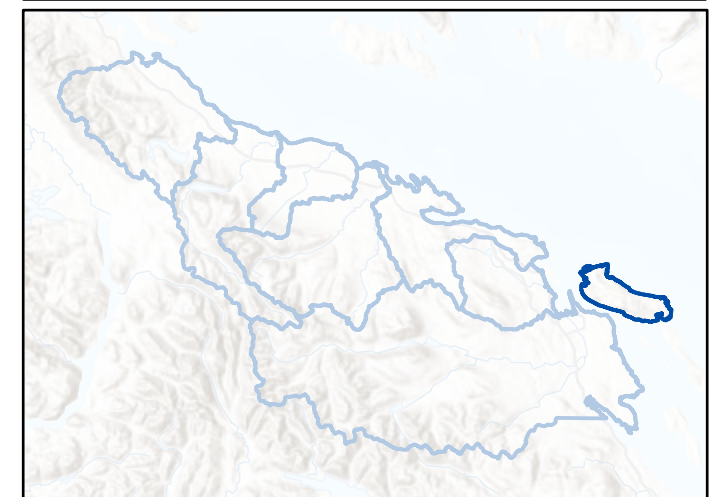
CMMN 2011-2020 Fall Exceedance Assessment

Note the exceedance frequency categories are reflective of the number of sample periods with exceedances, not the number or values of the exceedances.
