Community Watershed Monitoring Network 2019

Results by Water Region

Water Region 7
sampled by:

**Gabriola
Streamkeepers (GSK)**

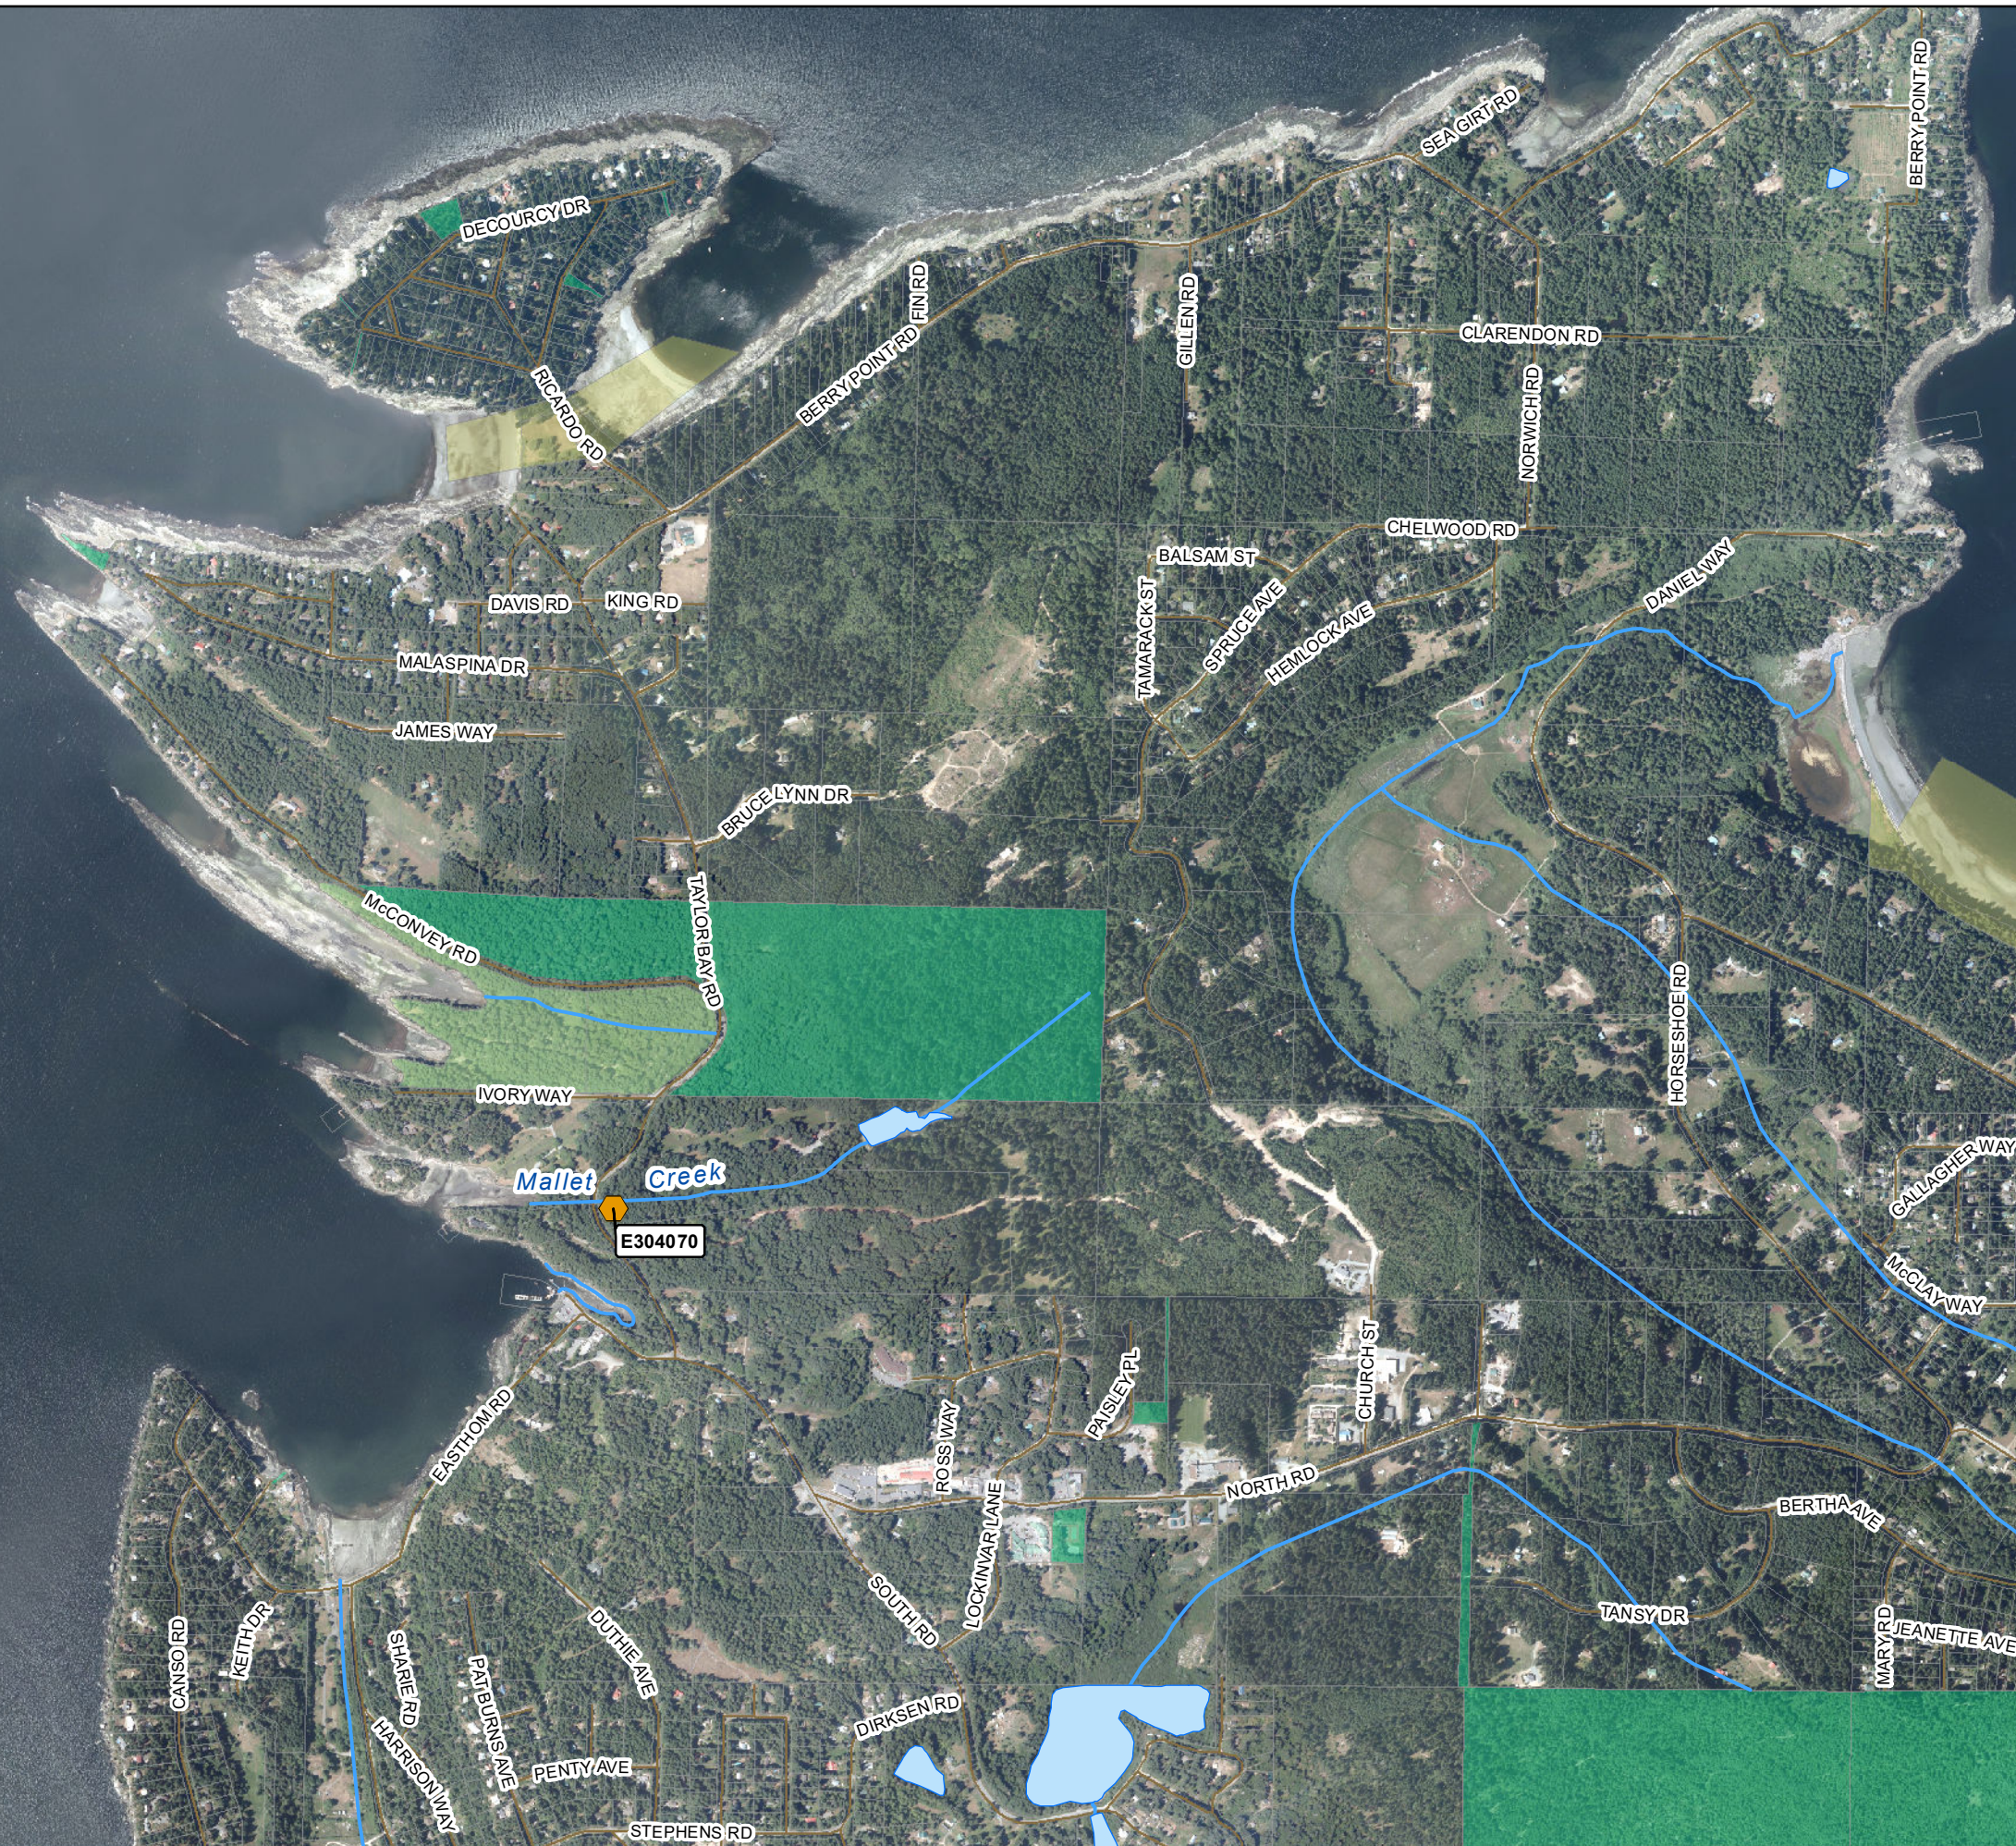
Gabriola Streamkeepers 2019 Monitoring Sites

Status

Active
-

Not Active

Watercourse
(approximate location)
