REGIONAL DISTRICT OF NANAIMO Water Service Area Annual Report 2015

Nanoose Bay Peninsula Water Service Area

June 2016

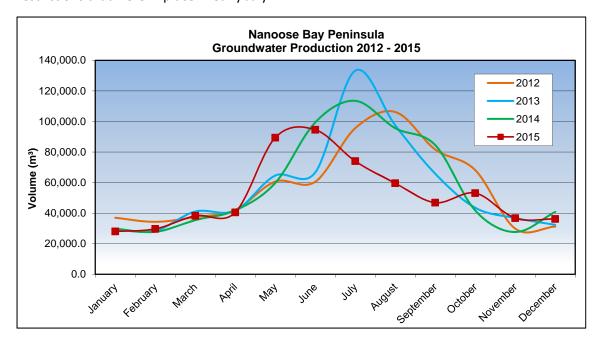
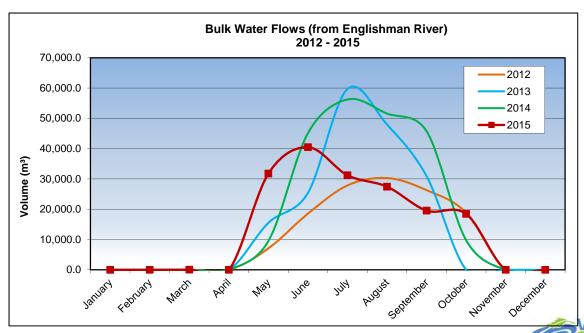
The monthly groundwater well production and bulk water flows for the past 4 years are shown in the charts below. Groundwater production in 2015 was generally lower in comparison to previous years, with the exception of an early peak in May/June, which can be attributed to an unseasonable warm and dry spring. Bulk water flows from the Englishman River also exhibited an early peak, but were typically lower than in 2013 and 2014 because of the Stage 4 watering restrictions that were in place in early July.
