REGIONAL DISTRICT OF NANAIMO

Water Service Area Annual Report 2015

Surfside Water System

June 2016

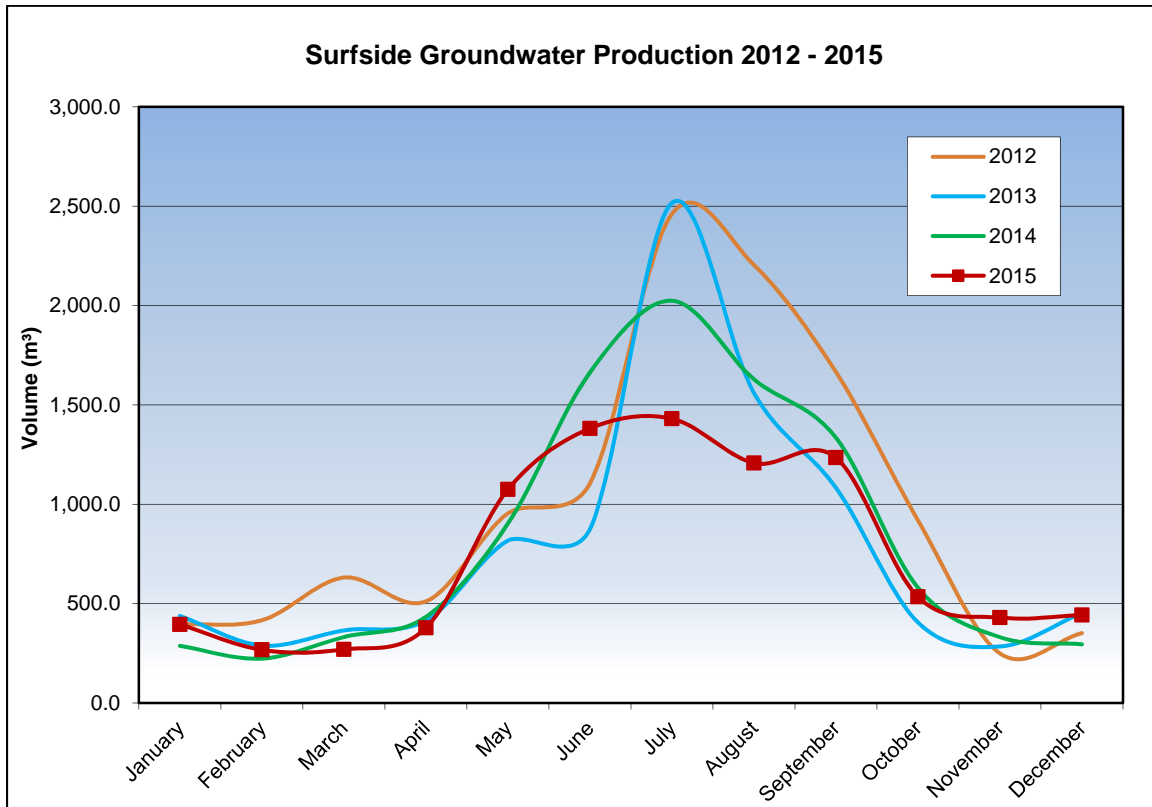
The monthly groundwater production in the Surfside Water Service Area for the past 4 years is shown in the chart below. Groundwater production in 2015 was typically lower than previous years. This is likely due to Stage 4 watering restrictions put in place in early July.
