REGIONAL DISTRICT OF NANAIMO

Water Service Area Annual Report 2018

Melrose Terrace Water Service Area

June 2019

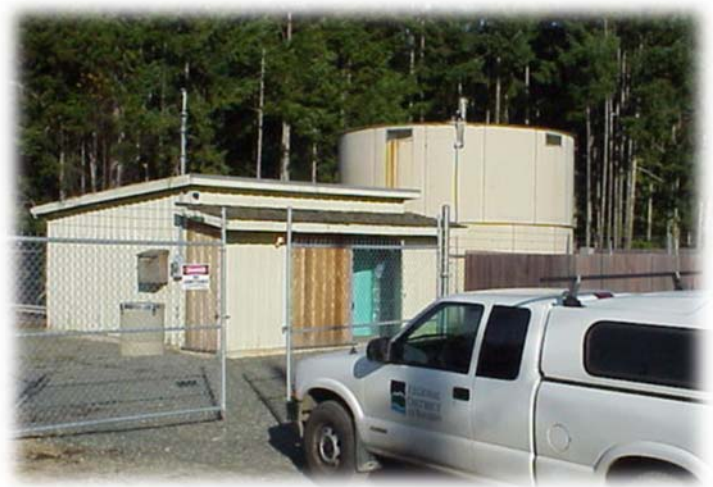
Melrose Pumphouse and Reservoir

One groundwater production well is present at the reservoir site on Melrose Road, west of Coombs, B.C.

One service reservoir (steel structure) is present at 3853 Melrose Road, and has a capacity of 136 m³ (30,000 imperial gallons).

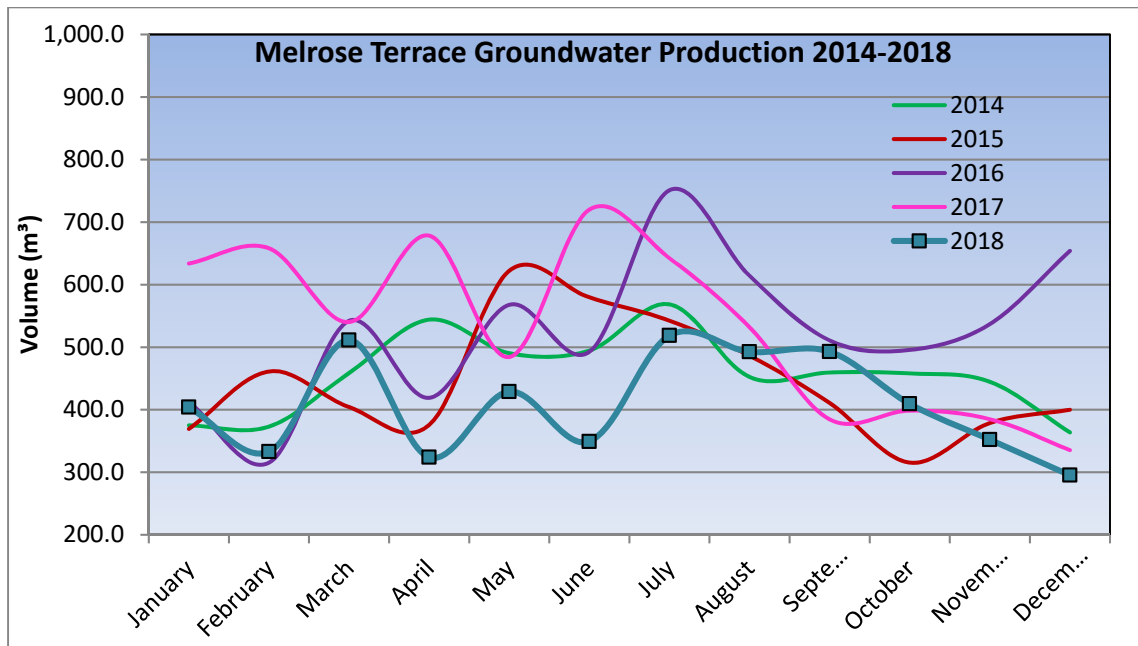
The monthly groundwater production in the Melrose system for the past 5 years is shown in the chart below. Groundwater production in 2018 fell to lower levels in the spring, but average levels in the summer months compared to previous years. Summer production levels did not dissipate as early as usual, indicating increased spans of high temperatures later in the summer.

In the Fall/Winter of 2018, the average usage per home in the Melrose Terrace water service area was approximately 0.34 cubic metres per day (74.8 imperial gallons). In the summer, the average water usage was 0.46 cubic metres per day (101.2 imperial gallons). Based on these figures, the annual consumption per capita is estimated to be 158 L/day (based on 2.4 people per household). This consumption is **46% less** than the RDN system average of 294 L/day/capita in 2018.
