REGIONAL DISTRICT OF NANAIMO

Water Service Area Annual Report 2019

Decourcey Water System

June 2020

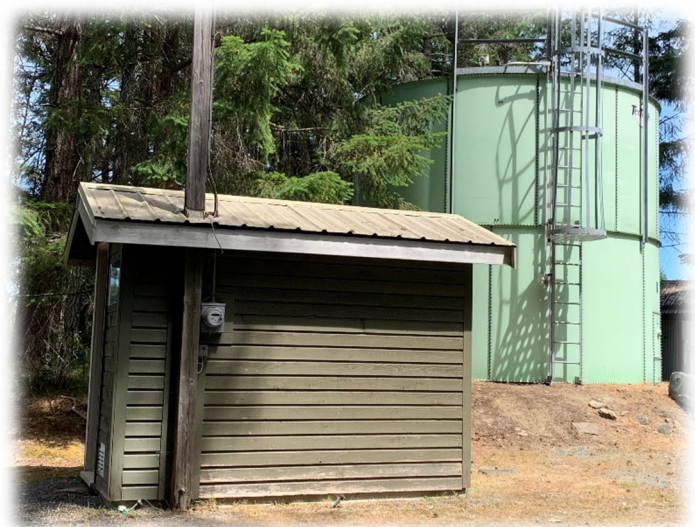
Decourcey Pumphouse and Water Storage Reservoir

One steel above-ground reservoir is present at 3284 Bissel Road, and has a capacity of 136 m³ (30,000 imperial gallons).

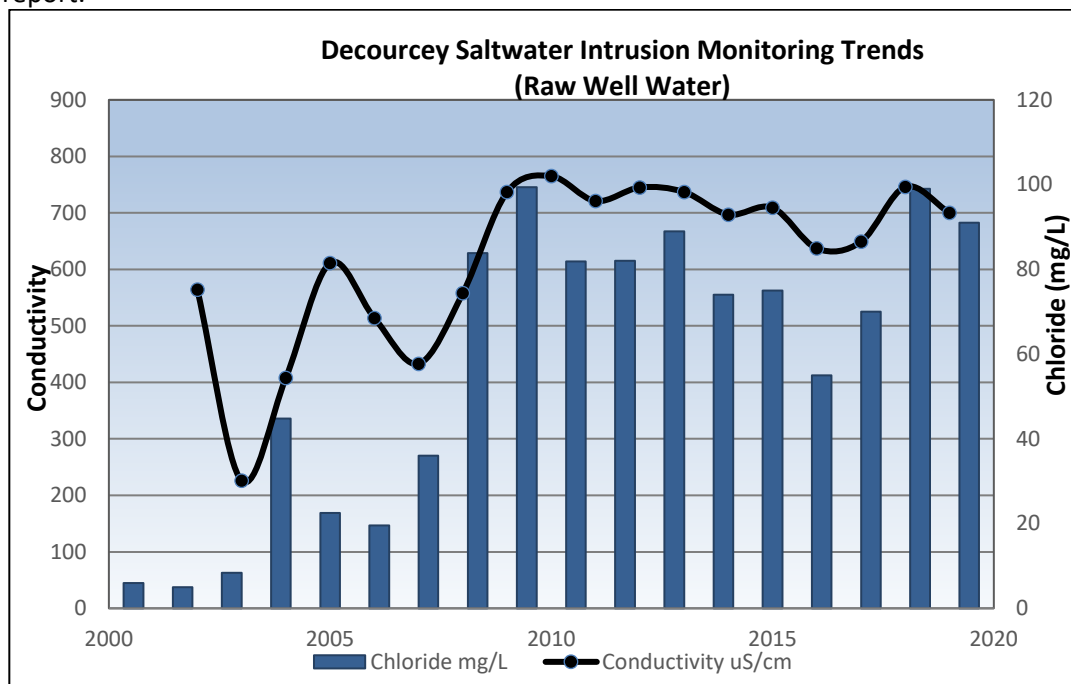
The Conductivity and Chloride levels in the Decourcey well water remain elevated, but stable.

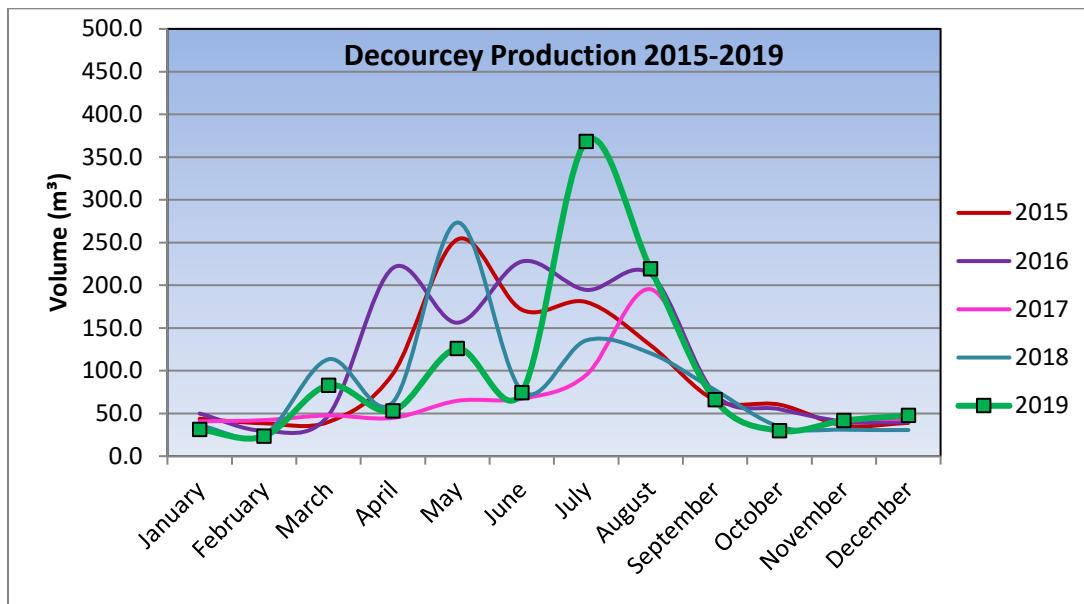
The monthly groundwater production in the Decourcey system for the past 5 years is shown in the chart below. Groundwater production in the summer of 2019 was substantially higher than in previous years. This increase could be attributed to higher than normal seasonal irrigation activities.

In the fall/winter of 2019, the average usage per home in Decourcey was 0.26 cubic metres per day (57.2 imperial gallons). In the summer of 2019, the average water usage was 1.11 cubic metres per day (244.2 imperial gallons). Based on these figures, the annual consumption per capita is estimated to be 226 L/day (based on 2.4 people/household). This consumption is **23% less** than the average of all the other RDN water systems of 295 L/day/capita in 2019.
