REGIONAL DISTRICT OF NANAIMO

Water Service Area Annual Report 2019

Descanso Bay Regional Park Water System

June 2020

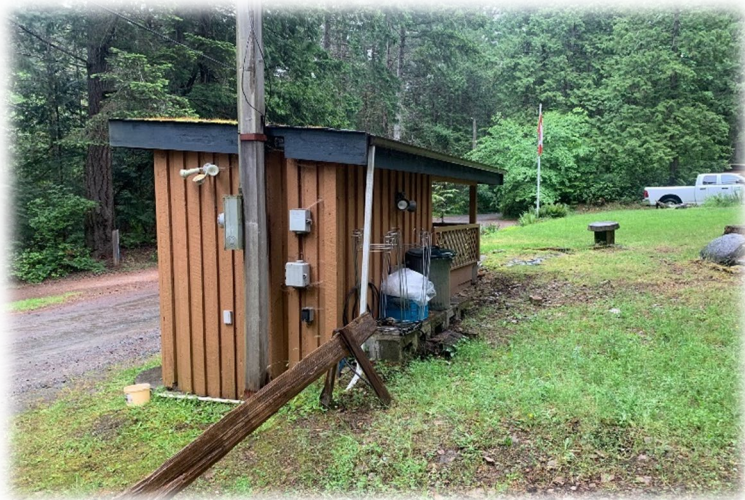
**Descanso Bay Park
Treatment Building**

The Descanso Bay Regional Park well is 54.8 metres deep and located approximately 50 metres northwest of the Park Office. The well water is filtered with a 5 and 10 micron filter, and then disinfected with UV (ultraviolet) radiation.

The 2,000 gallon cistern was removed from behind the treatment building. Water storage is now limited to the 40 gallon (0.2 m³) pressure tank inside the treatment building.
