REGIONAL DISTRICT OF NANAIMO

Water Service Area Annual Report 2019

Horne Lake Regional Park Water System

June 2020

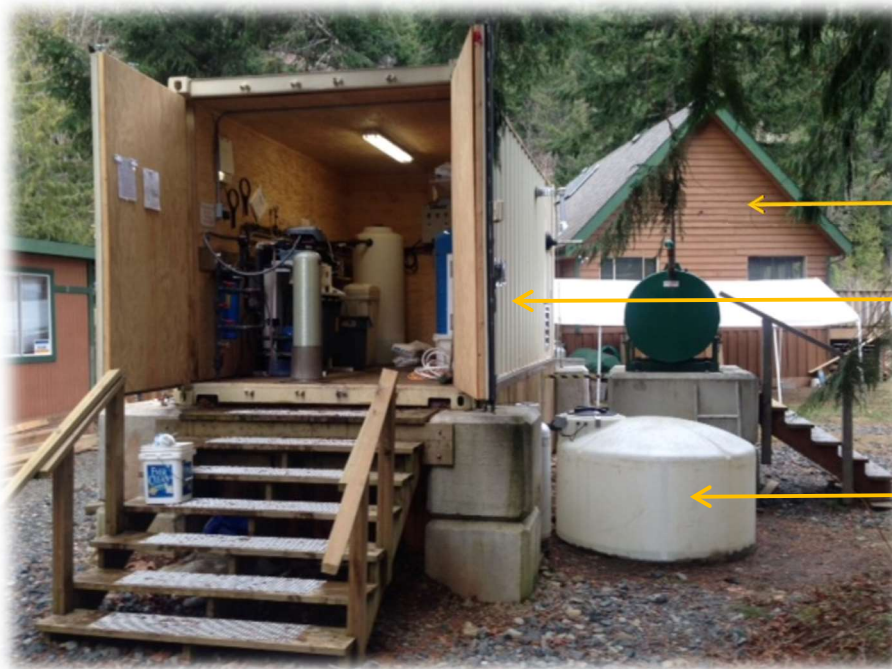
Horne Lake Regional Park

← Staff Residence

← Sea Can for water filtration and chlorination units

← Summer water storage tank

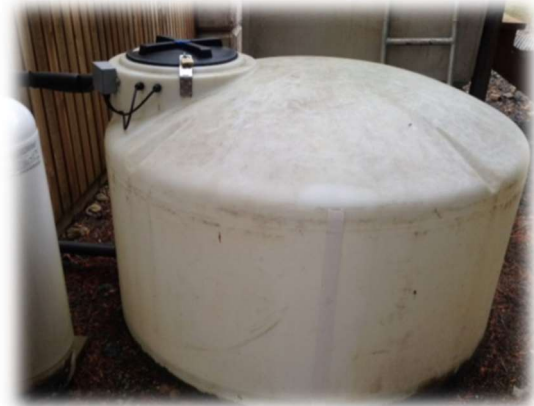
**Summer water storage tank at
Horne Lake Regional Park**

An alternate, larger, 500 gallon outdoor water storage tank is present on the ground outside and adjacent to the Sea Can container. This reservoir is used in the summer when the demand for water is greater. Both the summer and winter storage reservoirs are composed of white PVC plastic. These reservoirs are drained and cleaned alternately before use each season.

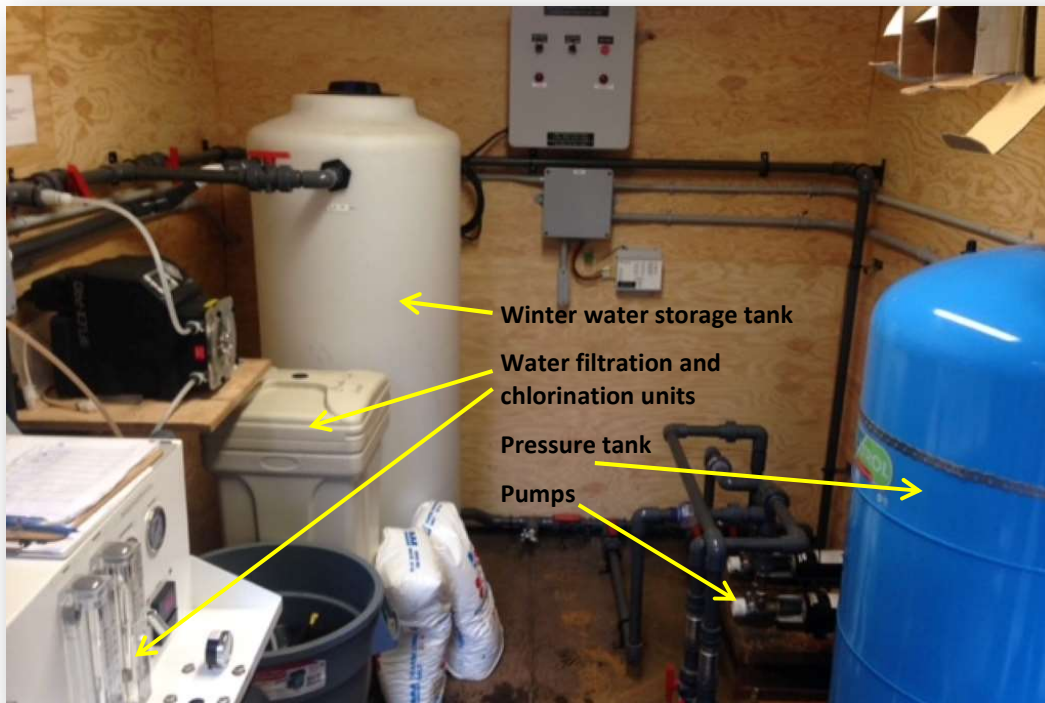
Photo depicting the inside of the Sea Can container at Horne Lake Regional Park

Two small water storage reservoirs are present at Horne Lake Regional Park. Drinking water from the well near the staff residence is filtered, chlorinated, and pumped to a small 50 gallon holding tank inside the Sea Can container during the winter. Then the drinking water is pumped via a pressure tank to the staff residence and yard hydrant on demand.

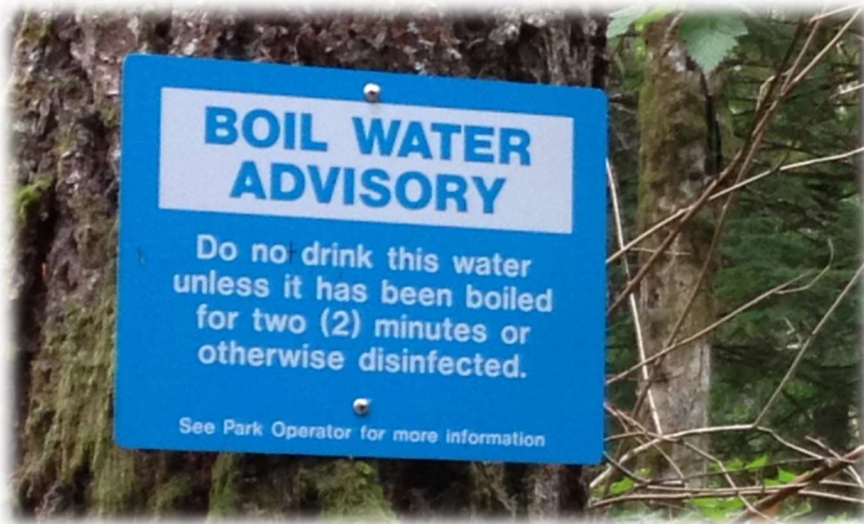
Sign above the hand-pump in the South Park campground

There is one hand-pump for the campground, located in the South Park. The water supply to the hand pump comes from a shallow well directly under the hand pump. The water available from this hand-pump is not potable, and there are posted signs indicating the hand-pump water is not to be used for drinking or cooking. Potable water is only available in the North Park at the staff residence and yard hydrant.

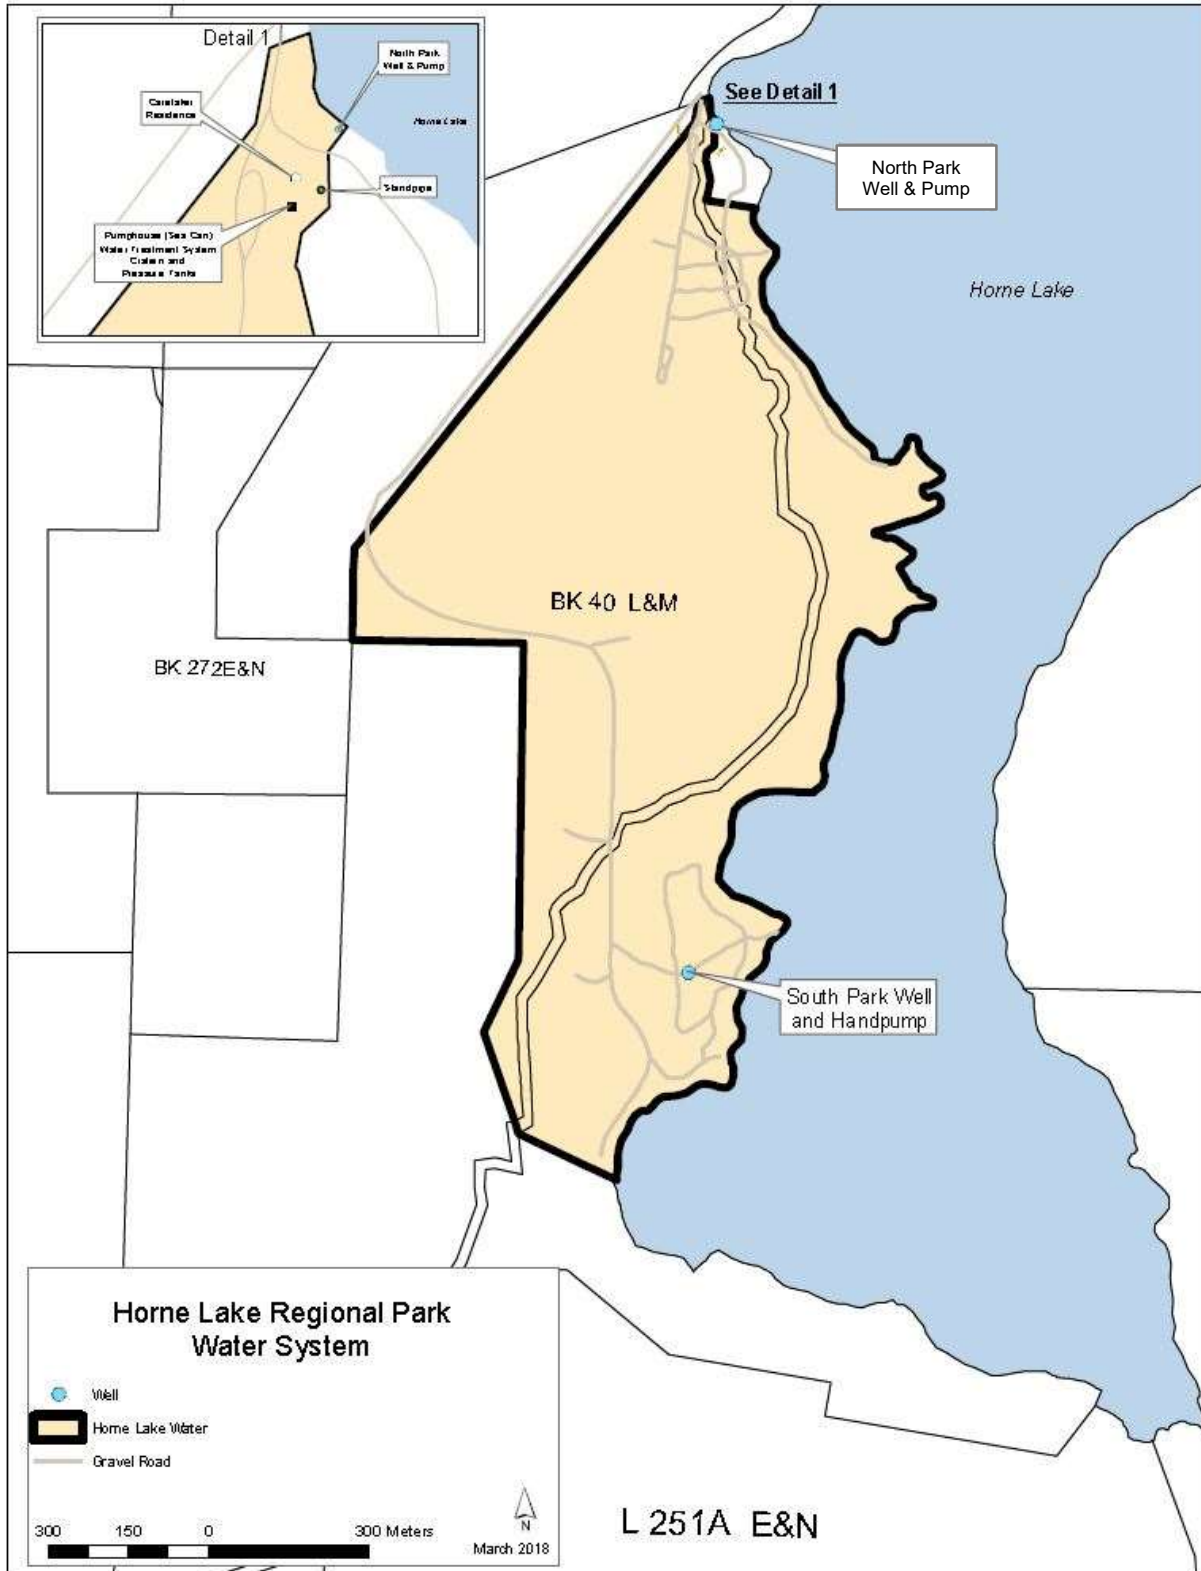
**MAP OF HORNE LAKE REGIONAL PARK
WATER SYSTEM**

HORNE LAKE REGIONAL PARK WATER SYSTEM
