REGIONAL DISTRICT OF NANAIMO

Water Service Area Annual Report 2019

Melrose Terrace Water Service Area

June 2019

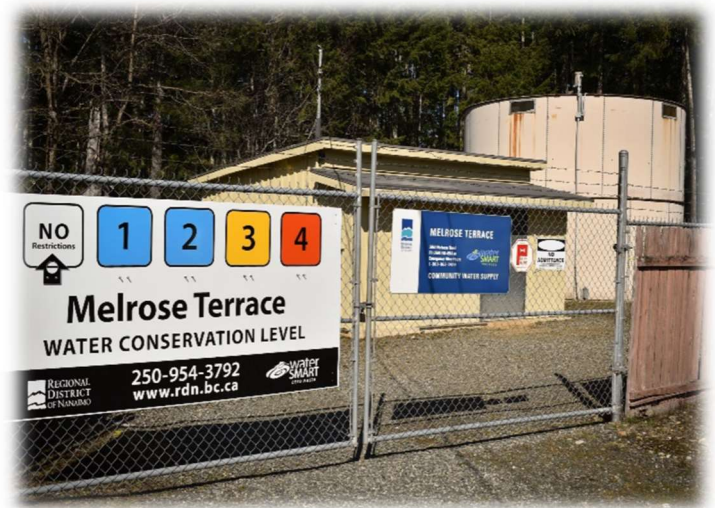
Melrose Pumphouse and Reservoir

One groundwater production well is present at the reservoir site on Melrose Road, west of Coombs, B.C.

One service reservoir (steel structure) is present at 3853 Melrose Road, and has a capacity of 136 m³ (30,000 imperial gallons).

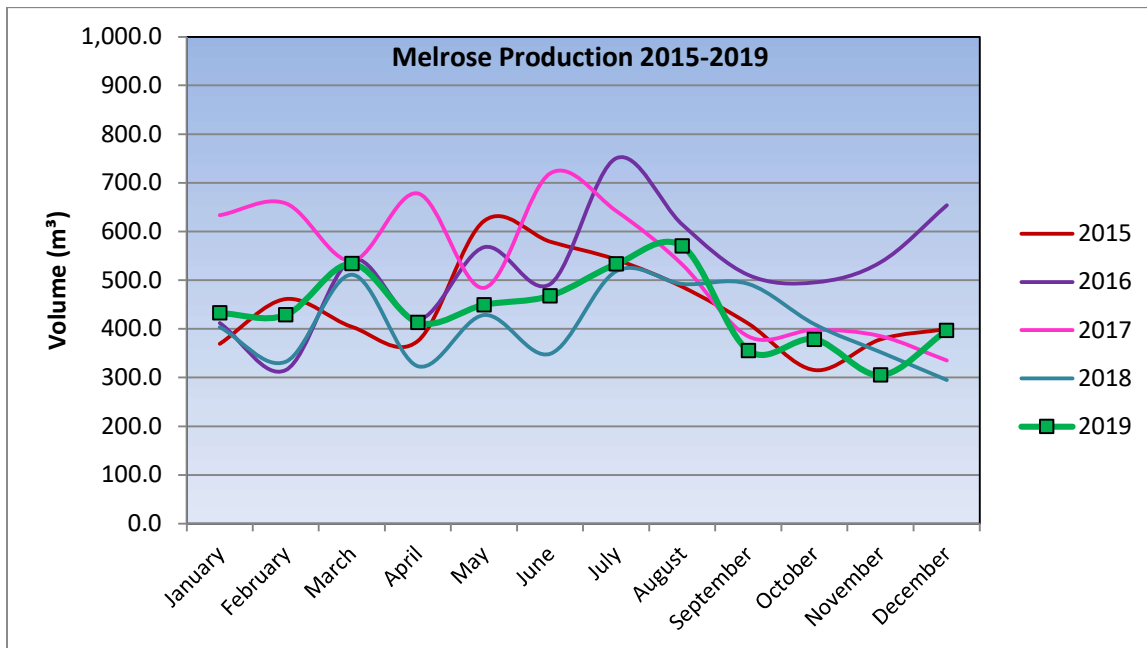
The monthly groundwater production in the Melrose system for the past 5 years is shown in the chart below. Average groundwater production in 2019 was lower than in previous years, but average levels in the summer months were higher than the previous year. High spring and summer production levels in 2019 compared to 2018 could be the result of high temperatures and increased irrigation activities.

In the Fall/Winter of 2019, the average usage per home in the Melrose Terrace water service area was approximately 0.36 cubic metres per day (79.2 imperial gallons). In the summer, the average water usage was 0.48 cubic metres per day (105.6 imperial gallons). Based on these figures, the annual consumption per capita is estimated to be 166 L/day (based on 2.4 people per household). This consumption is **44% less** than the RDN system average of 295 L/day/capita in 2019.

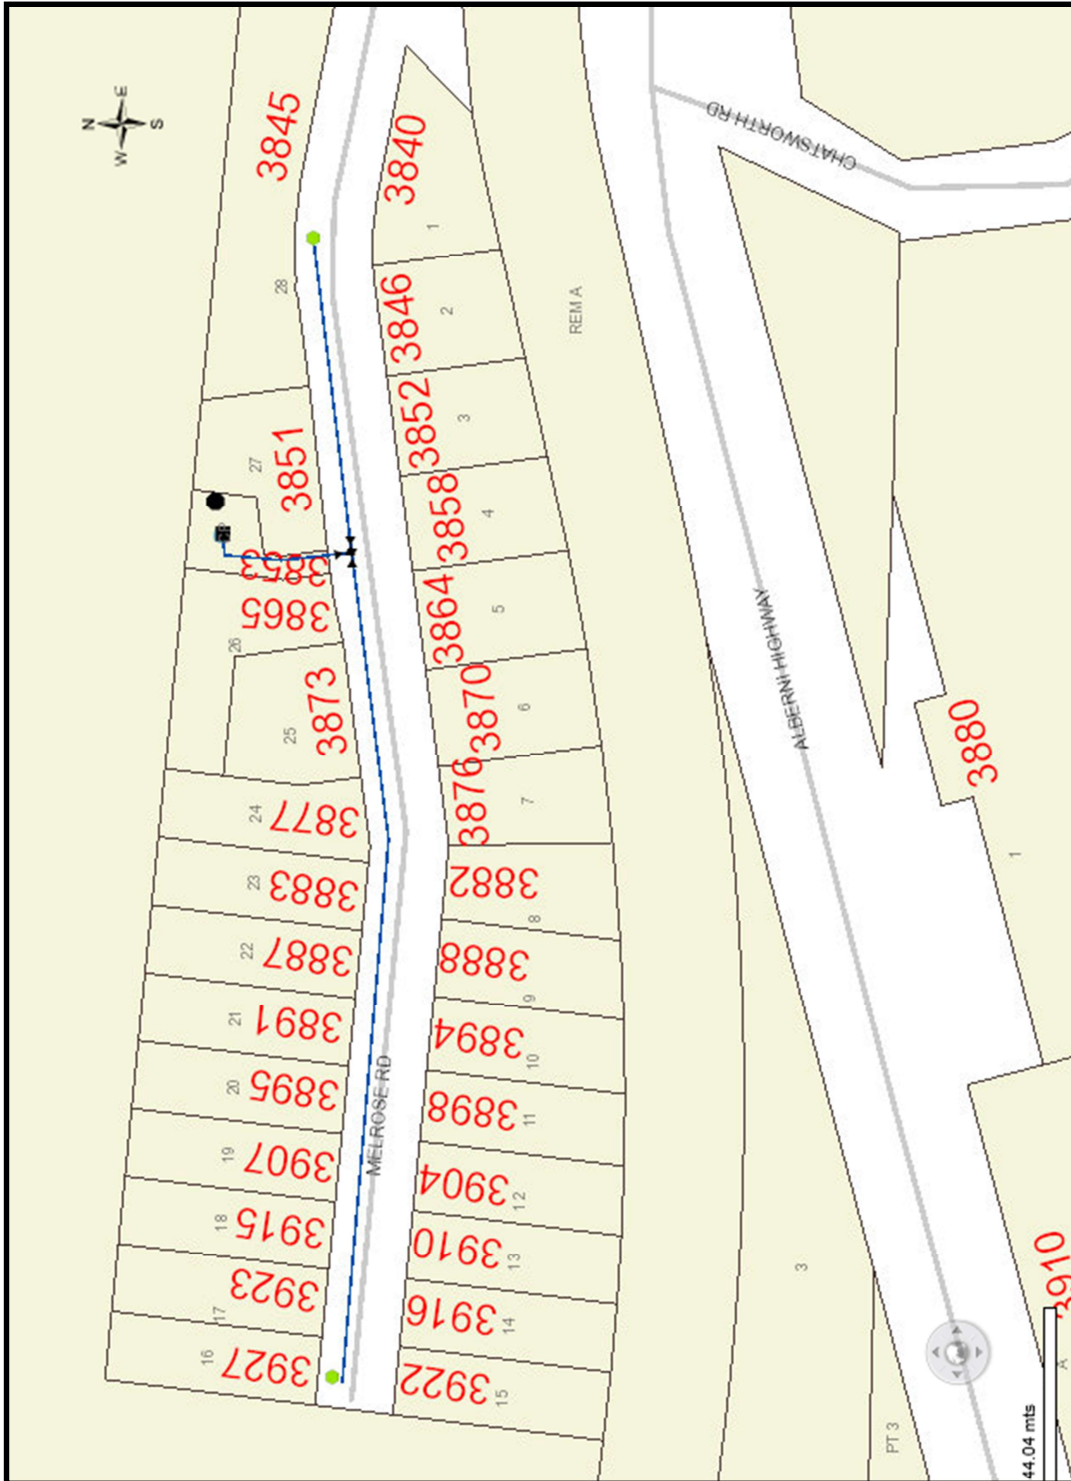
APPENDIX A

MAP OF MELROSE TERRACE

WATER SERVICE AREA

The Melrose Water Service Area was established in April 2005 when the RDN acquired the existing Melrose Terrace Strata Plan VIS3747 water system. The water service area is comprised of 28 residential properties on Melrose Road located near the Alberni Highway, west of Coombs. The water source for the Melrose Water Service Area comes from one groundwater well located nearby. The water is pre-chlorinated and stored in a single reservoir. The water is then filtered through sand and charcoal filters before entering the distribution system via booster pumps. A portable generator is available in the event of a power outage. A map of the Melrose Water Service Area is provided in Appendix A for reference.
