REGIONAL DISTRICT OF NANAIMO

Water Service Area Annual Report 2019

San Pareil Water Service Area

June 2020

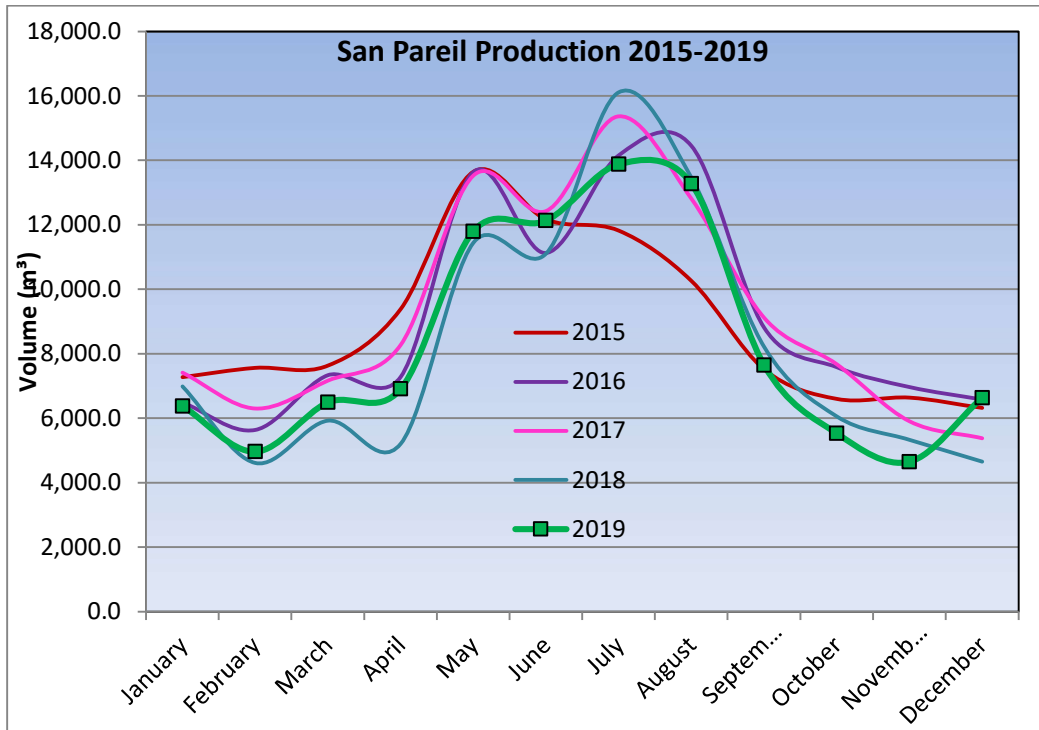
The monthly groundwater production for San Pareil for the past 5 years is shown in the chart below. In 2019, groundwater production was below average overall in comparison to previous years.

In the Fall/Winter of 2019, the average usage per home in San Pareil was 0.45 cubic metres per day (99 imperial gallons). In the summer, the average water usage was 1.13 cubic metres per day (248.6 imperial gallons). Based on these figures, the annual consumption per capita is estimated to be 283 L/day (based on 2.4 people/household). This consumption is **4% less** than all the other RDN water system averages of 295 L/day/capita in 2019.

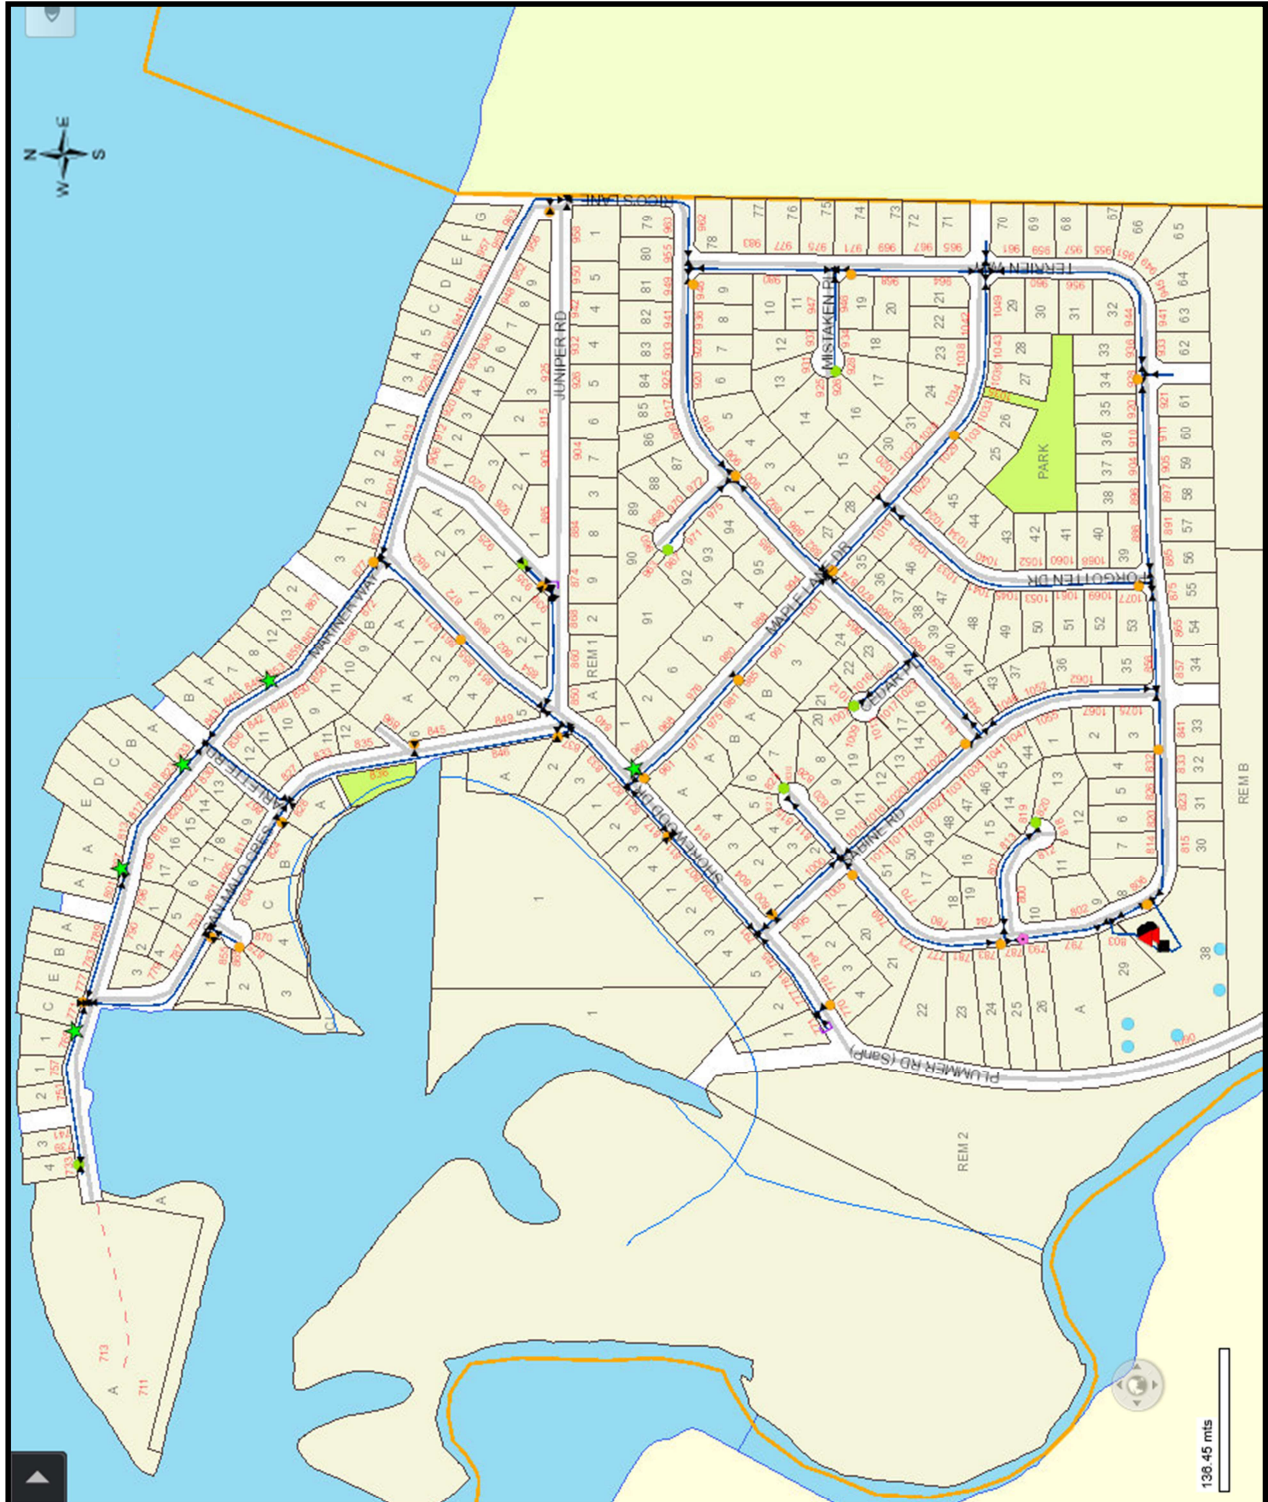
SAN PAREIL WATER SERVICE AREA

**MAP OF SAN PAREIL
WATER SERVICE AREA**

The San Pareil Water Service Area was established in 1999 when the RDN acquired the existing Bubbling Springs Water Utility. This system is located to the northeast of the Englishman River Bridge on the east side of the City of Parksville. There are 288 water service connections in San Pareil. The water source for the San Pareil Water Service Area comes from a series of groundwater wells located on Plummer Road. A map of the San Pareil Water System is provided in Appendix A.
