Habitat Assessment Report Fairwinds Schooner Cove Redevelopment

May 2017

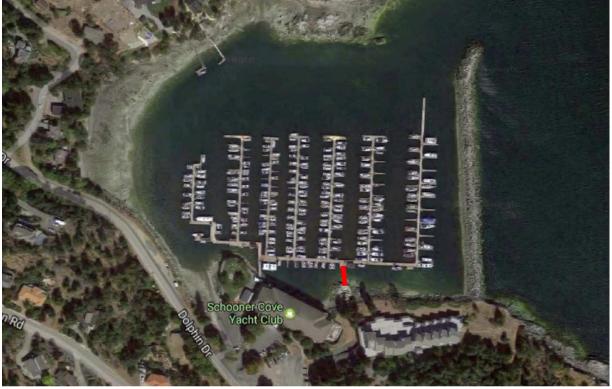
Figure 1. Nanoose Bay Schooner Cove. Red line indicates location of proposed overwater ramp.

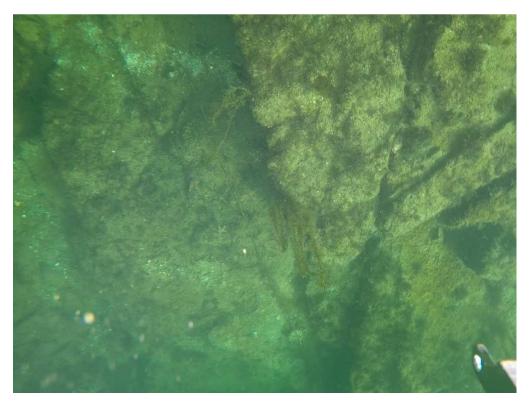
The proposed overwater ramp is located over a natural bedrock outcrop (Figure 3). The backshore is comprised of fill over bedrock with landscaping. The substrate from the supratidal² to shallow subtidal zone is bedrock. In the subtidal zone the substrate is a mix of boulder, coarse shell hash and sand (Figure 4).

Figure 4. Boulder, sand and shell hash substrate in subtidal zone of the proposed overwater ramp location.

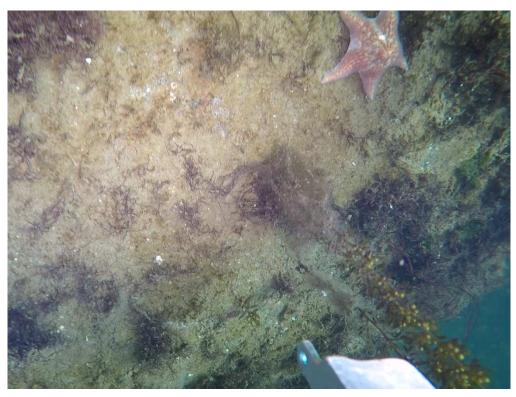
Vegetation in the riparian zone includes turf grasses and mature arbutus and Douglas fir. The supratidal zone is bare of vegetation and fauna, except for splash zone lichen. The intertidal zone contains sparse foliose red algae (*Pyropia*/*Porphyra* and *Mastocarpus*) in the upper intertidal; and a dense band of rockweed (*Fucus* sp.) with some foliose and filamentous green algae in the mid intertidal zone (Table 1; Figure 5). Japanese wireweed (*Sargassum muticum*) and tufted red algae is present in the subtidal zone of the proposed overwater ramp (Table 1; Figure 5 and Figure 6). Fauna includes abundant barnacles in the upper intertidal zone with some Pacific oyster (*Crassostrea gigas*) present; and leather star (*Dermasterias imbricata*) and orange sea cucumber (*Cucumaria miniata*) present in the subtidal zone (Table 1; Figure 6).

Figure 6. Brown algae (*Sargassum muticum*), tufted red algae, and leather star (*Dermasterias imbricata*) in the subtidal zone of the proposed overwater ramp location.

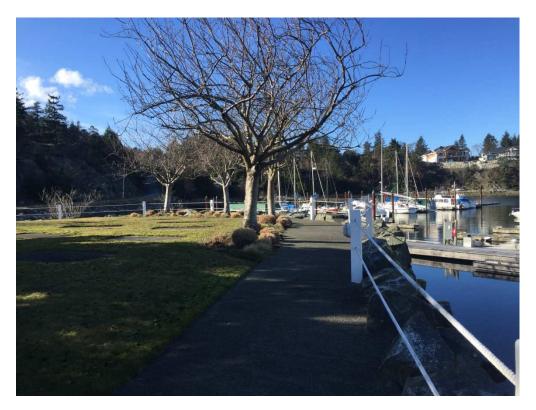
Figure 7. Landscaped viewing area in Schooner Cove

- Planting native coastal riparian grasses, herbs and shrubs in the viewing area (landscaped area to the west of hotel; Figure 7). The proposed landscaping plan fulfills these criteria.

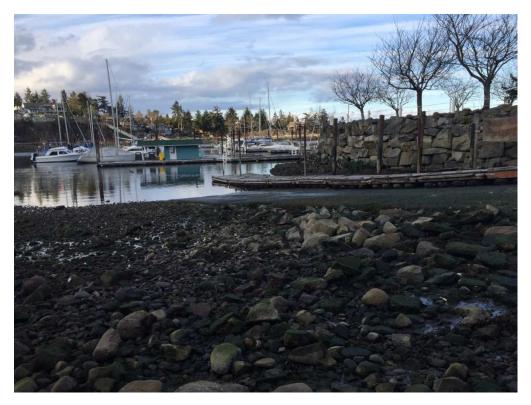
Figure 8. Boat ramp area in Schooner Cove.

- Planting native coastal riparian grasses, herbs and shrubs in the backshore adjacent to the proposed overwater ramp.
 - Planting native marsh vegetation at higher elevations of the beach at the existing boat ramp area (west of the hotel; Figure 8).

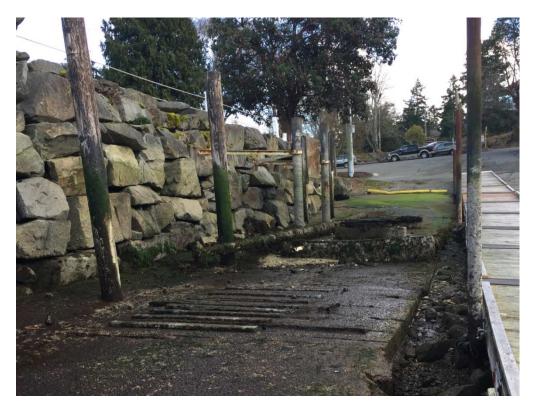
Figure 9. Boat cleaning grid in the boat ramp area of Schooner Cove.

- 2. Clean up of debris in the intertidal and subtidal zone. This includes:
 - Removing asphalt underneath the hotel footprint.
 - Breaking up and removing the boat cleaning grid by the boat ramp area during a low tide (Figure 9). Cap the boat cleaning grid footprint with clean pebble/cobble or pit run material.

- Remove piles in the boat ramp area, including piles from the boat cleaning grid (three creosote and two concrete; Figure 9) and the six short creosote pilings west of the boat ramp (Figure 10).

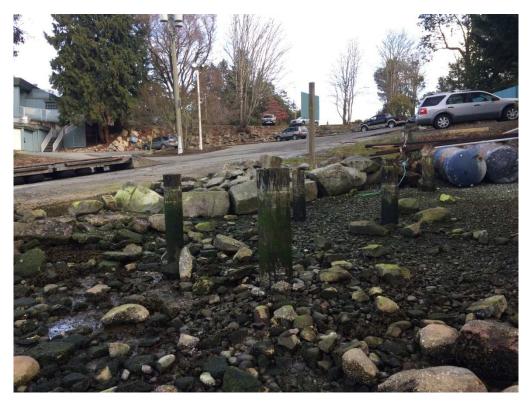
Figure 10. Piles to the west of boat ramp in Schooner Cove.
