REGIONAL DISTRICT OF NANAIMO

Water Service Area Annual Report 2017

Descanso Bay Regional Park Water System

June 2018

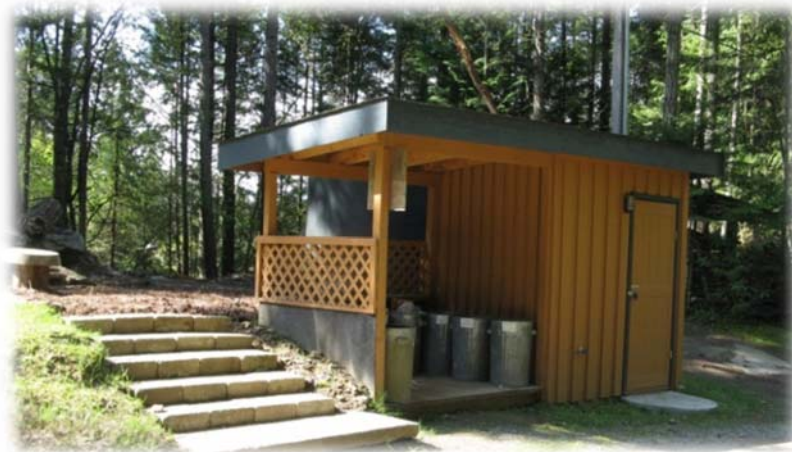
**Descanso Bay Park
Pumphouse
(green cistern is located
behind the pumphouse)**

One polyethylene cistern is located behind the pumphouse next to the Park Office. The cistern has a capacity of 9.0 m³ (2,000 imperial gallons).

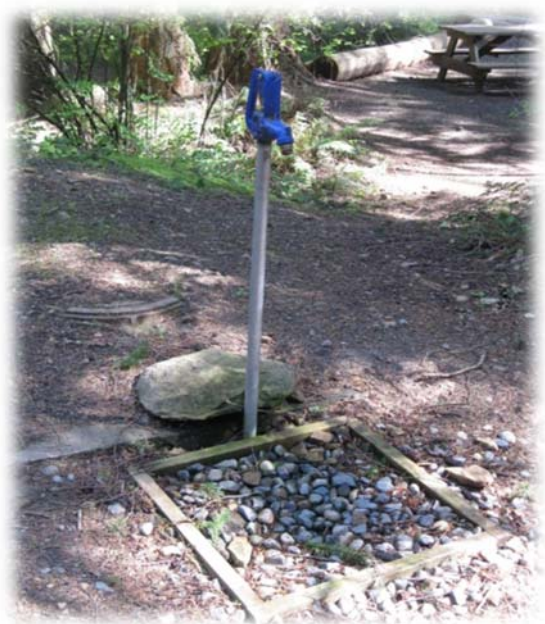
Standpipe for water supply in Descanso Bay Regional Park

The water distribution system is comprised of 675 metres of 3-inch PVC (poly-vinylchloride) pipe. There are no fire hydrants in this water system. There are five standpipes from which to draw drinking water in the campground (also known as yard hydrants).

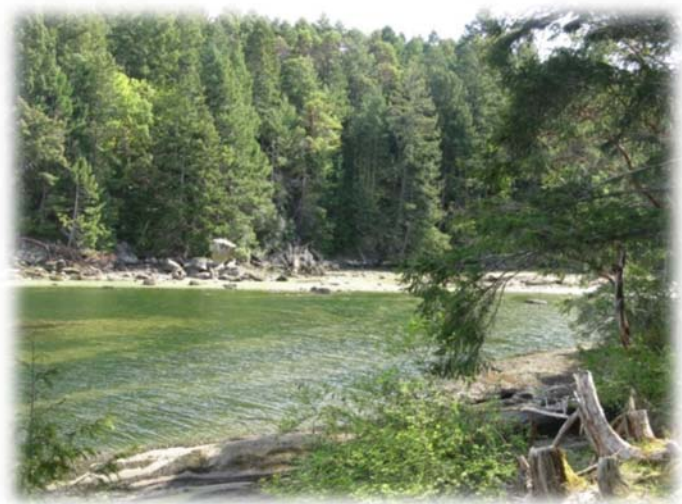
APPENDIX A

Appendix A - Map of Descanso Bay Regional Park Water System

The Regional District acquired the Descanso Bay Regional Park property in 2002 from the Coastal Community Credit Union. The park is accessed from Taylor Bay Road and comprises an area of 16 hectares (40 acres) on the west side of Gabriola Island. There are 5 standpipes (taps) for drinking water supply at the campground, including one at the Park Office. The water source comes from one groundwater well located within the park. The water is filtered, disinfected with ultraviolet radiation, and stored in one cistern. The on-site water treatment system was installed in 2010. A portable generator is available for emergency power outages. A map of the Descanso Bay Regional Park Water System is provided in Appendix A for reference.

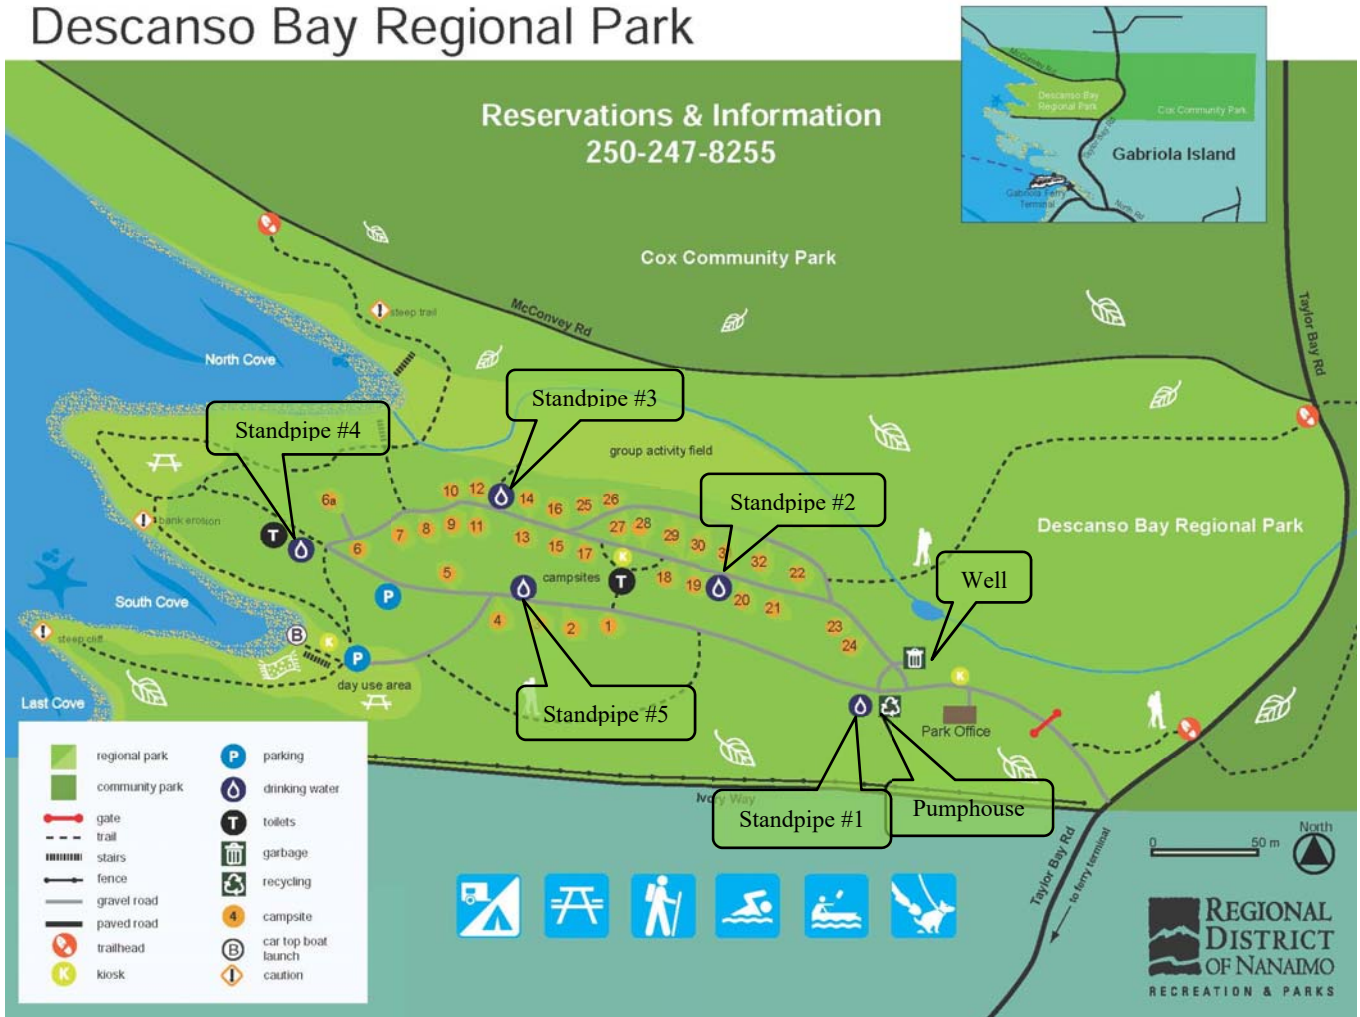
MAP OF DESCANSO BAY REGIONAL PARK

WATER SYSTEM
