# REGIONAL DISTRICT OF NANAIMO

## Water Service Area Annual Report 2017

### Rollo McClay Community Park Water System

June 2018

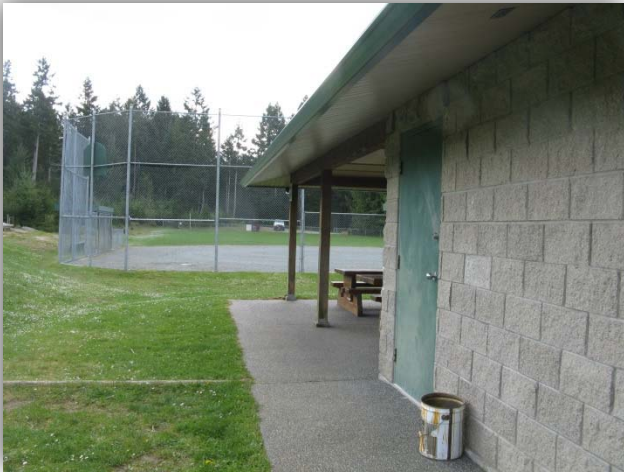
Rollo McClay  
Concession  
Building

There is no water distribution system in Rollo McClay Park. The cistern located inside the concession building supplies potable water to the kitchen and bathrooms. There are no fire hydrants in this water system.

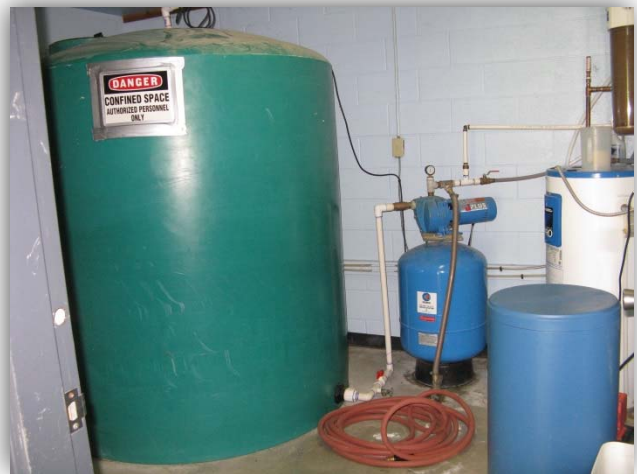
One polyethylene cistern is located inside the concession stand building. The cistern has a capacity of 5.5 m<sup>3</sup> (1,200 imperial gallons).

Rollo McClay  
Water  
Cistern

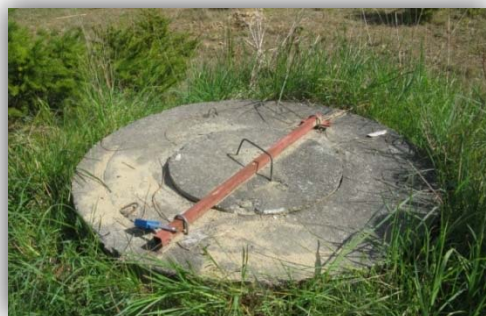
The Rollo McClay Community Park well is located inside a concrete manhole ring, approximately 50 meters to the southeast of the concession building. The well is 48.7 meters deep. The well is not currently in use, and its future is scheduled to be discussed in 2018.

**Rollo McClay Wellhead Cover in 2012**

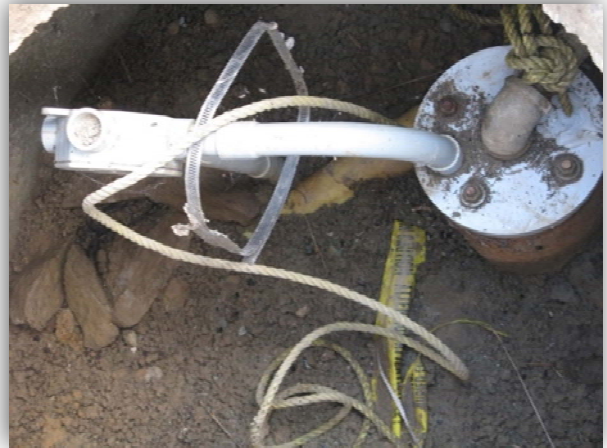
Rollo McClay Wellhead  
(2012)

- Consider closing the well permanently;
- Consider installing an additional storage cistern;
- Review and update the Emergency Response Plan;
- Complete the Cross Connection Control Bylaw; and
- Review and update the Drinking Water and Watershed Protection Action Plan.
