Stream Mapping Results Report

Beach Creek & Grandon Creek 2024-2025

Prepared for the Qualicum Beach Streamkeepers.

Date: September 15, 2025

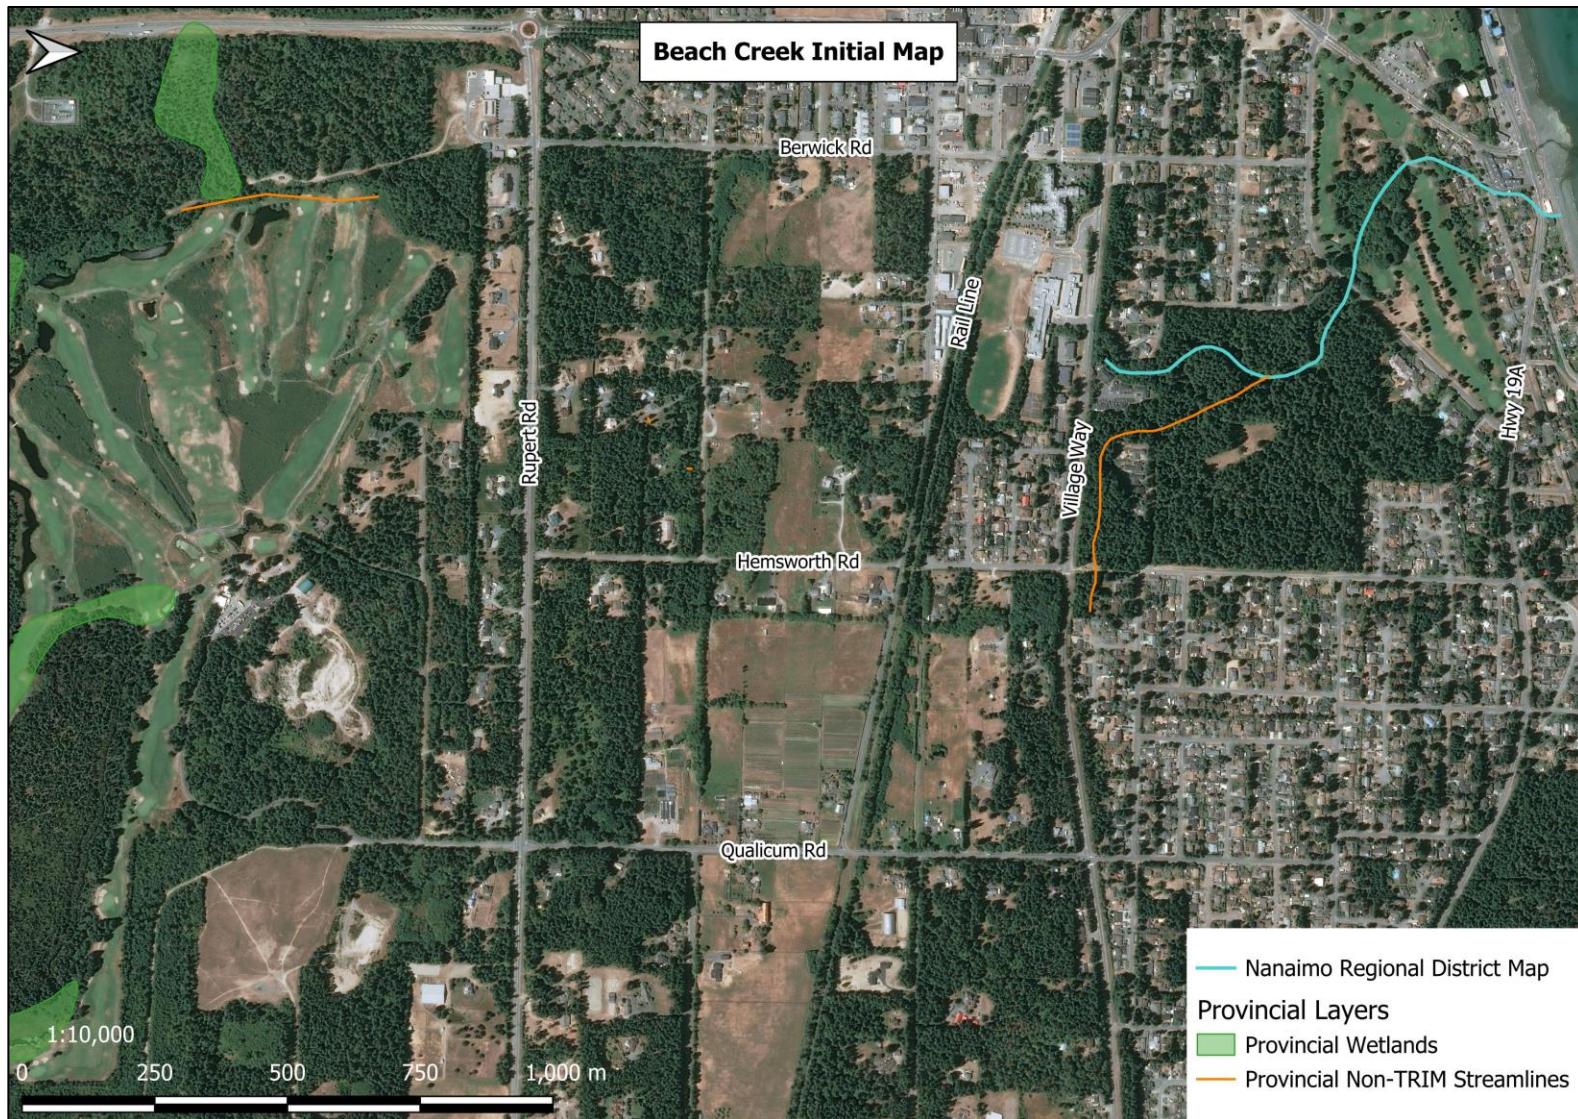
Figure 1. Initial Mapped Extent of Beach Creek, Qualicum Beach, BC.

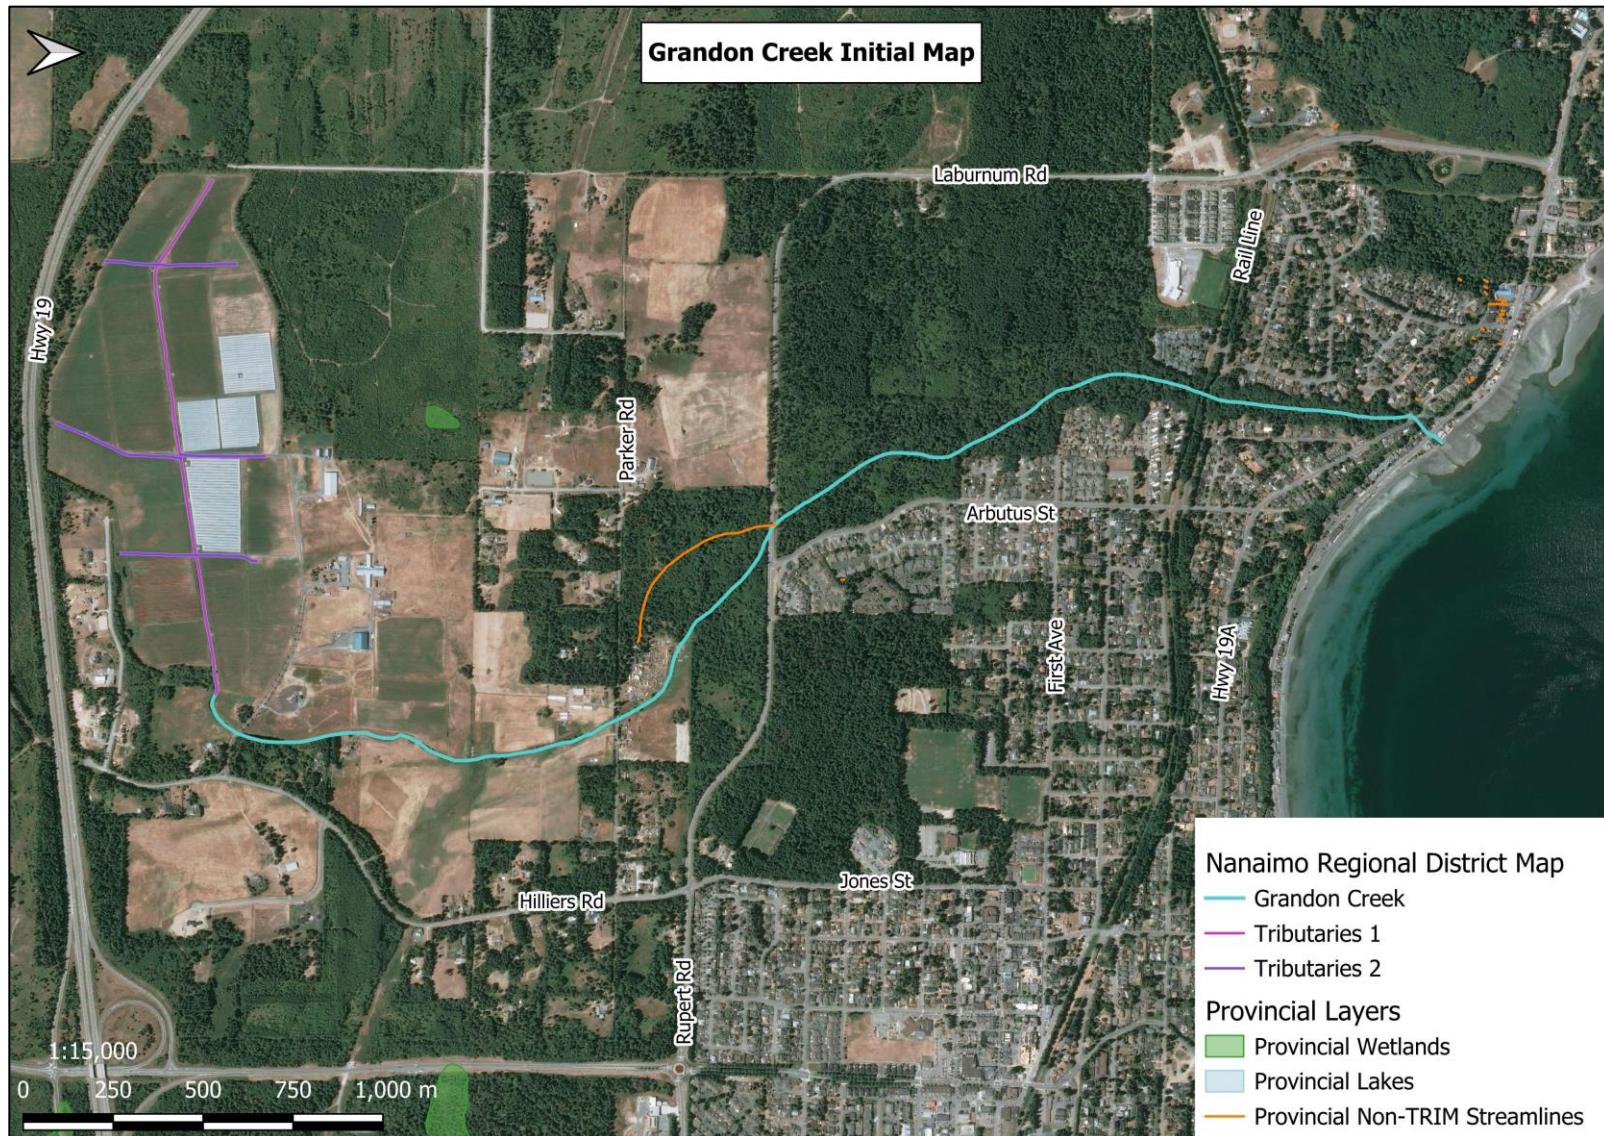
Figure 2. Initial Mapped Extent of Grandon Creek, Qualicum Beach, BC.

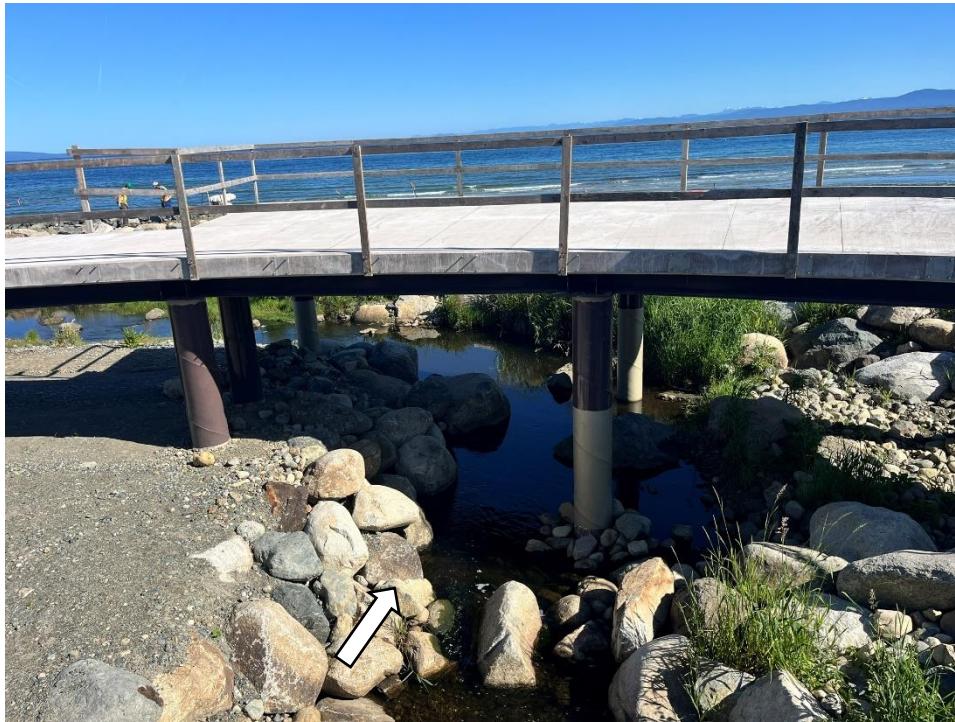
Figure 2. Outlet of Beach Creek under Hwy 19A, including fish-passable weirs. Arrow indicates flow direction. Photograph collected June 7, 2024.

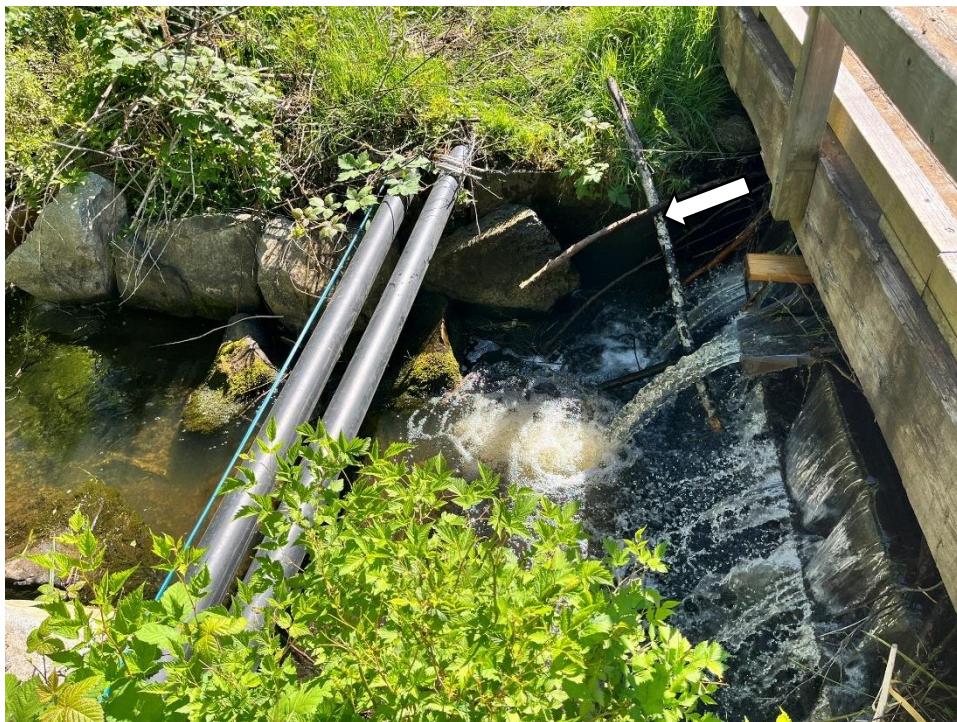
The constructed pond acts as a water feature and is regulated by a small dam. The pond is predominantly void of large trees within the riparian zone; the riparian zone averages 5 m in width and is composed primarily of shrubs and aquatic vegetation (i.e., reeds and sedges). Coho parr were observed near the margins of the pond, where the fish were utilizing overhanging and in-water vegetation for refuge. The outlet from the pond is perched and consists of a ~1.1 m drop over the dam structure. The dam height is controlled by the placement of stop logs (timber boards) that can be removed to enable fish passage upstream during spawning season. QBS team members provided dam operational information regarding fish passage.

Figure 4. Outlet from Golf Course pond beneath foot bridge: drop of ~1 m, though the drop is reduced to 0.8 m with boards removed (fish-passable). Arrow indicates flow direction. Photograph collected June 7, 2024.

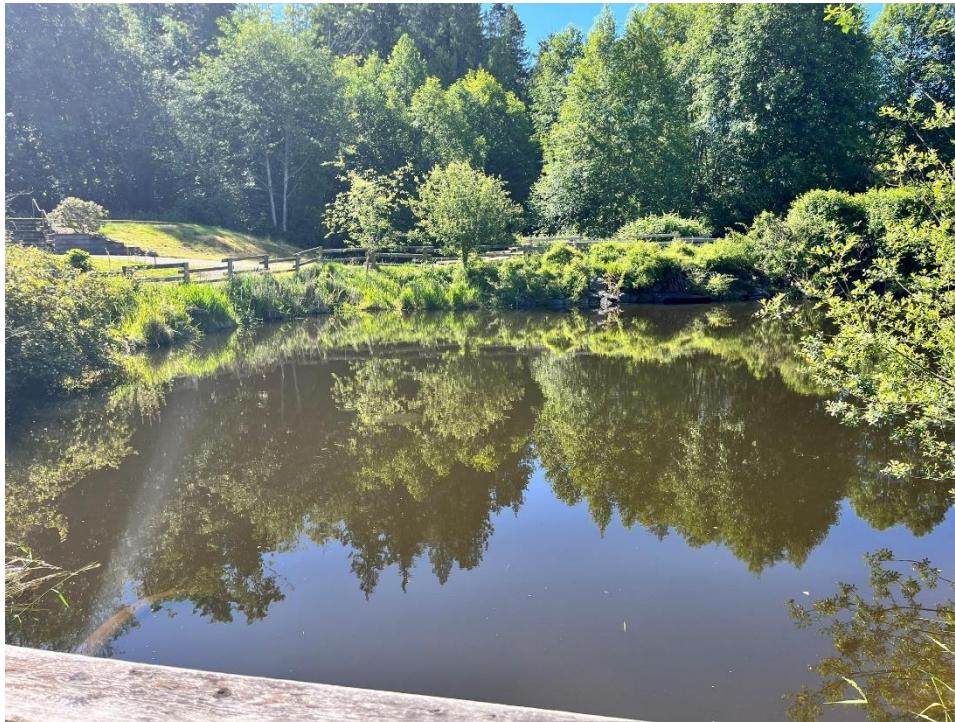
Figure 5. View of the Qualicum Memorial Golf Course pond with increased solar radiation and minimal riparian vegetation to provide shading. Coho fry observed. Photograph collected June 7, 2024.

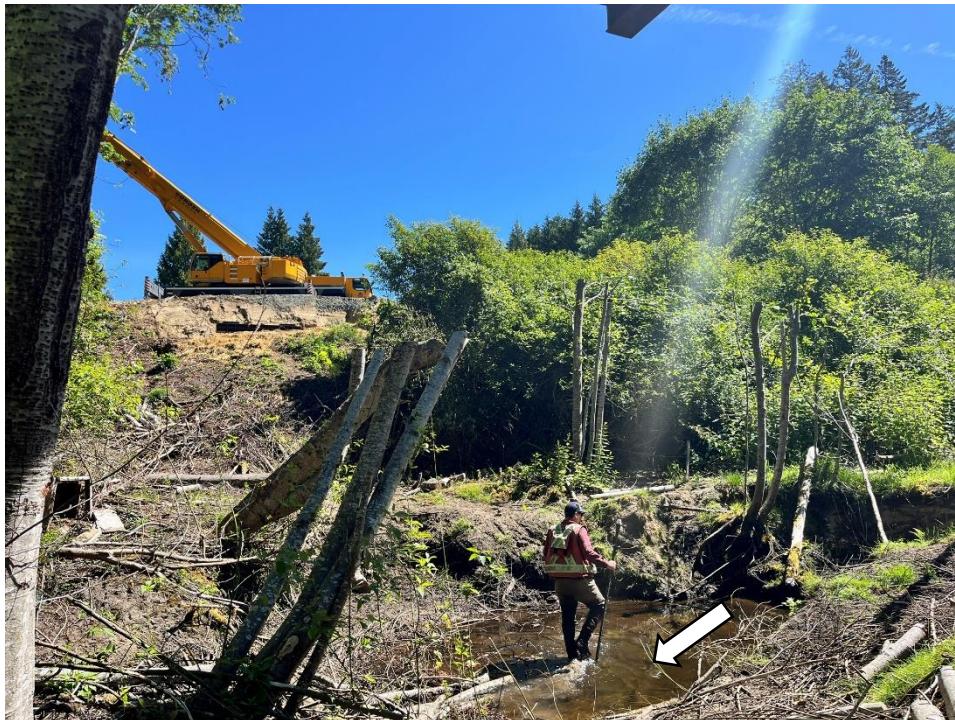
The riparian clearing that occurred upstream was to enable the construction of a new pedestrian/golf cart bridge from the top of the ravine banks. Several large trees were removed, and both ravine banks were replanted with riparian vegetation. Silt fencing and straw bales were observed to have been installed to mitigate sediment and erosion concerns. Coho salmon parr/fry were observed just upstream of this area at the culvert under Crescent Rd E.

Figure 7. Disturbed area for construction of new pedestrian/cart bridge at the Qualicum Beach Memorial Golf Course. Erosion and Sediment control concerns. Arrow indicates flow direction. Photograph collected June 7, 2024.

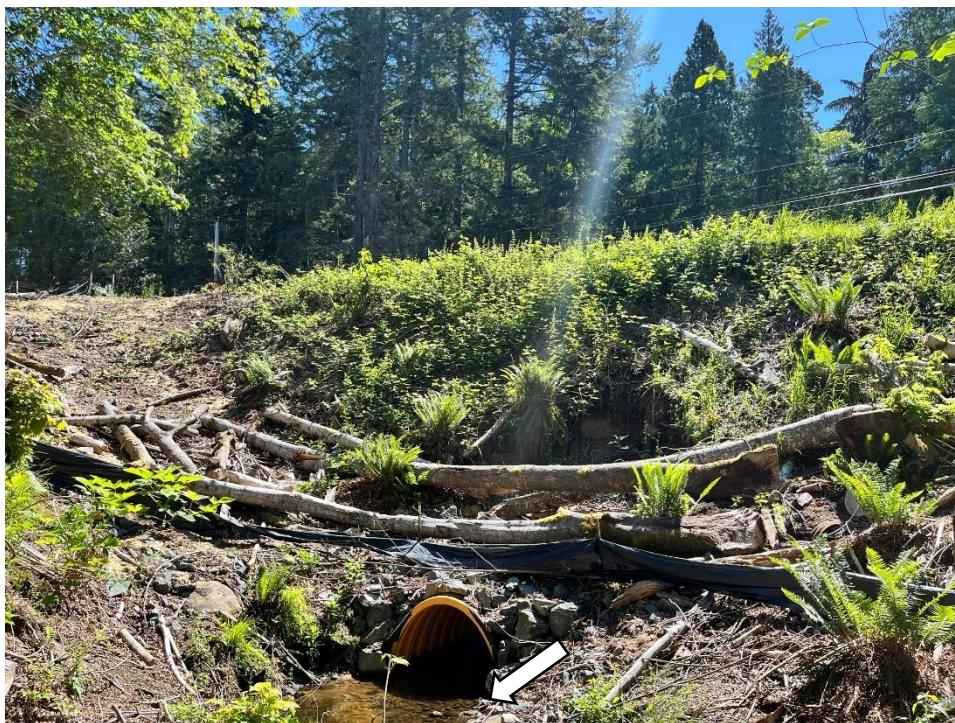
Figure 8. Outlet of culvert under Crescent Road E. Riparian remediation planting and sediment and erosion control measures in place. Arrow indicates flow direction. Photograph collected June 7, 2024.

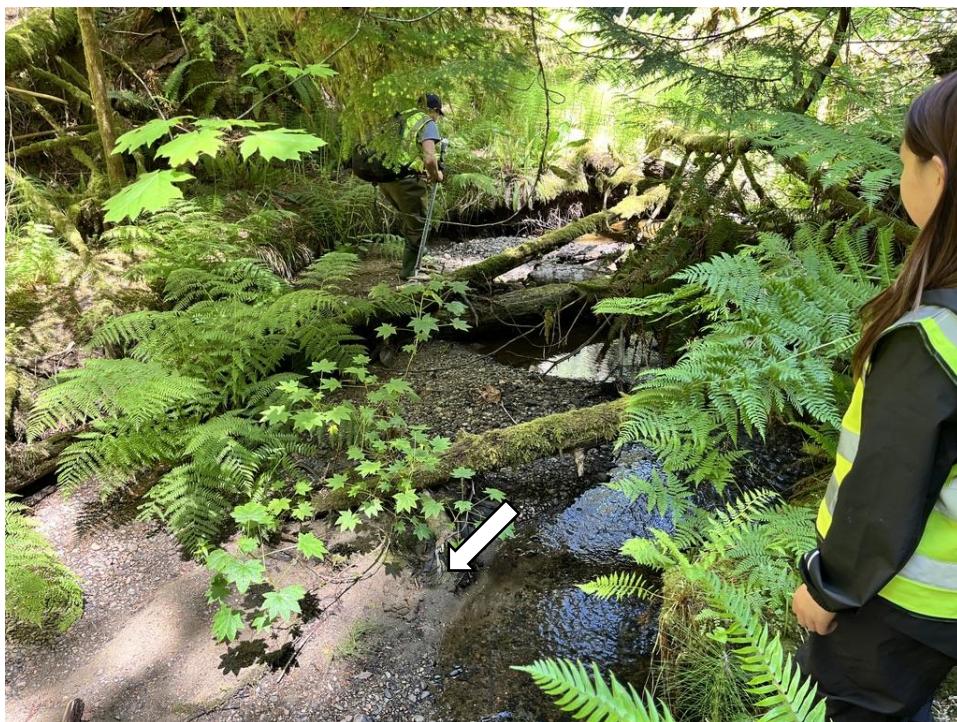
Figure 11. Representative view of gravel habitat in the creek bed within the Heritage Forest. Arrow indicates flow direction. Photograph collected June 7, 2024.

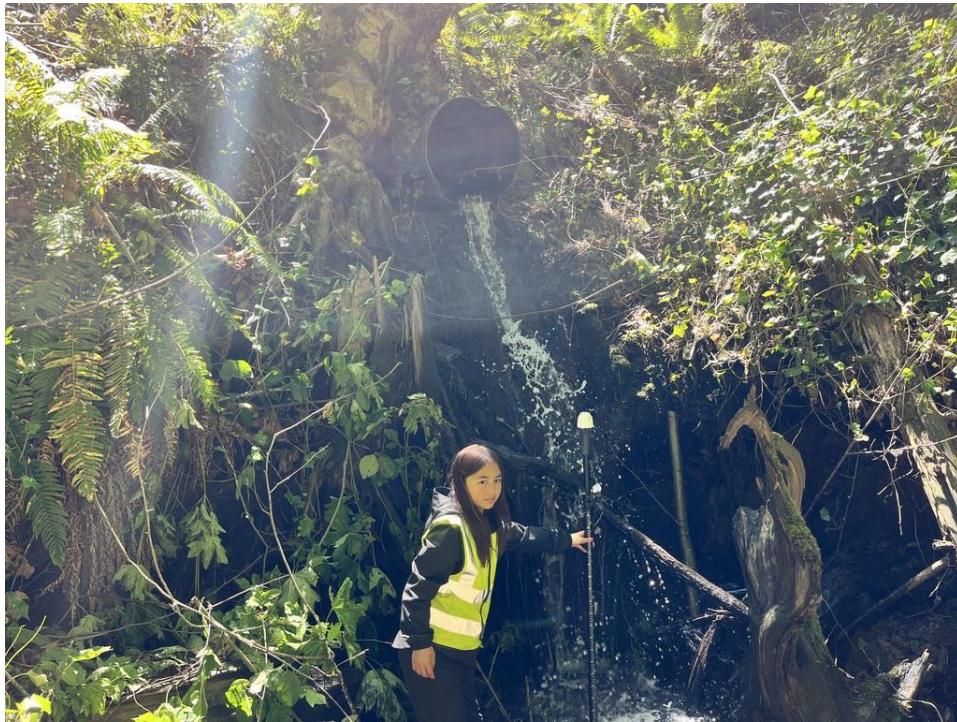
Figure 13. Perched culvert under Village Way from School Creek tributary. Culvert drop is 3.2 m (fish barrier). Arrow indicates flow direction. Photograph collected June 7, 2024.

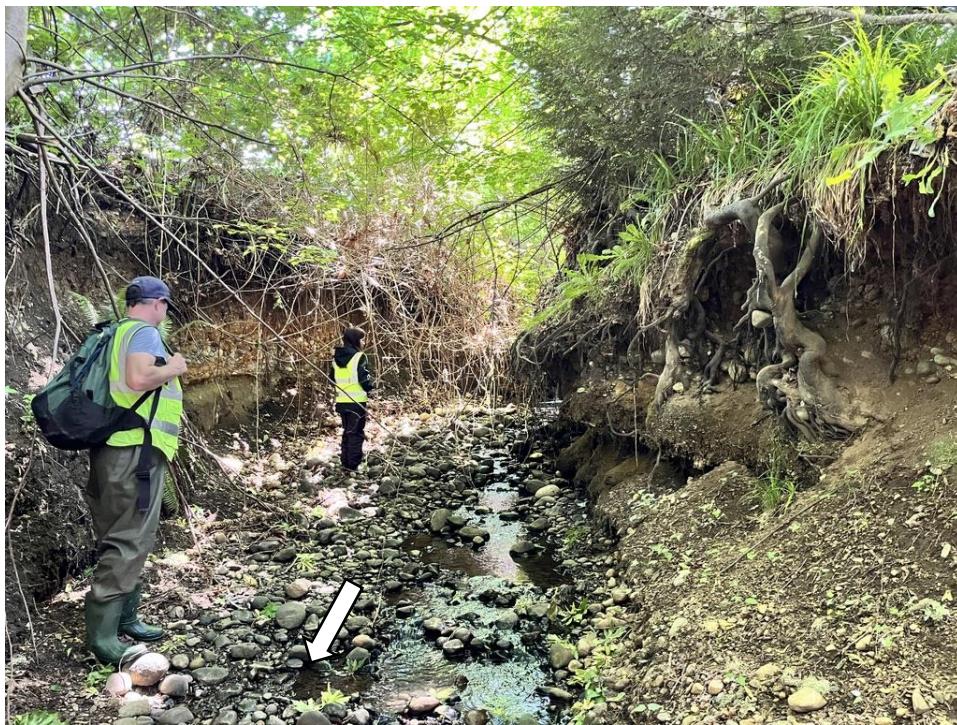
Figure 14. Representative view erosion concerns in School Creek tributary upstream of Village Way. Arrow indicates flow direction. Photograph collected June 7, 2024.

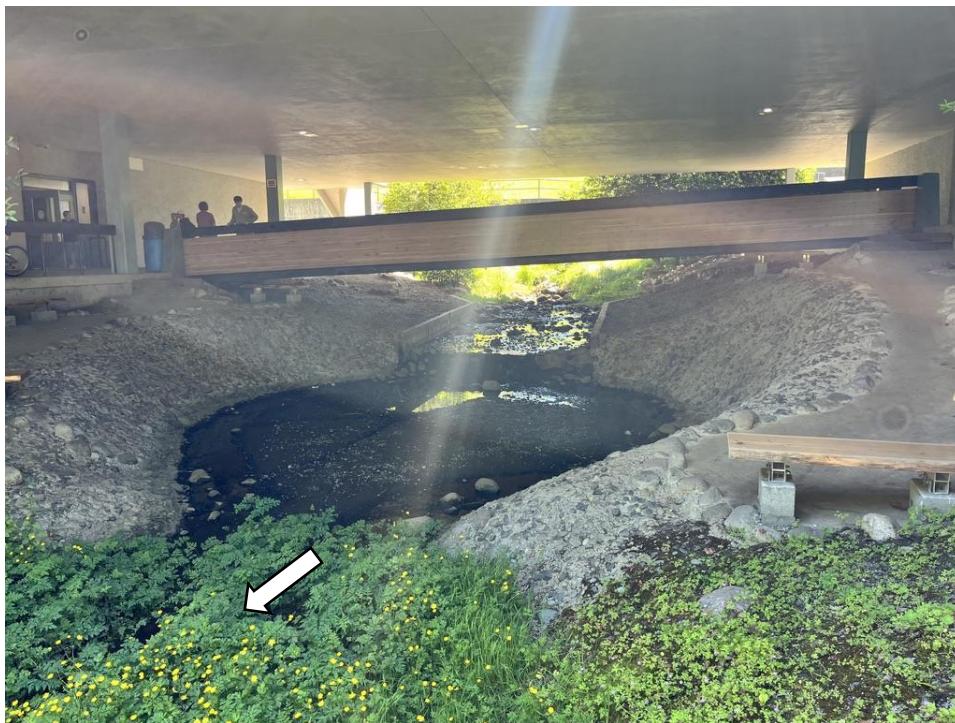
Figure 16. Representative view of School Creek tributary outflow from beneath Kwalicum Secondary School sports fields. Arrow indicates flow direction. Photograph collected June 7, 2024.

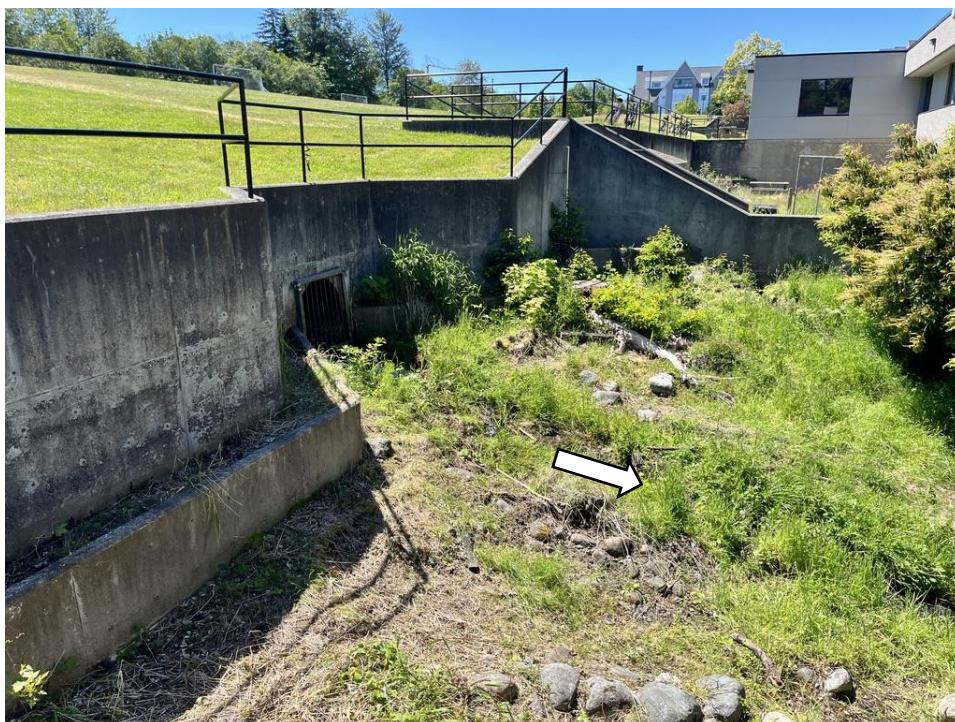
Figure 17. Representative view of the culvert inflow of School Creek tributary beneath the Kwalicum Secondary School sports fields. Arrow indicates flow direction. Photograph collected June 7, 2024.

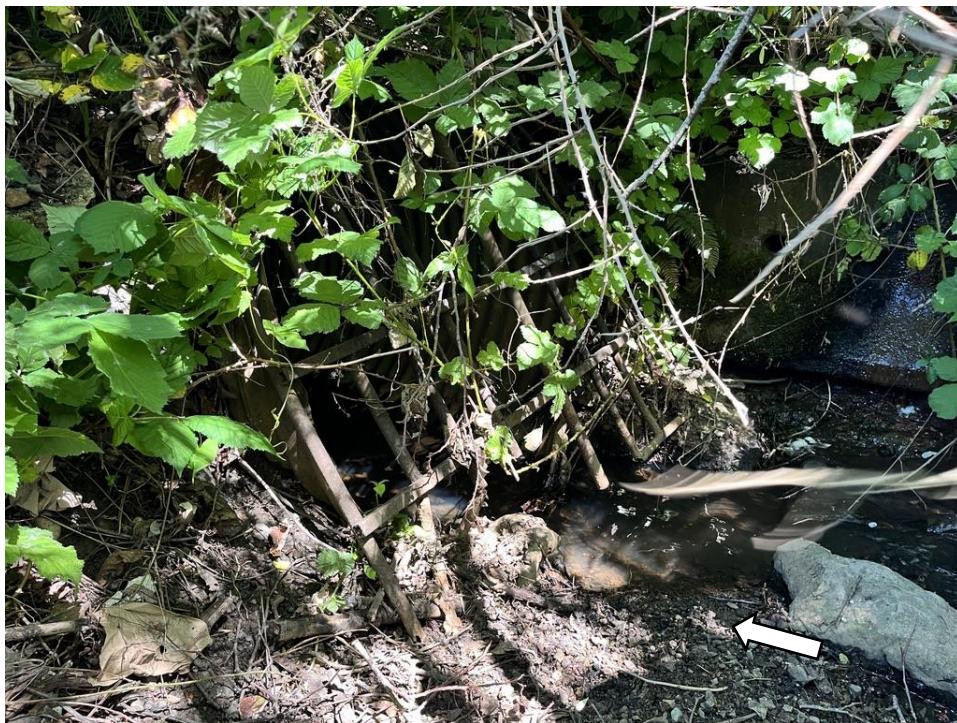
Figure 18. Representative view of the culvert inflow beneath the rail line. Arrows indicate flow direction. Photograph collected June 7, 2024.

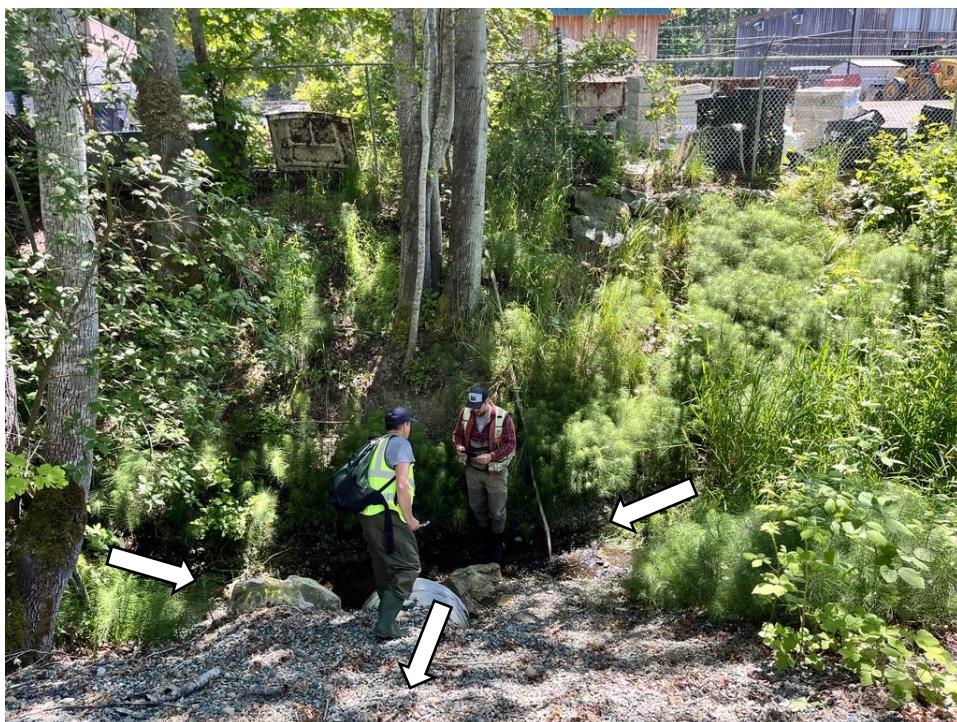
Figure 19. Representative view of the culvert inflow into railway ditching from the City of Qualicum Beach Stormwater system at the corner of Second Avenue E and Berwick Road S. Arrow indicates flow direction. Photograph collected June 7, 2024.

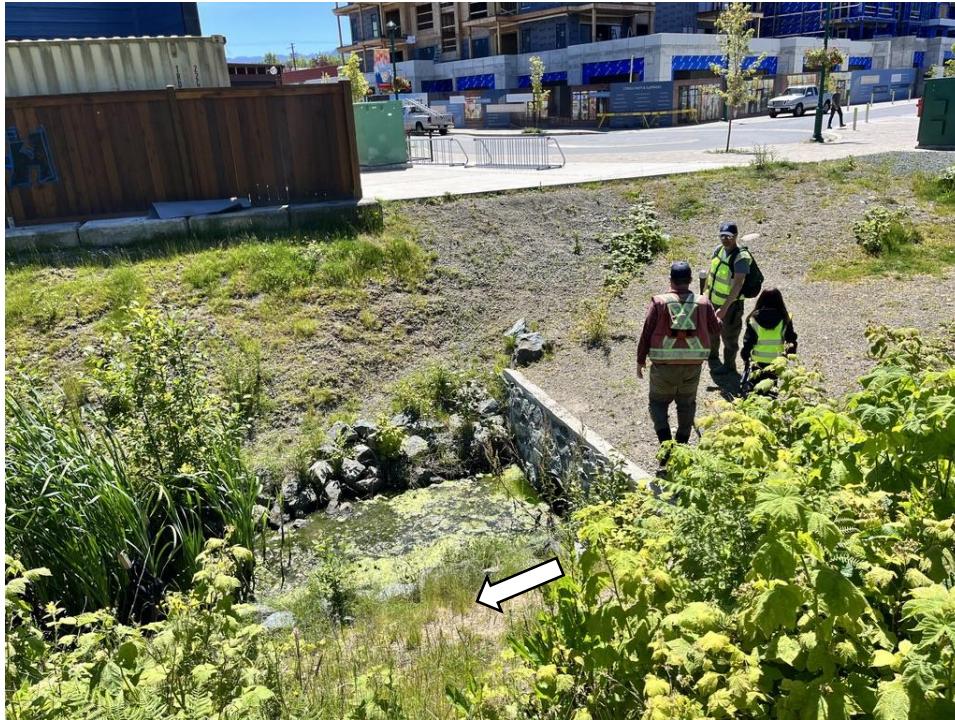
Figure 20. Newly identified river right tributary. Streambed mostly organics and fines, little gravel, likely ephemeral. Arrow indicates flow direction. Photograph collected December 2, 2024.

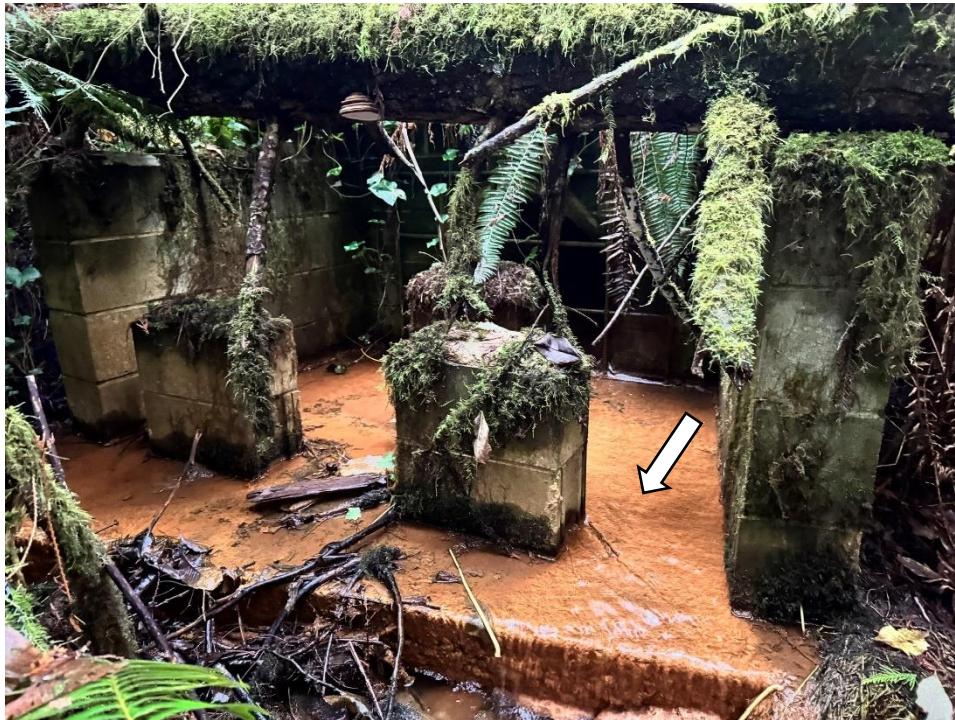
Figure 21. Historic culvert with weirs in river right tributary. Connects to City Stormwater (red algae abundant). Arrow indicates flow direction. Photograph collected December 2, 2024.

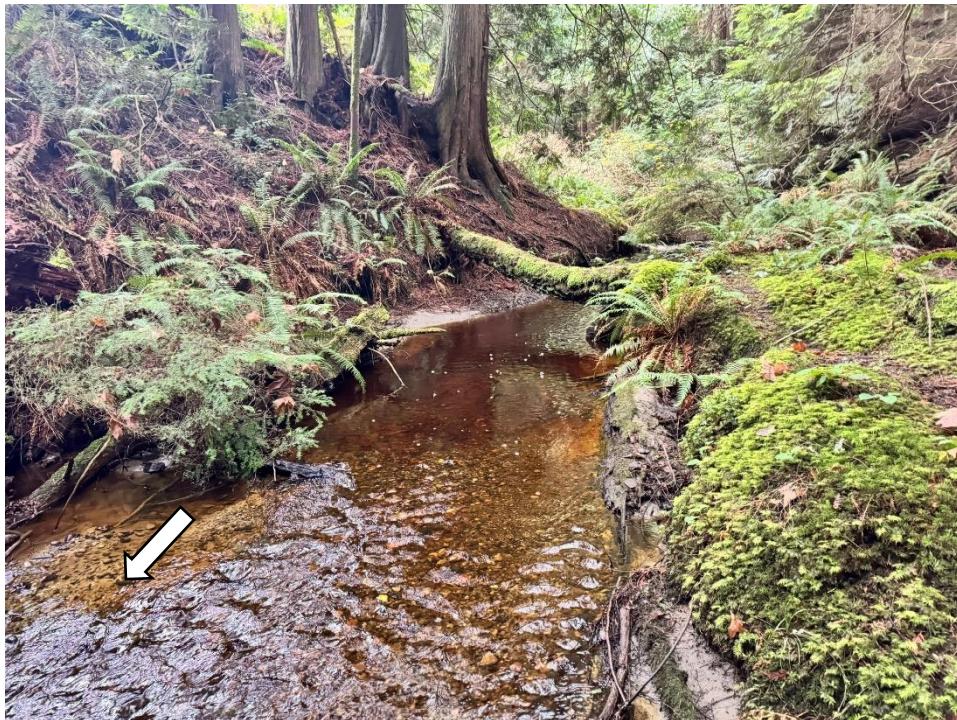
Figure 24. Representative view of Beach Creek mainstem. Gravel very suitable for Coho spawning. Arrow indicates flow direction. Photograph collected December 2, 2024.

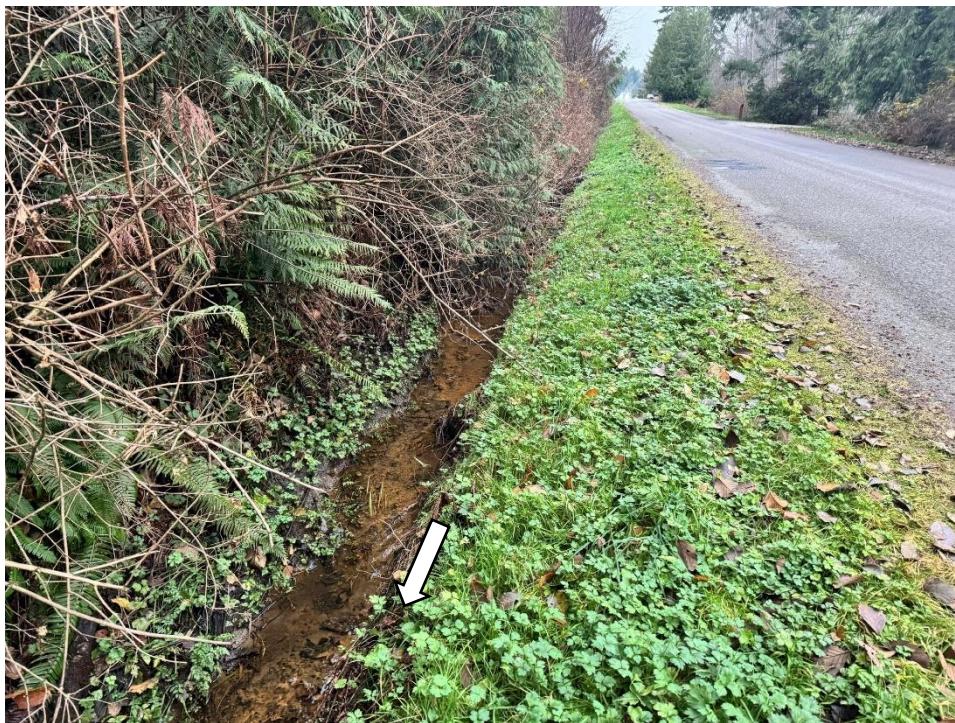
Figure 32. View of the culvert under Garden Road at the intersection with Hemsworth Rd. Arrow indicates flow direction. Photograph collected December 2, 2024.

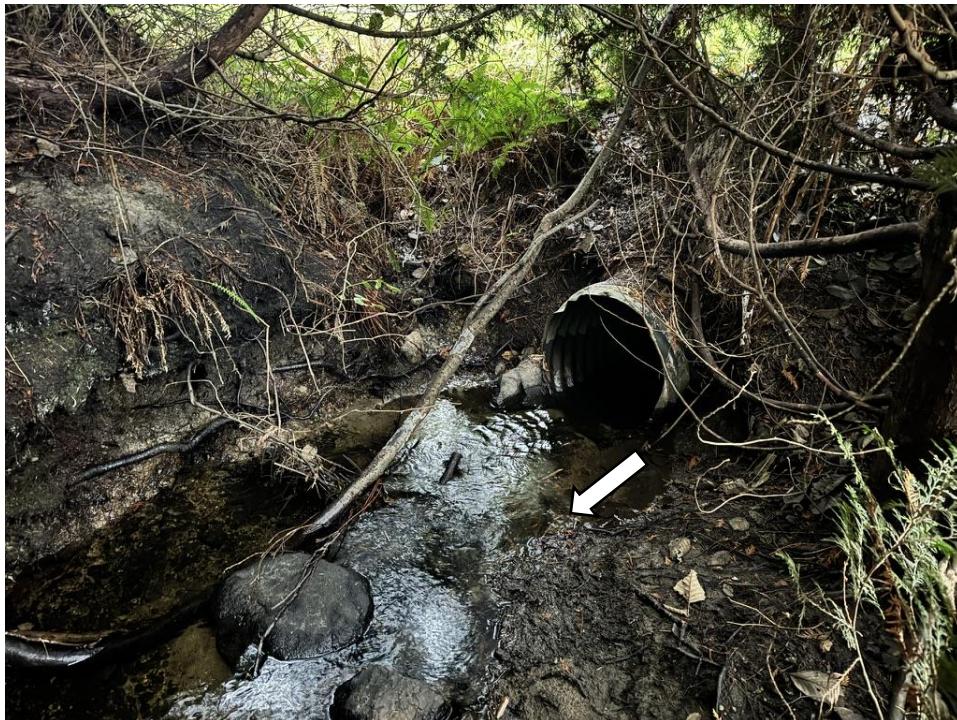
Figure 34. View downstream from Nenzel Road of the channelized portion of Beach Creek mainstem. Arrow indicates flow direction. Photograph collected December 2, 2024.

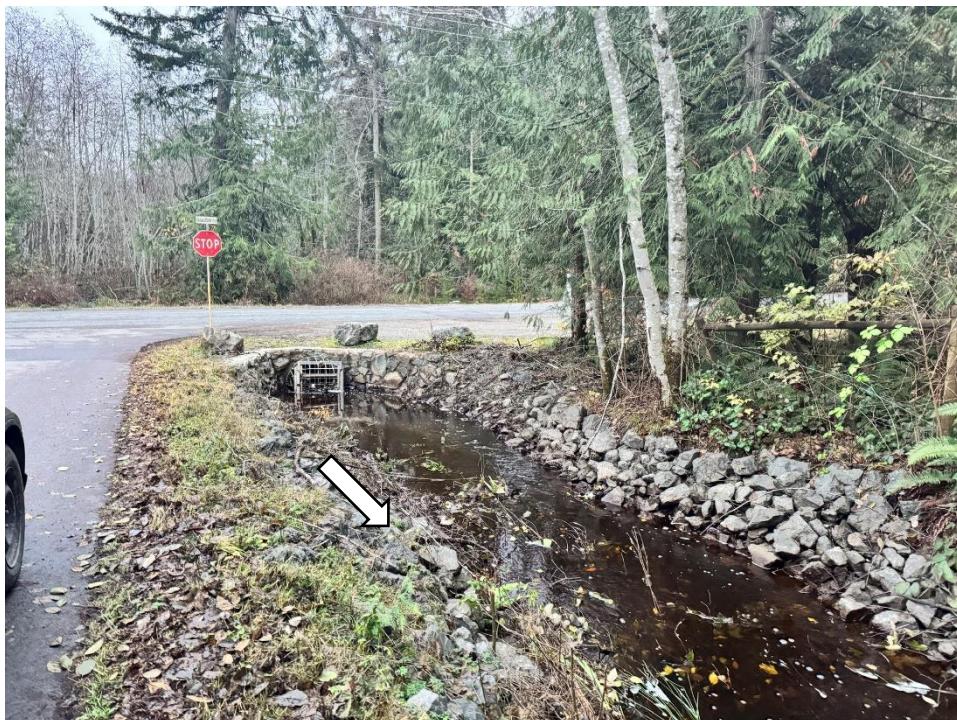
Figure 35. View upstream from the intersection of Nenzel Road and Qualicum Road of the Beach Creek mainstem. Arrow indicates flow direction. Photograph collected December 2, 2024.

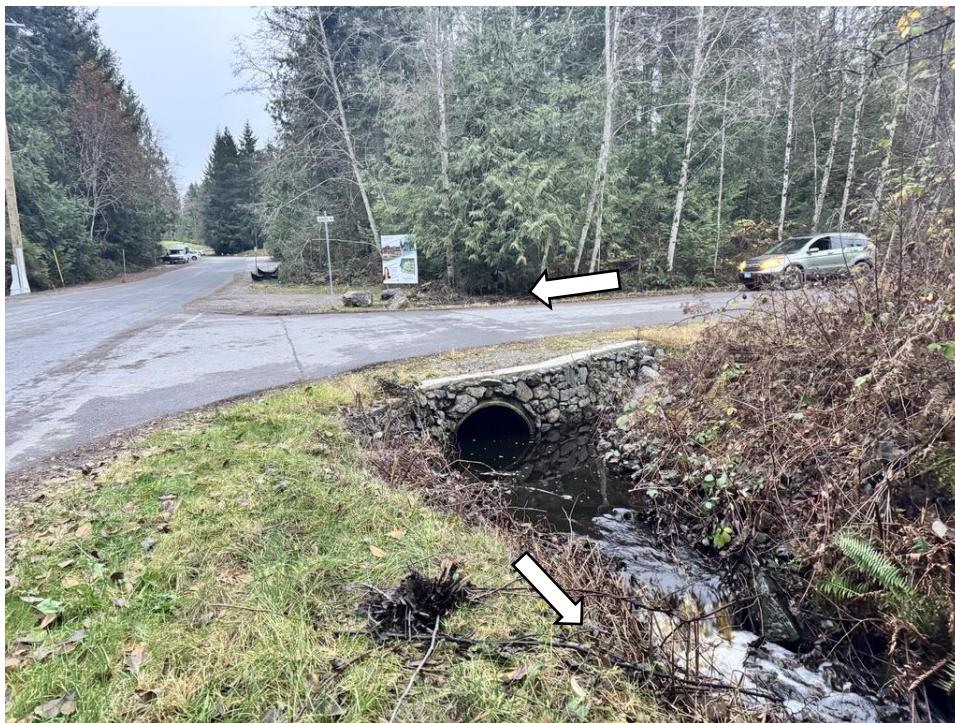
Figure 36. Example view of drainage upland of the Pheasant Glen Golf Course. Arrow indicates flow direction. Photograph collected December 2, 2024.

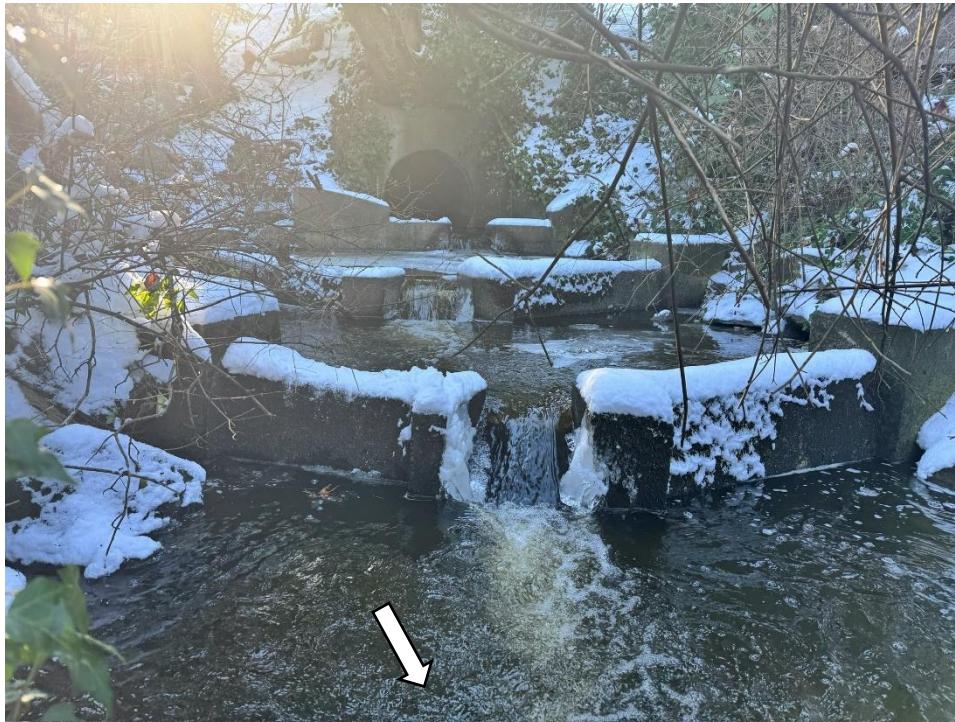
There were no observed fish barriers within this section of the mainstem of Grandon Creek. There are concrete fish ladders at the confluence with the ocean below Hwy 19A, and there are ~85 m of daylighted culverts between Hwy 19A and Crescent Rd to encourage fish passage upstream into Grandon Creek Trail Park. These improvements downstream of Grandon Creek Trail Park appears to be effective in allowing the anadromous migration upstream, as supported by Coho fry observations upstream during the survey (February 2025). In addition, the Qualicum Beach Streamkeepers (QBS) and the City of Qualicum Beach have completed other restoration works within the park in recent years (i.e., pool construction, LWD placement, and spawning gravel placement).

Figure 1. Constructed concrete weirs below Hwy 19A (fish passage). Arrow indicates flow direction. Photograph collected February 12, 2025.

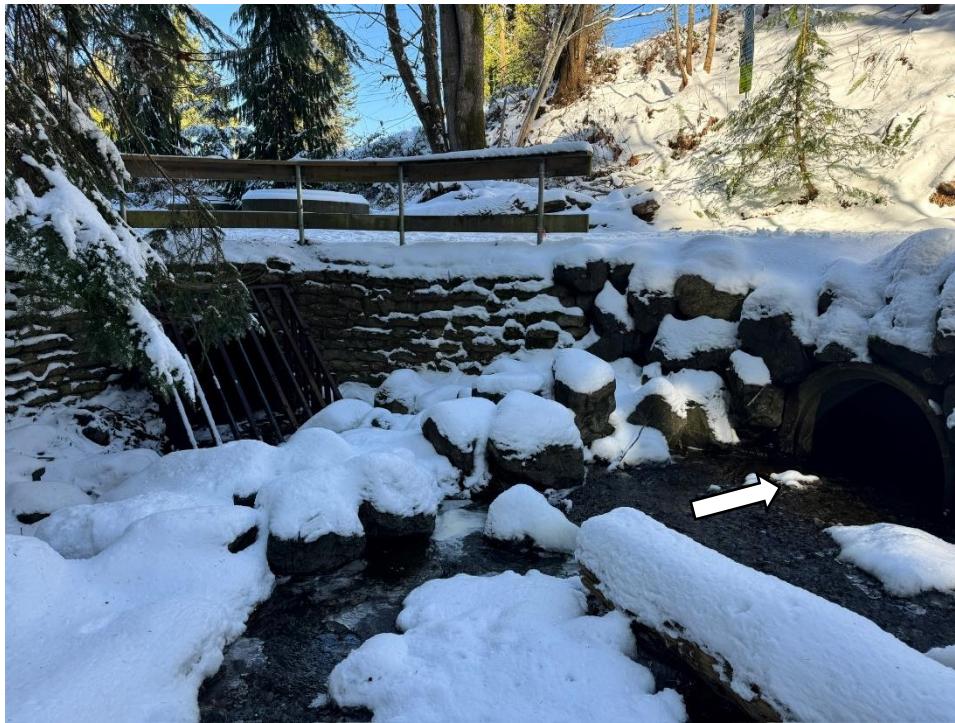
Figure 2. Inlet of culverts (including daylighting system) under Crescent Road at Grandon Creek Trail Park (culvert with grate accommodates high flows). Arrow indicates flow direction. Photograph collected February 12, 2025.

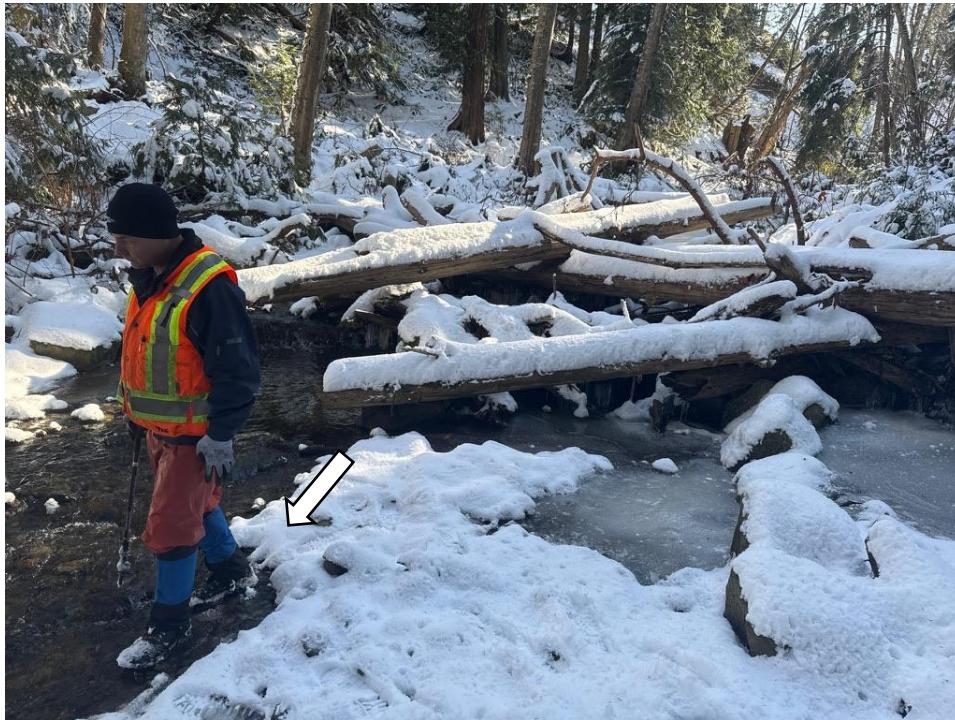
Figure 4. Representative view of the streambed habitat of boulder-cobble-gravel within Grandon Creek Trail Park. Arrow indicates flow direction. Photograph collected February 12, 2025.

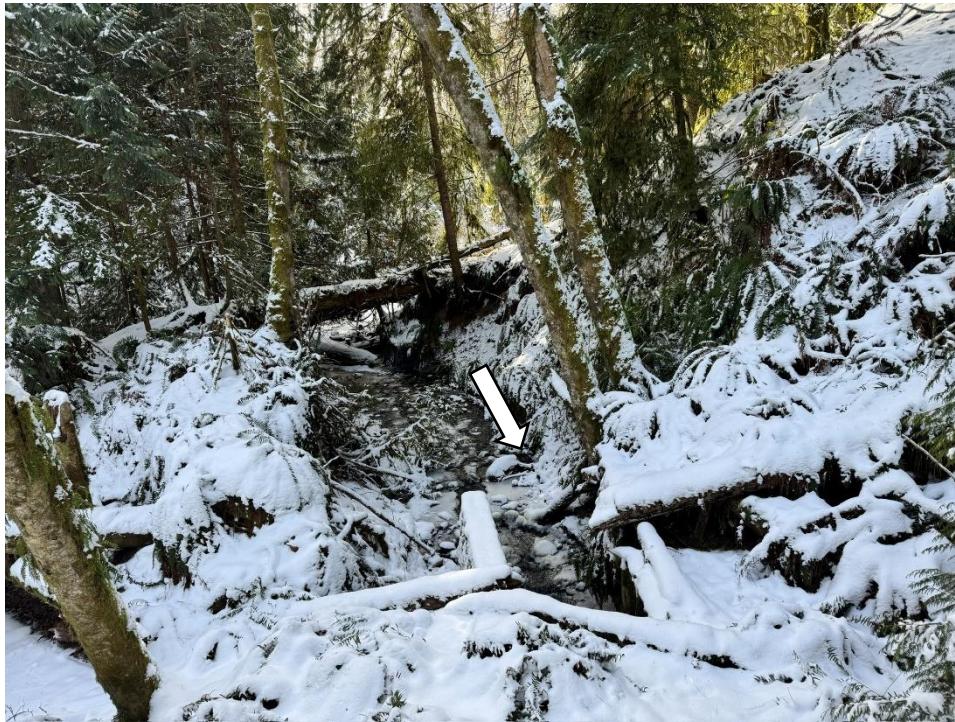
to fish passage in the past due to its length (~88 m), a change in direction leaving no visible exit, and a midpoint change in elevation. However, Coho salmon fry were observed upstream of Hoylake Rd during this assessment (February 2025). As such, we would classify the culvert as an obstacle to migration rather than an anadromous barrier. Passage concerns have been referred to DFO's Centre of Expertise (Peter Dekoning).

Figure 5. View upstream of the culvert inflow at Hoylake Road. Arrow indicates flow direction.

It is recommended to update the barrier assessment of the Hoylake Road culvert to determine fish passage limitations. Further engagement with DFO's Centre of Expertise is also encouraged to determine if fish passage within the existing culvert can be improved through the placement of baffles within the culvert or a ladder below.

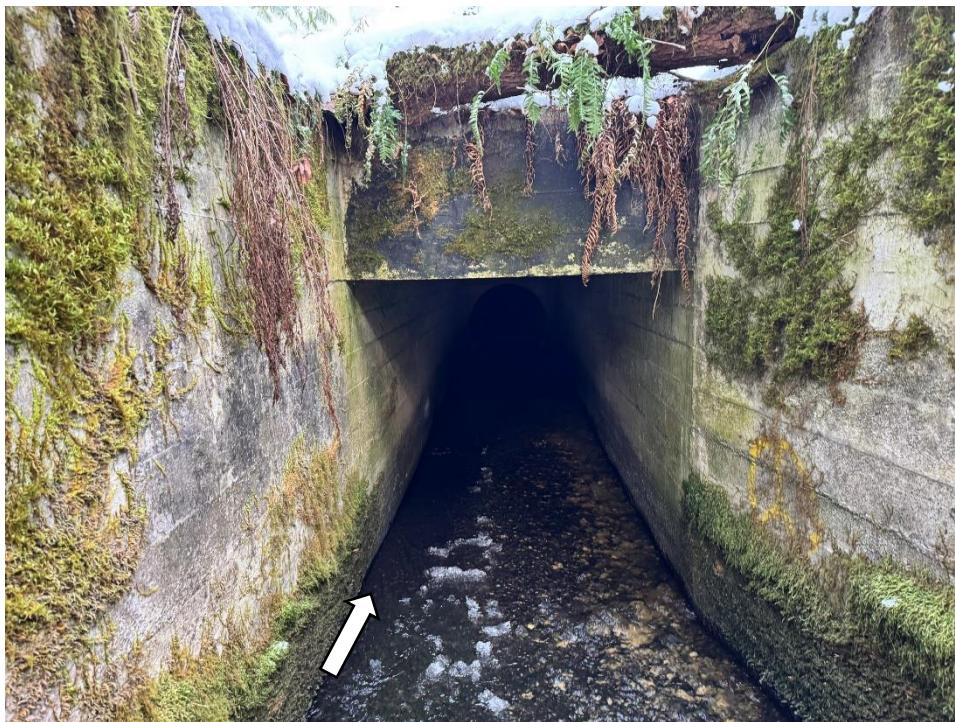
Figure 6. View downstream of the culvert under Hoylake Road. Arrow indicates flow direction.

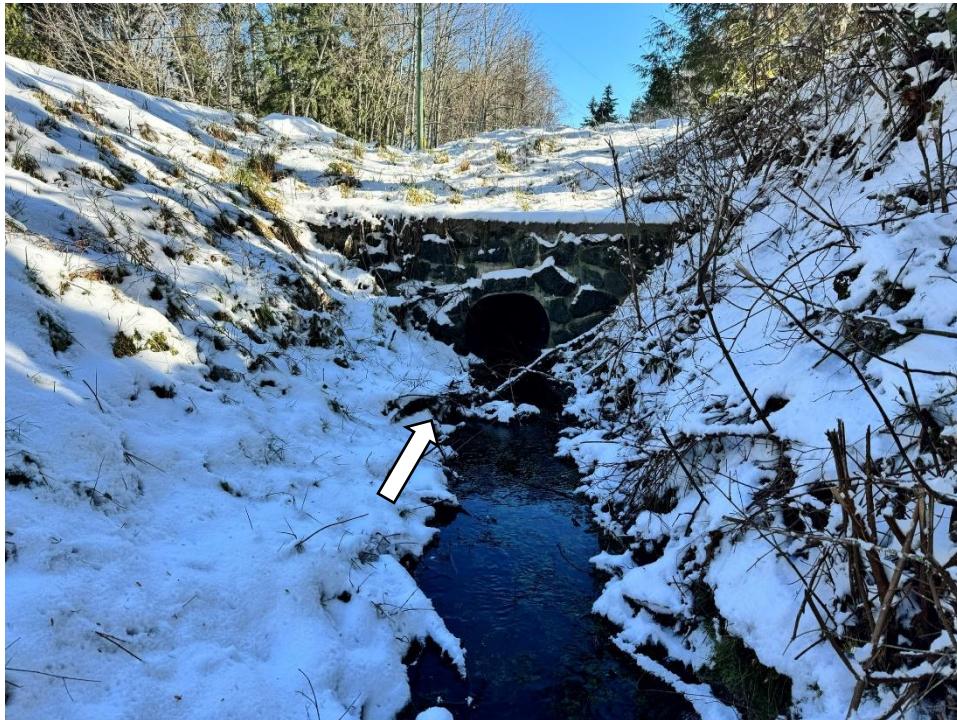
Figure 8. River left tributary ditching along rail trail. Photograph collected February 26, 2025.
