Stream Mapping Results Report

Beach Creek & Grandon Creek 2024-2025

Prepared for the Qualicum Beach Streamkeepers.

Date: September 15, 2025

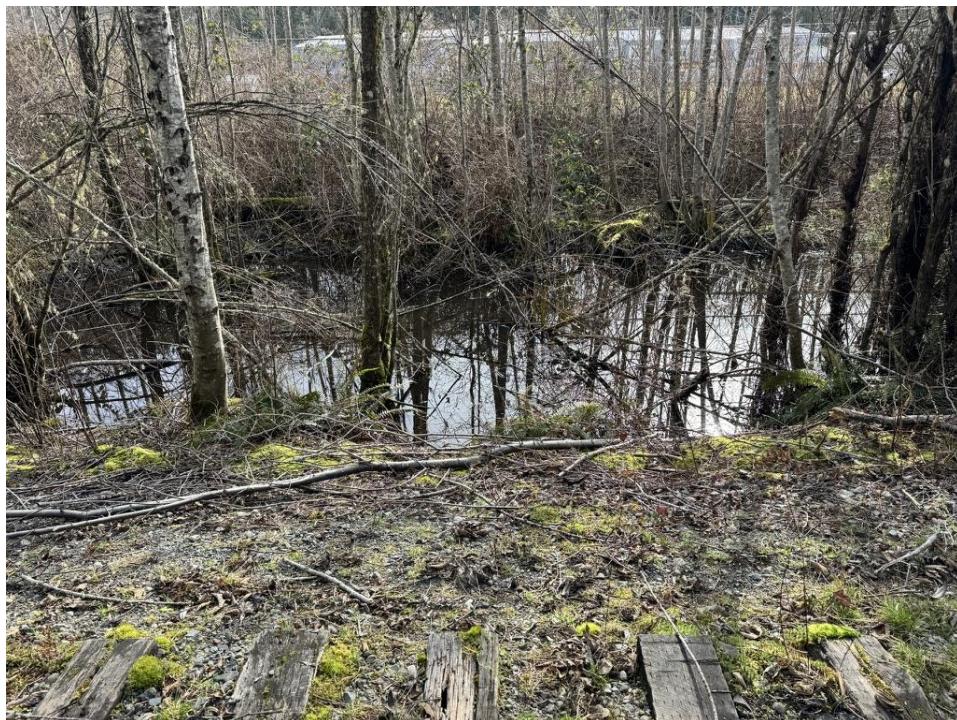
Figure 9. River left tributary ditching looking towards Laburnum Road. Arrow indicates flow direction. Photograph collected February 26, 2025.

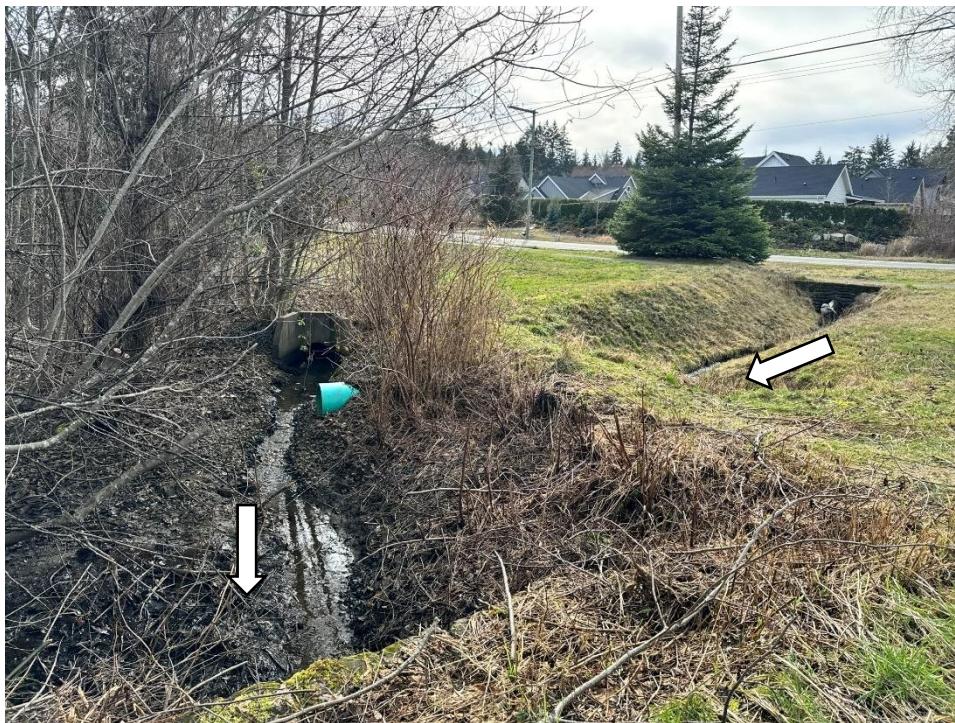
Figure 10. River right tributary along Hoylake Road. Arrow indicates flow direction. Photograph collected February 12, 2025.

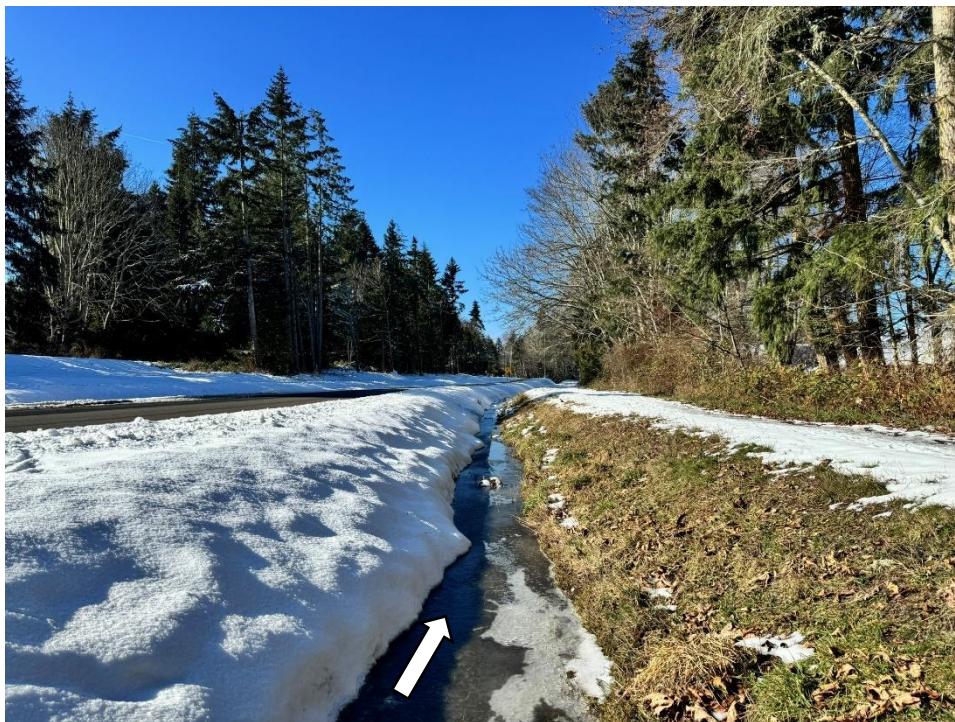
Figure 11. River right tributary culvert under Arbutus Street. Arrow indicates flow direction.
Photograph collected February 12, 2025

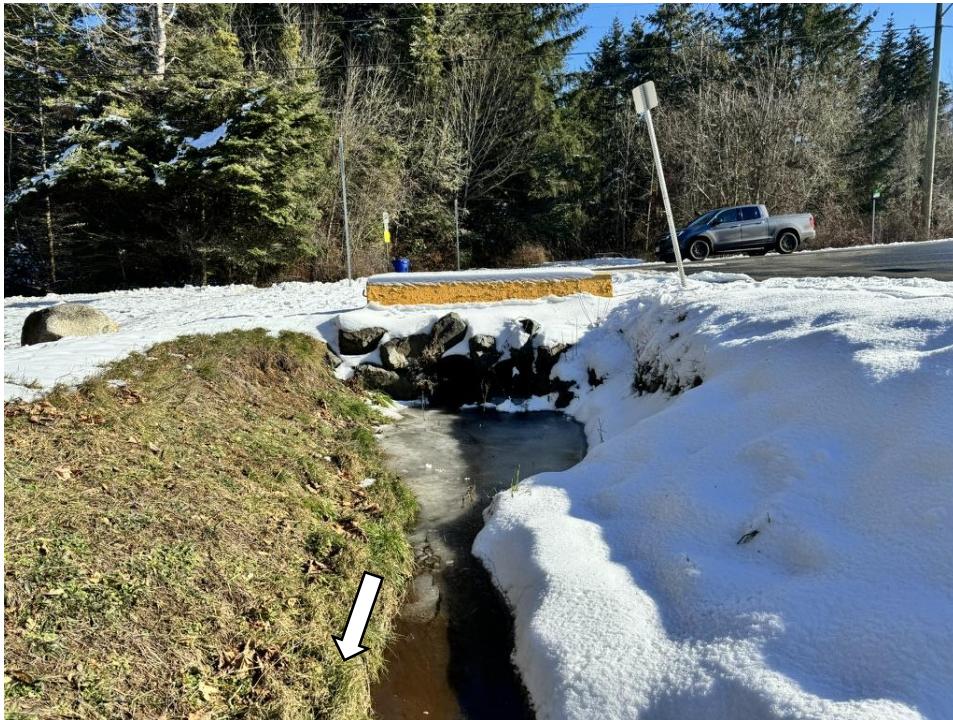
Figure 12. River right tributary culvert outflow under rail line. Arrow indicates flow direction.
Photograph collected February 12, 2025

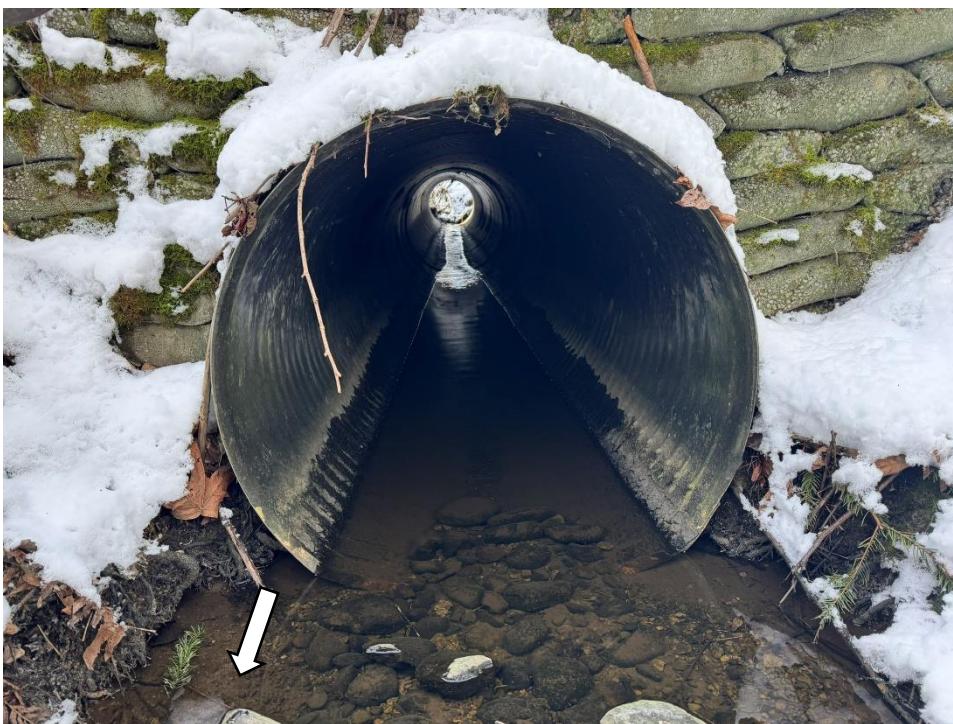
Figure 13. River right tributary culvert inflow under rail line. Arrow indicates flow direction.
Photograph collected February 12, 2025

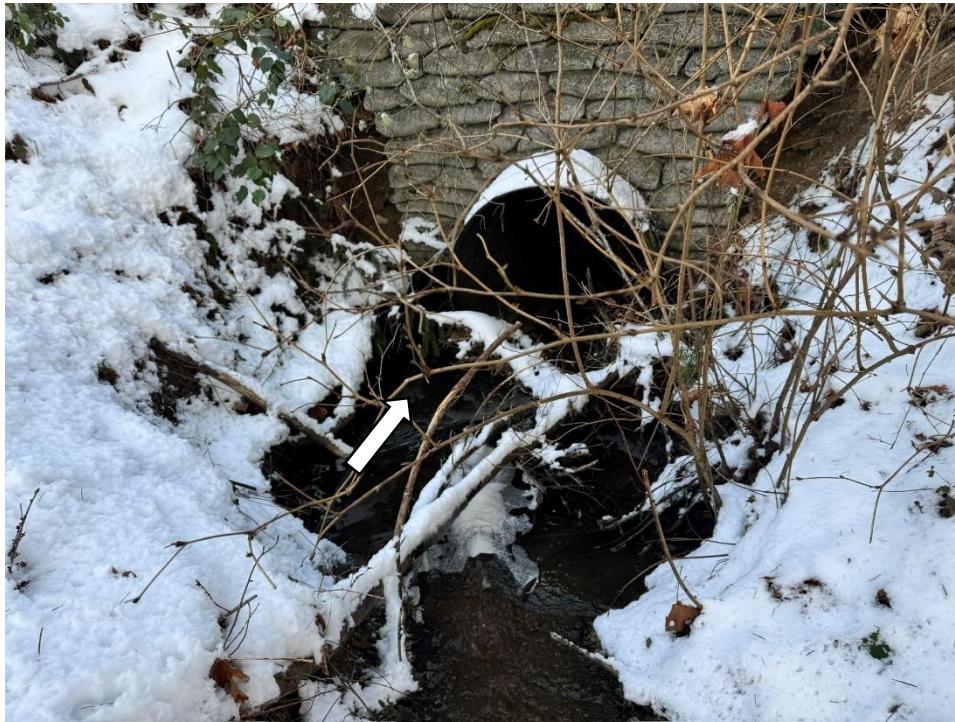
Figure 14. River right tributary along Harlech Road. Arrow indicates flow direction. Photograph collected February 12, 2025

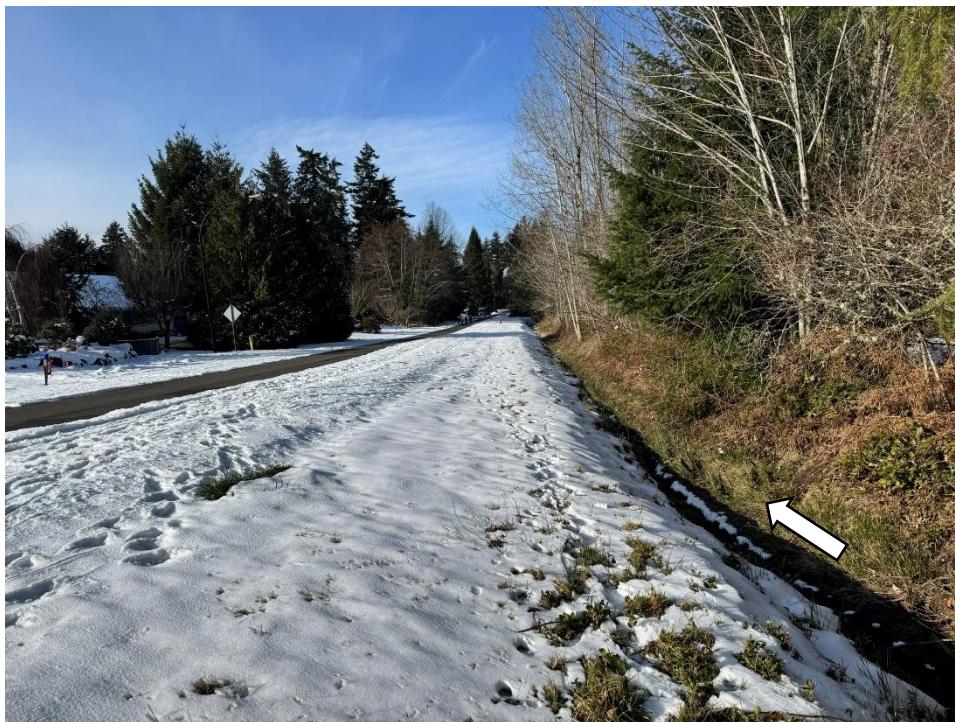
Figure 15. River right tributary along Hoylake Road sourced from City of Qualicum Beach stormwater at Harlech Road and Alder Street. Arrow indicates flow direction. Photograph collected February 12, 2025.

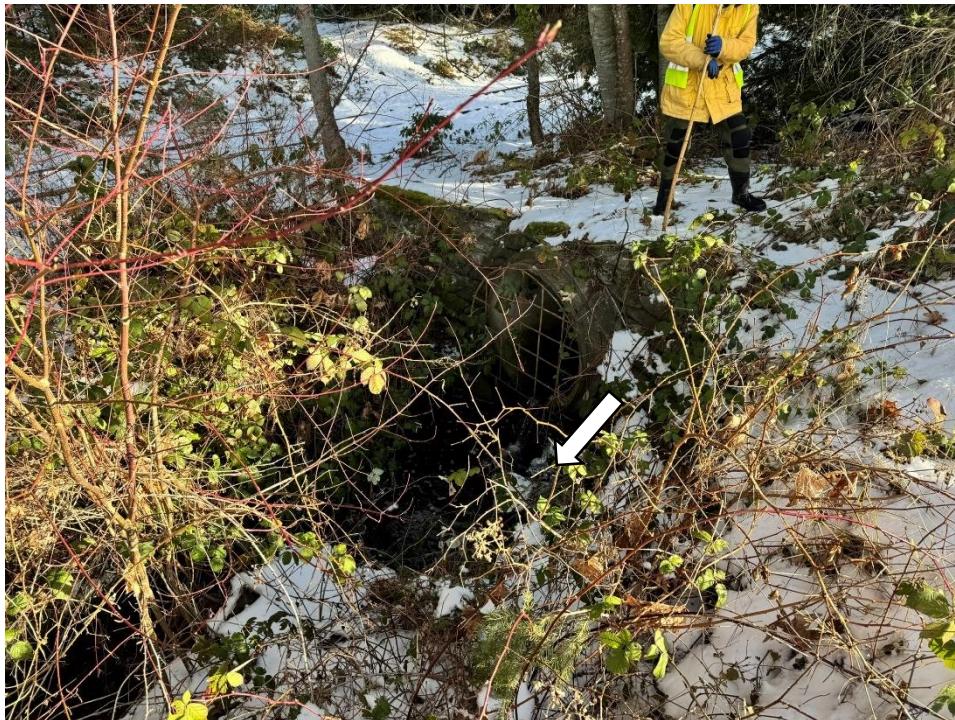
Figure 16. Small river right tributary near Claymore Road in a steep gully. Arrow indicates flow direction. Photograph collected February 12, 2025

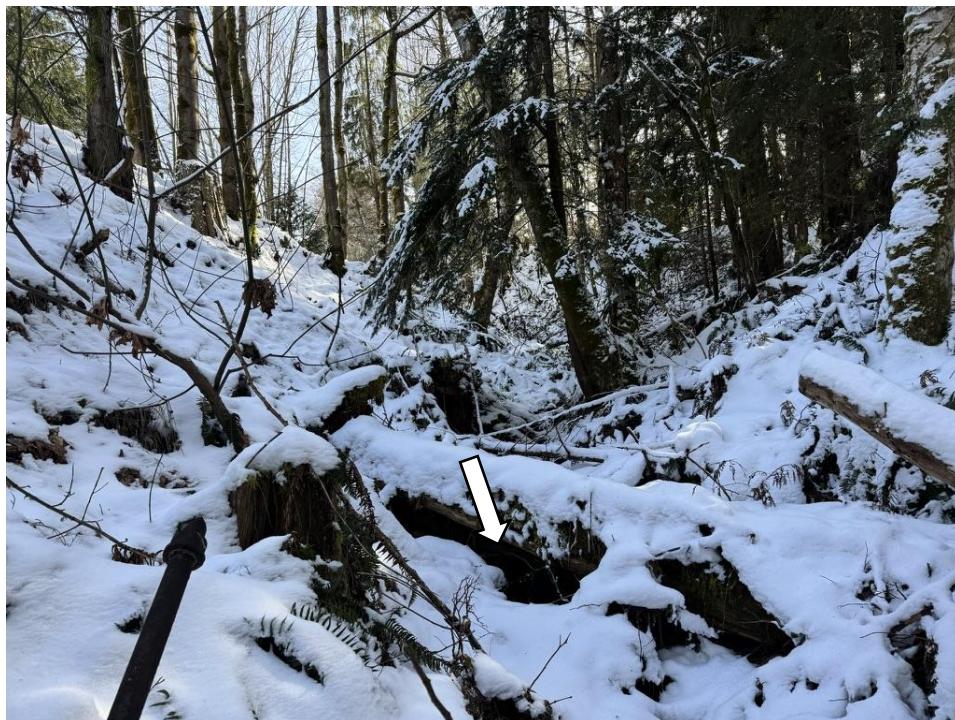
Figure 17. Representative view of the riparian habitat of Grandon Creek within Nature's Garden Park. Arrow indicates flow direction. Photograph collected February 12, 2025.

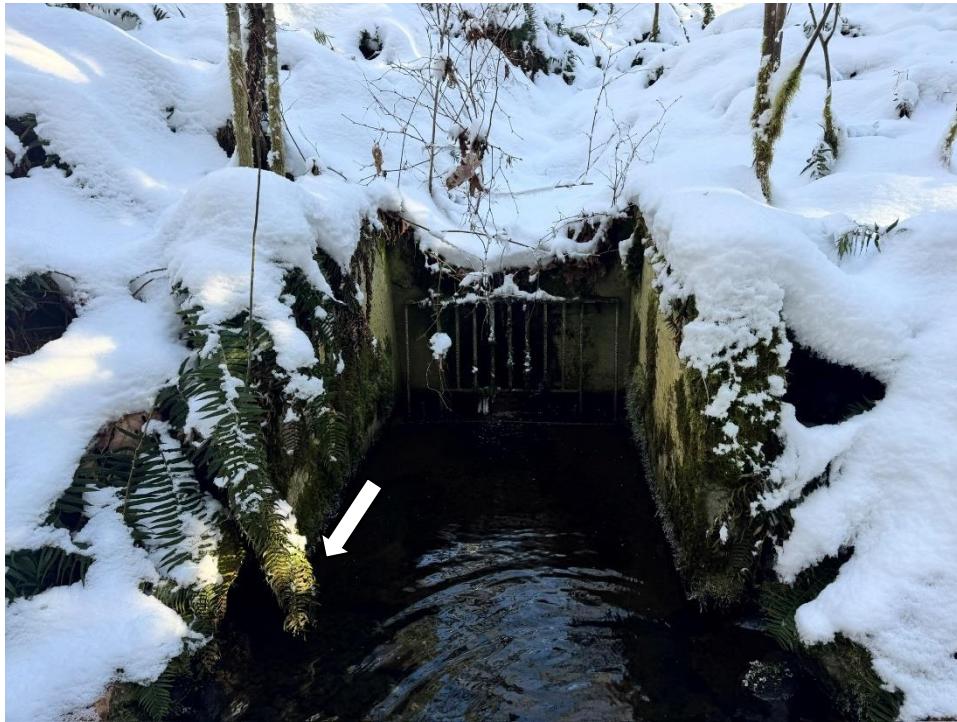
Figure 20. Example of piped rainwater runoff from residential areas into Grandon Creek. Arrow indicates flow direction. Photograph collected February 12, 2025.

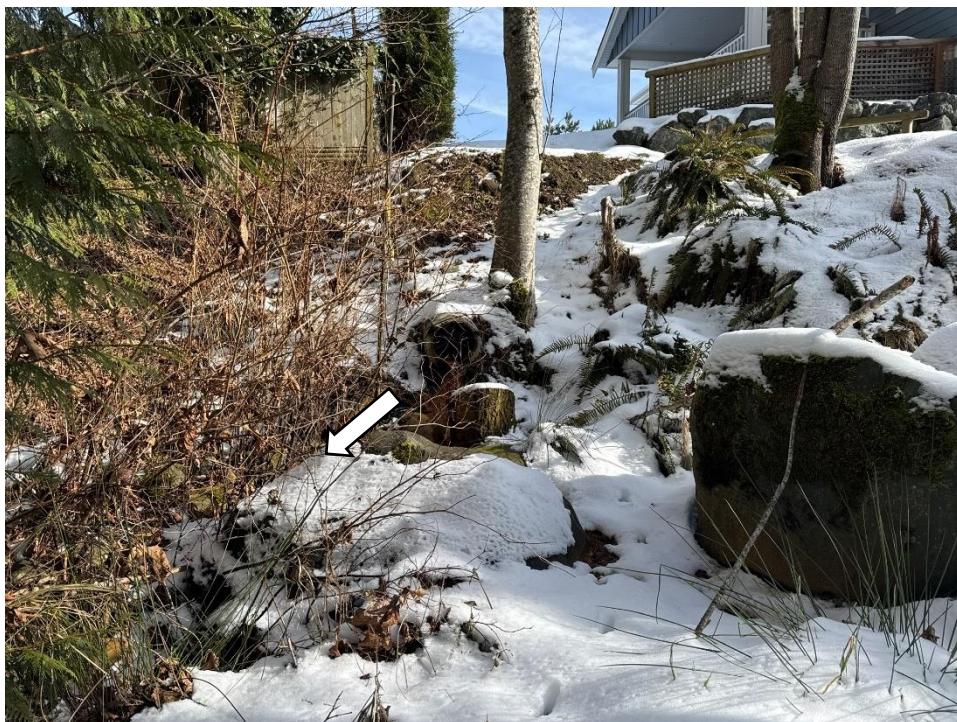
Figure 21. Rupert Road box culvert outflow. Arrow indicates flow direction. Photograph collected February 12, 2025.

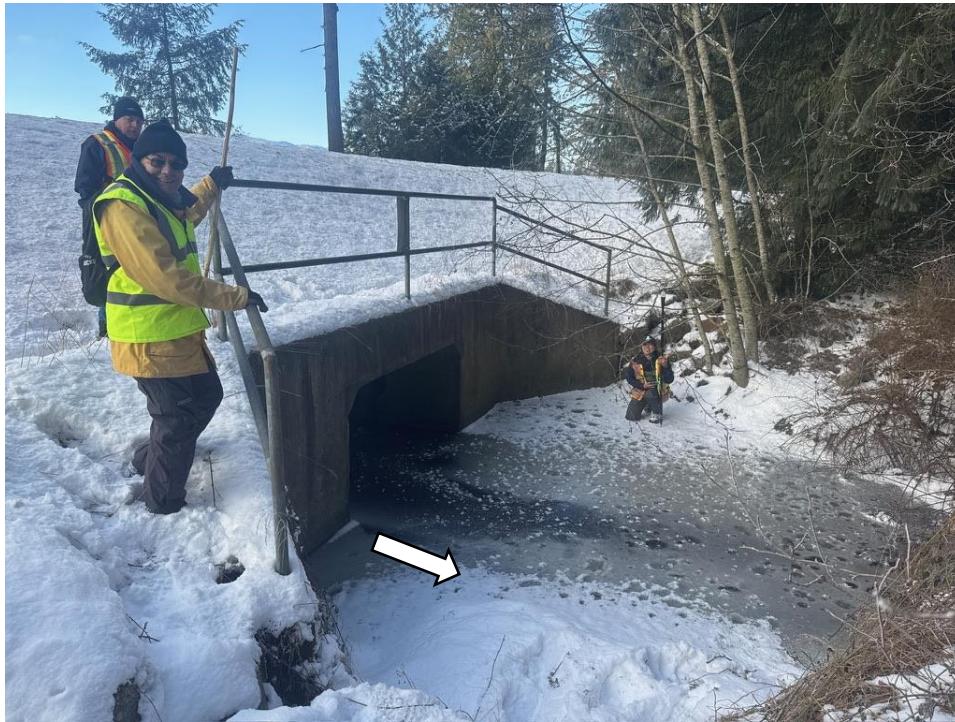
Figure 22. Rupert Road box culvert inflow. Arrow indicates flow direction. Photograph collected February 26, 2025.

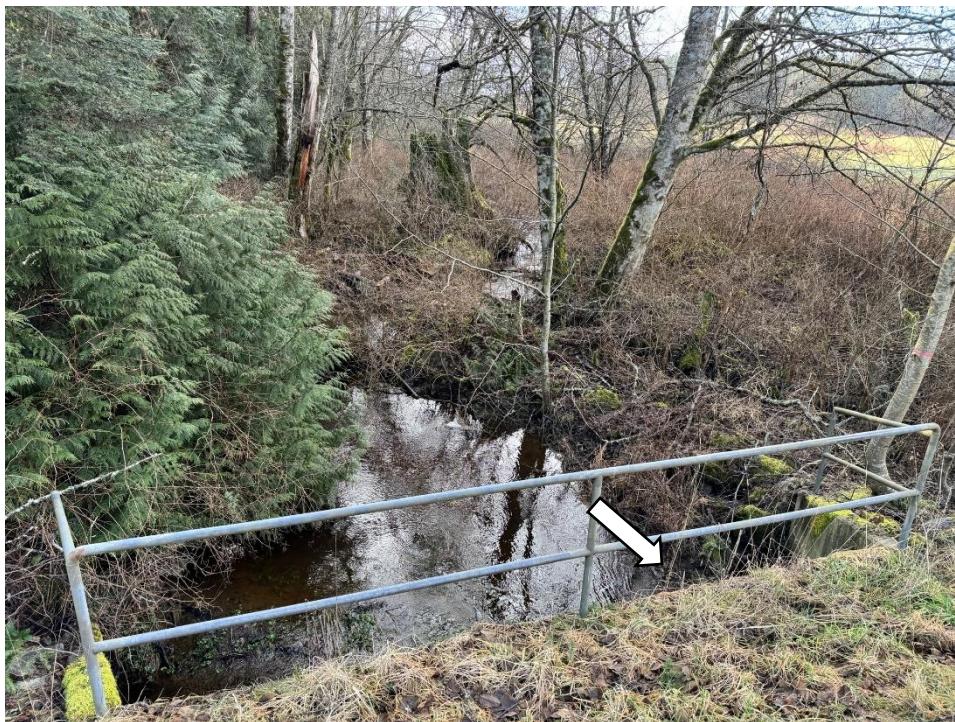
Figure 23. Ditch from agricultural field river left, upstream of Rupert Road. Arrow indicates flow direction. Photograph collected February 26, 2025.

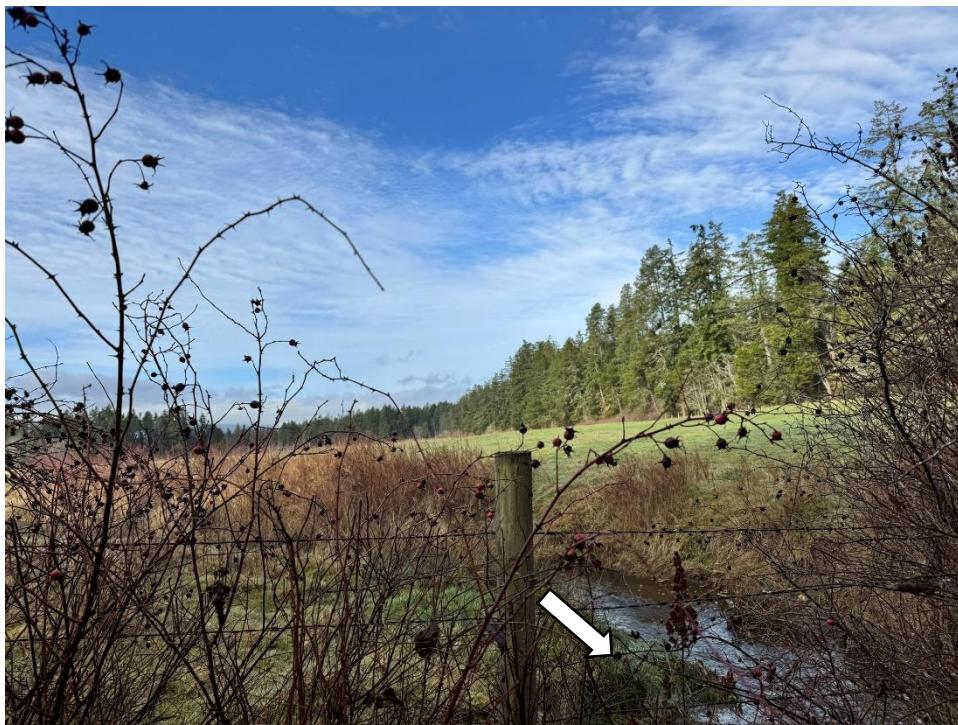
Figure 25. Wetland habitat between Rupert Road and Parker Road. The stream channel becomes unconfined through hardhack and sedges. Arrow indicates flow direction. Photograph collected February 26, 2025.

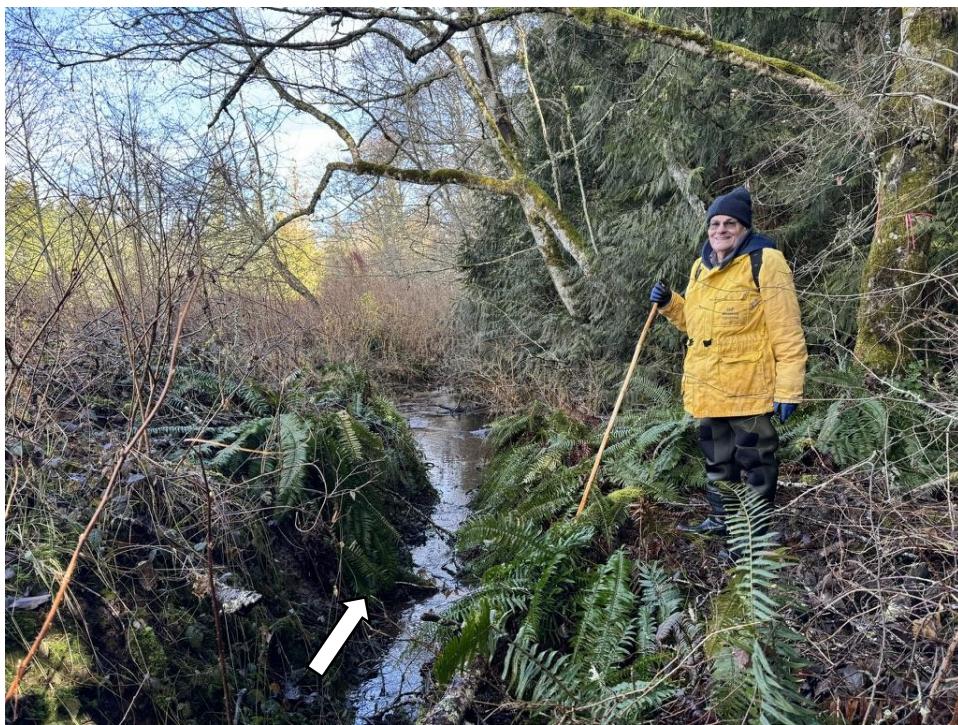
Above Rupert Rd, Grandon Creek becomes modified as a result of historic agricultural activities. Immediately upstream of Rupert Rd, the creek is channelized along a property line for ~120 m. Above this, the channel enters a wetland area to the east (i.e., becoming undefined and highly vegetated). The creek becomes channelized again as it travels east-south-east for ~280 m through a neighbouring property along Parker Rd. The riparian zone is highly degraded through this area (i.e., limited vegetation with no mature trees and dense Himalayan blackberry, *Rubus armeniacus*, presence). Mapping of this area was limited as access to this property had not been obtained prior to works commencing, and the channel was too overgrown to traverse. To address this, satellite imagery was reviewed to map the stream channel. During the review of aerial imagery, a large number of parked vehicles located next to the creek were observed. These were identified as an item of concern with regard to potential leakages of oils or fuels from these vehicles entering the creek and impacting the aquatic habitat.

Figure 24. Channelized stream along property line looking north towards Rupert Road. Arrow indicates flow direction. Photograph collected February 26, 2025.

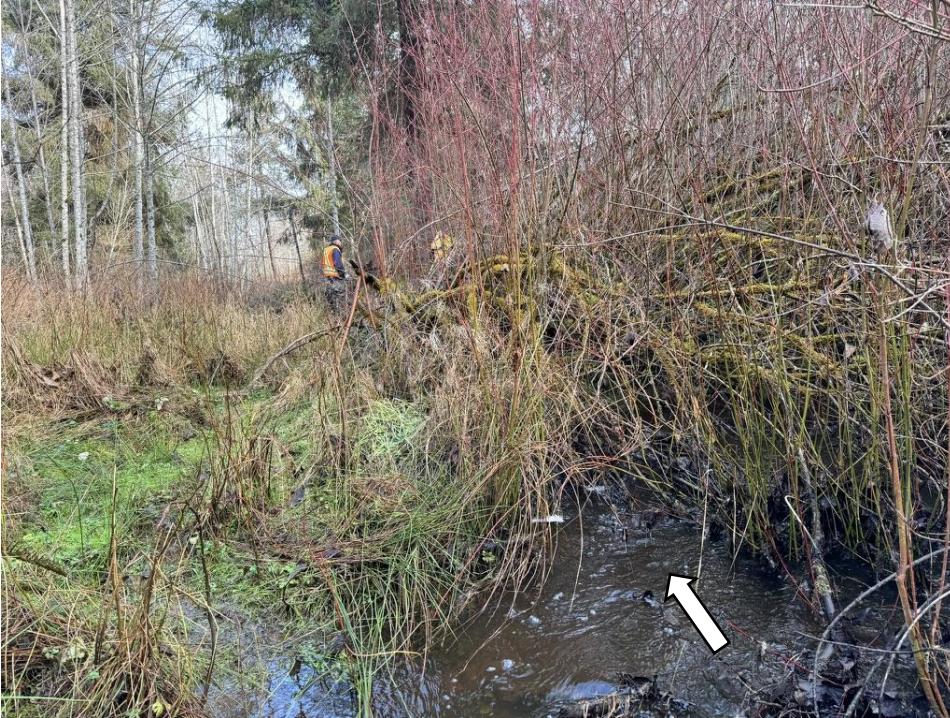
Figure 26. Tributary ditch along Parker Road. Arrow indicates flow direction. Photograph collected February 12, 2025.

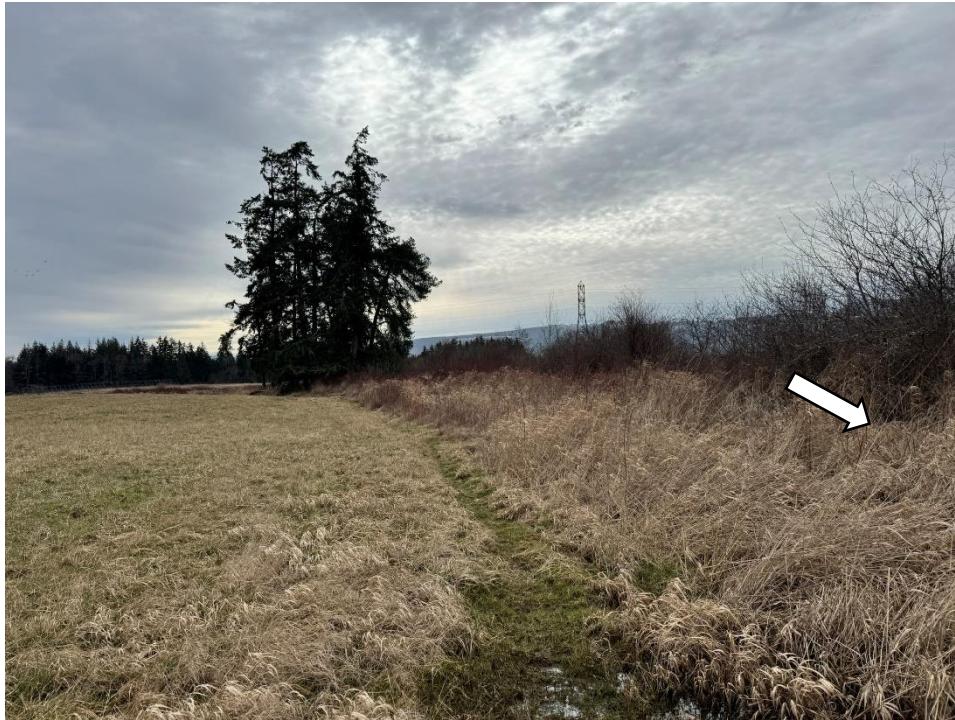
Figure 28. Channelized stream through agricultural field upstream of Parker Road with reed canary grass and livestock trampling. Arrow indicates flow direction. Photograph collected February 26, 2025.

We encourage continued riparian remediation efforts, including planting native vegetation and removal of invasive plant species. Observed invasive plant species include reed canary grass, English ivy, and Himalayan blackberry. Working with private land owners to develop strategies to improve fish habitat in the upper reaches is also encouraged (i.e., increase riparian buffers, apply reed canary grass treatment, install fencing to keep livestock out of riparian zones).

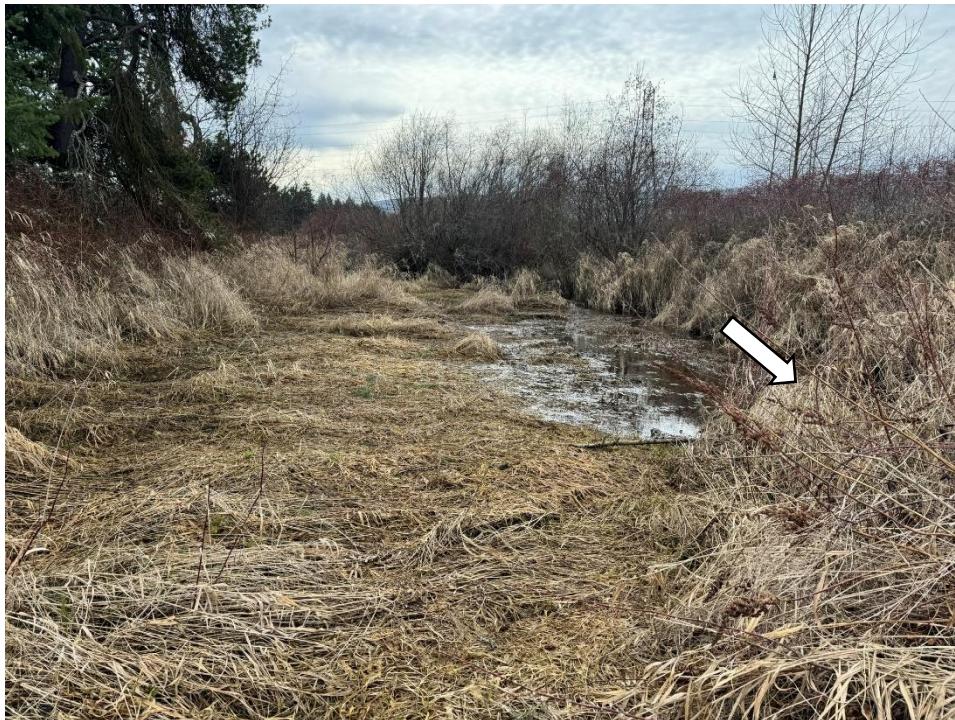
Upstream of Parker Rd (~380 m), Grandon Creek remains channelized, and the riparian zone continues to be highly degraded by invasive plant species (i.e., Himalayan blackberry, *Rubus armeniacus*, and reed canary grass, *Phalaris arundinacea*) and the lack of mature trees needed to provide shading. In addition, livestock are free to enter the riparian zone, which results in increased sediment through bank disturbances and animal waste inputs into the creek. Engagement with one of the property owners during the survey was encouraging, as they were eager to learn how to improve fish habitat within their property. We encourage QBS and others to help support local farmers and other landowners to undertake riparian improvements.

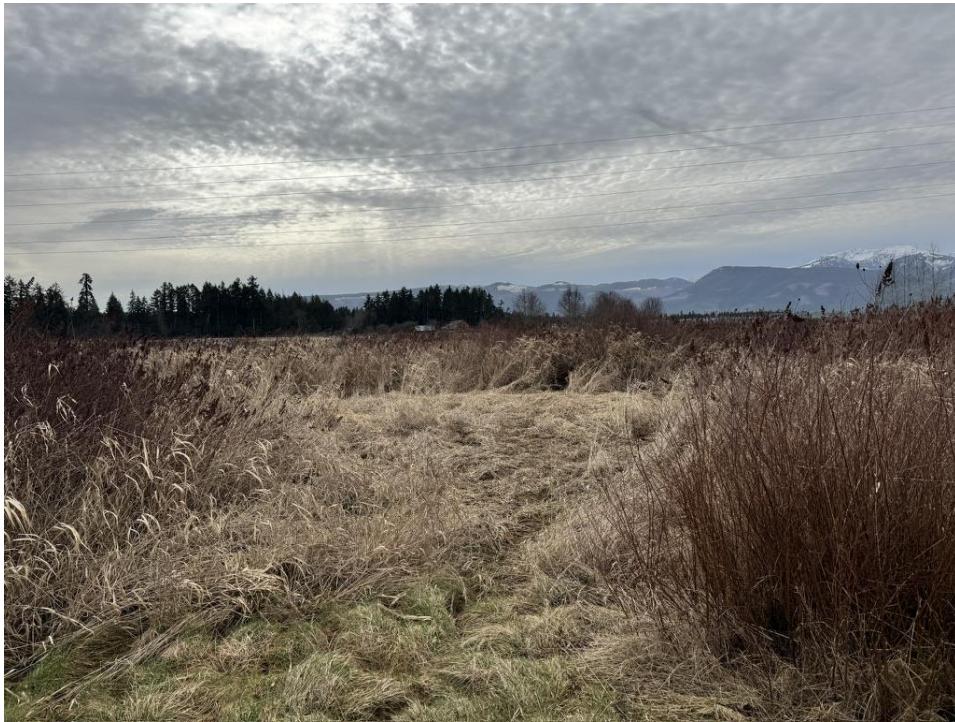
Figure 29. Beginning of wetland complex through agricultural land. Presence of reed canary grass and hardhack. Arrow indicates flow direction. Photograph collected February 26, 2025.
