Regional District of Nanaimo

2018 Biosolids Management Summary

February 2019

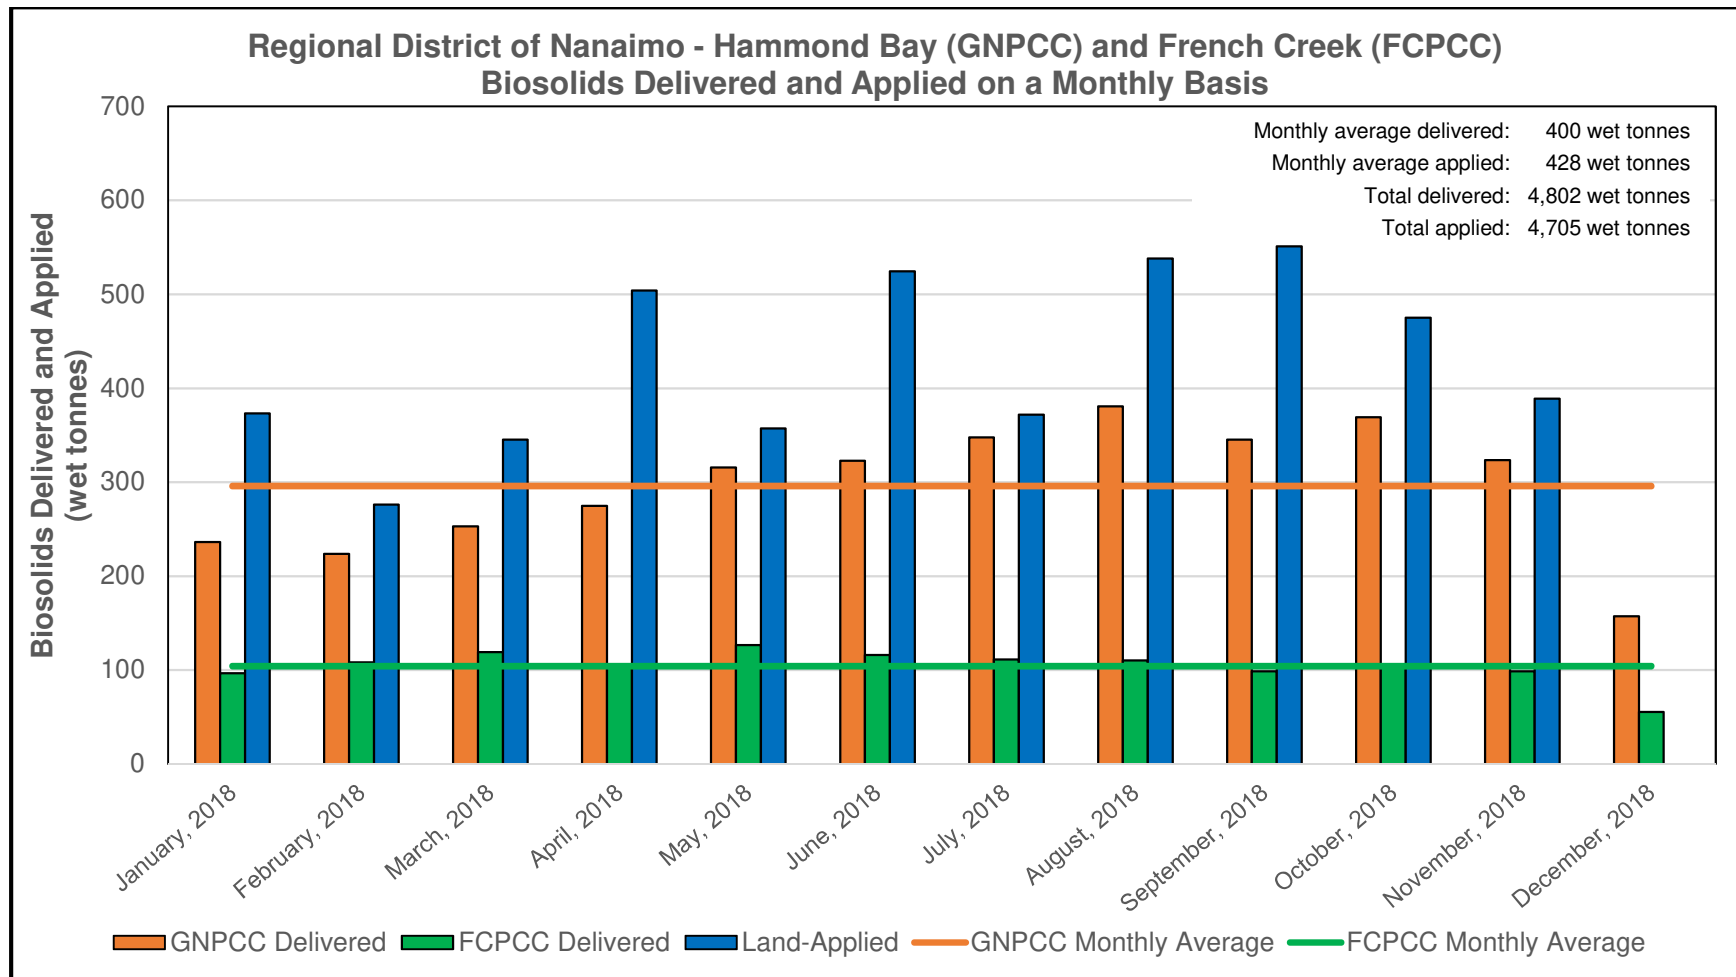
Figure 1: Tonnage of Regional District of Nanaimo – Hammond Bay (GNPCC) and French Creek (FCPCC) dewatered biosolids delivered and applied at the TimberWest Properties by month in 2018.

In 2018, 4,802 wt of RDN biosolids (1,252 wt from FCPC; 3,550 wt from GNPCC) were transported by DBL Disposal to the TimberWest Properties (Table 2). Monthly tonnage delivered in 2018 is graphically summarized in Figure 1.

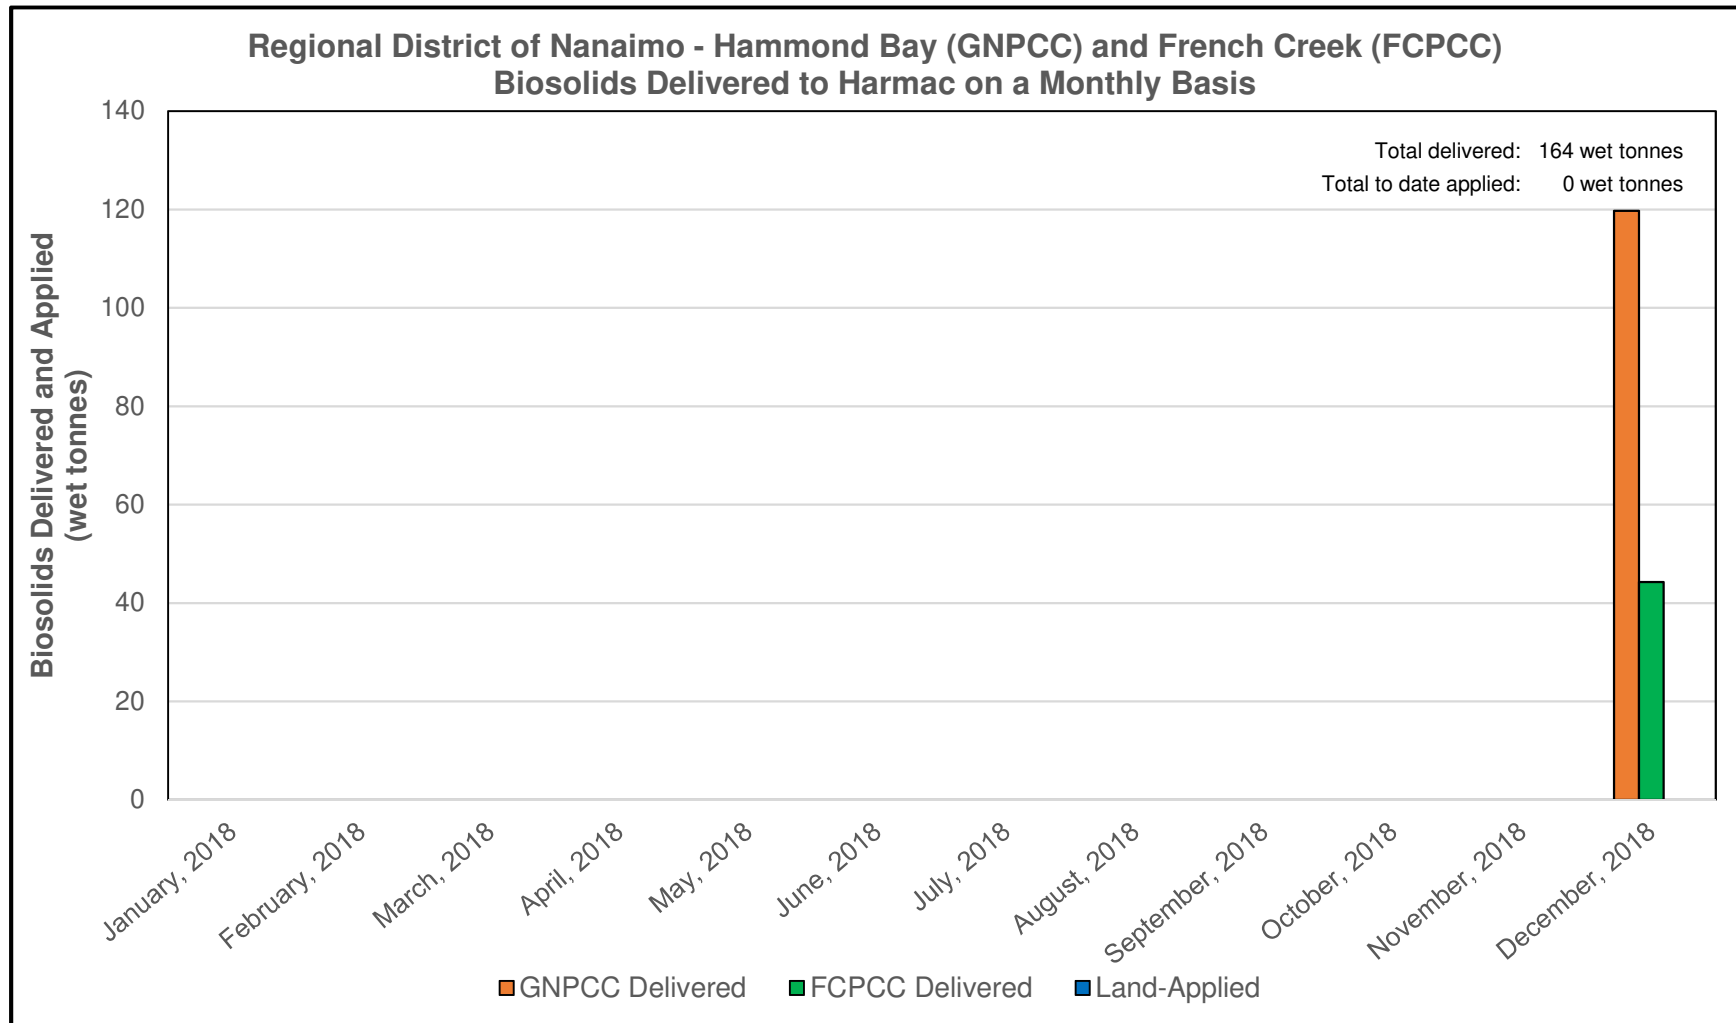
Figure 2: Tonnage of Regional District of Nanaimo – Hammond Bay (GNPCC) and French Creek (FCPCC) dewatered biosolids delivered to the Harmac Mill by month in 2018.

In 2018, 164 wt of RDN biosolids (44 wt from FCPC; 120 wt from GNPCC) were transported by DBL Disposal to Harmac (Table 2). Monthly tonnage delivered in 2018 is graphically summarized in Figure 2.

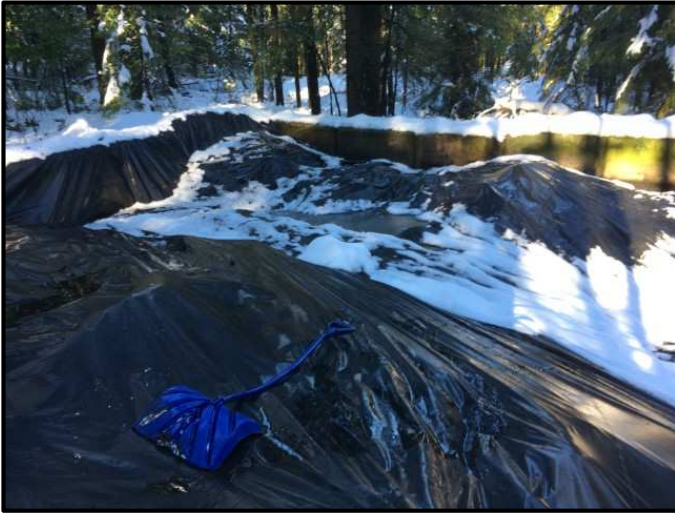
Photograph 1: RDN biosolids are stored and tarped from October to March at the TimberWest Properties as required by the OMRR.
(January, 2018)

Four storage facilities exist at the TimberWest Properties (A, B, C, and D), each consisting of an asphalt base with lock blocks delineating three sides of the facility. Three of the facilities (A, B, and C) were utilized for biosolids stockpiling in 2018. Biosolids storage conformed to rainy season storage practices where biosolids are required by the OMRR to be covered from October 1st to March 31st of every year (Photograph 1).

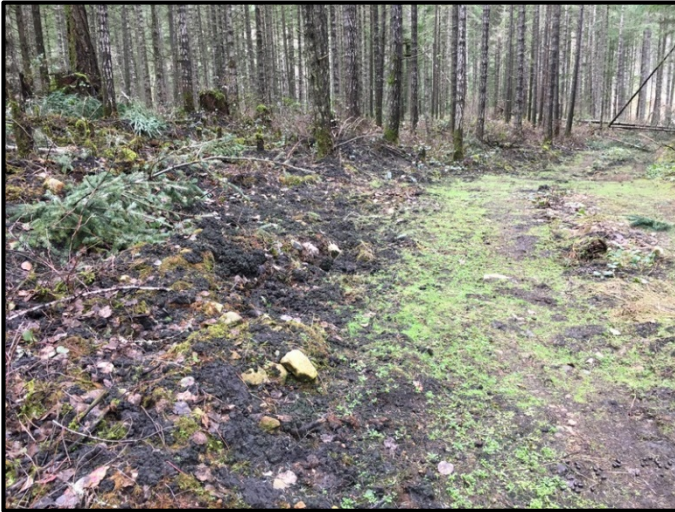
Photograph 2: RDN biosolids were land-applied to forest stands at the TimberWest Properties throughout 2018.
(March, 2018)

In 2018, 4,705 wt of RDN biosolids (1,226 wt from FCPC; 3,479 wt from GNPCC) were applied as a fertilizer and soil amendment to the TimberWest Properties (Table 2 and Photograph 2). Biosolids were land-applied to 64 hectares (ha) of forested lands at the TimberWest Properties for a site-wide average application rate of 73.1 wt/ha (18.5 dry tonnes or dt/ha), 97% of the

Biosolids were land-applied using a side-discharge spreader equipped with a hydraulic fan which propels the biosolids up to 30 m into forest stands. All biosolids applications adhered to a 30-m setback distance from permanent water features and identified ephemeral water features. Biosolids applications were completed bi-weekly throughout 2018 except during periods of extreme weather (i.e., snowfall, heavy rainfall) or when ground was snow-covered: land application operations were suspended during these times. Extreme weather, including snowfall or snow cover, occurred in late January/early February and late February/early March in 2018.

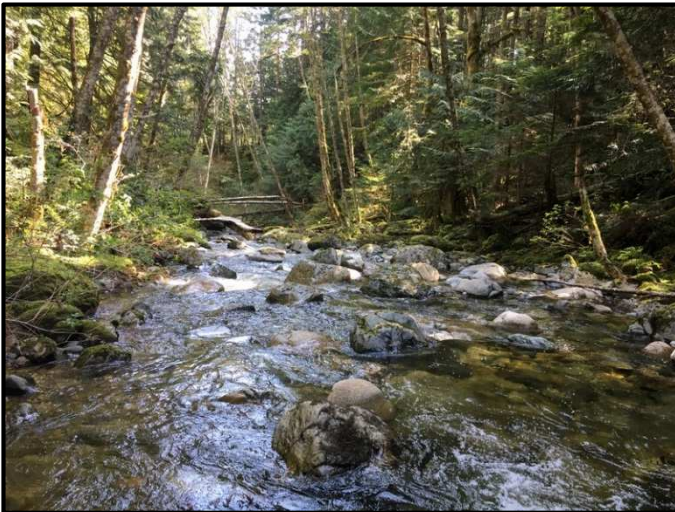
Photograph 3: Surface water locations were monitored at the TimberWest Properties in spring and fall 2018.
(May, 2018)

Surface water was monitored at the TimberWest Properties in spring and fall 2018 by SYLVIS (Photograph 3). Biosolids fertilization has had no discernable effect on surface water quality with the possible exception of nitrate, which at a site-wide average of 1.3 mg/L, is still within the range of reference values for ambient surface concentration (0.3 – 2 mg/L) and below the BC Approved Water Quality Guideline for protection of freshwater aquatic life (30-day mean of 3 mg/L). Details of the surface water monitoring program can be found in the SYLVIS report *Regional District of Nanaimo Biosolids Management Program - 2017-2018 Surface Water Report* (document # 1211-19).
