Regional District of Nanaimo

2019 Biosolids Management Summary

February 2020

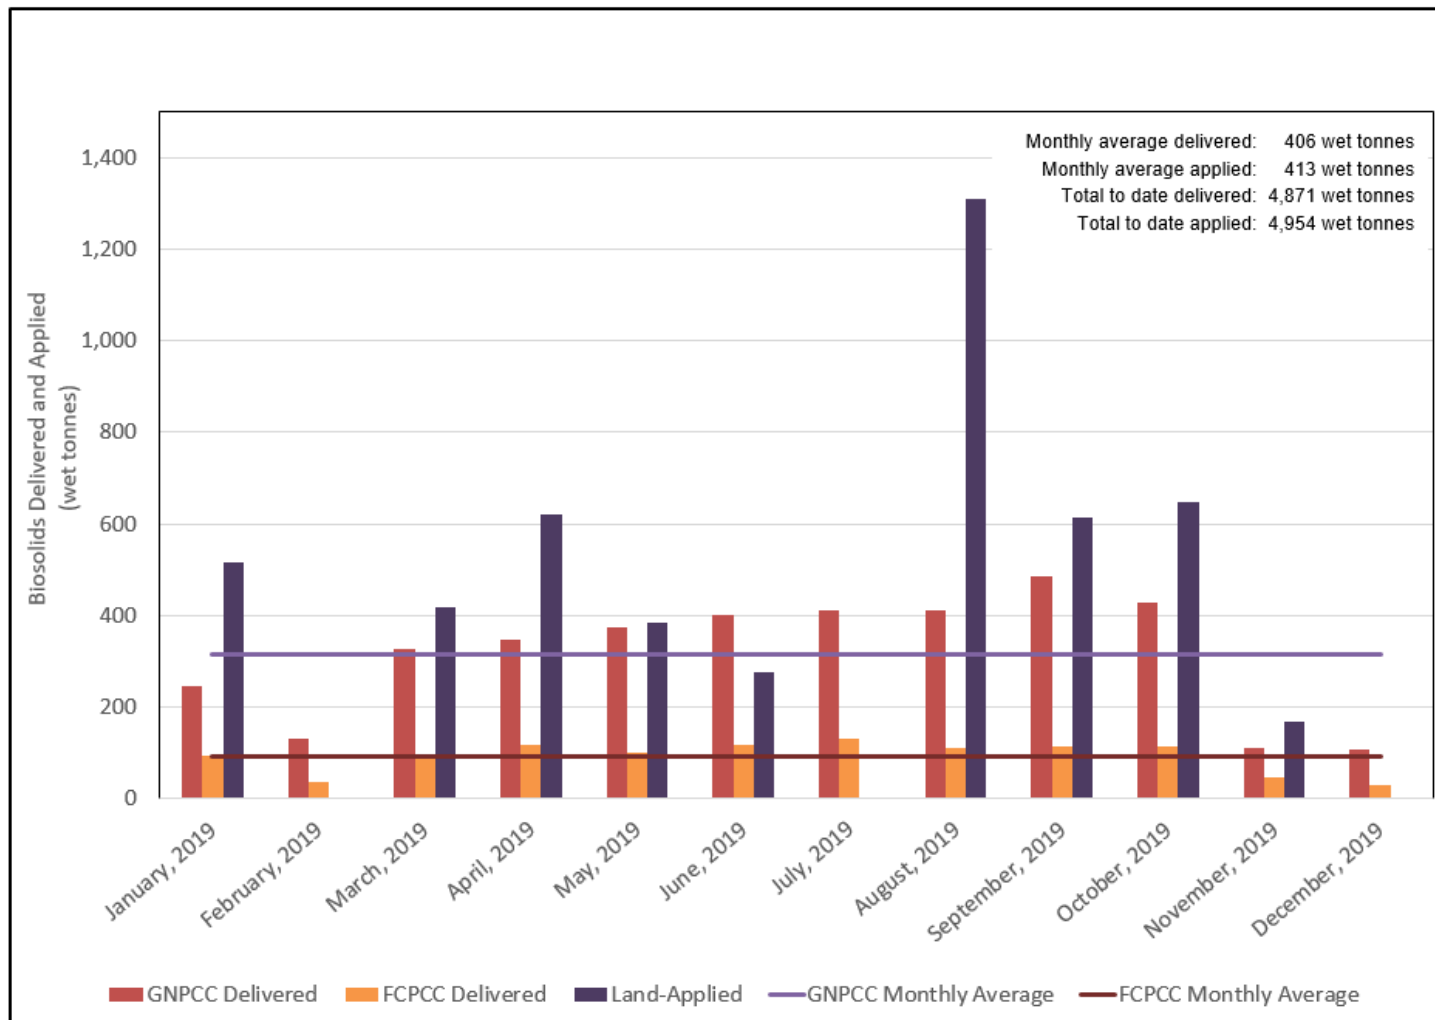
Figure 1: Tonnage of Regional District of Nanaimo – Greater Nanaimo Pollution Control Centre (GNPCC) and French Creek Pollution Control Centre (FCPCC) dewatered biosolids delivered and applied at the TimberWest Properties by month in 2019.

In 2019, 4,871 wt of RDN biosolids (1,095 wt from FCPCC; 3,776 wt from GNPCC) were transported by DBL Disposal to the TimberWest Properties (Table 2). Monthly tonnage delivered in 2019 is graphically summarized in Figure 1.

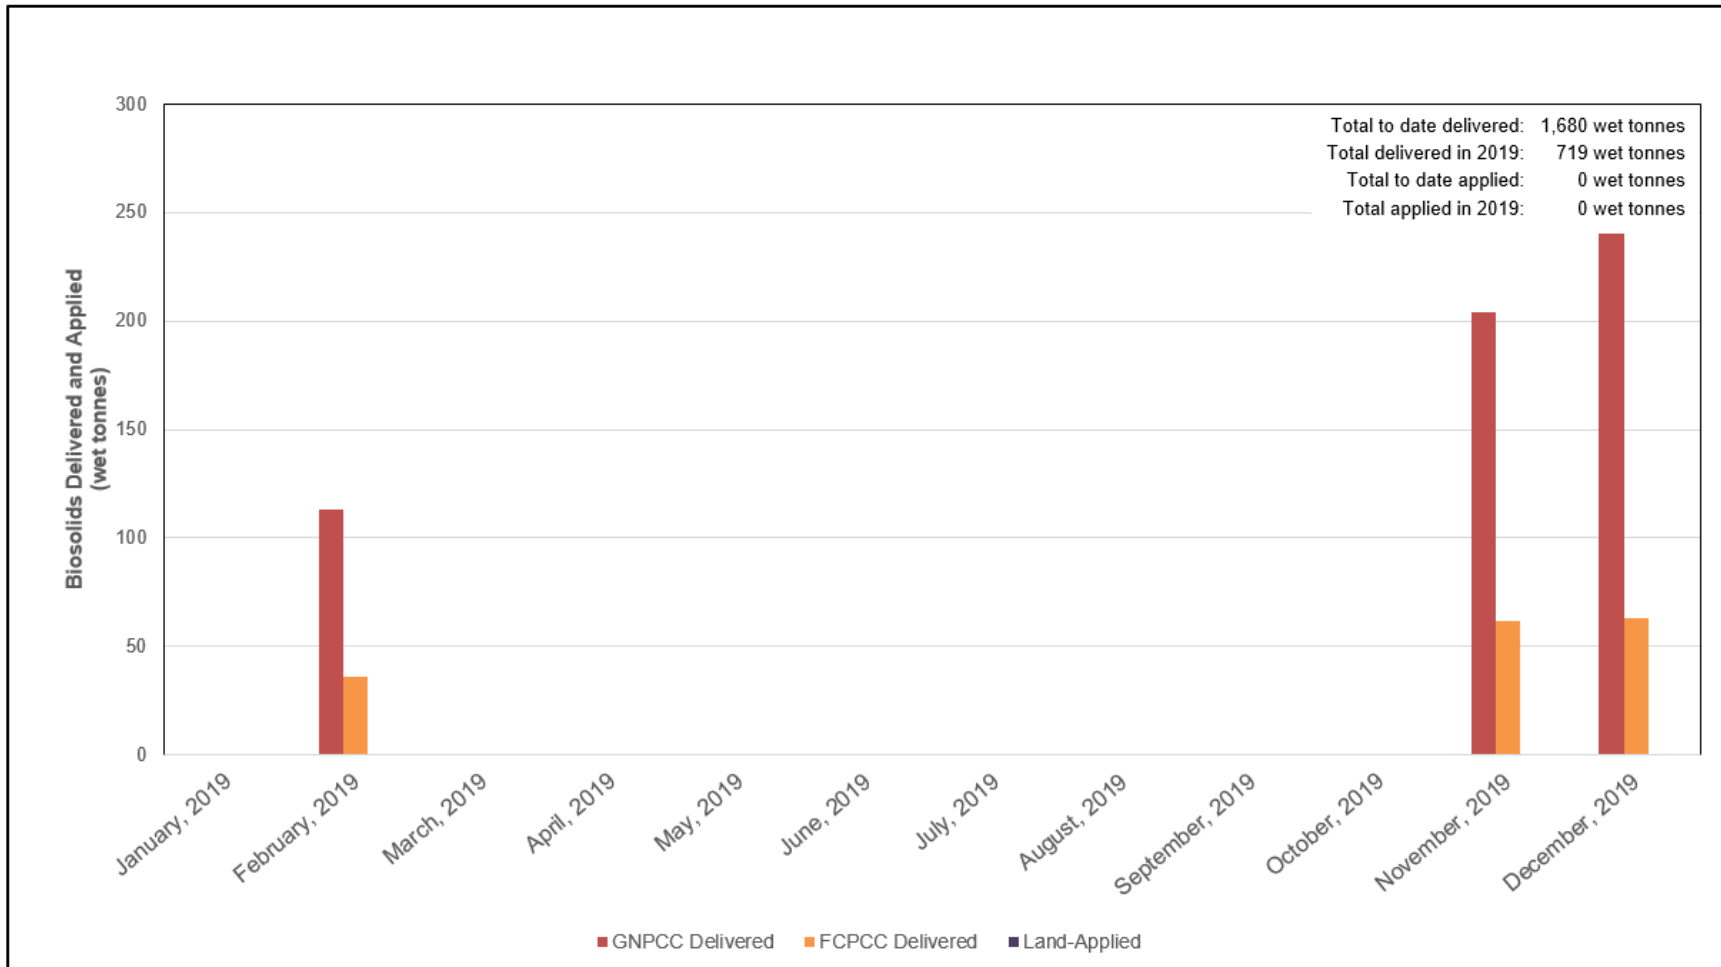
Figure 2: Tonnage of Regional District of Nanaimo – Greater Nanaimo Pollution Control Centre (GNPCC) and French Creek Pollution Control Centre (FCPCC) dewatered biosolids delivered to Harmac by month in 2019.

In 2019, 719 wt of RDN biosolids (161 wt from FCPCC; 558 wt from GNPCC) were transported by DBL Disposal to Harmac (Table 2). Monthly tonnage delivered in 2019 is graphically summarized in Figure 2.

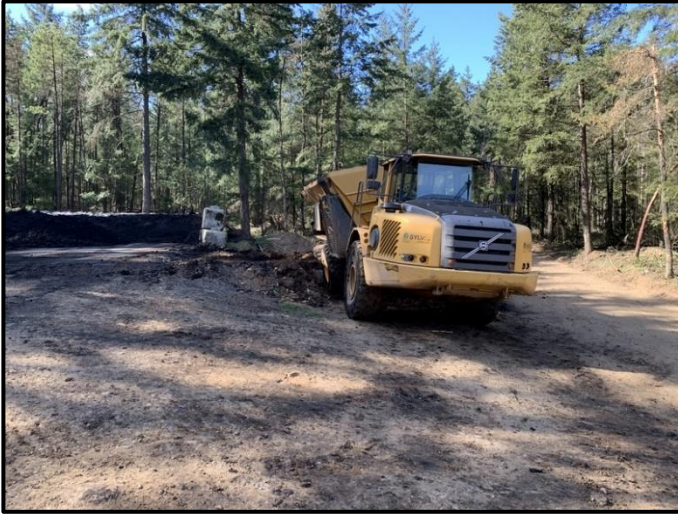
Photograph 1: RDN biosolids are stockpiled in storage areas and land-applied using specialized equipment. (March 2019)

Four storage areas exist at the TimberWest Properties (A, B, C, and D), each consisting of an asphalt base with lock blocks delineating three sides of the facility (Photograph 1). All four storage areas were utilized for biosolids stockpiling in 2019. Biosolids storage conformed to rainy season storage practices where biosolids are required by the OMRP to be covered from October 1st to March 31st of every year.

Biosolids were land-applied using a side-discharge spreader equipped with a hydraulic fan which propels the biosolids up to 30 m into forest stands. All biosolids applications adhered to a 30-m setback distance from permanent water features and identified ephemeral water features. Biosolids applications were completed bi-weekly throughout 2019 except during periods of extreme weather (i.e., snowfall, heavy rainfall) or when ground was snow-covered; land application operations were suspended during these times. Extreme weather, including snowfall or snow cover, occurred in February and March in 2019.

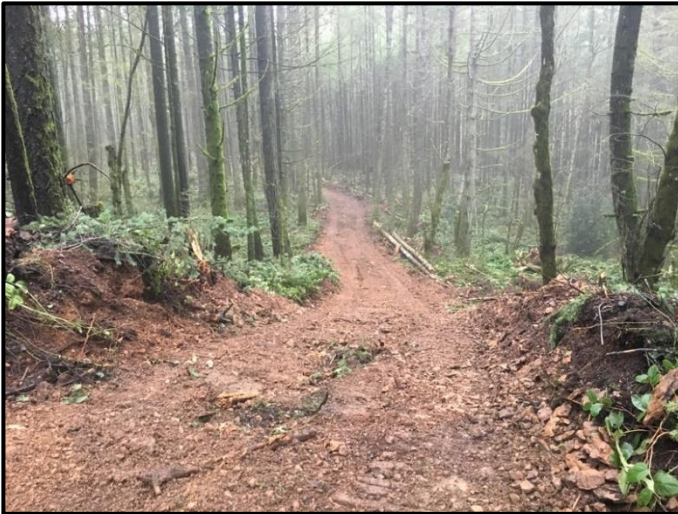
Photograph 2: RDN biosolids are land-applied to forest stands along application trails throughout the TimberWest Properties. (January 2019)

In 2019, 4,954 wt of RDN biosolids (1,113 wt from FCPCC; 3,841 wt from GNPCC) were applied as a fertilizer and soil amendment to the TimberWest Properties (Table 2 and Photograph 2). Biosolids were land-applied to 90 hectares (ha) of forested lands at the TimberWest Properties at application rates specific to the individual fertilization units based on their history of previous biosolids land applications. Across the site, the biosolids application rate was an average of 91% of the agronomic rates. No individual application rates exceeded the application rate specified in

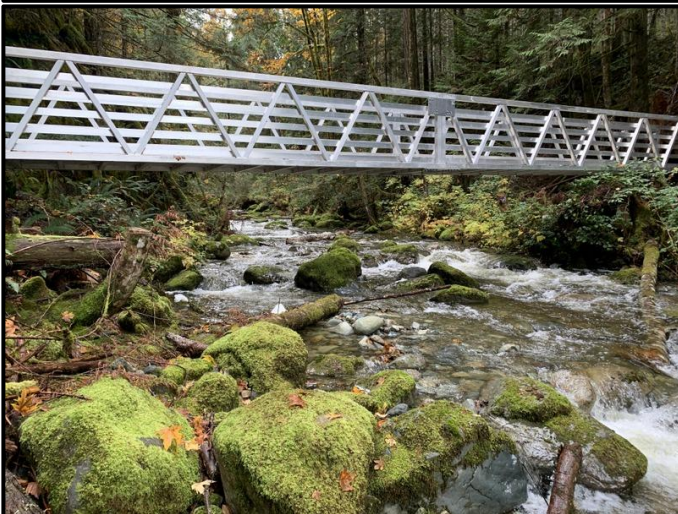
Photograph 3: Surface water locations were monitored at various locations within the TimberWest Properties as well as in Benson Creek, depicted here. (March 2019)

Surface water at two locations was monitored by SYLVIS at the TimberWest Properties throughout 2019 and at five locations in the spring and fall of 2019 by SYLVIS (Photograph 3). Biosolids fertilization appears to have had no meaningful effect on surface water quality with the possible exception of nitrate, which is expected for a fertilized site. Details of the surface water monitoring program can be found in the SYLVIS report *Regional District of Nanaimo Biosolids Management Program - 2019 TimberWest Properties Surface Water Report* (document #1289-20).
