# REGIONAL DISTRICT OF NANAIMO

## Water Service Area Annual Report 2024

### San Pareil

### June 2025

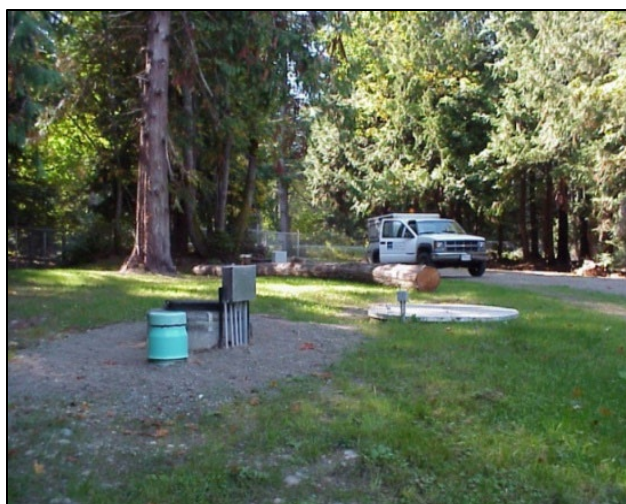
**San Pareil  
Well Site**

Two active groundwater production wells are present in the well field at 1090 Plummer Road, Parksville, B.C. Well #2 was closed in 2012. Well #3 is utilized as a monitoring well, but also serves as a backup well to Well #4.

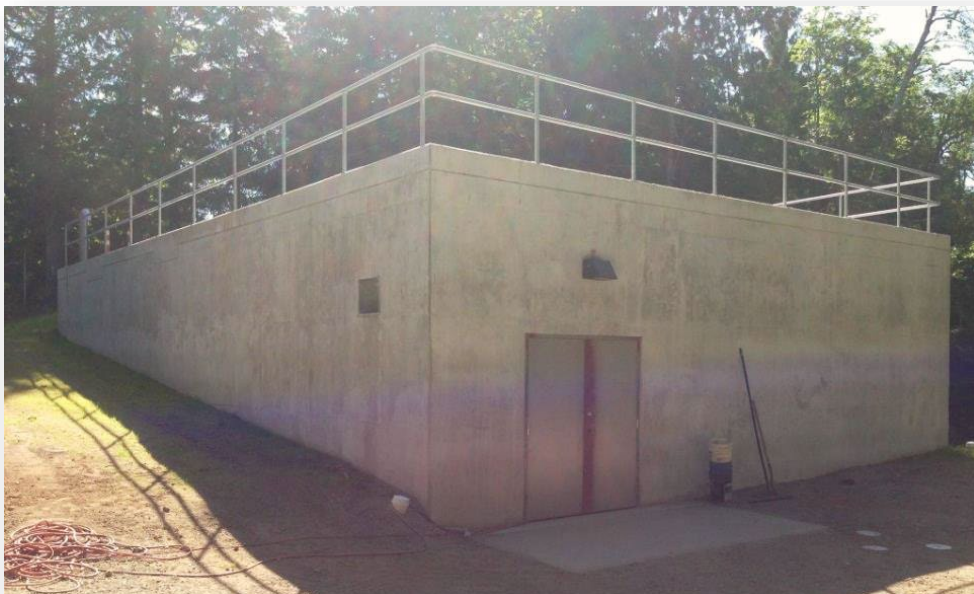
**San Pareil  
Reservoir #2**

Two concrete service reservoirs are present at 1090 Plummer Road, and have a capacity of 340 m<sup>3</sup> (75,000 imperial gallons) each.
