Community Watershed Monitoring Network 2020

Results by Water Region

Water Region 4
sampled by:
**Mid Vancouver Island
Habitat Enhancement Society
(MVIHES)**

CMMN Water Quality Trend Analysis 2011-2020

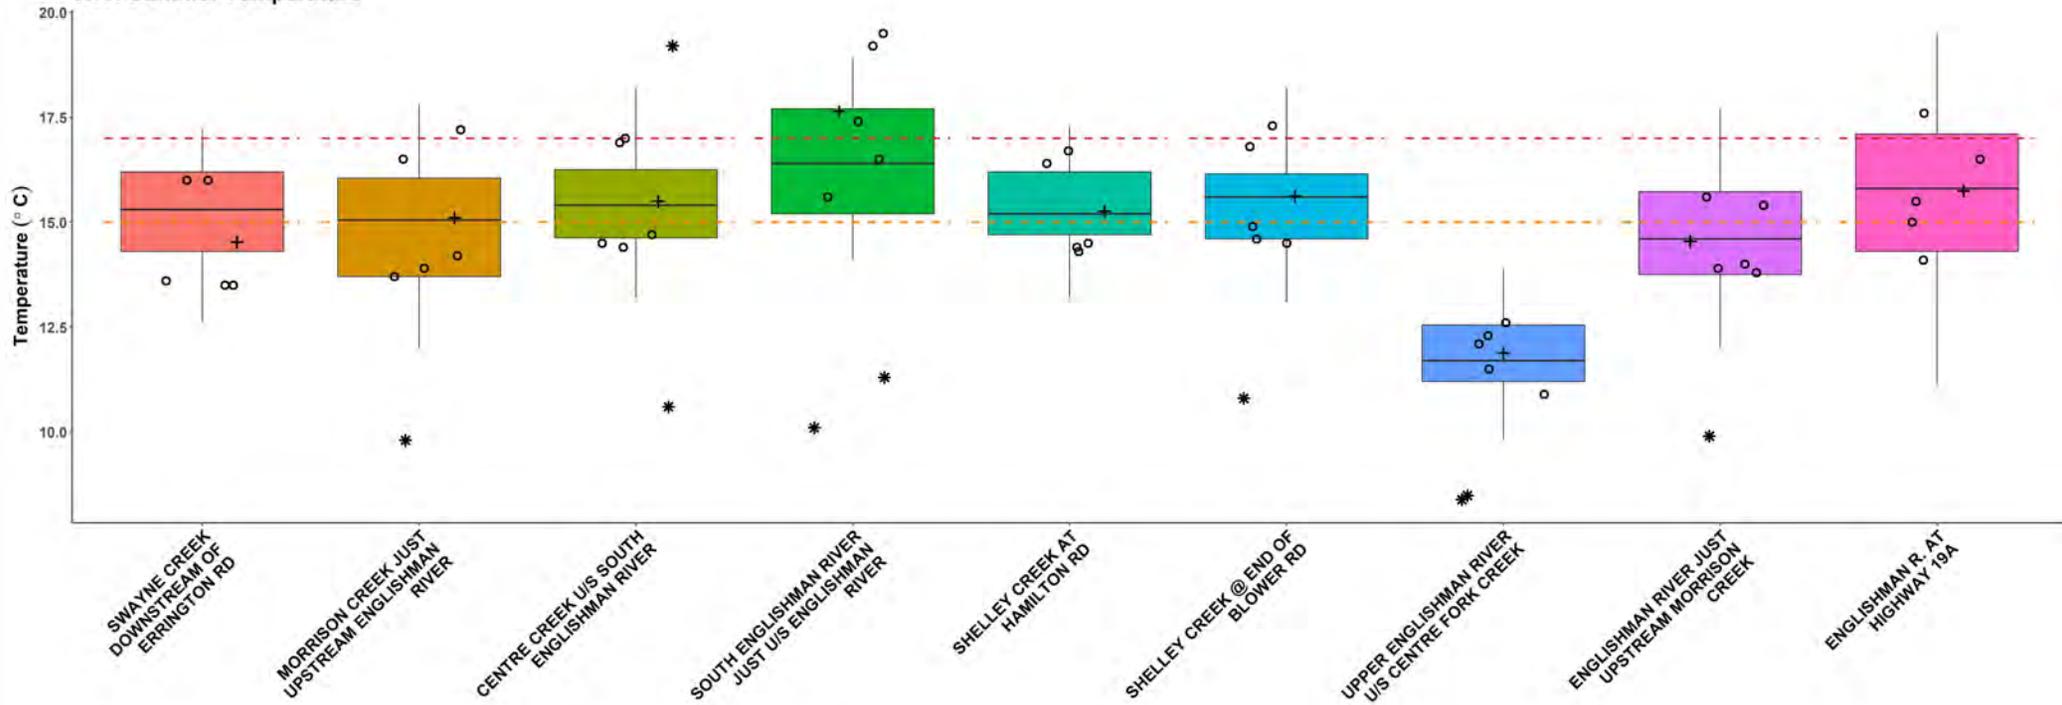
WR4 Summer Temperature

○ 2020 Samples
 * Outlier 2011-2019
 + 2020 30 Day Avg

- - Aesthetic Drinking Water Objective (15°C)
 - - Aquatic Life Guideline for Coho Rearing (17°C)

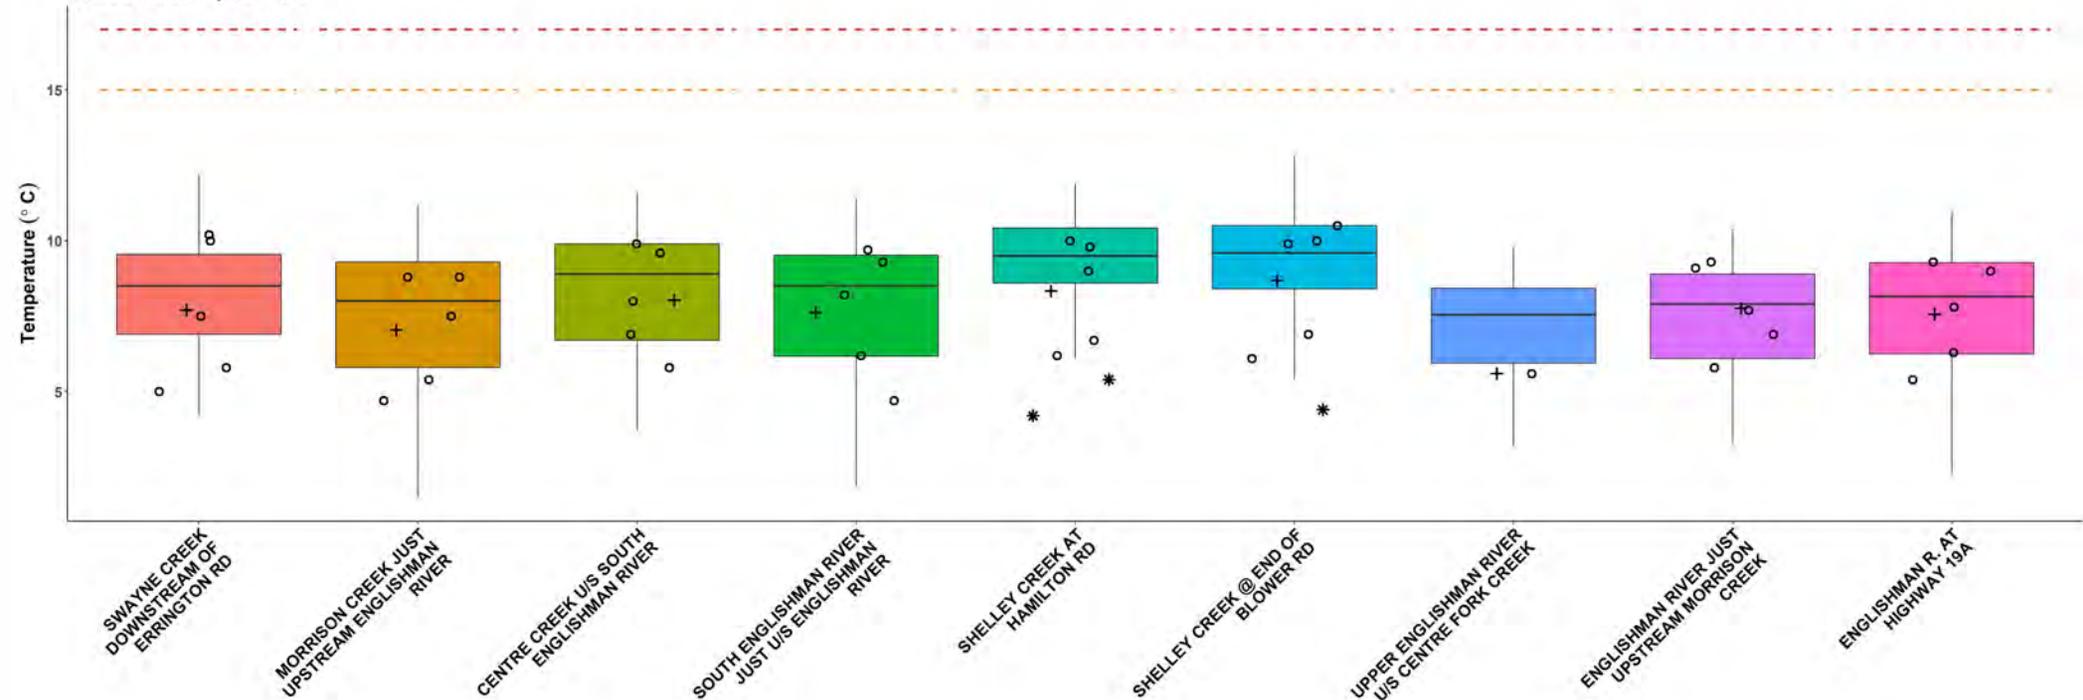
WR4 Fall Temperature

○ 2020 Samples
 * Outlier 2011-2019
 + 2020 30 Day Avg

- - Aesthetic Drinking Water Objective (15°C)
 - - Aquatic Life Guideline for Coho Rearing (17°C)

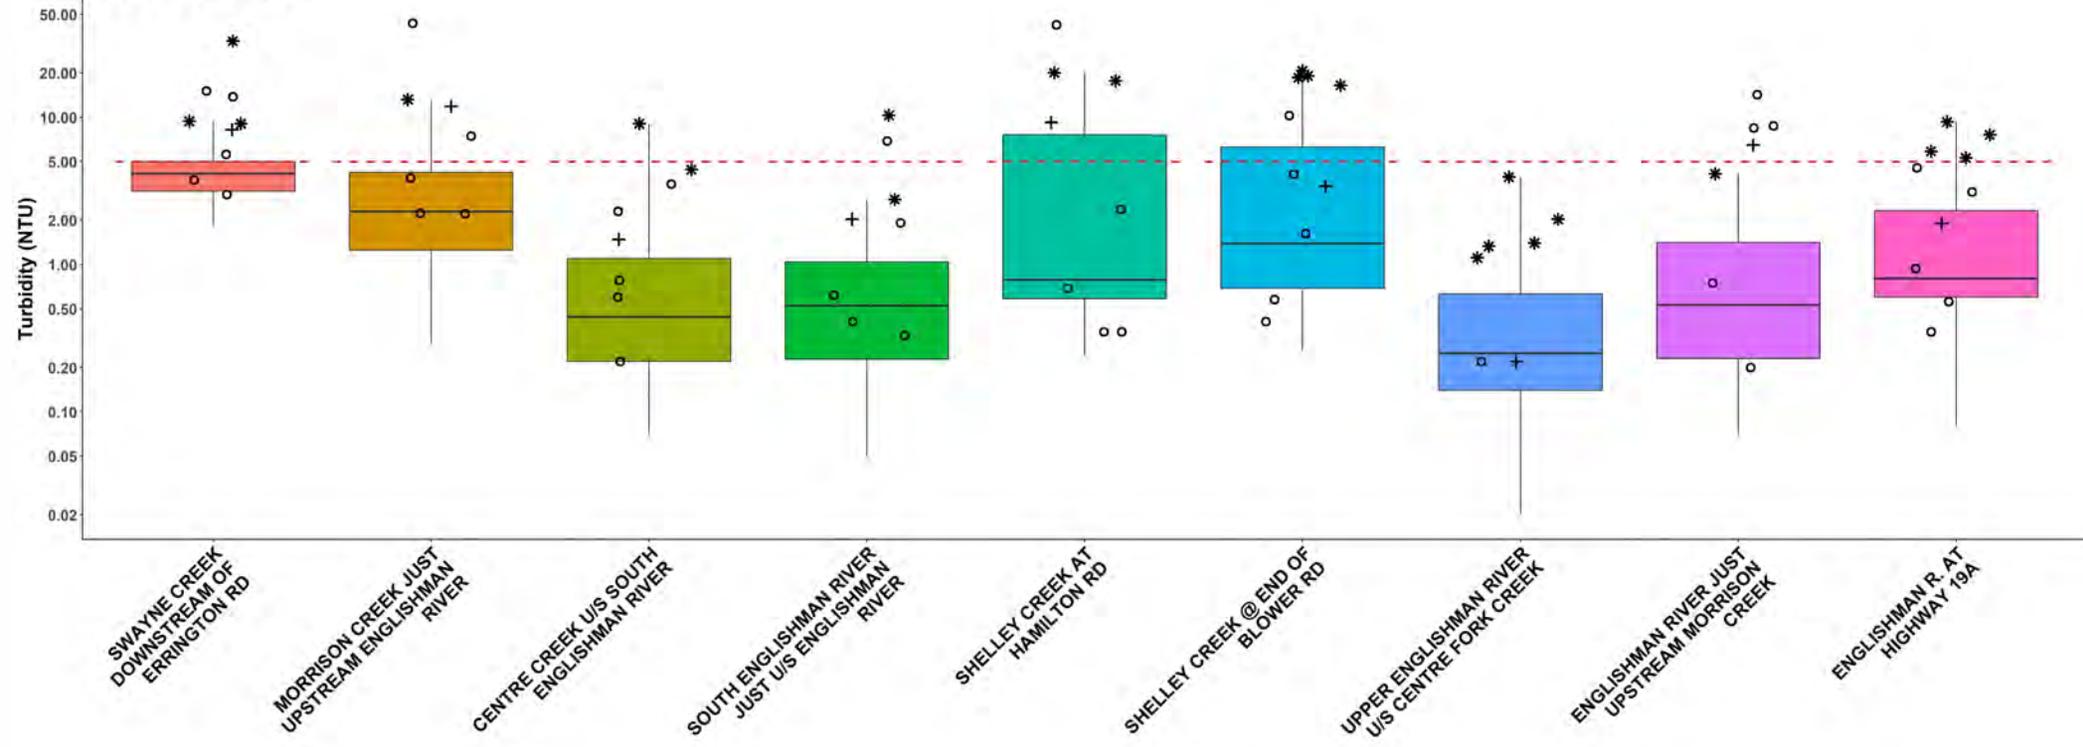
WR4 Fall Turbidity

-- Oct-Dec Max (5 NTU)

o 2020 Samples

* Outlier 2011-2019

+ 2020 30 Day Avg

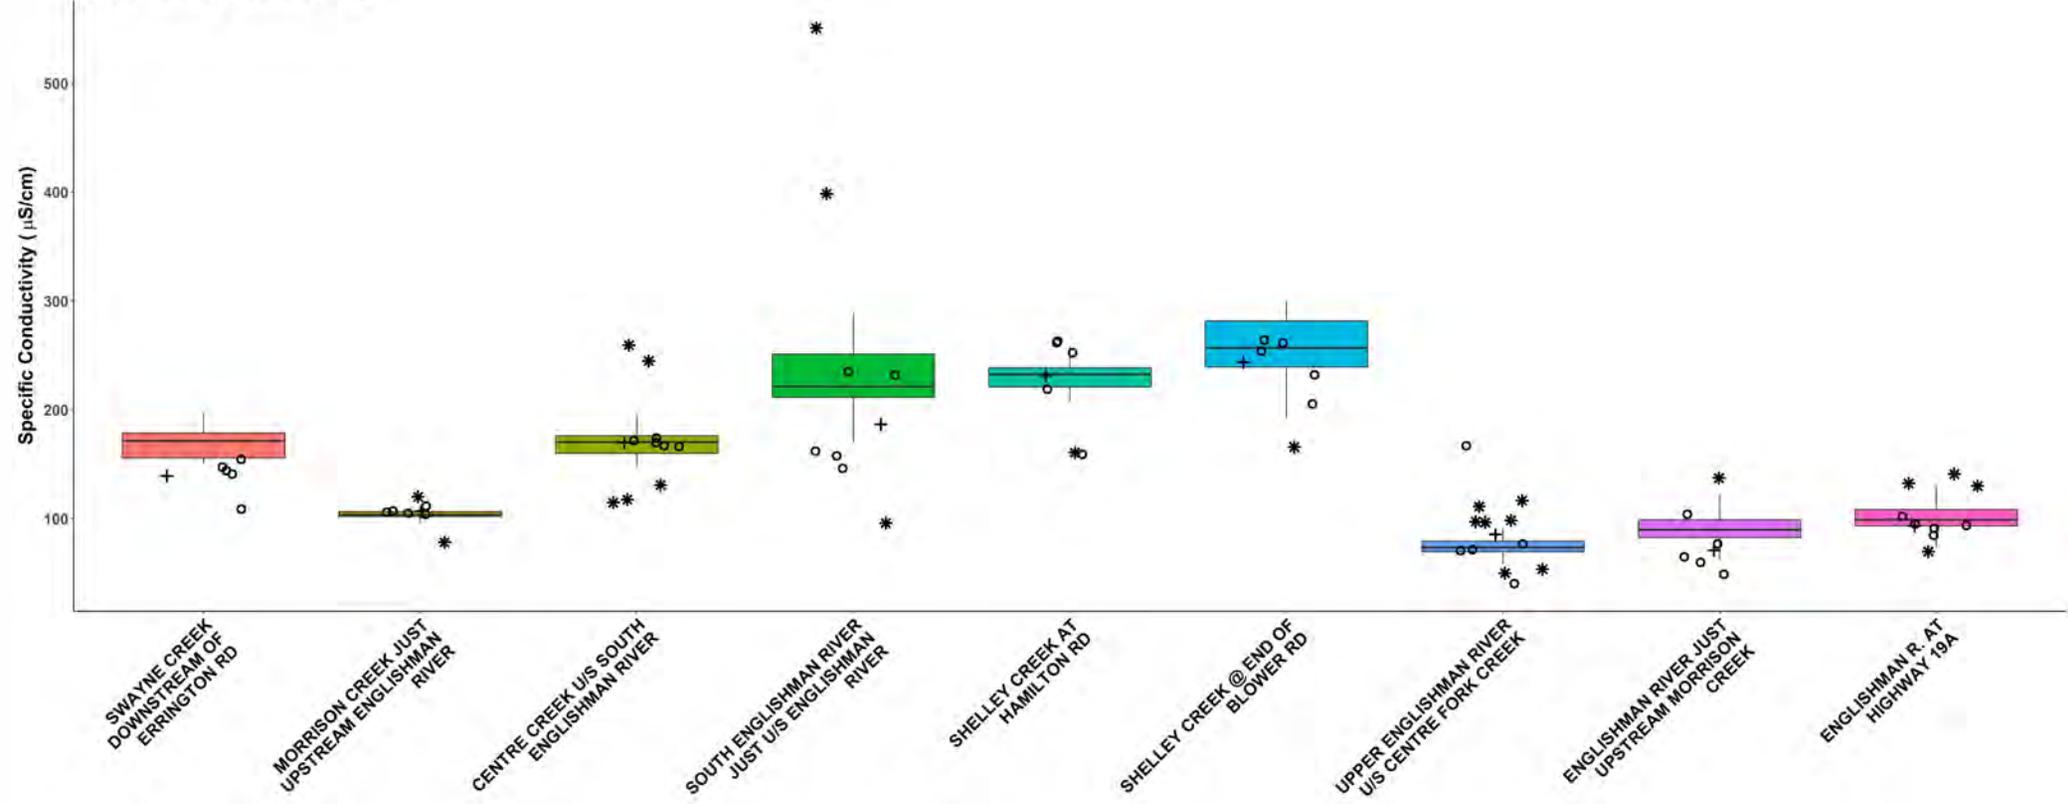
WR4 Summer Conductivity

○ 2020 Samples * Outlier 2011-2019 + 2020 30 Day Avg

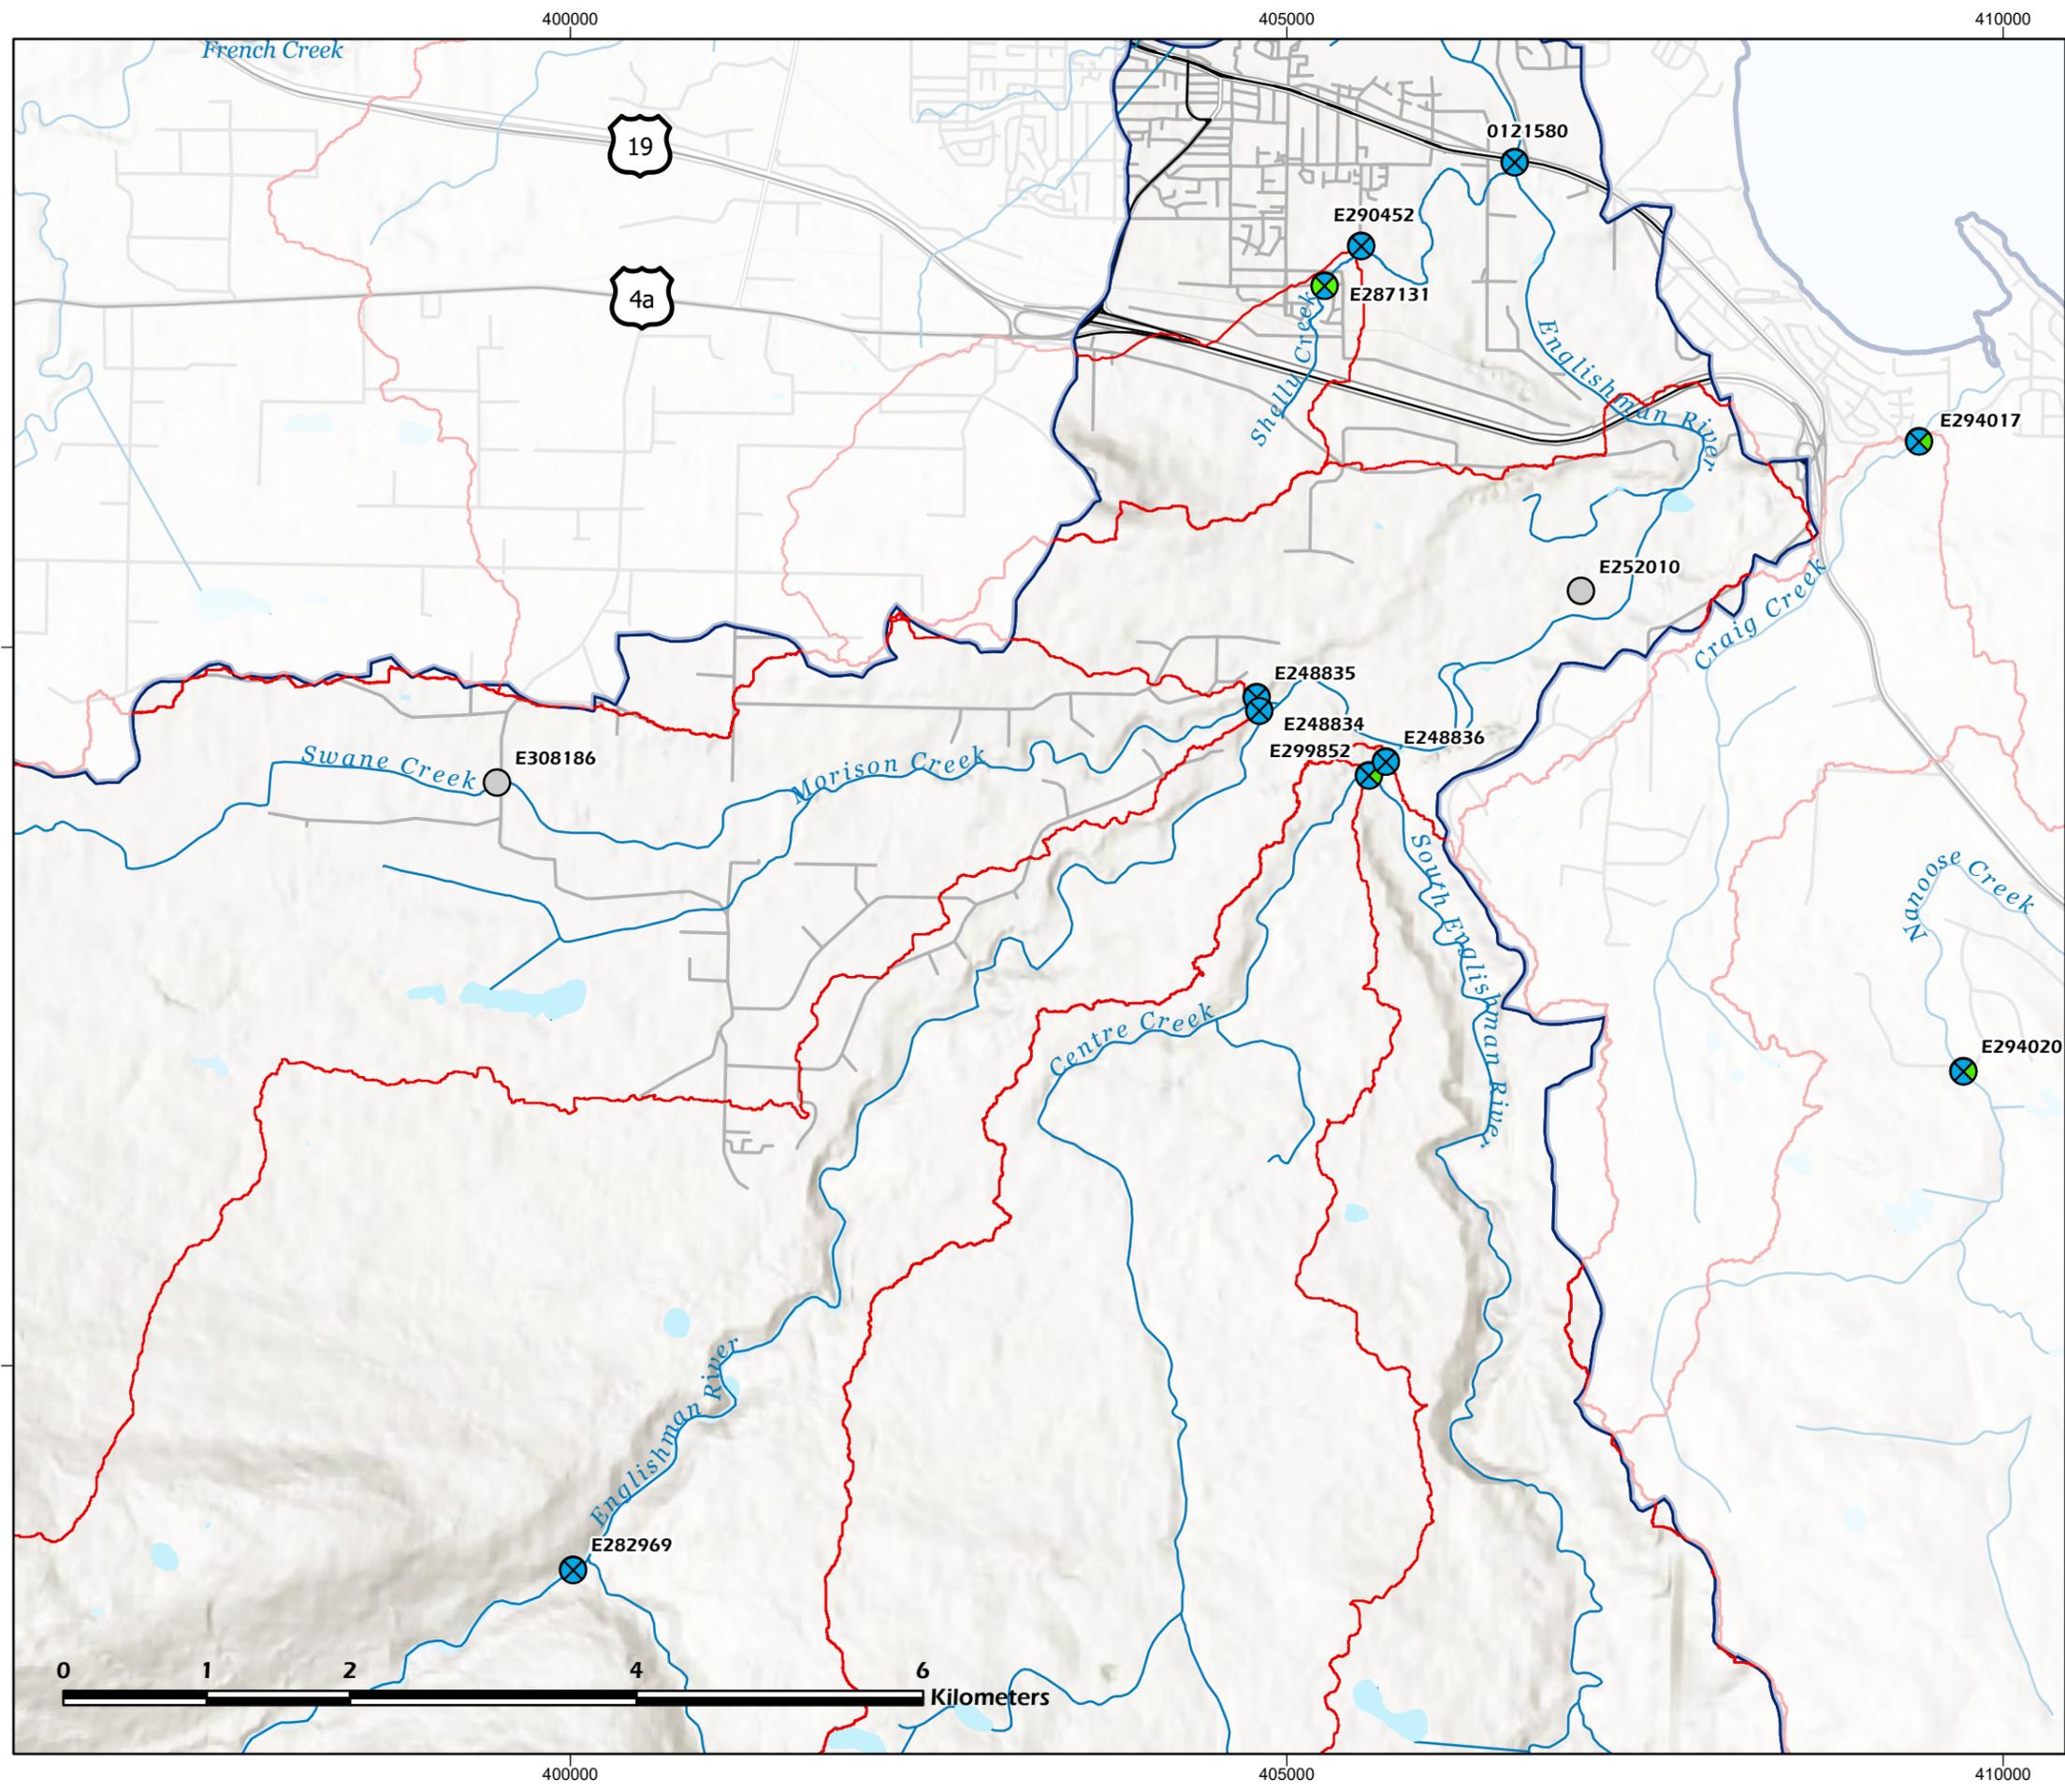
WR4a: Englishman River

Conductivity can be influenced by factors such as groundwater and ocean spray that are not necessarily indicative of a degrading condition. For simplicity, an increase in conductivity is categorized here as degrading.

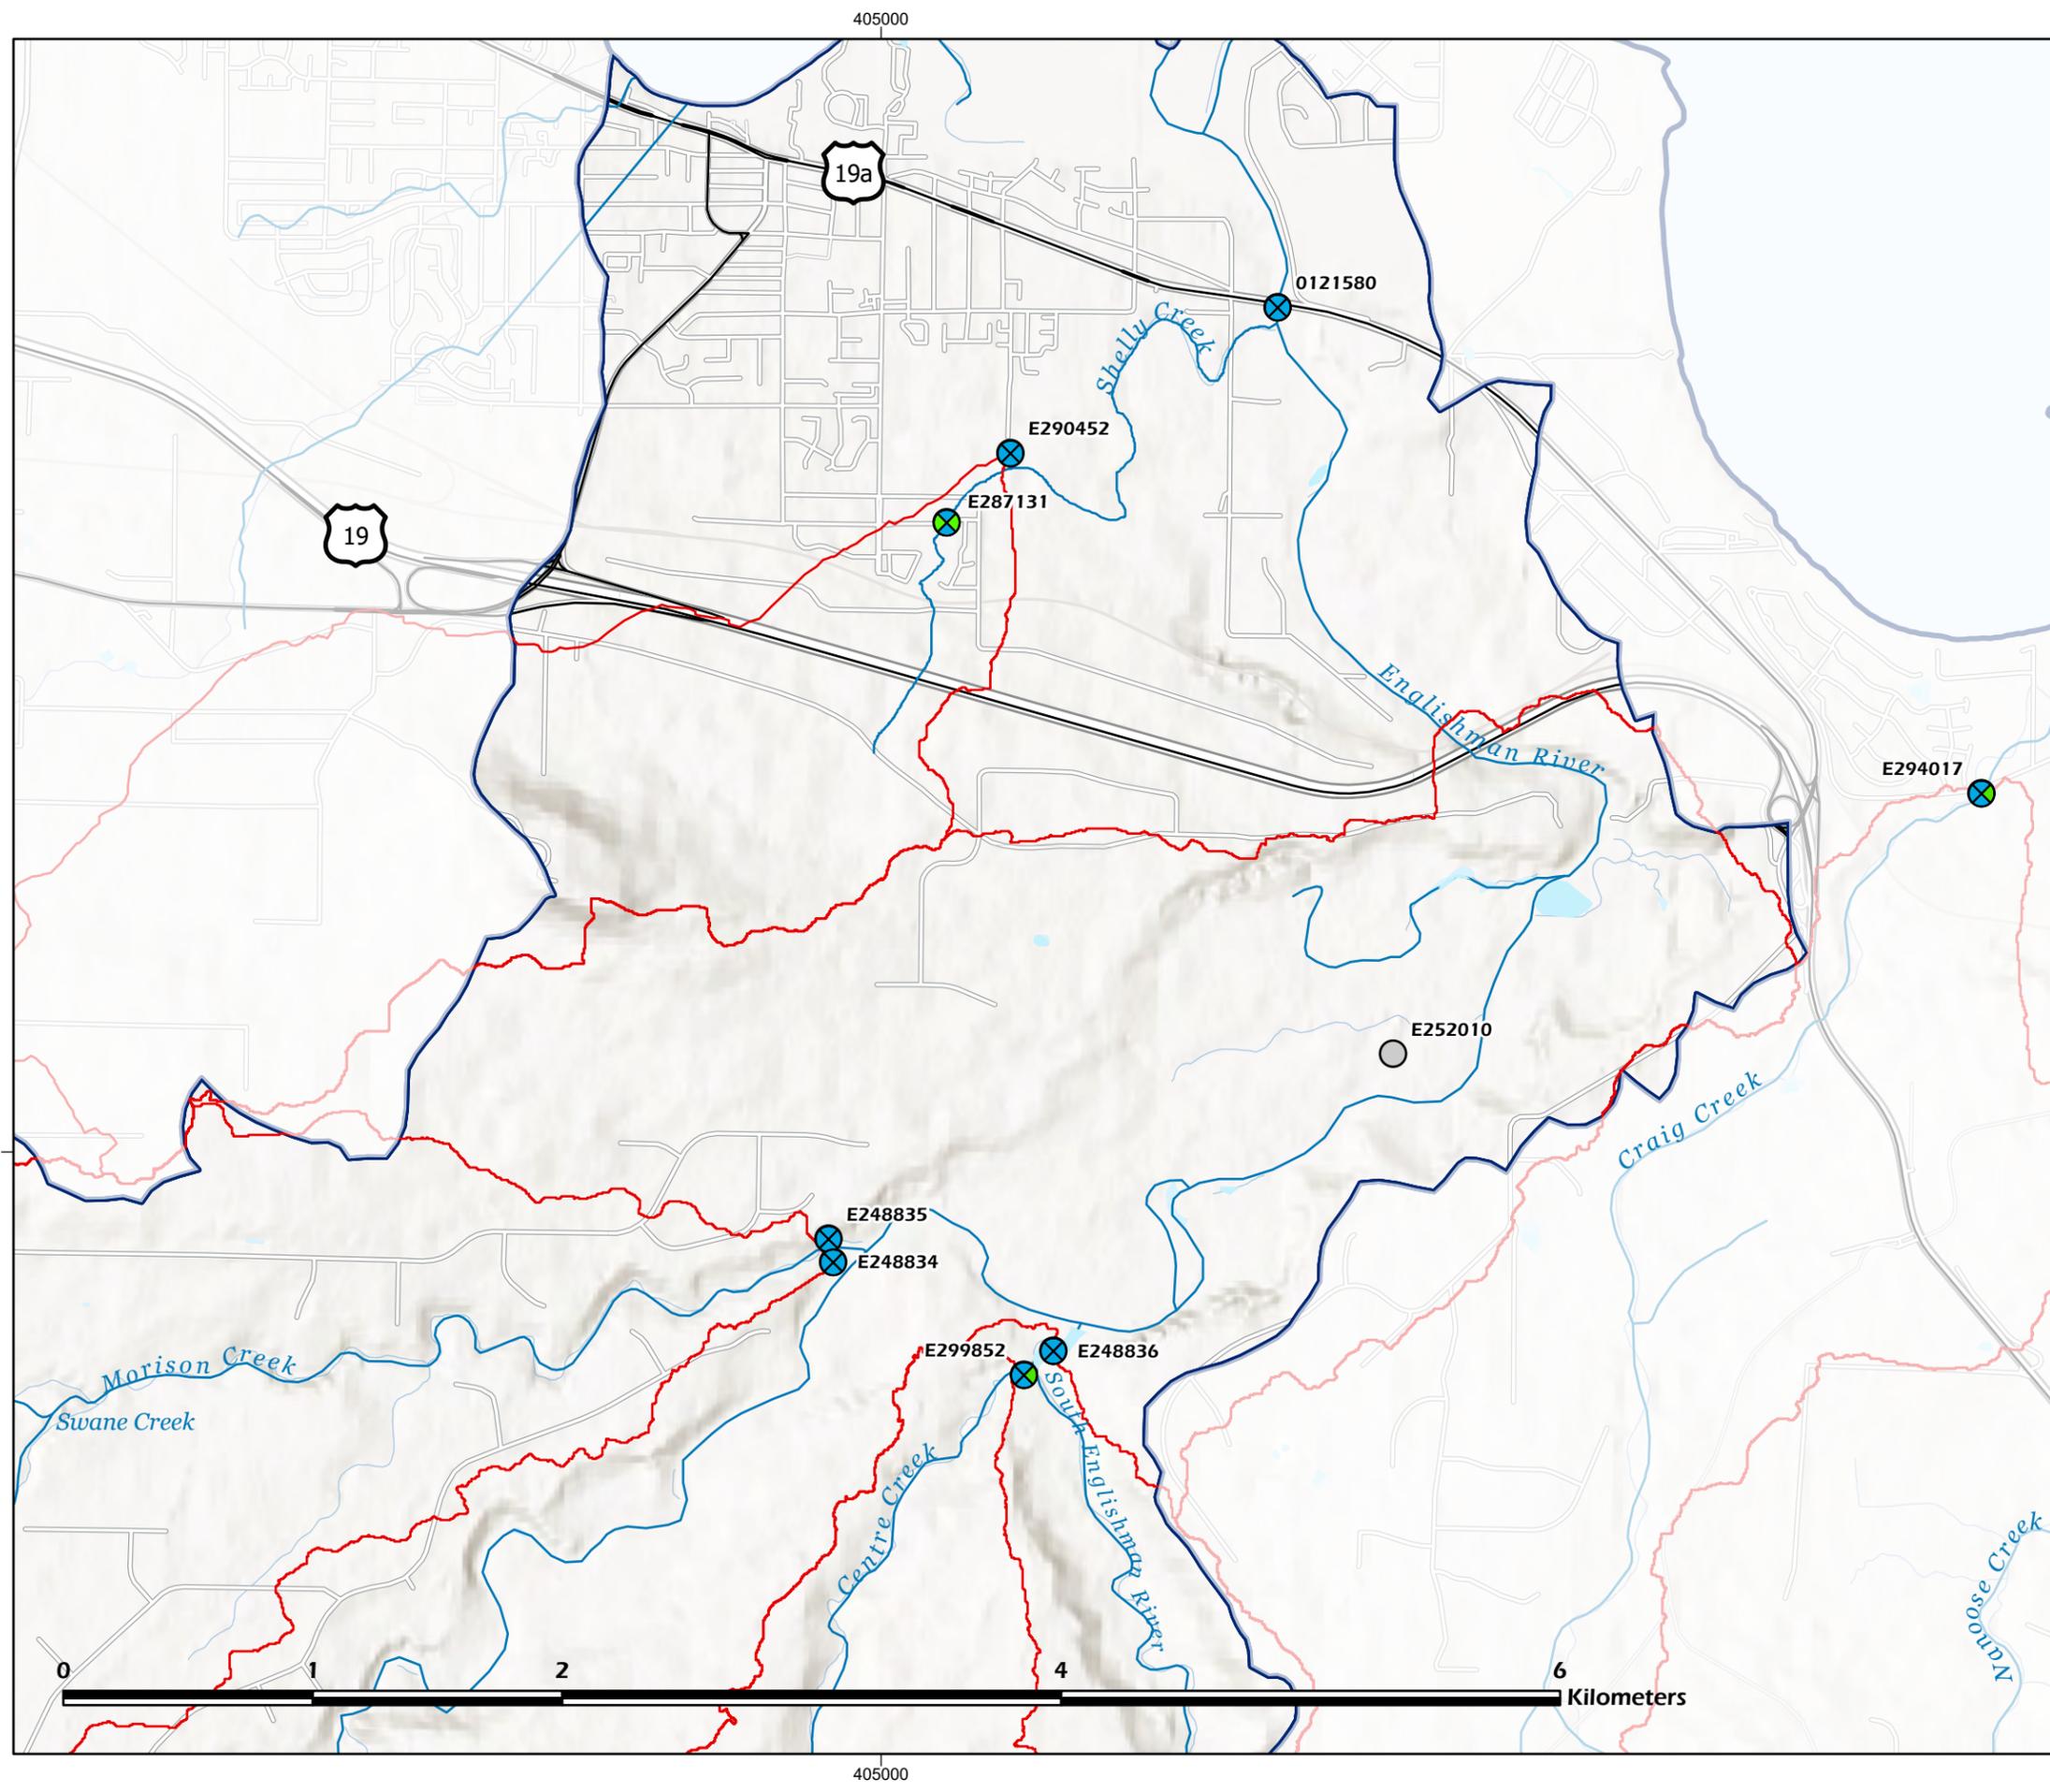
WR4b: Englishman River

CMMN Water Quality Trend Analysis 2011-2020

Conductivity can be influenced by factors such as groundwater and ocean spray that are not necessarily indicative of a degrading condition. For simplicity, an increase in conductivity is categorized here as degrading.

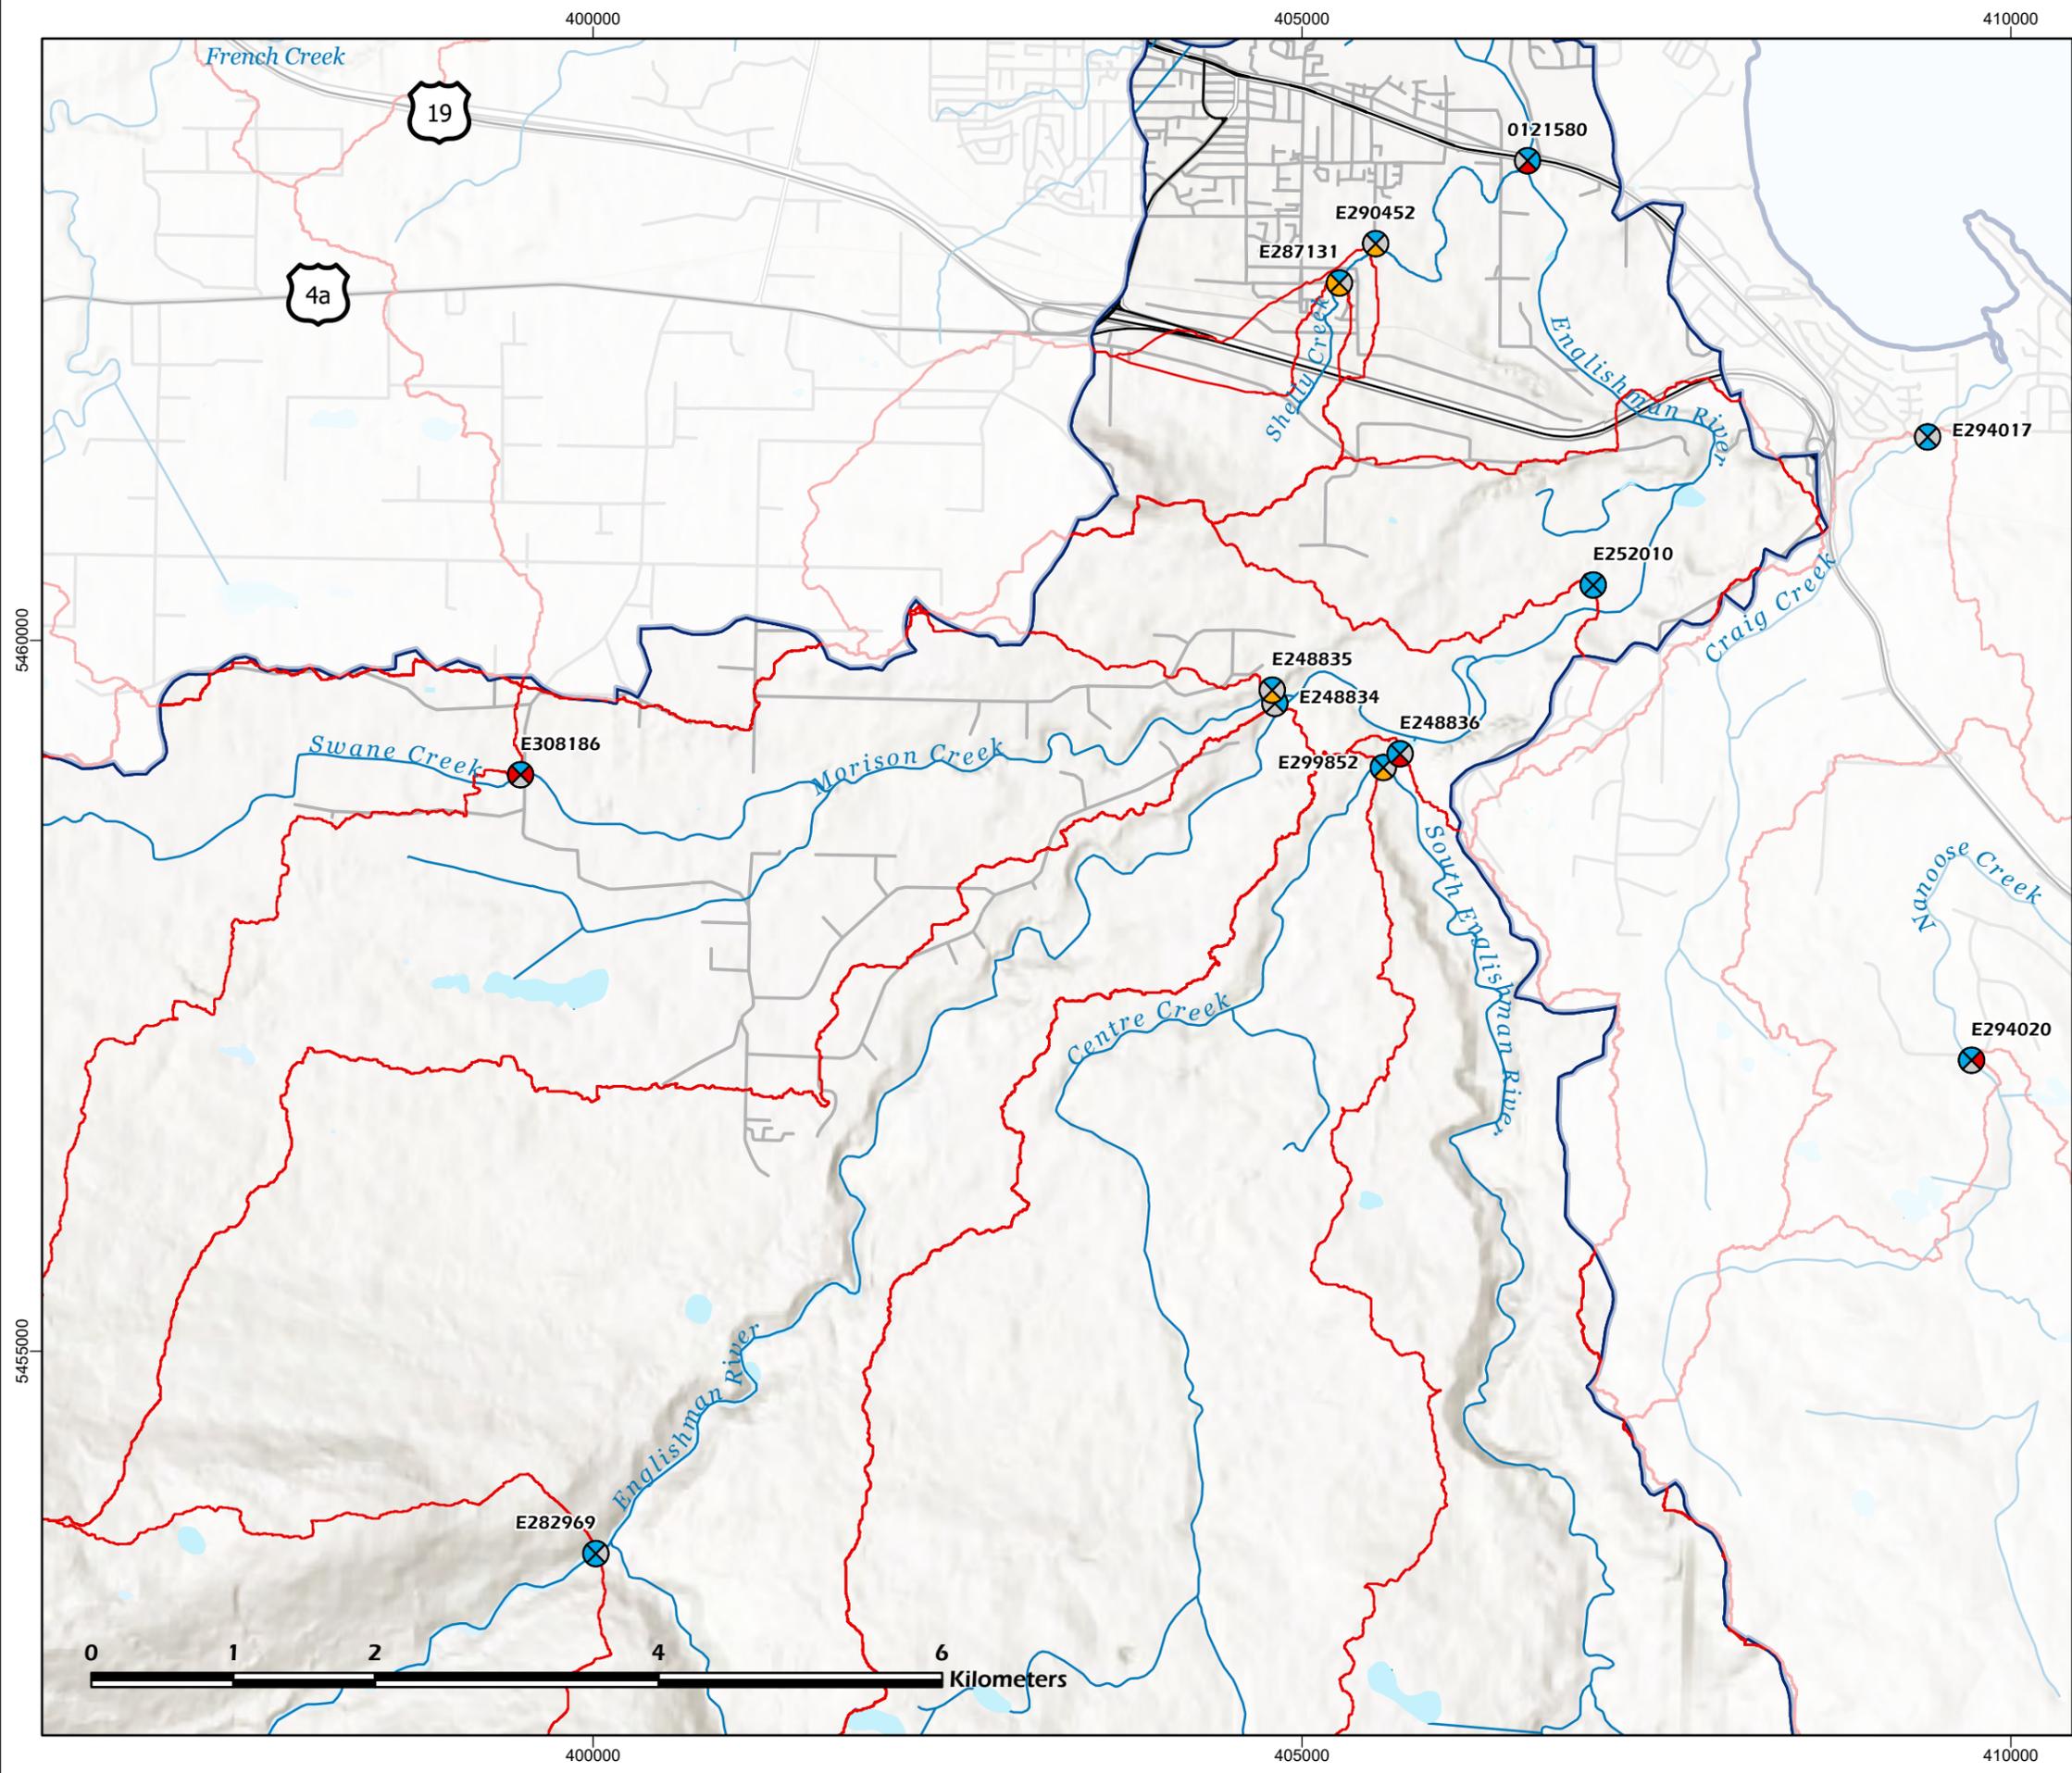
WR4a: Englishman River

CMMN 2011-2020 Summer Exceedance Assessment

Lake
- Note the exceedance frequency categories are reflective of the number of sample periods with exceedances, not the number or values of the exceedances.*

The summer and fall exceedance frequency maps included in this package express the number of sample periods (summer low-flow / fall flush) with exceedances for each site. There are four frequency categories for the number of sample periods with exceedances: no exceedance recorded (0), low (1 – 2), moderate (3 – 4), and high (5 or more). The exceedance categories are for the three parameters with aquatic water quality guidelines and objectives based on the following thresholds: temperature $\geq 17^{\circ}\text{C}$, dissolved oxygen $\leq 5\text{mg/L}$, summer turbidity $\geq 2\text{NTU}$, and fall turbidity $\geq 5\text{NTU}$.

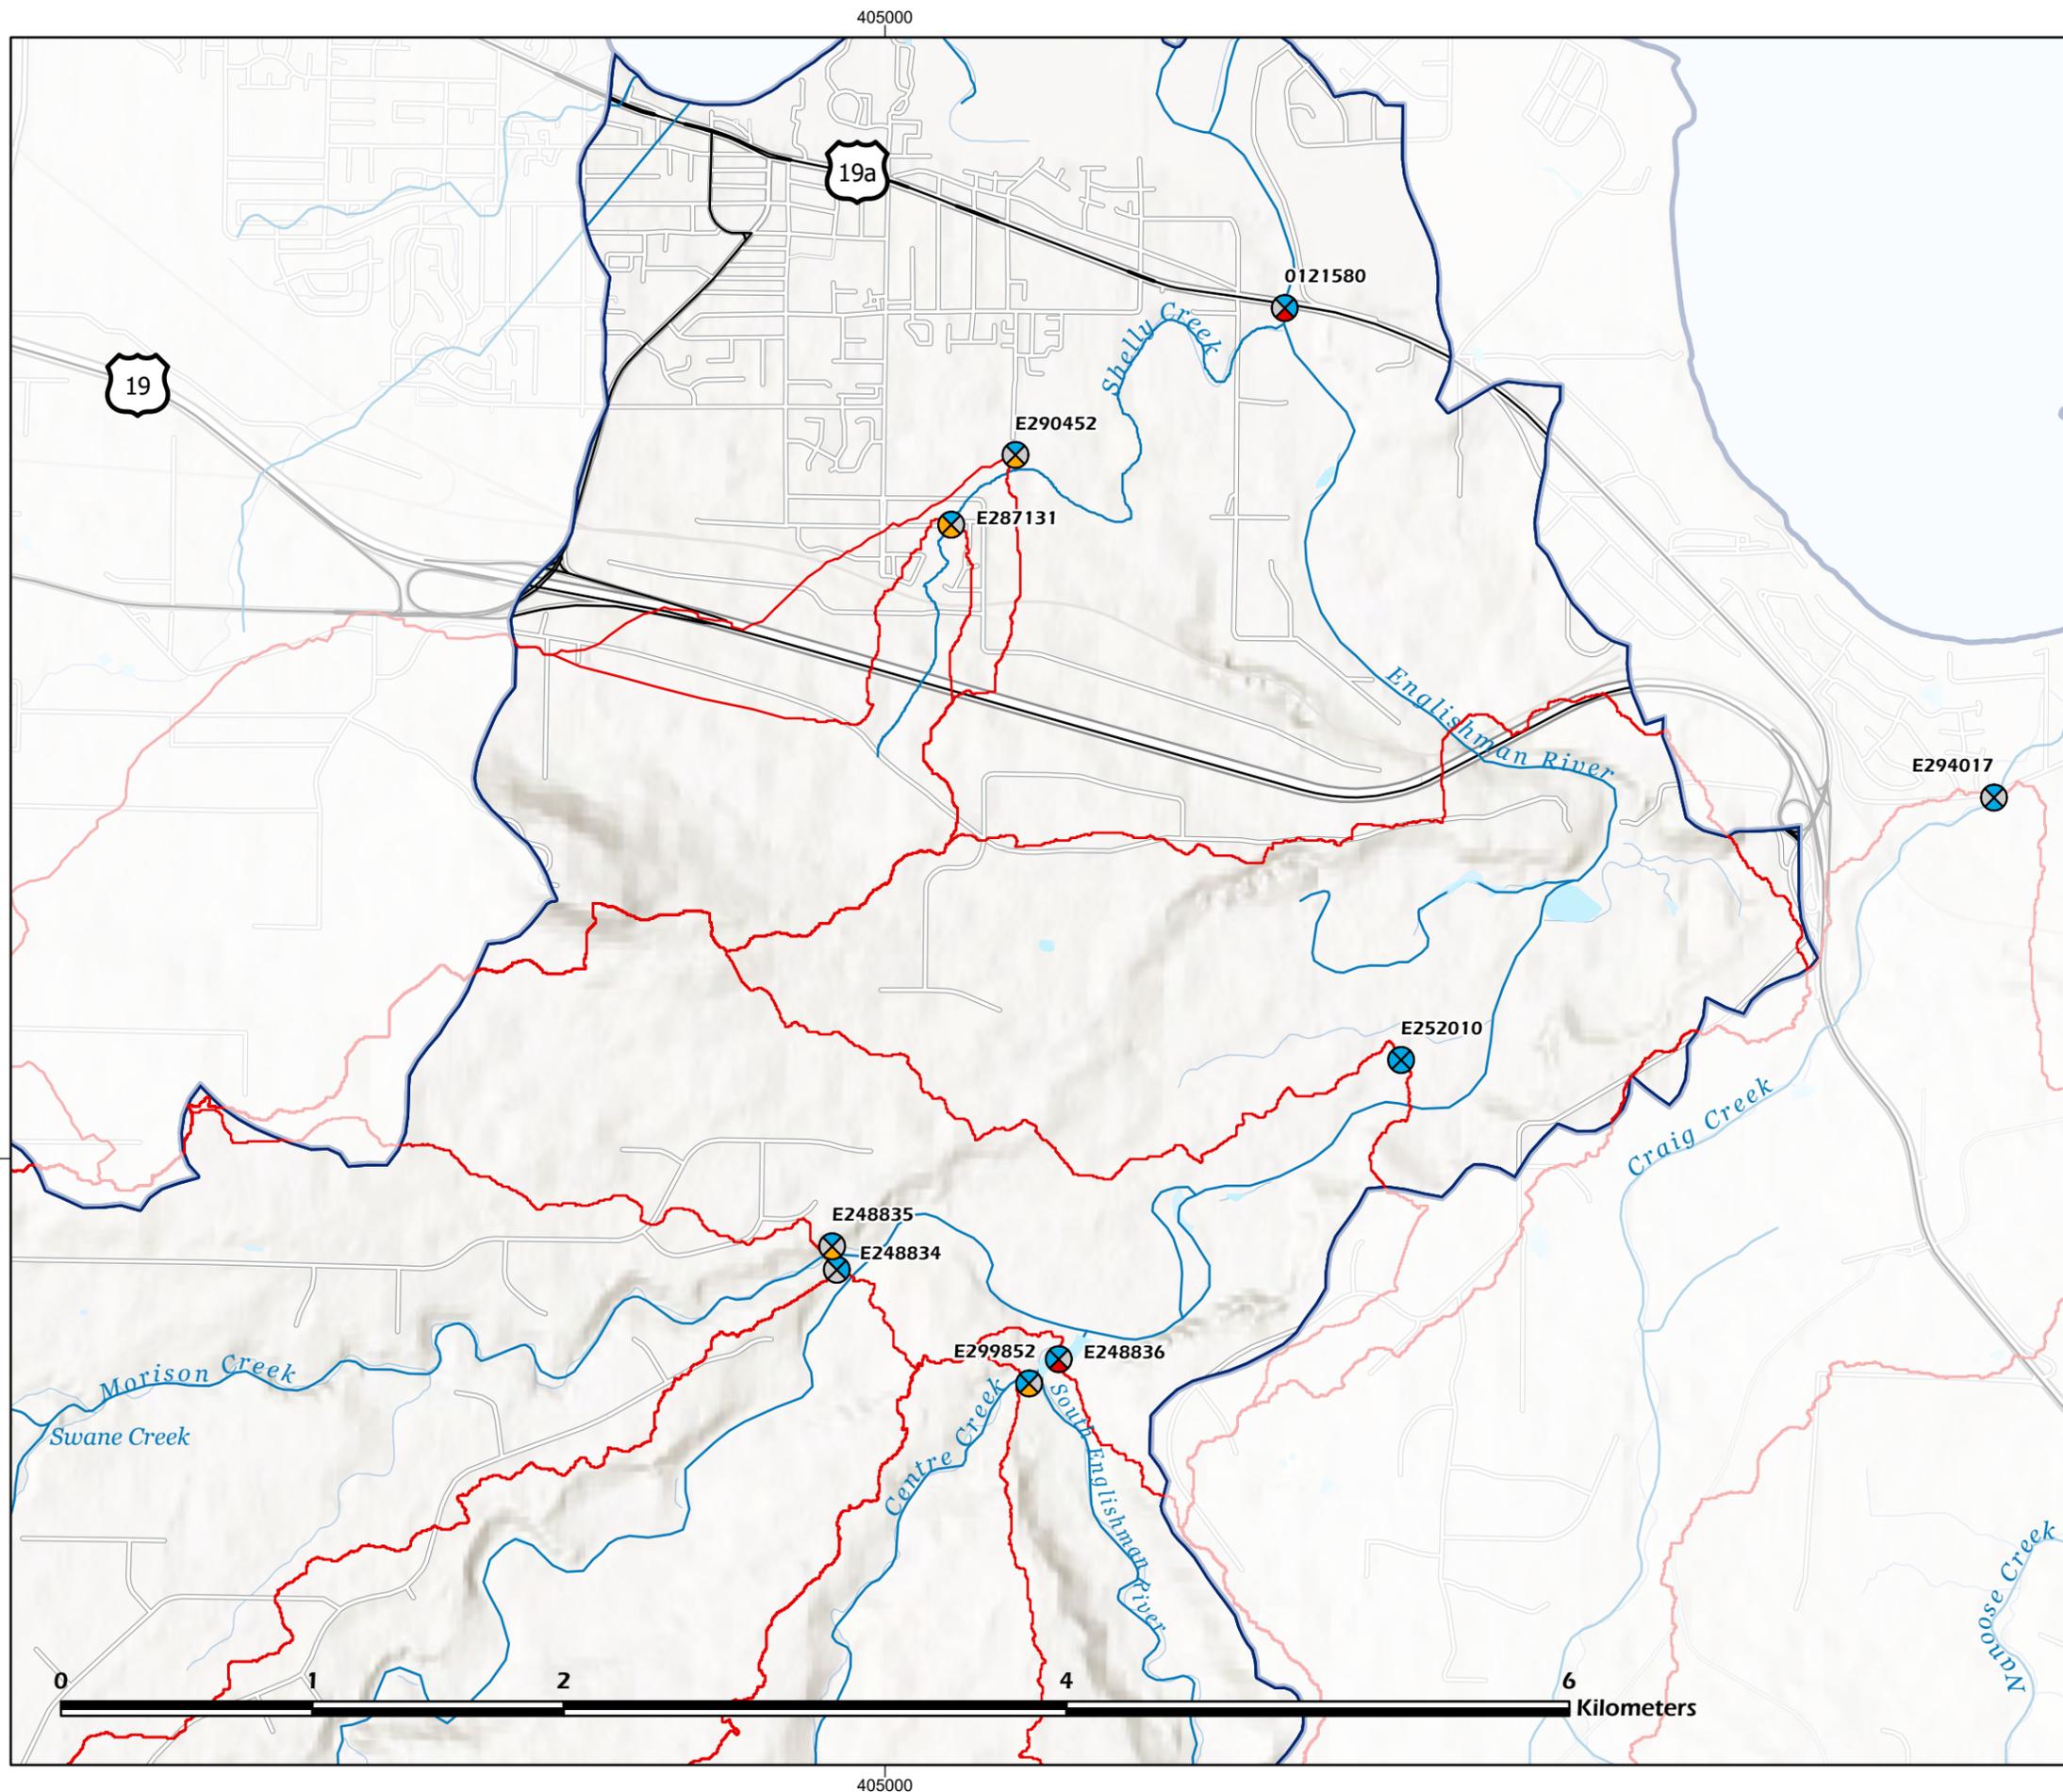
WR4b: Englishman River

CMMN 2011-2020 Summer Exceedance Assessment

- ⊗ Sample Site
 - Highway
 - Stream
 - ▭ Watershed
 - ▭ Water Region
 - ▭ Lake
- Note the exceedance frequency categories are reflective of the number of sample periods with exceedances, not the number or values of the exceedances.*
