Community Watershed Monitoring Network 2020

Results by Water Region

Water Region 4
sampled by:
**Mid Vancouver Island
Habitat Enhancement Society
(MVIHES)**

CMMN Water Quality Trend Analysis 2011-2020

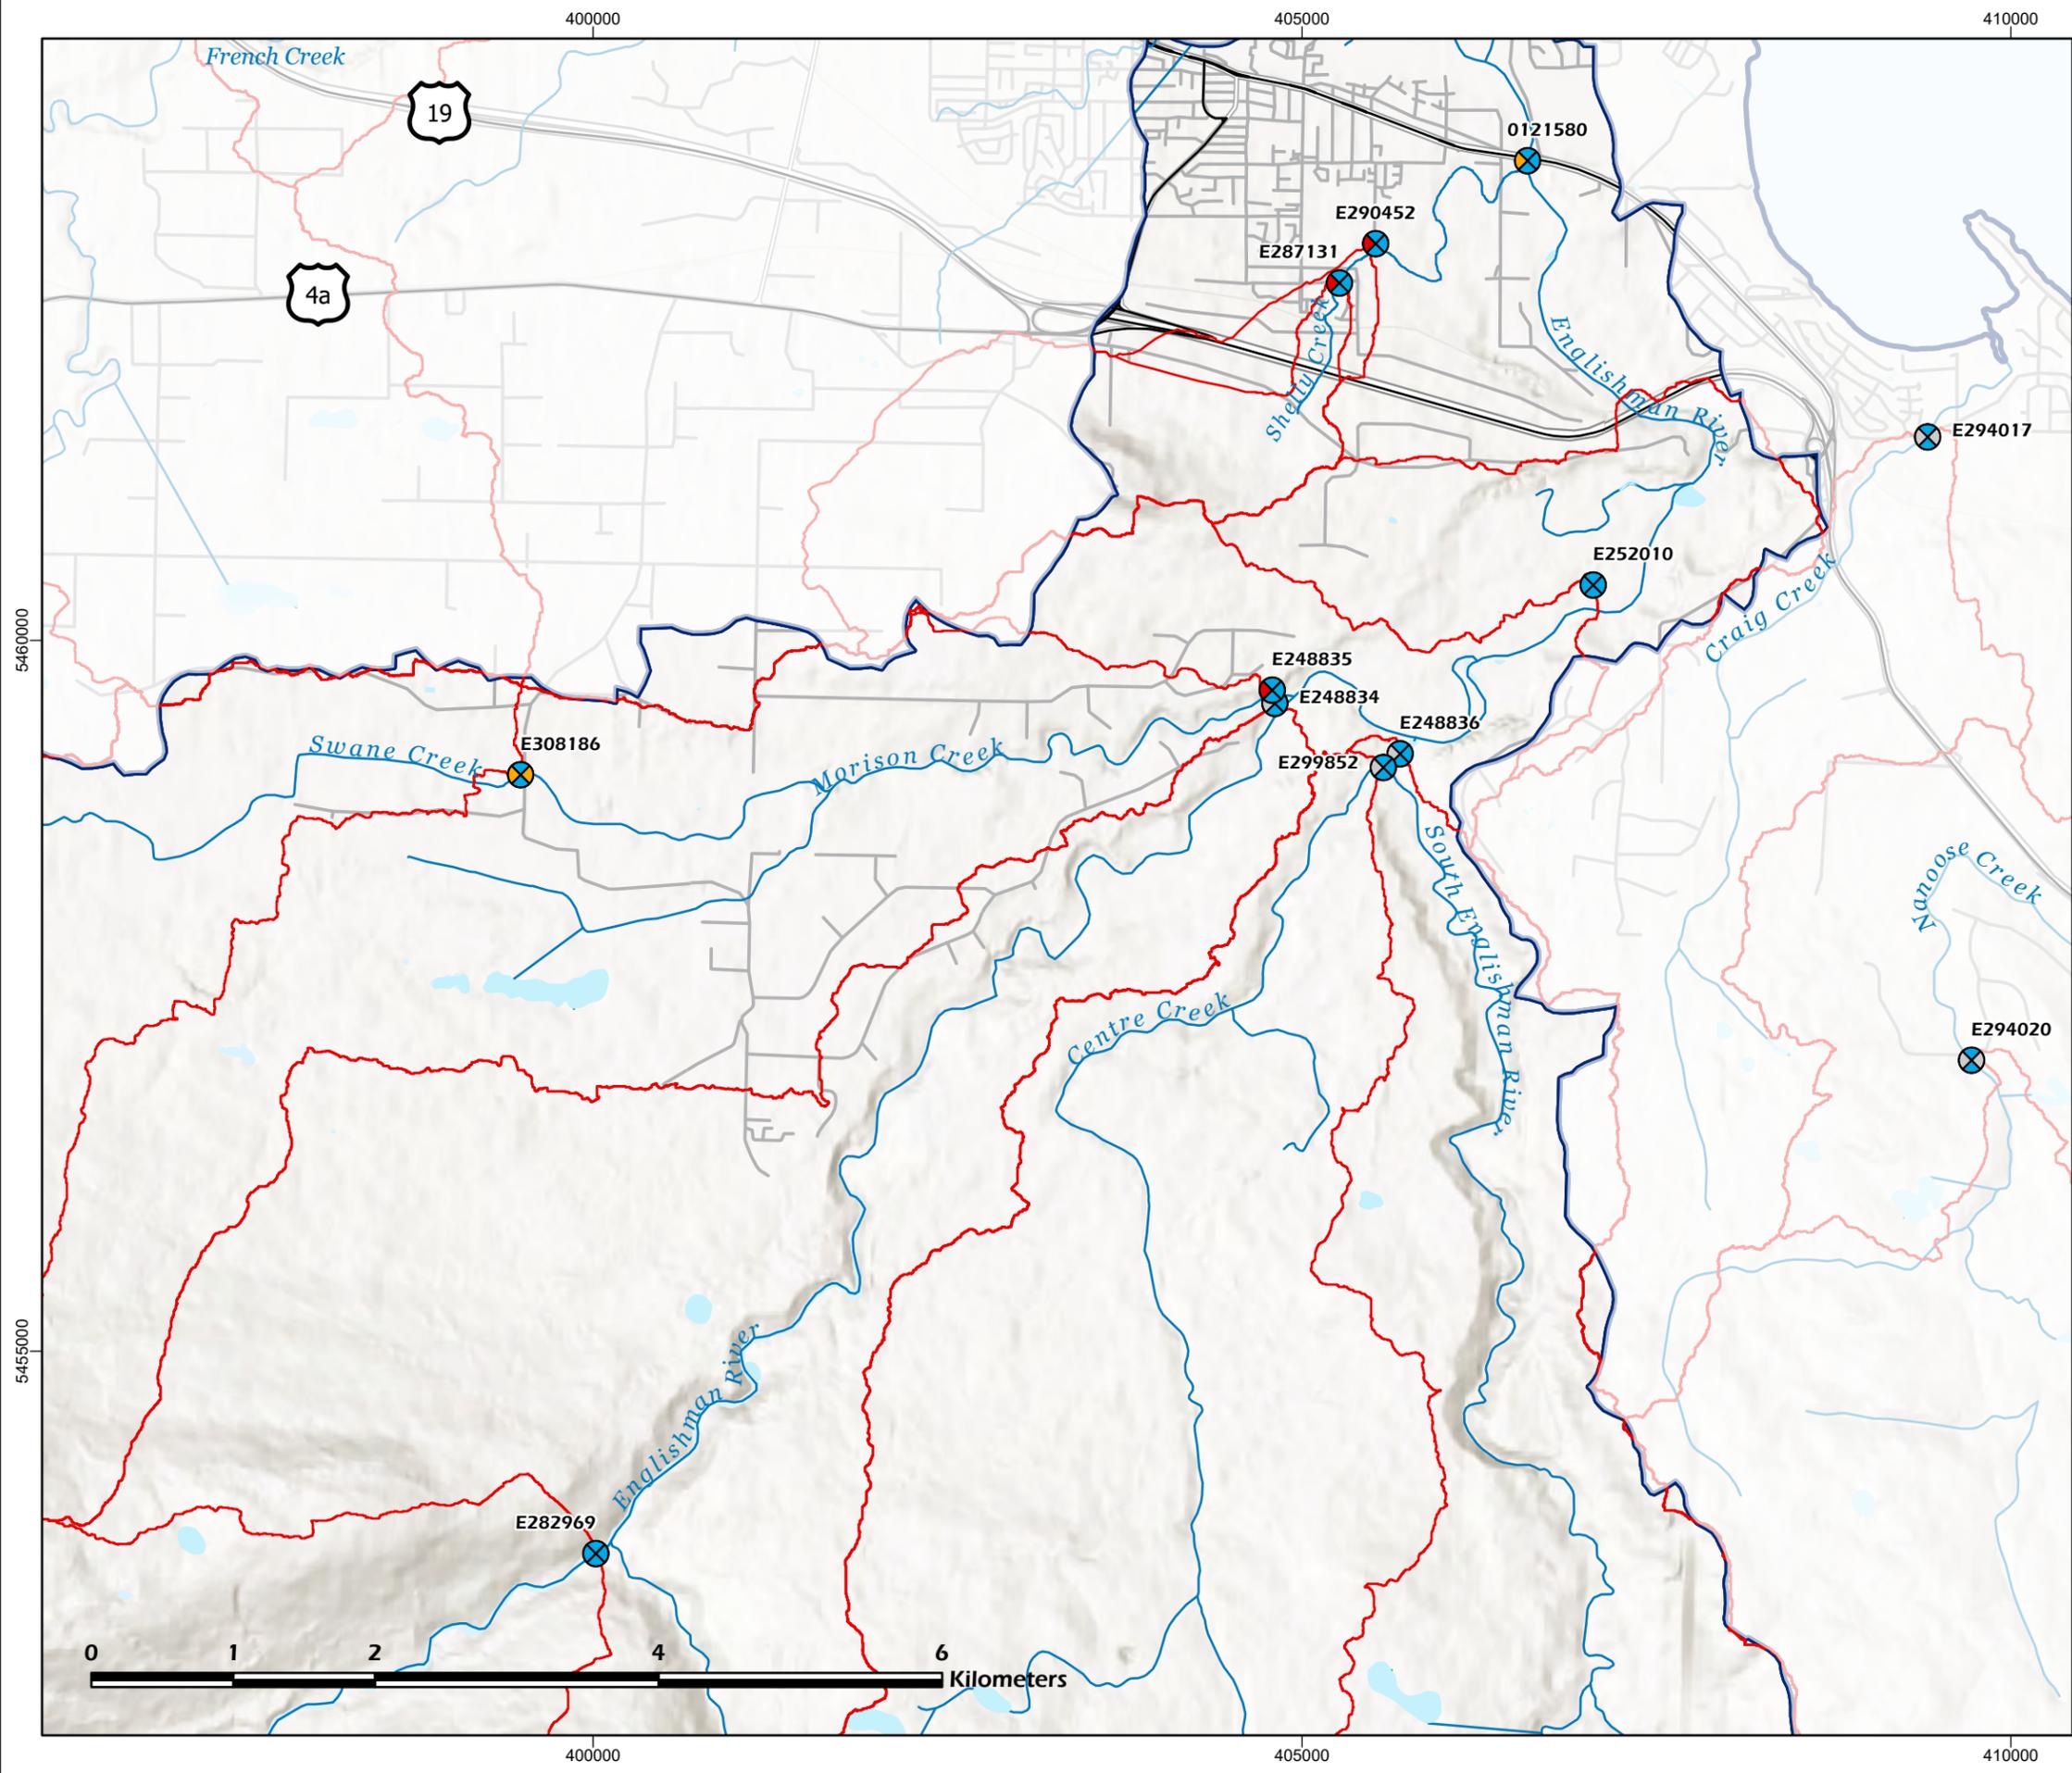
WR4a: Englishman River

CMMN 2011-2020 Fall Exceedance Assessment

Lake
- Note the exceedance frequency categories are reflective of the number of sample periods with exceedances, not the number or values of the exceedances.*

The summer and fall exceedance frequency maps included in this package express the number of sample periods (summer low-flow / fall flush) with exceedances for each site. There are four frequency categories for the number of sample periods with exceedances: no exceedance recorded (0), low (1 – 2), moderate (3 – 4), and high (5 or more). The exceedance categories are for the three parameters with aquatic water quality guidelines and objectives based on the following thresholds: temperature $\geq 17^{\circ}\text{C}$, dissolved oxygen $\leq 5\text{mg/L}$, summer turbidity $\geq 2\text{NTU}$, and fall turbidity $\geq 5\text{NTU}$.

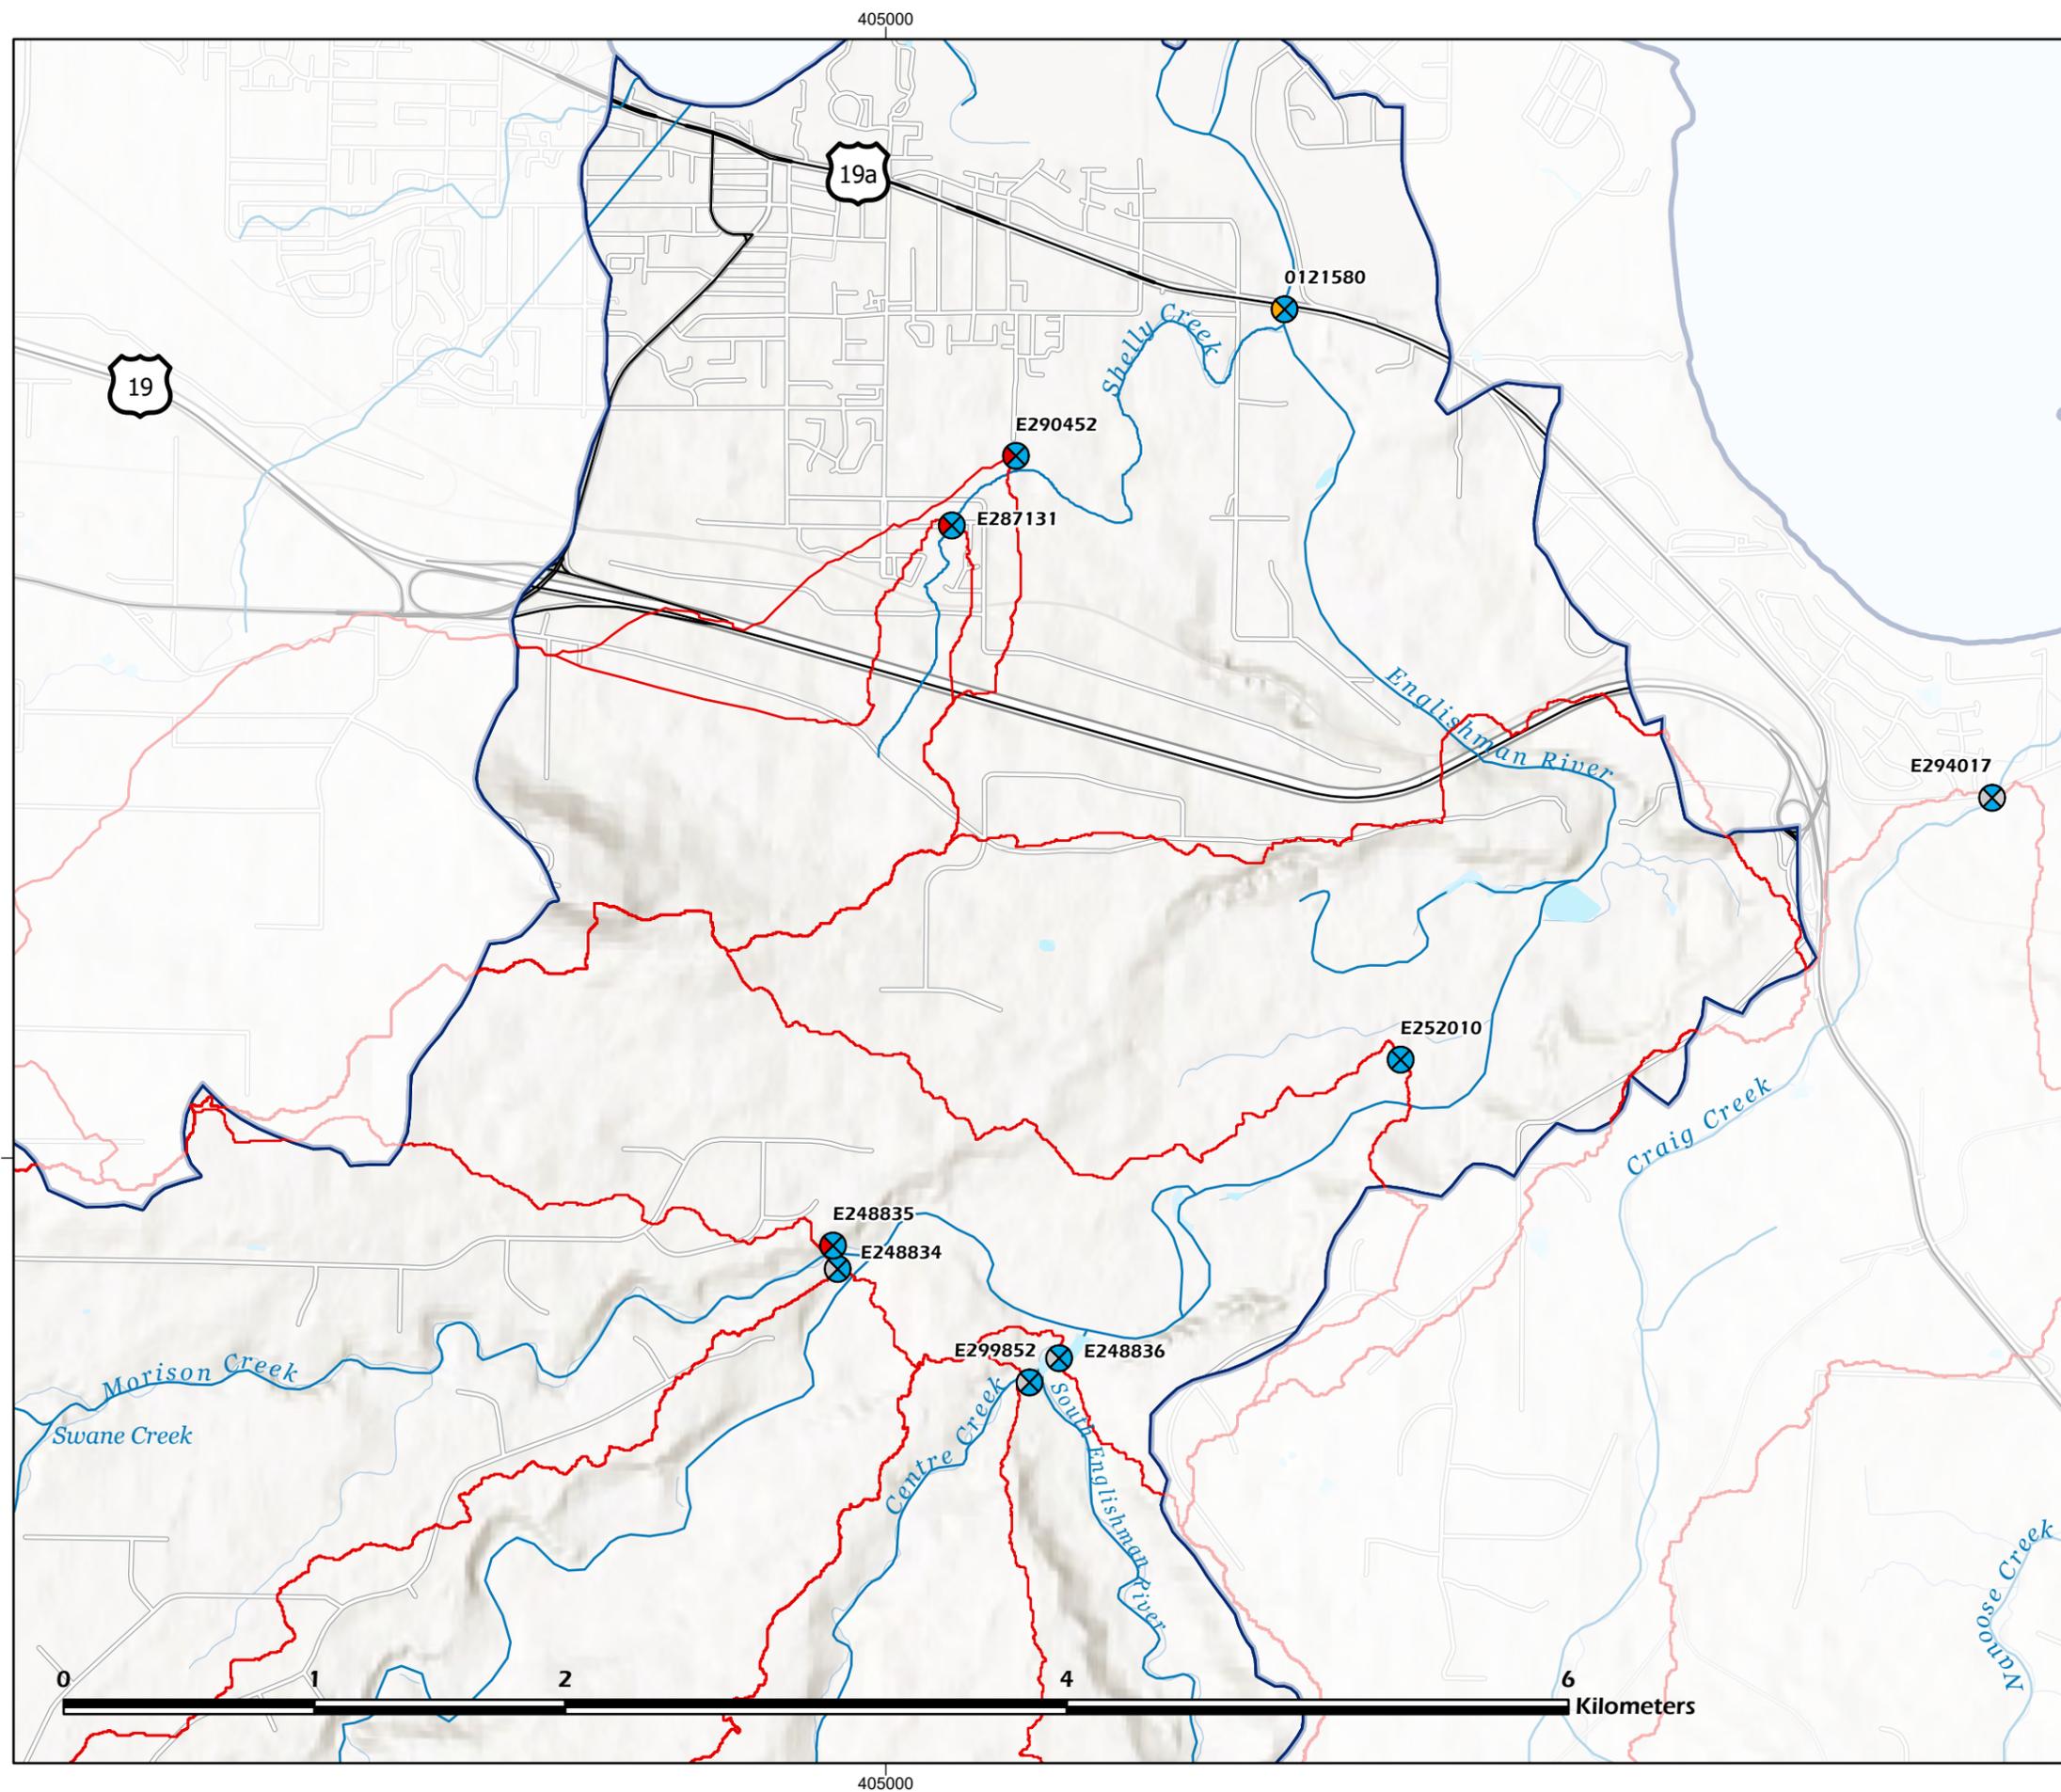
WR4b: Englishman River

CMMN 2011-2020 Fall Exceedance Assessment

- ⊗ Sample Site
 - Stream
 - Highway
 - ▭ Watershed
 - ▭ Water Region
 - ▭ Lake
- Note the exceedance frequency categories are reflective of the number of sample periods with exceedances, not the number or values of the exceedances.*

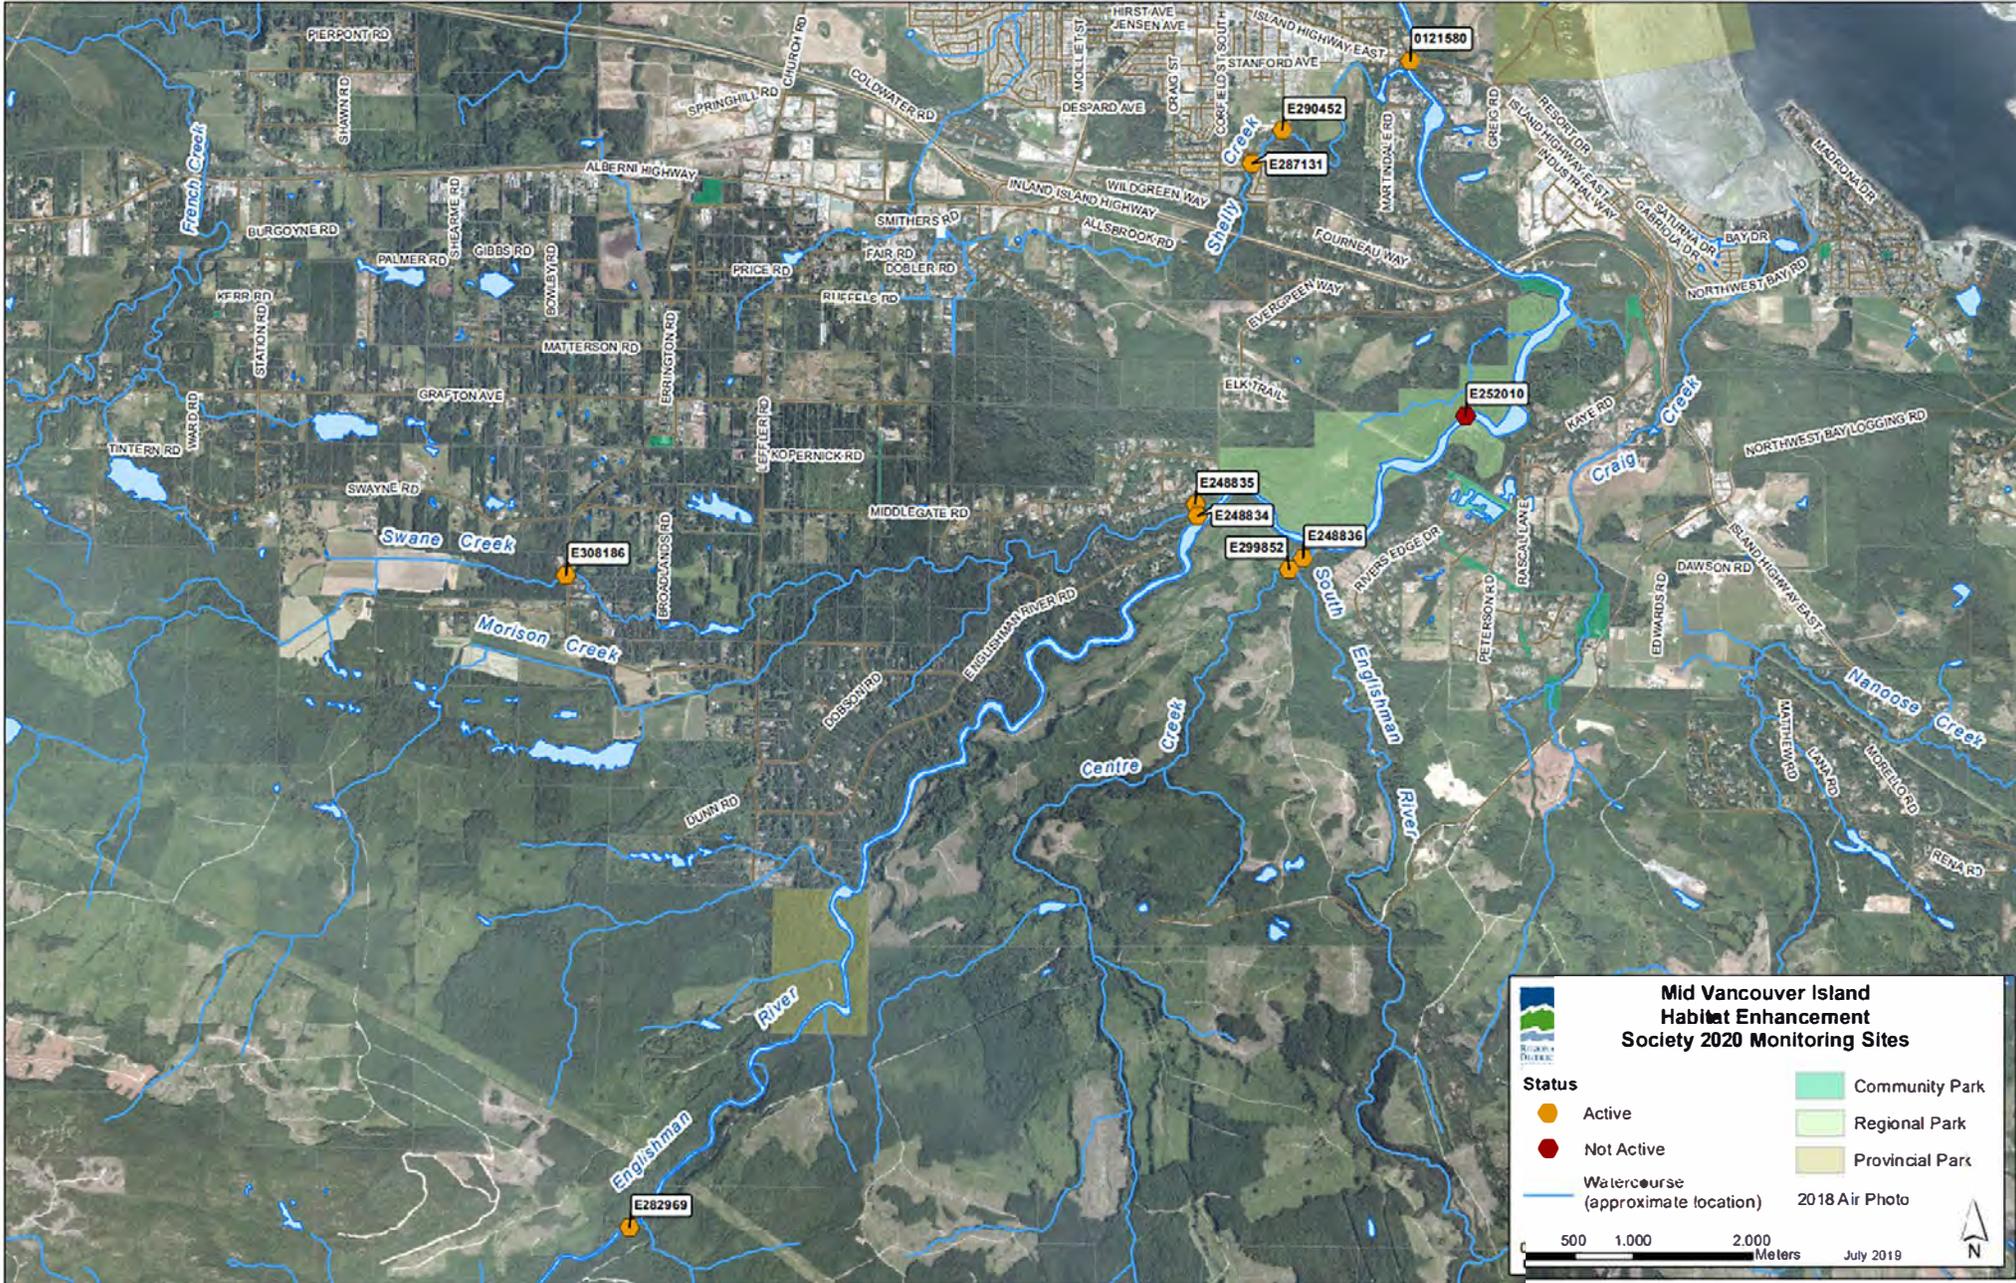
**Mid Vancouver Island
Habitat Enhancement
Society 2020 Monitoring Sites**

Status	Community Park
Active	Regional Park
Not Active	Provincial Park
Watercourse (approximate location)	2018 Air Photo
