Community Watershed Monitoring Network 2020

Results by Water Region

CMMN Water Quality Trend Analysis 2011-2020

WR5-1a: South Wellington to Nanoose

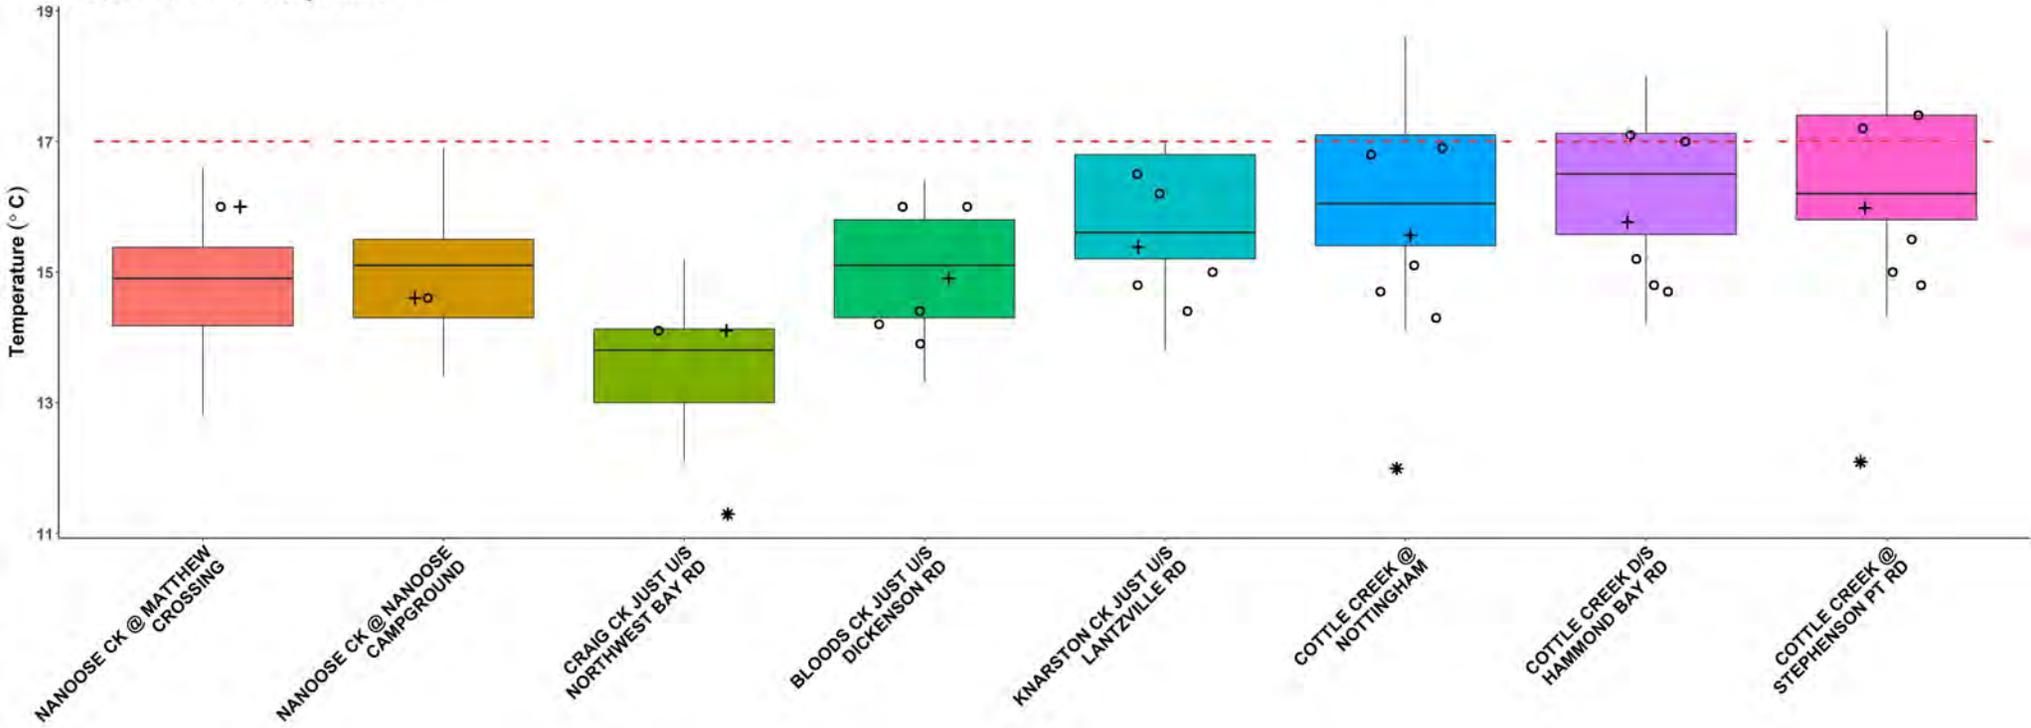
WR5-1a Summer Temperature

○ 2020 Samples
 * Outlier 2012-2019
 + 2020 30 Day Avg

-- Aquatic Life Guideline for Coho Rearing (17°C)

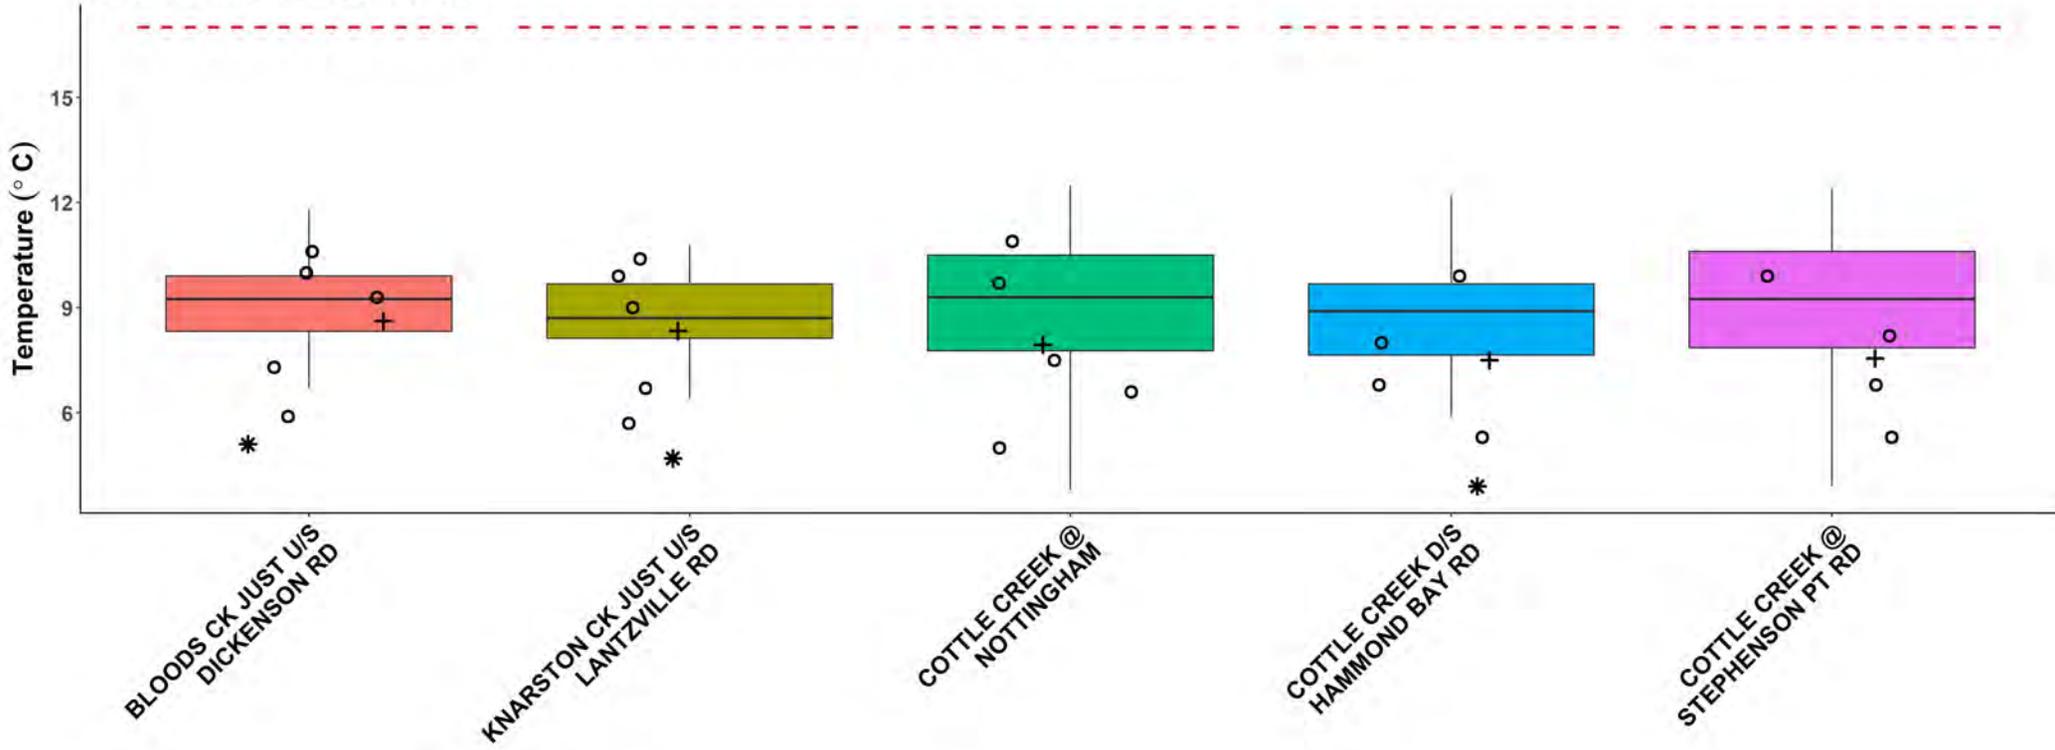
WR5-1a Fall Temperature

○ 2020 Samples
* Outlier 2012-2019
+ 2020 30 Day Avg

Guideline
-- Aquatic Life Guideline for Coho Rearing (17°C)

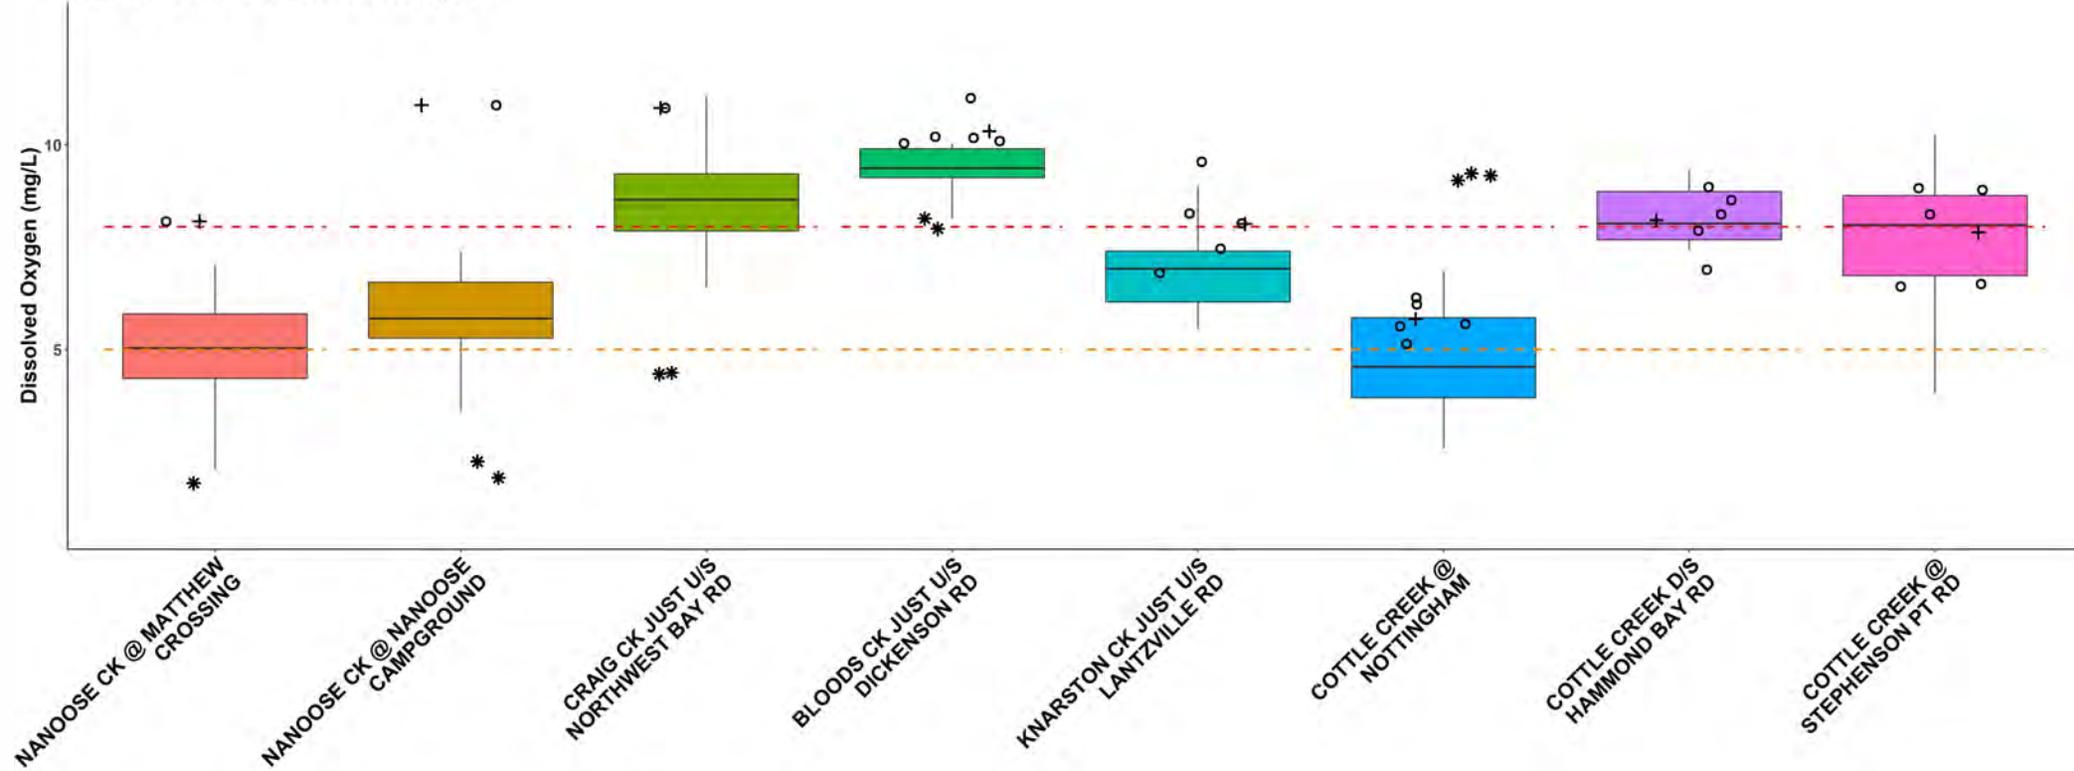
WR5-1a Summer Dissolved Oxygen

- 2020 Samples
 - * Outlier 2012-2019
 - + 2020 30 Day Avg
- Guideline**
- 30 Day Average (<8 mg/L)
 - Instantaneous Minimum (<5 mg/L)

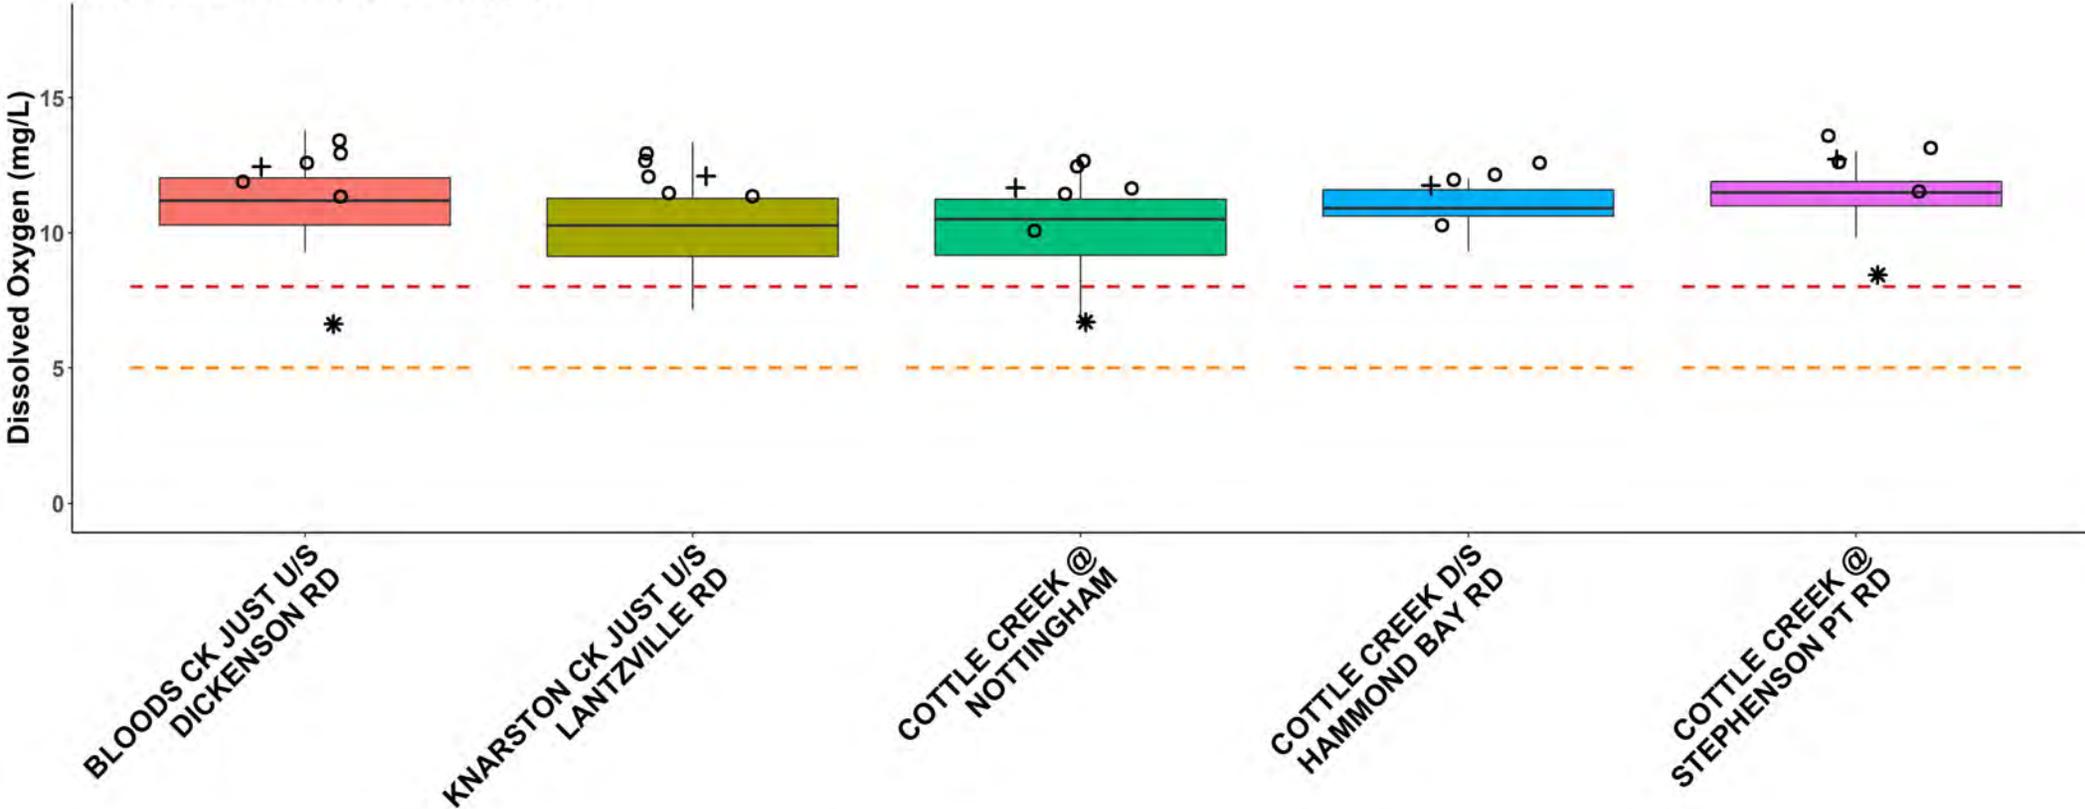
WR5-1a Fall Dissolved Oxygen

○ 2020 Samples
 * Outlier 2012-2019
 + 2020 30 Day Avg

Guideline
 - - 30 Day Average (<8 mg/L)
 - - Instantaneous Minimum (<5 mg/L)

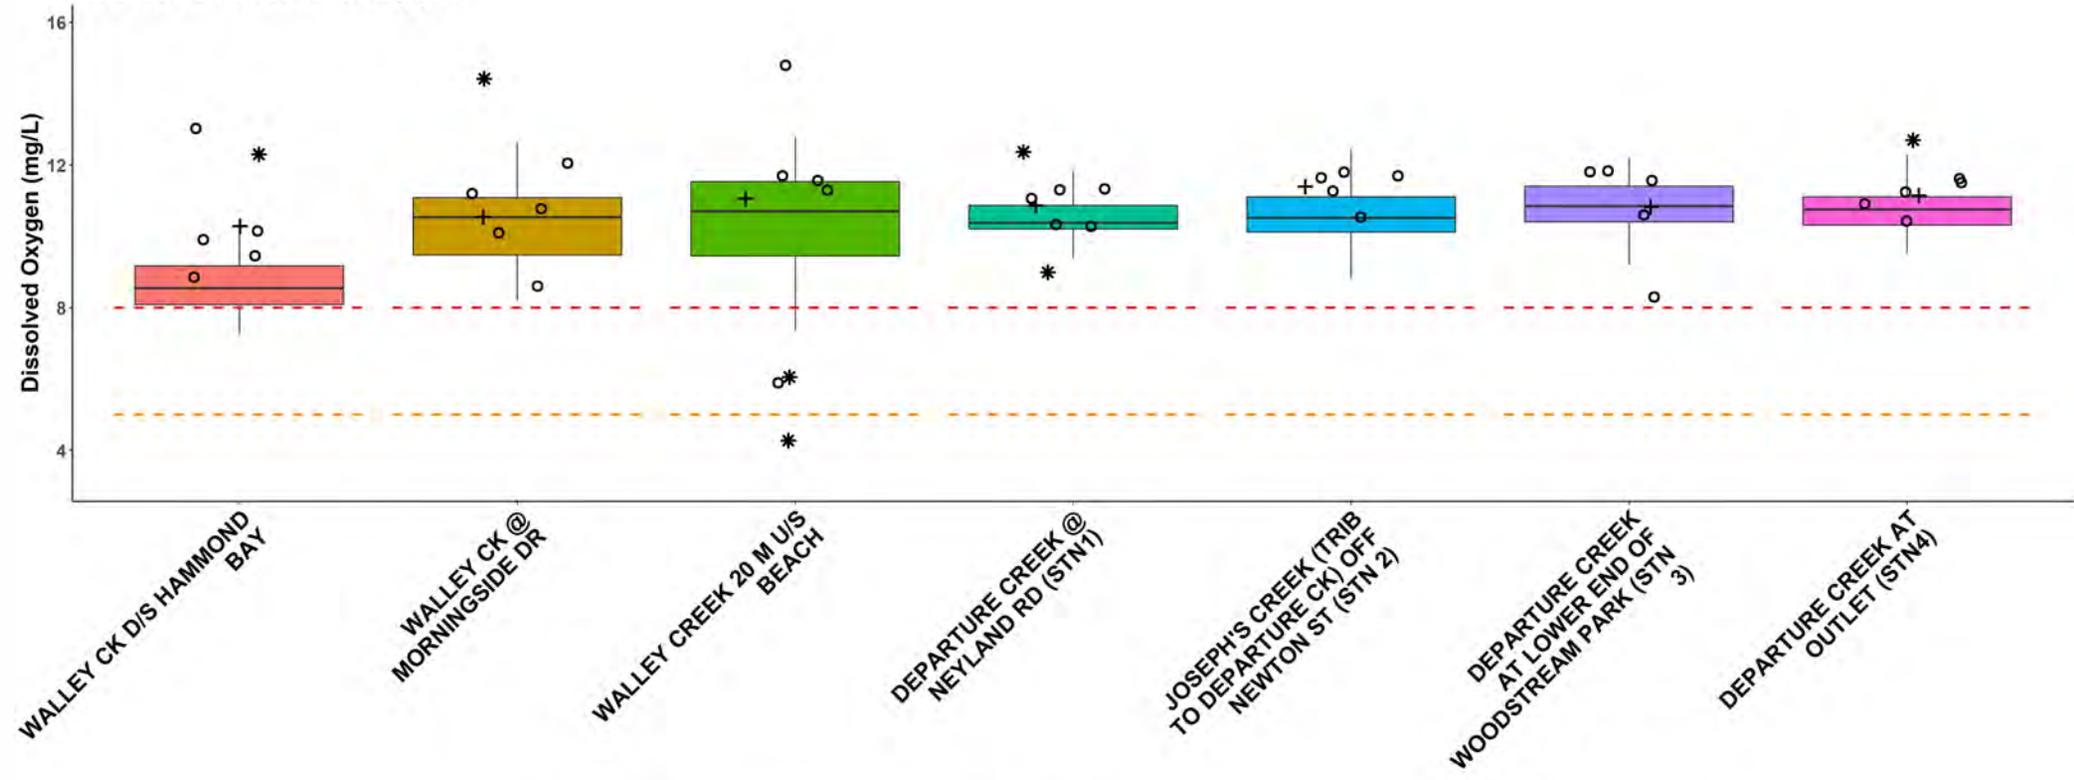
WR5-1b Fall Dissolved Oxygen

- 2020 Samples
 - * Outlier 2012-2019
 - + 2020 30 Day Avg
- Guideline**
- 30 Day Average (<8 mg/L)
 - Instantaneous Minimum (<5 mg/L)

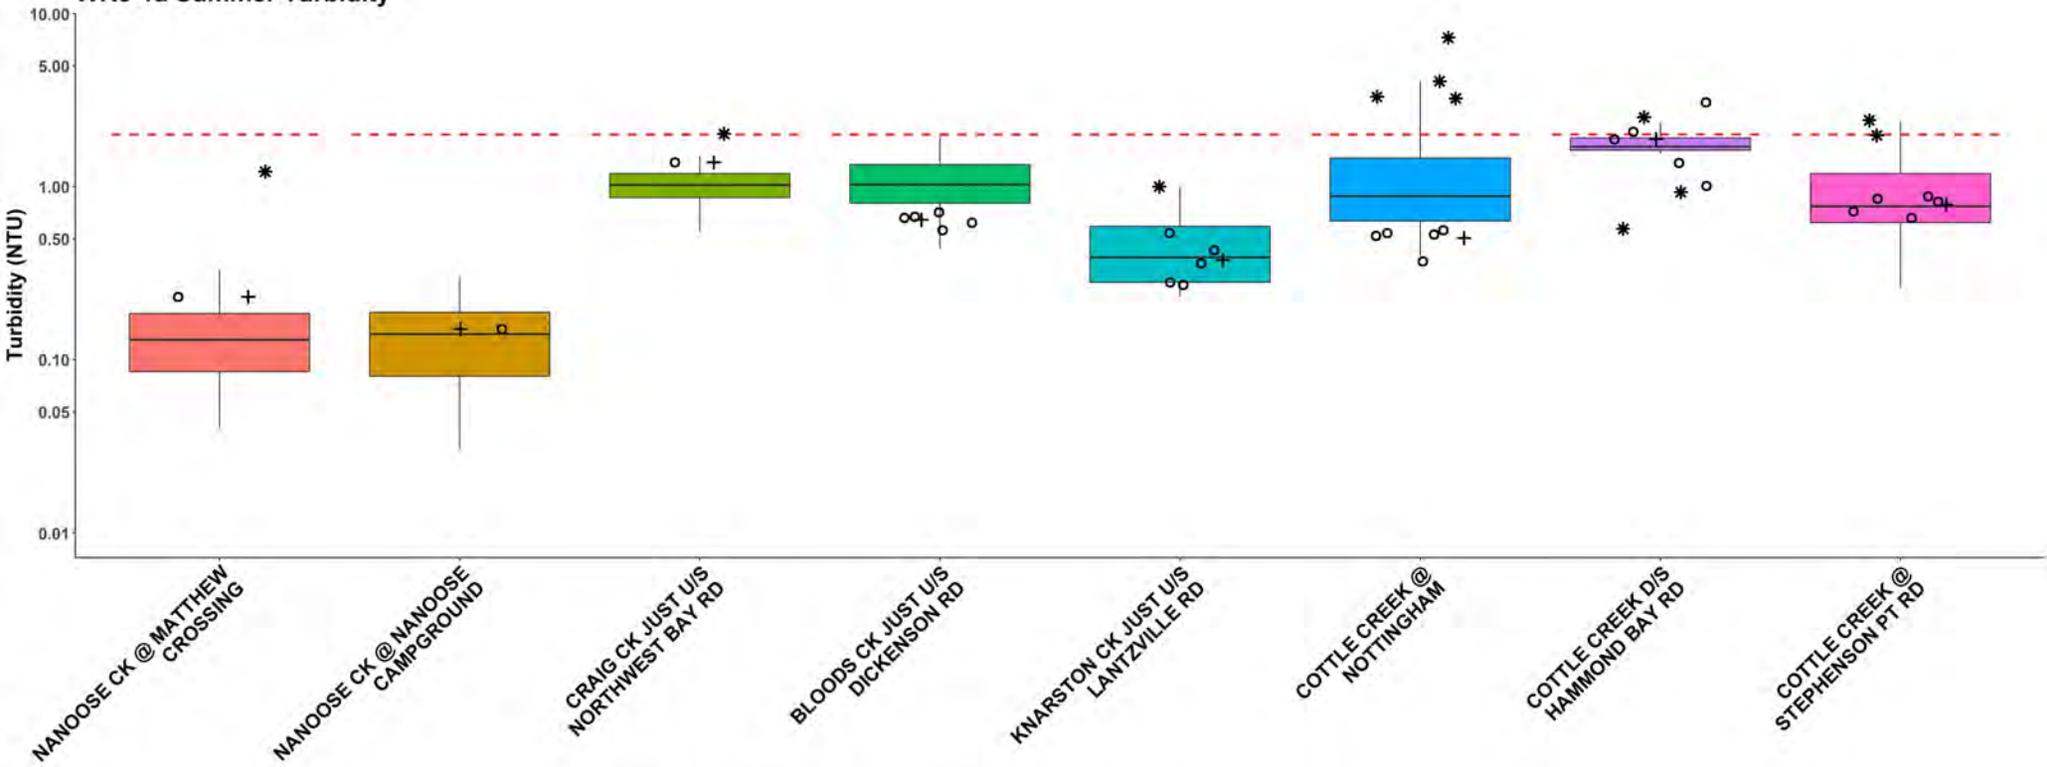
WR5-1a Summer Turbidity

○ 2020 Samples * Outlier 2012-2019 Guideline
 + 2020 30 Day Avg - - Jan-Sept Max (2 NTU)

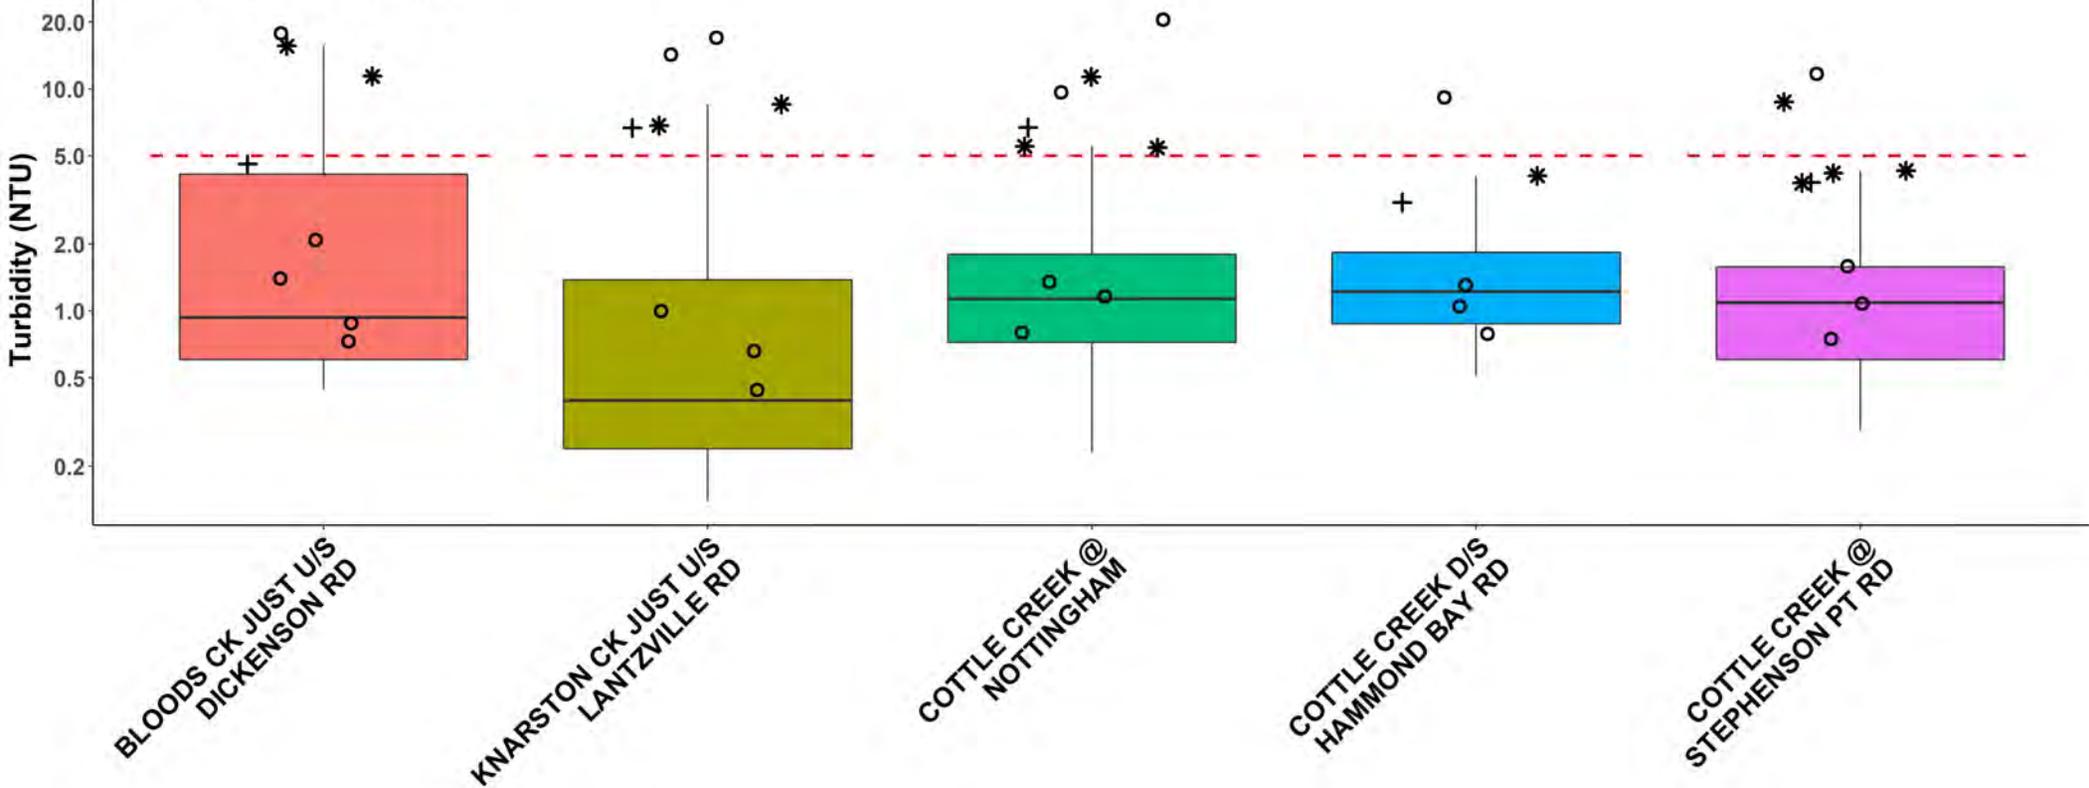
WR5-1a Fall Turbidity

- 2020 Samples
- * Outlier 2012-2019
- + 2020 30 Day Avg
- Guideline
- - Oct-Dec Max (5 NTU)

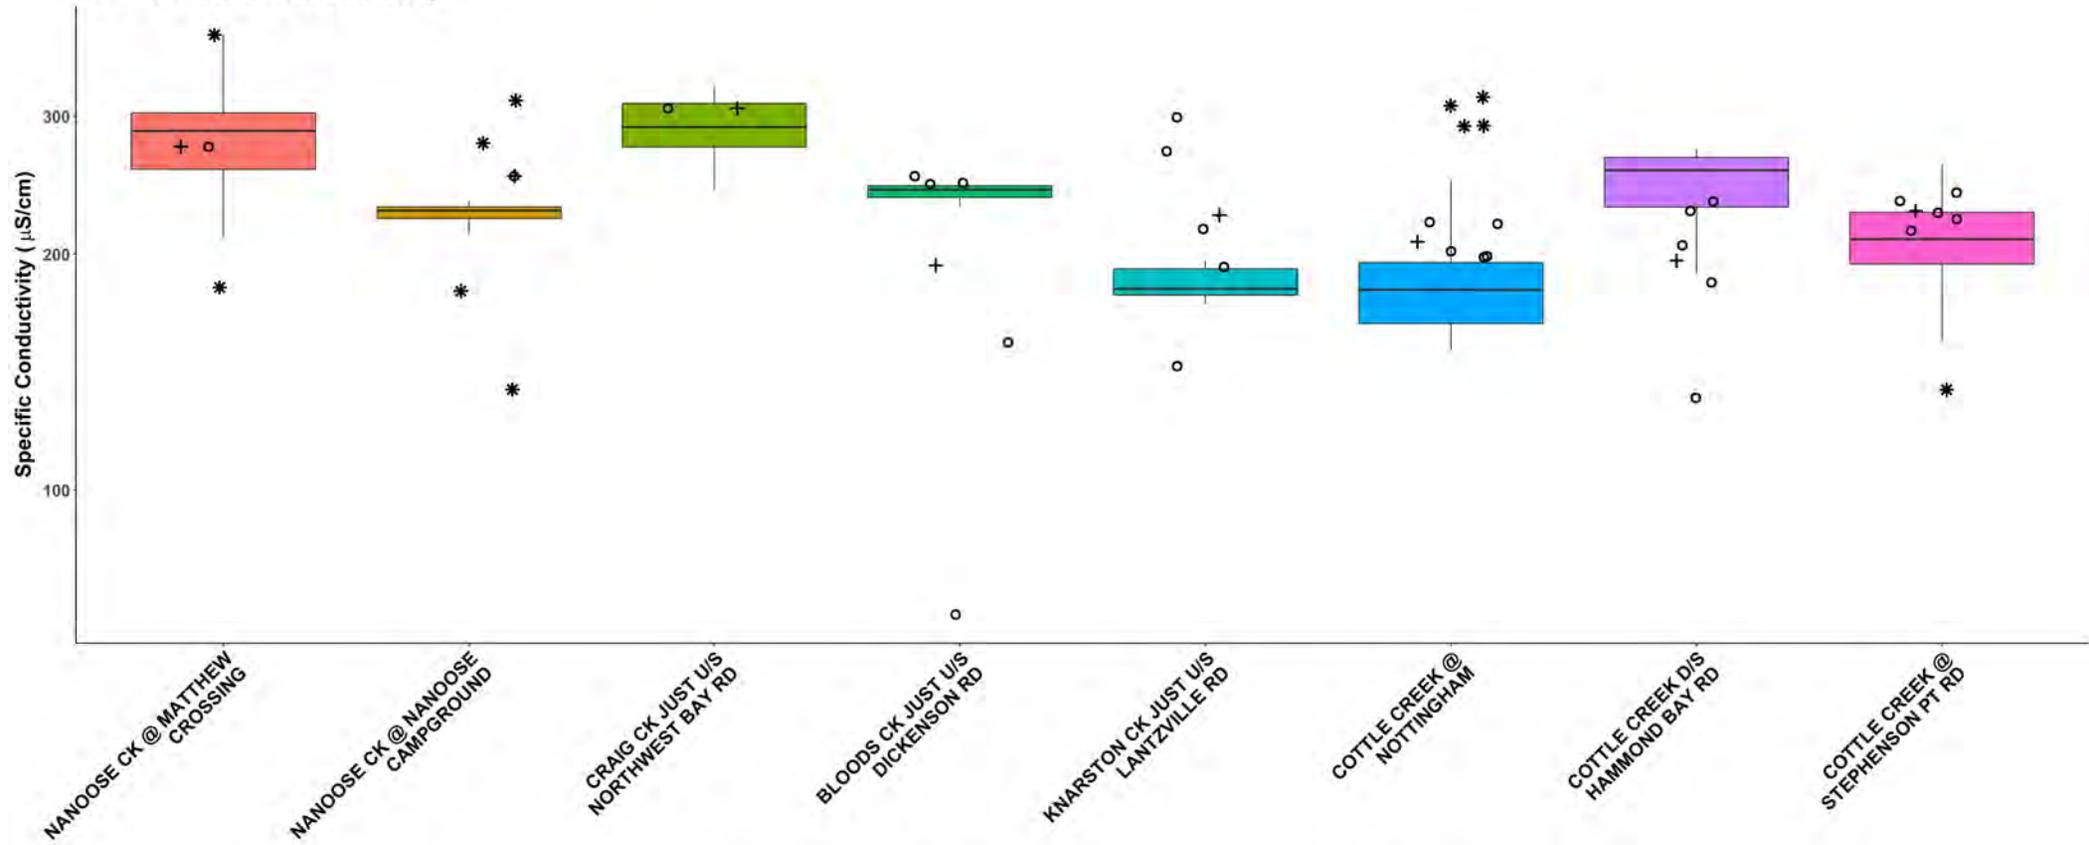
WR5-1a Summer Conductivity

◦ 2020 Samples * Outlier 2012-2019 + 2020 30 Day Avg

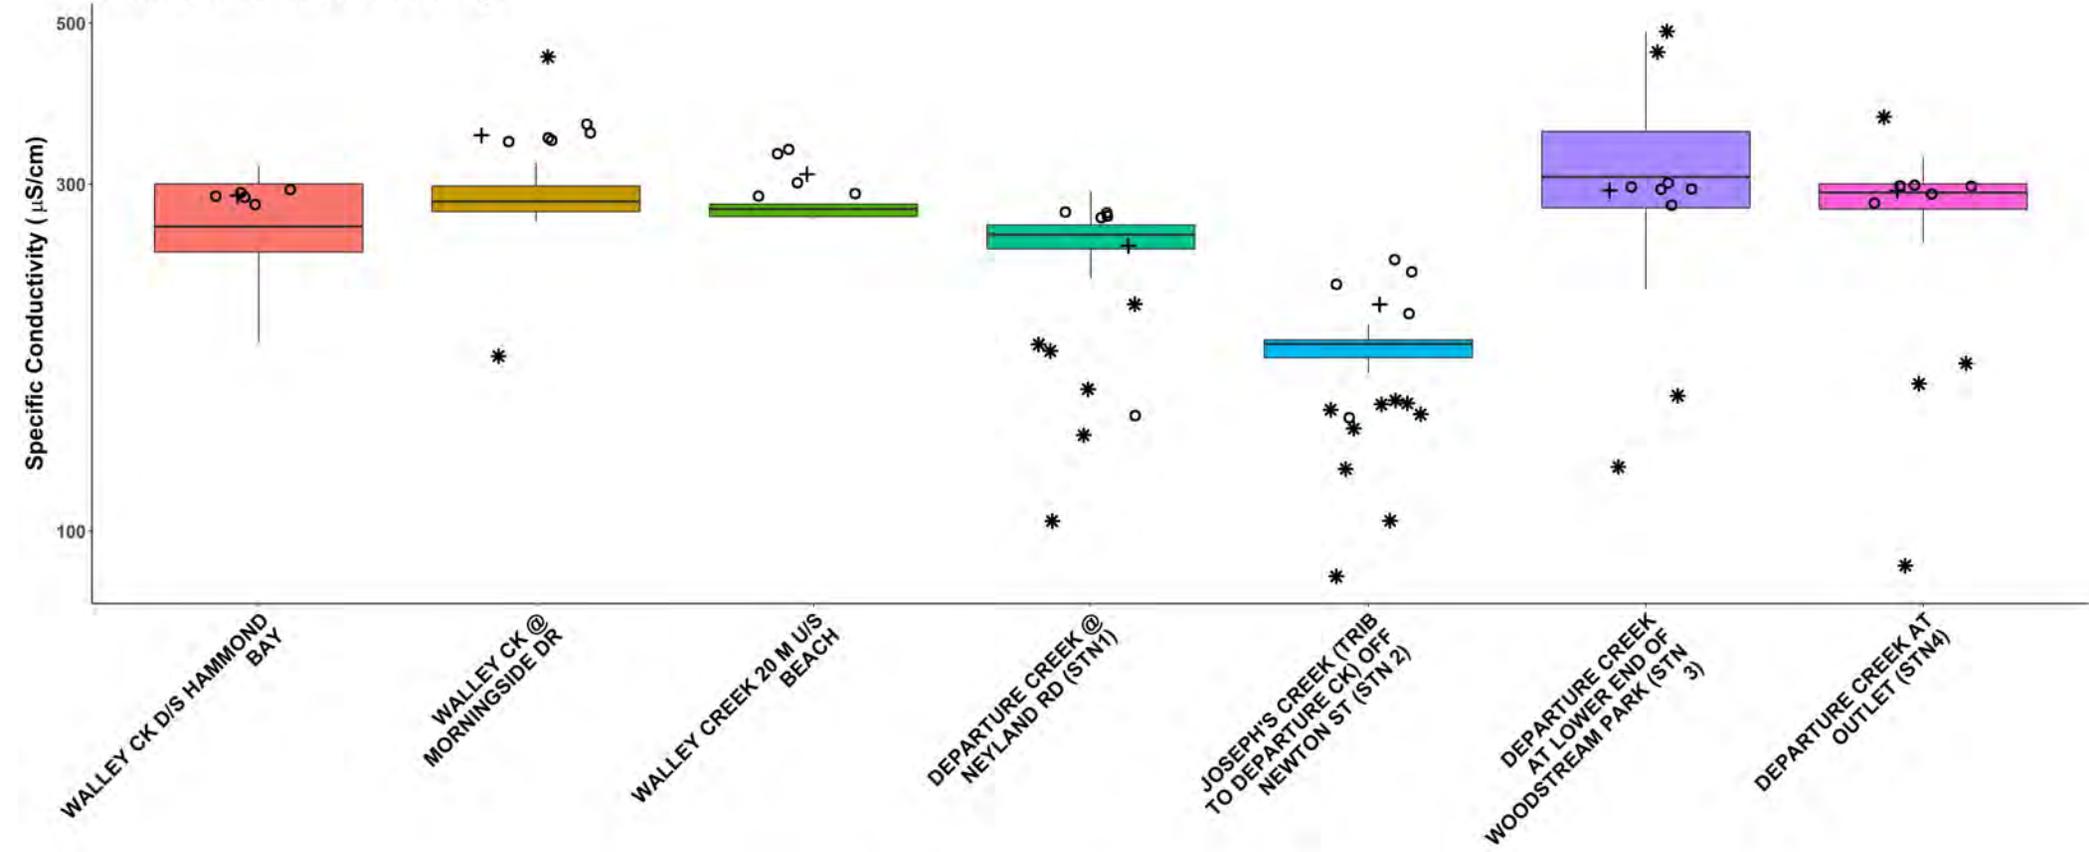
WR5-1b Summer Conductivity

\circ 2020 Samples * Outlier 2012-2019 + 2020 30 Day Avg

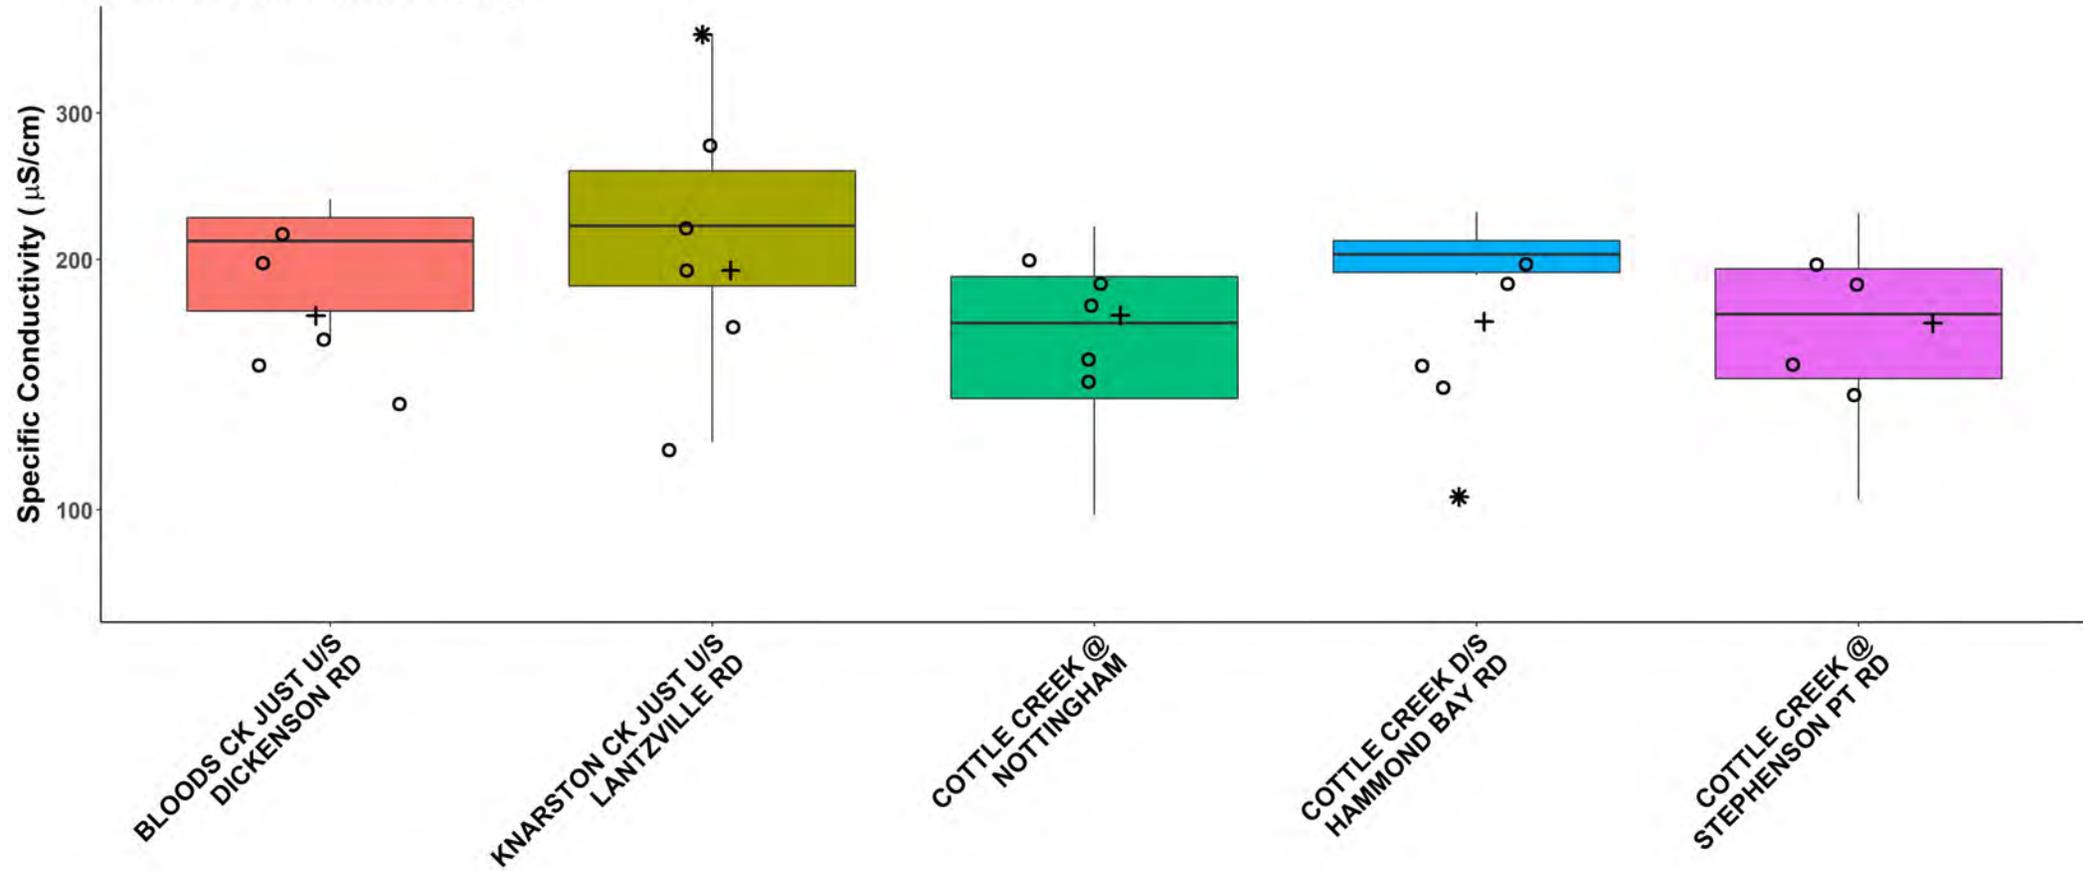
WR5-1a Fall Conductivity

○ 2020 Samples * Outlier 2012-2019 + 2020 30 Day Avg

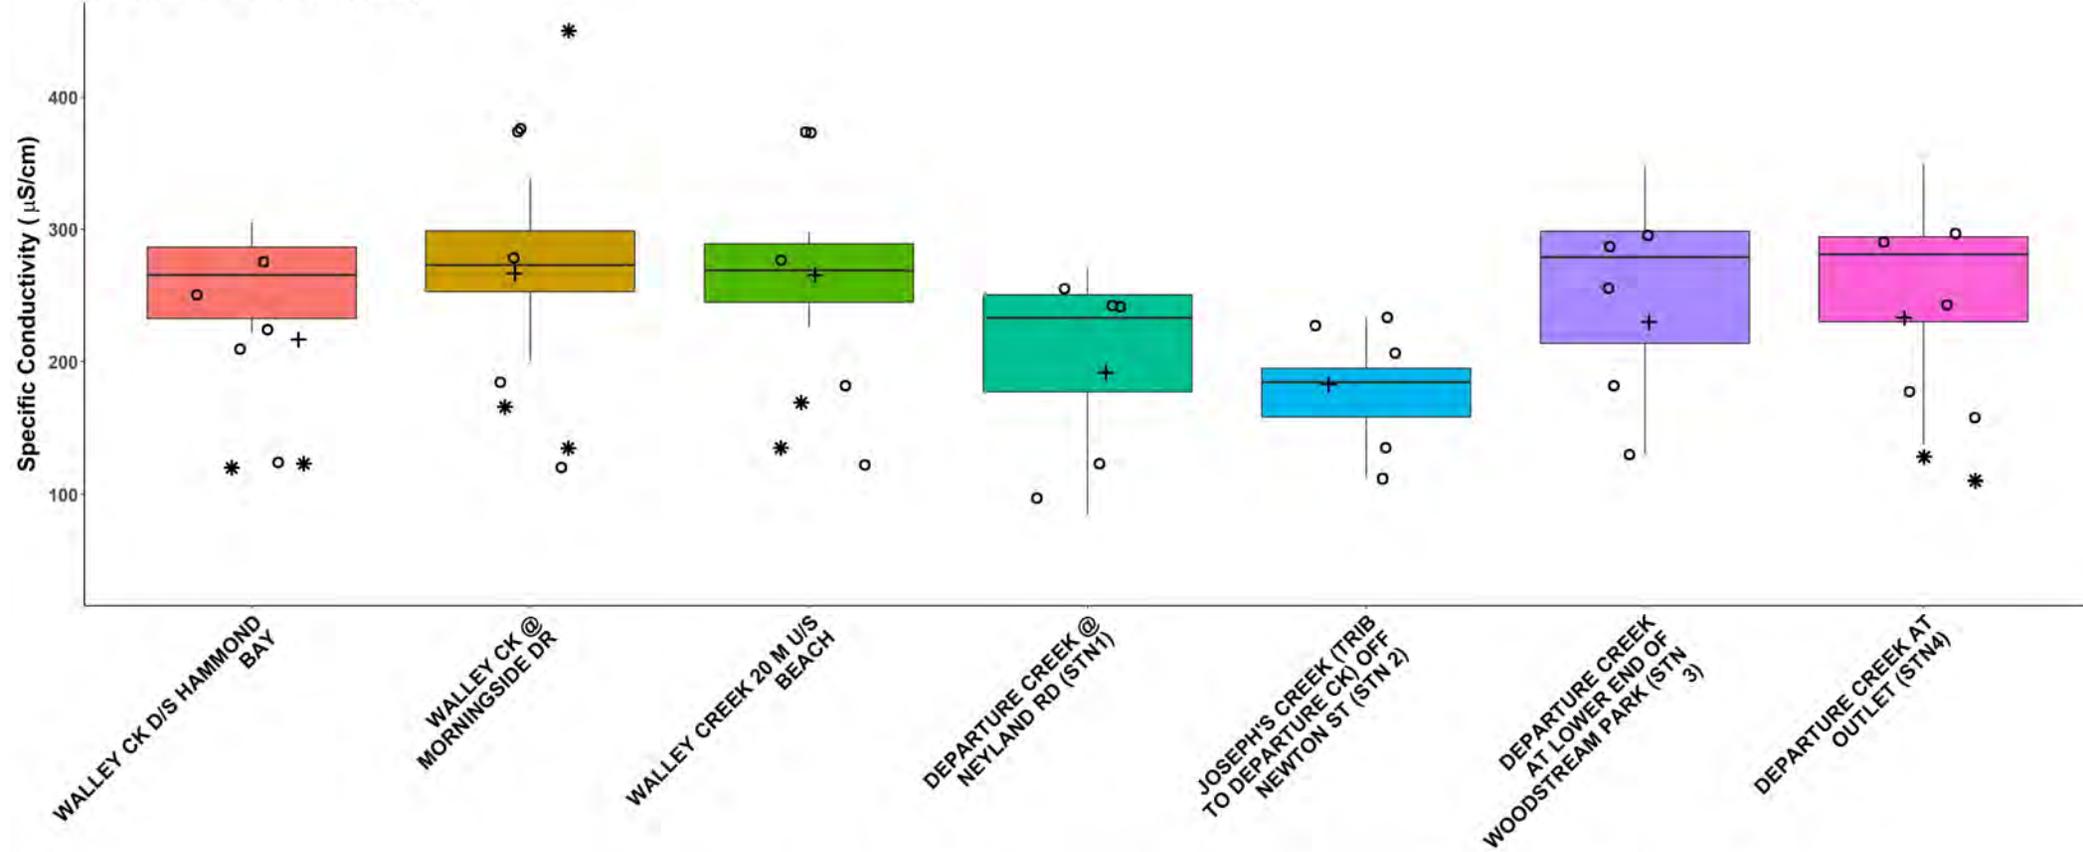
WR5-1b Fall Conductivity

○ 2020 Samples * Outlier 2012-2019 + 2020 30 Day Avg

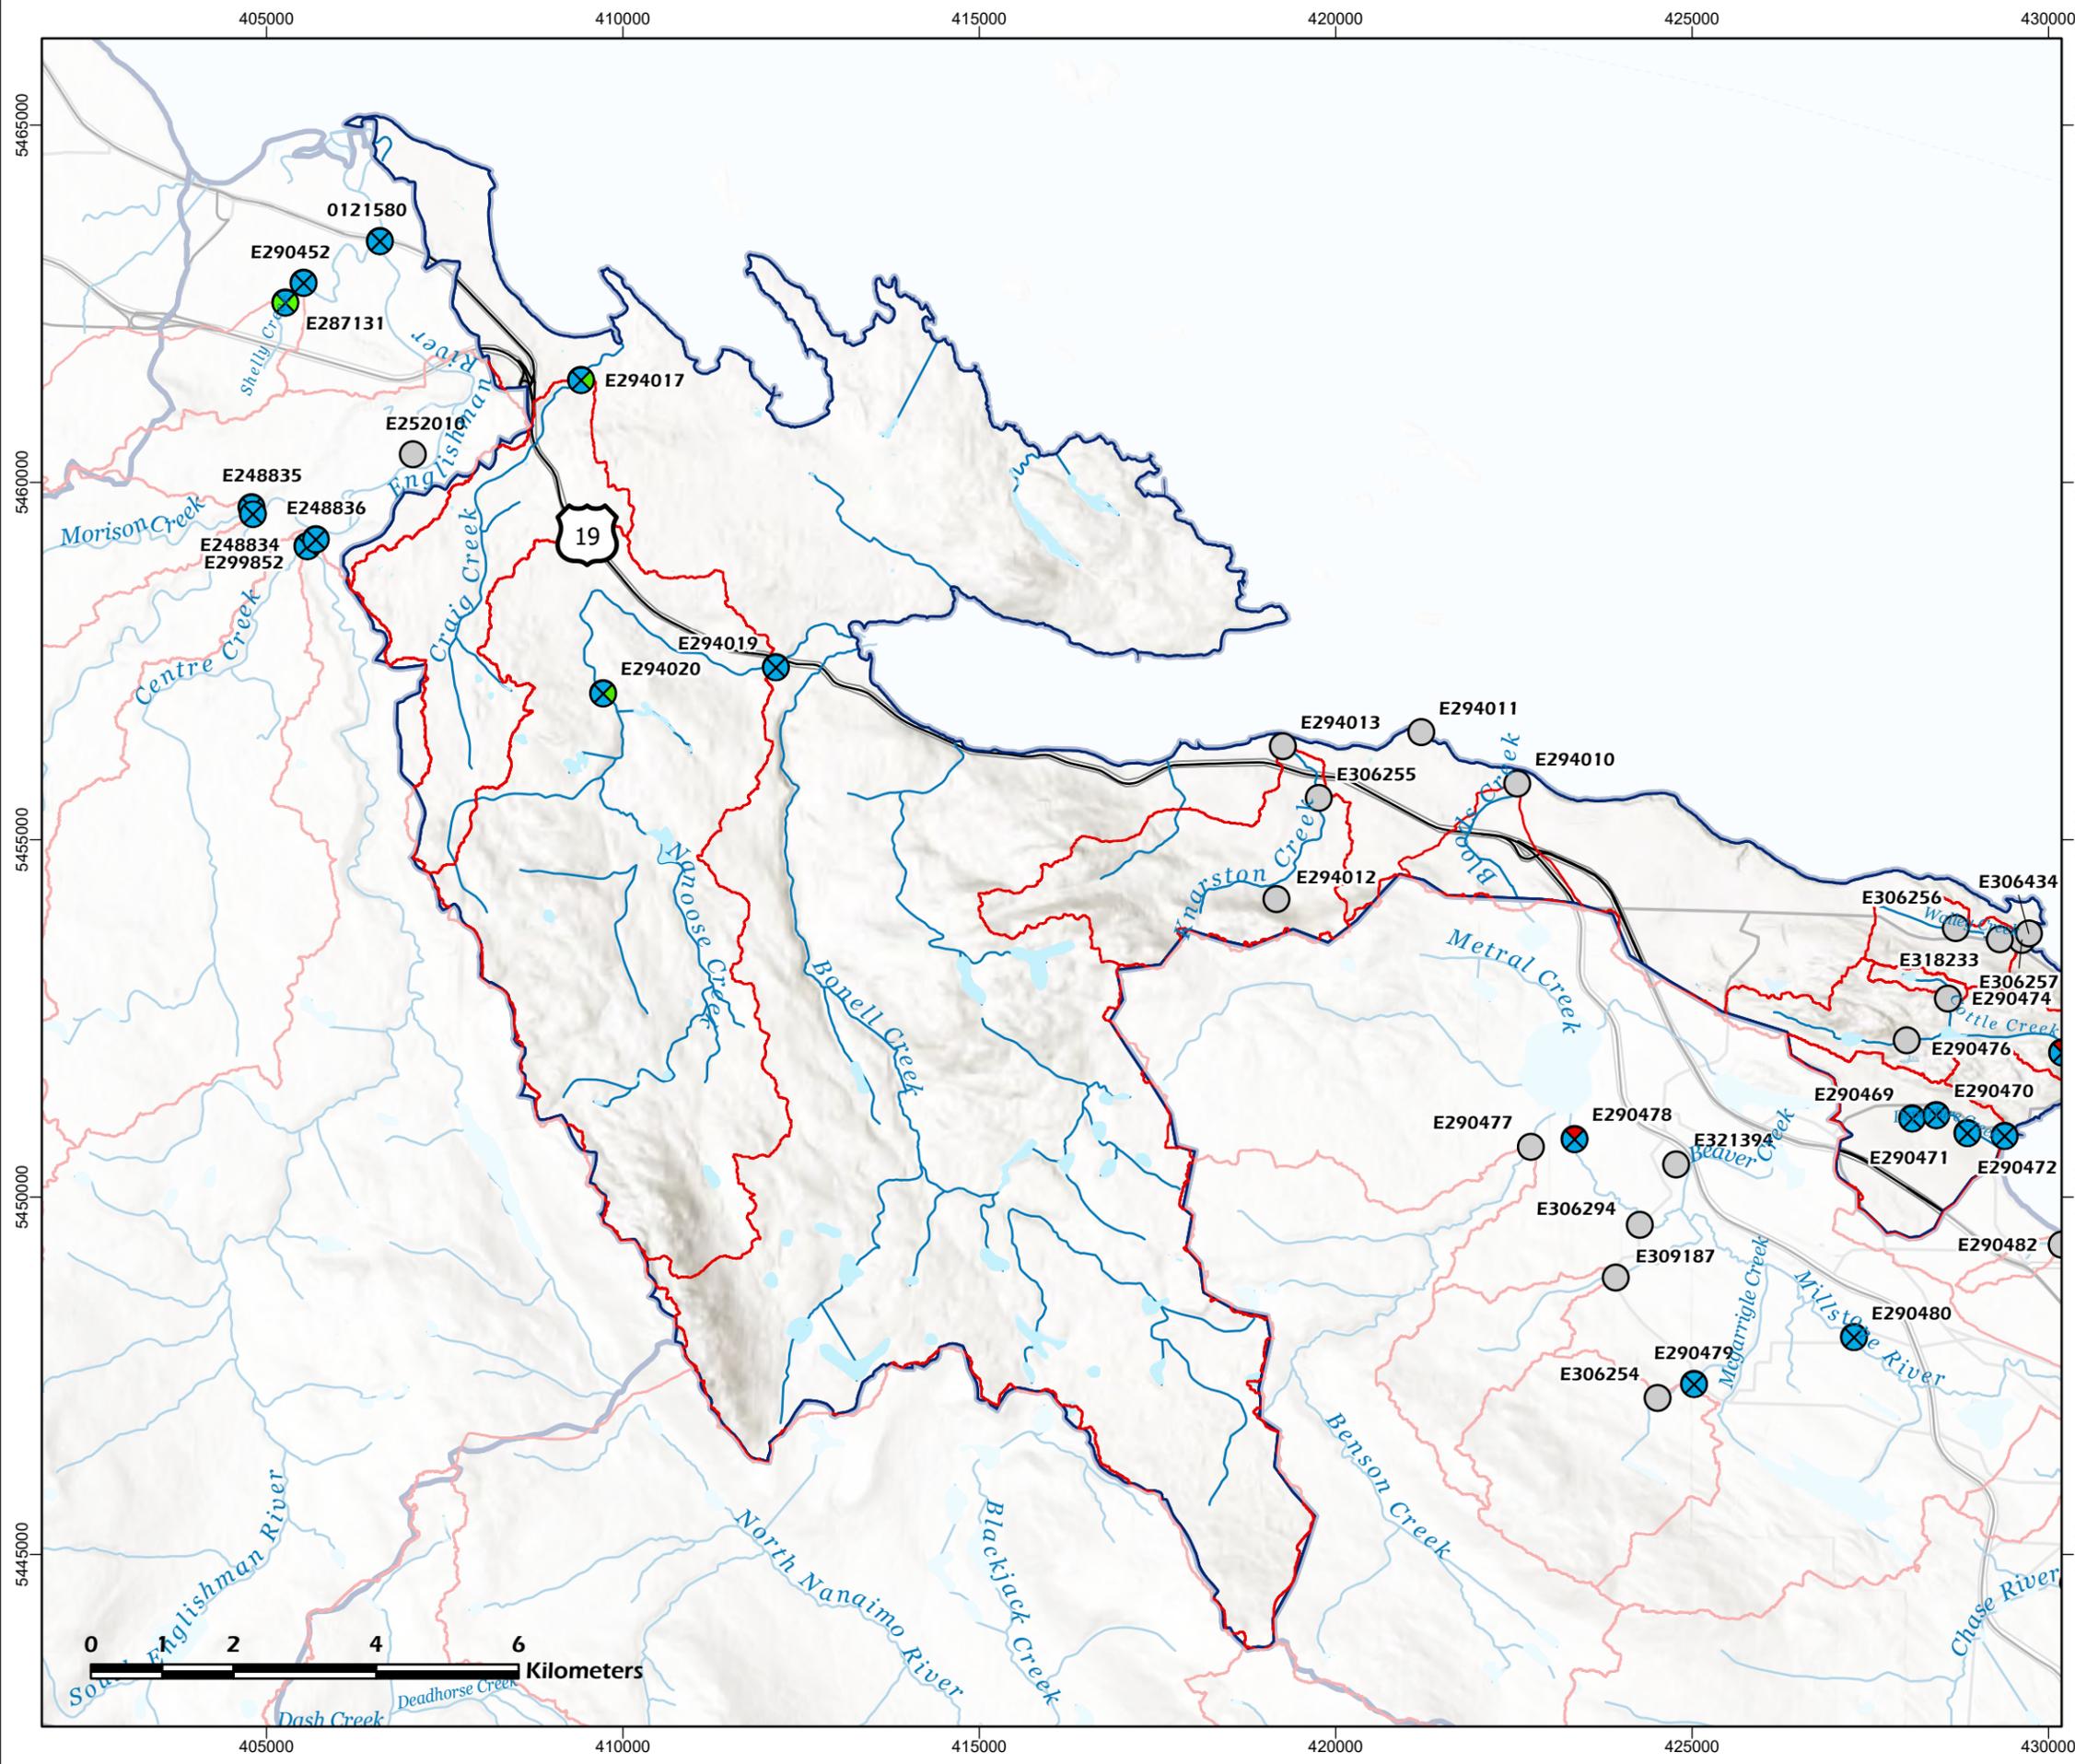
Conductivity can be influenced by factors such as groundwater and ocean spray that are not necessarily indicative of a degrading condition. For simplicity, an increase in conductivity is categorized here as degrading.
