Community Watershed Monitoring Network 2020

Results by Water Region

CMMN Water Quality Trend Analysis 2011-2020

WR5-1a: South Wellington to Nanoose

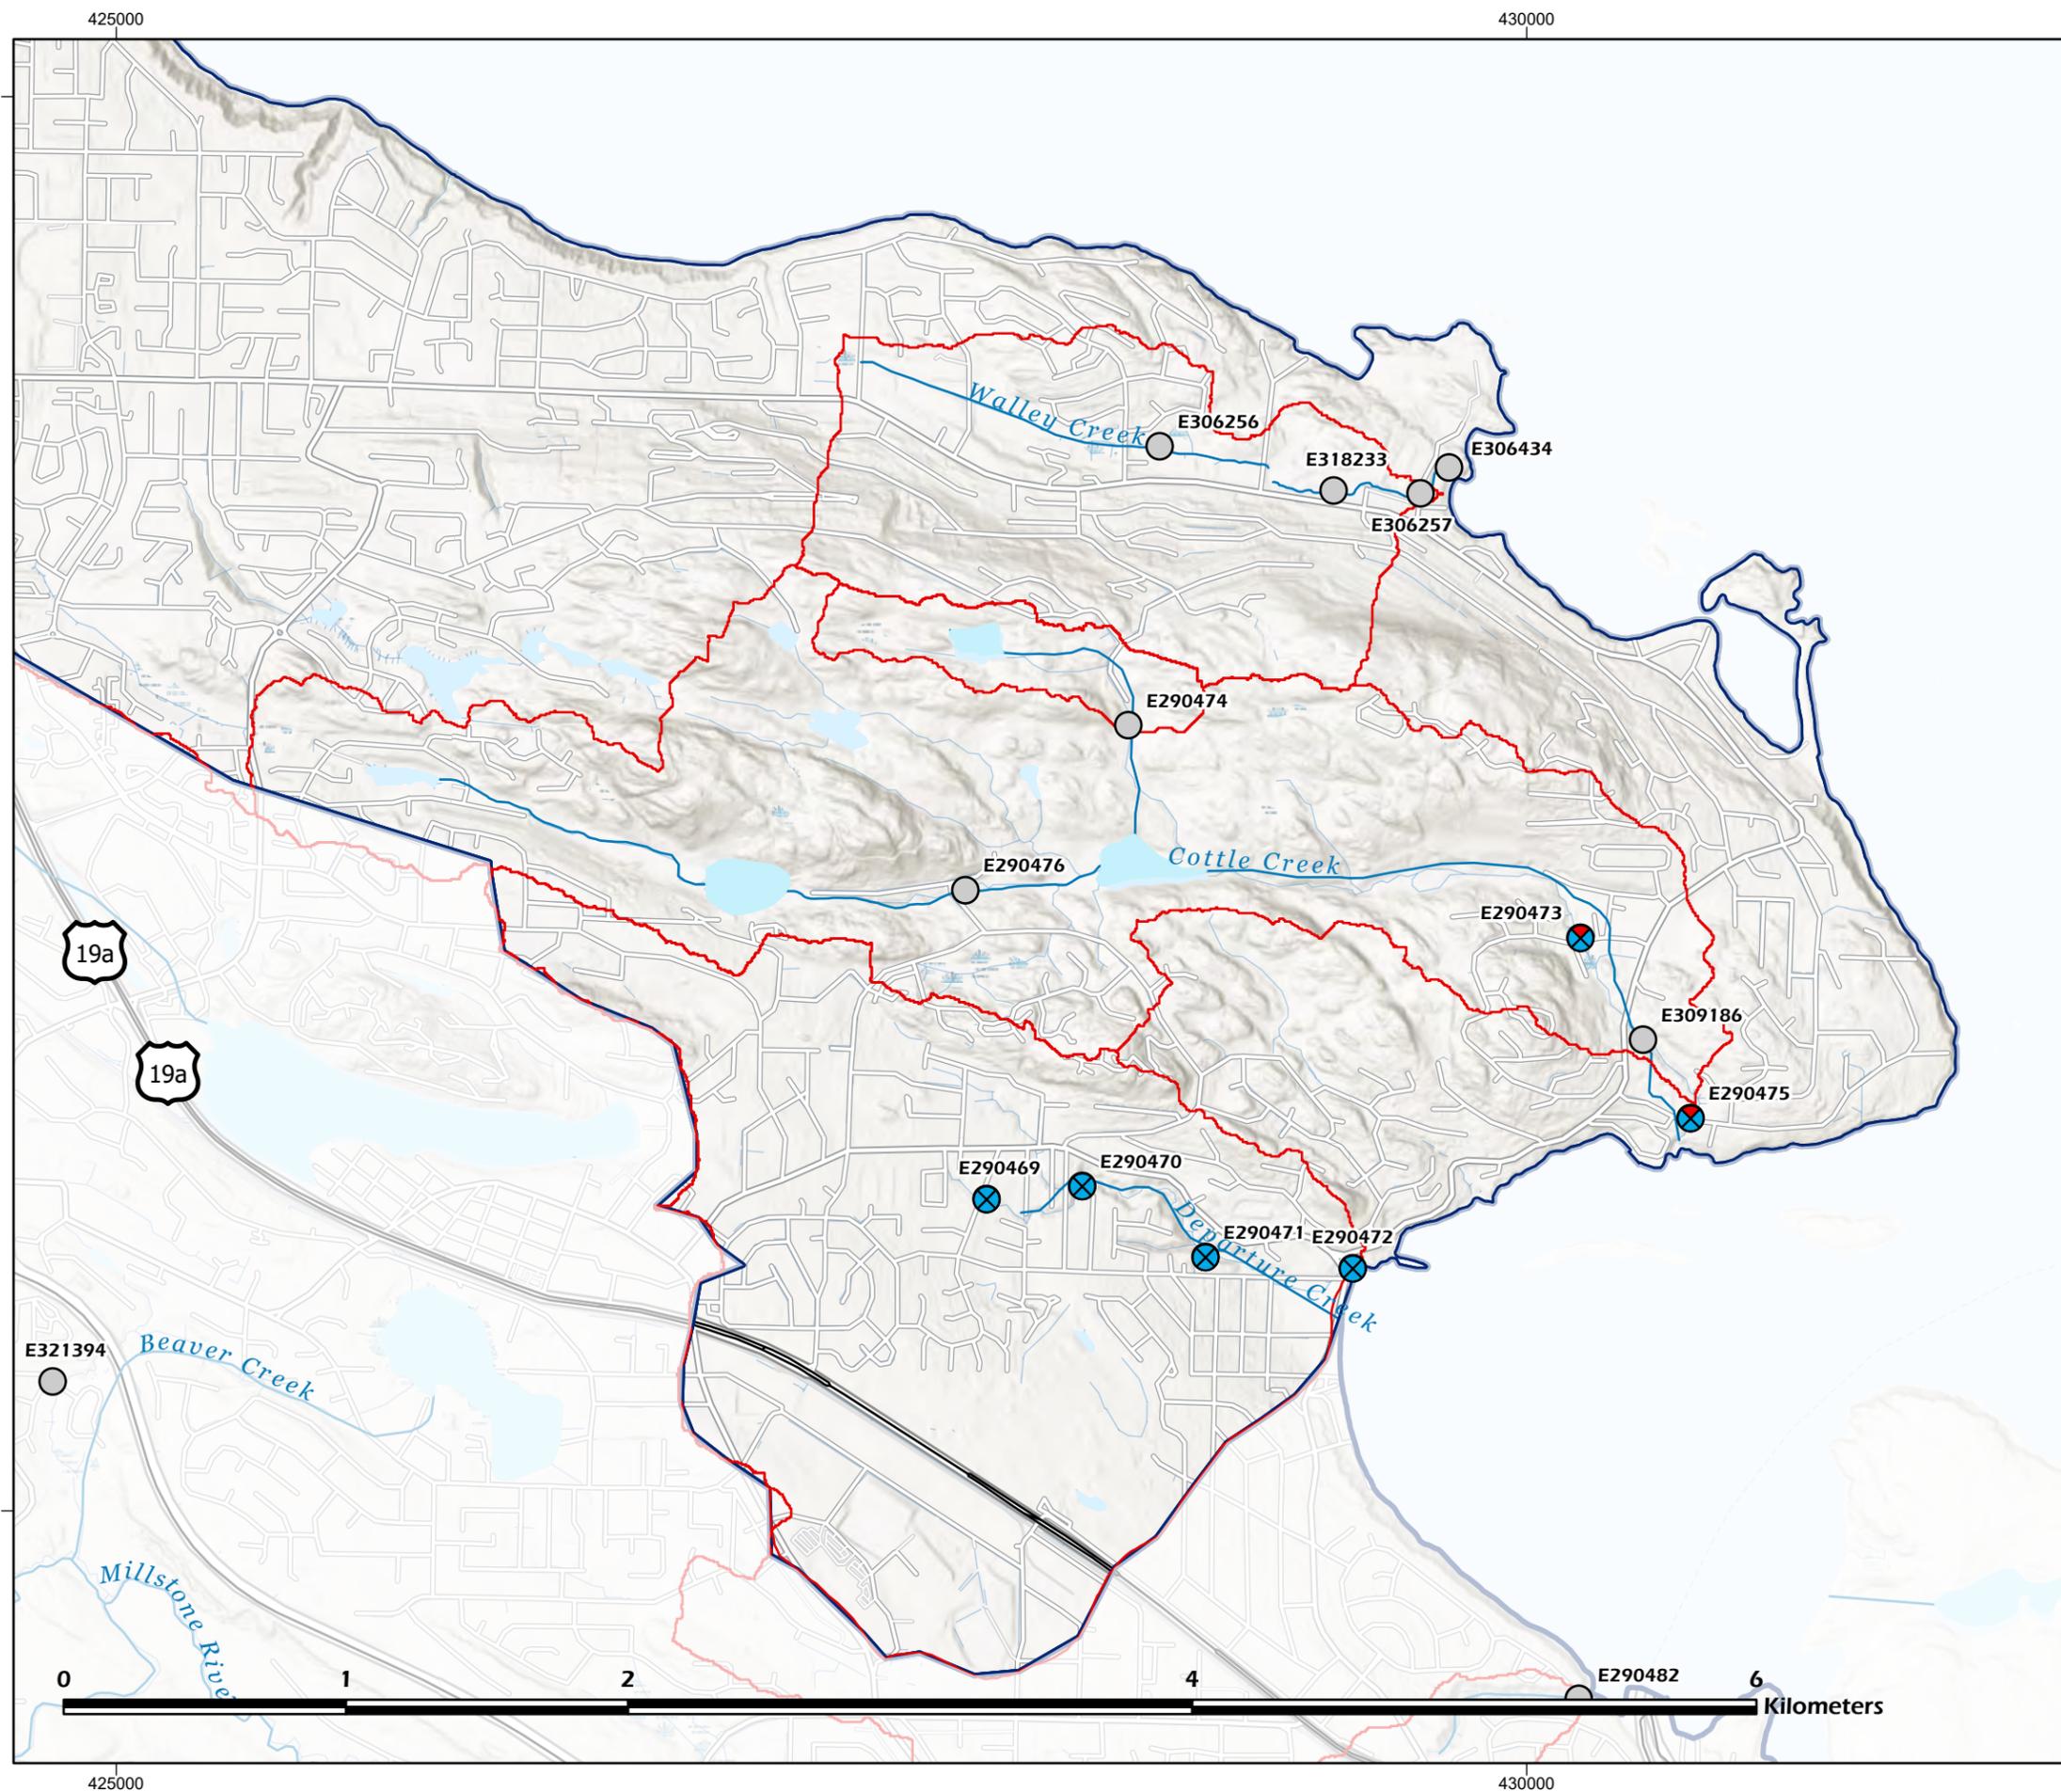
WR5-1b: South Wellington to Nanoose

CMMN Water Quality Trend Analysis 2011-2020

Conductivity can be influenced by factors such as groundwater and ocean spray that are not necessarily indicative of a degrading condition. For simplicity, an increase in conductivity is categorized here as degrading.

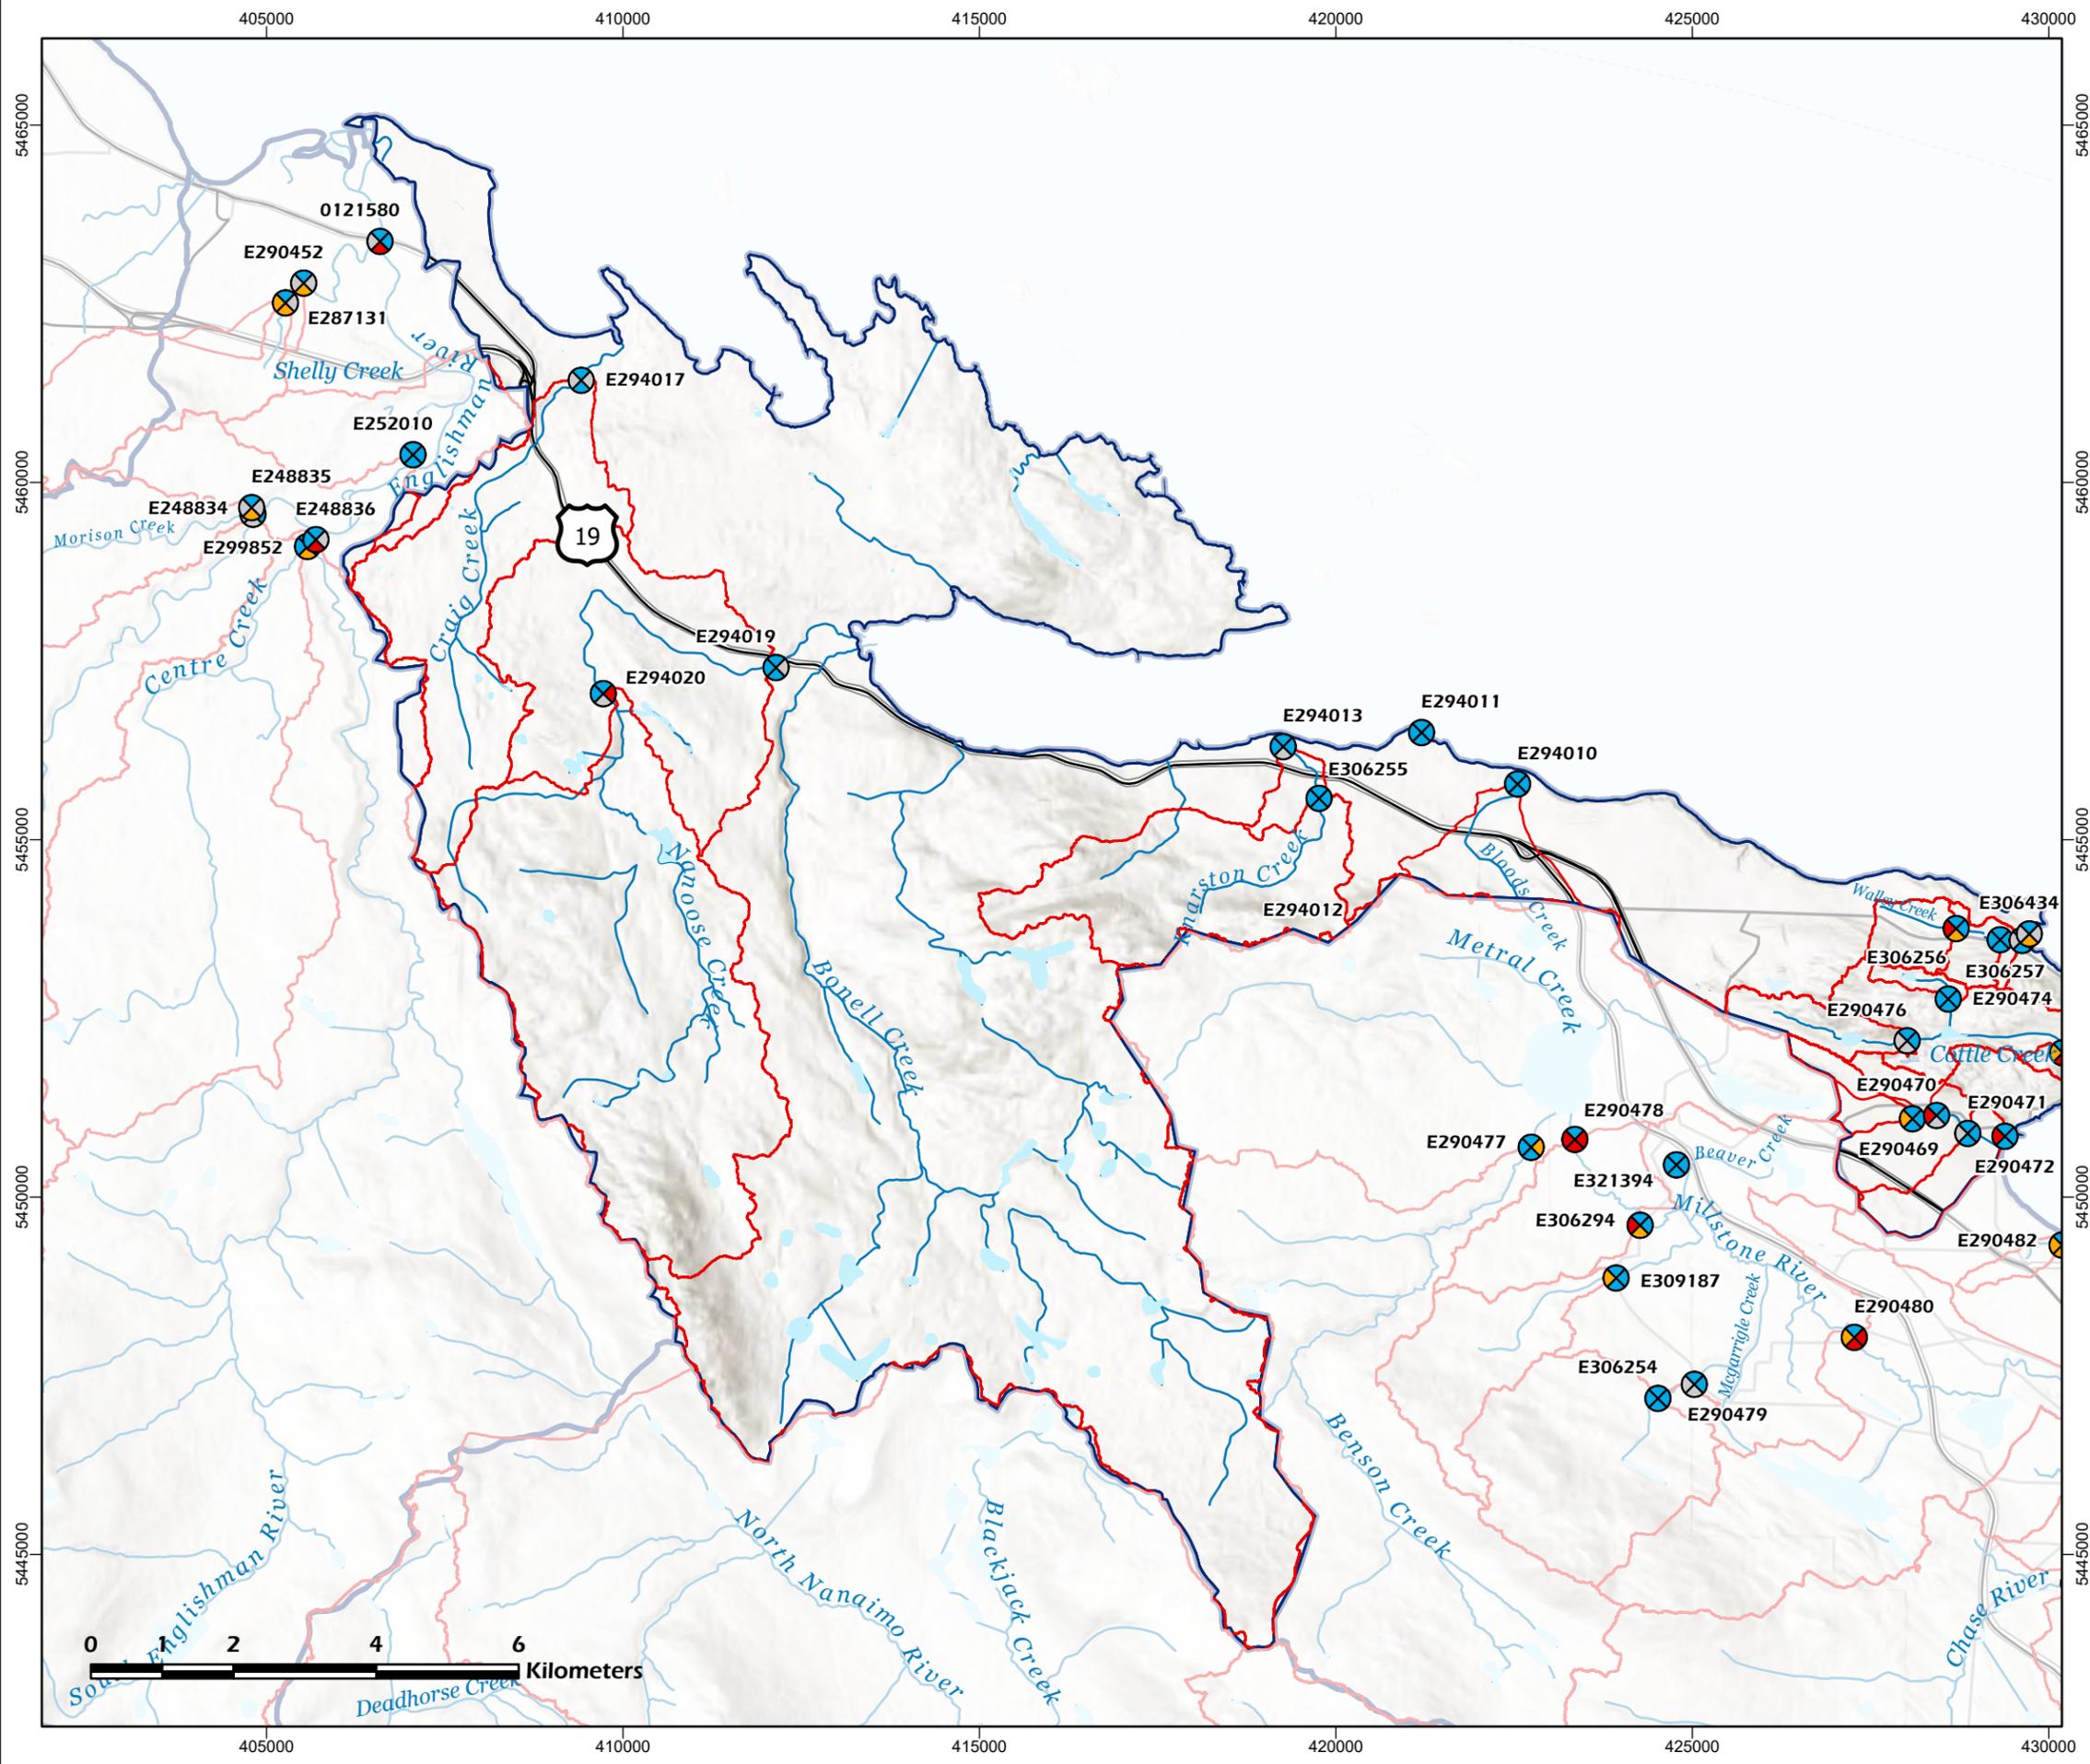
WR5-1a: South Wellington to Nanoose

CMMN 2011-2020 Summer Exceedance Assessment

Lake
- Note the exceedance frequency categories are reflective of the number of sample periods with exceedances, not the number or values of the exceedances.*

The summer and fall exceedance frequency maps included in this package express the number of sample periods (summer low-flow / fall flush) with exceedances for each site. There are four frequency categories for the number of sample periods with exceedances: no exceedance recorded (0), low (1 – 2), moderate (3 – 4), and high (5 or more). The exceedance categories are for the three parameters with aquatic water quality guidelines and objectives based on the following thresholds: temperature $\geq 17^{\circ}\text{C}$, dissolved oxygen $\leq 5\text{mg/L}$, summer turbidity $\geq 2\text{NTU}$, and fall turbidity $\geq 5\text{NTU}$.

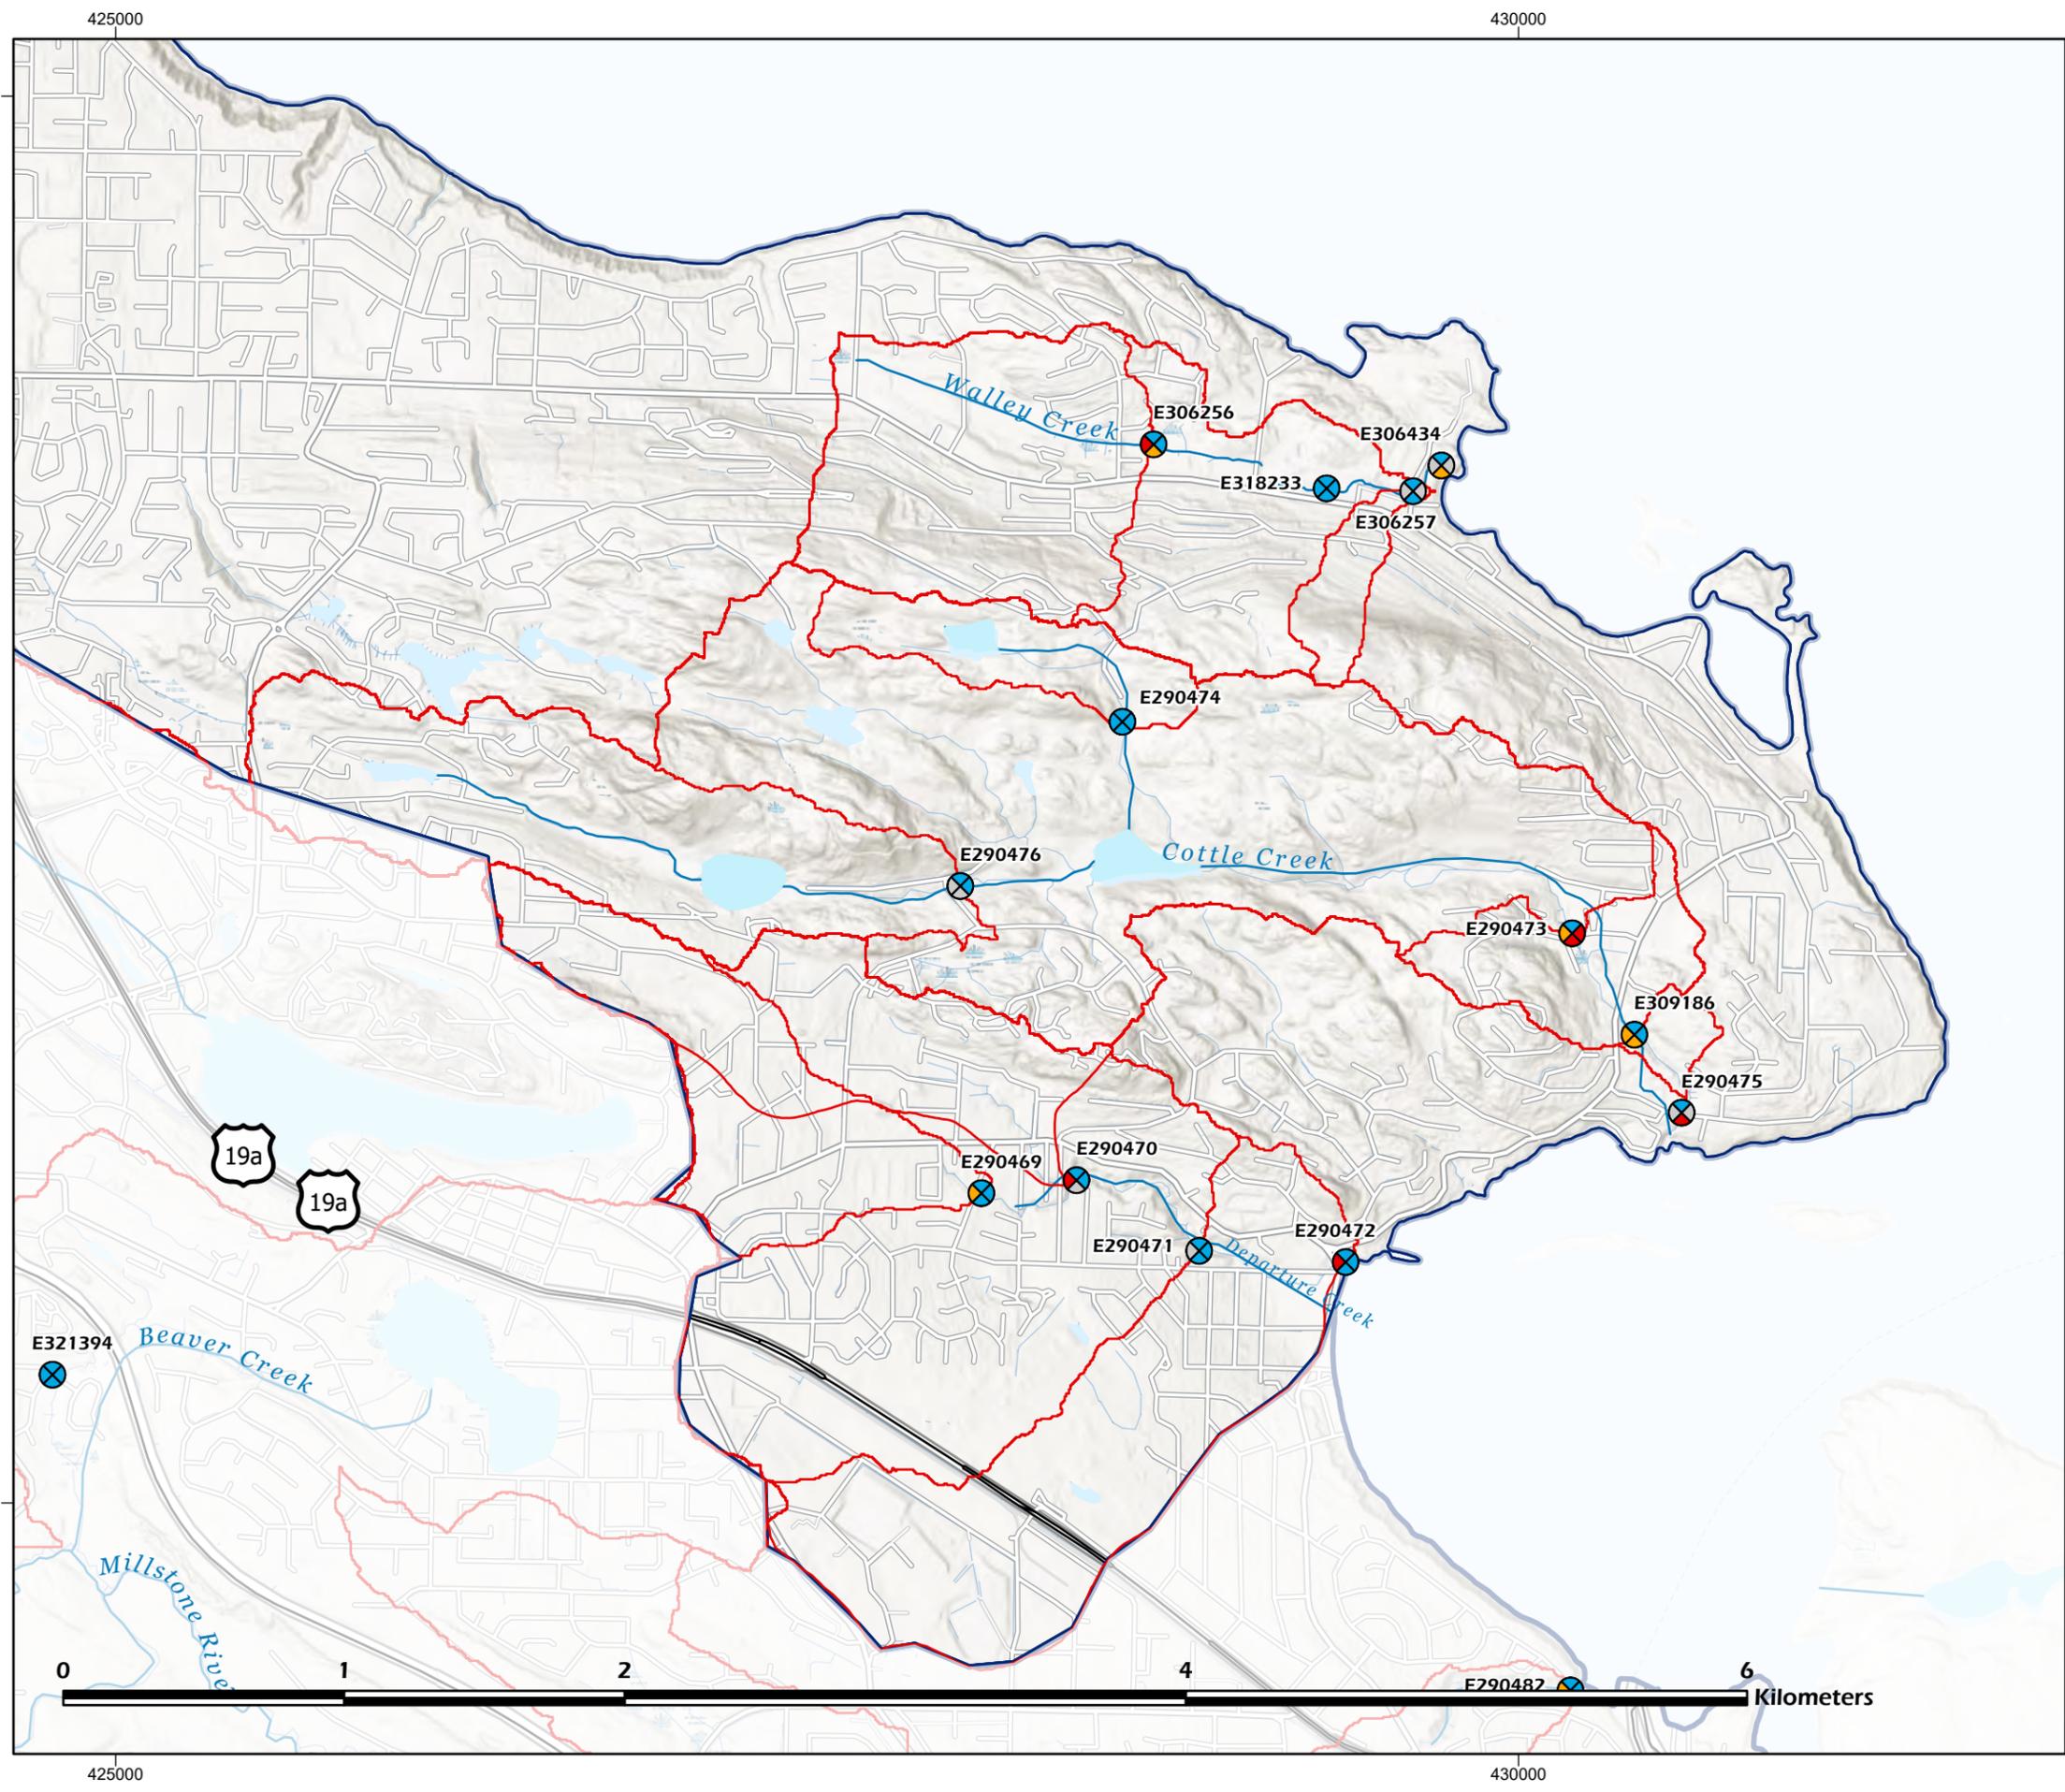
WR5-1b: South Wellington to Nanoose

CMMN 2011-2020 Summer Exceedance Assessment

Lake
- Note the exceedance frequency categories are reflective of the number of sample periods with exceedances, not the number or values of the exceedances.*

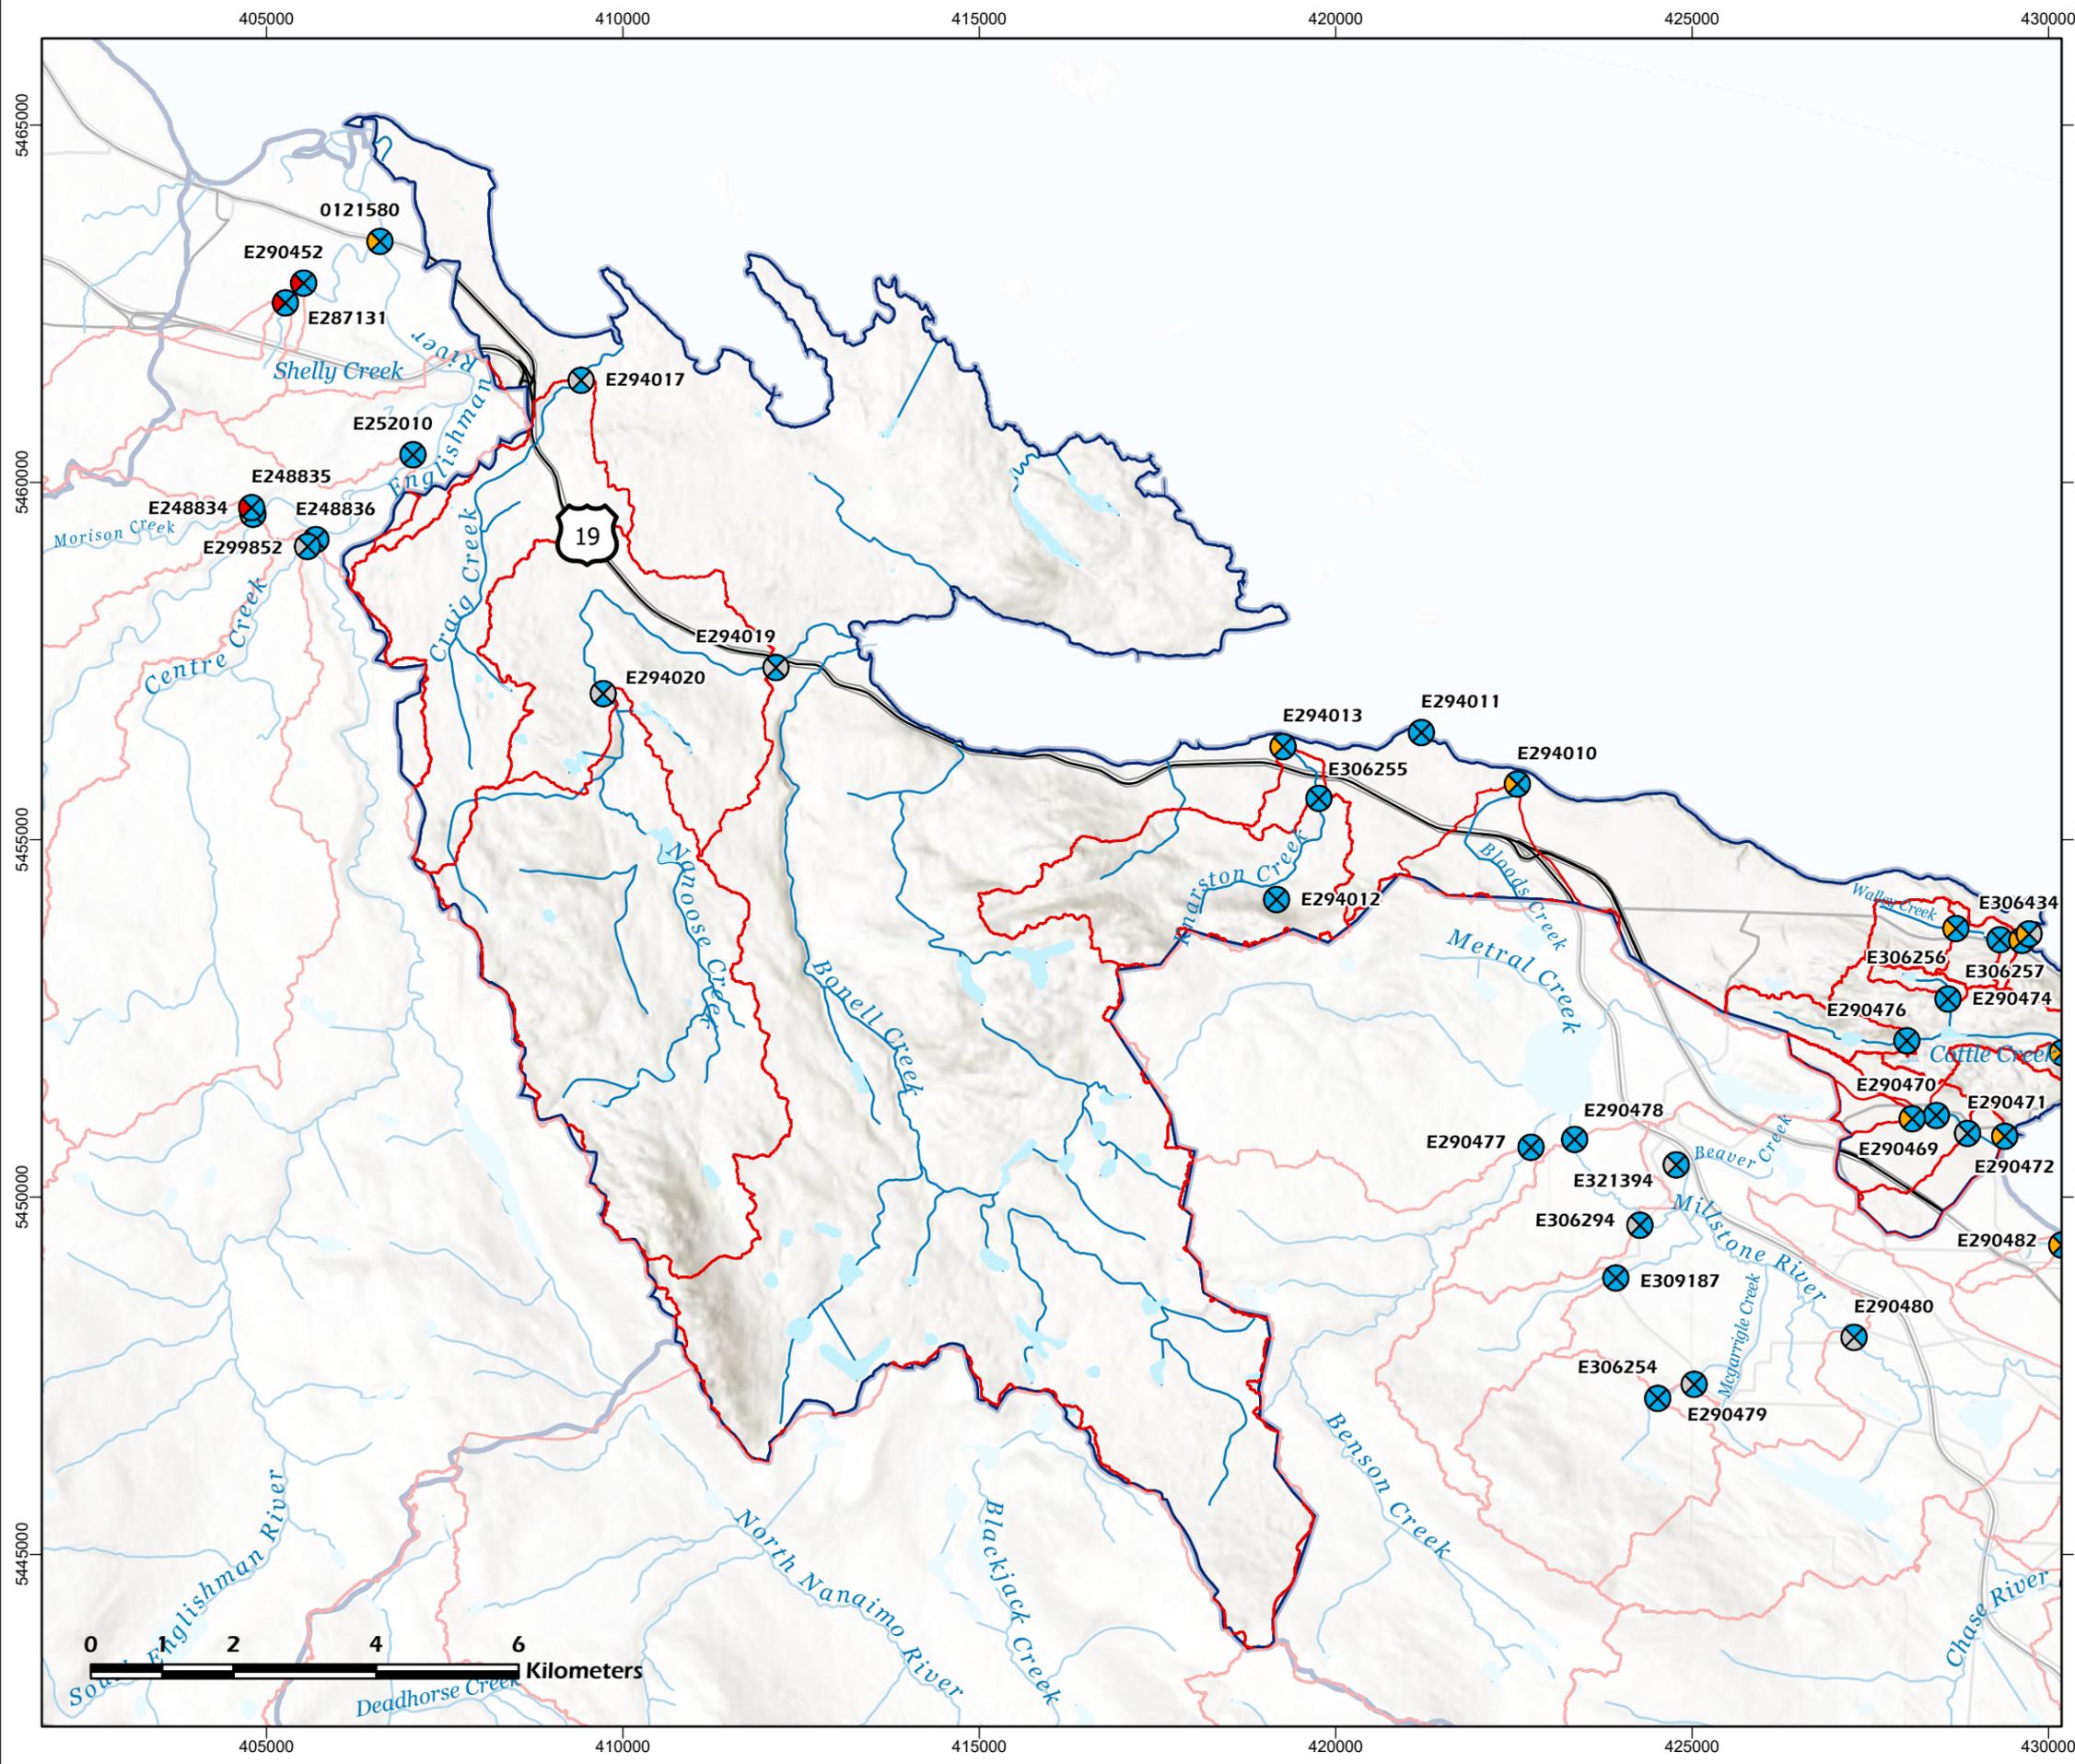
WR5-1a: South Wellington to Nanoose

CMMN 2011-2020 Fall Exceedance Assessment

- ⊗ Sample Site
 - Stream
 - Highway
 - ▭ Watershed
 - ▭ Water Region
 - ▭ Lake
- Note the exceedance frequency categories are reflective of the number of sample periods with exceedances, not the number or values of the exceedances.*

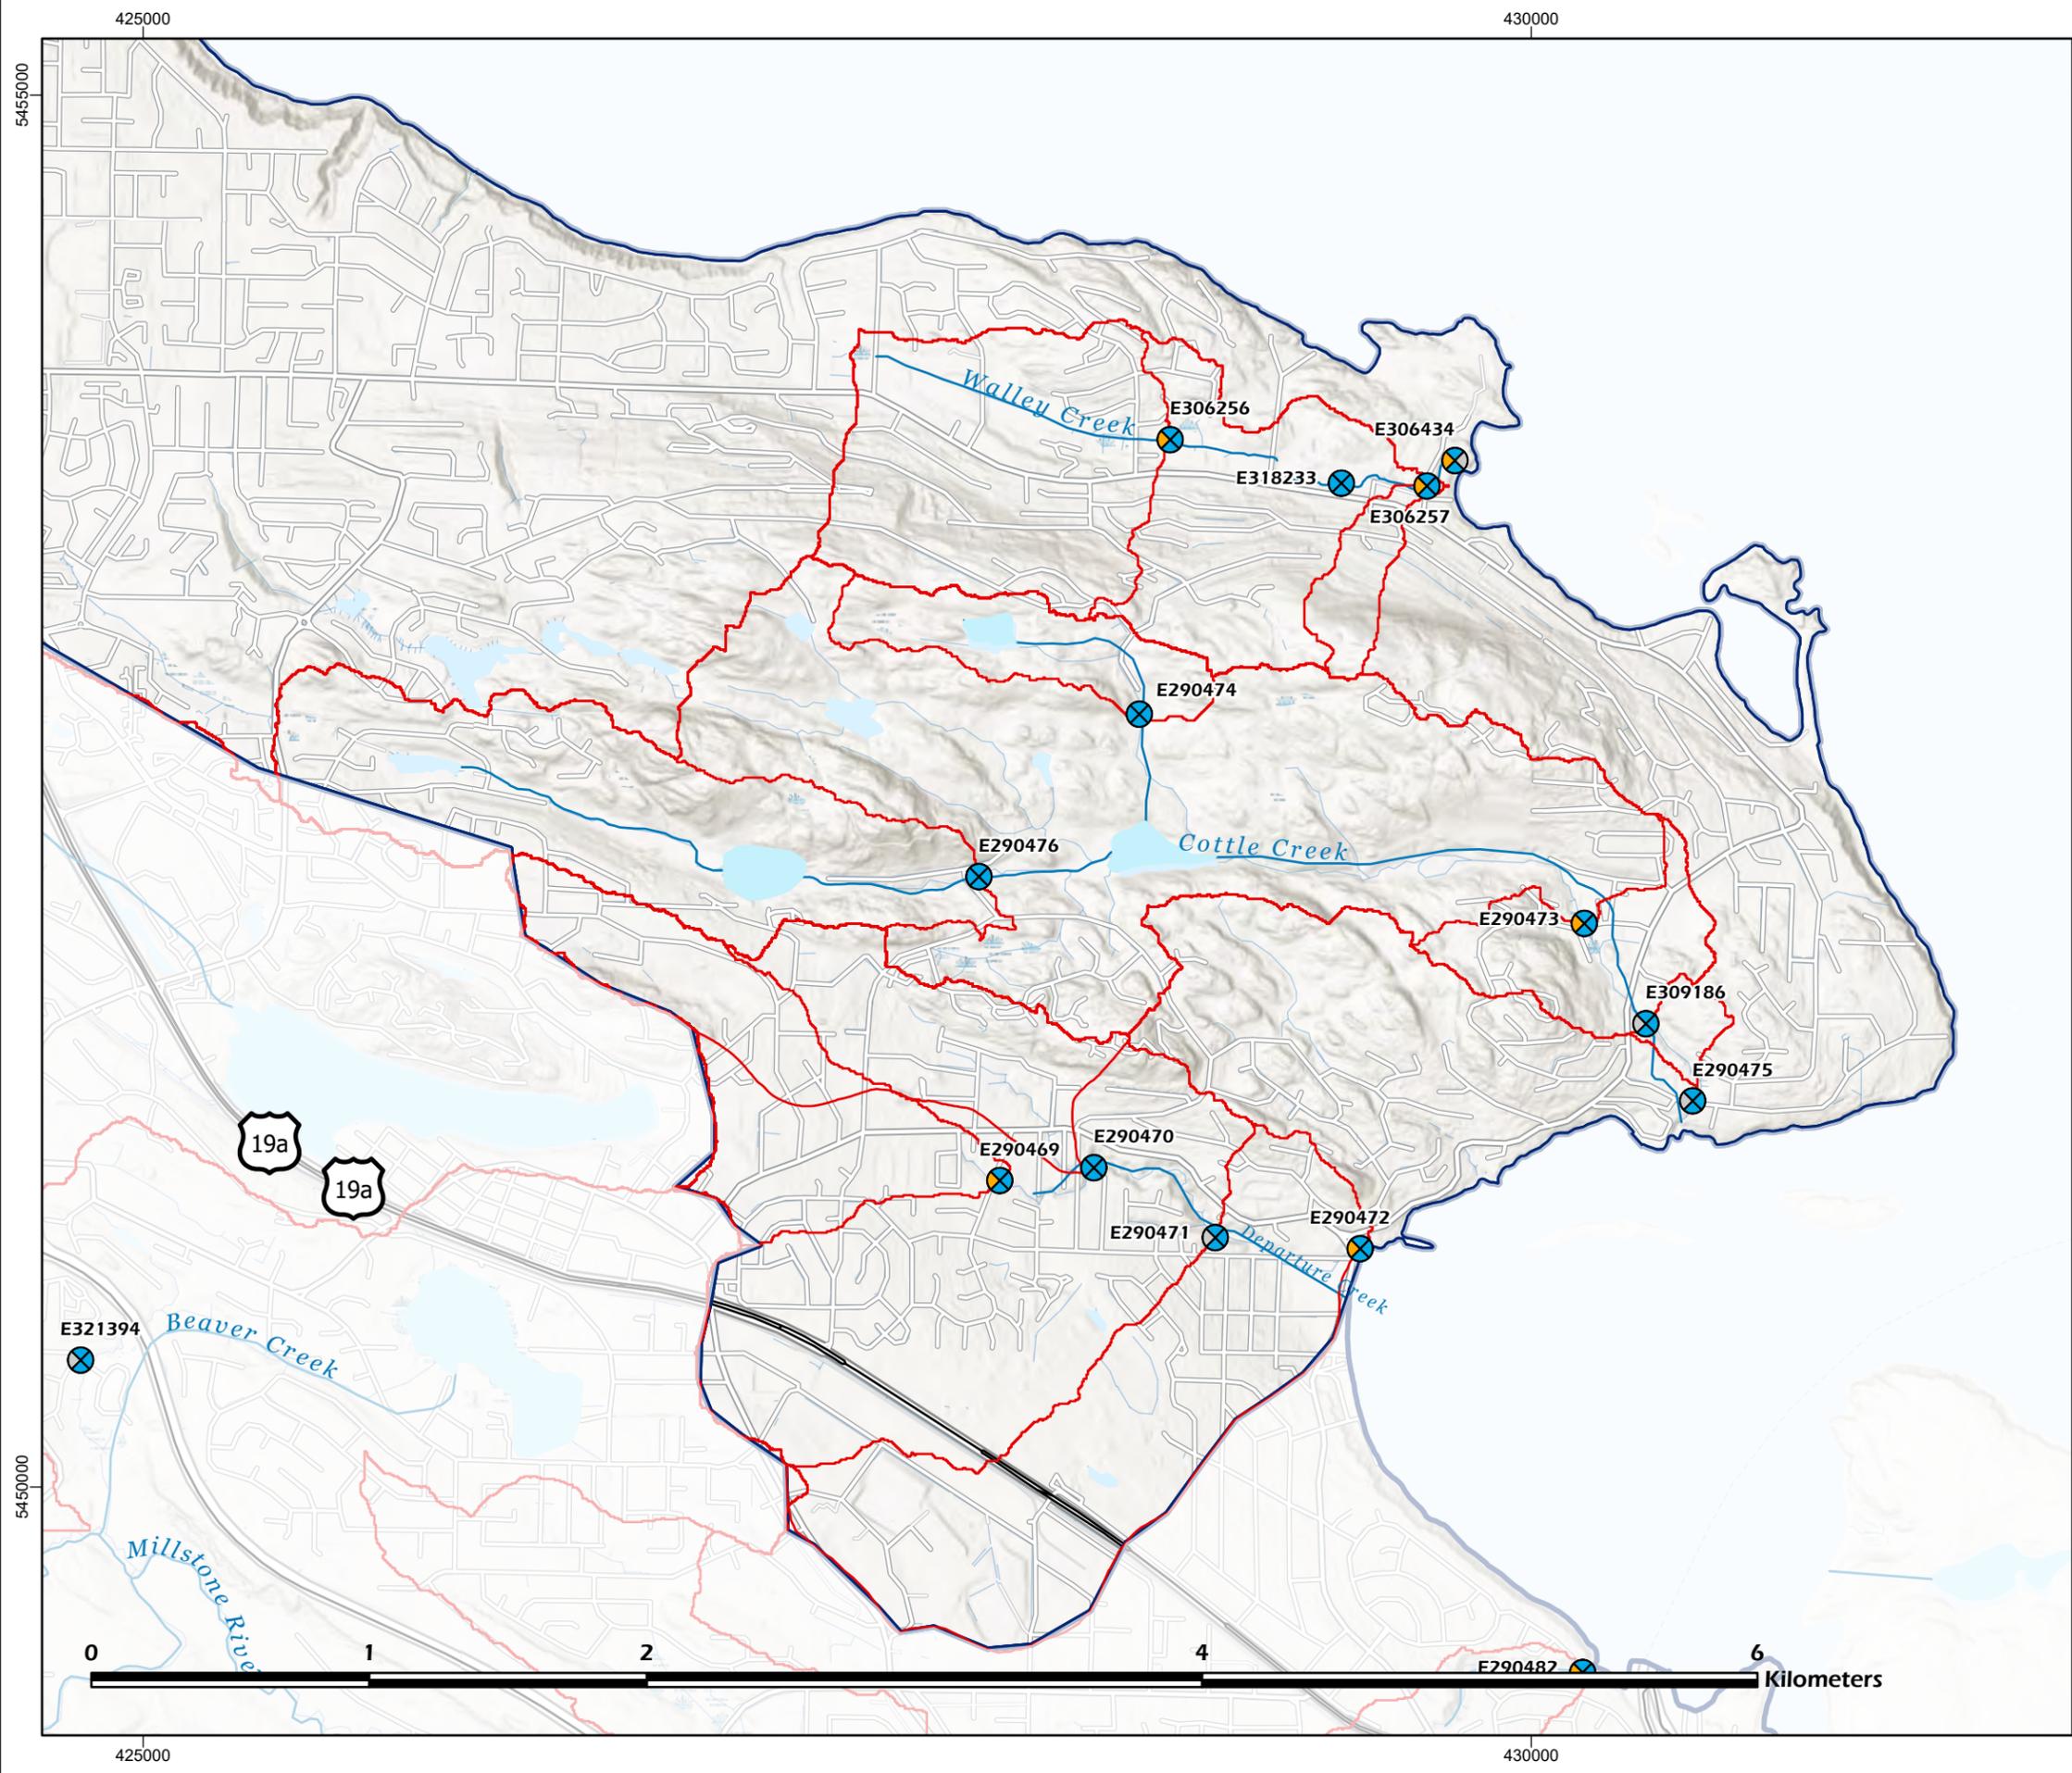
WR5-1b: South Wellington to Nanoose

CMMN 2011-2020 Fall Exceedance Assessment

- ⊗ Sample Site
 - Stream
 - Highway
 - ▭ Watershed
 - ▭ Water Region
 - ▭ Lake
- Note the exceedance frequency categories are reflective of the number of sample periods with exceedances, not the number or values of the exceedances.*
