# Community Watershed Monitoring Network 2020

## Results by Water Region

## **CWMN Sample Sites in WR 6:**

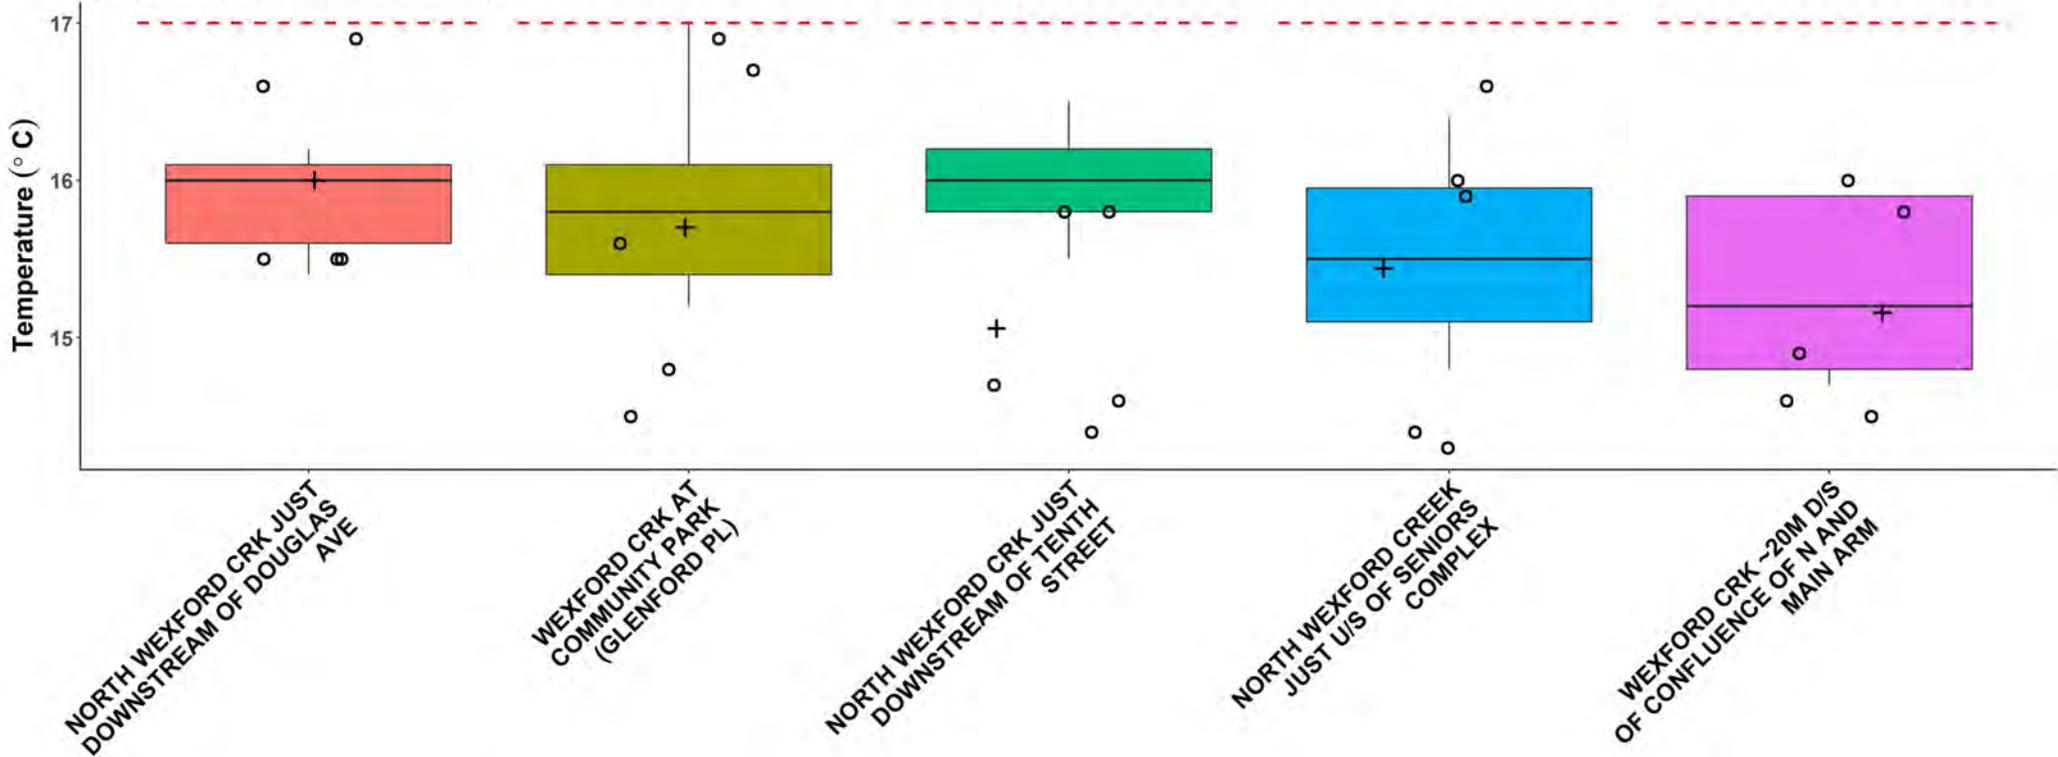
# WR6a Summer Temperature

○ 2020 Samples  
+ 2020 30 Day Avg

**Guideline**  
-- Aquatic Life Guideline for Coho Rearing (17°C)

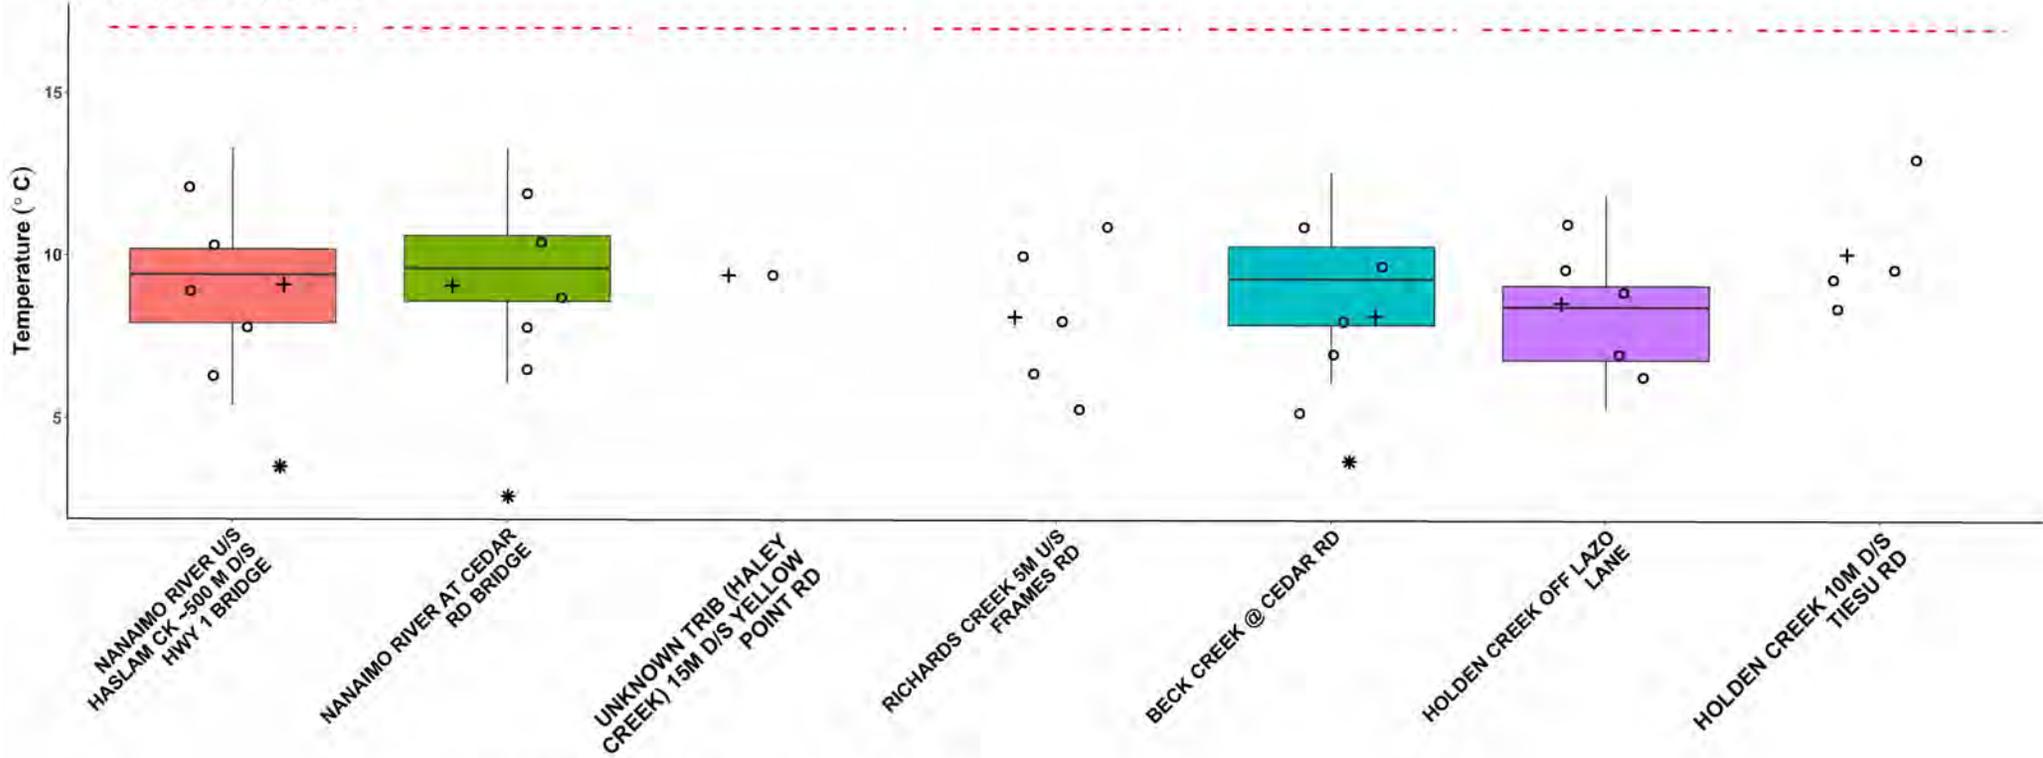
### WR6b Fall Temperature

- 2020 Samples
- \* Outlier 2011-2019
- + 2020 30 Day Avg

-- Aquatic Life Guideline for Coho Rearing (17°C)

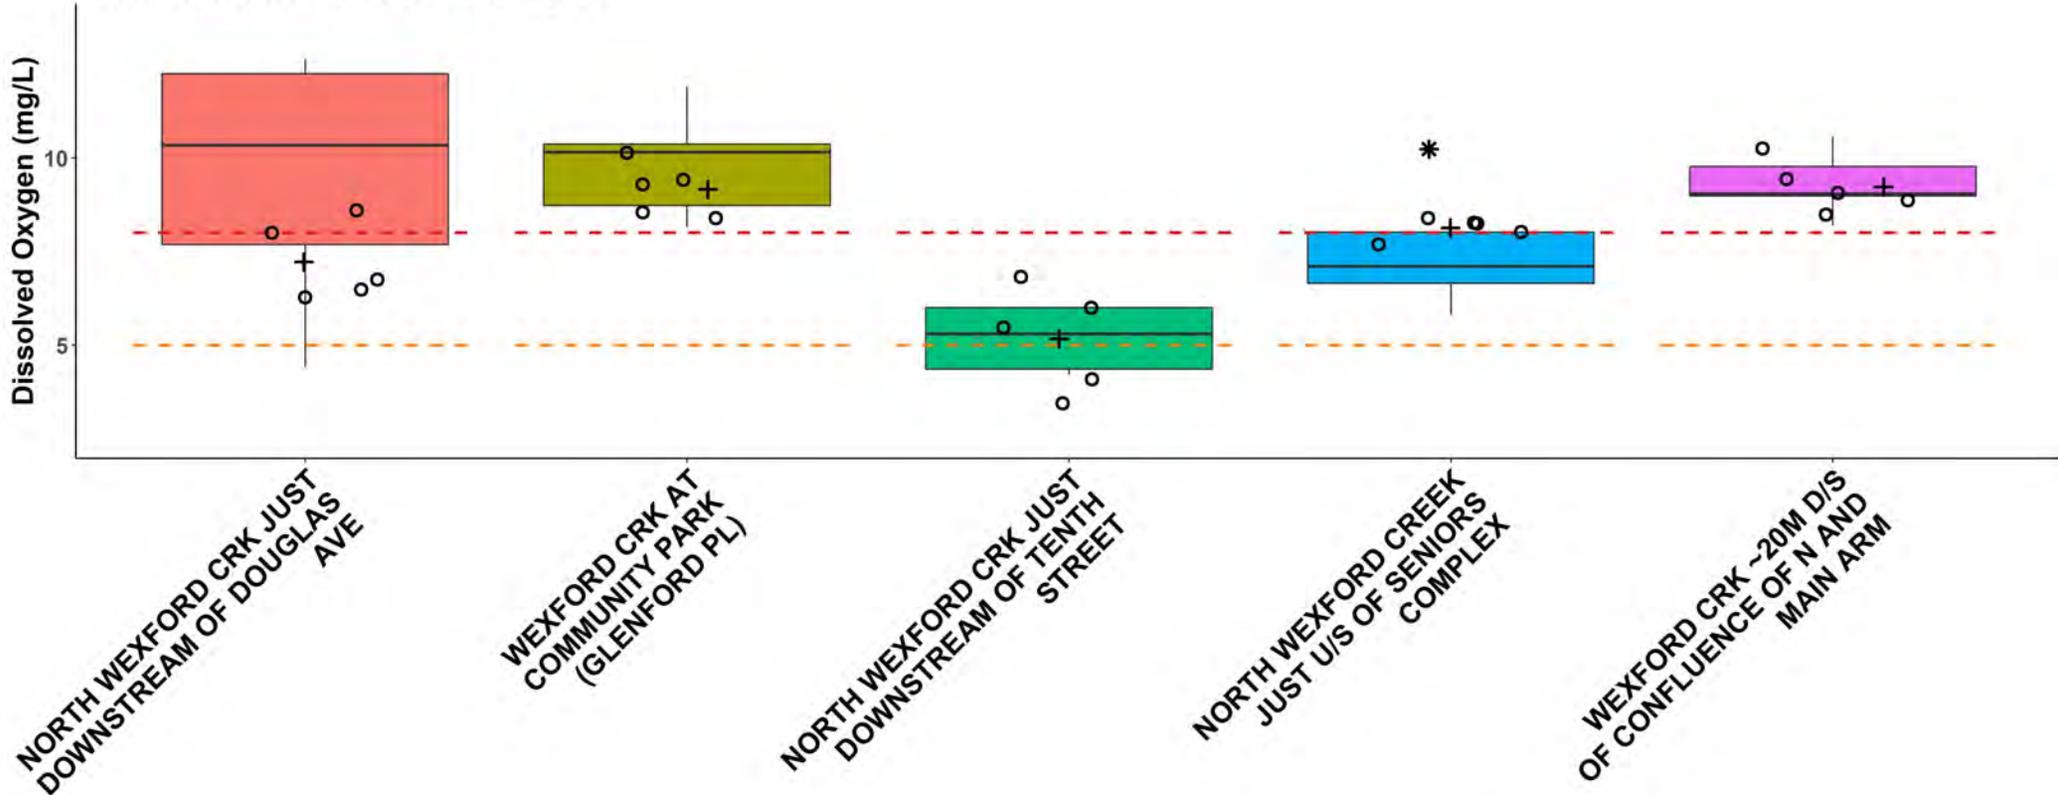
# WR6a Summer Dissolved Oxygen

- - 30 Day Average (<8 mg/L)
- - Instantaneous Minimum (<5 mg/L)

- 2020 Samples
- \* Outlier 2019-2020
- + 2020 30 Day Avg

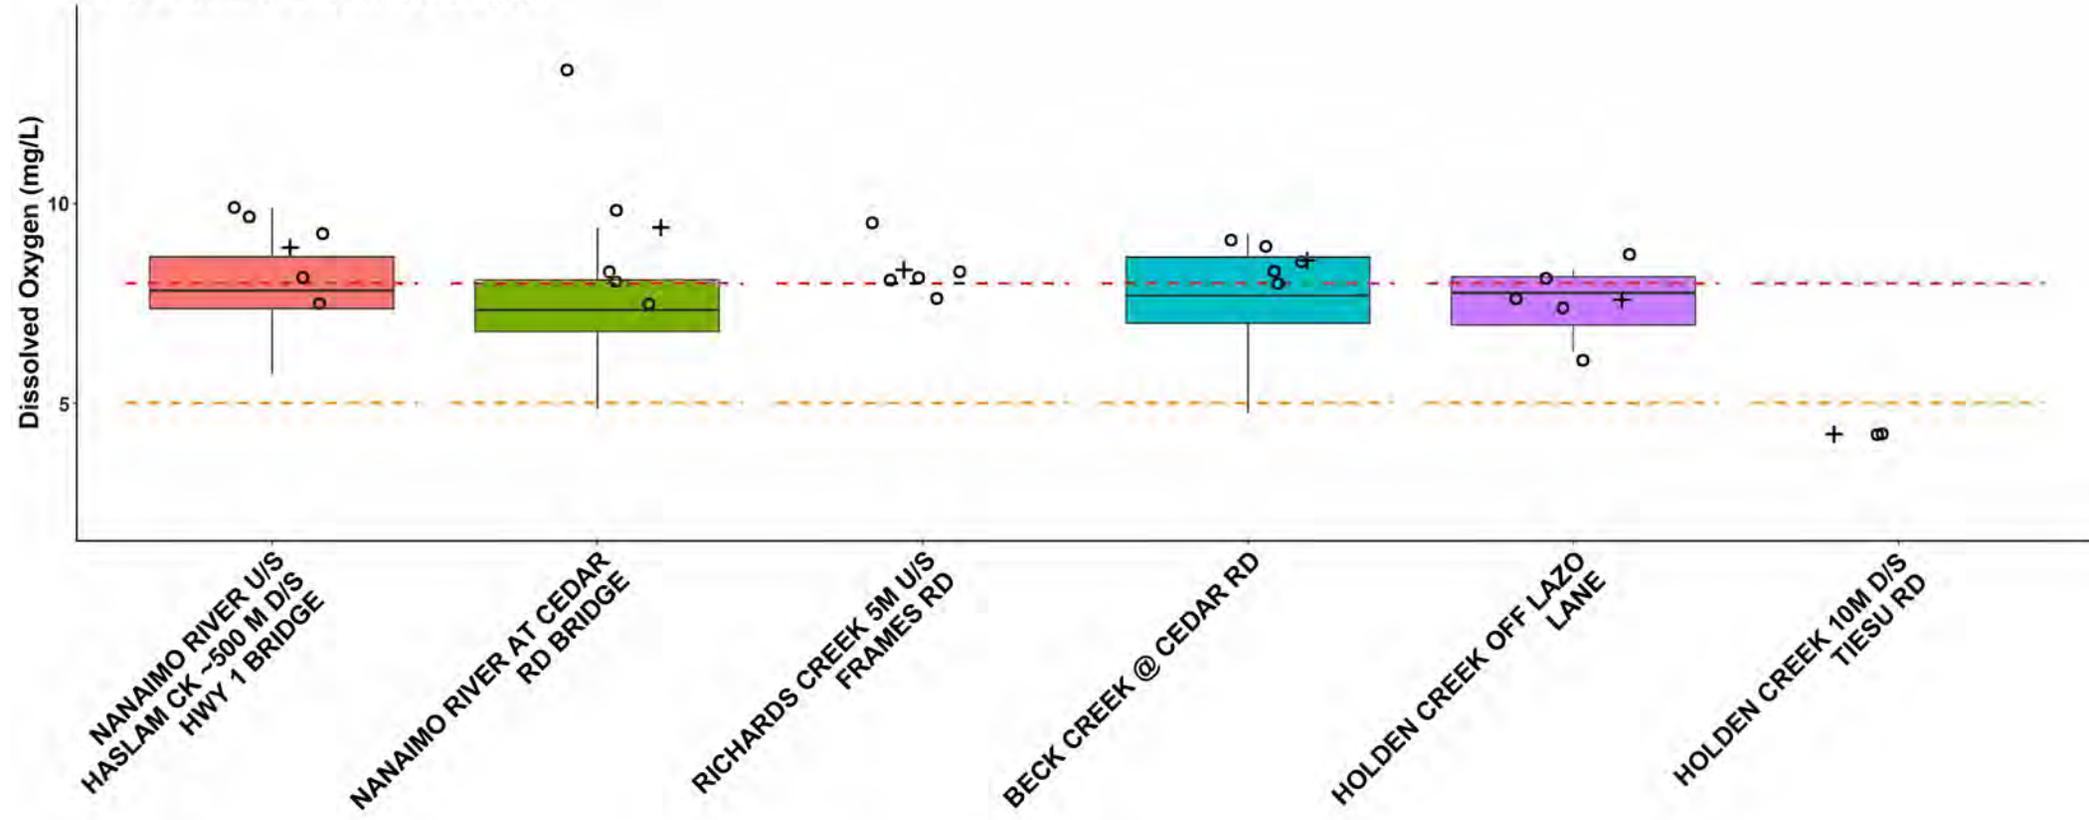
# WR6b Summer Dissolved Oxygen

○ 2020 Samples  
 + 2020 30 Day Avg  
**Guideline**  
 - - 30 Day Average (<8 mg/L)  
 - - Instantaneous Minimum (<5 mg/L)

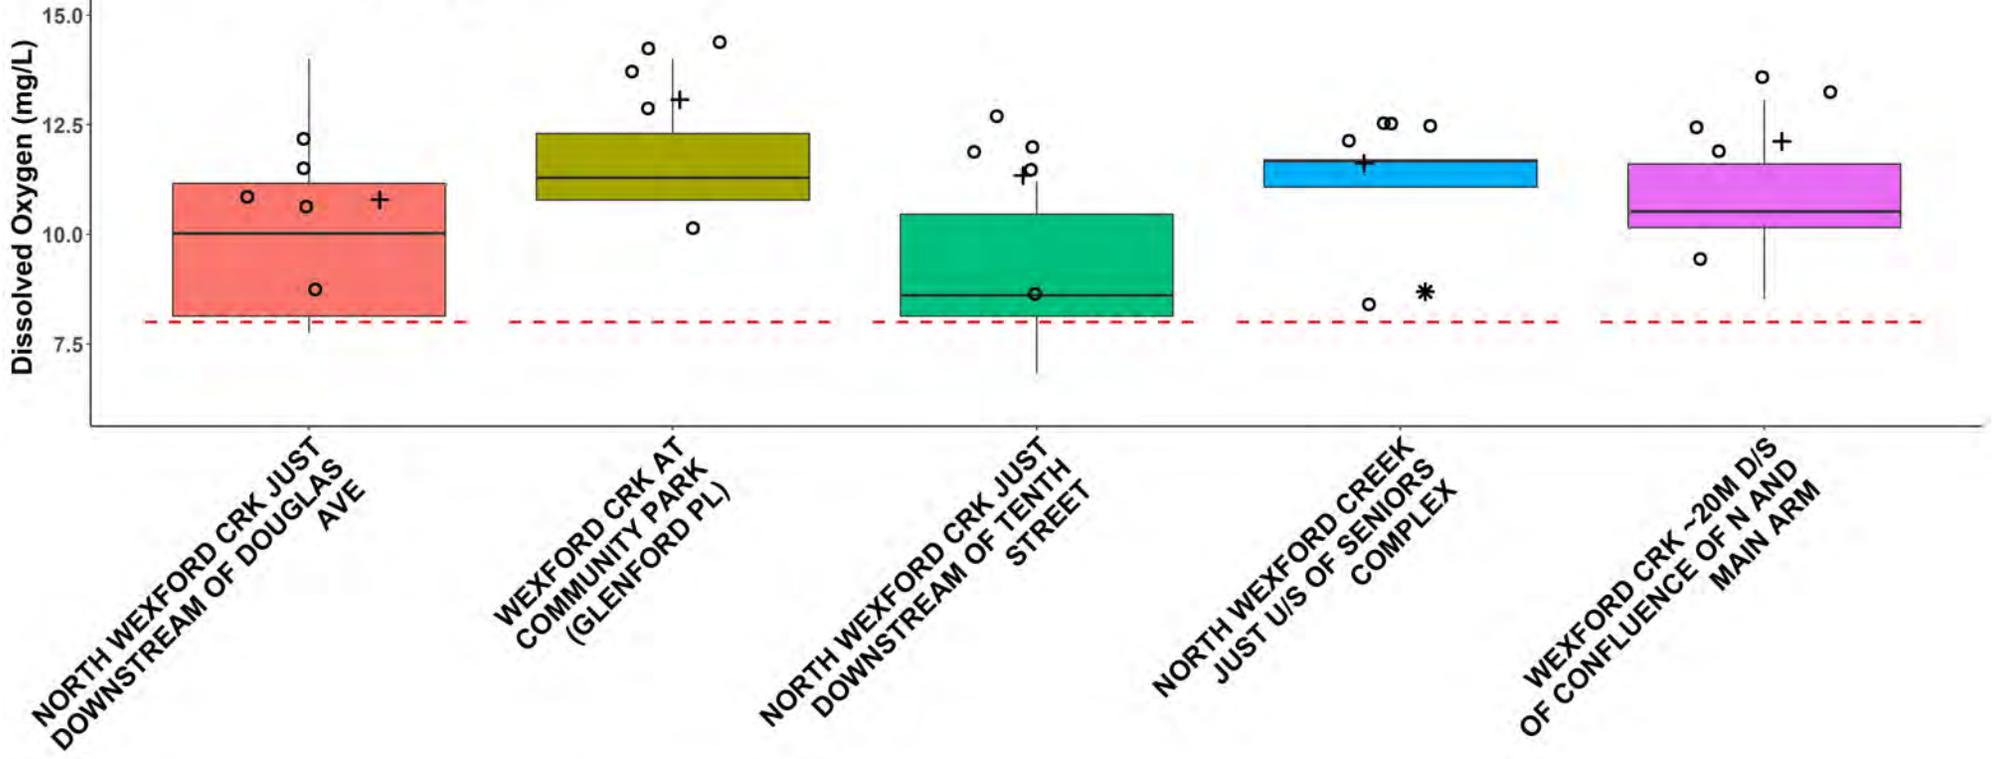
# WR6a Fall Dissolved Oxygen

- - 30 Day Average (<8 mg/L)
- - Instantaneous Minimum (<5 mg/L)

- 2020 Samples
- \* Outlier 2019-2019
- + 2020 30 Day Avg

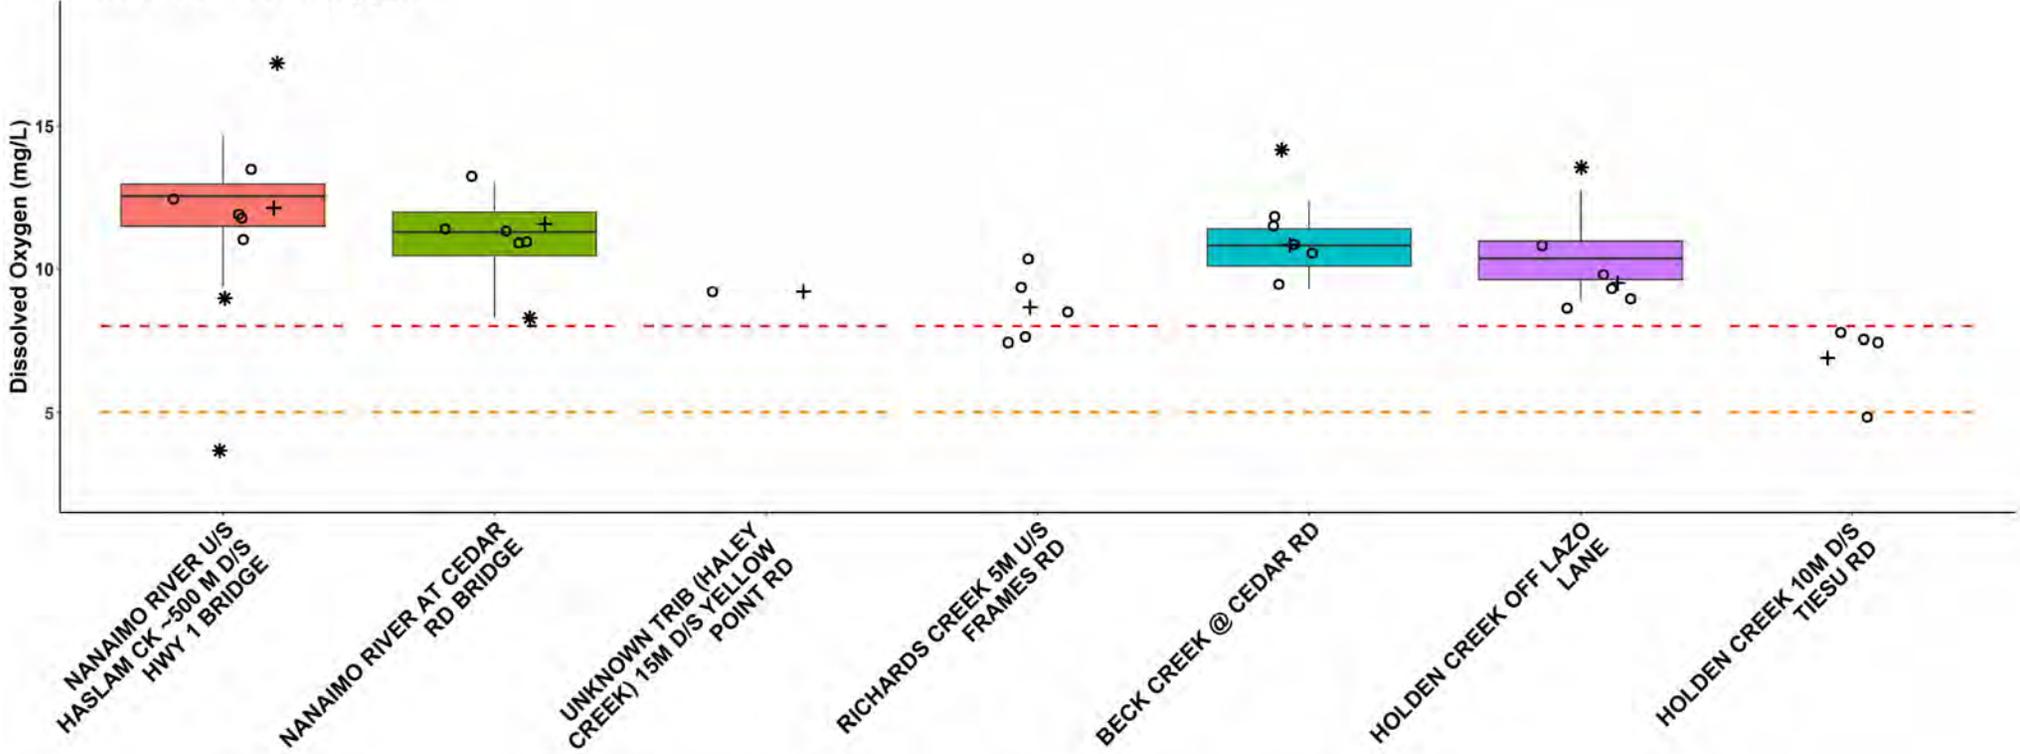
### WR6b Fall Dissolved Oxygen

- 2020 Samples
  - \* Outlier 2011-2019
  - + 2020 30 Day Avg
- Guideline**
- 30 Day Average (<8 mg/L)
  - Instantaneous Minimum (<5 mg/L)

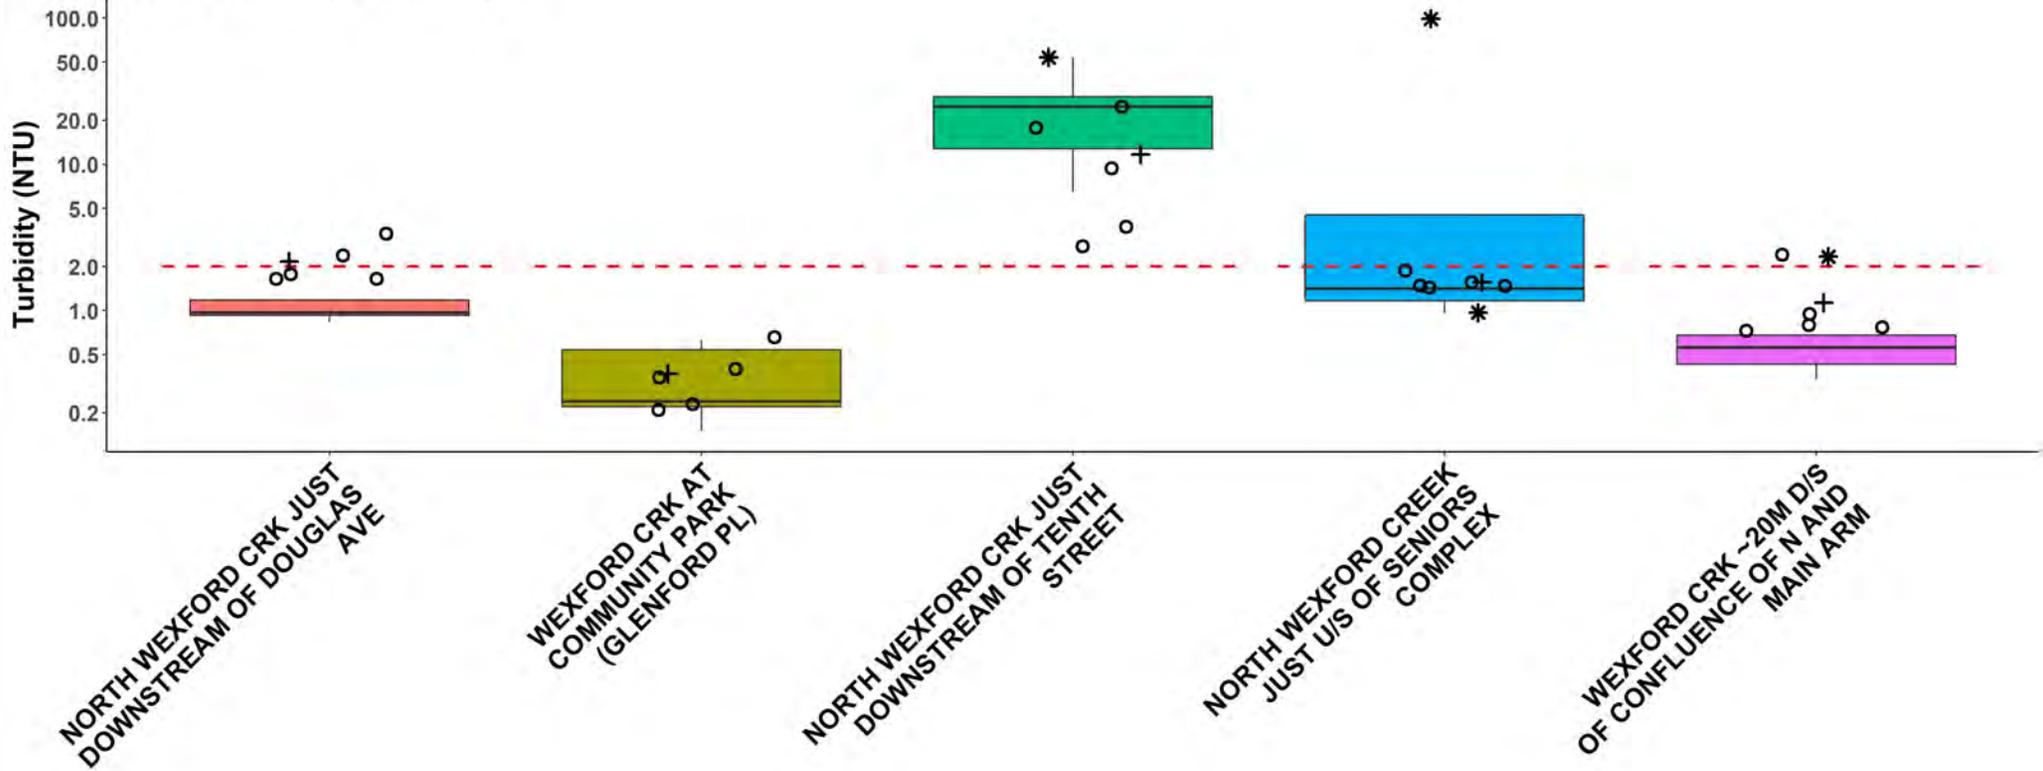
# WR6a Summer Turbidity

**Guideline**  
 - - Jan-Sept Max (2 NTU)

o 2020 Samples  
 \* Outlier 2019-2019  
 + 2020 30 Day Avg

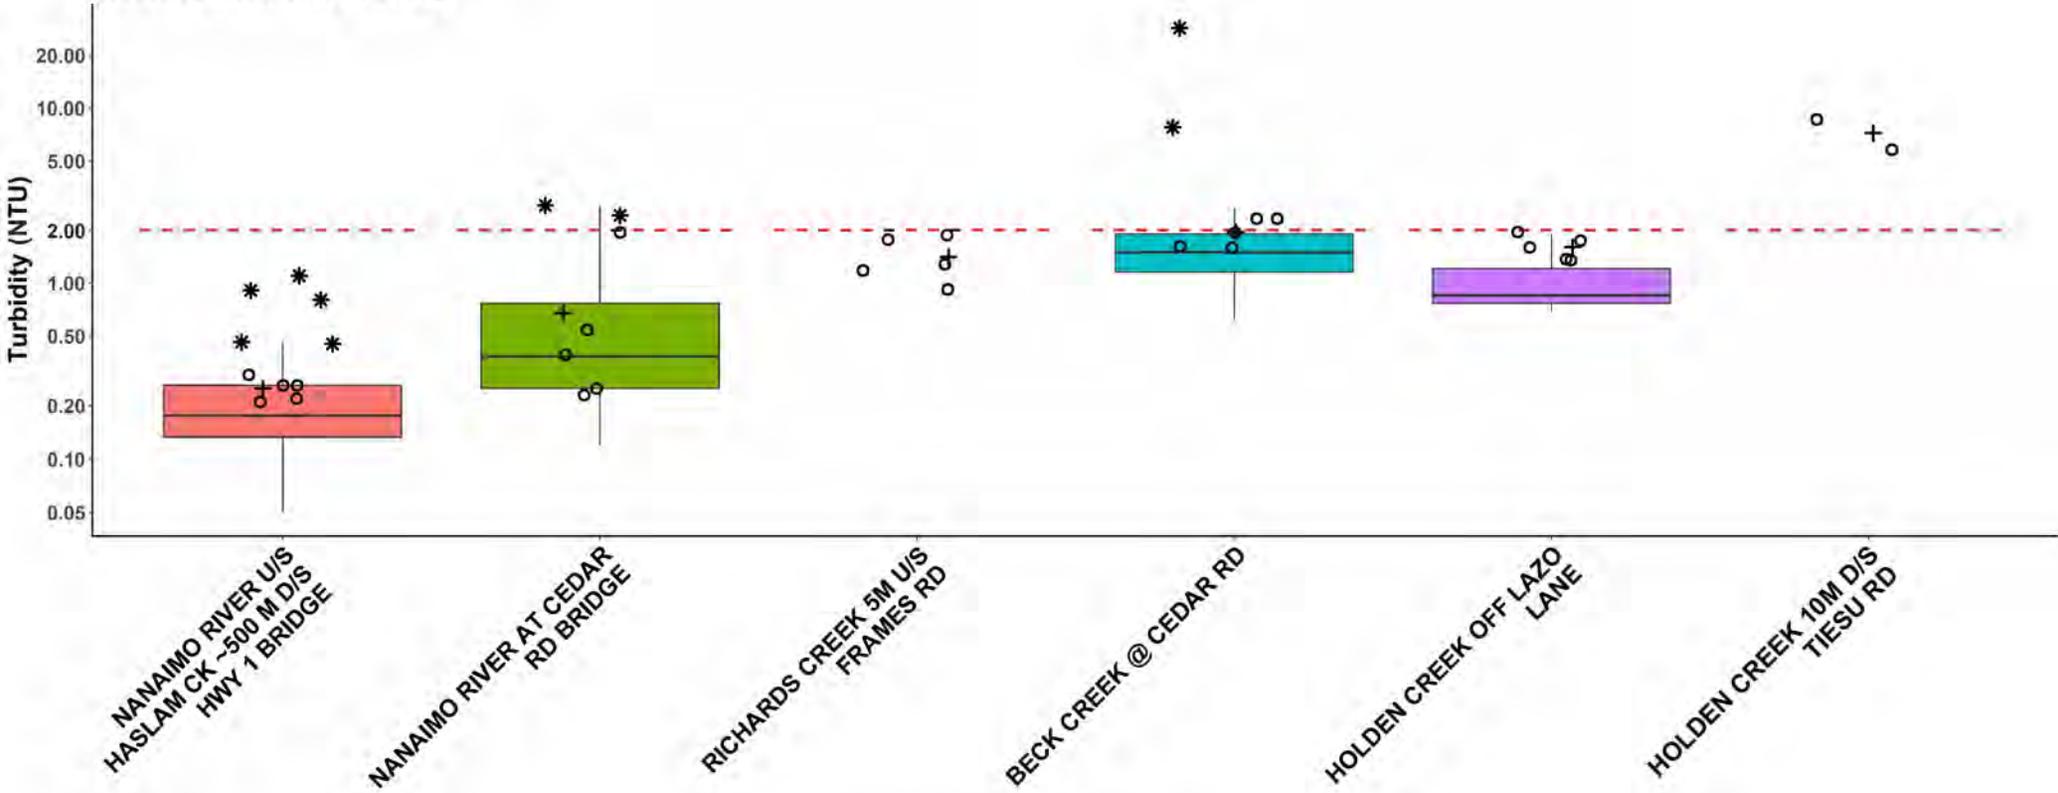
# WR6b Summer Turbidity

○ 2020 Samples  
 \* Outlier 2011-2019  
 + 2020 30 Day Avg  
**Guideline**  
 - - Jan-Sept Max (2 NTU)

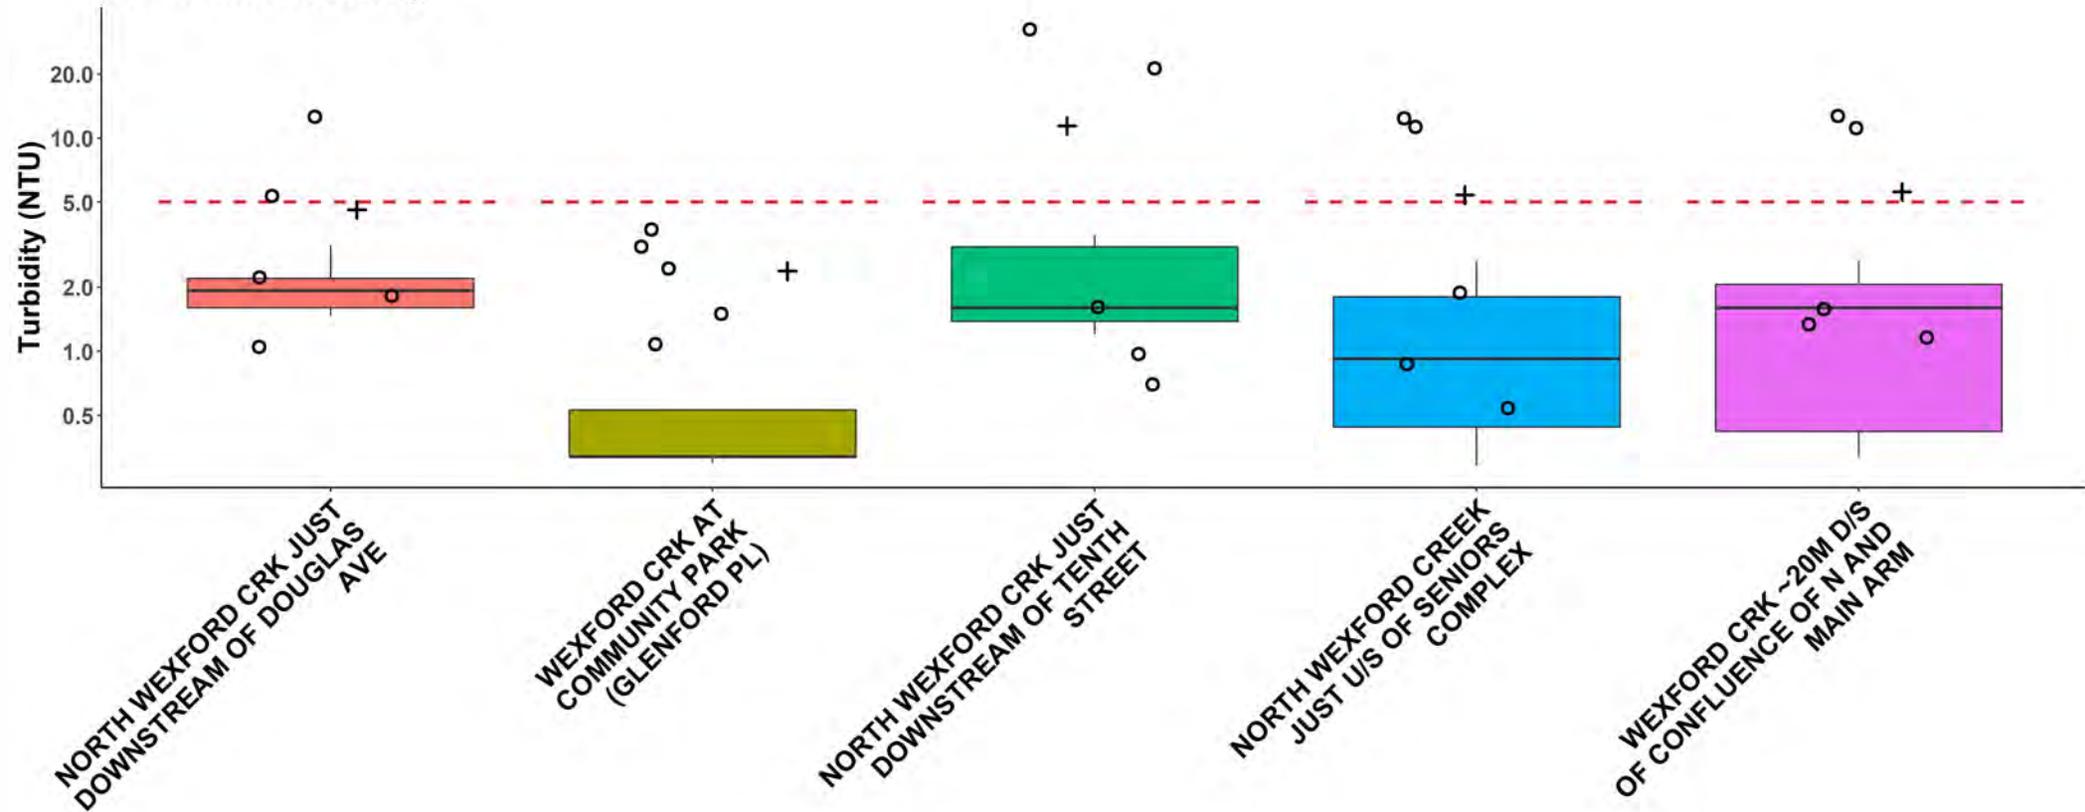
# WR6a Fall Turbidity

○ 2020 Samples      + 2020 30 Day Avg      Guideline  
-- Oct-Dec Max (5 NTU)

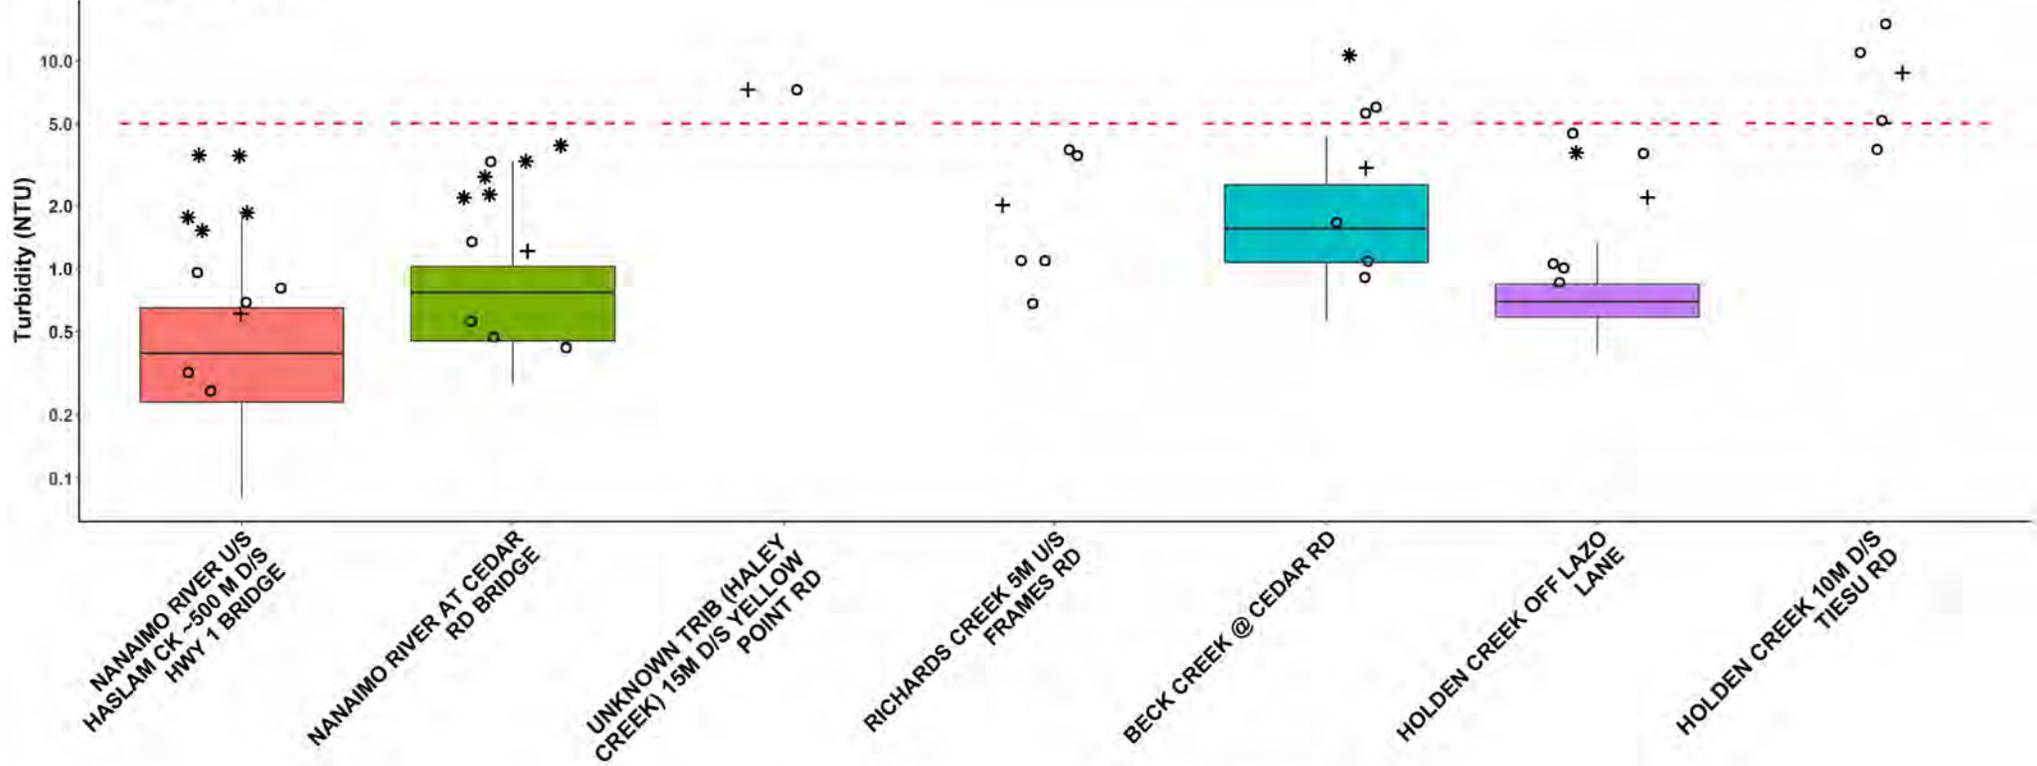
### WR6b Fall Turbidity

-- Oct-Dec Max (5 NTU)

- 2020 Samples
- \* Outlier 2011-2019
- + 2020 30 Day Avg

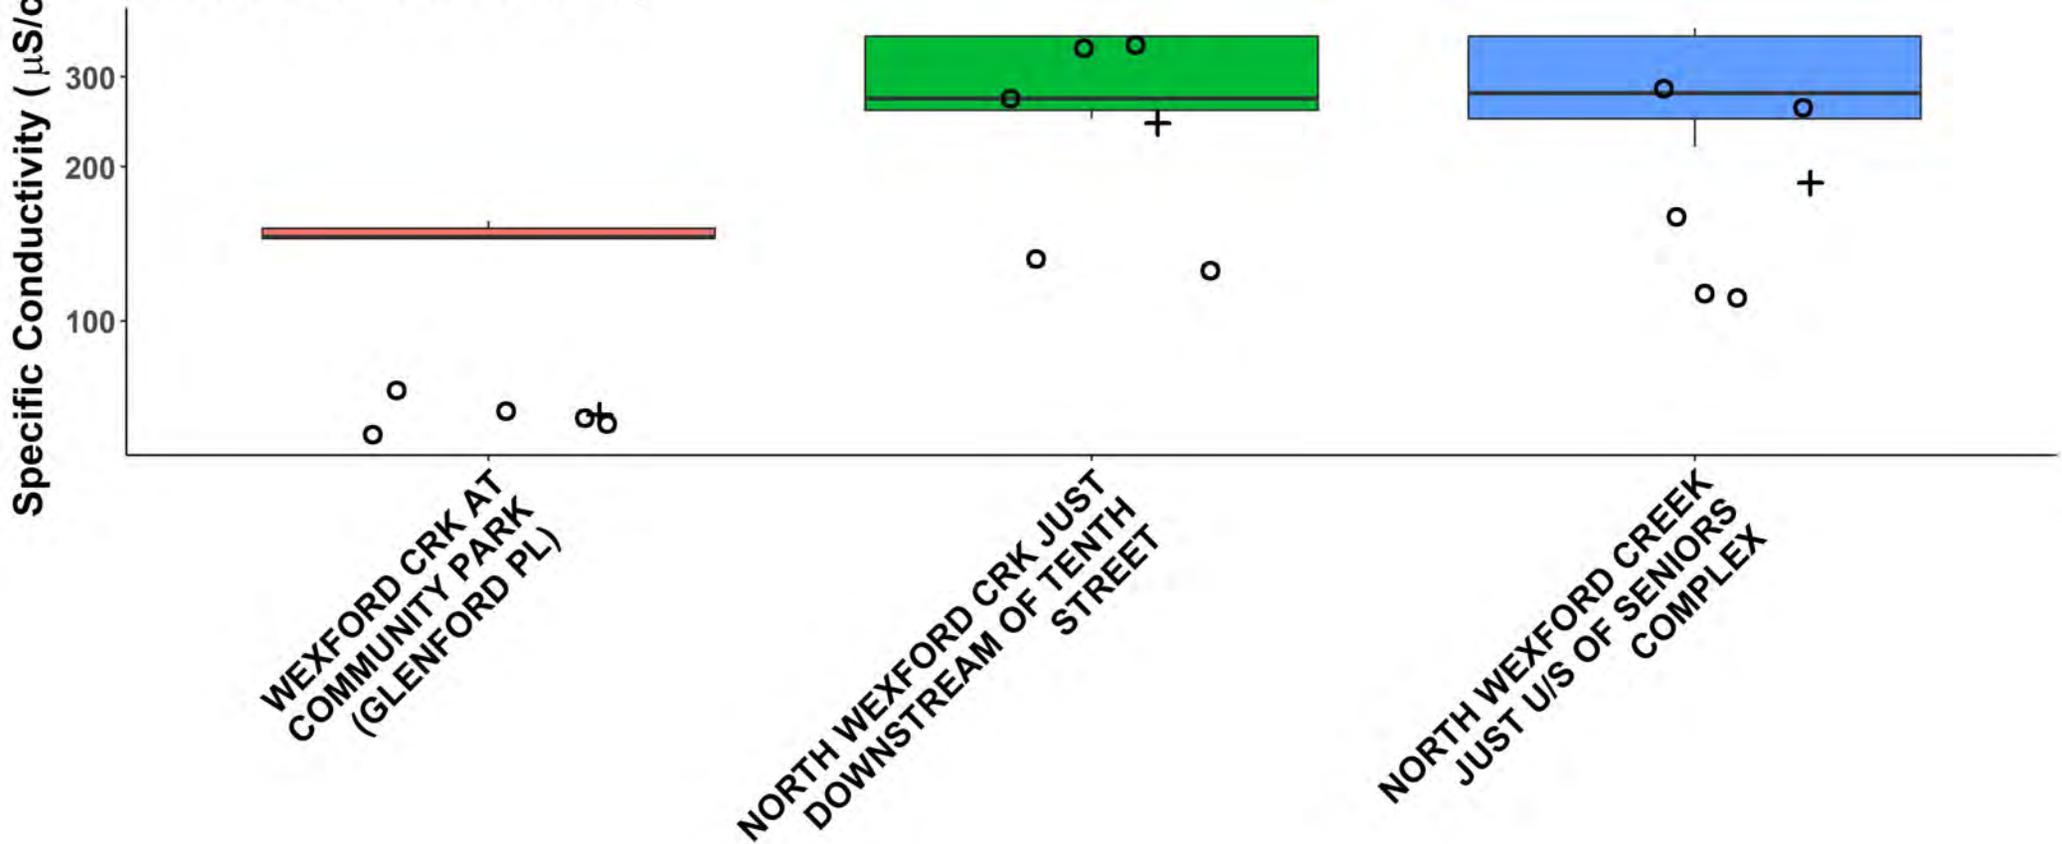
# WR6a Fall Conductivity

○ 2020 Samples + 2020 30 Day Avg

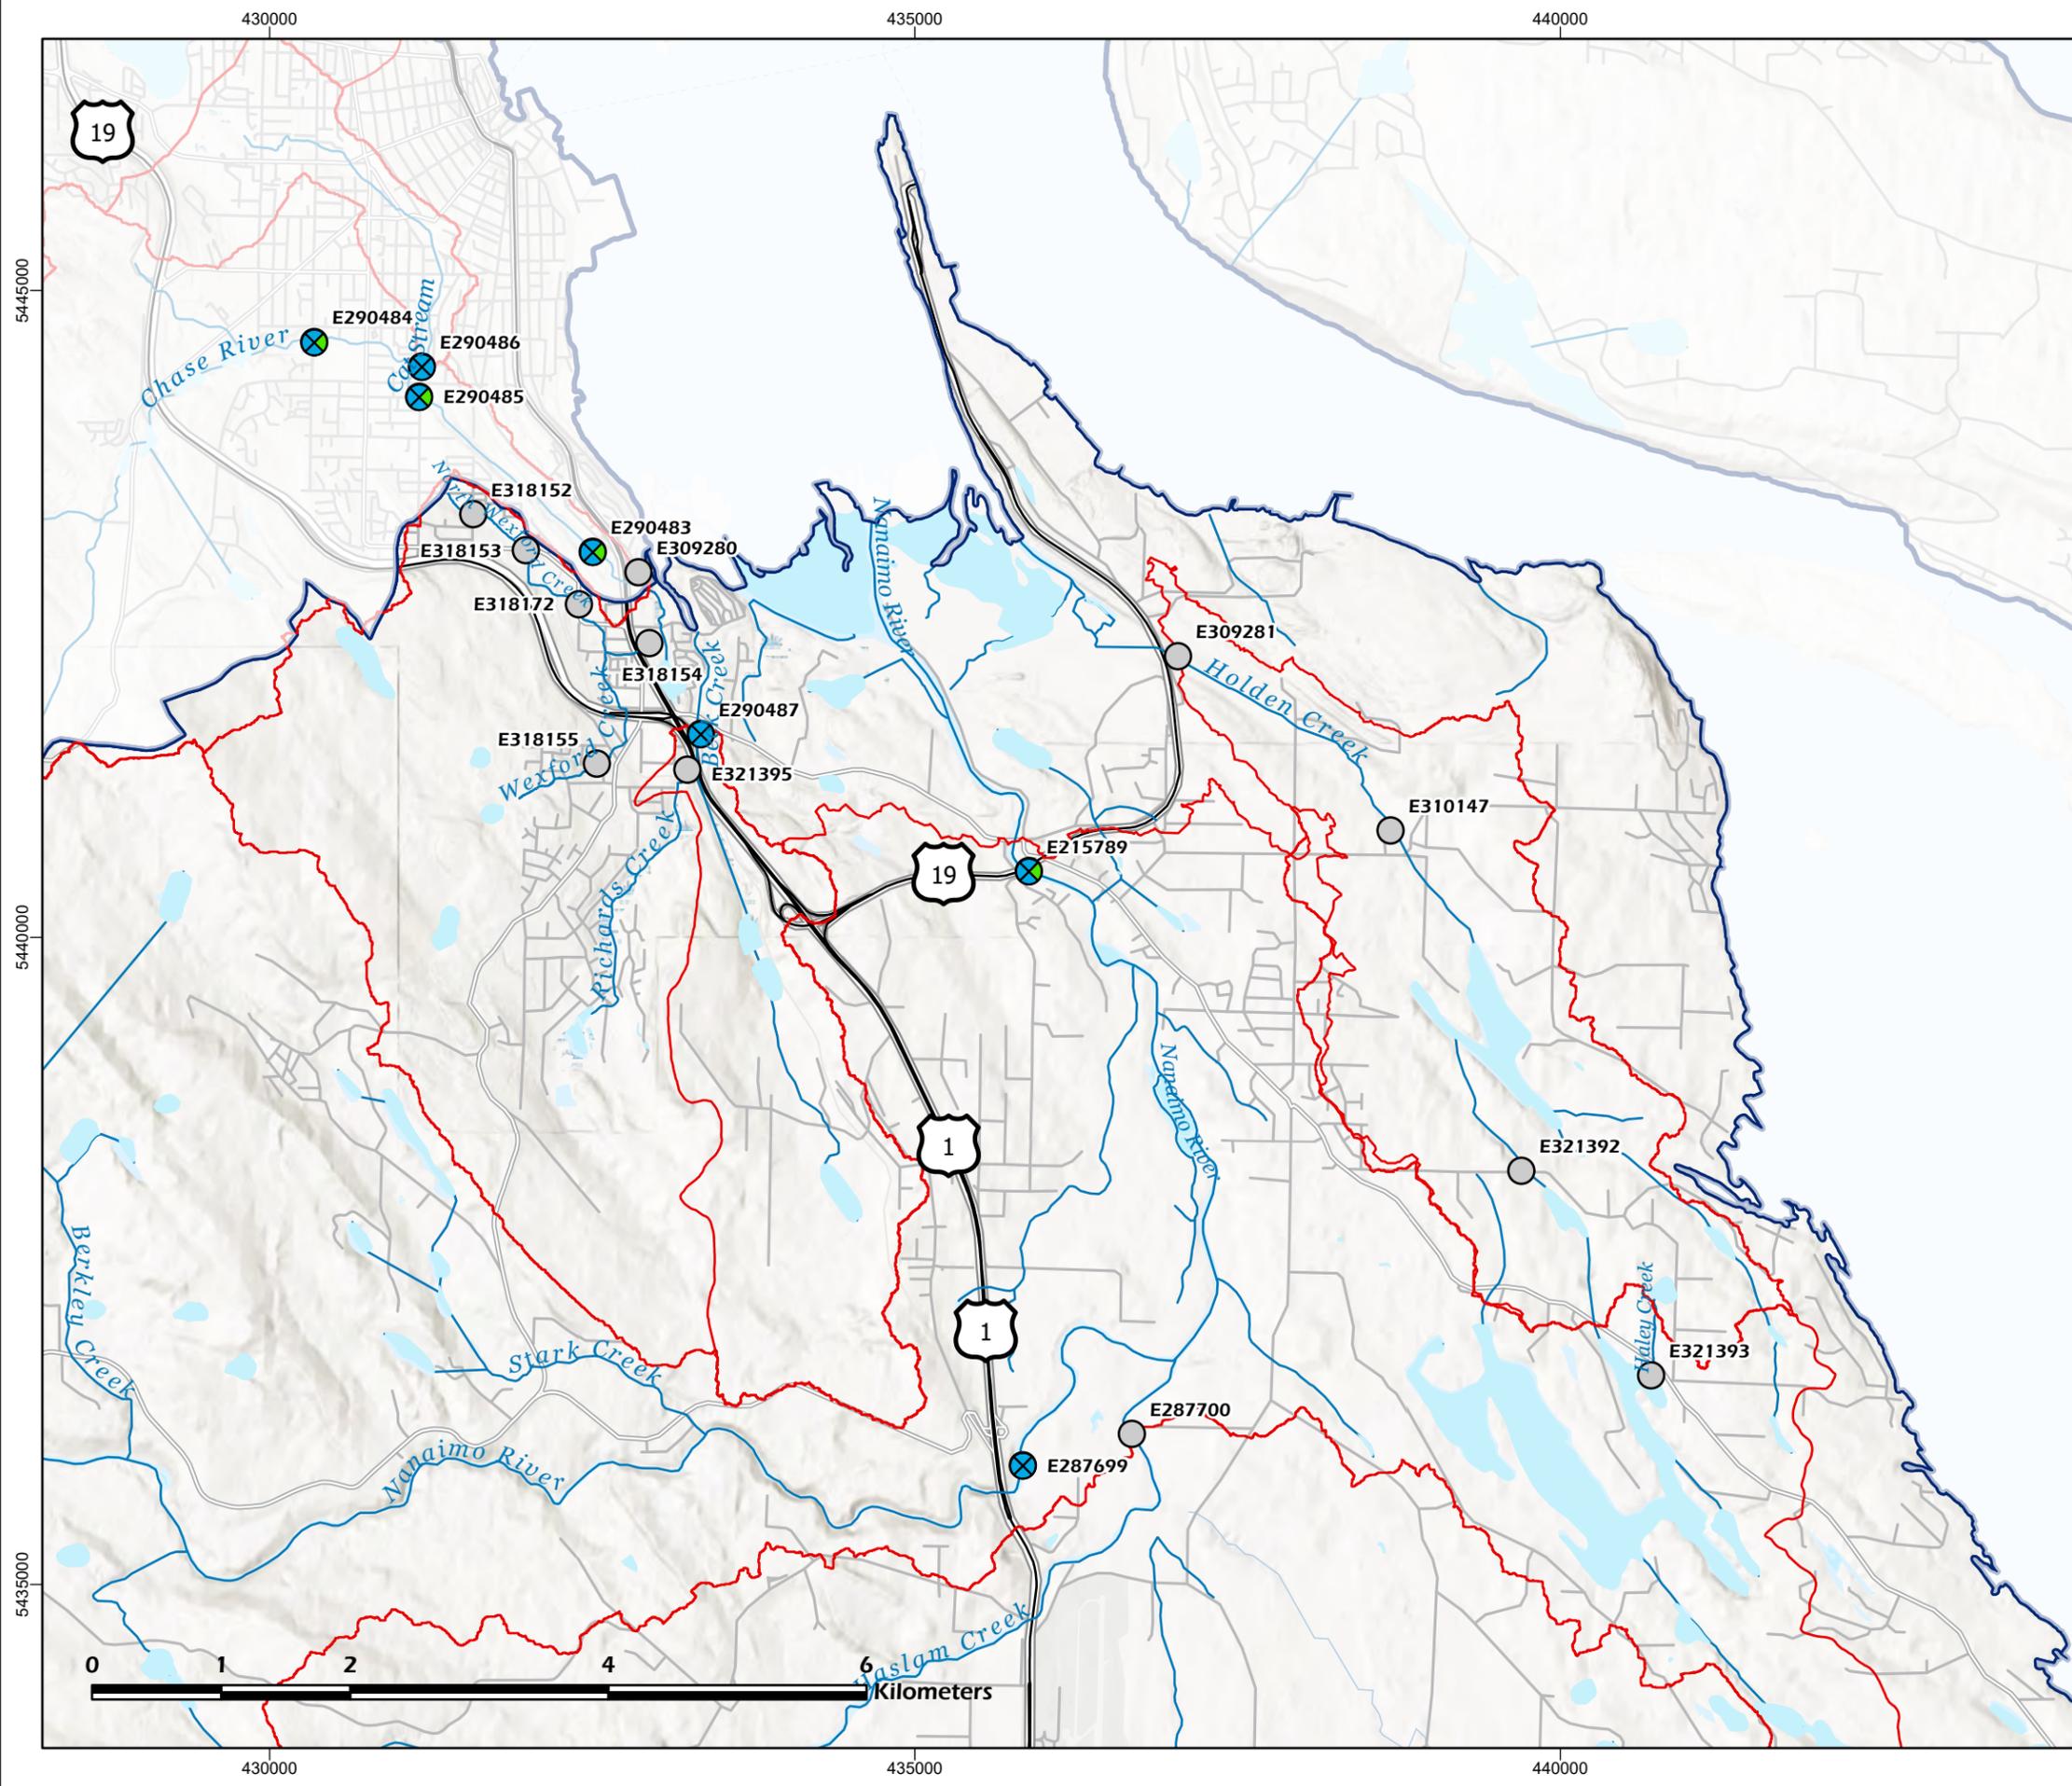
## CMMN Water Quality Trend Analysis 2011-2020

Conductivity can be influenced by factors such as groundwater and ocean spray that are not necessarily indicative of a degrading condition. For simplicity, an increase in conductivity is categorized here as degrading.
