# Community Watershed Monitoring Network 2020

## Results by Water Region

## **CWMN Sample Sites in WR 6:**

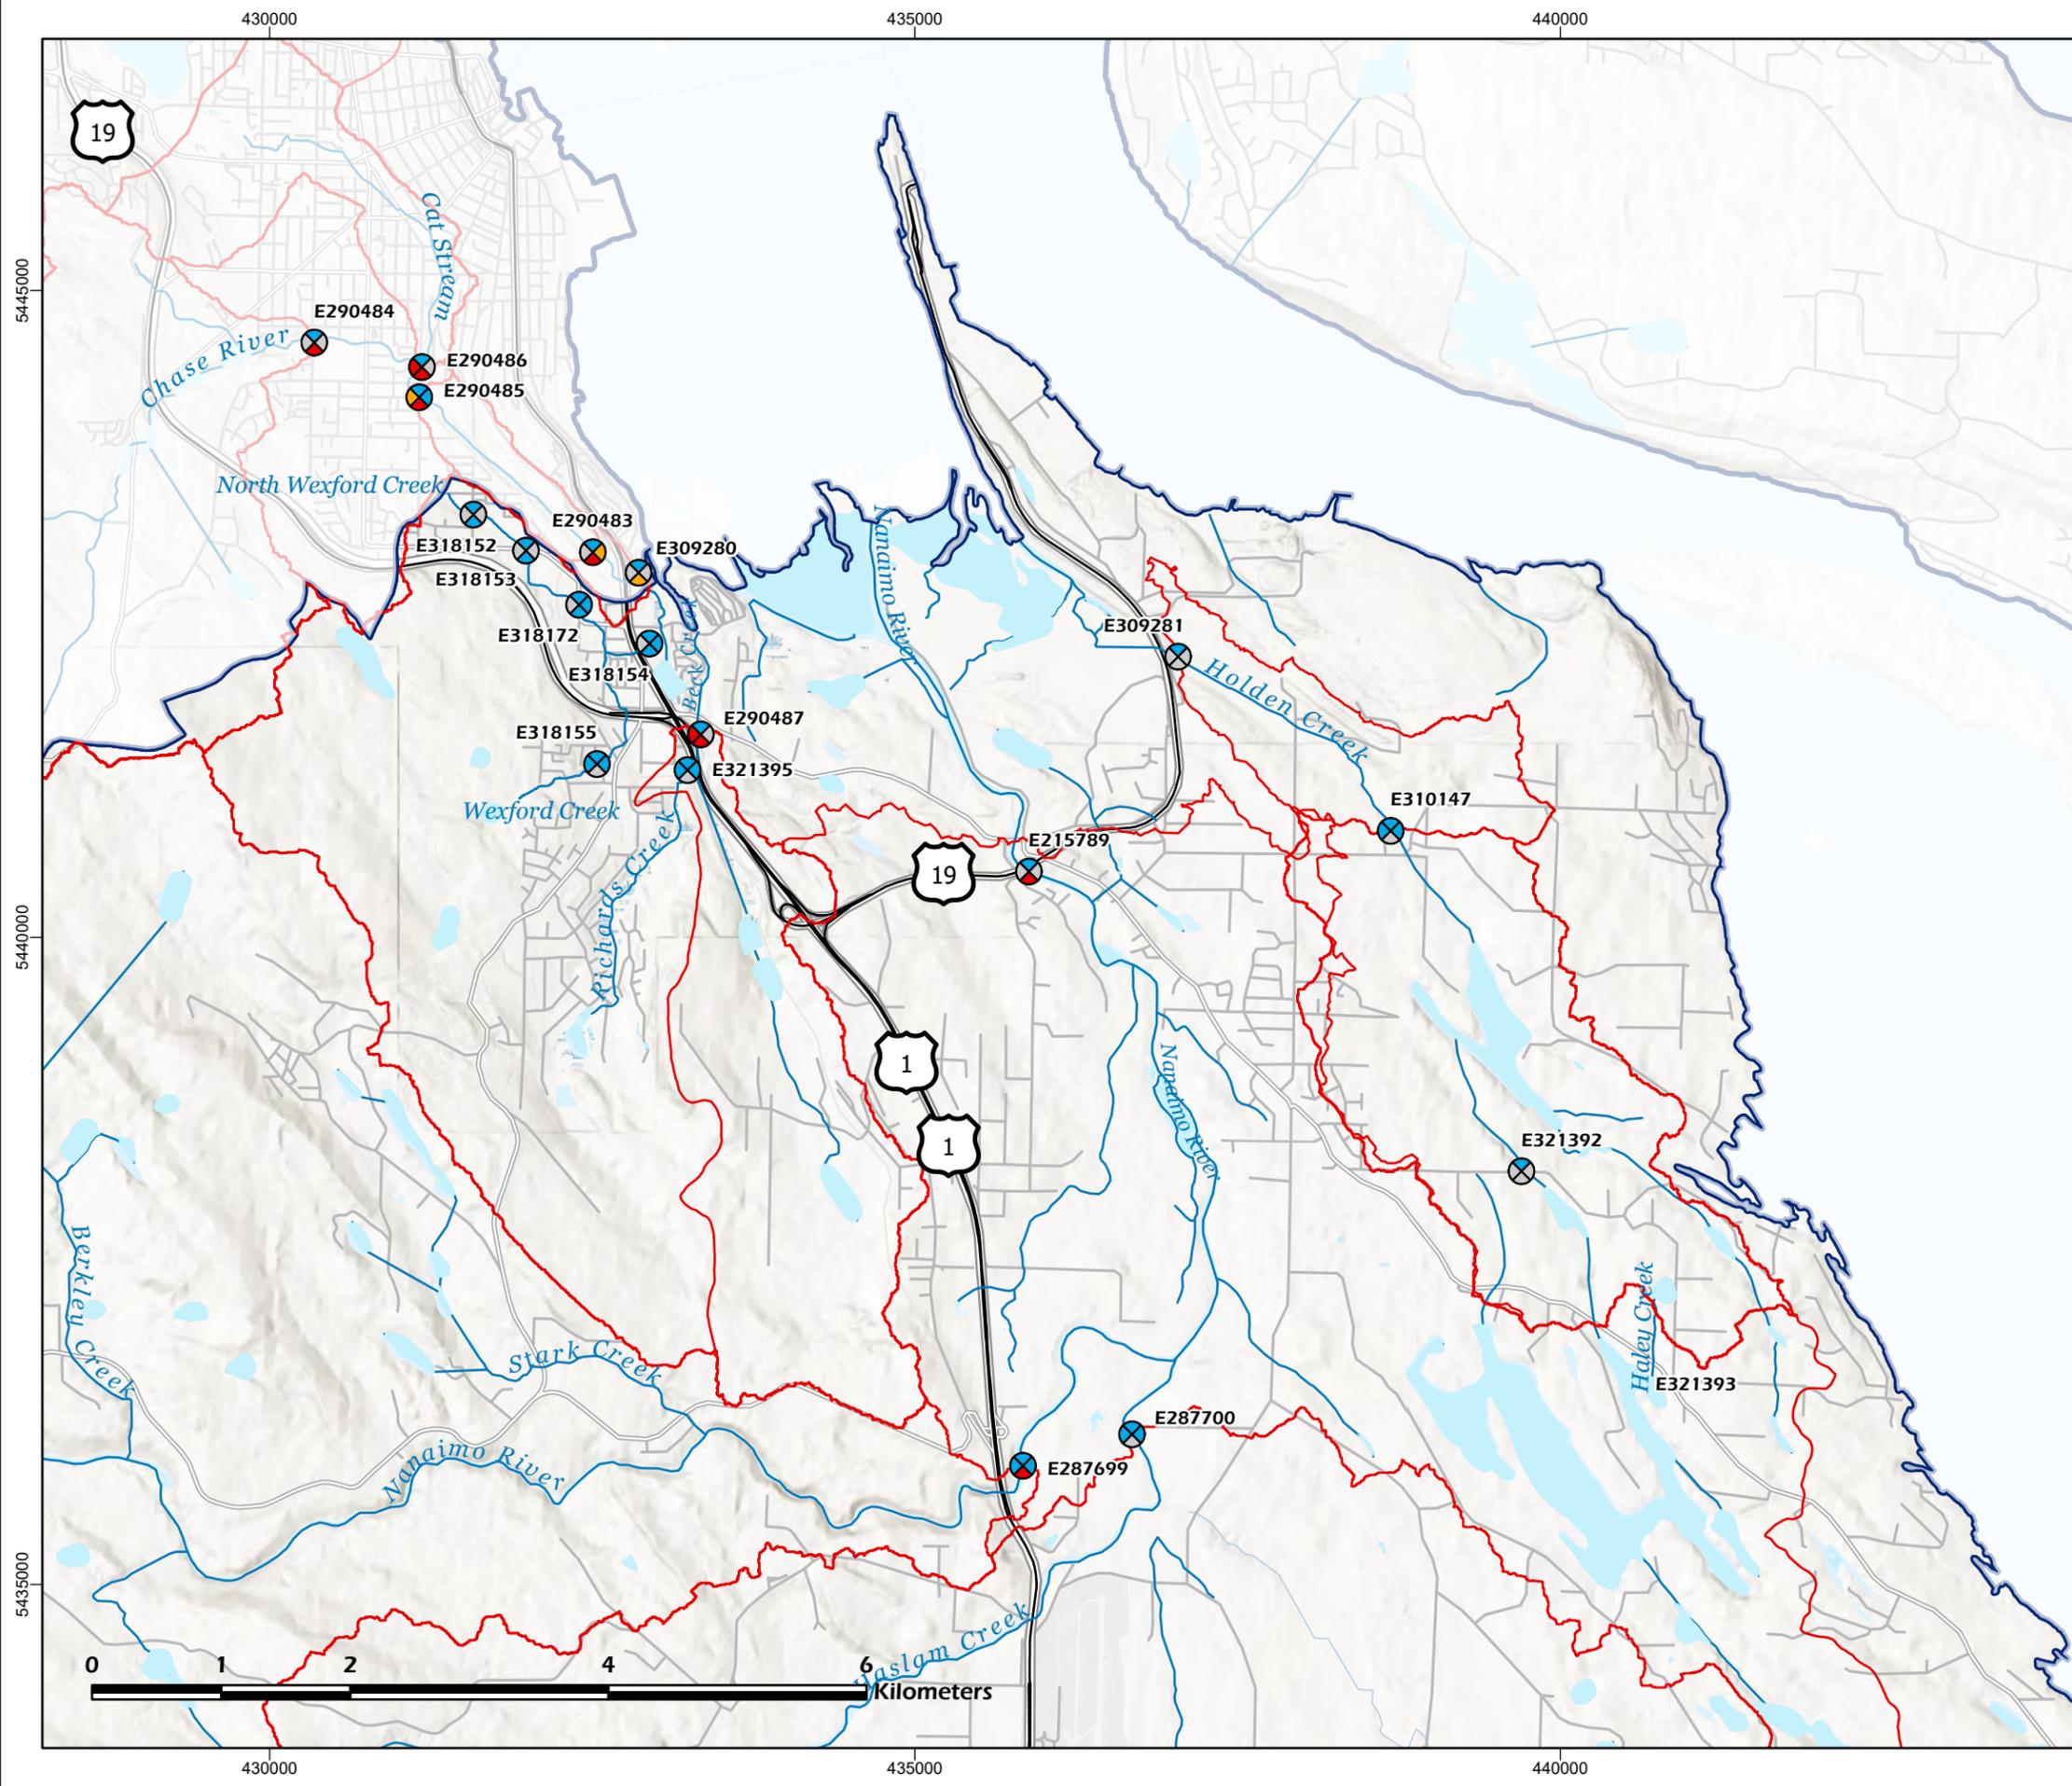
CMMN 2011-2020 Summer Exceedance Assessment

- Sample Site
  - Highway
  - Stream
  - Watershed
  - Water Region
  - Lake
- Note the exceedance frequency categories are reflective of the number of sample periods with exceedances, not the number or values of the exceedances.*

The summer and fall exceedance frequency maps included in this package express the number of sample periods (summer low-flow / fall flush) with exceedances for each site. There are four frequency categories for the number of sample periods with exceedances: no exceedance recorded (0), low (1 – 2), moderate (3 – 4), and high (5 or more). The exceedance categories are for the three parameters with aquatic water quality guidelines and objectives based on the following thresholds: temperature  $\geq 17^{\circ}\text{C}$ , dissolved oxygen  $\leq 5\text{mg/L}$ , summer turbidity  $\geq 2\text{NTU}$ , and fall turbidity  $\geq 5\text{NTU}$ .

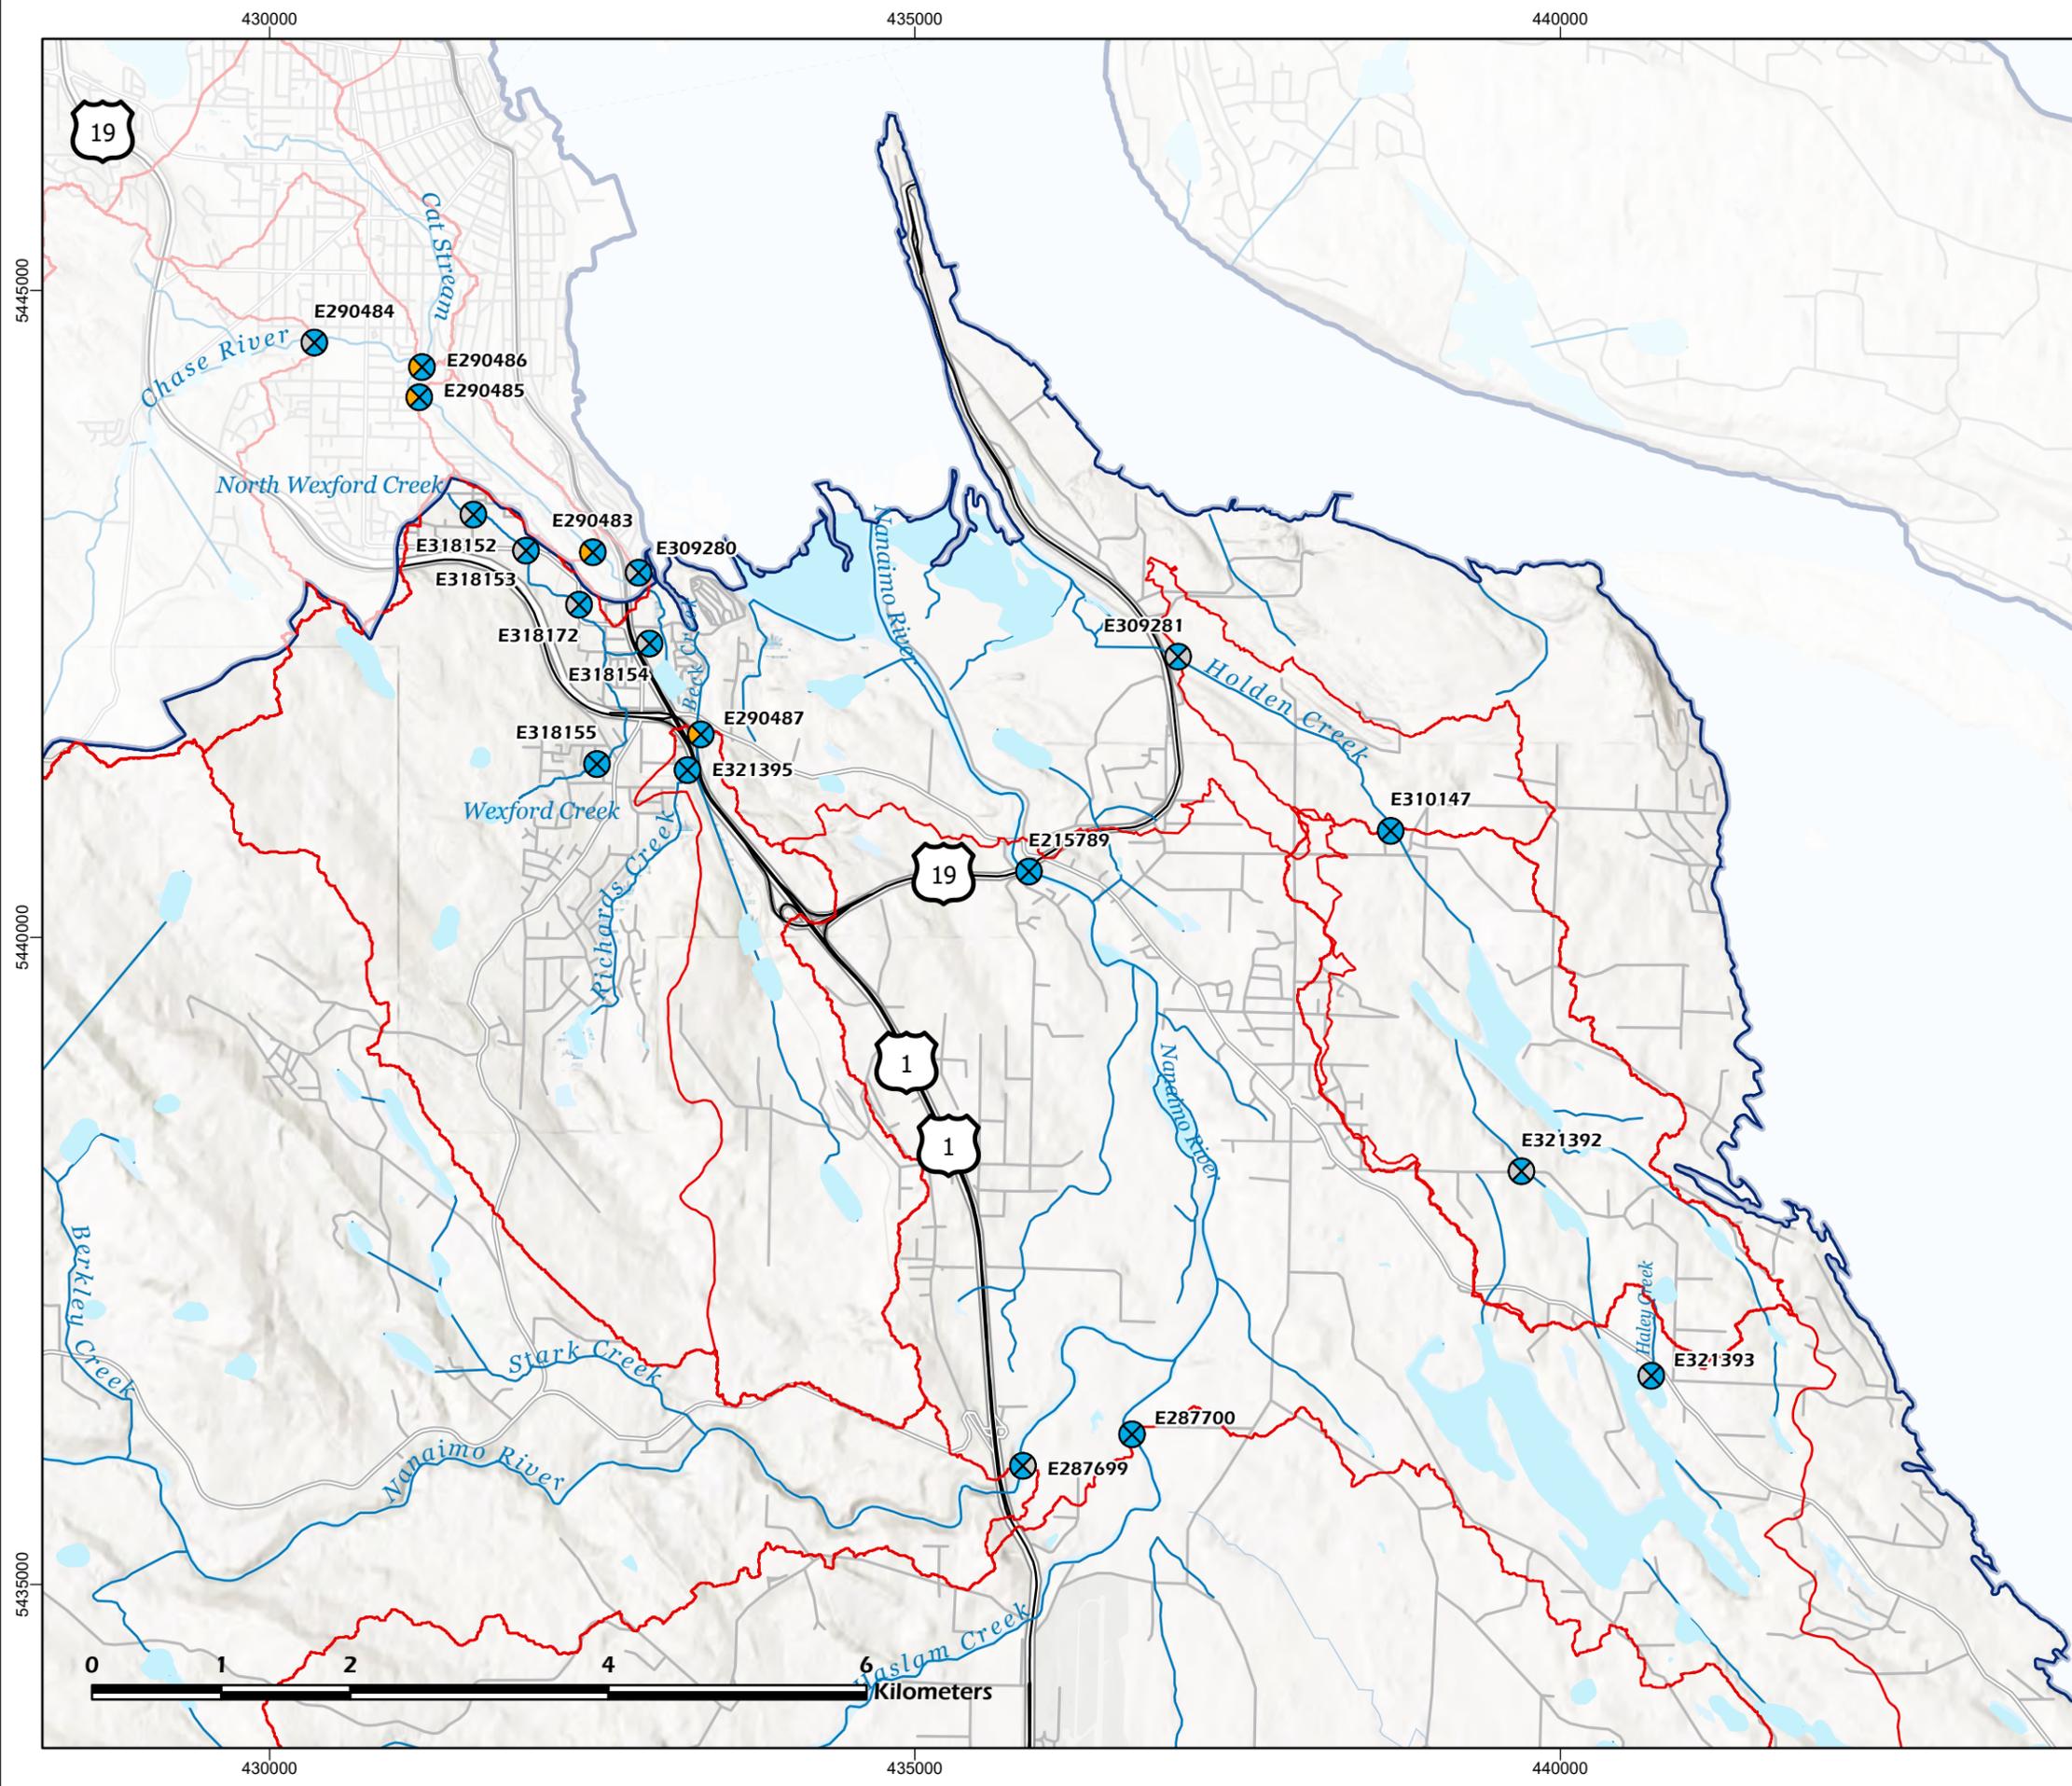
## CMMN 2011-2020 Fall Exceedance Assessment

- ⊗ Sample Site
  - Stream
  - Highway
  - ▭ Watershed
  - ▭ Water Region
  - ▭ Lake
- Note the exceedance frequency categories are reflective of the number of sample periods with exceedances, not the number or values of the exceedances.*
