# Community Watershed Monitoring Network 2024 Results by Water Region

Included in Water Region (WR) 6 package:

1. CWMN WR6 sample sites
2. How to interpret a box plot
3. Box Plot Comparison – 2024 data to previous years: *displayed by parameter (Turbidity, Dissolved Oxygen, Temperature, Conductivity) & sample period (summer, fall)*
4. Wexford Creek Streamkeepers (WxCS) map
5. Nanaimo and Area Land Trust (NALT) map

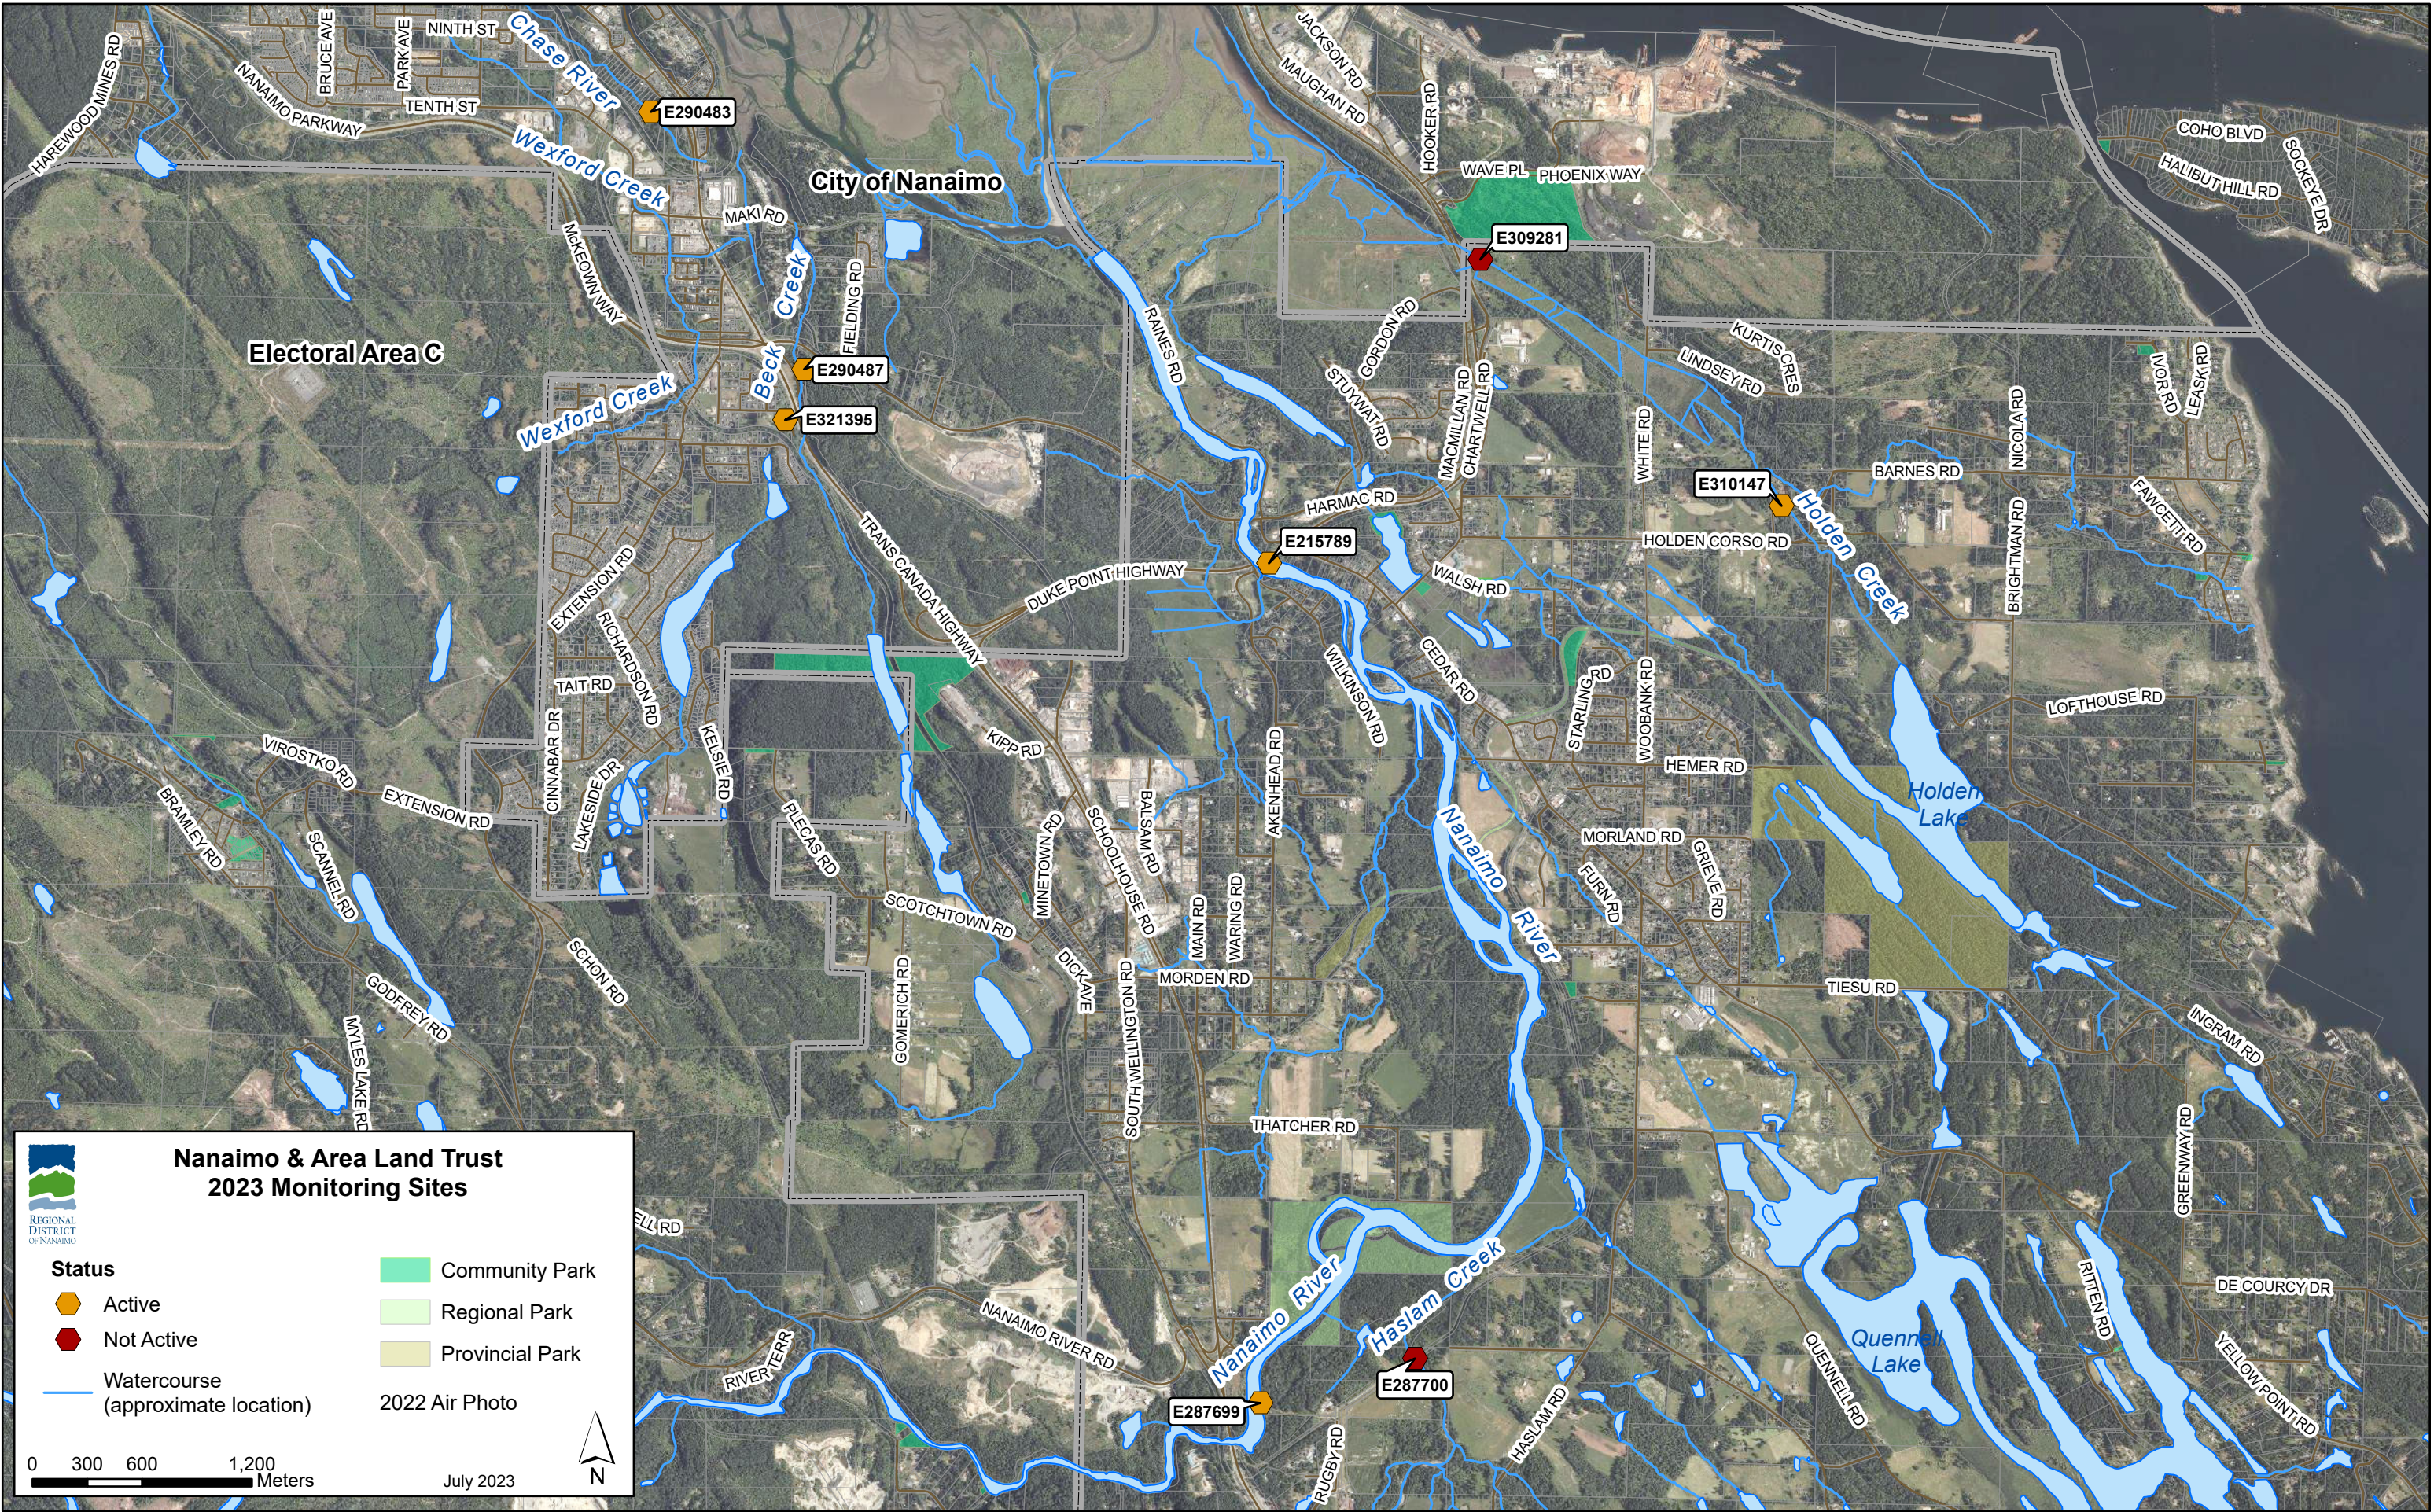
# Wexford Creek Streamkeepers 2023 Monitoring Sites

- Active
- Not Active

Watercourse  
(approximate location)
