### **South Wellington School Renovation Design Consulting Services**

**Addendum 1 (191 pages)**

## FEASIBILITY STUDY REPORT

## **BUILDING CONDITION ASSESSMENT REPORT**

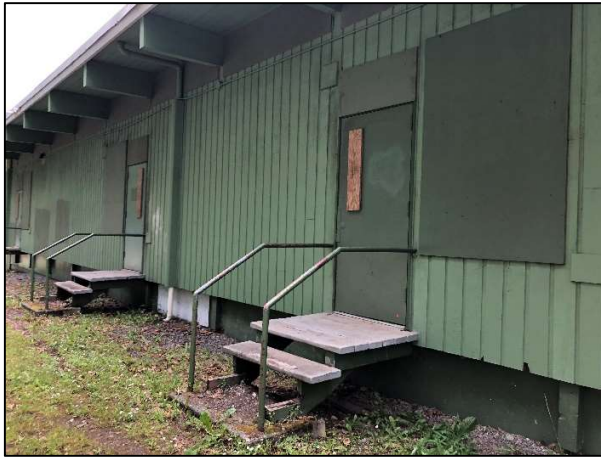
Photo 1 - Stairs leading to gravel at rear of building

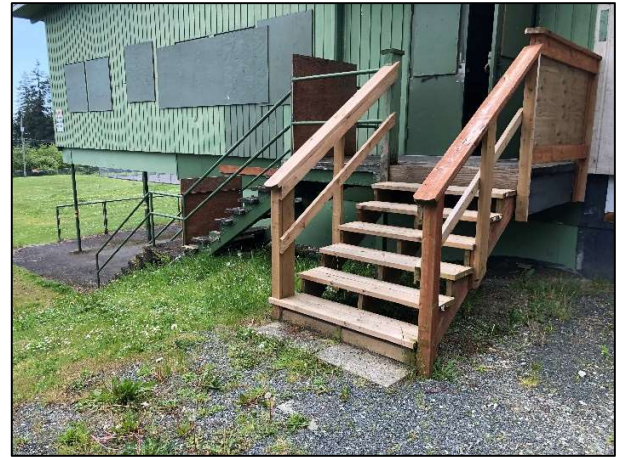
Photo 2 - Gravel and grass at north elevation

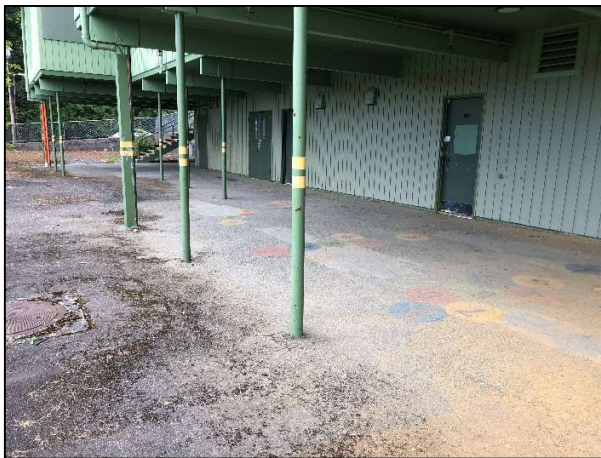
Photo 3- Asphalt surfaces at East Elevation

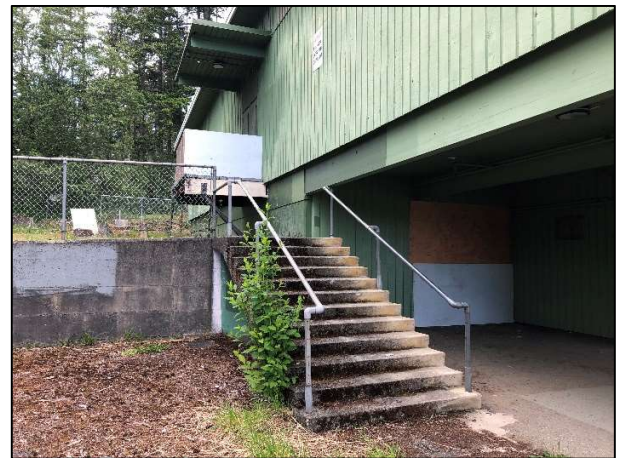
Photo 4 - Asphalt surfaces and concrete stairs

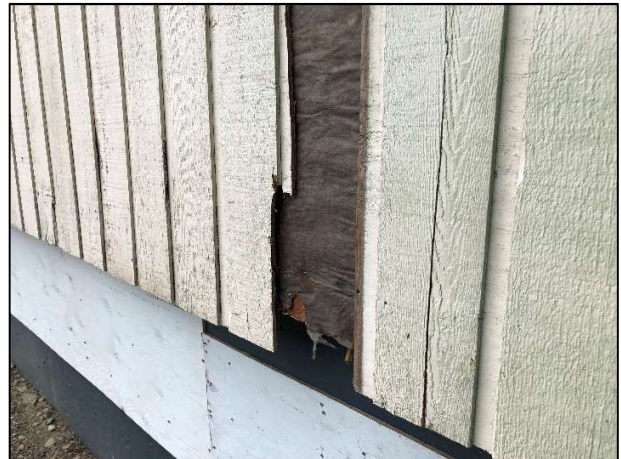
Photo 2 - Vertical painted cedar cladding installed over building paper

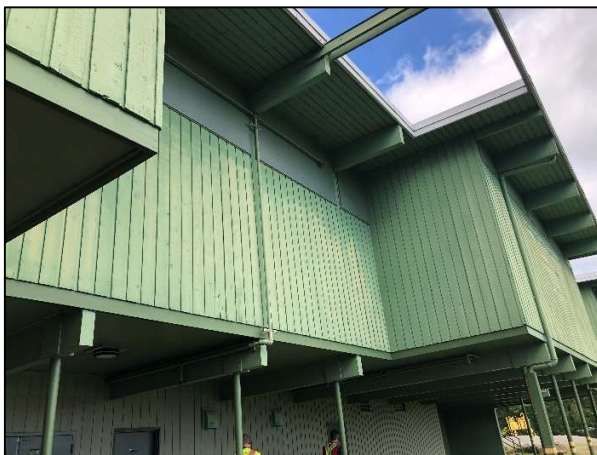
Photo 3 - Exterior wall paint has faded

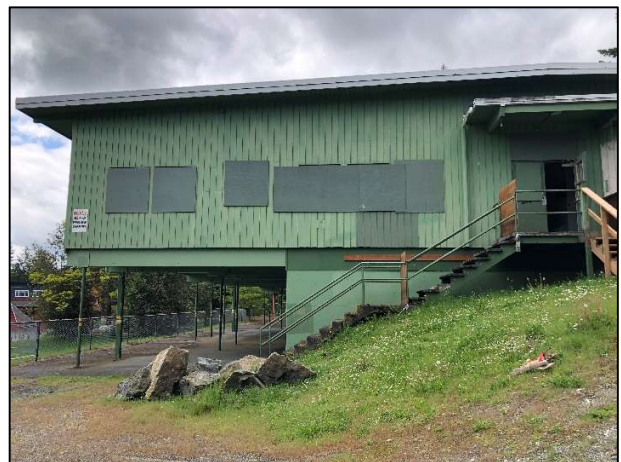
Photo 4 - North elevation shows cladding and boarded windows and doors

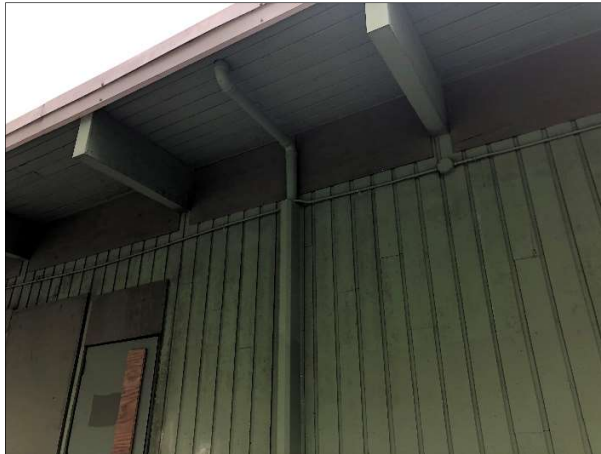
Photo 1 - Typical window openings at top of wall

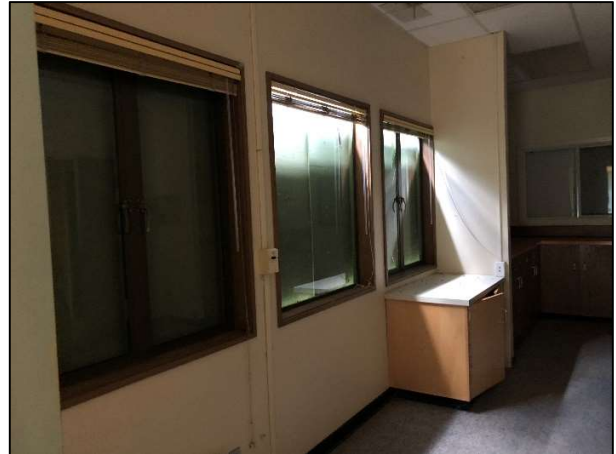
Photo 2 - Metal framed windows

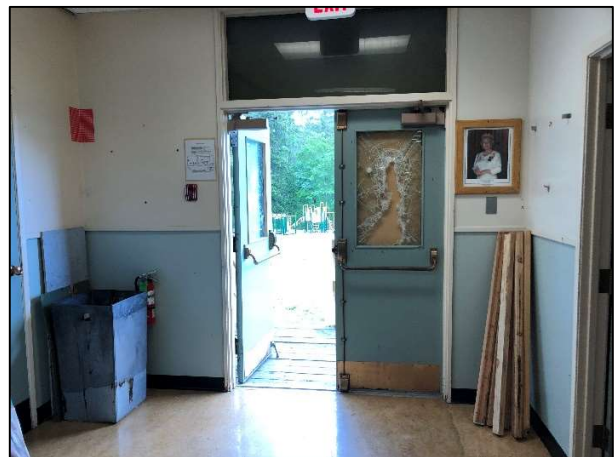
Photo 4 - Glass has been smashed in at least one door

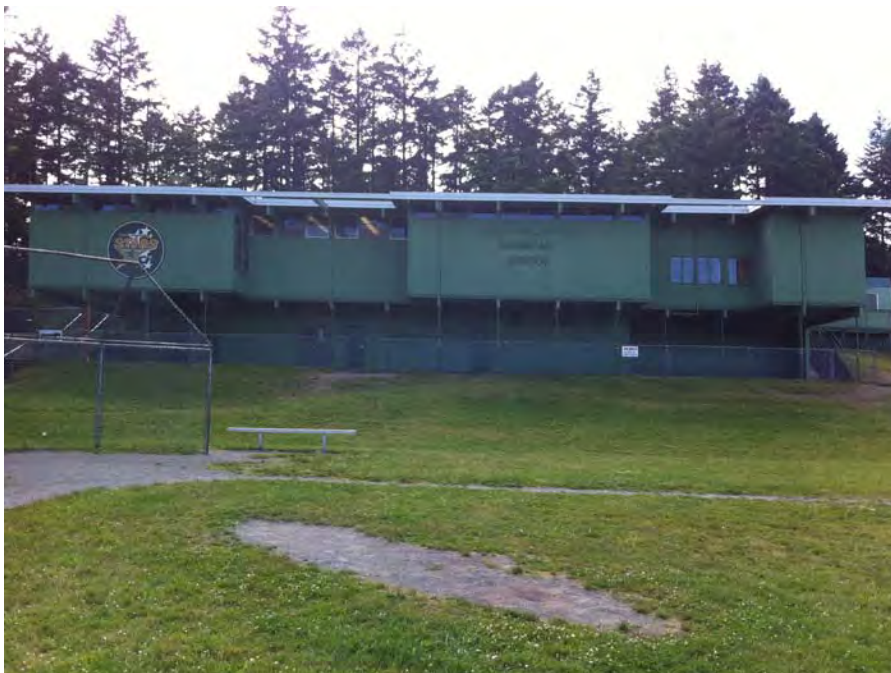
East elevations showing extent of glazing

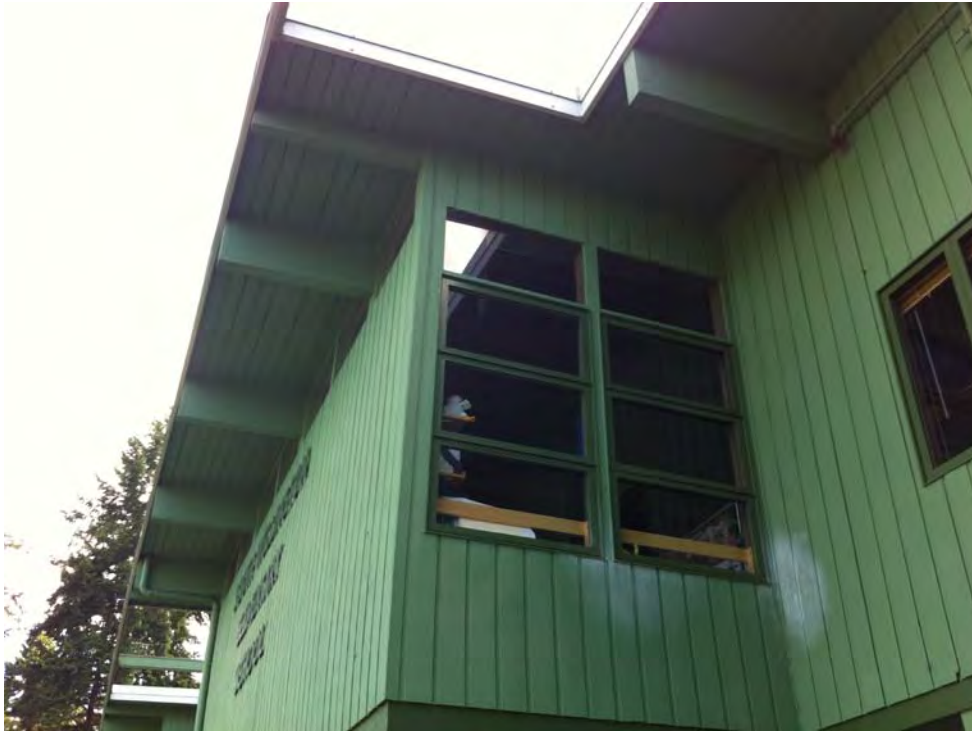
Side windows on east elevation bays

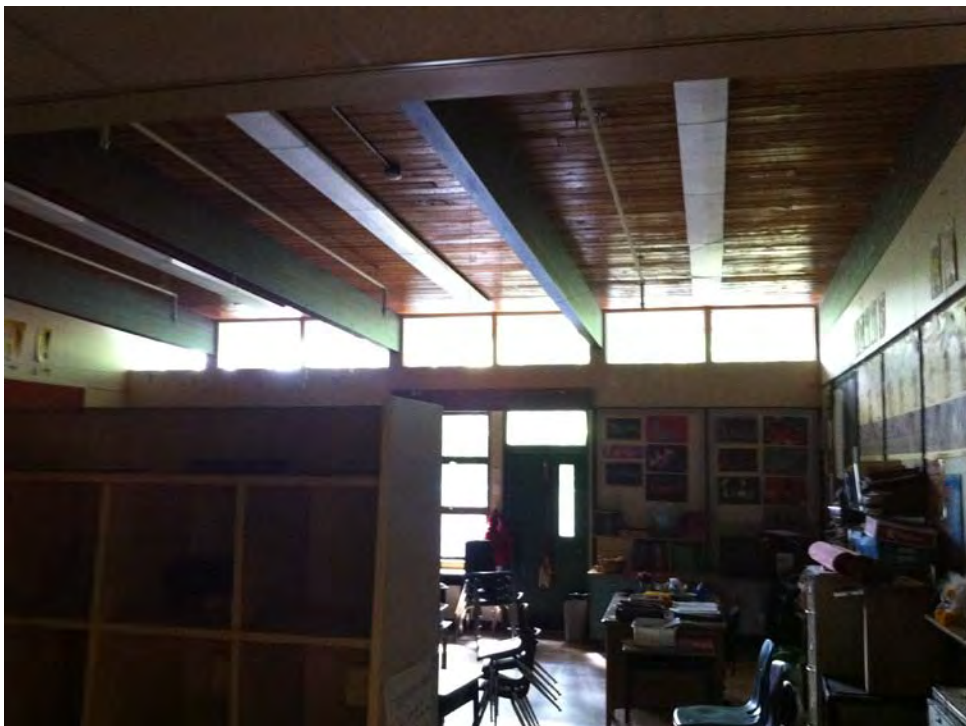
Typical interior view showing roof structure and support

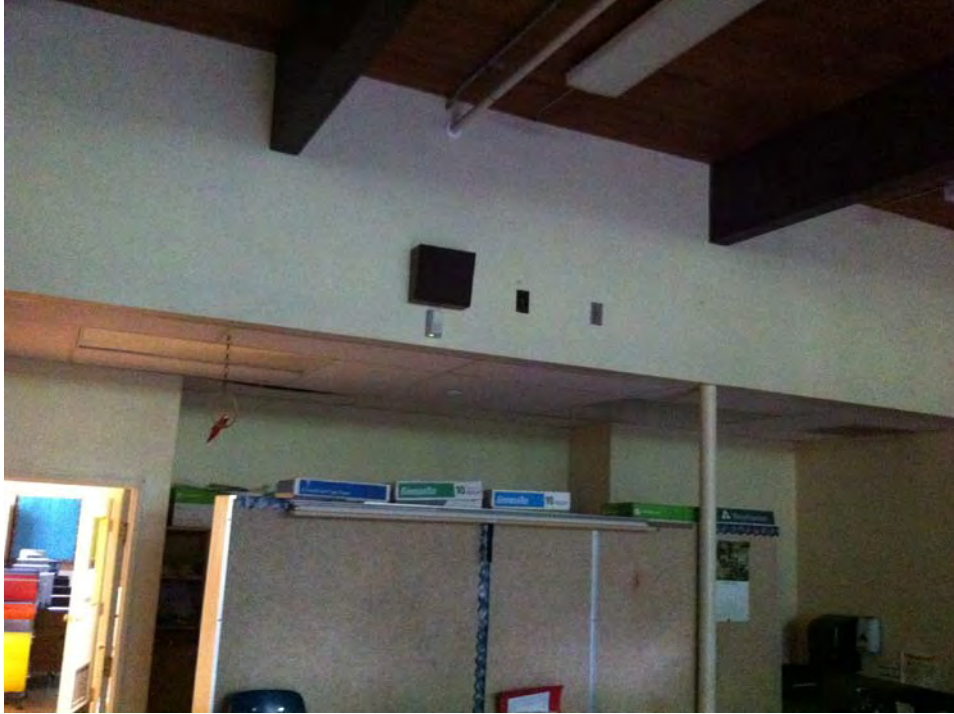
Interior view of classroom looking towards corridor showing supporting pipe column

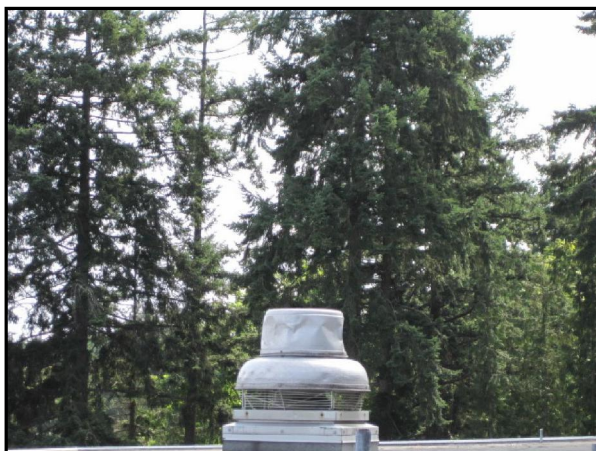
Exhaust System - General Building Renewal

Auto generated renewal for Exhaust System - General Building. System Description: The HVAC ventilation system includes rooftop exhaust fan.

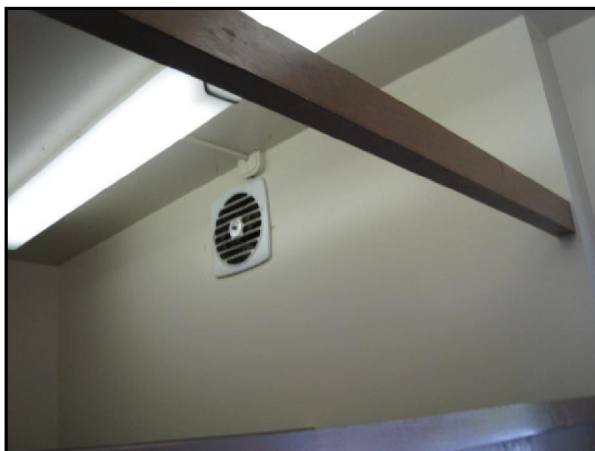
Exhaust System - Residential Type Renewal

Auto generated renewal for Exhaust System - Residential Type. System Description: HVAC ventilation system includes residential type exhaust fans located in the building.

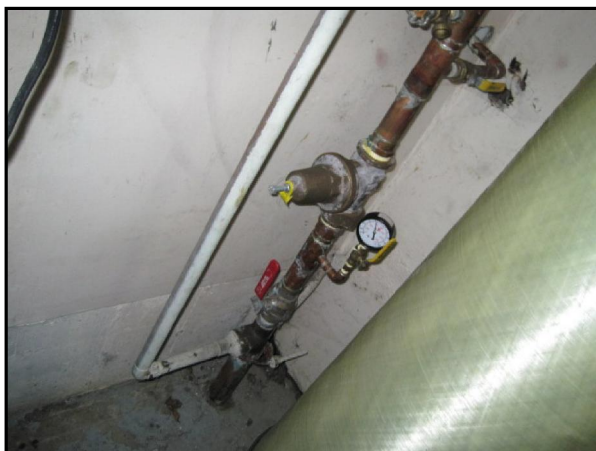
Water Dist Complete Renewal

Auto generated renewal for Water Dist Complete. System Description: The building domestic water system includes a main water supply line entering in the mechanical furnace room with associated distribution piping. Water is feed from a water well, located in the pump house (outside).

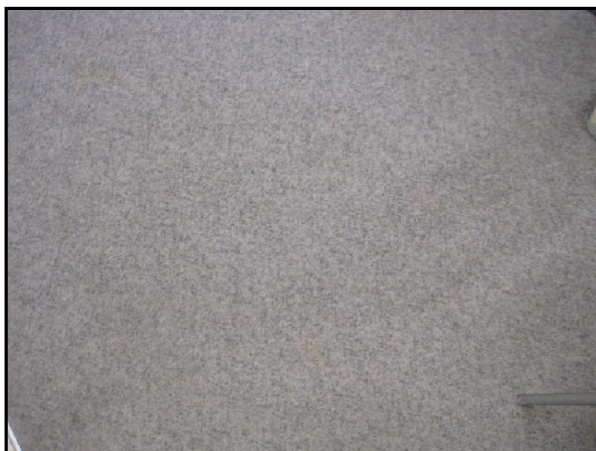
Carpeting - Broadloom Renewal

Auto generated renewal for Carpeting - Broadloom. System Description: Floor finishes include medium priced carpeting and base. System quantities are estimated for budgetary purposes only. Actual replacement quantities are subject to site verification by others.

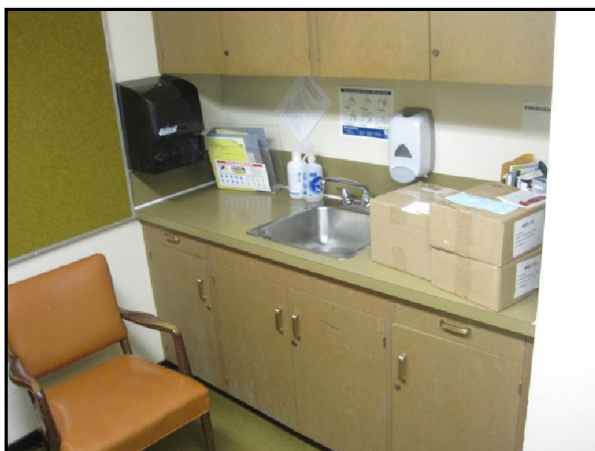
Casework - Elementary School Renewal

Auto generated renewal for Casework - Elementary School. System Description: The building includes typical classroom, library, kitchen, administration and office casework for an elementary school. System quantities are estimated for budgetary purposes only. Actual replacement quantities are subject to site verification by others.

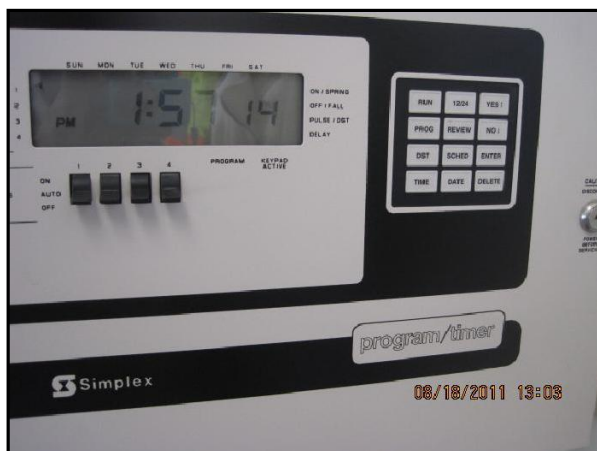
Clock System Renewal

Auto generated renewal for Clock System. System Description: The building has a Simplex clock system that includes master control station, clocks, wire, fittings. The system is aged beyond the BOMA life expectancy of 10 years and replacement should be planned.

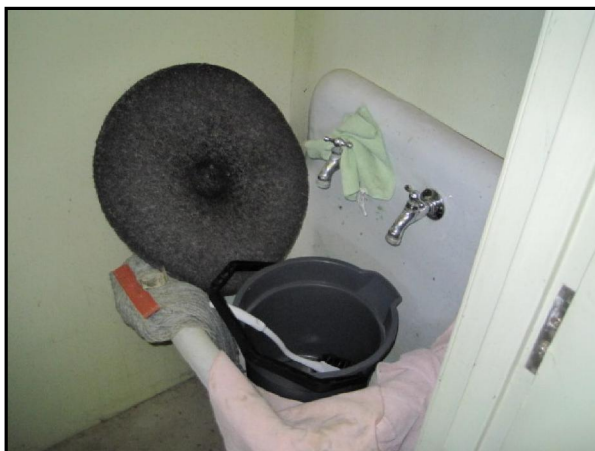
Custodial Sink Renewal

Auto generated renewal for Custodial Sink. System Description: The plumbing fixtures include wall hung custodial sink.

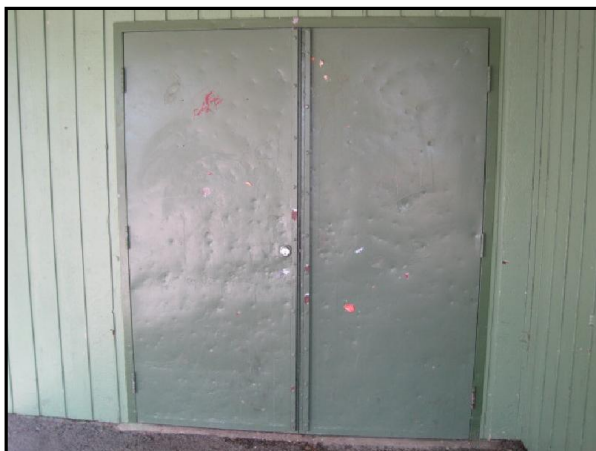
Door Assembly - Double Renewal

Auto generated renewal for Door Assembly - Double. System Description: Exterior doors include double-leaf doors and frames with standard hardware.

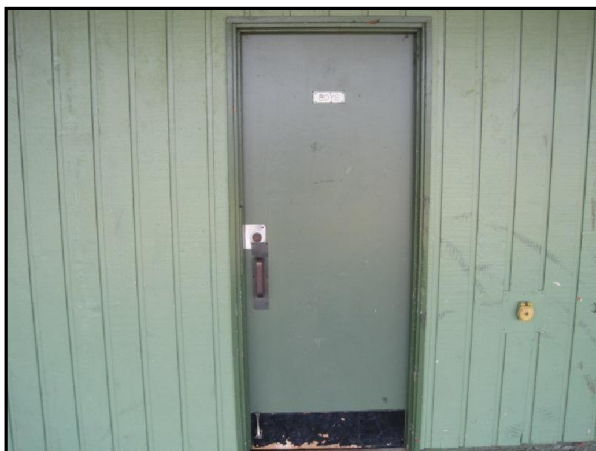
Door Assembly - Single Renewal

Auto generated renewal for Door Assembly - Single. System Description: Exterior doors include single-leaf door and frames with standard hardware.

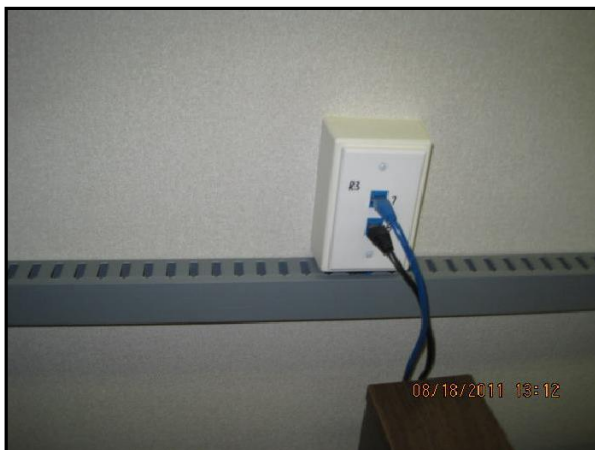
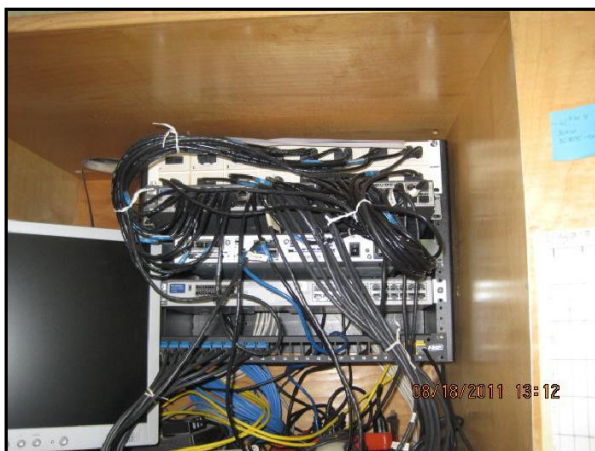
LAN System Renewal

The system is approaching the end of BOMA life expectancy of 15 years and replacement should be planned.

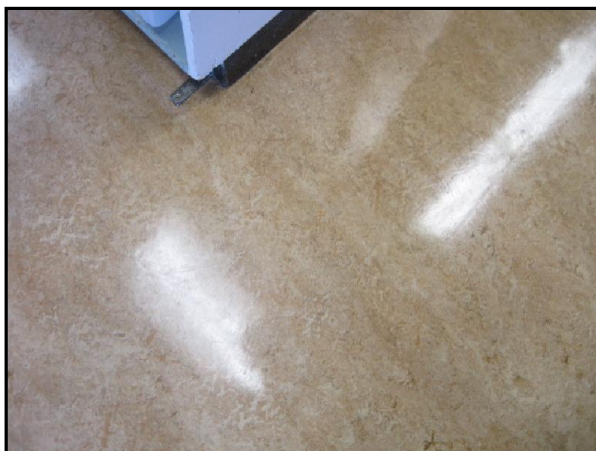
Linoleum Sheet Goods Renewal

Auto generated renewal for Linoleum Sheet Goods. System Description: Floor finishes include areas of linoleum and or marmoleum sheet goods flooring and related base. System quantities are estimated for budgetary purposes only. Actual replacement quantities are subject to site verification by others.

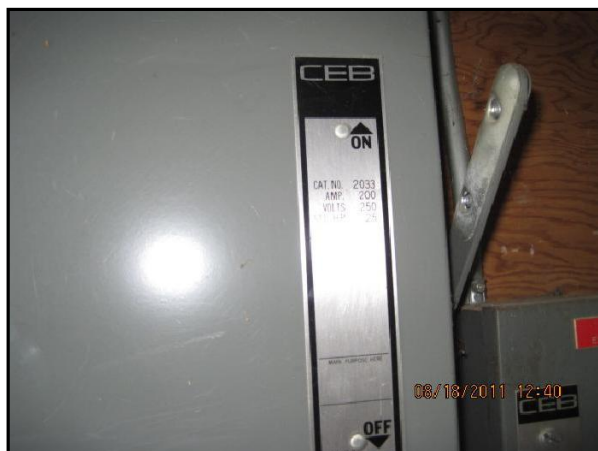
Main Electrical Service - 200A 120/240V Renewal

Auto generated renewal for Main Electrical Service - 200A 120/240V. System Description: The building includes a typical electrical service, which includes incoming feeders, 200A main disconnect, disconnects, CT section, and metering. The system is aged beyond the BOMA life expectancy of 30 years and replacement should be planned.

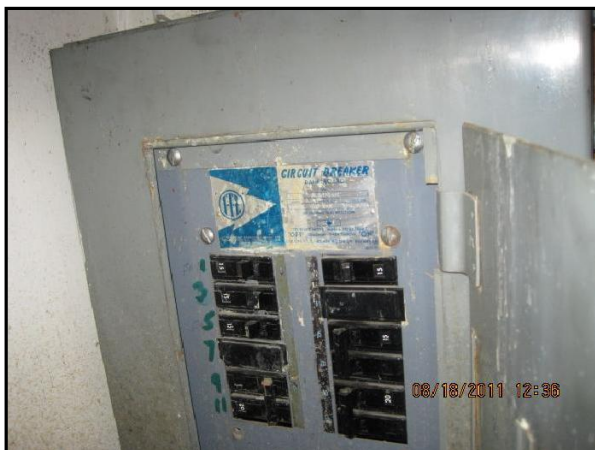
Panelboards, Feeders and Disconnects - 120/240V Renewal

Auto generated renewal for Panelboards, Feeders and Disconnects - 120/240V. System Description: The electrical distribution system includes 100 and 200 amp panelboards, disconnects and associated equipment. The system is aged beyond the BOMA life expectancy of 30 years and replacement should be planned.

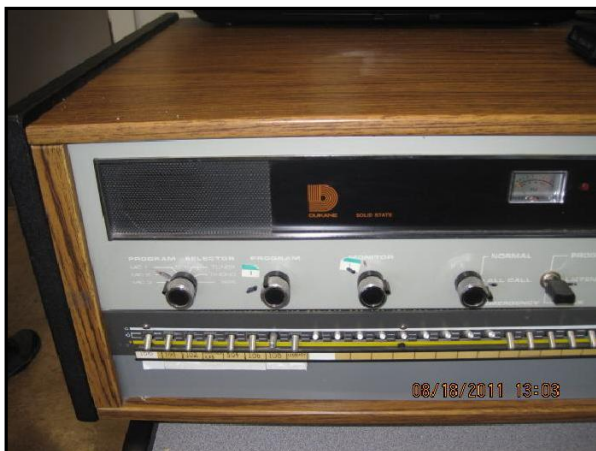
Public Address System Renewal

Auto generated renewal for Public Address System. System Description: The public address system includes a Dukane master console, speakers, conduit and shielded wiring. The system is aged beyond the BOMA life expectancy of 20 years and replacement should be planned.

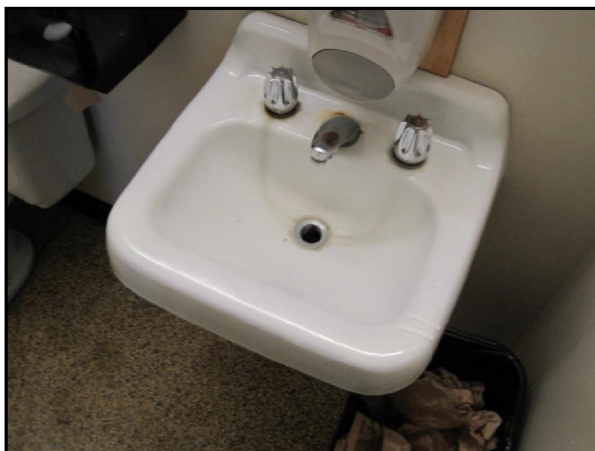
Restroom Fixtures - 1969 Renewal

Auto generated renewal for Restroom Fixtures - 1969. System Description: The restroom fixtures include vitreous china water closets and lavatories.

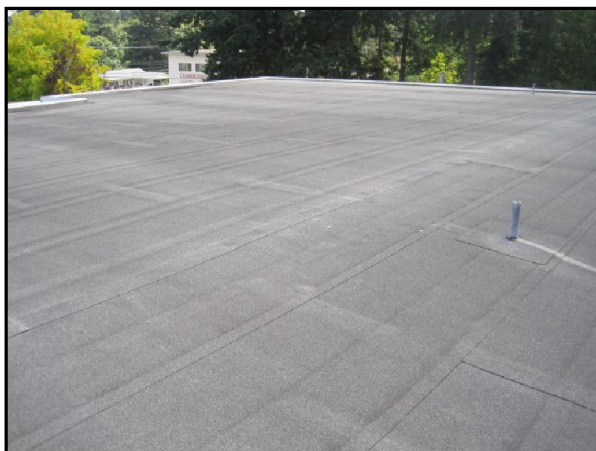
SBS Modified Bitumen Membrane Renewal

Auto generated renewal for SBS Modified Bitumen Membrane. System Description: The building's insulated roof is finished with an SBS Granulated Bitumen Membrane type. The cost estimate includes rigid insulation.

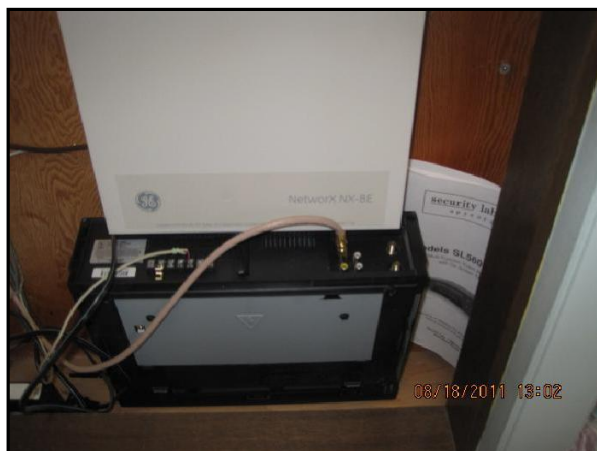
Security System Renewal

Auto generated renewal for Security System. System Description: The school is equipped with a security system which monitors access and unauthorized entry with keypads, motion detectors and alarm monitoring audible sound systems. The system includes Legend100 control panel. The system is aged beyond the BOMA life expectancy of 10 years and replacement should be planned.

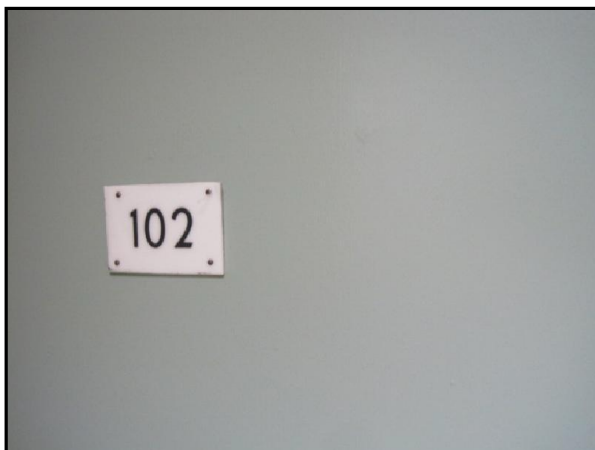
Signage (Room Numbering and Identification) Renewal

Auto generated renewal for Signage (Room Numbering and Identification). System Description: The building has way finding signage which typically includes door numbers, names and graphics. System quantities are estimated for budgetary purposes only. Actual replacement quantities are subject to site verification by others.

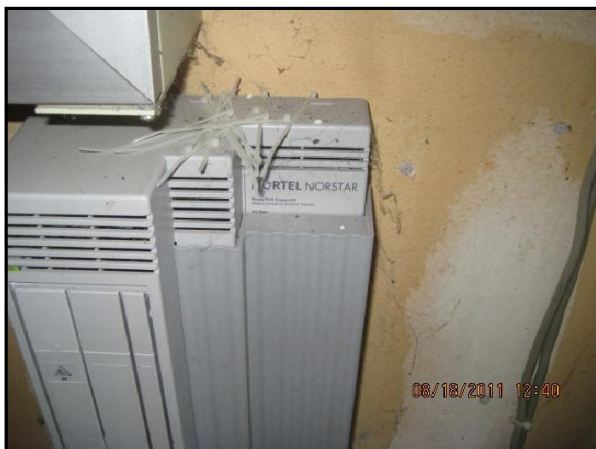
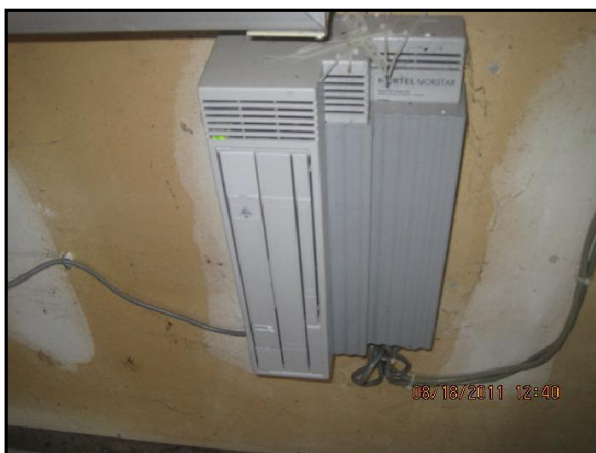
Telephone System Renewal

Auto generated renewal for Telephone System. System Description: The school has Nortel telephone system that includes cabling, RJ-11 Terminations and BX-panels. The system is aged beyond the BOMA life expectancy of 20 years and replacement should be planned.

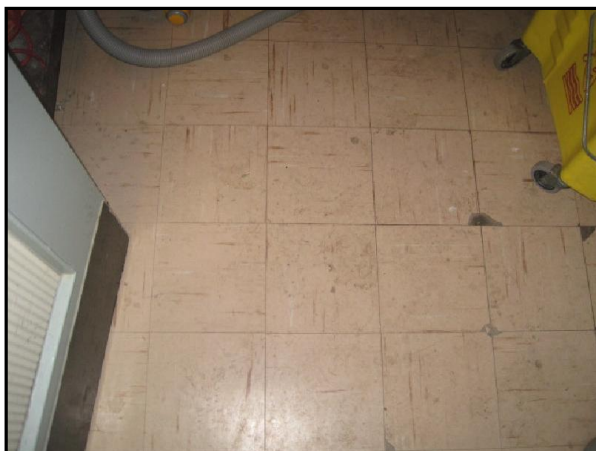
Vinyl Composite Tile Standard Renewal

Auto generated renewal for Vinyl Composite Tile Standard. System Description: Floor finishes include areas of standard VCT flooring and related base. System quantities are estimated for budgetary purposes only. Actual replacement quantities are subject to site verification by others.

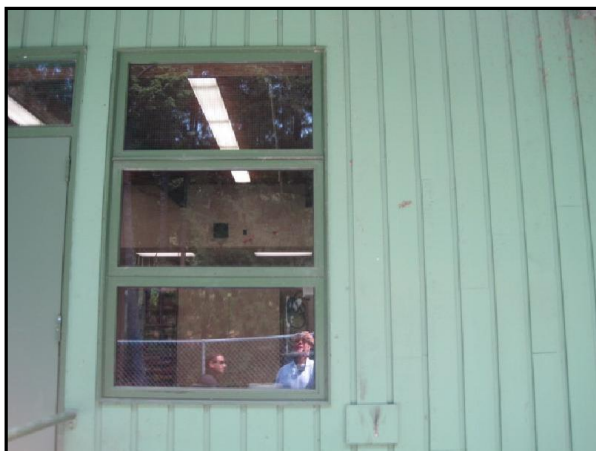
Windows - Metal Renewal

Auto generated renewal for Windows - Metal. System Description: The building includes metal framed exterior units with non-insulating glass. System quantities are estimated for budgetary purposes only. Actual replacement quantities are subject to site verification by others.

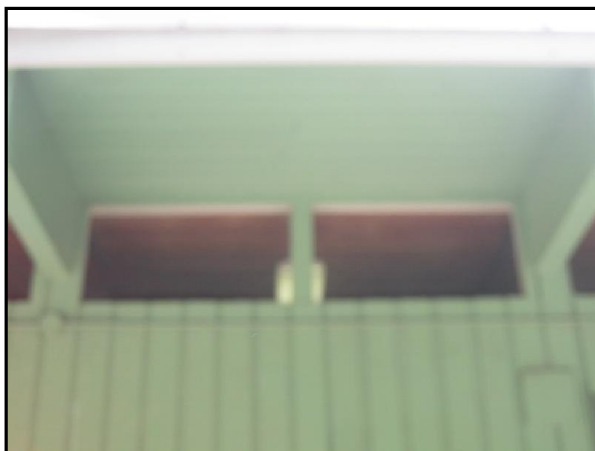
Windows - Wood Renewal

Auto generated renewal for Windows - Wood. System Description: The building includes wood framed exterior units with non-insulating glass. System quantities are estimated for budgetary purposes only. Actual replacement quantities are subject to site verification by others.

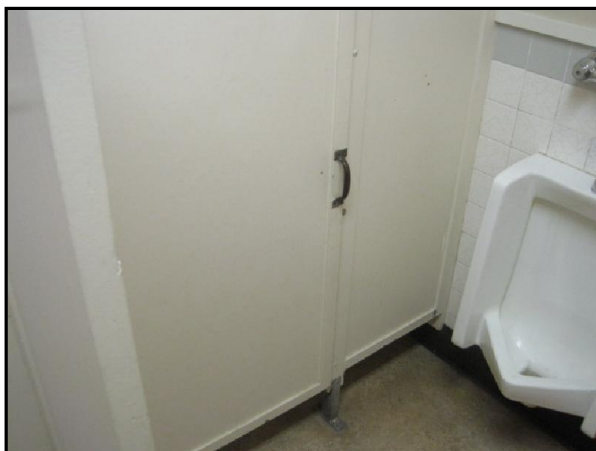
Wood Partitions Washrooms Renewal

Auto generated renewal for Wood Partitions Washrooms. System Description: The washrooms are equipped with floor mounted painted wood toilet partitions.

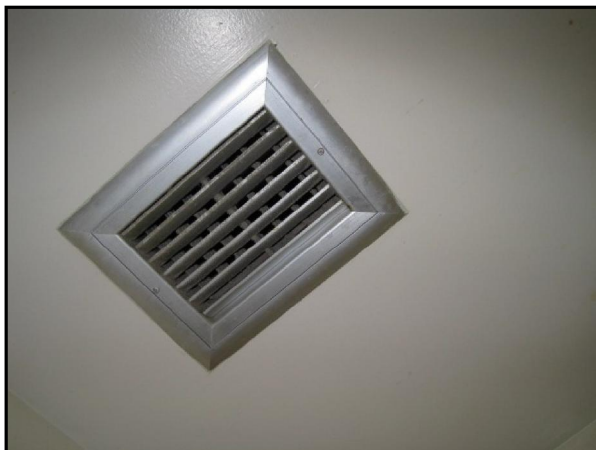
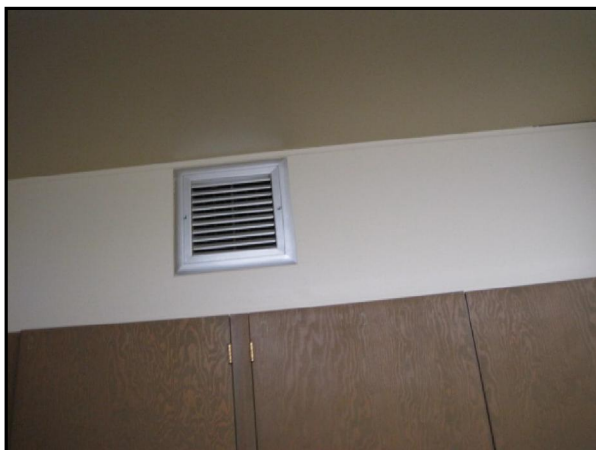
Distribution Systems - HVAC Ductwork Dirty

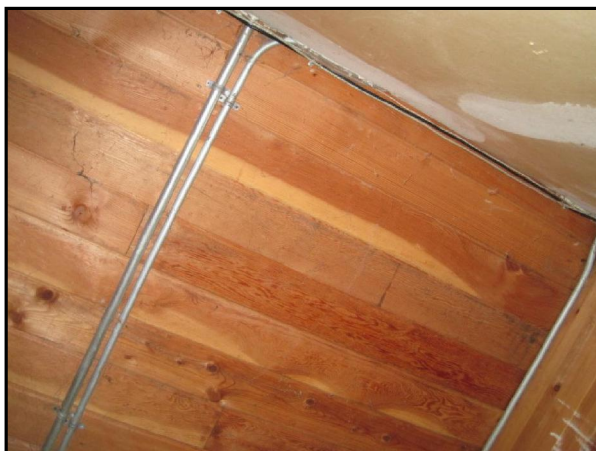
The electrical room does not have any exhaust ventilation system installed. Installation of one would improve work place safety and indoor air quality.

Distribution Systems - Ventilation System Not Installed

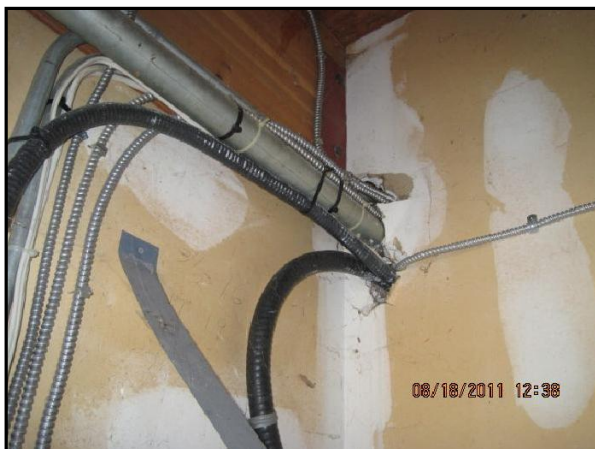
The electrical conduits in electrical room 1319 do not have fire stopping installed as required by BCBC 2006 Section 3.1.9.1.

Electrical Conduits - Fire Stopping Not Installed

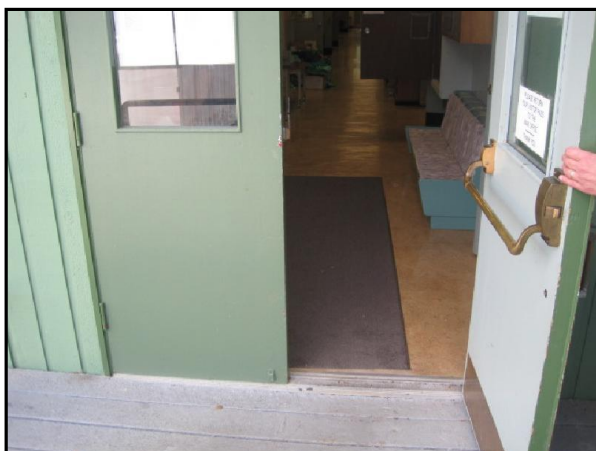
The entrance doors do not have automatic door openers installed in accordance with BC Building Code Article 3.8.2.17.

Exterior Doors - Automatic Door Openers Lacking at Entry

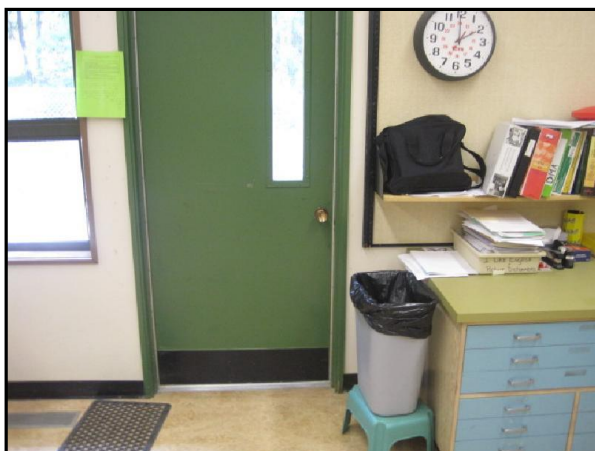
The knob door hardware in the facility does not conform to the requirements of the 2006 British Columbia Building Code section 3.3.1.13.10)c) as the door handles require tight grasping or twisting of the wrist to operate.

Interior Doors - Hardware Not Accessible

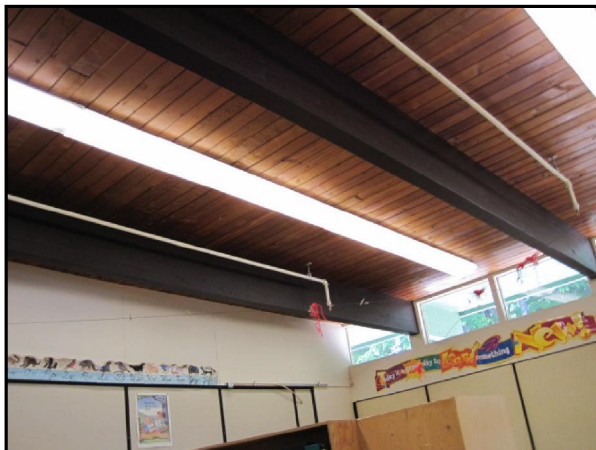
The sprinkler piping in the classrooms is not seismically restrained to prevent falling. When rated per National Standard of Canada - CAN/CSA - S832-06 entitled "Seismic Risk Reduction of Operational and Functional Components of Building", these sprinkler piping had a risk index score of 20.4000.

Fire Protection - Sprinkler Piping - No Seismic Restraint

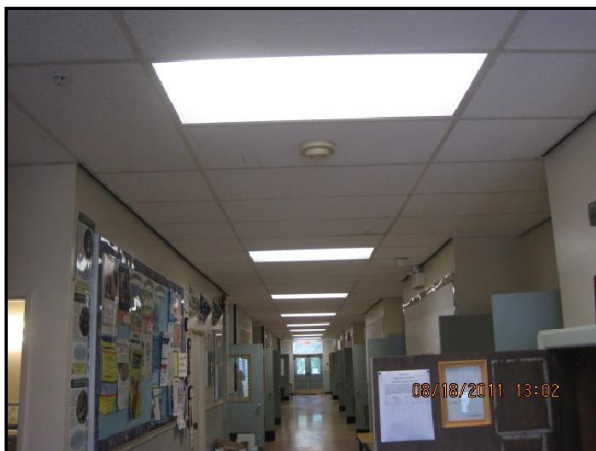
Light fixtures, especially recessed type, in the corridors are not seismically secured.

Non-Seismic Luminaire - Corridors

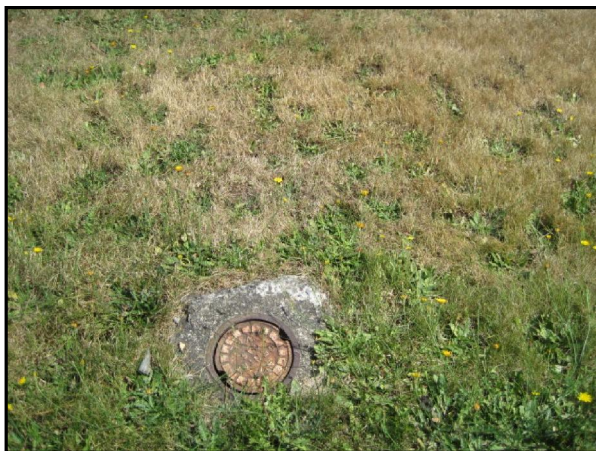
Auto generated renewal for Underground Oil Tank - Steel. System Description: An underground oil storage tank is located on the property line.

Underground Oil Tank - Steel Renewal

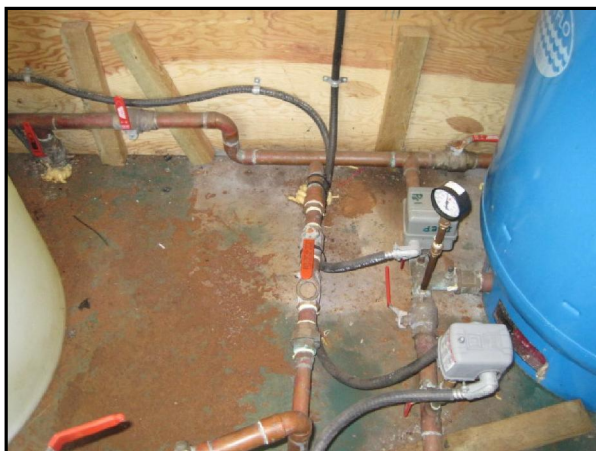
Auto generated renewal for Water Supply Piping. System Description: The site includes main water supply line with associated valves and distribution piping. The water is feed from the water well, located in the pump house.

Water Supply Piping Renewal

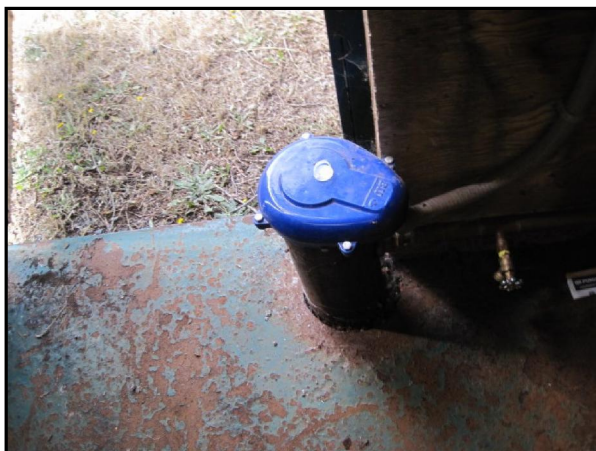
Auto generated renewal for Water Well. System Description: System includes water well located in the pump house that supplies domestic water to the facility.

Water Well Renewal
