REGIONAL DISTRICT OF NANAIMO

Water Service Area Annual Report 2014

San Pareil Water Service Area

June 2015

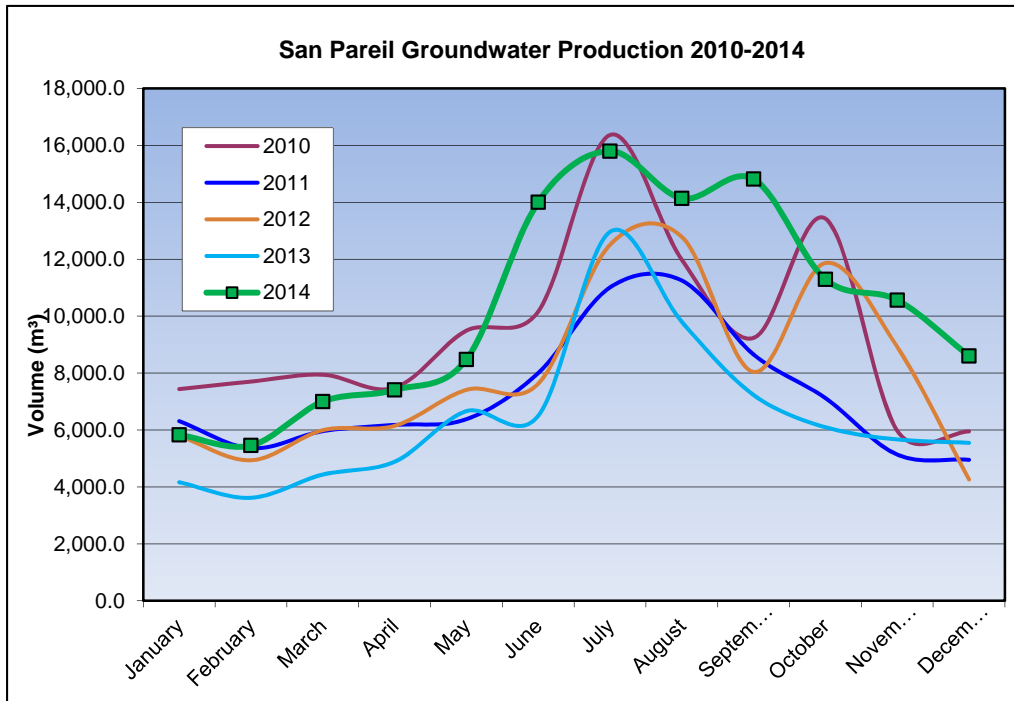
The monthly groundwater production for San Pareil for the past 5 years is shown in the chart below. Groundwater production in 2014 was typically higher than previous years. This is due to hydrant flow testing, and reservoir cleaning and commissioning.

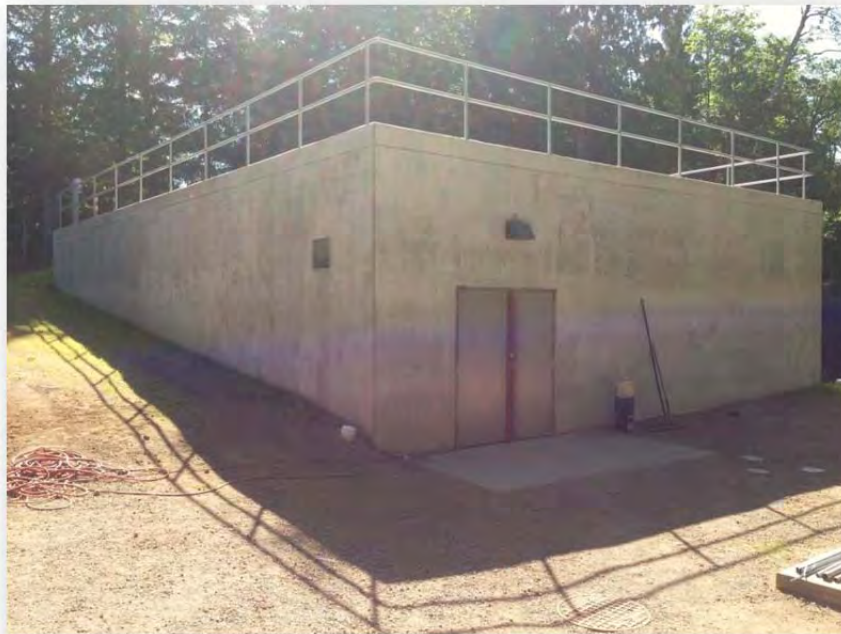
San Pareil
Reservoir #2
June 2014

- Constructed a new (second) reservoir and pump station facility;
- Installed an in-line turbidity meter with alarm notification;
- Updated the Standard Operating Procedures;

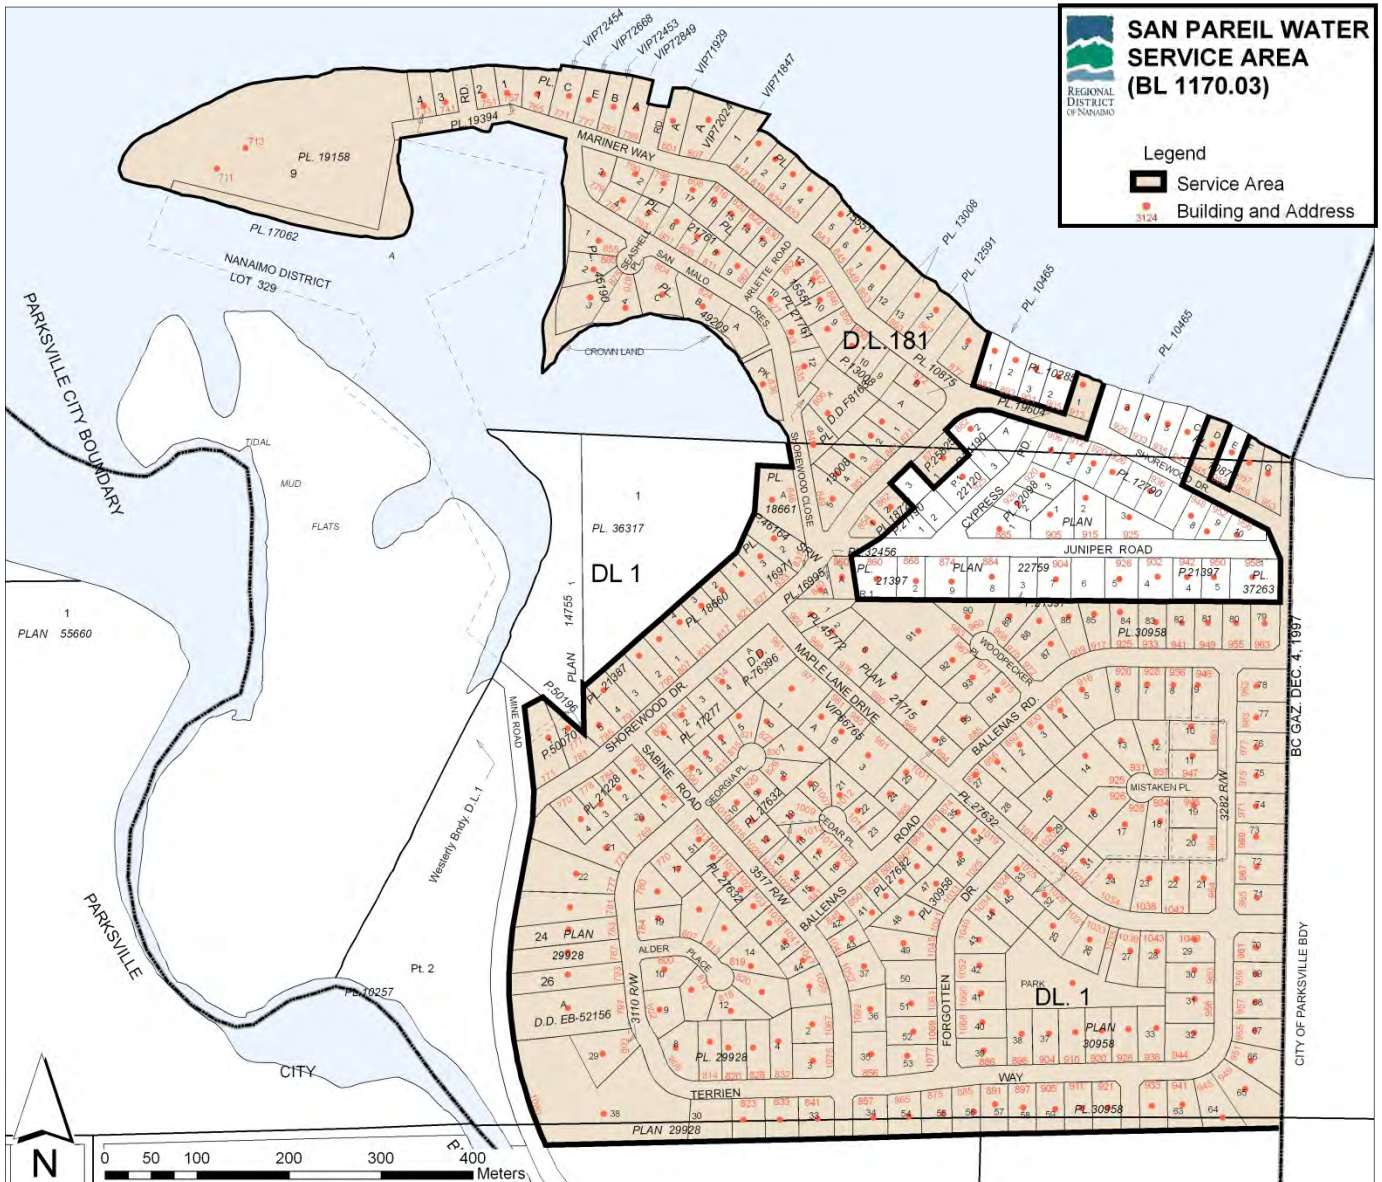
SAN PAREIL WATER SERVICE AREA

**MAP OF SAN PAREIL
WATER SERVICE AREA**

The San Pareil Water Service Area was established in 1999 when the RDN acquired the existing Bubbling Springs Water Utility. This system is located to the northeast of the Englishman River bridge on the east side of the City of Parksville. There are 280 water service connections in San Pareil. The water source for the San Pareil Water Service Area comes from a series of groundwater wells located in the well field on Plummer Road. The well water is chlorinated and stored in one reservoir. A map of the San Pareil Water System is provided in Appendix A.

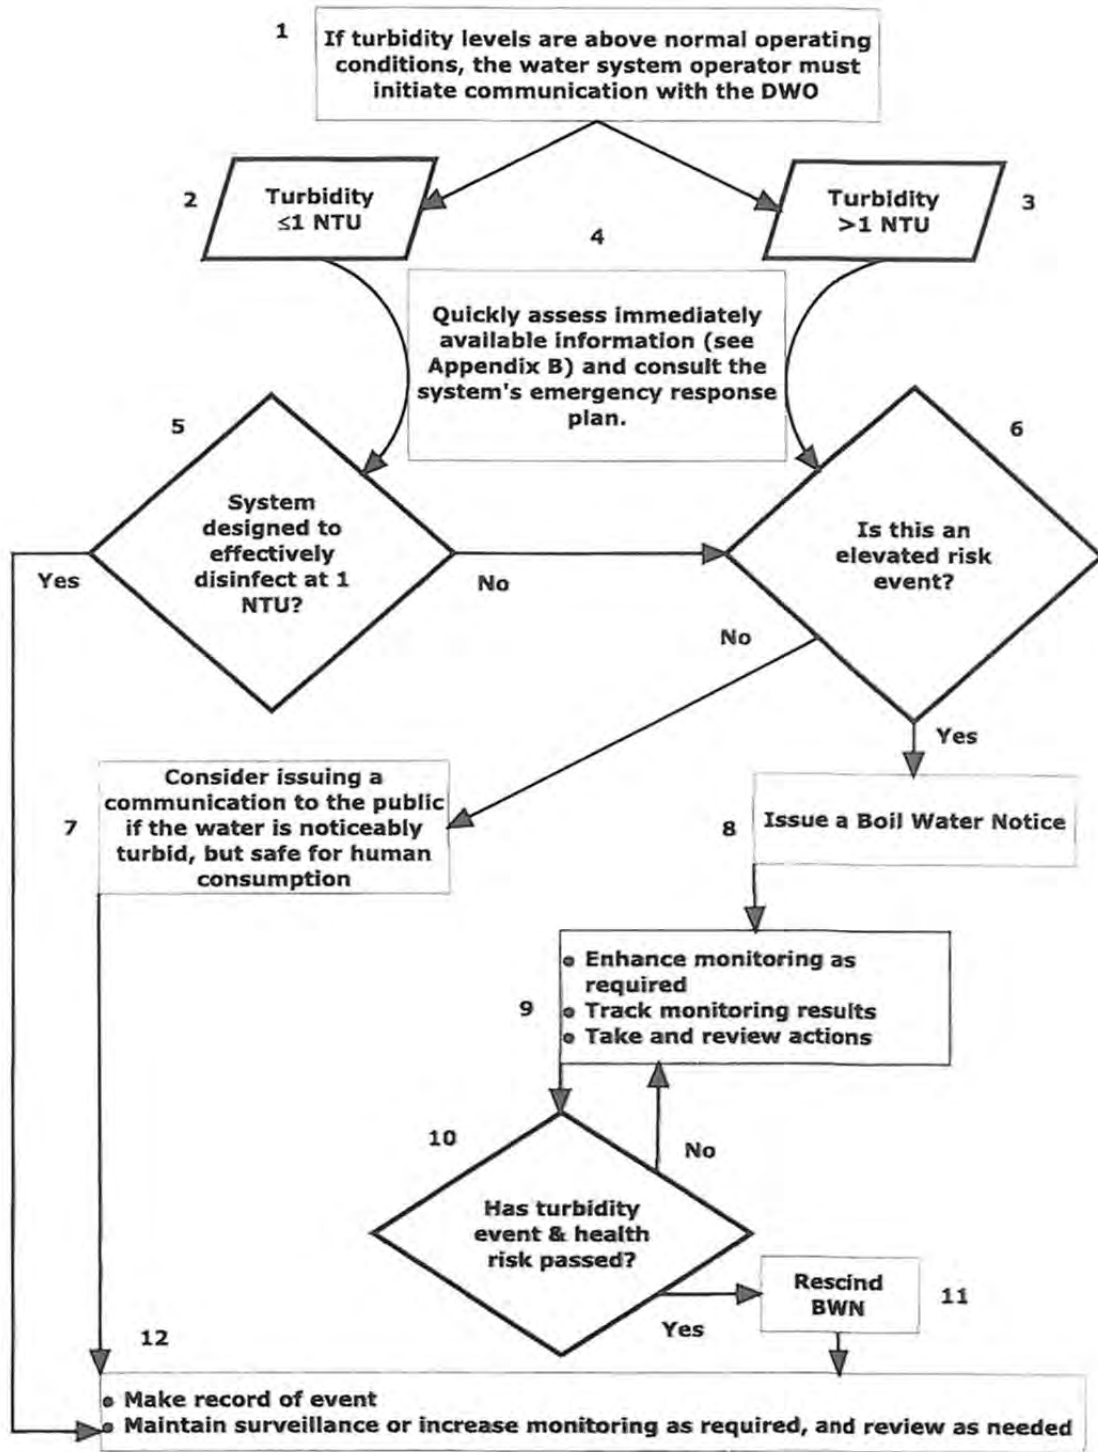
Decision Tree for Responding to a Turbidity Event in Unfiltered Drinking Water
