HAZARDOUS MATERIALS SURVEY REPORT

585 North Road

Gabriola Island

Regional District of Nanaimo

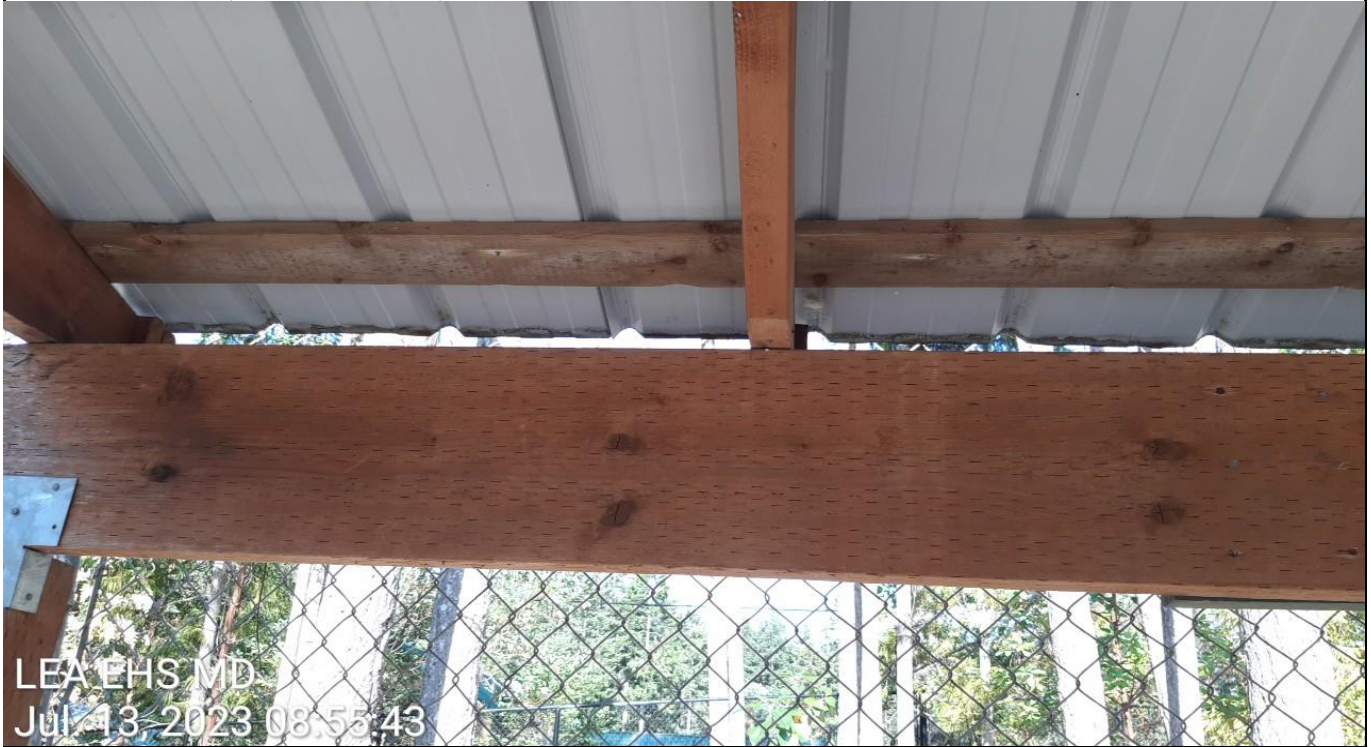
5.3 Arsenic-Containing Materials: Arsenic-containing or CCA treated lumber was observed on the site.

Figure 1. Pressure Treated Lumber on Exterior Posts/Framing

6.1 Arsenic-Containing Materials: Pressure-treated lumber containing arsenic should be removed intact and separated from general waste for proper disposal. Dry stripping of paints or coatings containing arsenic should be avoided. If undertaken, an Exposure Control Plan and related Safe Work Procedures will be required for these activities. (Occupational safety hazard assuming no dry stripping – Low)

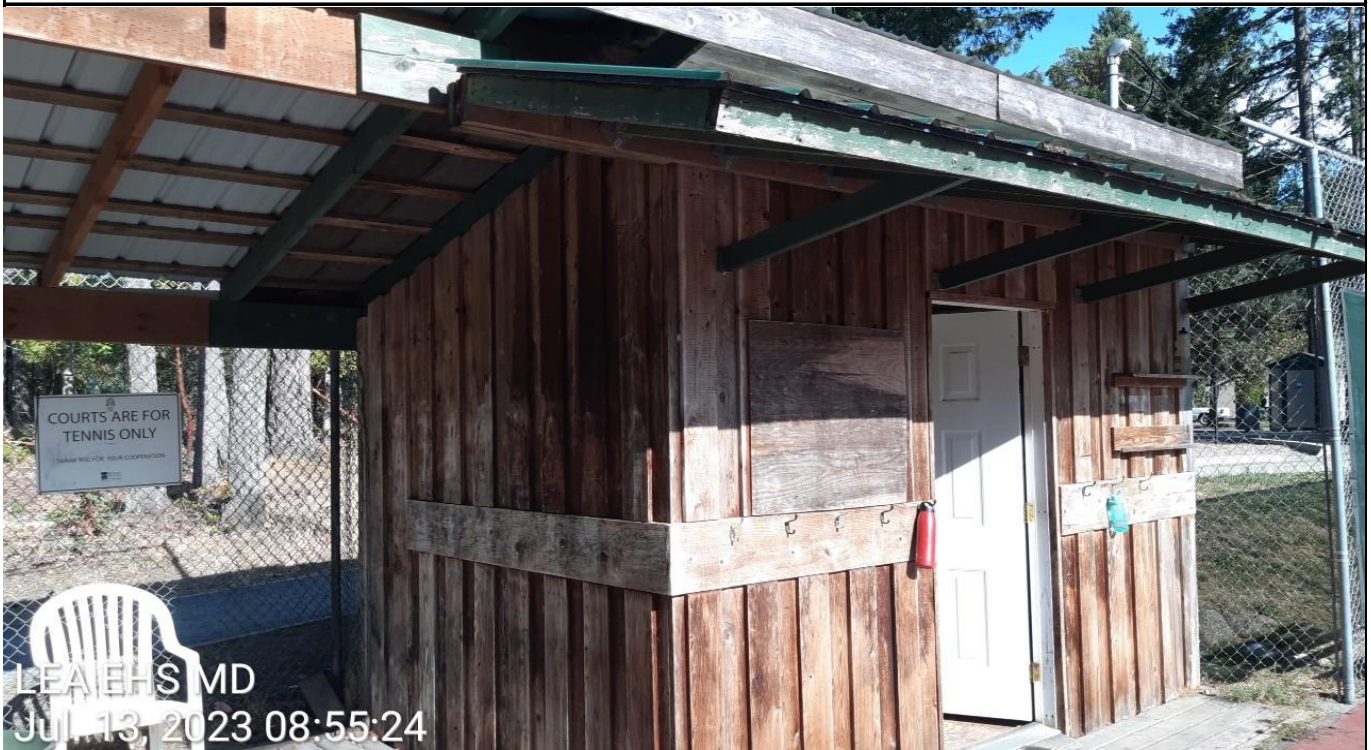
Figure 2. Exterior of Building Showing Wood Siding and Sheet Metal Roofing
