# REGIONAL DISTRICT OF NANAIMO

## Water Service Area Annual Report 2020

### Rollo McClay Community Park Water System

June 2021

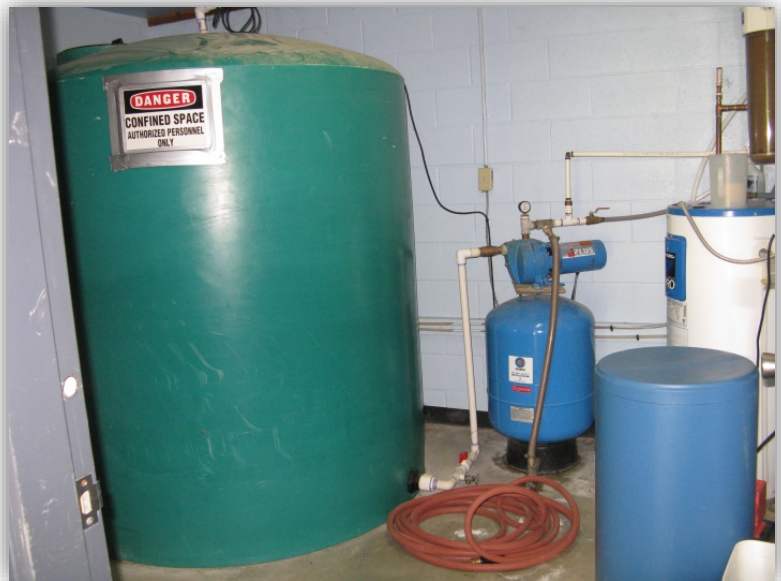
Rollo McClay  
Water  
Cistern

One polyethylene cistern is located inside the concession stand building. The cistern has a capacity of 5.5 m<sup>3</sup> (1,200 imperial gallons).

Chlorine residuals are taken and recorded 2-3 times weekly by the local water system operator on Gabriola Island while the concession building is open (summer months only). The water storage cistern is drained for the winter season, and cleaned/disinfected every Spring before being filled.

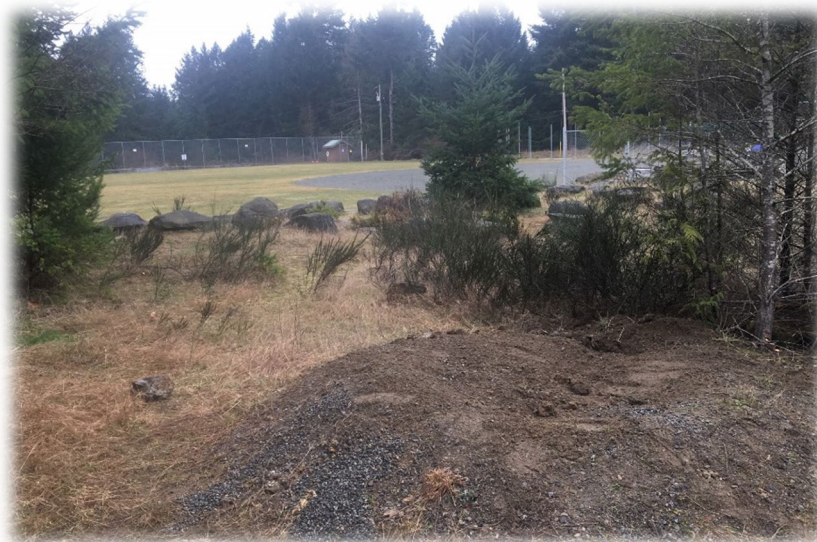
**Rollo McClay  
Wellhead  
Decommissioned**

The Rollo McClay Community Park well was not used for several years due to poor water quality, and was subsequently decommissioned (filled-in) by a certified well driller in 2019.

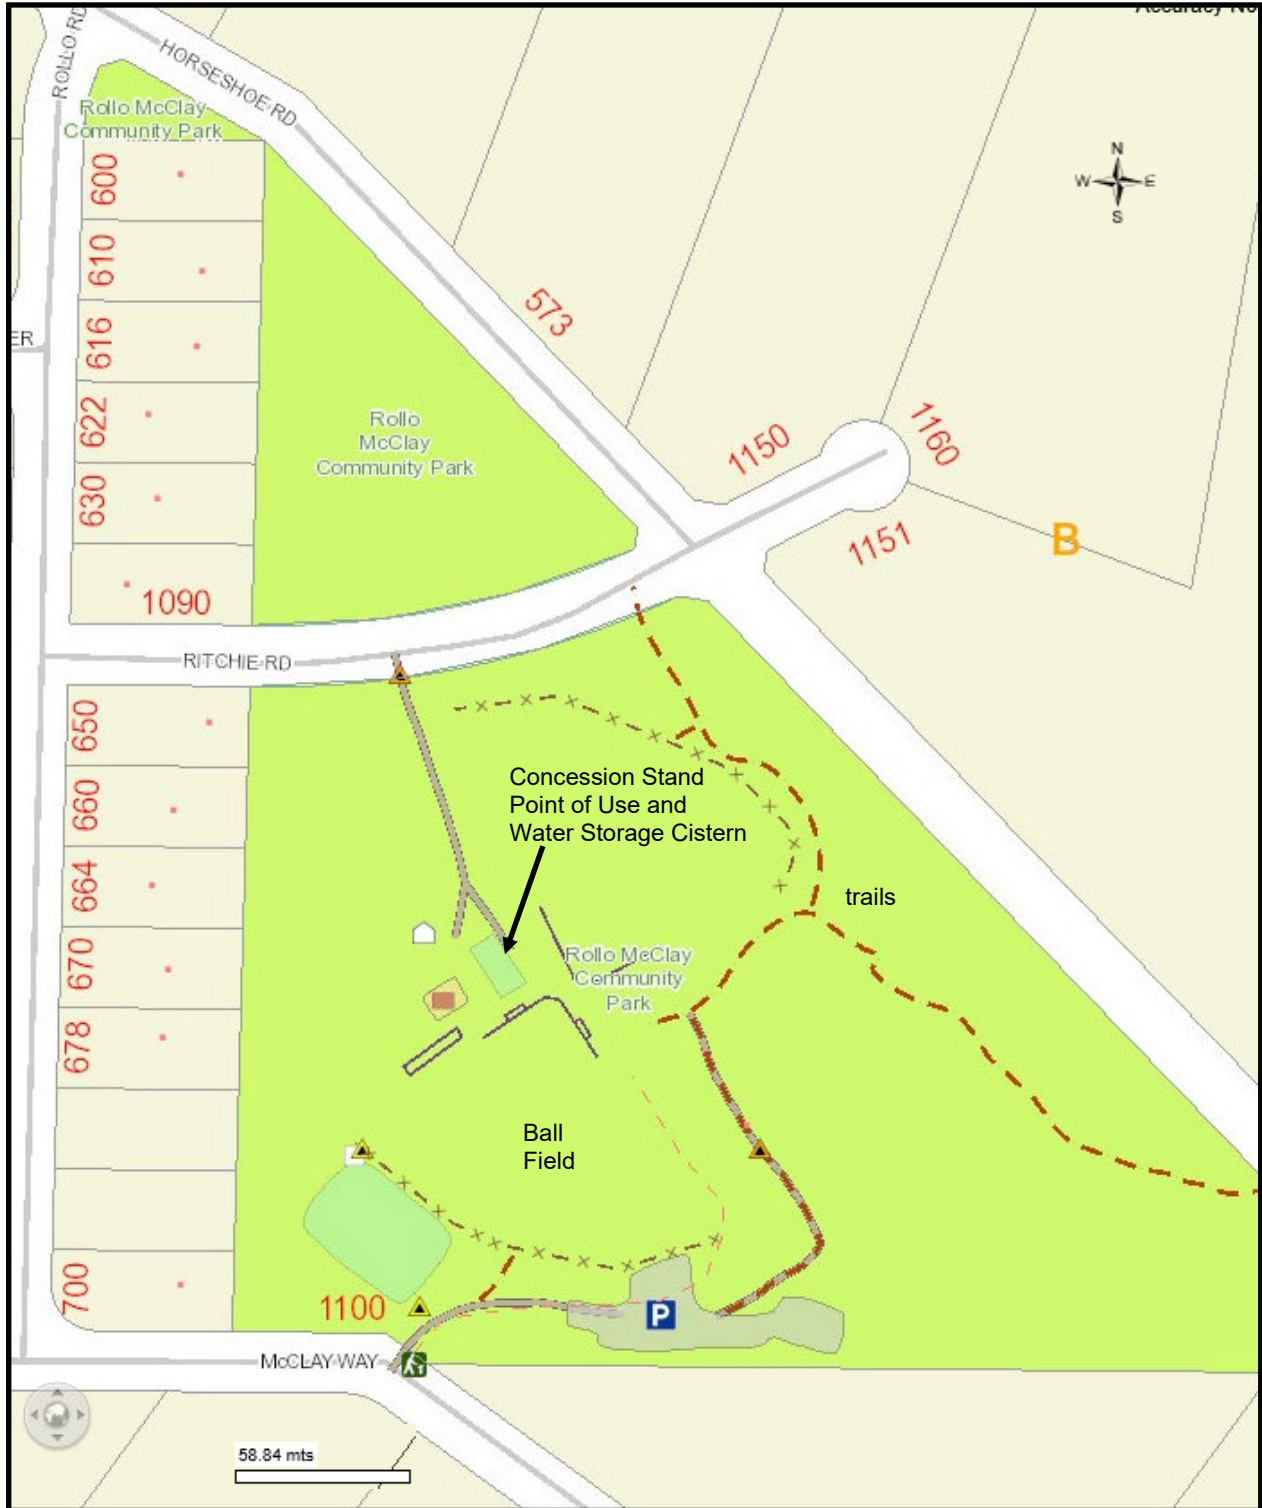
APPENDIX A

MAP OF ROLLO McCLAY COMMUNITY PARK WATER SYSTEM
