REGIONAL DISTRICT OF NANAIMO

Water Service Area Annual Report 2013

San Pareil Water Service Area

June 2014

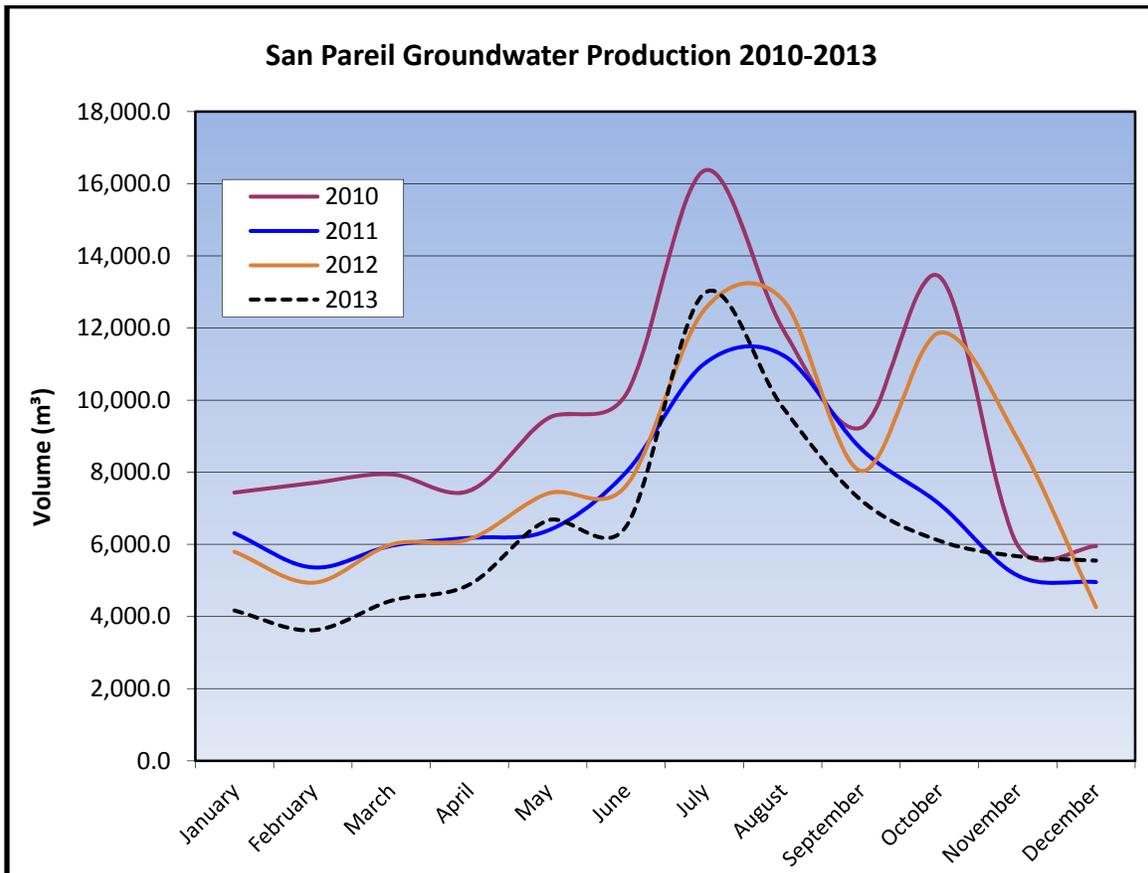
The monthly groundwater production for San Pareil for the past 4 years is shown in the chart below. Groundwater production in 2013 was typically lower than previous years.
