# REGIONAL DISTRICT OF NANAIMO

## Water Service Area Annual Report 2014

### Melrose Terrace Water System

June 2015

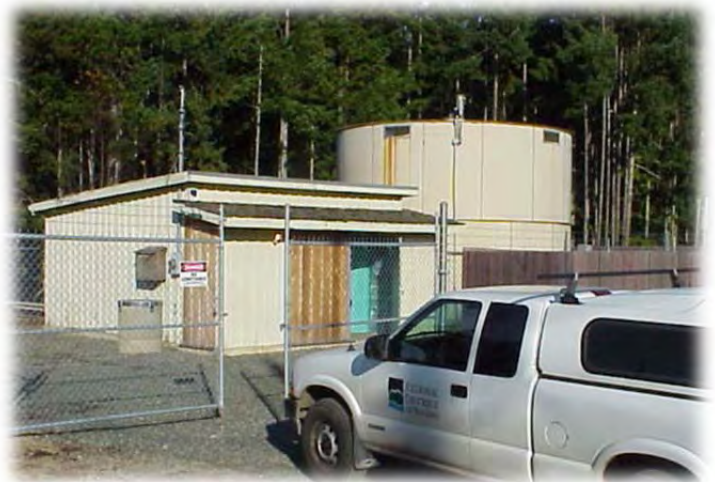
One service reservoir (steel structure) is present at 3853 Melrose Road, and has a capacity of 136 m<sup>3</sup> (30,000 imperial gallons).

**Melrose Pumphouse and Reservoir**

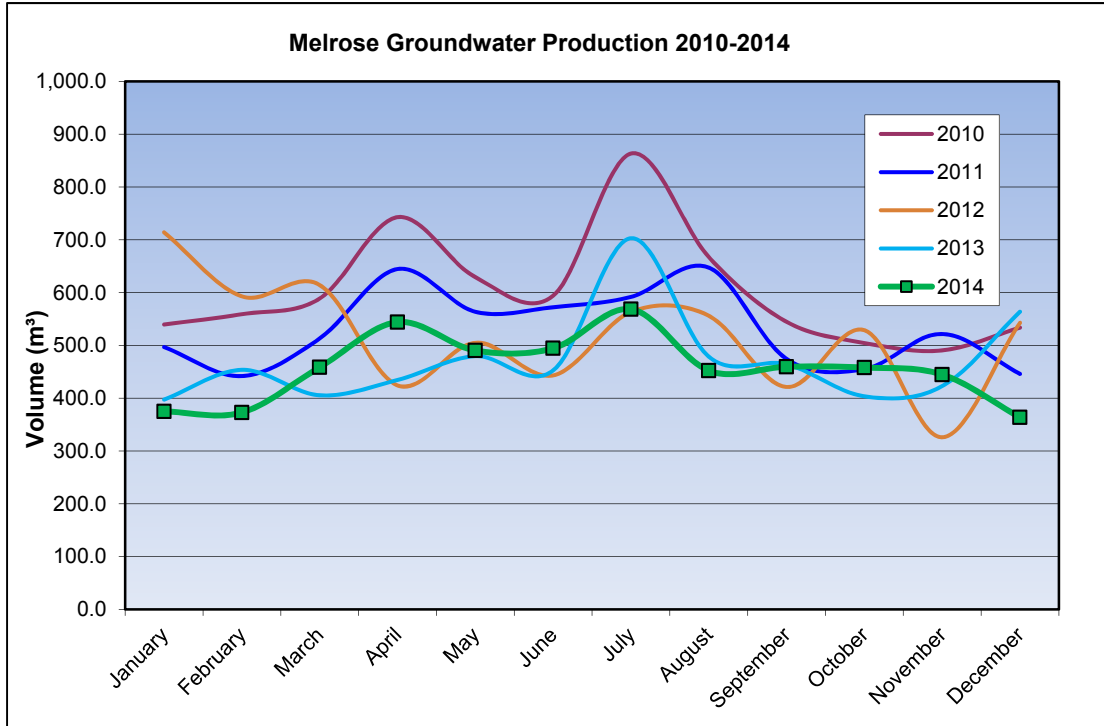
The monthly groundwater production in the Melrose system for the past 5 years is shown in the chart below. Groundwater production in 2014 was lower than previous years.

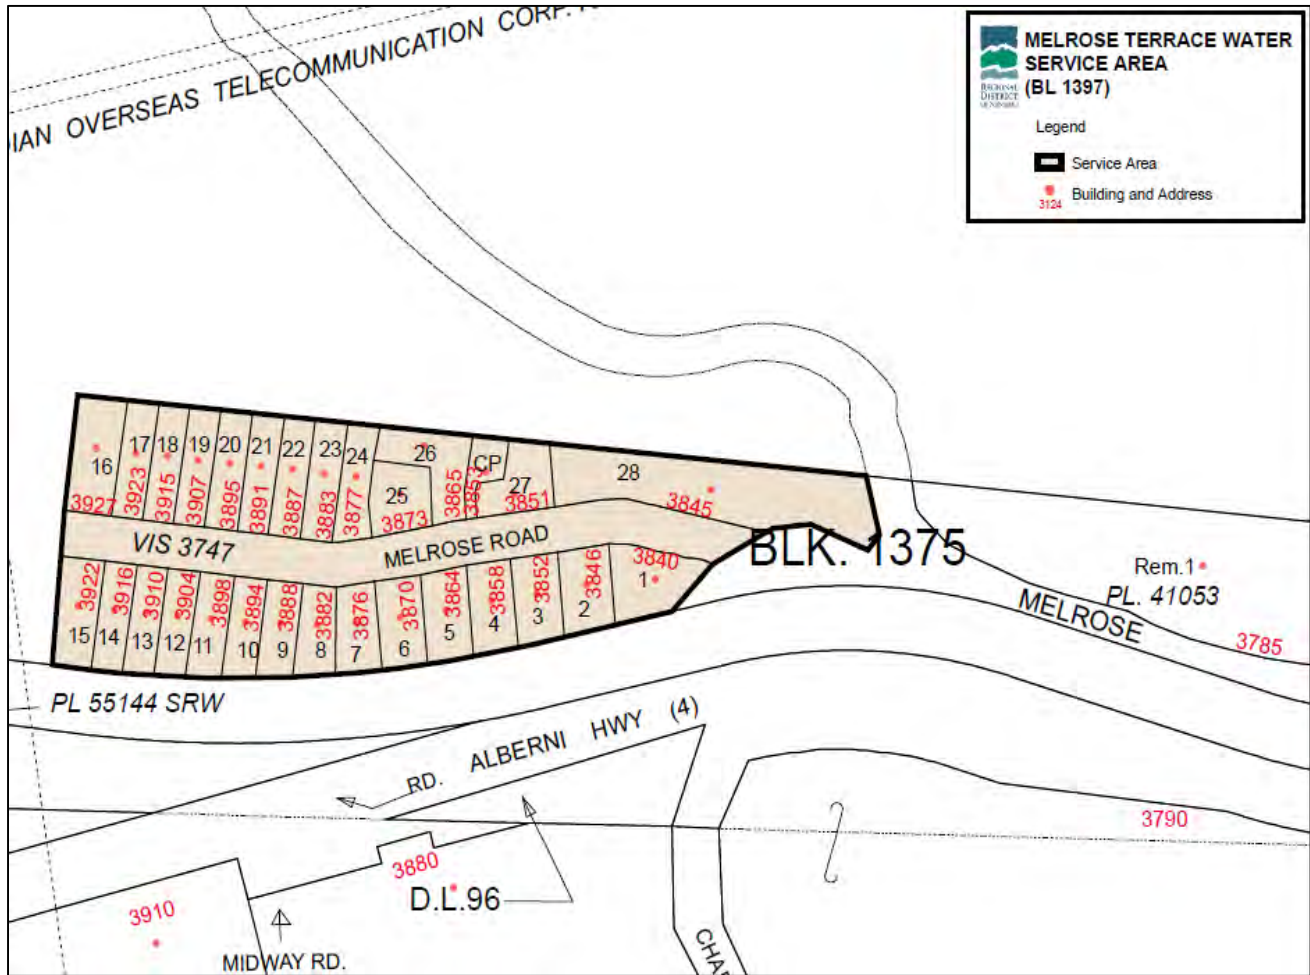
**MAP OF MELROSE  
WATER SERVICE AREA**

MELROSE  
WATER SERVICE AREA

The Melrose Water Service Area was established in April 2005 when the RDN acquired the existing Melrose Terrace Strata Plan VIS3747 water system. The water service area is comprised of 28 residential properties on Melrose Road located near the Alberni Highway southwest of Coombs. The water source for the Melrose Water Service Area comes from one groundwater well located nearby. The water is chlorinated and stored in a single reservoir. The water is then filtered through sand and charcoal filters before entering the distribution system. A portable generator is available in the event of a power outage. A map of the Melrose Water Service Area is provided in Appendix A for reference.

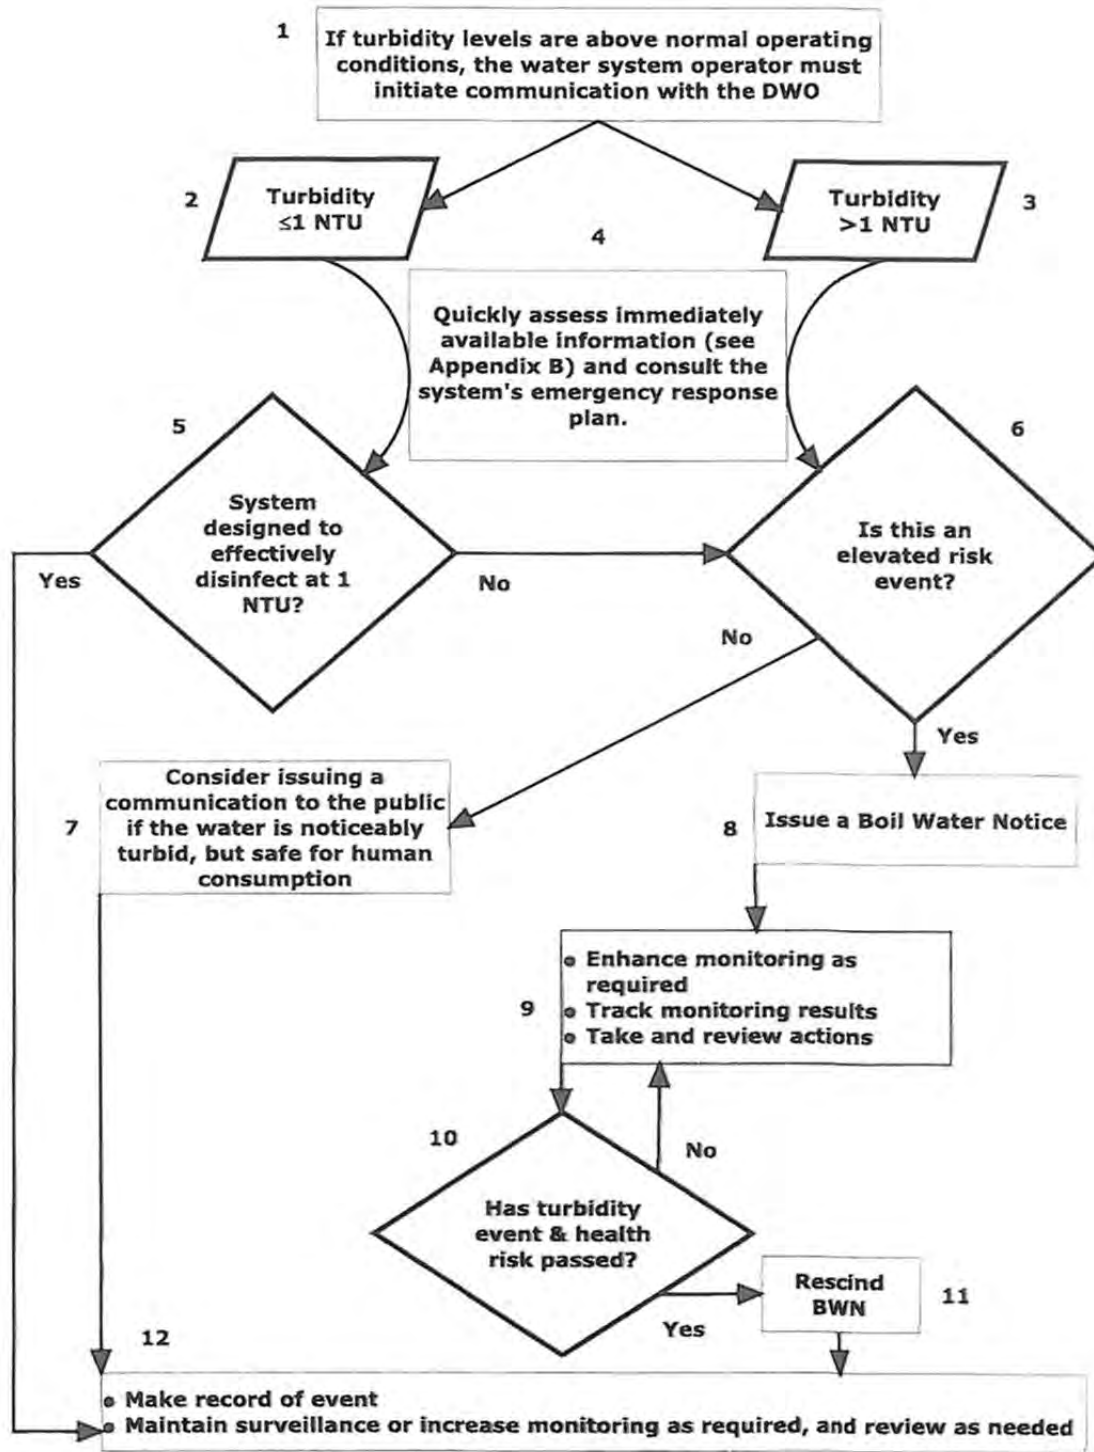
Decision Tree for Responding to a Turbidity Event in Unfiltered Drinking Water
