## General Exterior Reference Photos

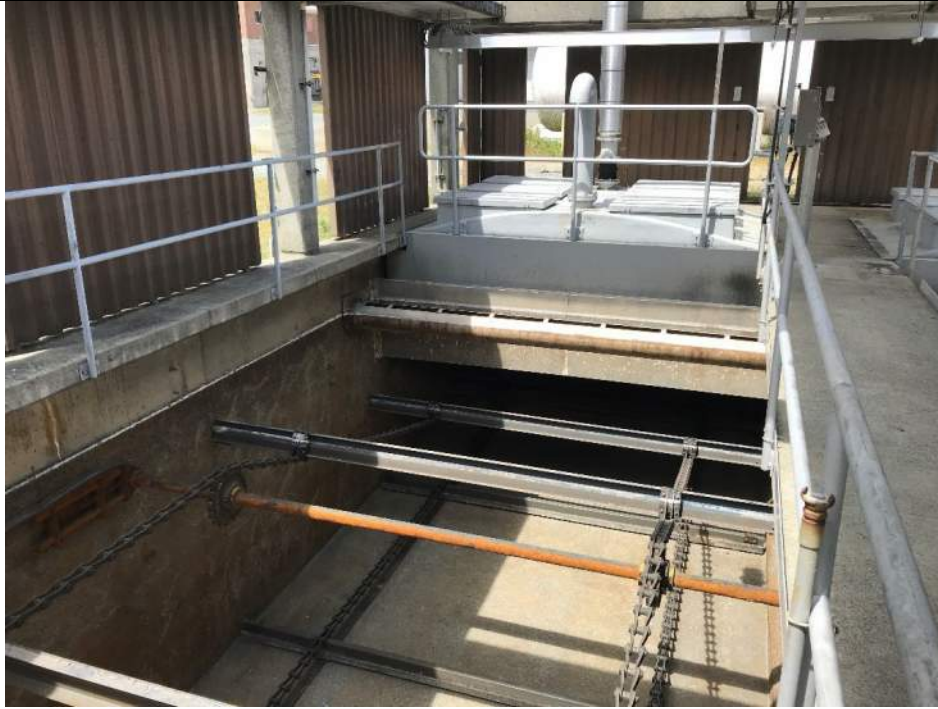
5. West bay scum skimmer and effluent discharge odour collection hood, looking north.

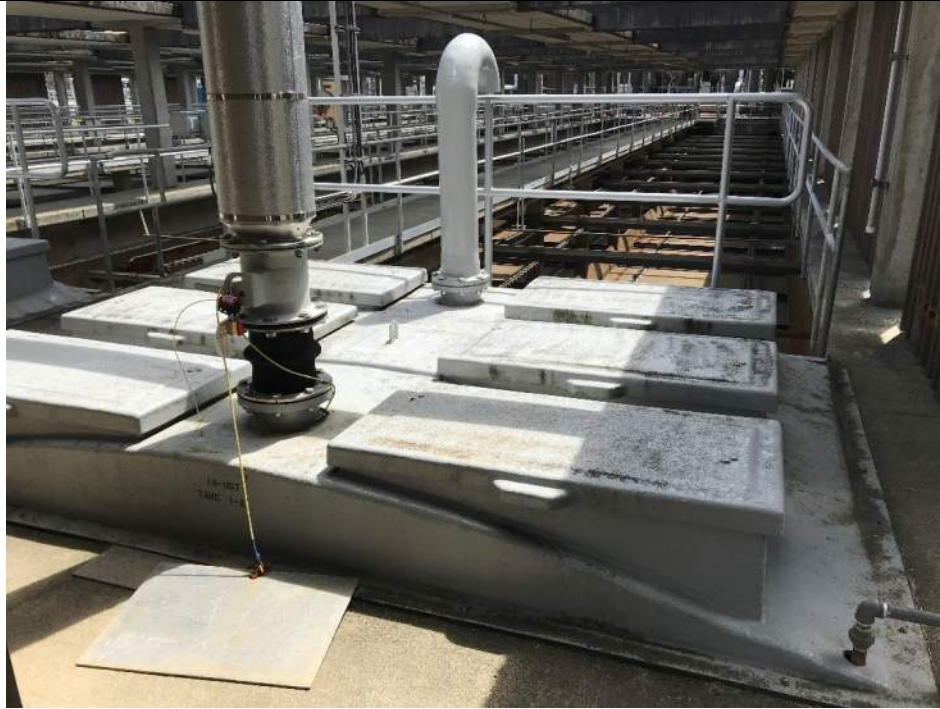
7. West bay effluent discharge odour collection hood, looking south.

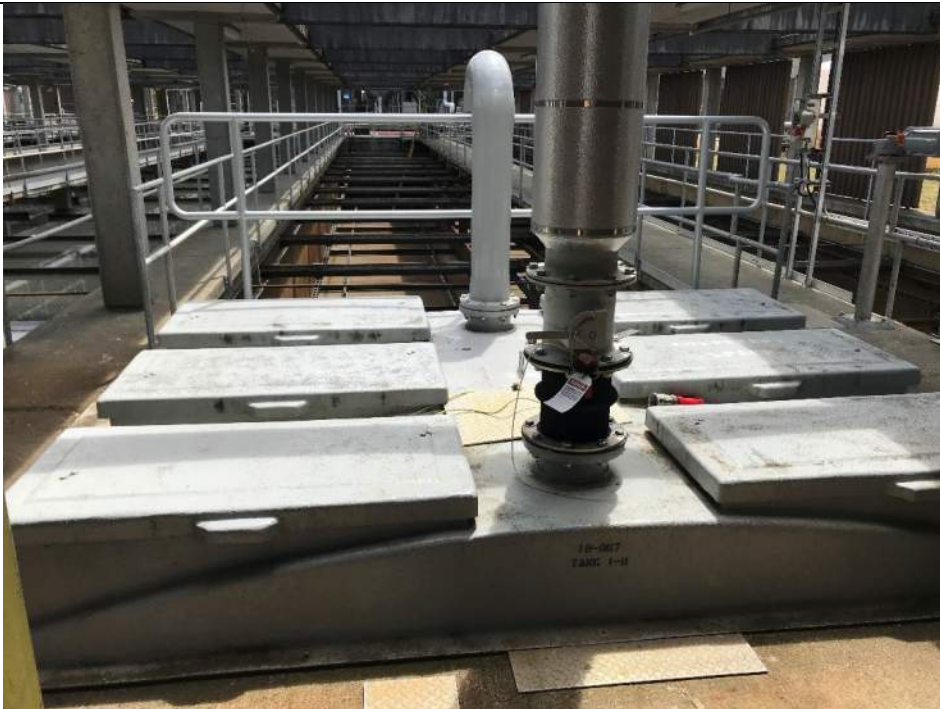
8. East bay effluent discharge odour collection hood, looking south.

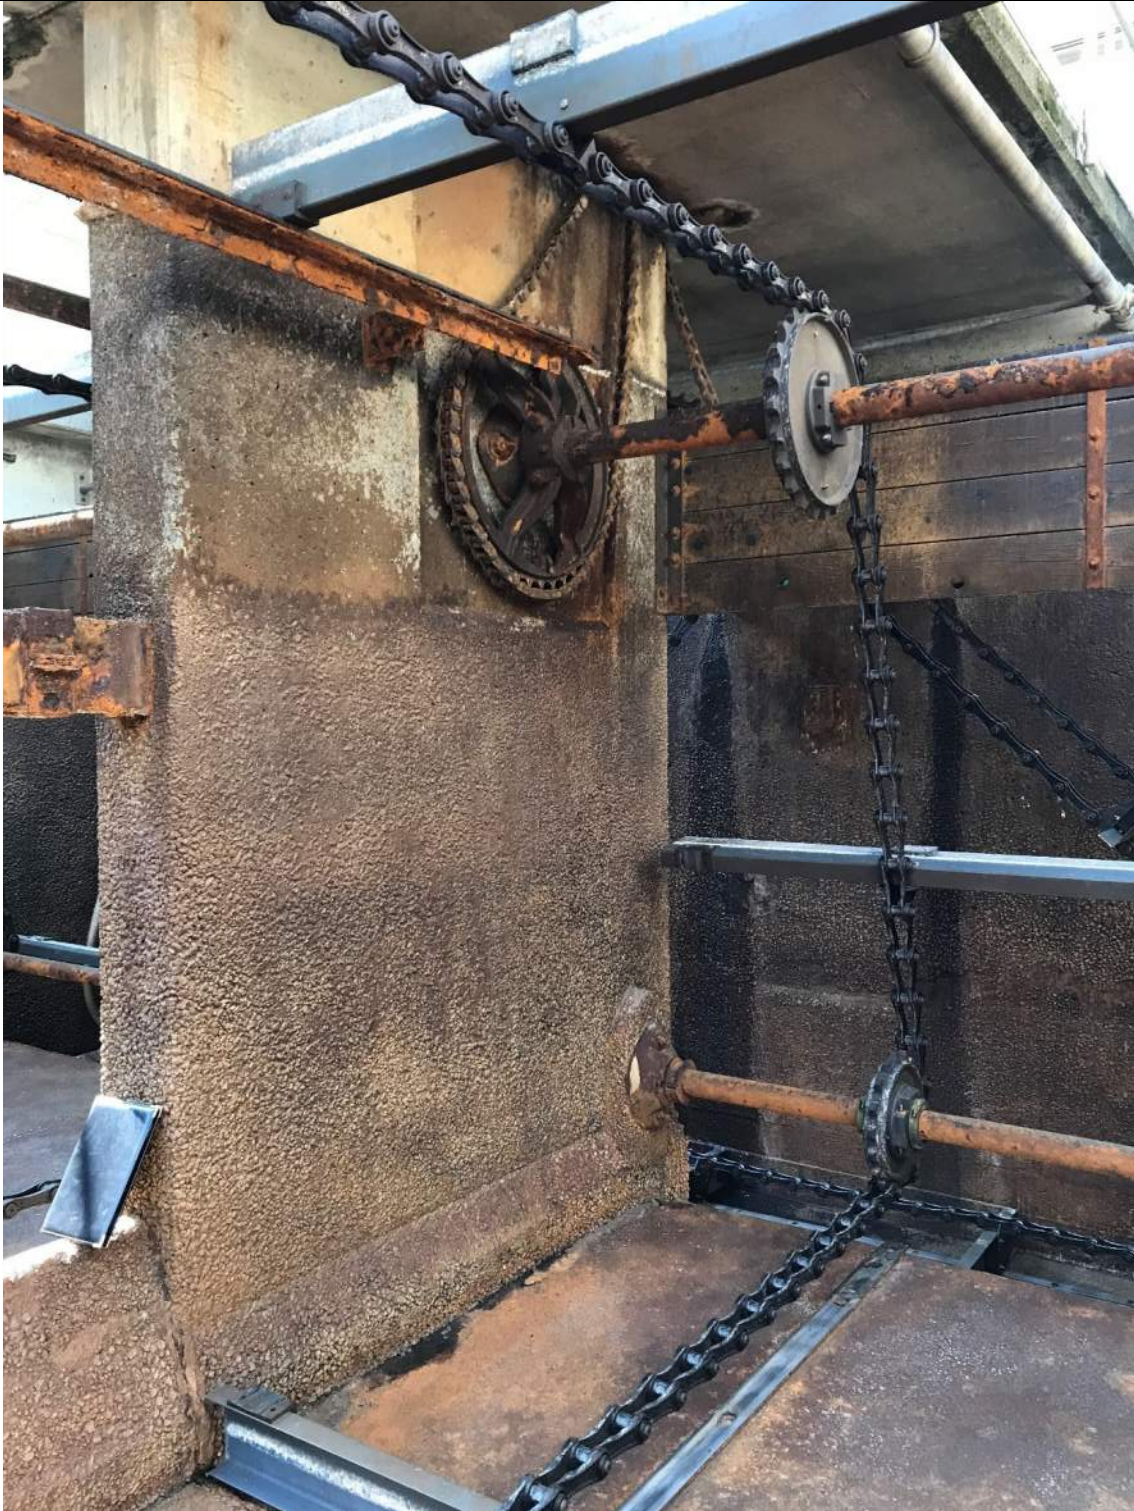
15. Collector drive support wall, with west bay longitudinal collector headshaft, drive bull sprocket and drive sprocket at upper right.

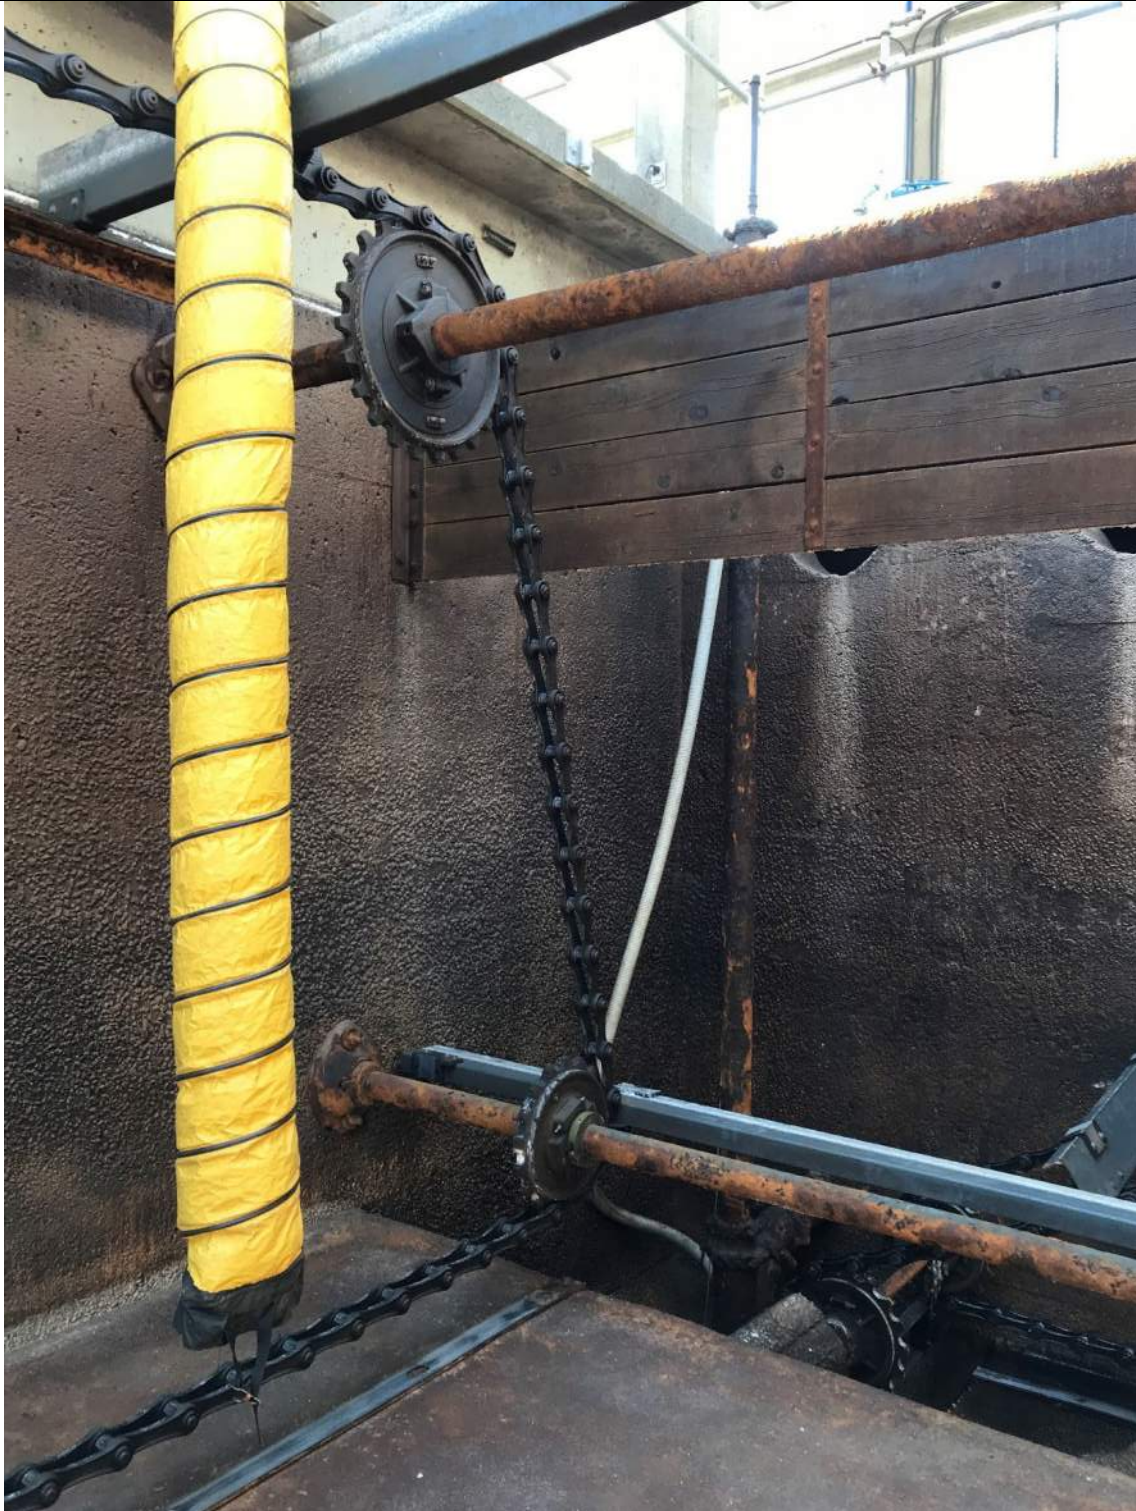
20. From left: East wall, SE corner and south wall of tank. Headshaft and east drive sprocket at upper/left.

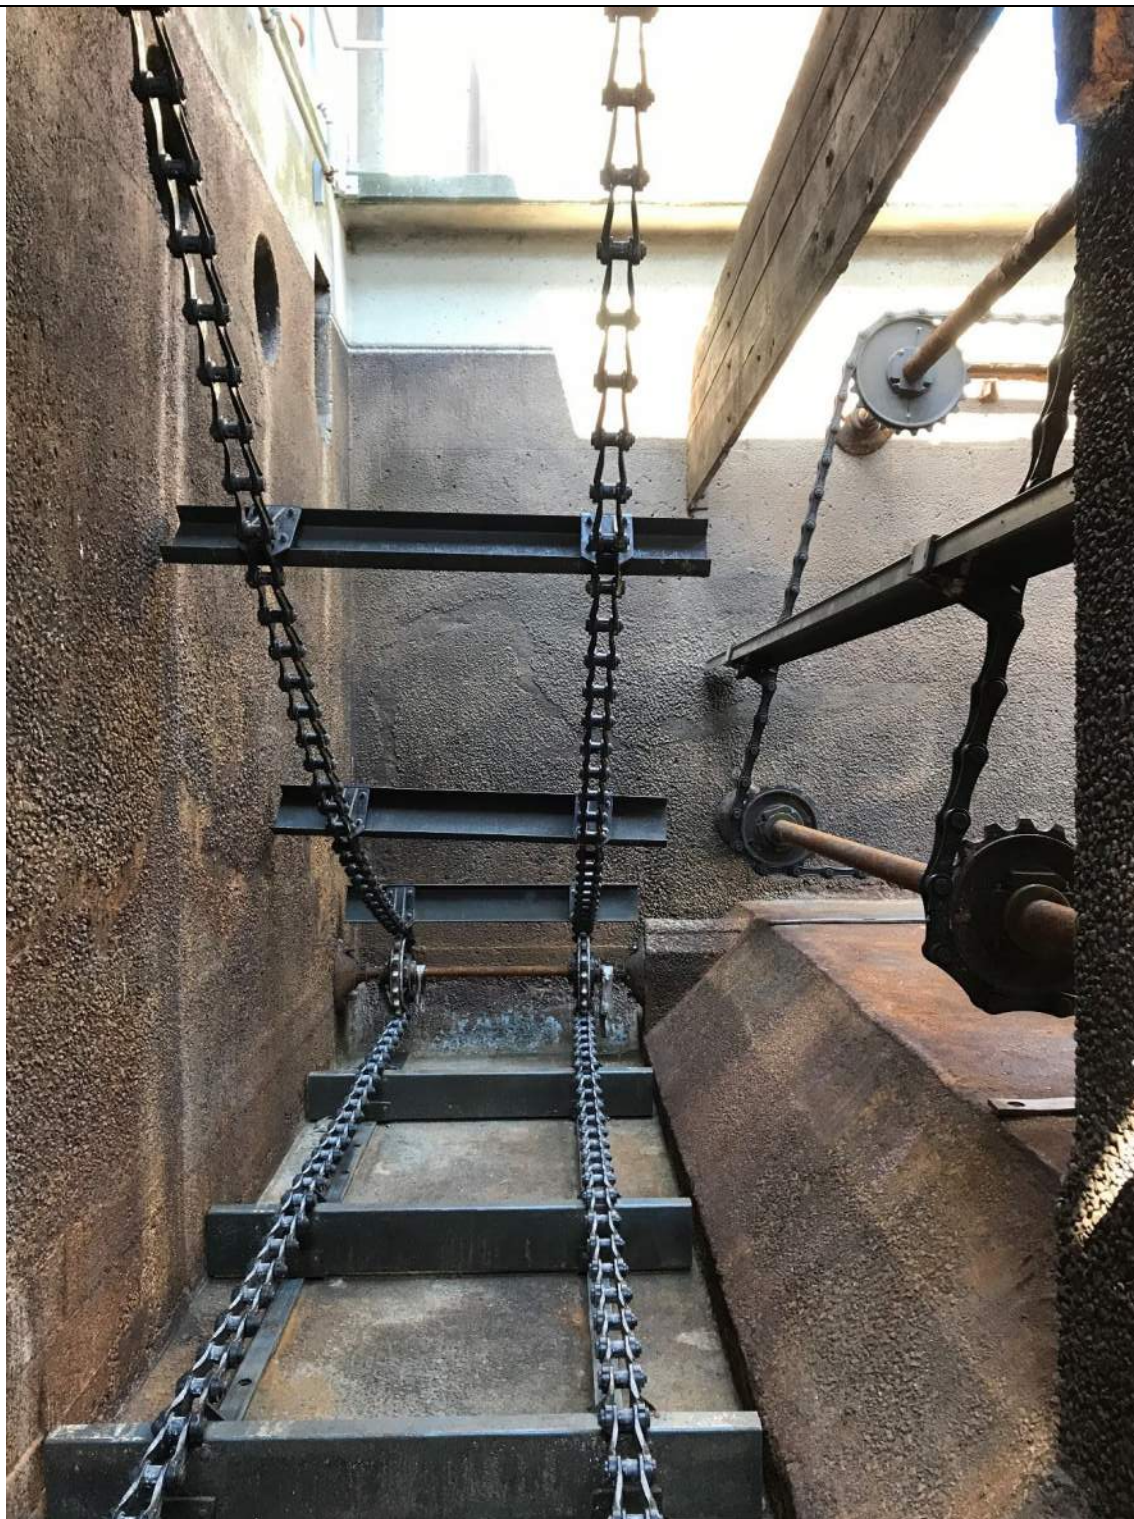
21. Drive (west) end idler of cross collector, wooden inlet baffle and west wall of tank.

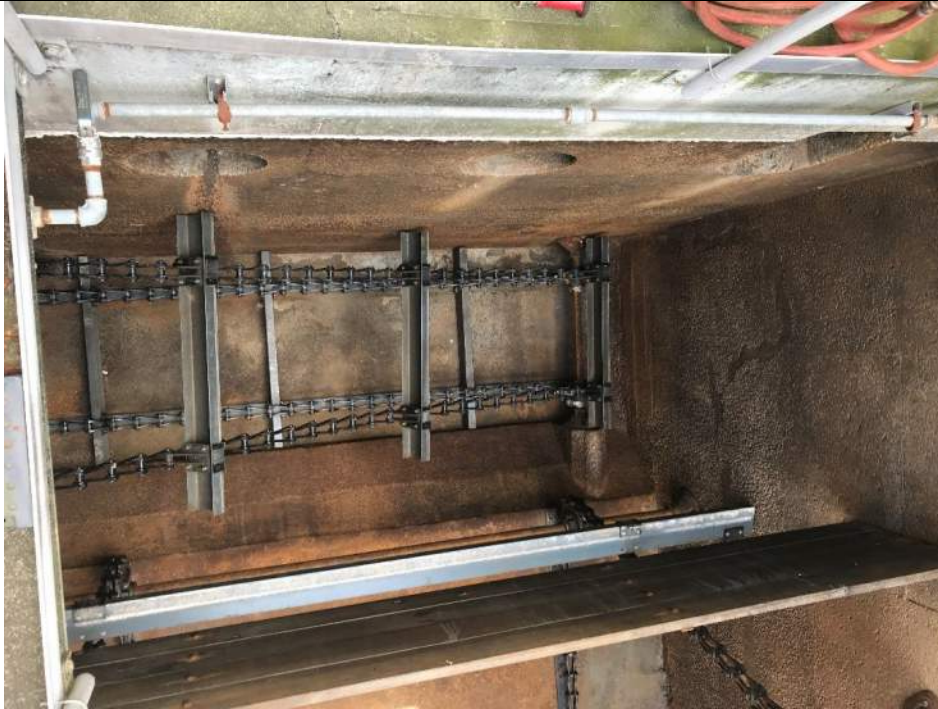
25. Top view of cross collector drive chain, flights and (west) end idler shaft and sprockets.

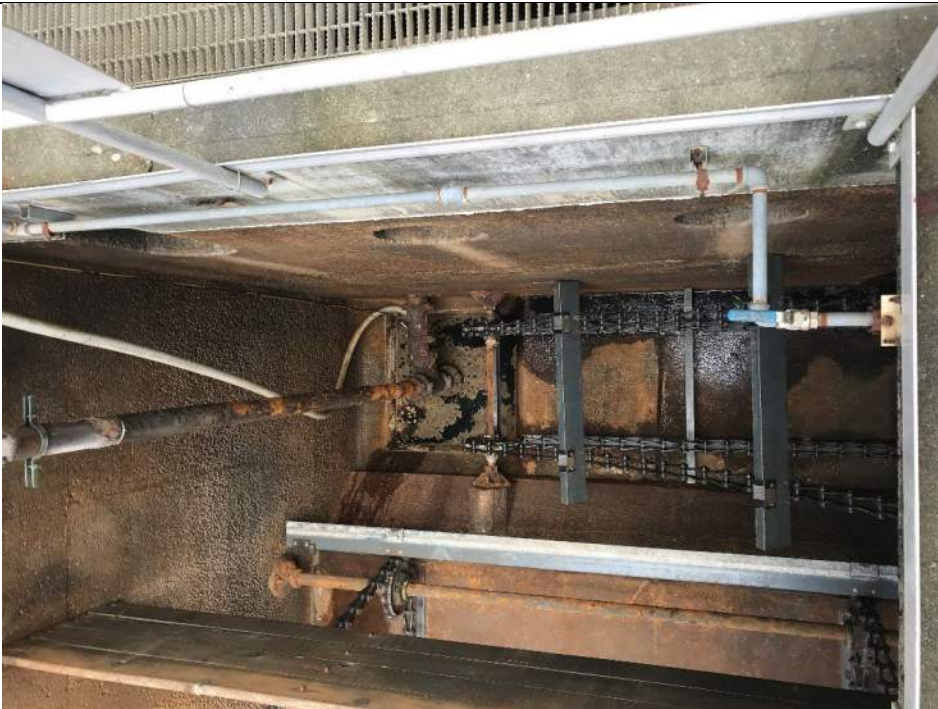
26. Top view of cross collector drive chain, flights and tail (east) end shaft and sprockets. Sludge discharge sump and piping at left.

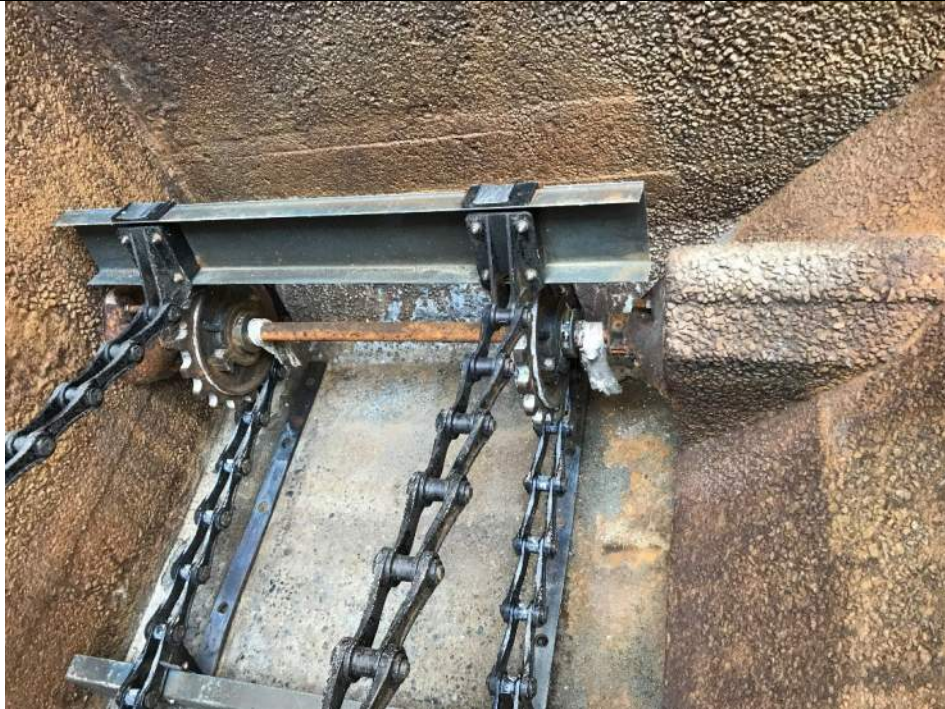
27. West end of cross collector trough, chain, flights and idler shaft and sprockets.

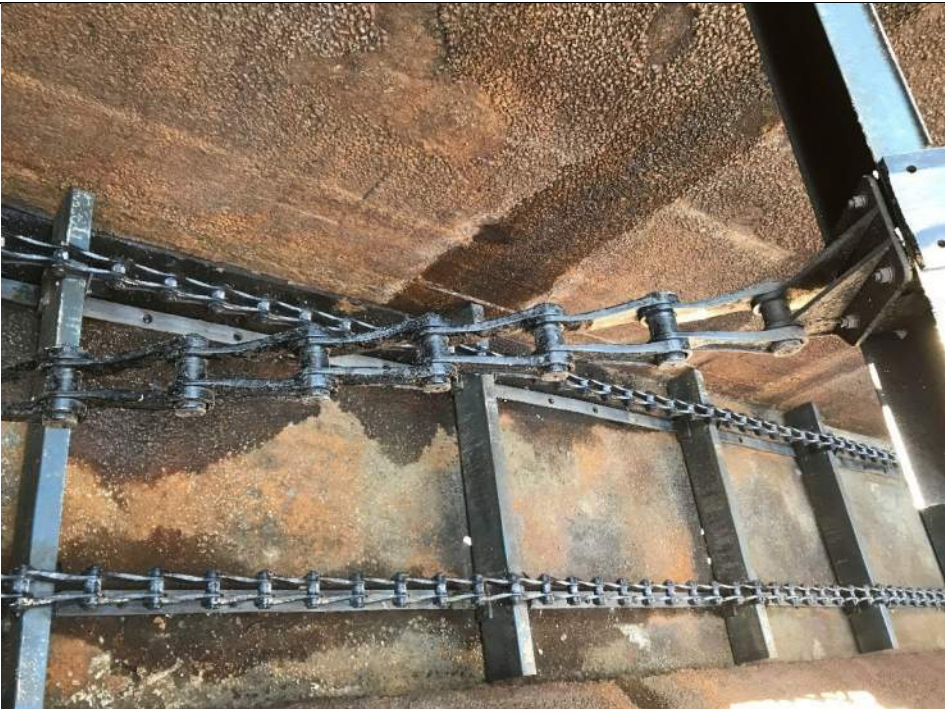
28. Cross collector trough, chain and flights, moving east from photo 25.

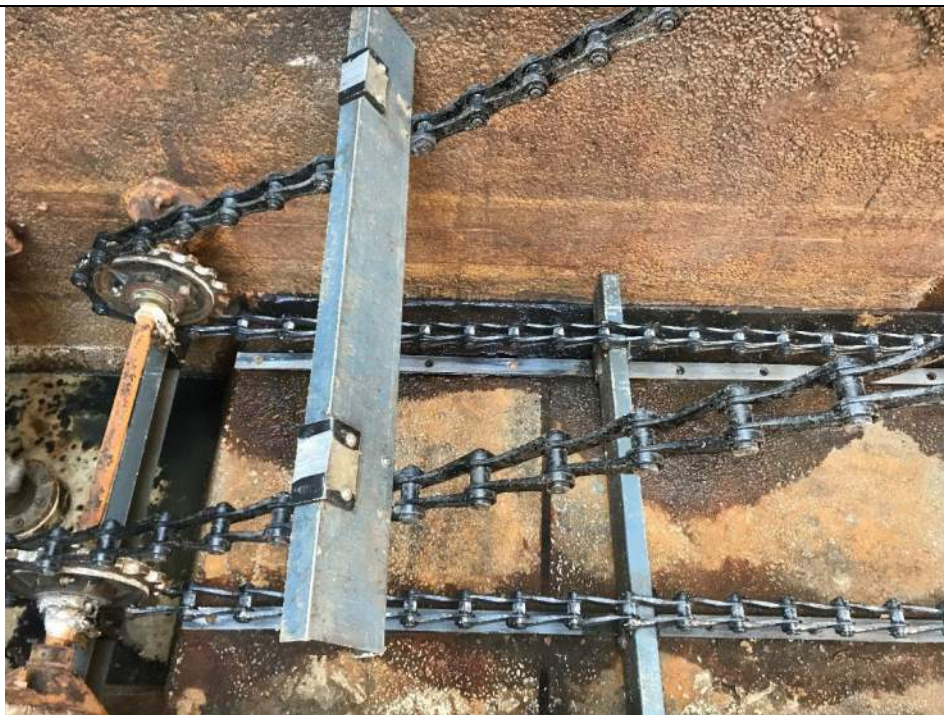
29. Cross collector trough, chain, flights, tail (west) end shaft and sprockets, moving east from photo 26.

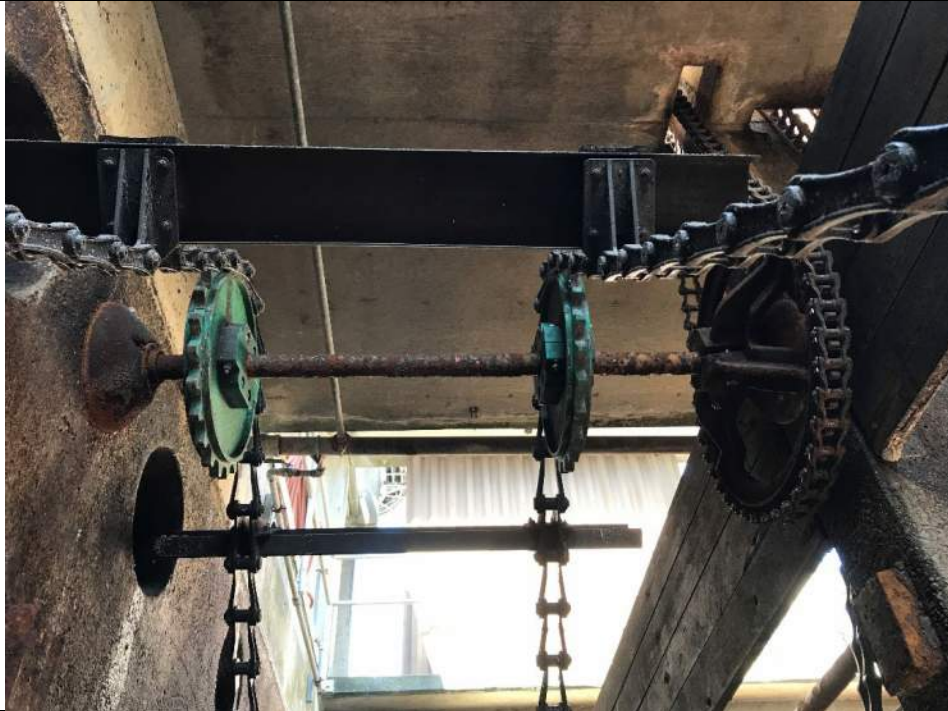
31. Cross collector drive shaft/sprockets and drive bull sprocket (at right).

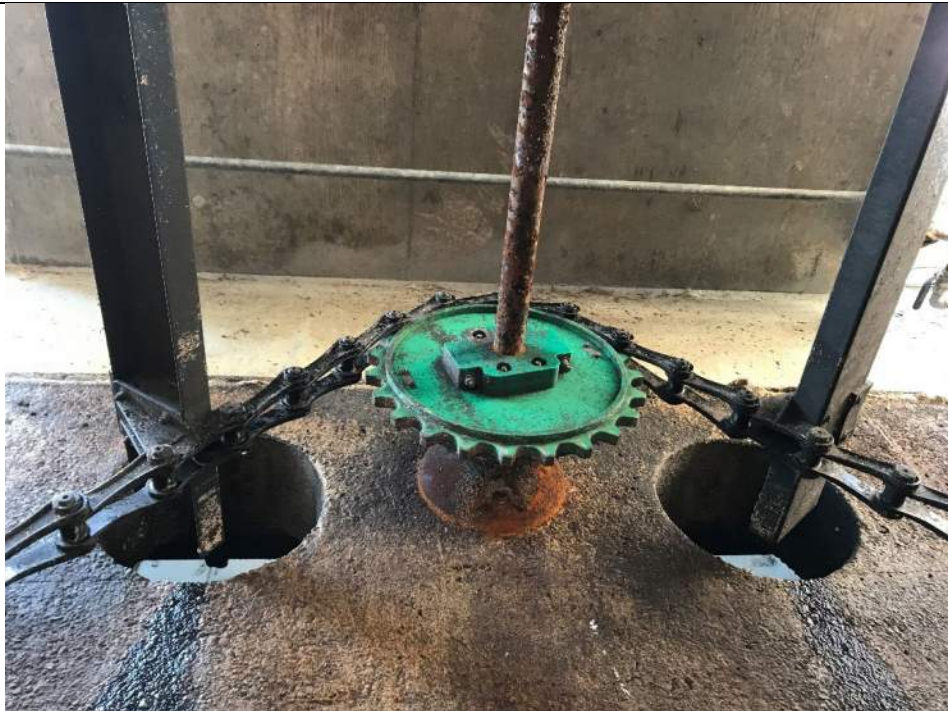
32. Cross collector south drive sprocket and shaft bearing.

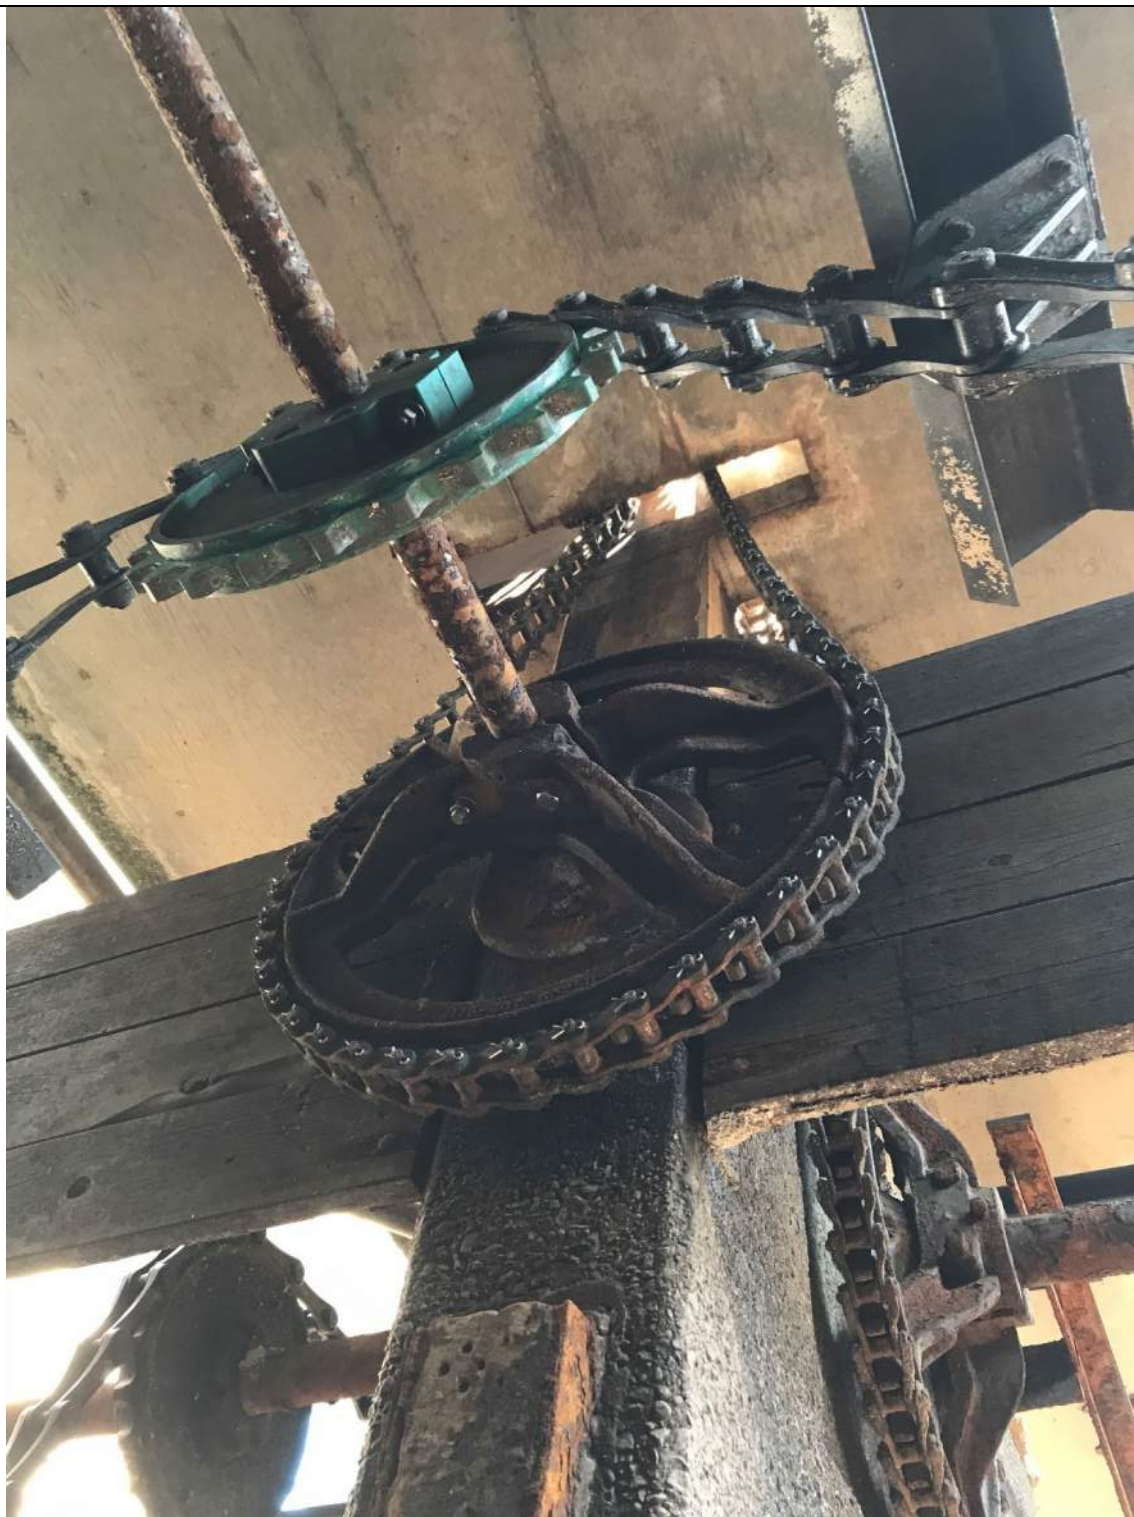
33. Cross collector north drive sprocket (green), drive bull sprocket and north shaft bearing.

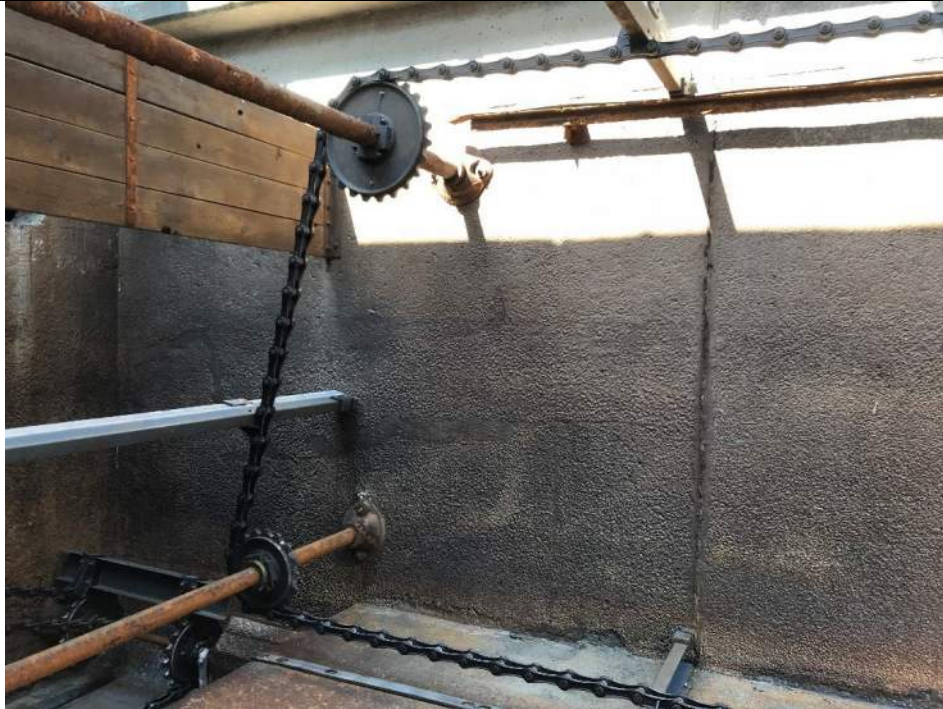
36. West tank wall at south end (longitudinal collector head shaft and drive sprocket visible upper left).

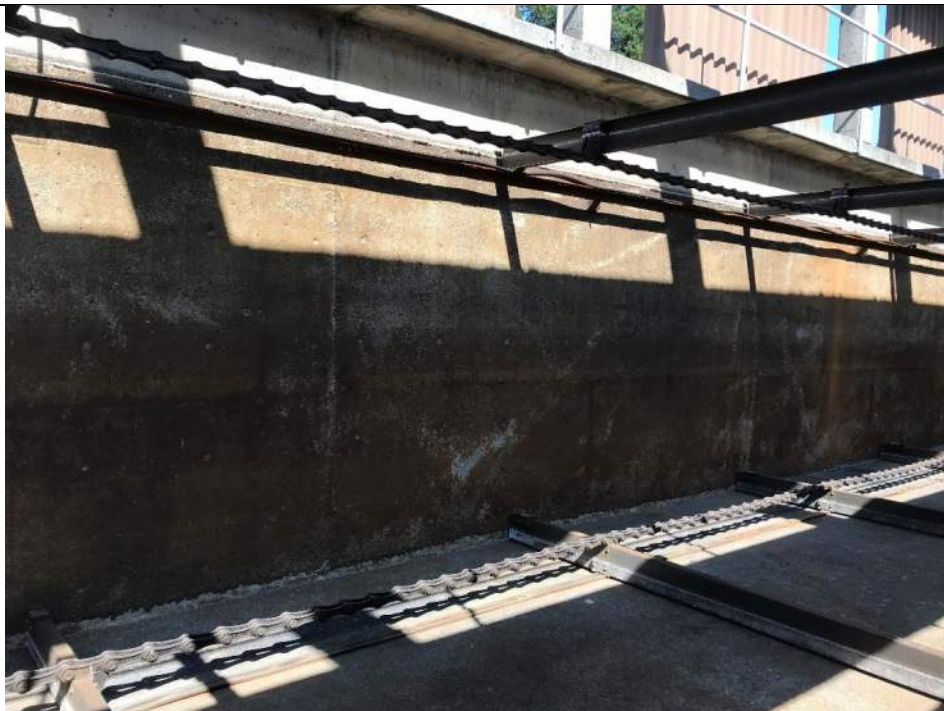
41. West wall of tank, north of photo 40.

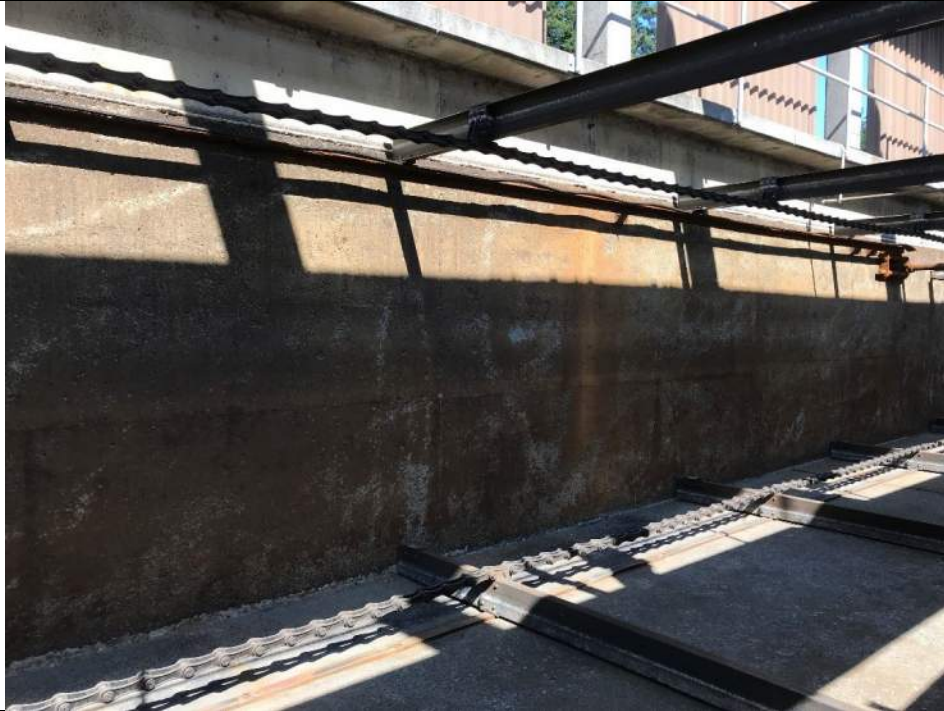
42. West wall of tank, north of photo 41.

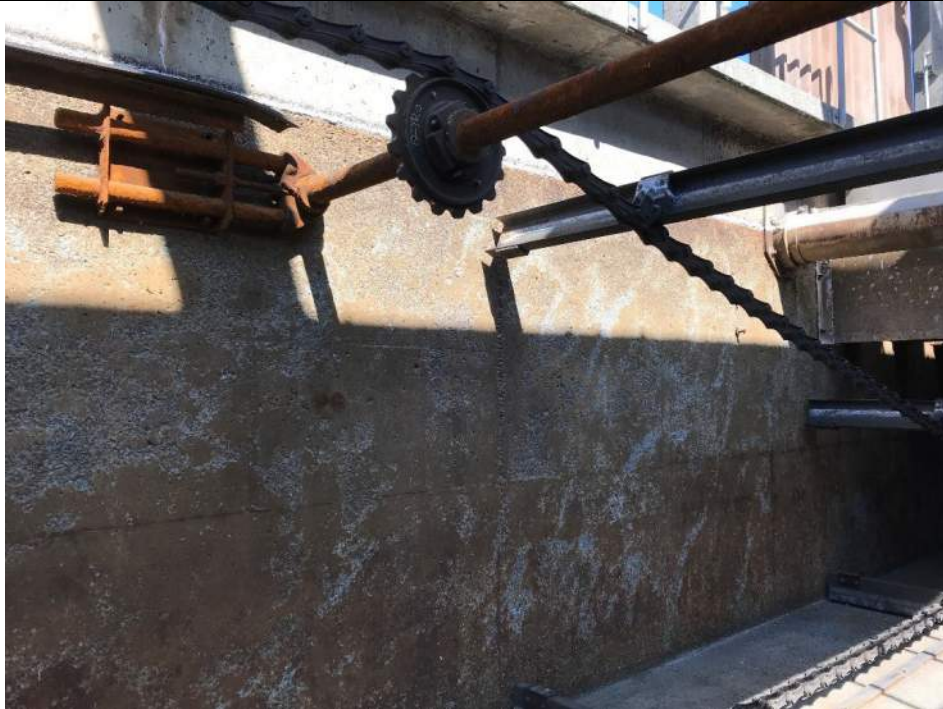
44. Close-up view of west bay longitudinal collector west tail-end idler shaft/sprocket (upper) and chain tensioner (upper left)

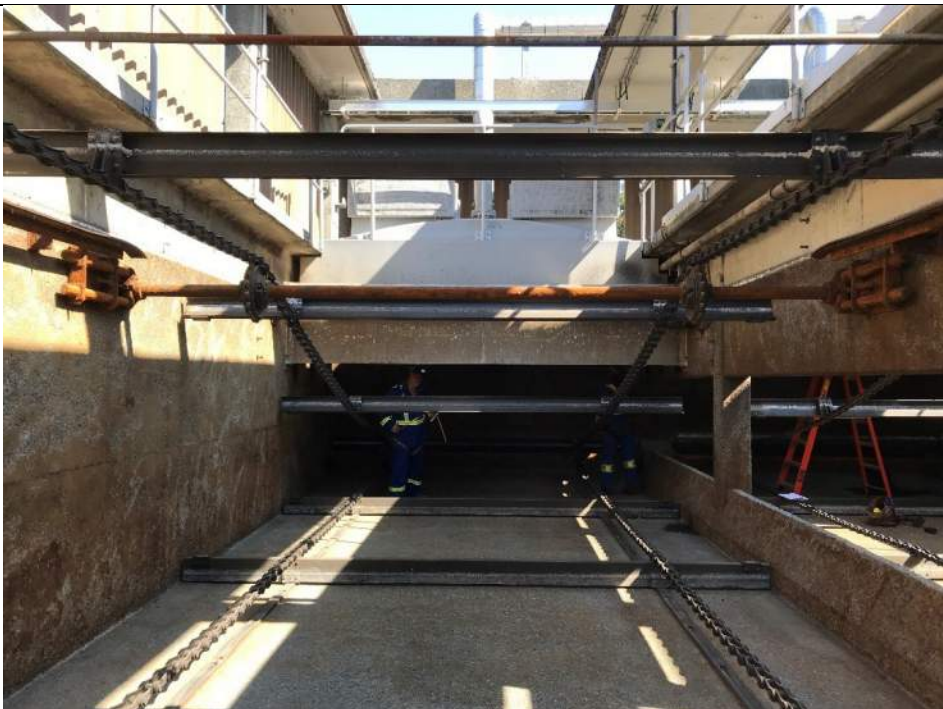
45. View of west bay longitudinal collector tail end shafts, scum baffle and effluent discharge channel odour collection hood.

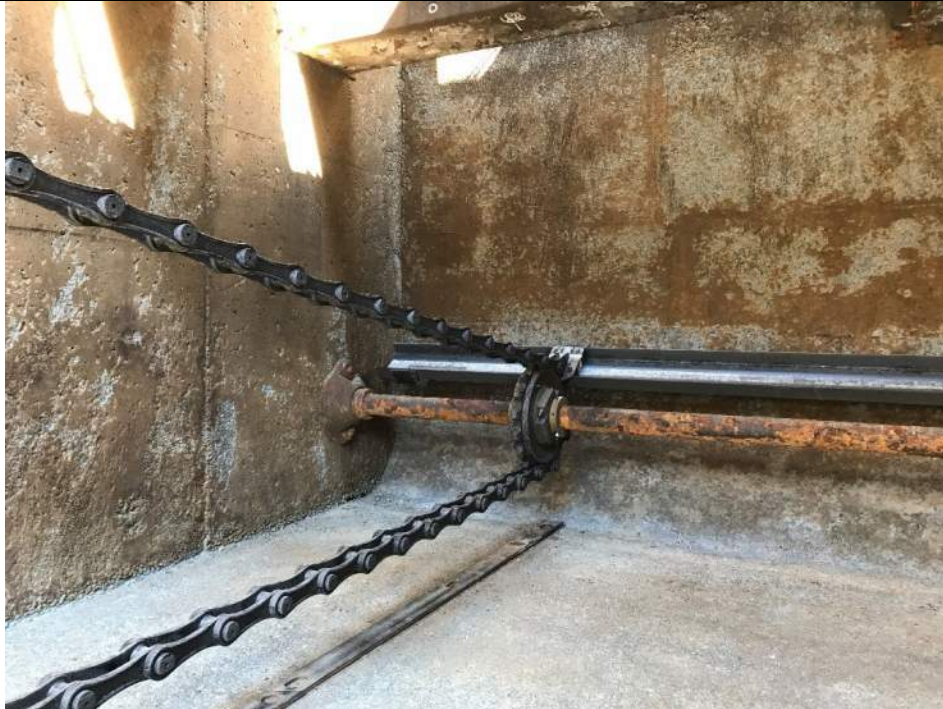
46. West end of west bay longitudinal collector tail shaft.

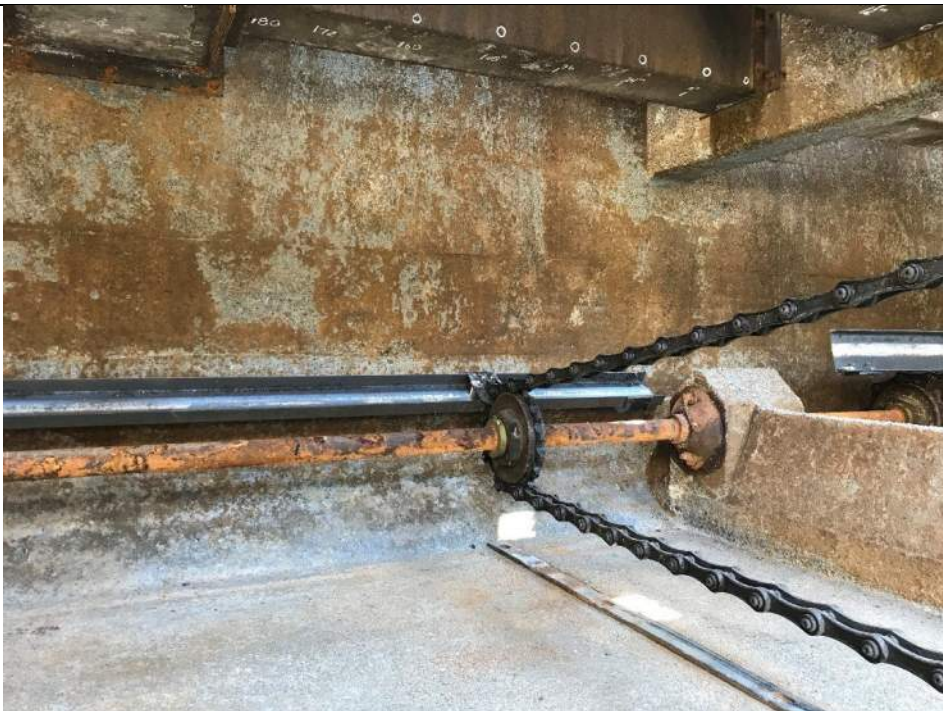
47. East end of west bay longitudinal collector tail shaft.

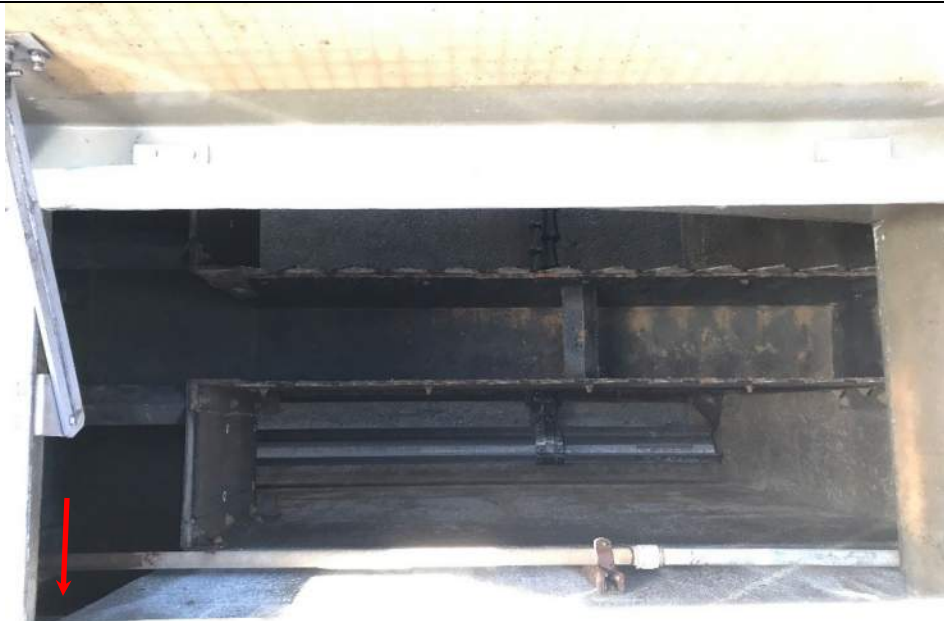
48. Top view of northernmost west bay effluent discharge channel weir box and water piping (tank discharge shown by red arrow).

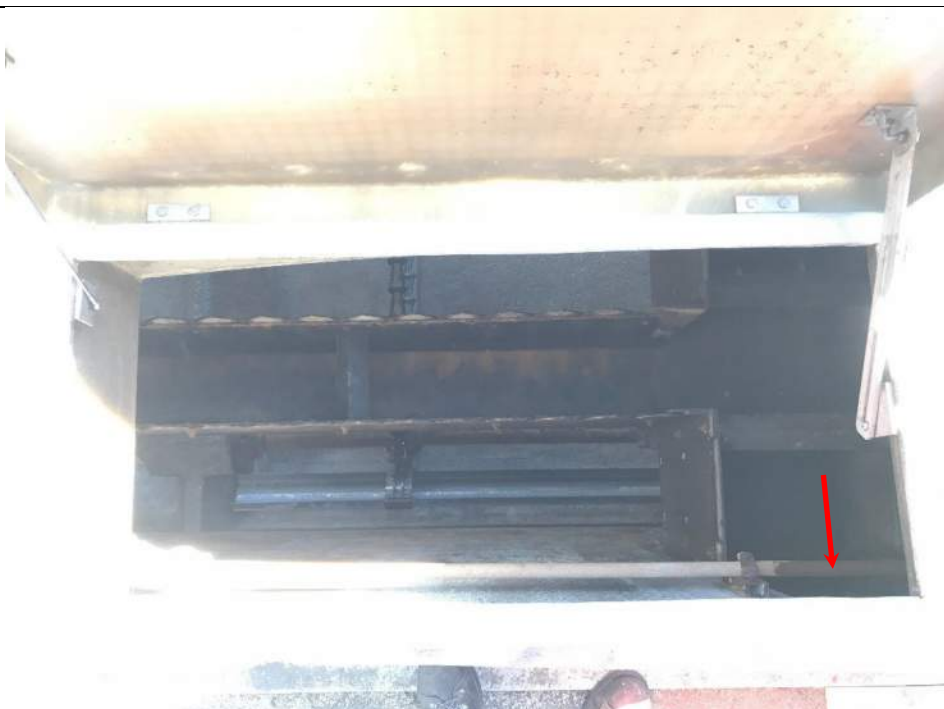
49. Top view of northernmost west bay effluent discharge channel weir box and water piping (tank discharge shown by red arrow).

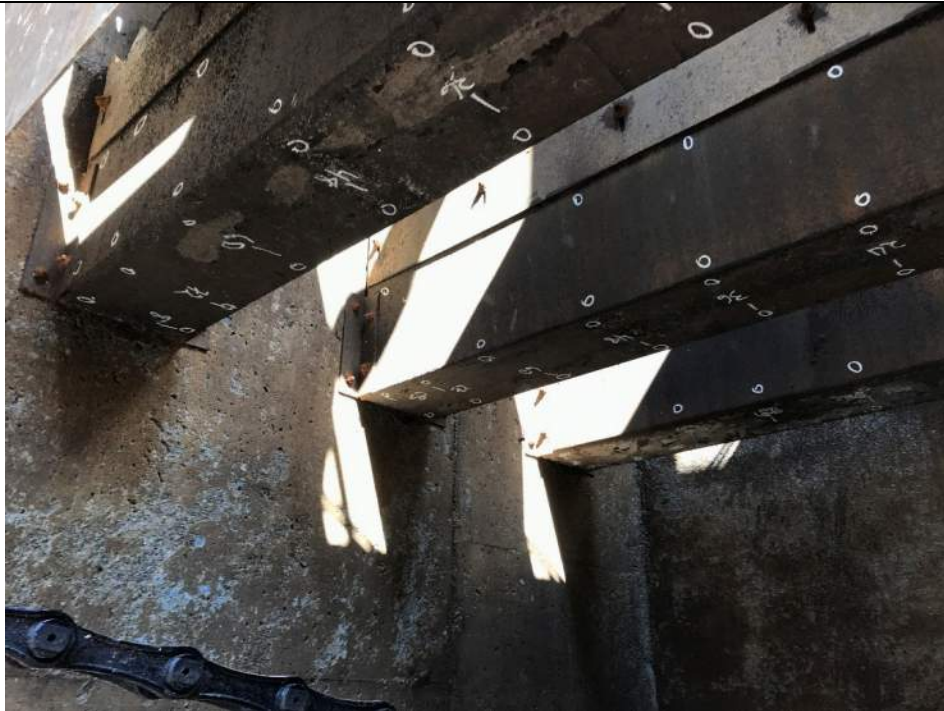
50. Bottom west side of west bay effluent discharge channel weir boxes (marked for thickness testing).

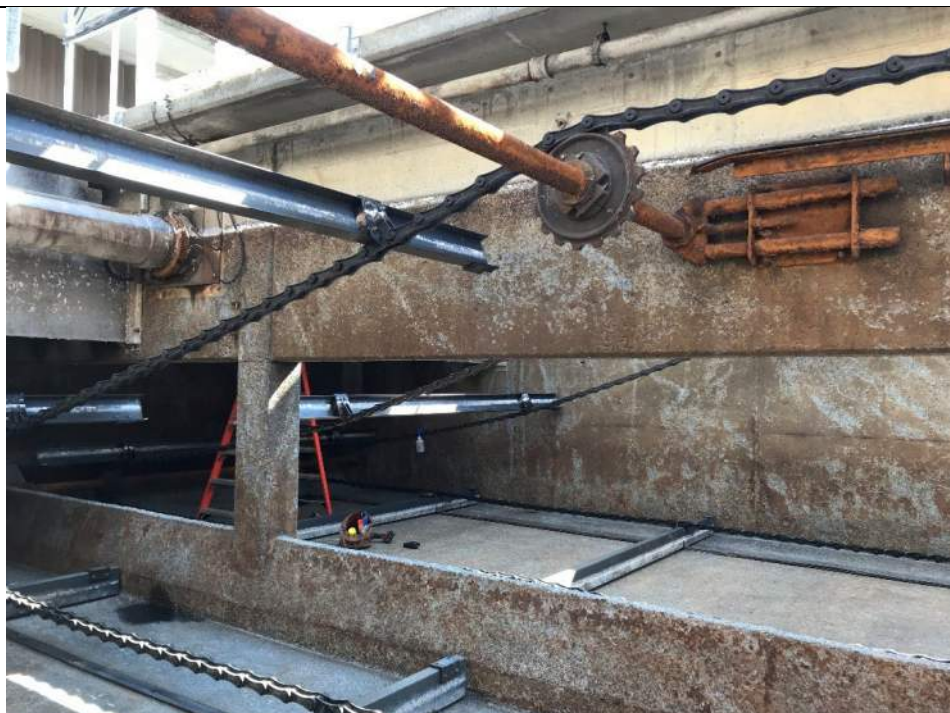
53. Close-up view of west bay longitudinal collector east tail-end idler shaft/sprocket (upper) and chain tensioner (upper right)

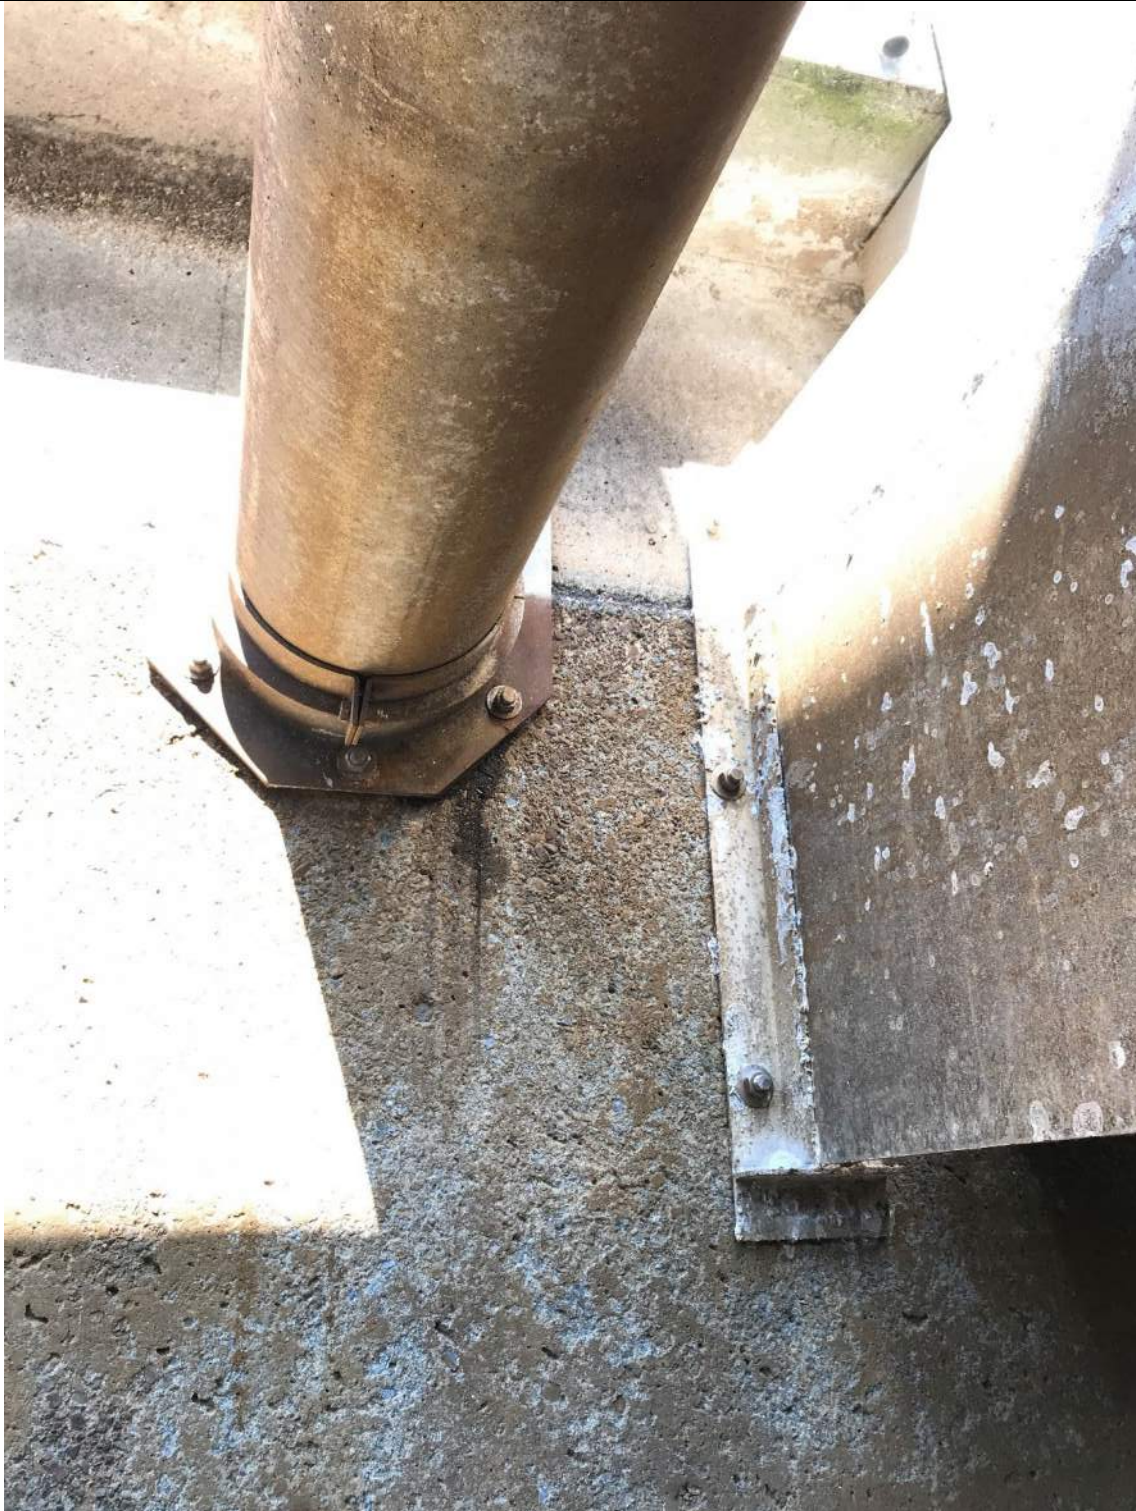
55. Close-up view of non-drive (west) end of west bay scum skimmer and adjacent scum baffle.
