## General Exterior Reference Photos

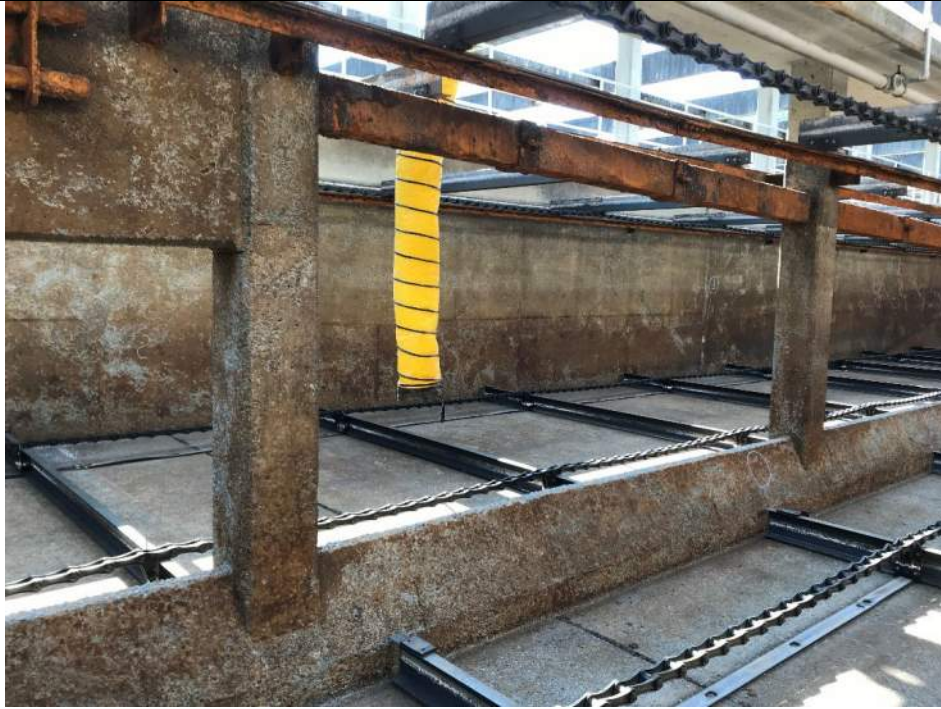
56. Tank center columns cont'd from photo 53, viewed from west bay (Note black asbestos containing sealant in floor expansion joint).

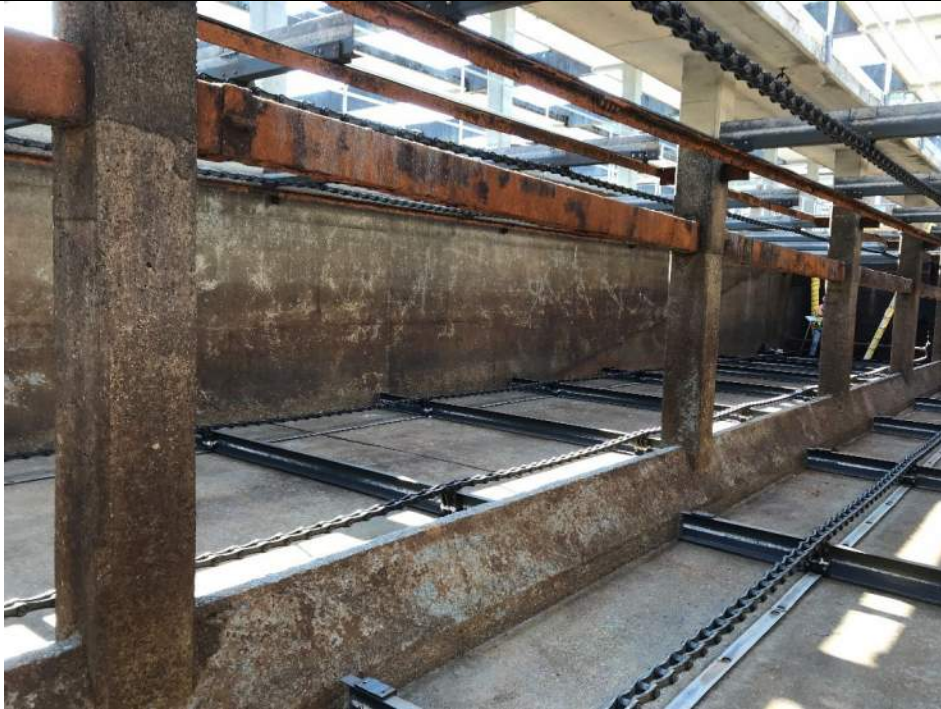
58. Tank center columns cont'd from photo 57, viewed from west bay.

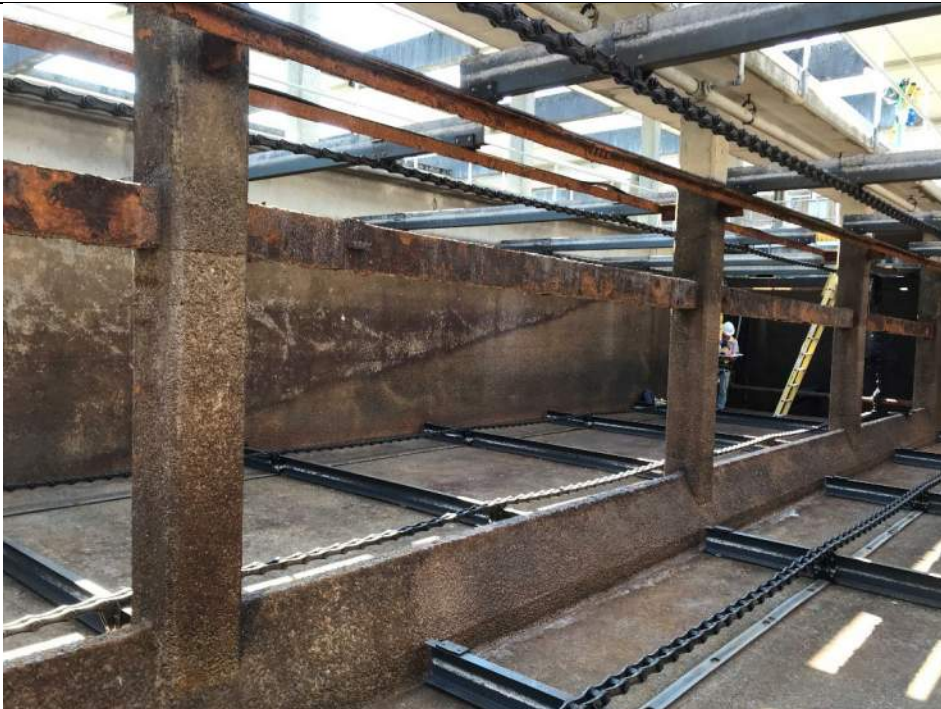
59. Tank center columns cont'd from photo 58, viewed from west bay. Note exposed concrete aggregate.

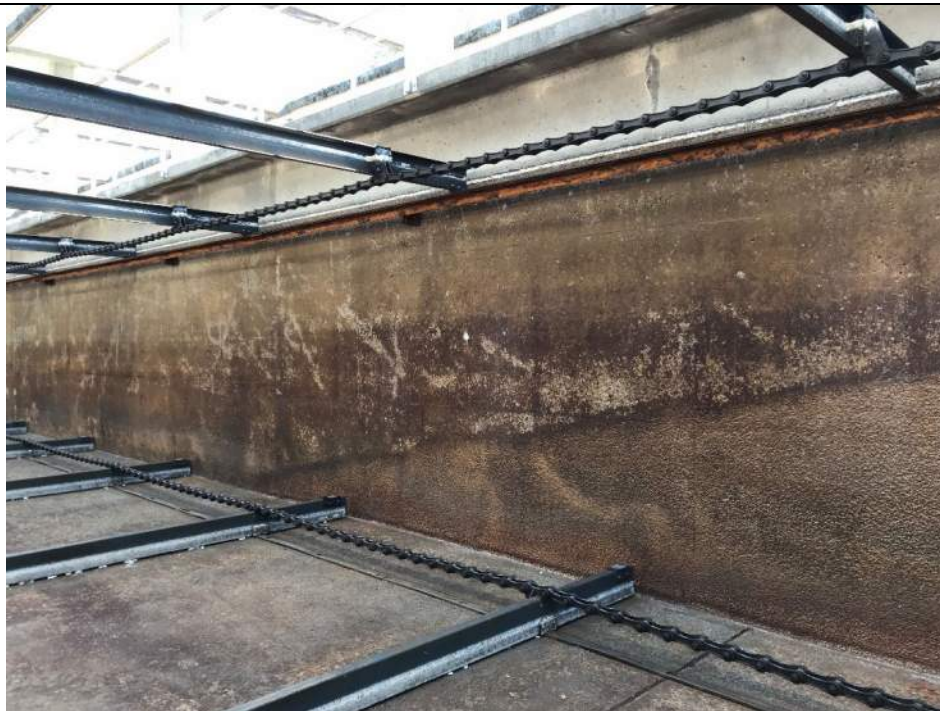
62. East wall of tank, north of photo 61 (diagonal line is where previous coating ends).

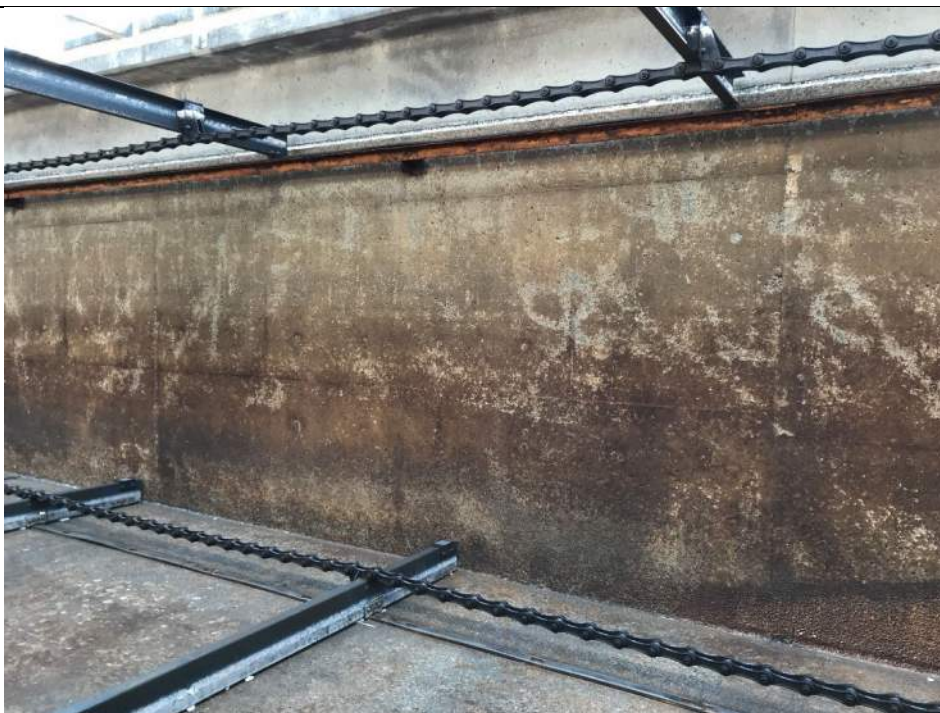
63. East wall of tank, north of photo 62. End of wall coating at bottom right.

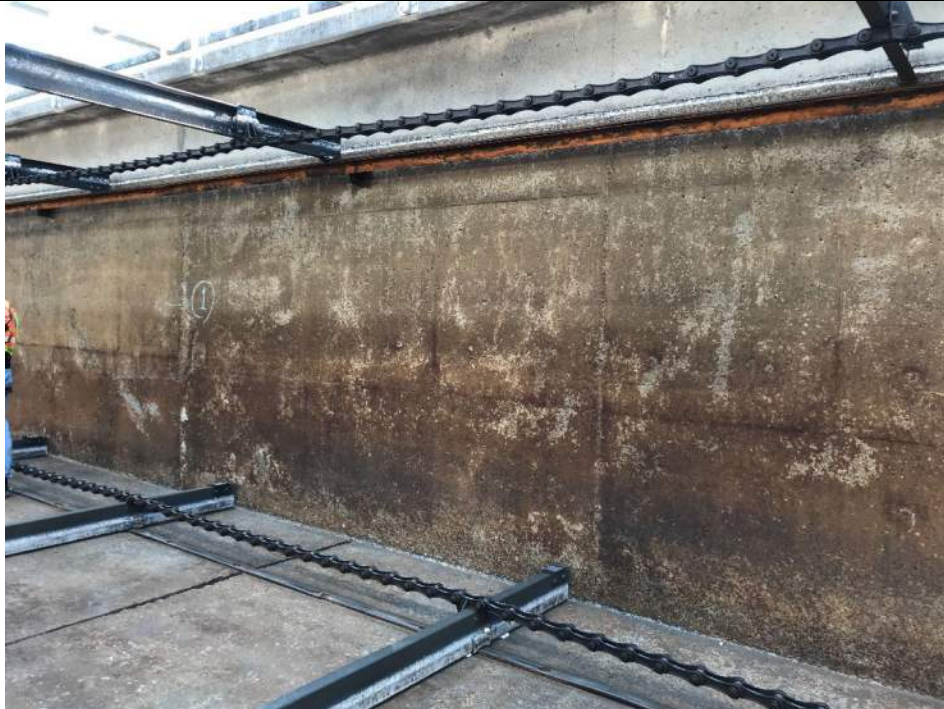
64. East wall of tank, north of photo 63. Wall construction joint indicated by number 1.

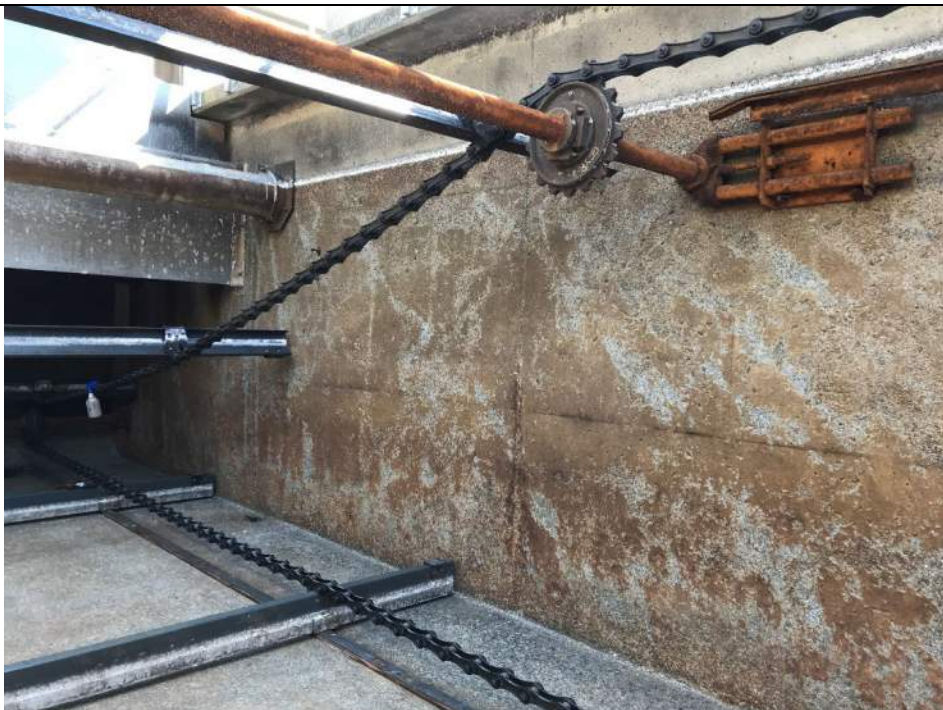
67. Close-up of east bay tail end idler shaft, sprocket and tensioner; scum-skimmer and scum baffle in left background

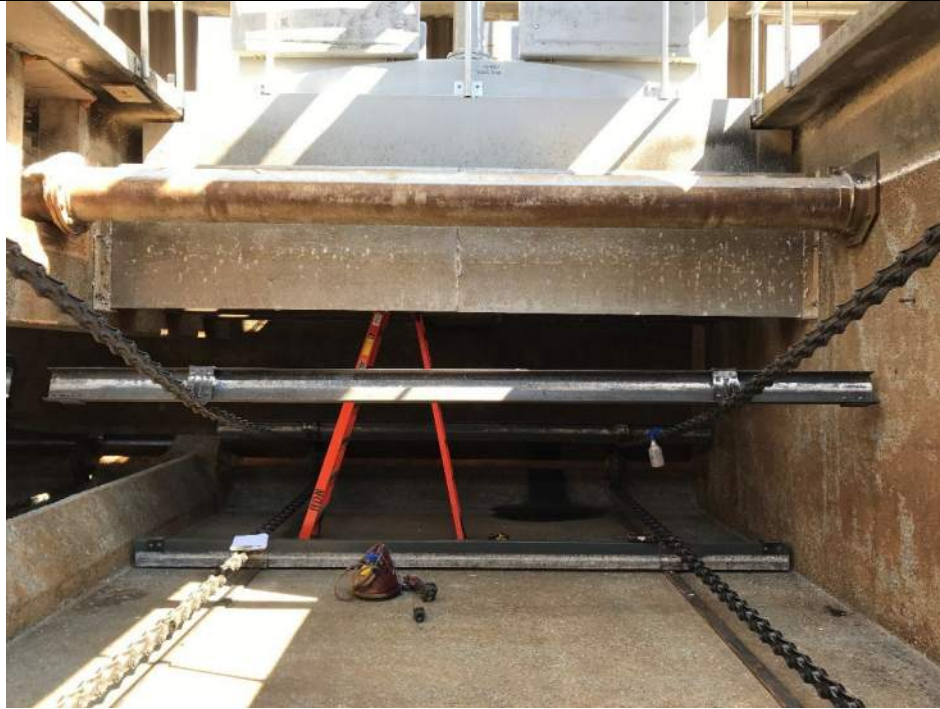
68. View of east bay longitudinal collector tail end shaft, scum skimmer/baffle and effluent discharge channel odour collection hood.

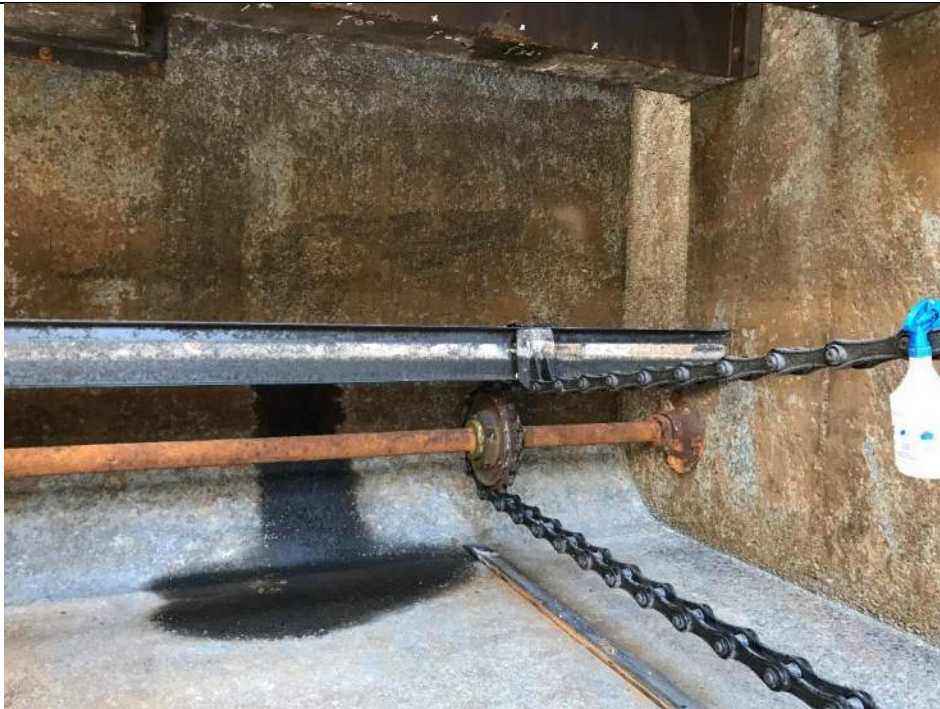
69. East end of east bay longitudinal collector tail shaft.

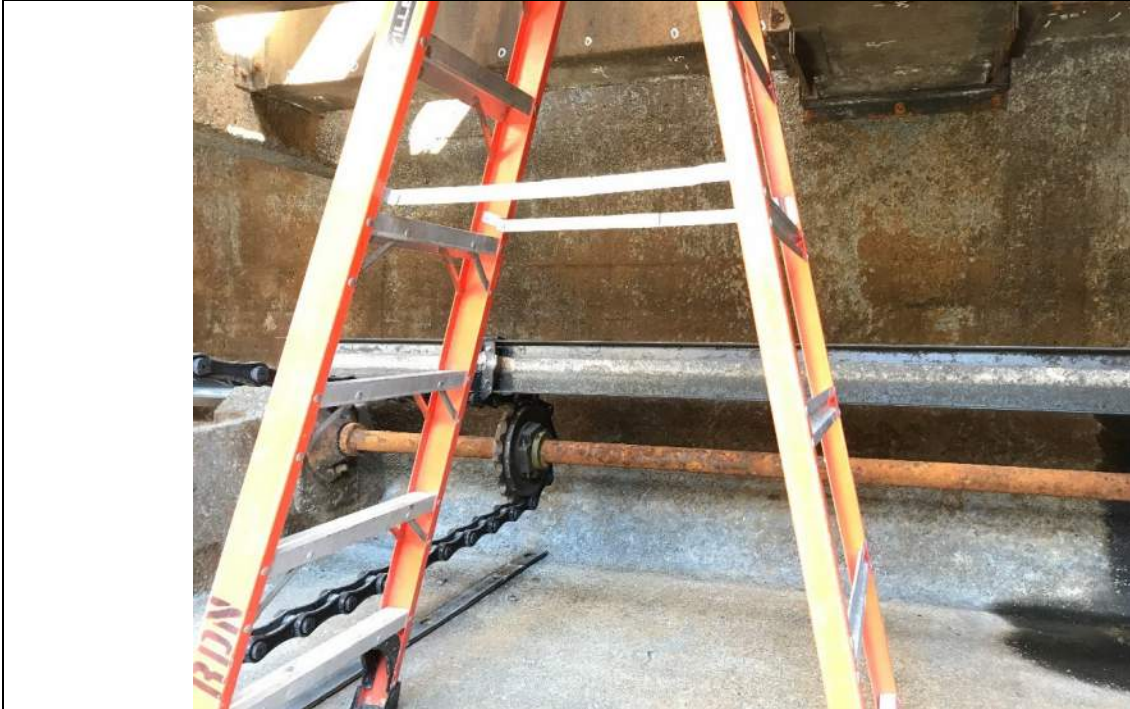
70. West end of east bay longitudinal collector tail shaft.

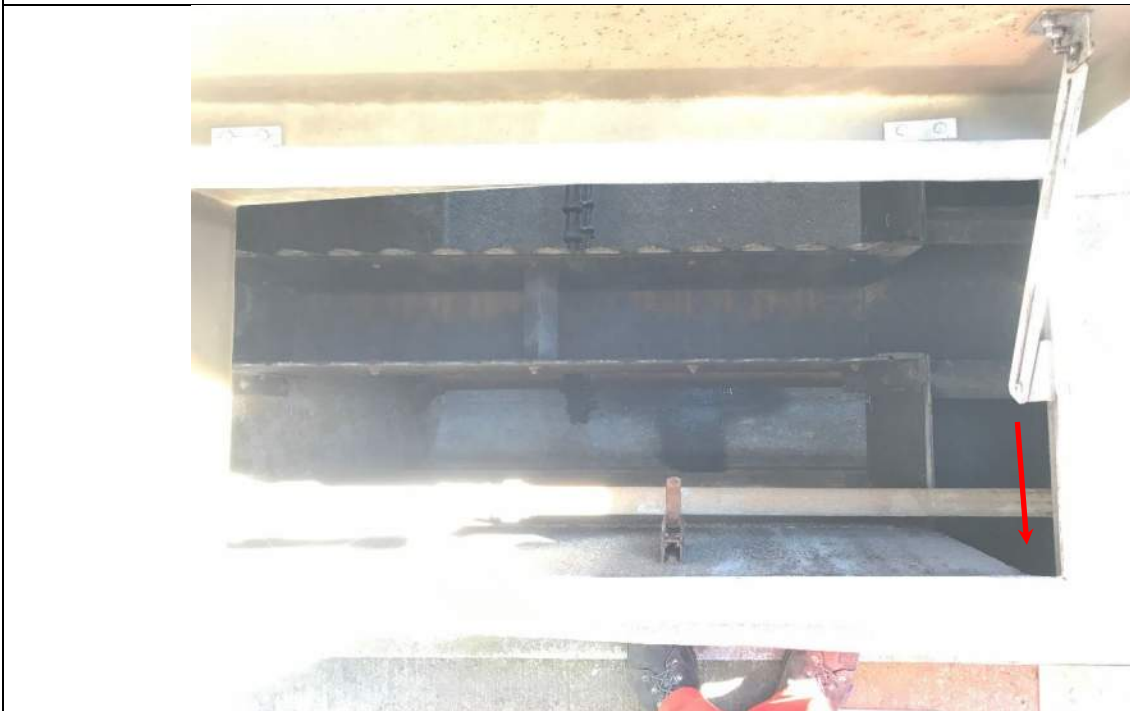
71. Top view of northernmost east bay effluent discharge channel weir box and water piping (tank discharge shown by red arrow).

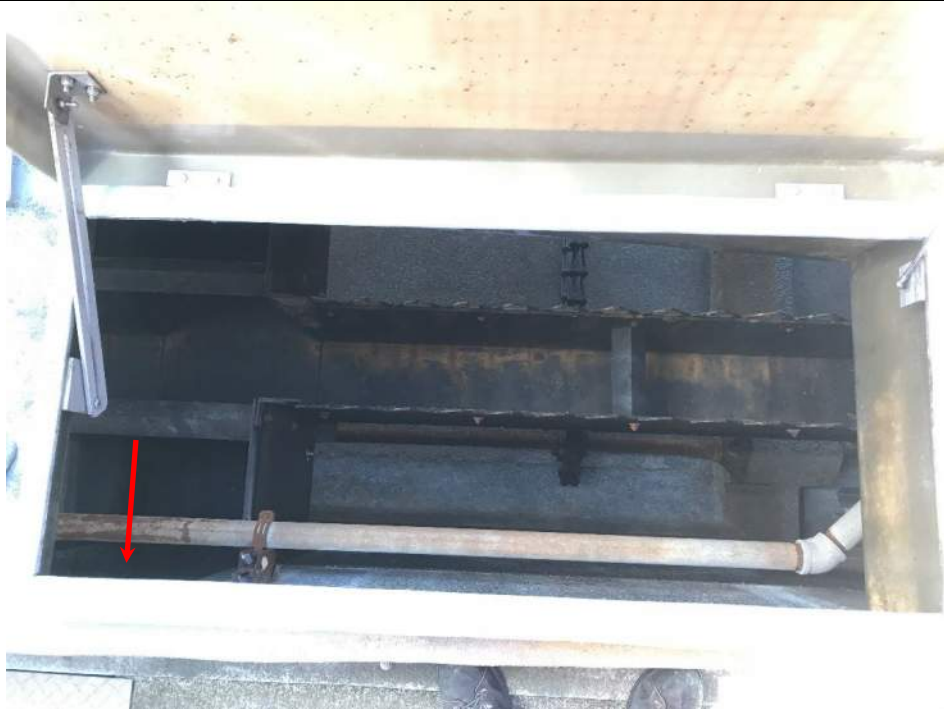
72. Top view of northernmost east bay effluent discharge channel weir box and water piping (tank discharge shown by red arrow).

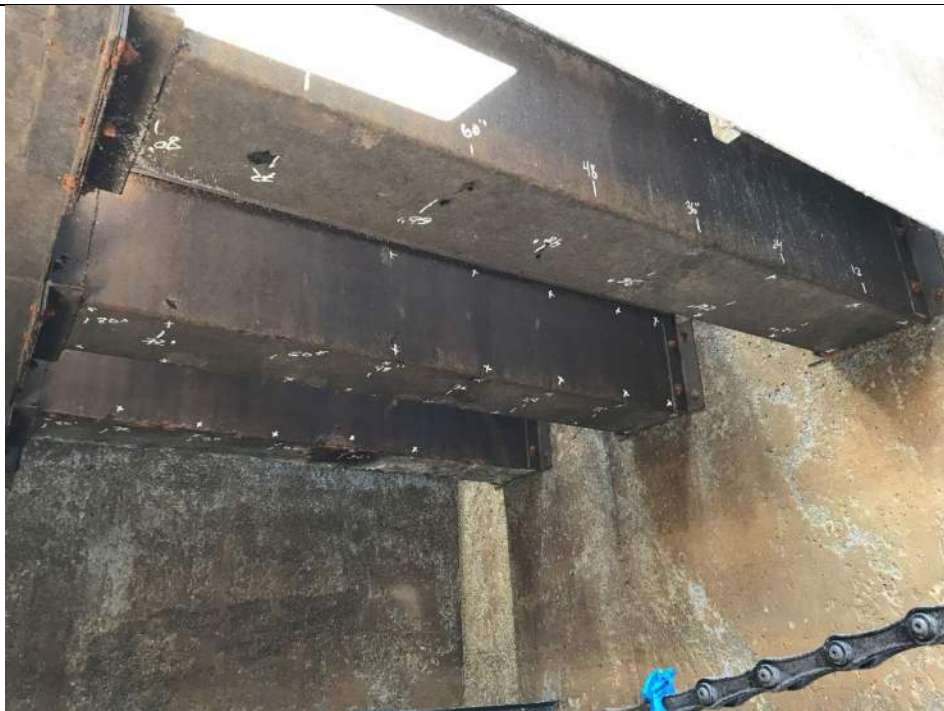
73. Bottom east side of east bay effluent discharge channel weir boxes (marked for thickness testing).

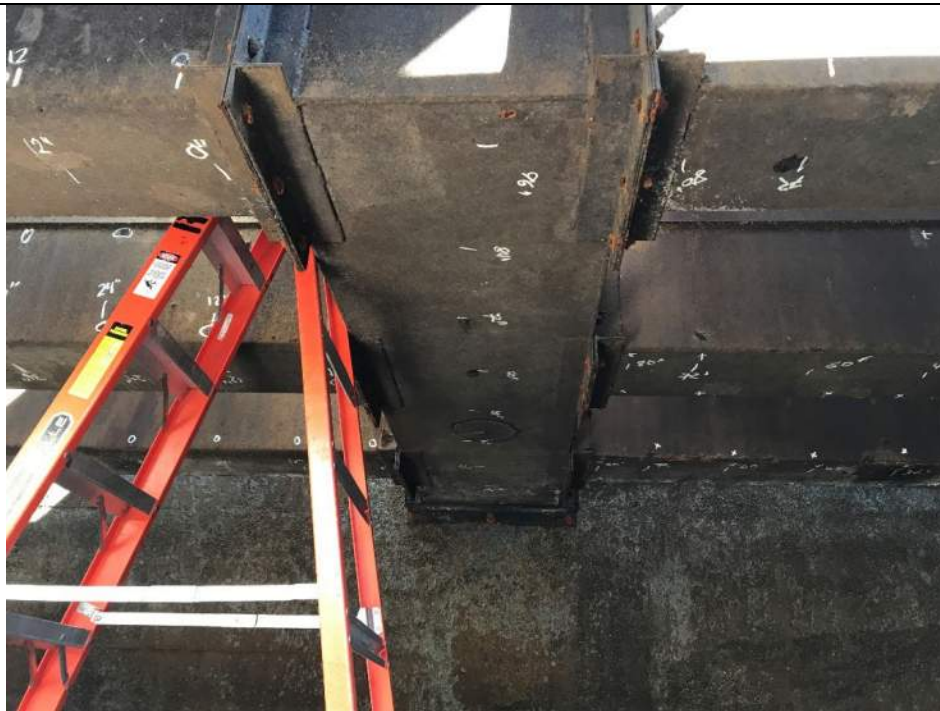
74. Bottom middle of east bay effluent discharge channel weir boxes (marked for thickness testing). Note – black coating contains lead.

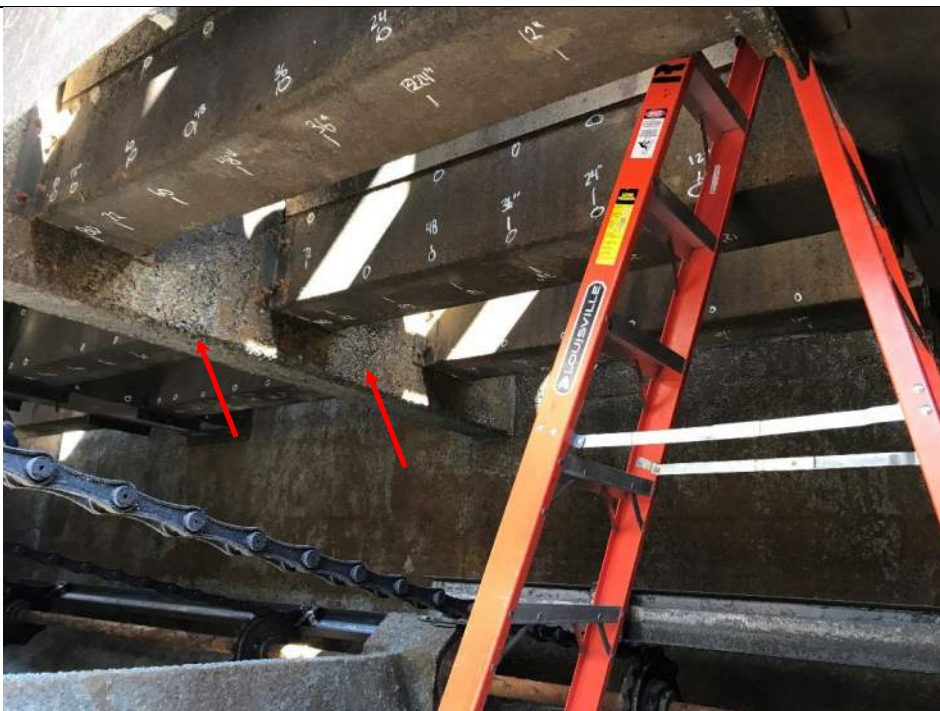
75. Bottom west side of east bay effluent discharge channel weir boxes. Note exposed concrete aggregate (red arrows)

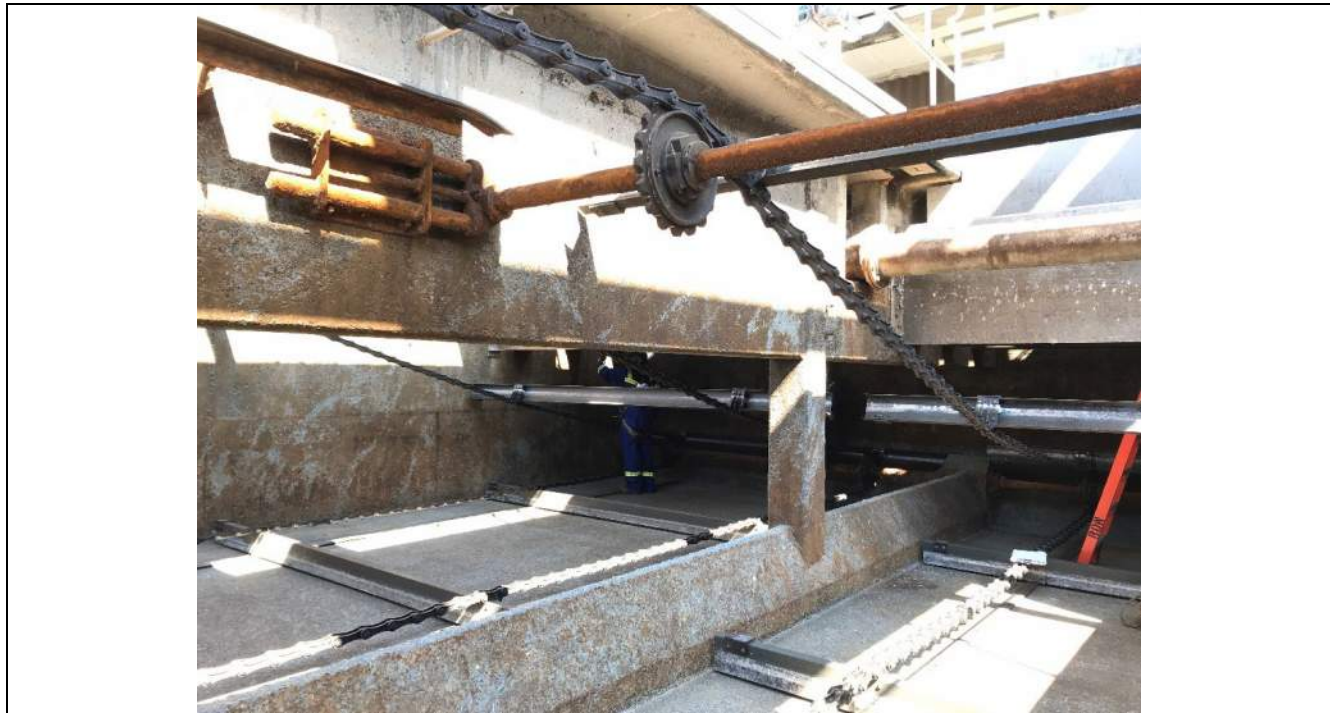
76. Close-up of west east bay tail end idler shaft, sprocket and tensioner; scum-skimmer and scum baffle in left background

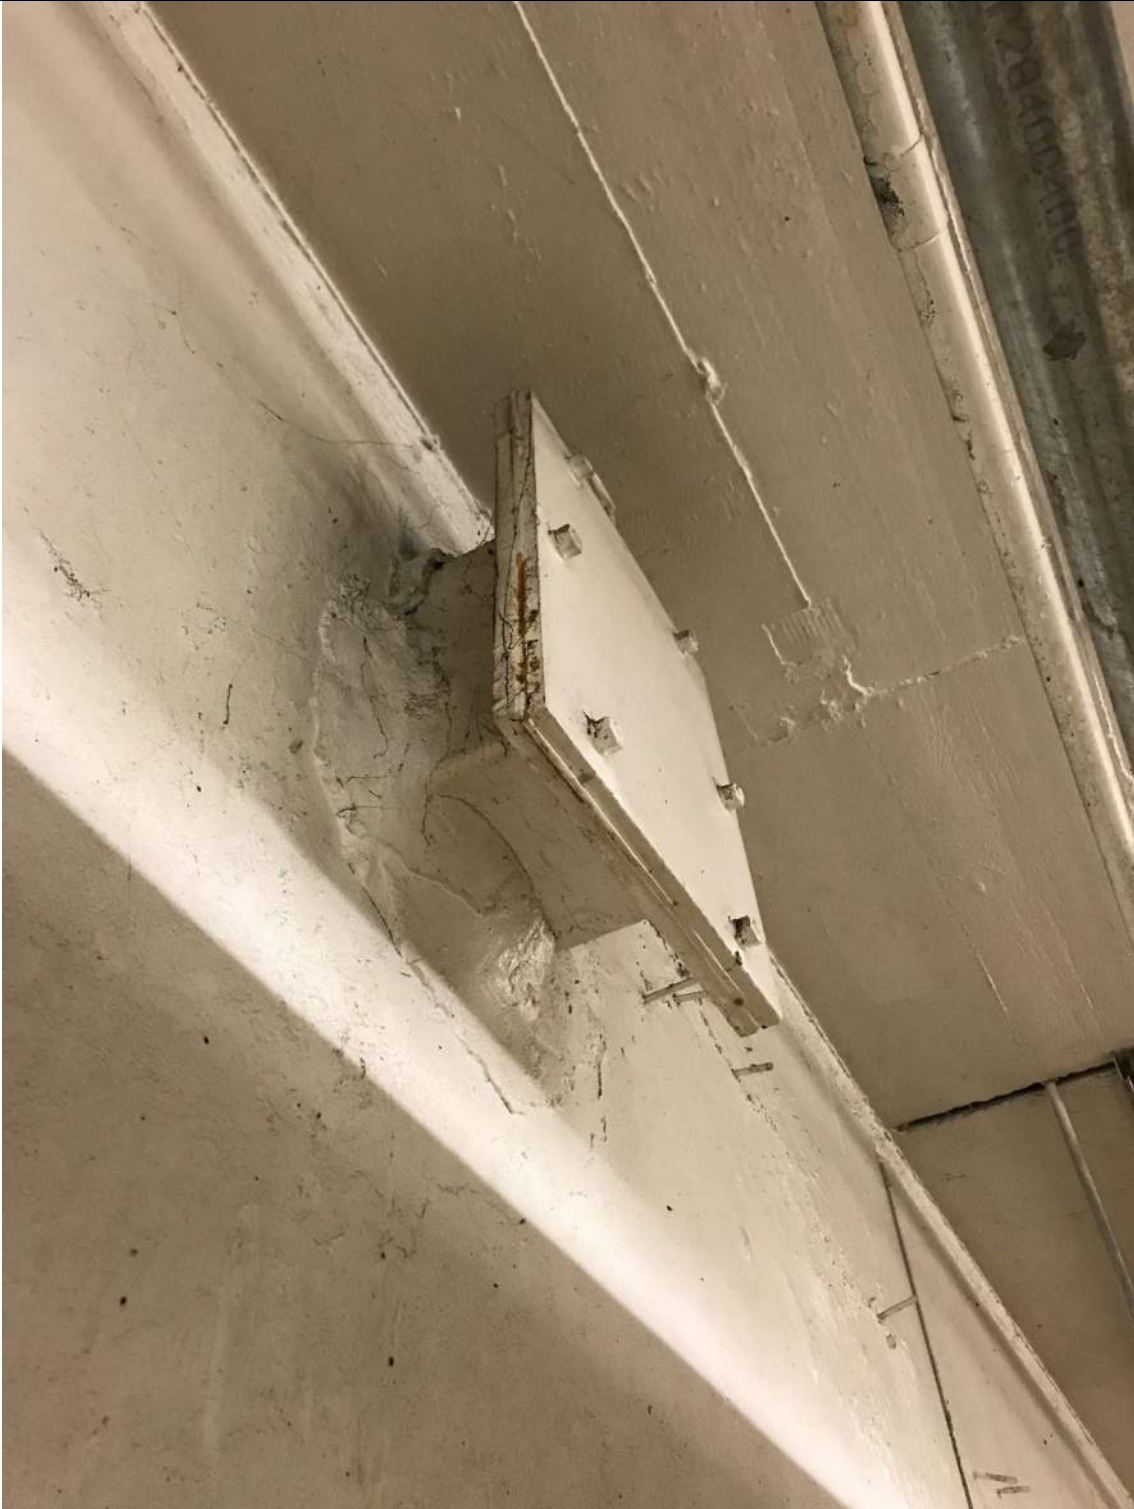
82. Left side view of blanked HSS in photo 81.

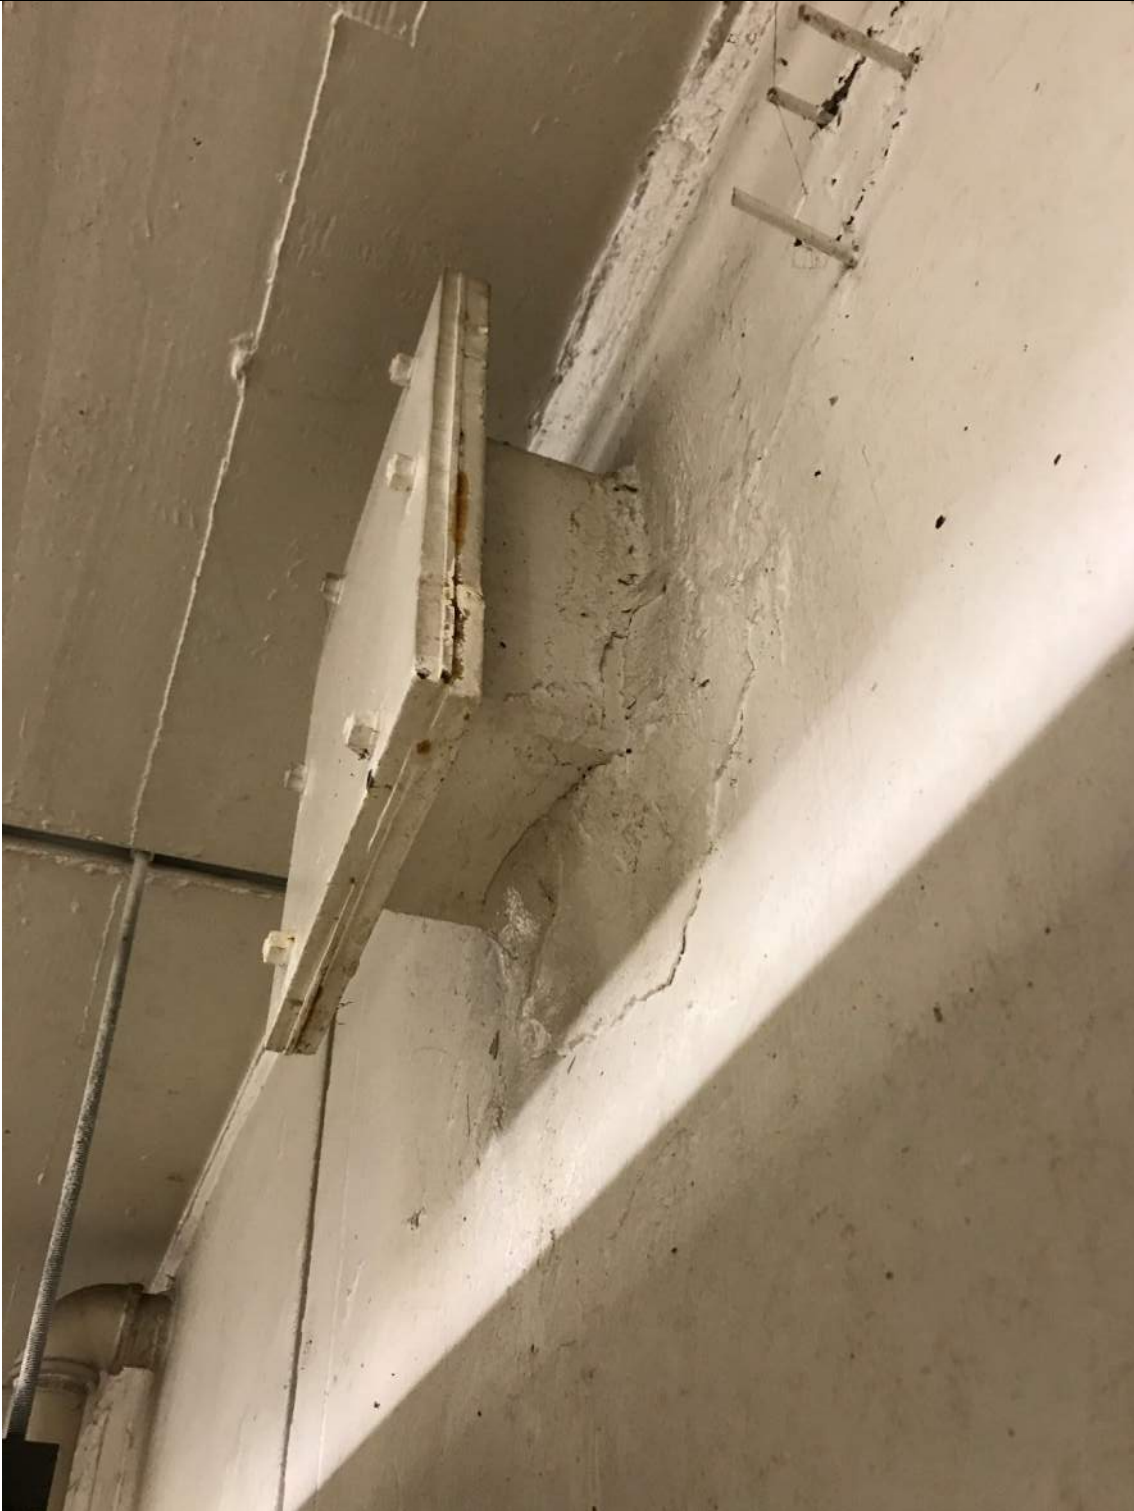
83. Right side view of blanked HSS in photo 81.
